**Test Report No. 405160-20**

## **MASH TL-3 TESTING AND EVALUATION OF THE W-BEAM GUARDRAIL ON SLOPE**

Test No.: 405160-20-1 and 405160-20-2

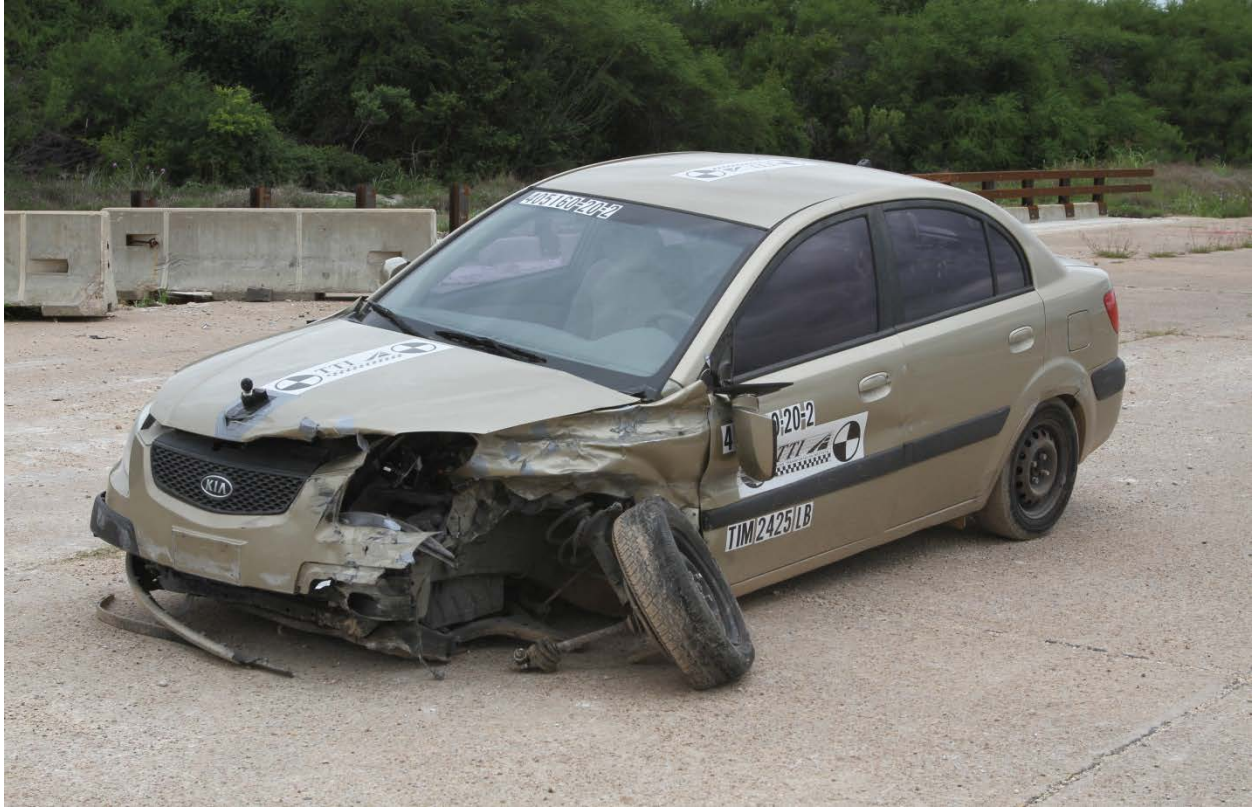
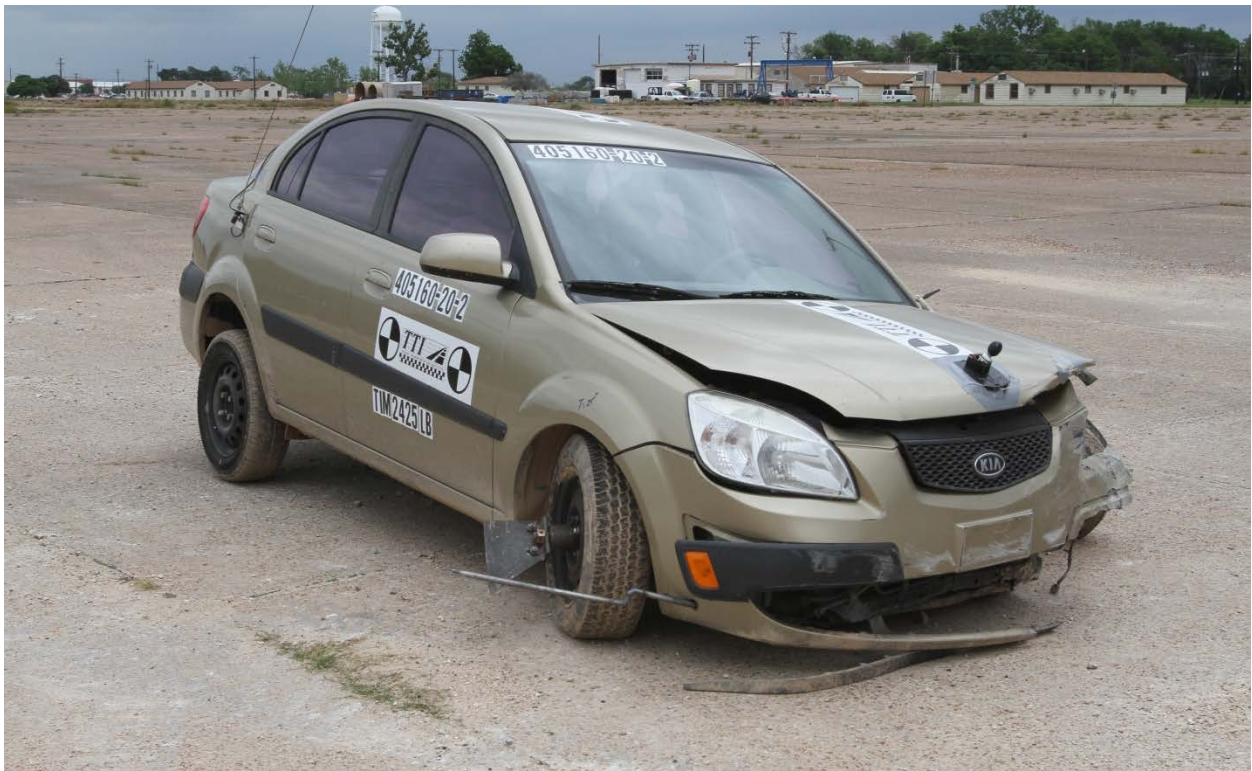
Figure 6.5. Vehicle after test 405160-20-2.

Figure 6.5 shows the damage sustained by the vehicle. The left front strut and strut tower, left inner CV joint, and left lower A-arm and ball joint were deformed. Also damaged were the front bumper, grill, hood, left front fender, left front tire and wheel rim, left front and left rear doors, and left rear quarter panel. The windshield sustained stress cracks radiating from the left lower corner. Maximum exterior crush to the vehicle was 10.5 inches in the front plane at the left front corner at bumper height. No occupant compartment deformation occurred. Photographs of the interior of the vehicle are shown in figure 6.6. Exterior vehicle crush and occupant compartment measurements are shown in appendix E, tables E2 and E3.
