PERFORMANCE EVALUATION OF THE MIDWEST GUARDRAIL SYSTEM – UPDATE TO NCHRP 350 TEST NO. 3-11 (2214MG-1)

MwRSF Research Report No. TRP-03-170-06

October 10, 2006

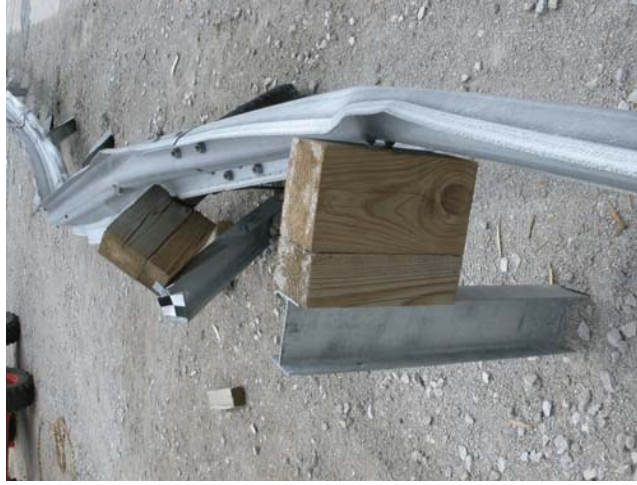
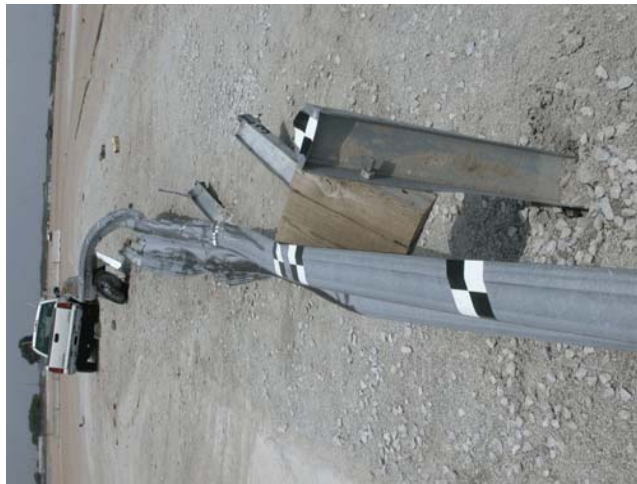
Figure 23. Midwest Guardrail System Barrier Damage, Test 2214MG-1

Damage to the barrier was moderate, as shown in Figures 23 through 28. Barrier damage consisted of deformed guardrail posts, disengaged wooden blockouts, contact marks on a guardrail section and posts, and deformed W-beam rail. The length of vehicle contact along the MGS system

The permanent set of the barrier system is shown in Figure 23. The maximum lateral permanent set rail and post deflections were 1,089 mm (42.875 in.) at the centerline of post no. 16 and 648 mm (25.5 in.) at post no. 13, as measured in the field. The maximum lateral dynamic rail and post deflections were 1,447 mm (57.0 in.) at the midspan between post nos. 14 and 15 and 764 mm (30.1 in.) at post no. 13, as determined from high-speed digital video analysis. The working width of the system was found to be 1,456 mm (57.3 in.).

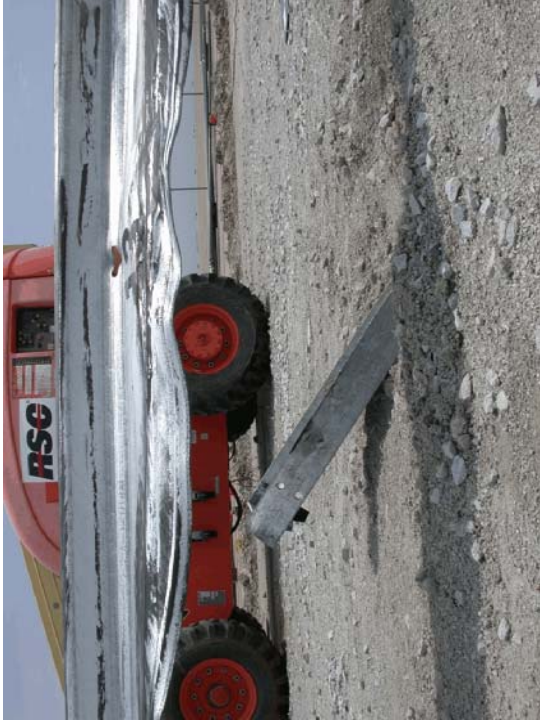
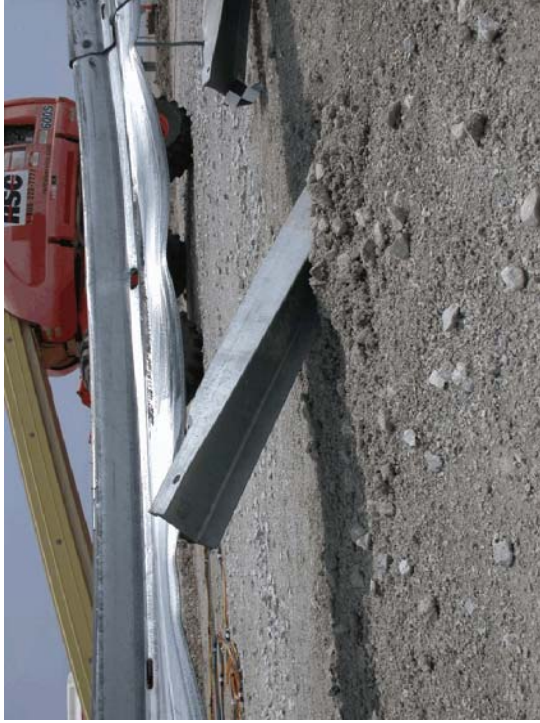
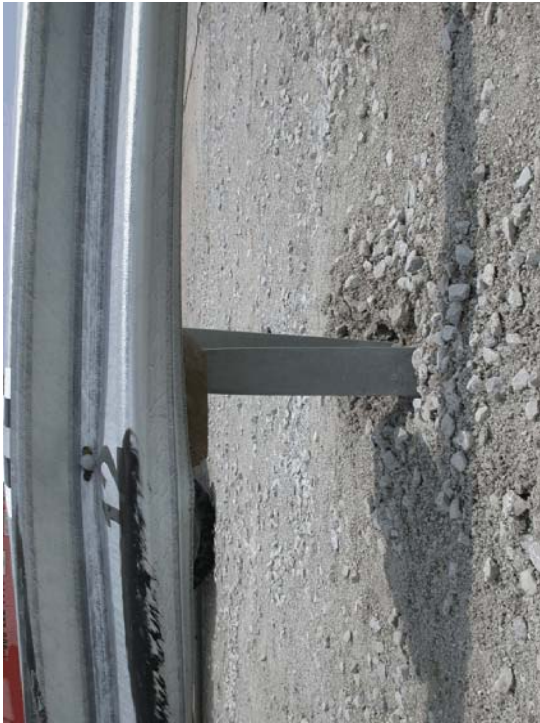
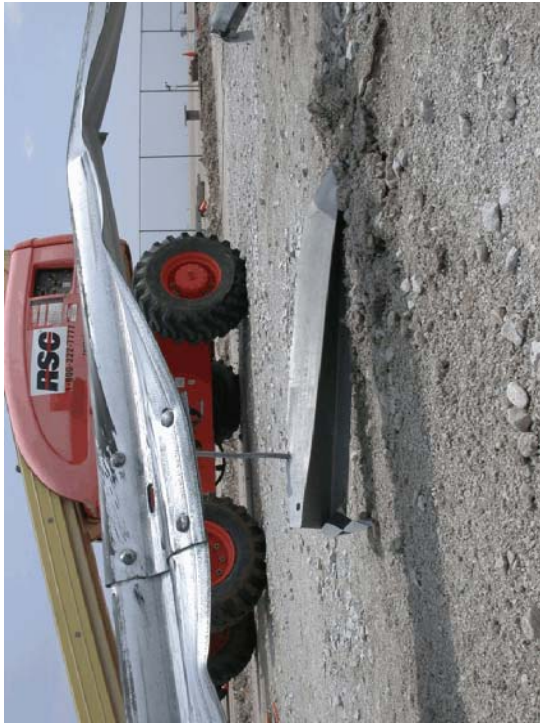
Figure 24. Midwest Guardrail System Post Nos. 12 through 15 Damage, Test 2214MG-1

slightly downstream. Post nos. 13 and 19 rotated backwards slightly, while post no. 19 also encountered minor buckling of the web. Post nos. 14 through 18 were bent longitudinally downstream toward the ground. Post no. 14 encountered significant buckling of the downstream front flange. Post no. 15 and 17 were severely buckled, while the bolt hole of post no. 17 was torn out. The right flange of post no. 16 and the web of post no. 18 buckled. Contact marks were found on the upstream edge of the back flange of post no. 16 and toward the top of the upstream edge of the back flange of post no. 17. Small gouges were found in the web of post no. 17 from the post bolt. The post bolts at post nos. 13 and 15 sheared off. The upstream and downstream anchorage systems moved longitudinally and the ground struts encountered plastic deformations on both ends. The upstream anchorage posts deflected downstream, while the downstream anchorage posts deflected upstream, but all four wood BCT posts remained undamaged.

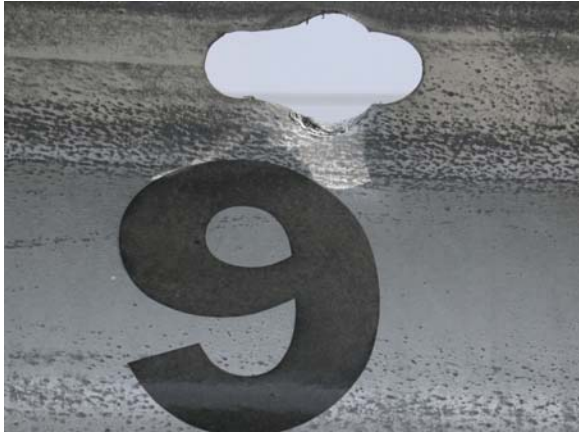
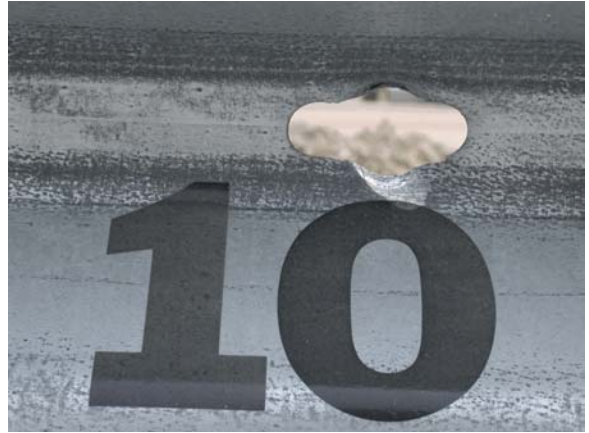
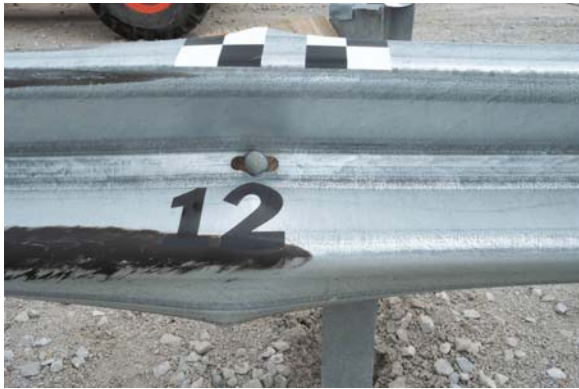
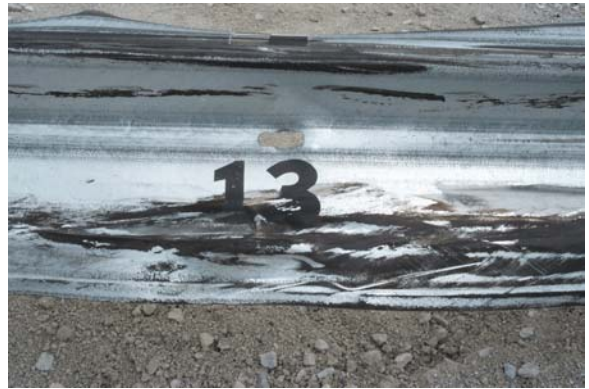
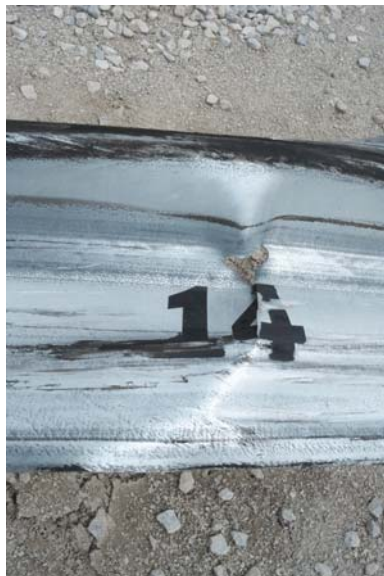
Figure 26. Post Nos. 9, 10, and 12 through 14 Guardrail Damage, Test 2214MG-1

Moderate deformation and flattening of the impacted section W-beam rail occurred between post nos. 13 and 18. Contact marks were found on the guardrail between post nos. 12 and 19. A small tear was found in the top corrugation 6 mm (0.25 in.) upstream of post no. 14. The guardrail buckled at 216 mm (8.5 in.) upstream of post no. 11, 64 mm (2.5 in.) downstream of the midspan between post nos. 11 and 12, and at post no. 12. The guardrail also buckled at the upstream side of splice between post nos. 12 and 13, at the post bolt hole of post no. 14, and 368 mm (14.5 in.) downstream from the midspan between post nos. 13 and 14. Other guardrail buckle points were found at 267 mm (10.5 in.) upstream of post no. 15 and 1,276 mm (50.25 in.) downstream of post no. 15. The guardrail encountered numerous buckle points at post no. 16. Major buckling of the guardrail occurred at 533 mm (21 in.) downstream of post no. 16. The guardrail also buckled at 51 mm (2 in.) upstream of post no. 18, 254 mm (10 in.) downstream of post no. 18, at post no. 19, and 279 mm (11 in.) downstream of post no. 19. The W-beam was pulled off post nos. 3 through 10 and 13 through 18. The W-beam rail sustained tearing and significant yielding around the post bolt slots at post nos. 14 through 19, while only minor yielding occurred around the post bolt slots at post nos. 11 through 13. No significant guardrail damage occurred downstream of post no. 20, except for slight rail deflection and minor contact marks between post nos. 22 and 25 due to secondary vehicle contact with the system before coming to rest.

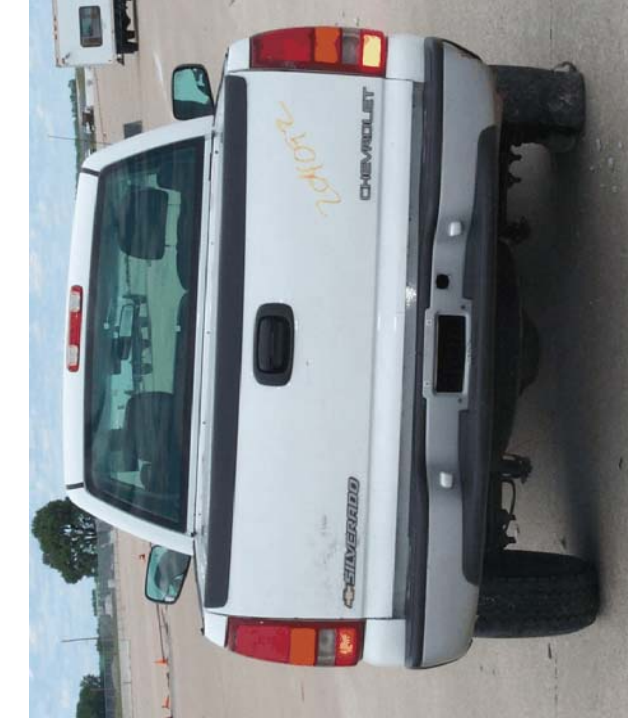
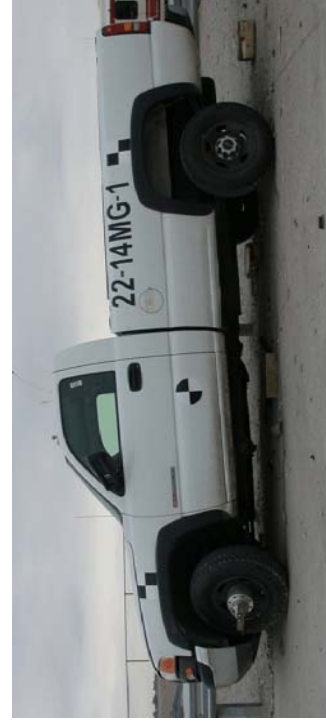
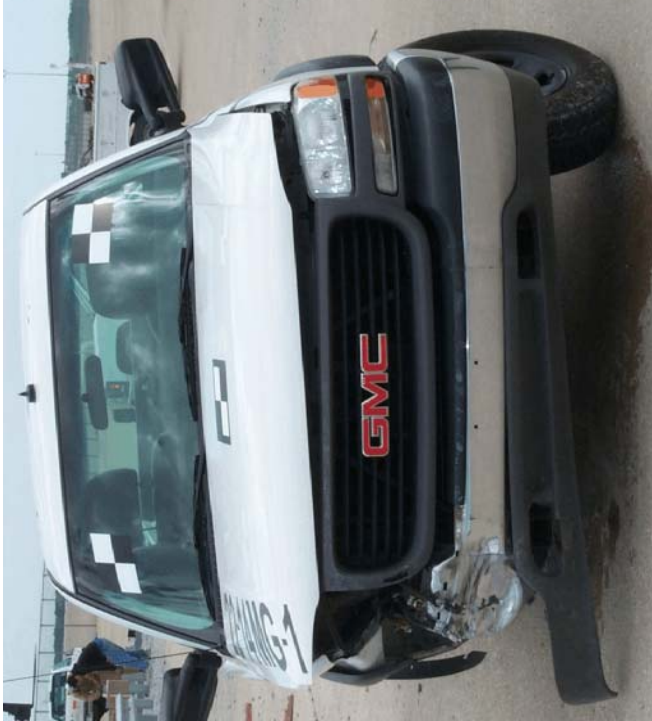
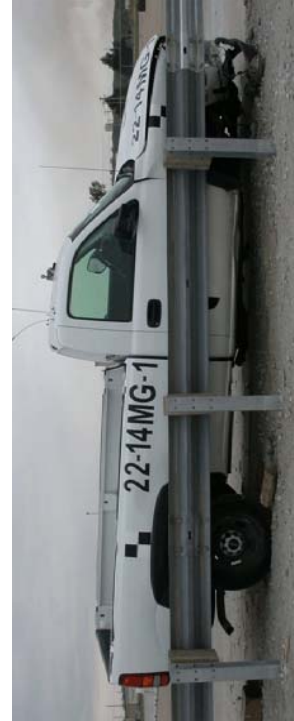
Figure 29. Vehicle Damage, Test 2214MG-1

Exterior vehicle damage was moderate, as shown in Figures 29 through 32. Occupant compartment deformations to the right side and center of the floorboard, as shown in Figure 32, were judged insufficient to cause serious injury to the vehicle occupants. Maximum longitudinal deflections of 13 mm (0.5 in.) were located near the center of the right-side floor pan. Maximum lateral deflections of 25 mm (1.0 in.) were located near the center of the right-side floor pan. Maximum vertical deflections of 13 mm (0.5 in.) were located near the firewall at the right-front corner and center of the right side. Complete occupant compartment deformations and the corresponding locations are provided in Appendix C.

Damage was concentrated on the right-front corner of the vehicle. The right-front quarter panel was deformed inward and downward toward the engine compartment. The right side of the front bumper was flattened and bent back toward the engine compartment and contacted the lower frame rail. The box was bent upward and inward behind the right-rear wheel. The right side of the hood was bent slightly. The right-front wheel assembly deformed and crushed inward toward the engine compartment. The right-side ball joints and steering linkage were fractured. The upper control arm was bent. The right-front tire disengaged from the rest of the wheel assembly. The right-rear tire deflated. The right-side headlight and park light fractured and disengaged from the vehicle. All window glass remained undamaged. The left side and rear of the vehicle remained undamaged.
