**PERFORMANCE EVALUATION OF THE  
FREE-STANDING TEMPORARY BARRIER –  
UPDATE TO NCHRP 350 TEST NO. 3-11 WITH 28"  
C.G. HEIGHT (2214TB-2)**

**MIDWEST ROADSIDE SAFETY FACILITY**

MwRSF Research Report No. TRP-03-174-06

October 12, 2006

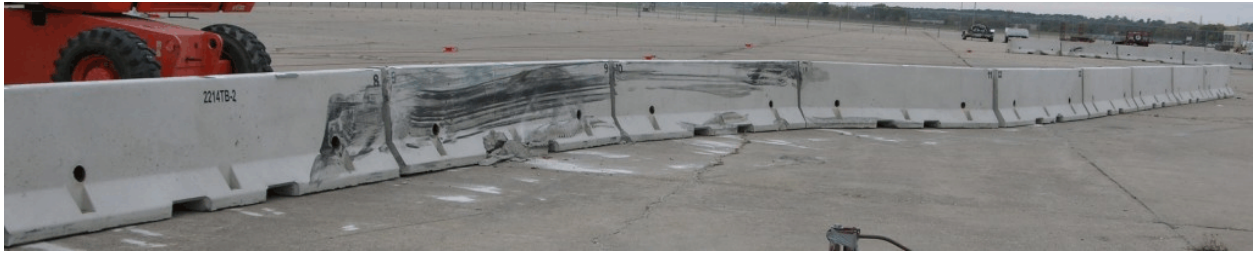
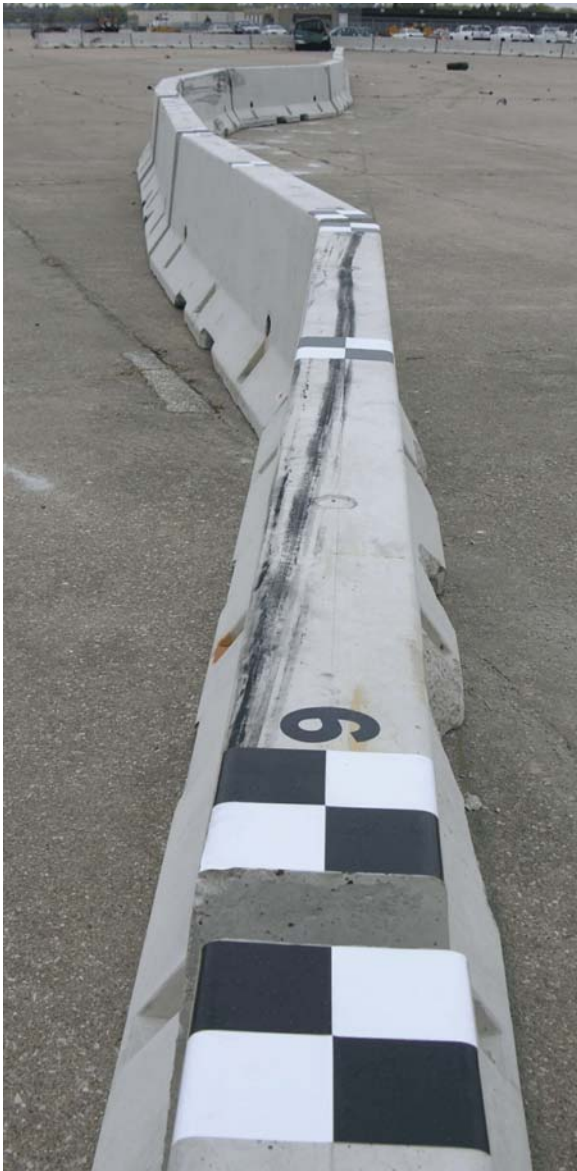
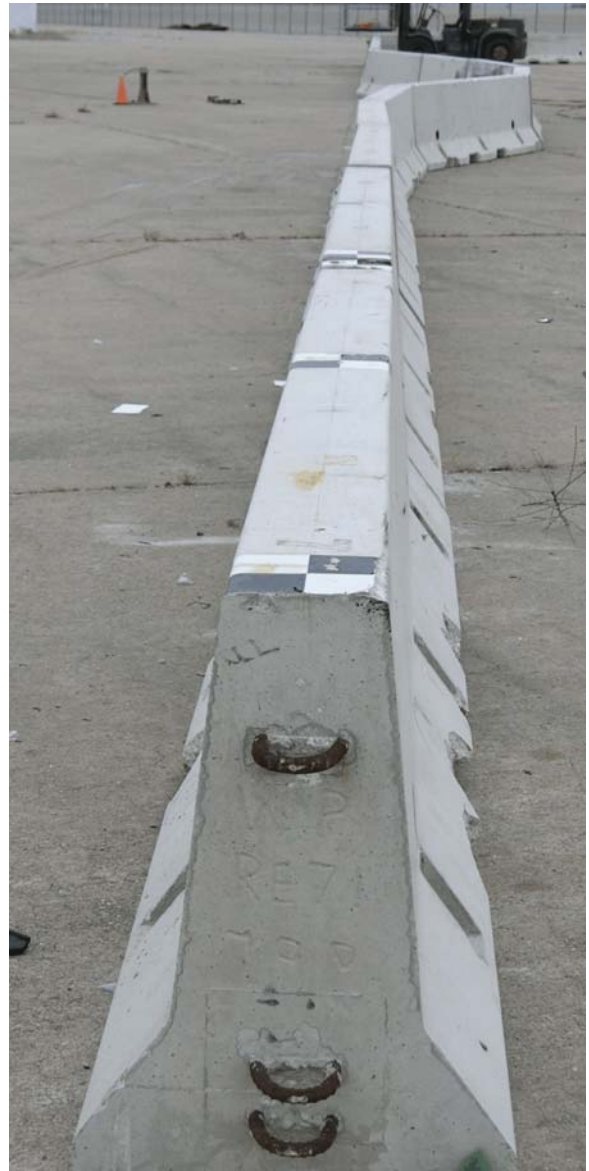
Figure 22. Temporary Barrier Damage, Test 2214TB-2

### **5.3 Barrier Damage**

The permanent set of the barrier system is shown in Figure 22. Barrier nos. 6 through 12 encountered longitudinal and lateral movement while barrier nos. 5 and 13 through 16 only moved longitudinally. The maximum lateral permanent set barrier deflection was 1,854 mm (73 in.) at the downstream end of barrier no. 9 and upstream end of barrier no. 10, as measured in the field. The maximum lateral dynamic barrier deflection was 2,023 mm (79.65 in.) at the downstream end of barrier no. 9, as determined from high-speed digital video analysis. The working width of the system was found to be 2,595 mm (102.2 in.).

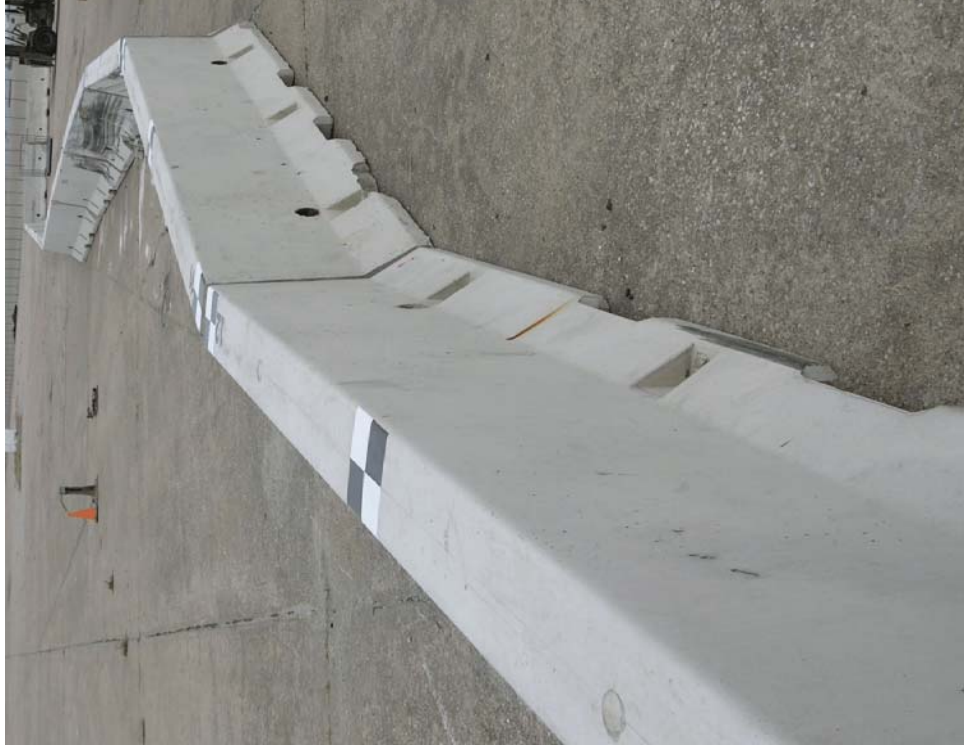
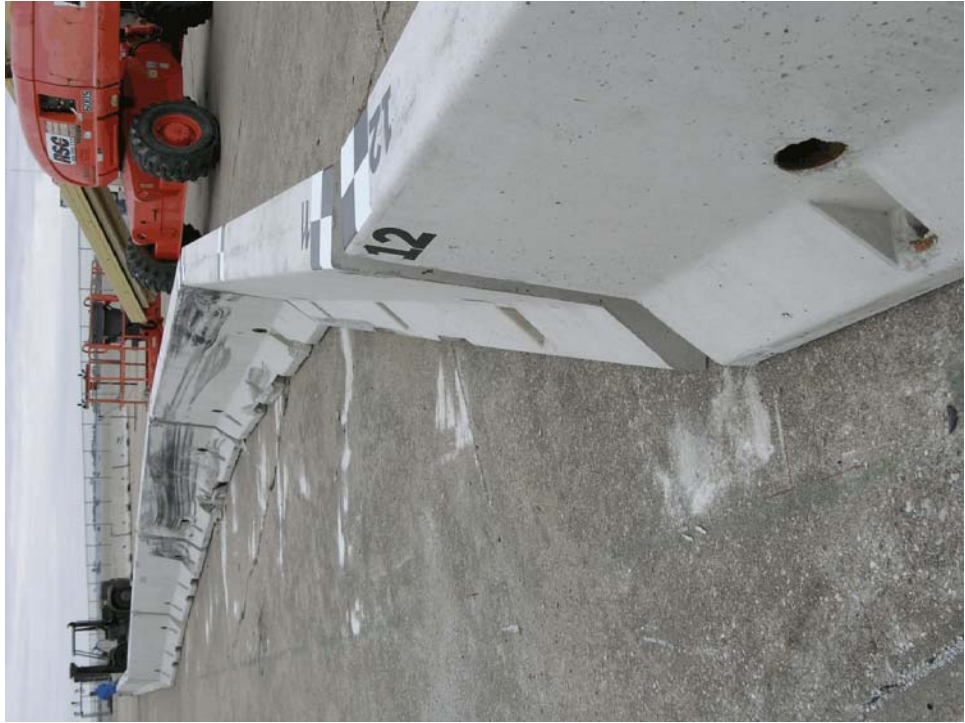
Figure 23. Temporary Barrier Damage, Test 2214TB-2

began at about the middle of barrier no. 9. A 171-mm (6.75-in.) wide scratch, beginning 749 mm (29.5 in.) upstream from the downstream end, was found on barrier no. 8. Minor random scratches were found on barrier no. 9.

Cracking was found on the front face of barrier no. 8 beginning at the upper corners of the lifting slots and propagated up to the top of the barrier. Major cracking was found throughout barrier no. 9.

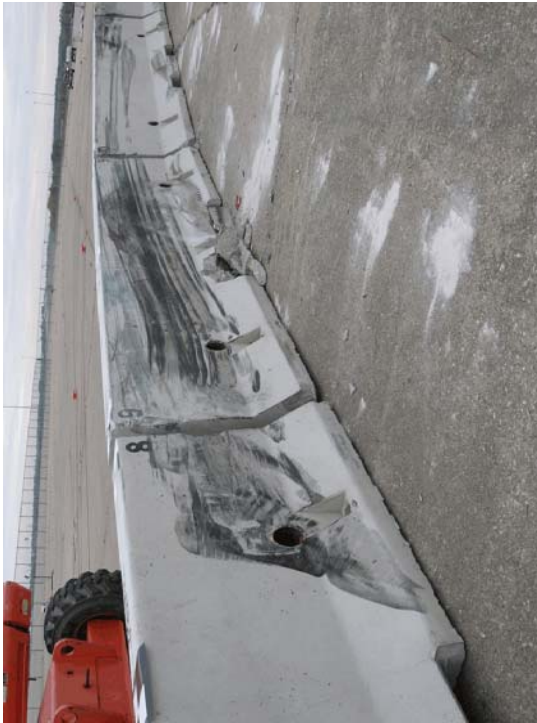
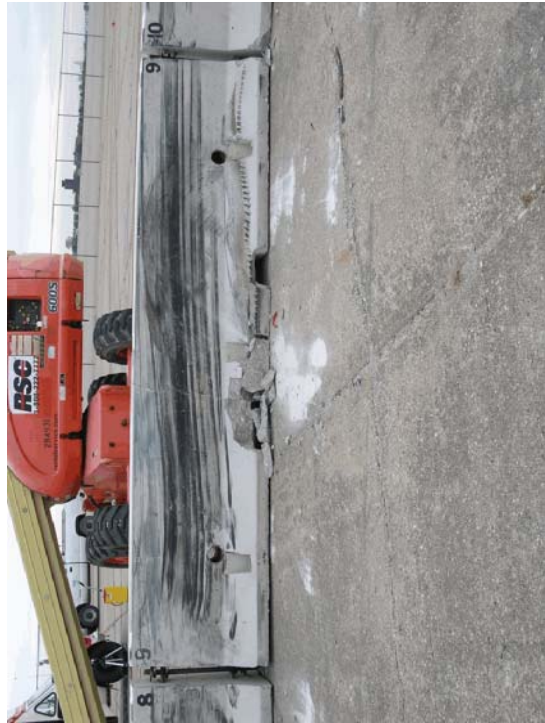
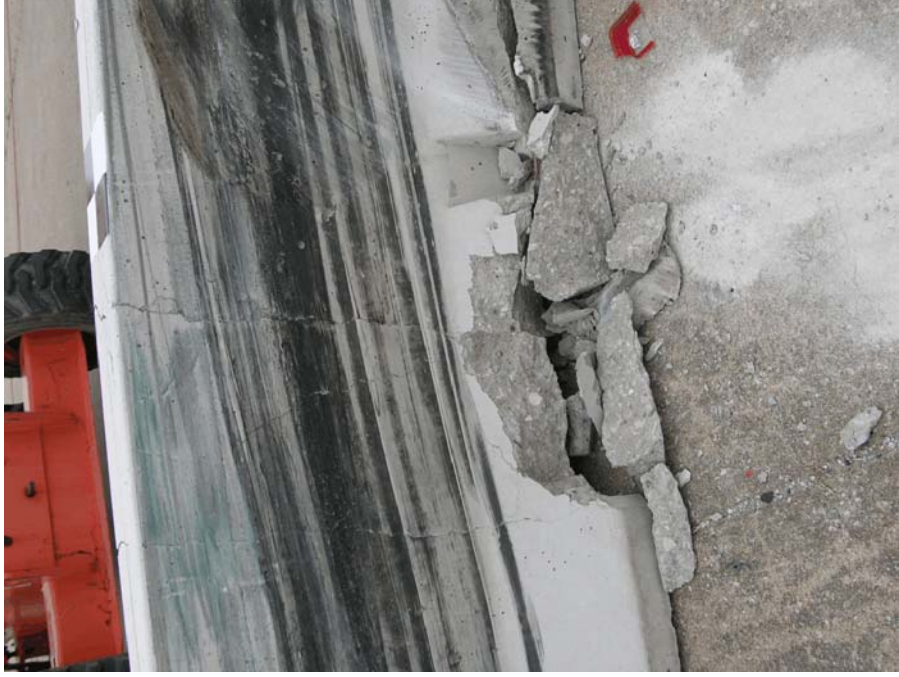
Figure 24. Temporary Barrier Damage, Test 2214TB-2

The downstream end of barrier no. 8 encountered concrete spalling located 241 mm (9.5 in.) from the top of the barrier and was 191 mm (7.5 in.) long. Concrete spalling, 127 mm (5 in.) in length, was found 102 mm (4 in.) from the top of the barrier on the upstream end of barrier no. 9. Concrete spalling occurred on the lower-front face of barrier no. 9 from 1,270 mm (50 in.) to 2,216 mm (87.25 in.) downstream from the barrier's upstream end. Minor concrete spalling was also found on the lower-front corner of the upstream and downstream ends of barrier no. 9 and the upstream end of barrier no. 10.

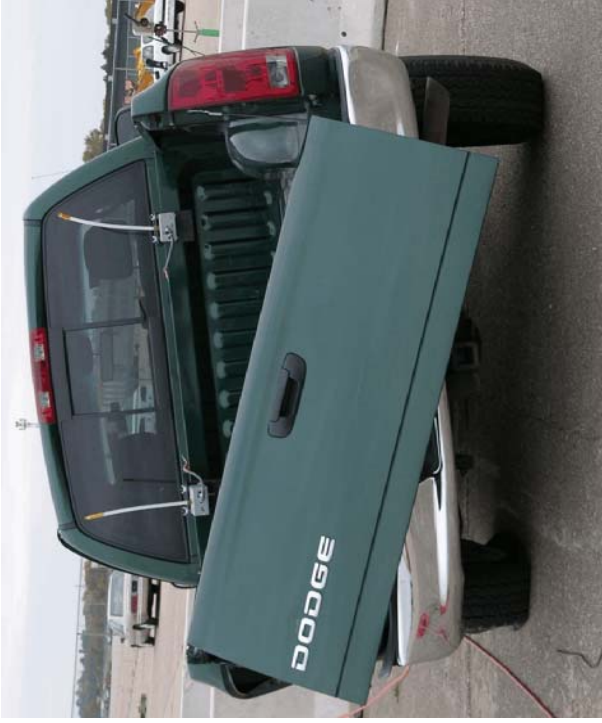
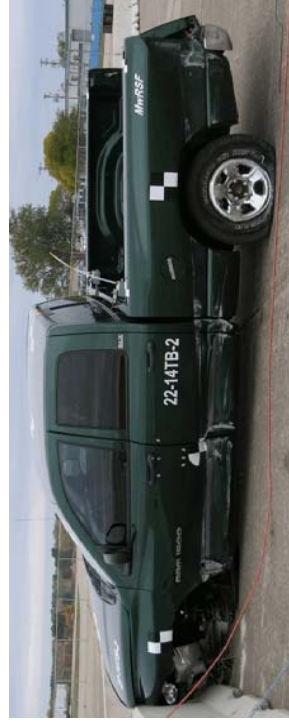
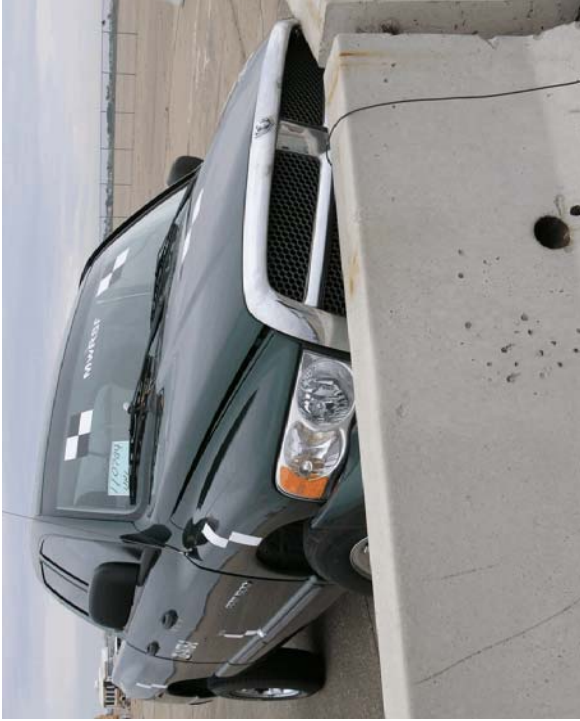
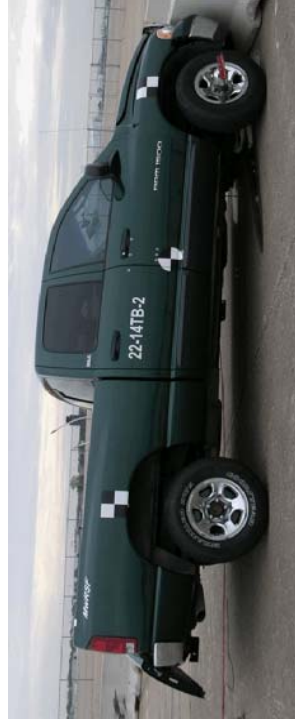
Figure 26. Vehicle Damage, Test 2214TB-2

Exterior vehicle damage was moderate, as shown in Figures 26 through 28. Occupant

Damage was concentrated on the left-front corner of the vehicle. The hood, front bumper, grill, and the left-side and right-side front-quarter panels shifted toward the right. The left-front quarter panel was deformed inward and downward toward the engine compartment. The left side of the front bumper was flattened and bent back toward the engine compartment. A buckle point was located near the center of the front bumper. The left side of the grill fractured and was deformed inward toward the engine compartment. The radiator and air conditioning units were deformed into the engine. Minor paint scratches were observed on the front of the hood and on the tailgate. The top of the left door was ajar. The vehicle encountered numerous sheet metal scratches and tears along its left side. The left-front side of the frame and engine mount were bent inward toward the center of the vehicle. The left-front upper A-arm was bent. The left-side lower ball joint was fractured and removed from the lower A-arm. The left-side tie rod disengaged from the rest of the wheel assembly. The left-side bump stop bracket was deformed upward and the brake line was severed. The left-front and left-rear steel rims were deformed and dented. The left-front tire's lug nuts were scratched. The left-rear tire's hub cap was bent and deformed. The left-front and left-rear tires' side walls were torn, and the tires deflated. The rear bumper was dented on the left side. The

right-side tailgate connection fractured, but the tailgate remained attached to the vehicle. The left-front wheel assembly disengaged from the vehicle. The left-side headlight and park light were fractured. The left-side tail light was detached from the vehicle. All window glass remained undamaged.

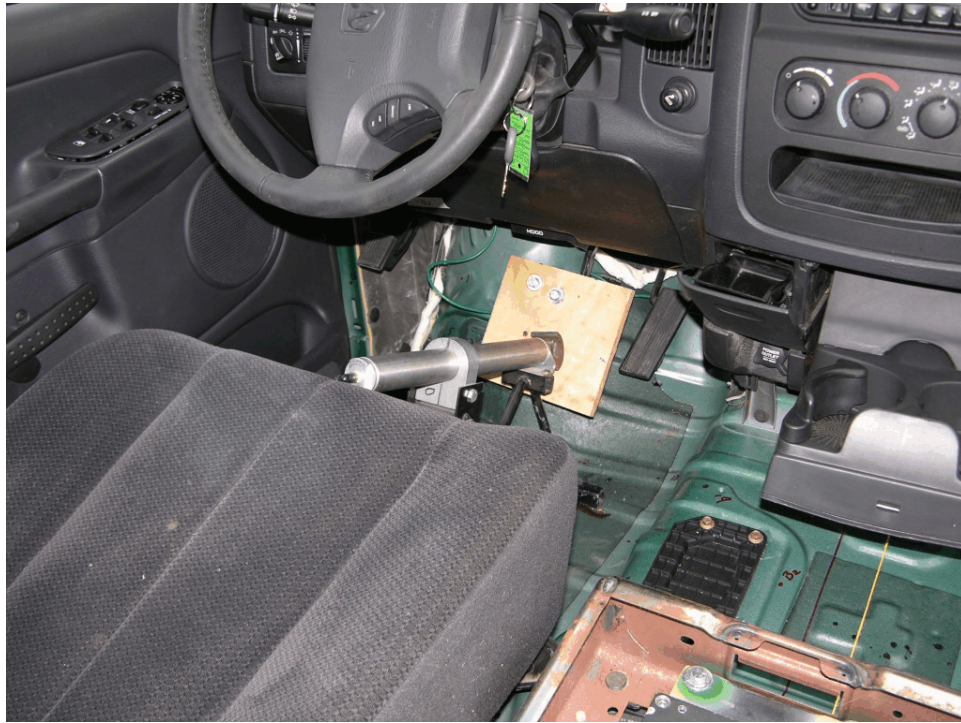
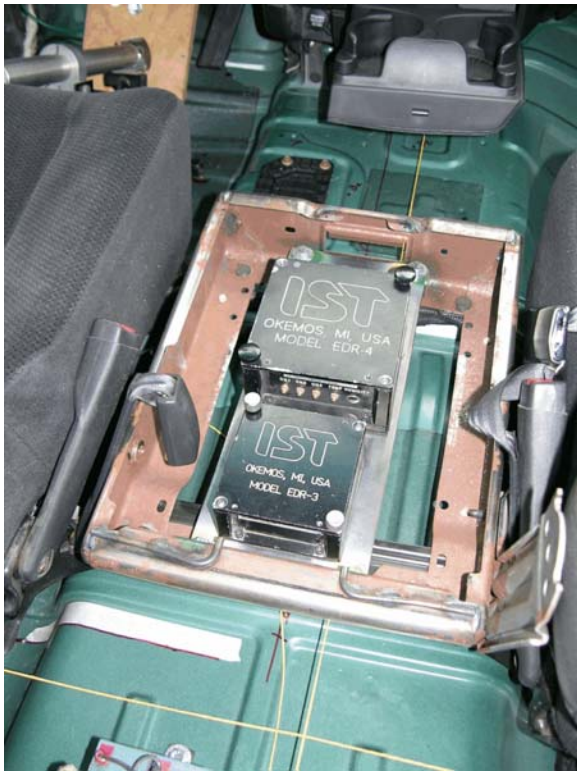
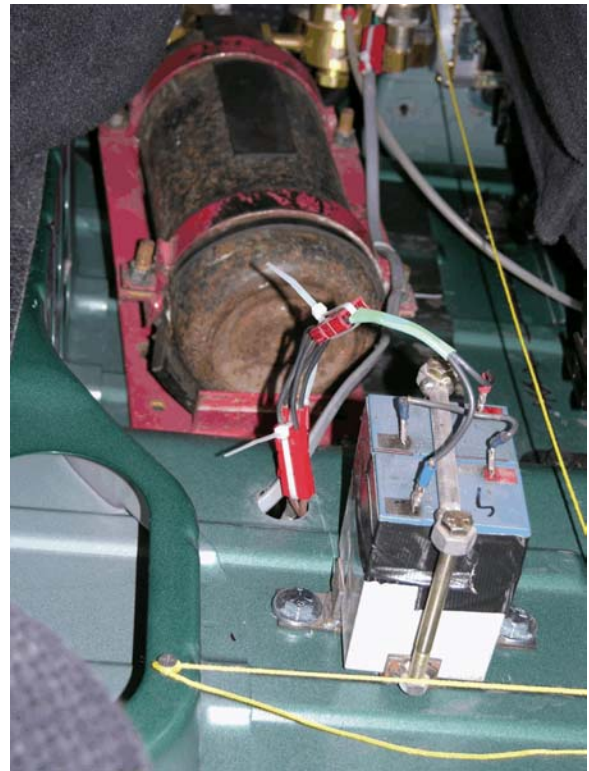
Figure 29. Occupant Compartment Deformation, Test 2214TB-2

compartment deformations to the left side and center of the floorboard, as shown in Figure 29, were judged insufficient to cause serious injury to the vehicle occupants. Maximum longitudinal deflections of 108 mm (4.25 in.) were located near the left-front corner of the left-side floor pan. Maximum lateral deflections of 32 mm (1.25 in.) were located near the left-front corner of the left-side floor pan. Maximum vertical deflections of 102 mm (4 in.) were located near the left-front corner of the left-side floor pan. Complete occupant compartment deformations and the corresponding locations are provided in Appendix C.
