Test Report No. 405160-20
Test Report Date: March 2013

MASH TL-3 TESTING AND EVALUATION OF THE W-BEAM GUARDRAIL ON SLOPE

Contract No.: T4541-AT
Test No.: 405160-20-1 and 405160-20-2
Test Dates: 2012-01-18 and 2012-04-20

TEXAS A&M TRANSPORTATION INSTITUTE PROVING GROUND

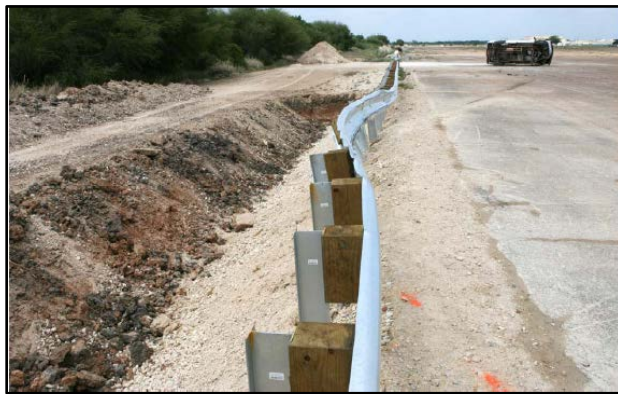
The crash test performed was *NCHRP Report 350* test designation 3-11, which involved a 2000 kg (4409 lb) pickup truck impacting the CIP of the length of need section at a nominal speed of 100 km/h (62 mi/h) and a nominal angle of 25 degrees. The vehicle was redirected by the guardrail system; however, it rolled on its side upon exiting the guardrail system. Figure 1.4 shows sequential photos of the impact event. Figure 1.5 and figure 1.6 show damage to the guardrail and the vehicle respectively.

Figure 1.5. Guardrail damage.

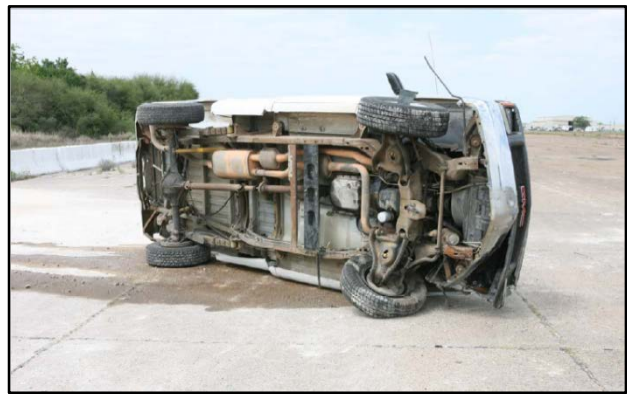
Figure 1.6. Vehicle damage.

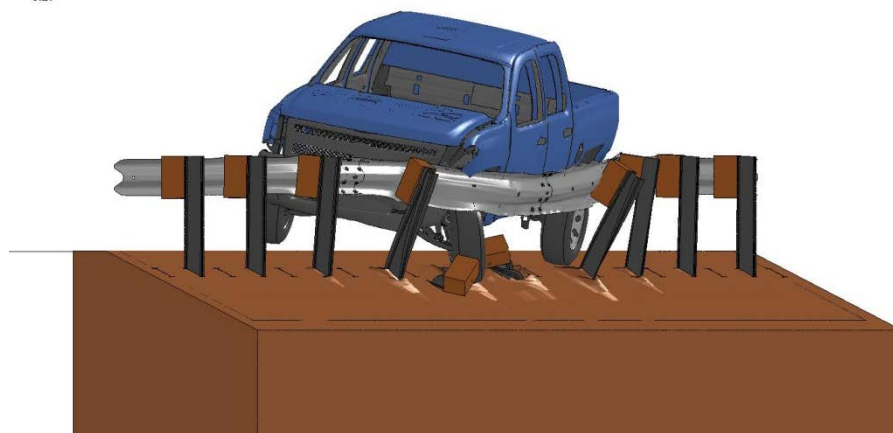
At 0.27 seconds, the front left suspension of the Silverado model started to fail as a result of post contact, and allowed the front left wheel of the truck began to deflect outward, as shown in figure 1.28 and figure 1.29.

Figure 1.28. Case 2 suspension failure of Silverado model.

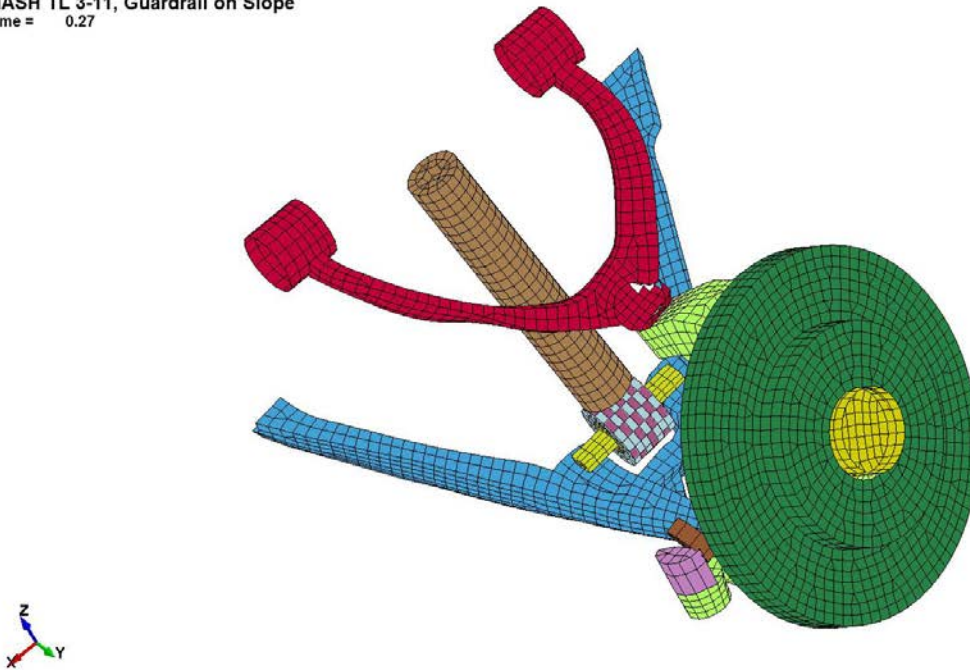
Figure 1.29. Front left suspension of Silverado model at failure.

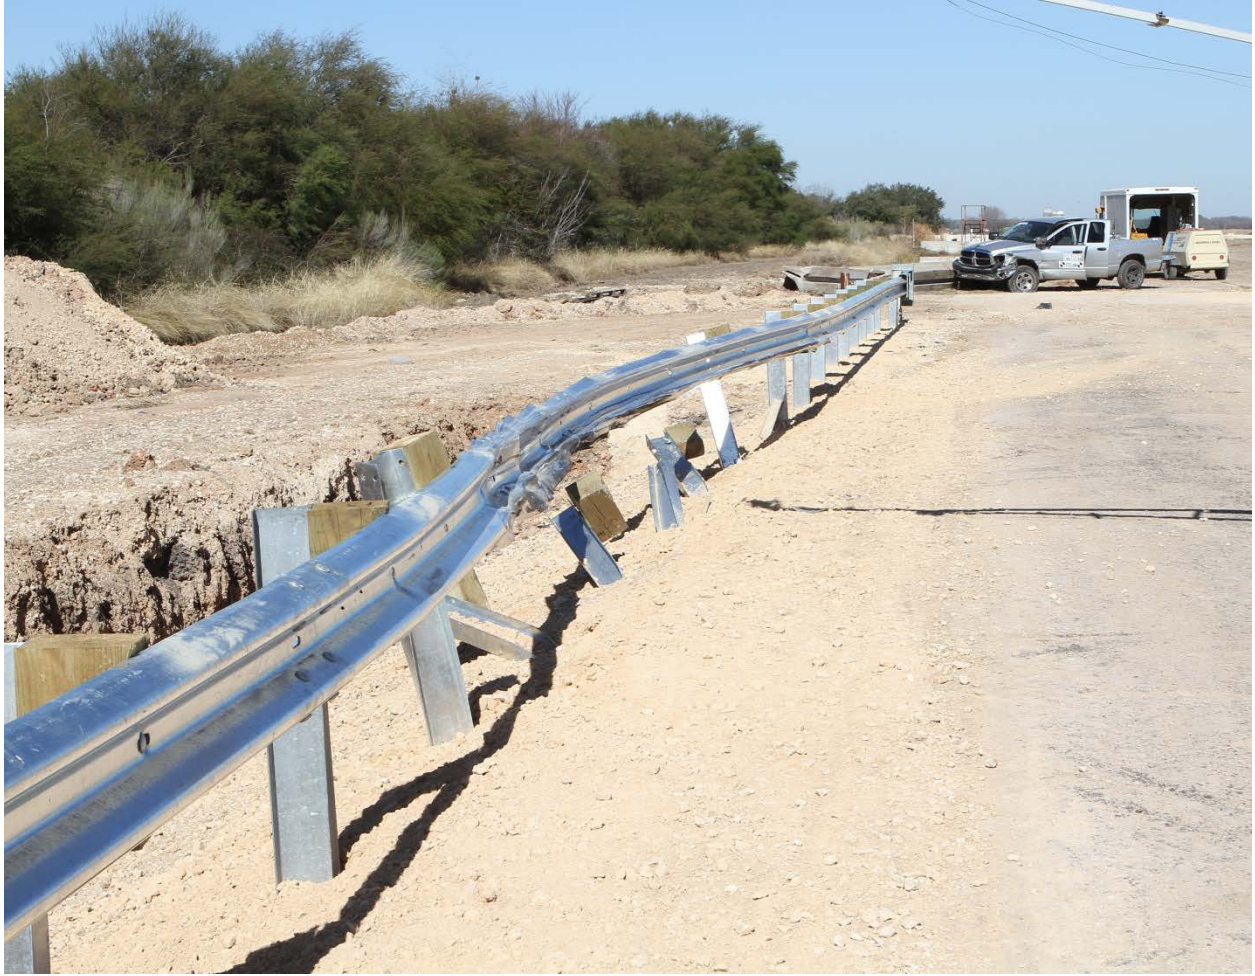
Figure 5.3. Vehicle/installation positions after test 405160-20-1.

Damage to the guardrail on slope is shown in figures 5.3 and 5.4. Post 1 was pulled downstream 1.75 inches at ground level and post 2 through 9 rotated 5 degrees counterclockwise. Post 13 was deflected toward the field side 1 inch at ground level and rotated 5 degrees counterclockwise. Post 14 was rotated 75 degrees counterclockwise. Post 15 was rotated toward the field side 90 degrees and downstream 45 degrees. Posts 16 through 18 rotated 80 degrees, and the blockout separated from post 17. Post 19 was deflected toward the field side 15 degrees and downstream 5 degrees, and post 20 was deflected toward the field side 5 degrees. The W-beam rail element separated from posts 10 and 11, and posts 14 through 19. Post 30 was pulled upstream 0.25 inch at ground level. Length of contact of the vehicle with the guardrail was 41.4 ft. Working width was 4.6 ft. Maximum dynamic deflection of the rail element during the test was 4.3 ft, and maximum permanent deformation of the rail element after the test was 3.1 ft.

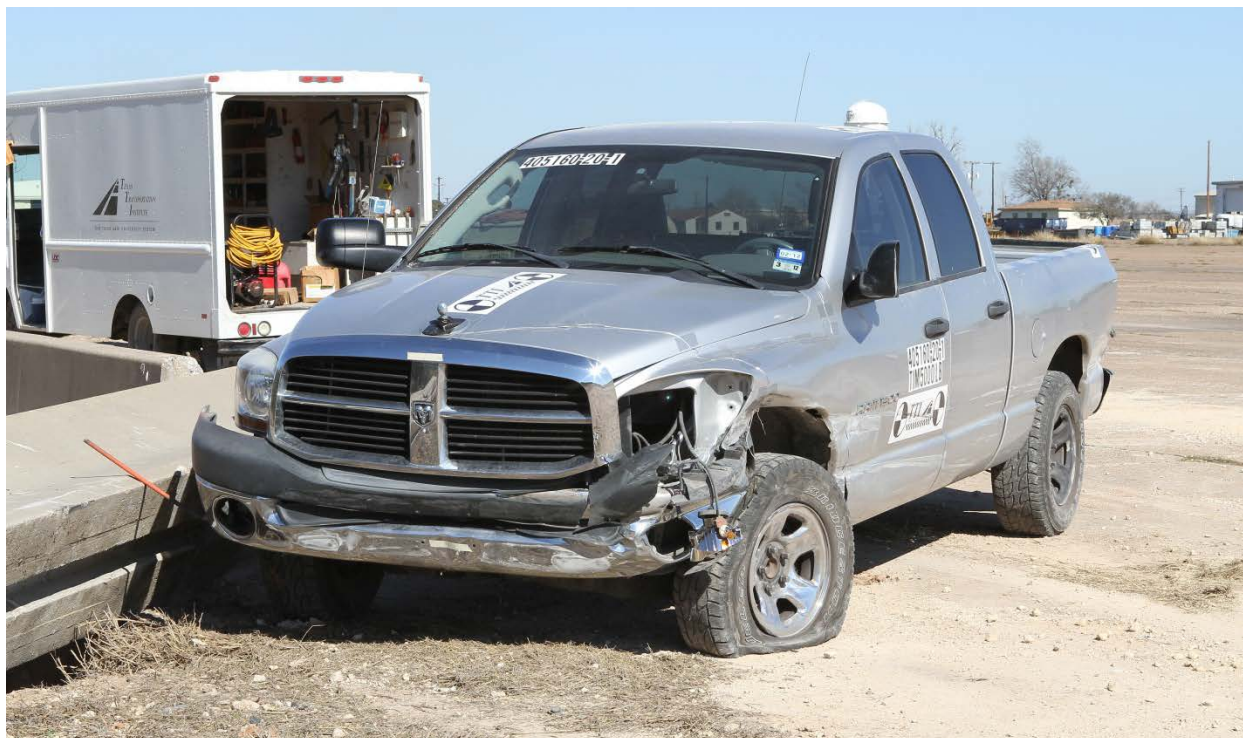
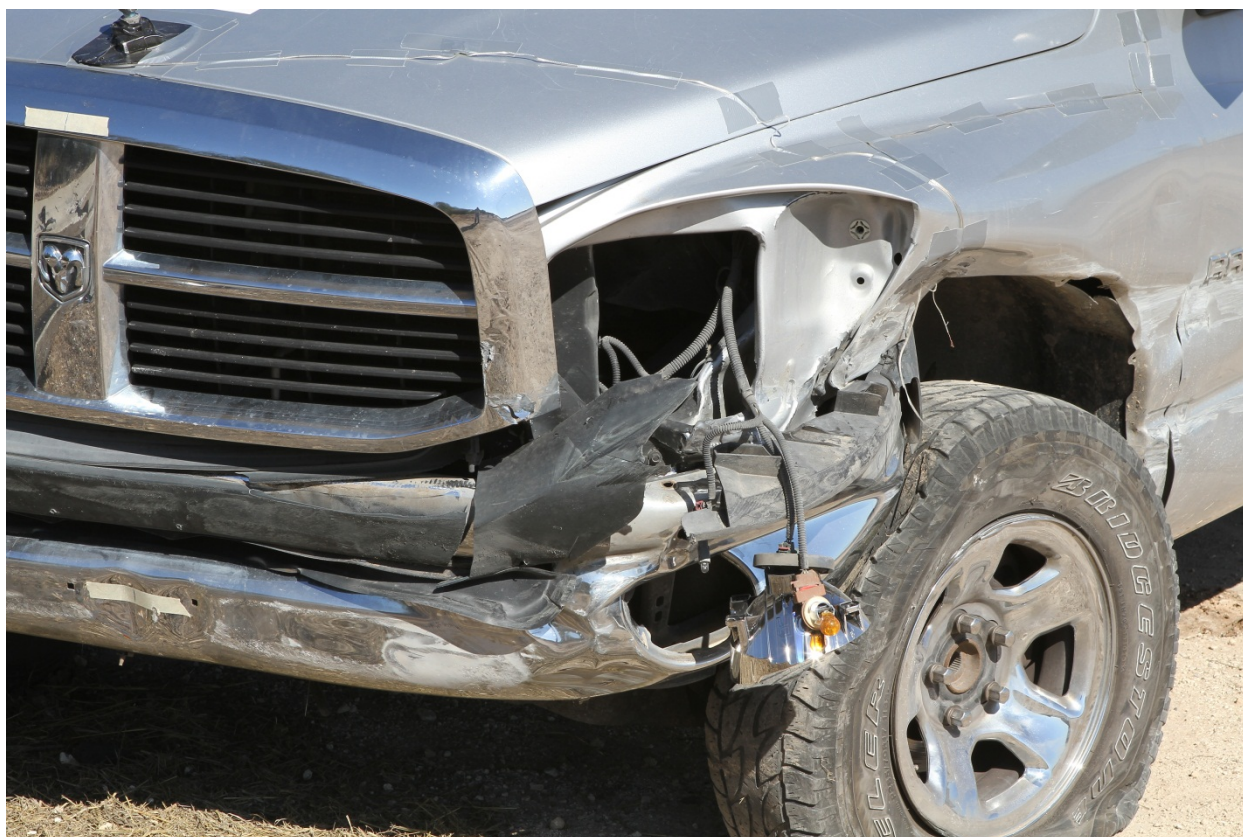
Figure 5.5. Vehicle after test 405160-20-1.

Figure 5.5 shows the damage sustained by the vehicle. The left tie rod end, left lower A-arm, and left frame rail were deformed. Also damaged were the front bumper, grill, hood, left front fender, left front tire and wheel rim, left front and left rear doors, left rear exterior bed, and the rear bumper. Maximum exterior crush to the vehicle was 11.0 inches in the front plane at the left front corner at bumper height. No occupant compartment deformation occurred. Photographs of the interior of the vehicle are shown in figure 5.6. Exterior vehicle crush and occupant compartment measurements are shown in appendix D, tables D3 and D4.

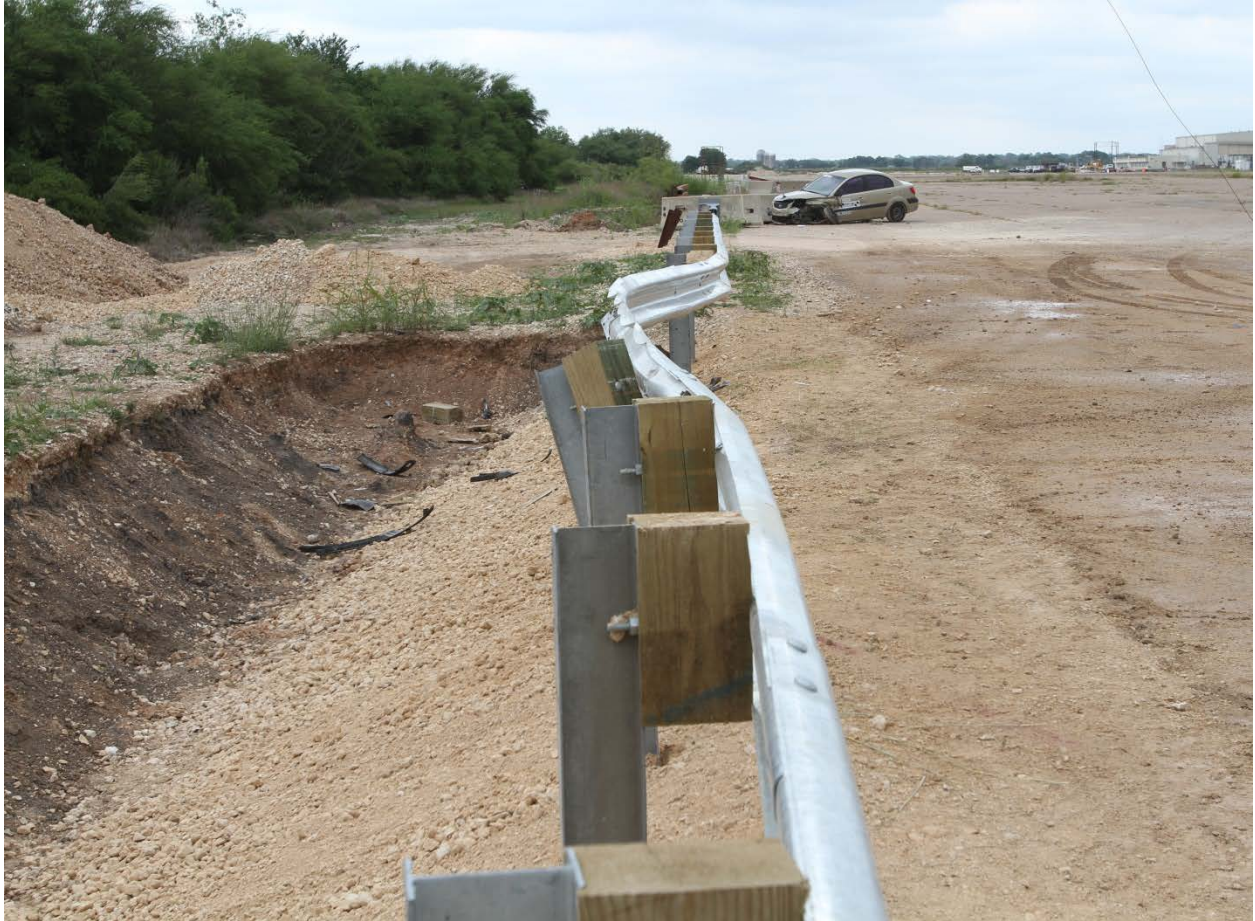
Figure 6.3. Vehicle/installation positions after test 405160-20-2.

Damage to the guardrail on slope is shown in figures 6.3 and 6.4. The soil around post 1 was disturbed. Post 14 was pushed toward the field side 1.0 inch at ground level. The metal rail element was separated from post 15 through 19. Post 15 was pushed toward the field side 5.0 inches at ground level and was leaning downstream 20 degrees. Post 16 through 18 were pushed toward the field side 5.0 inches and were leaning downstream 65 degrees. Post 19 was leaning toward the field side and downstream 45 degrees and rotated 60 degrees counterclockwise in the soil. Post 20 was leaning toward the field side 0.5 inch at ground level. Length of contact of the vehicle with the guardrail was 25.3 ft. Working width was 3.1 ft. Maximum dynamic deflection of the rail element during the test was 2.7 ft, and maximum permanent deformation of the rail element after the test was 1.9 ft.

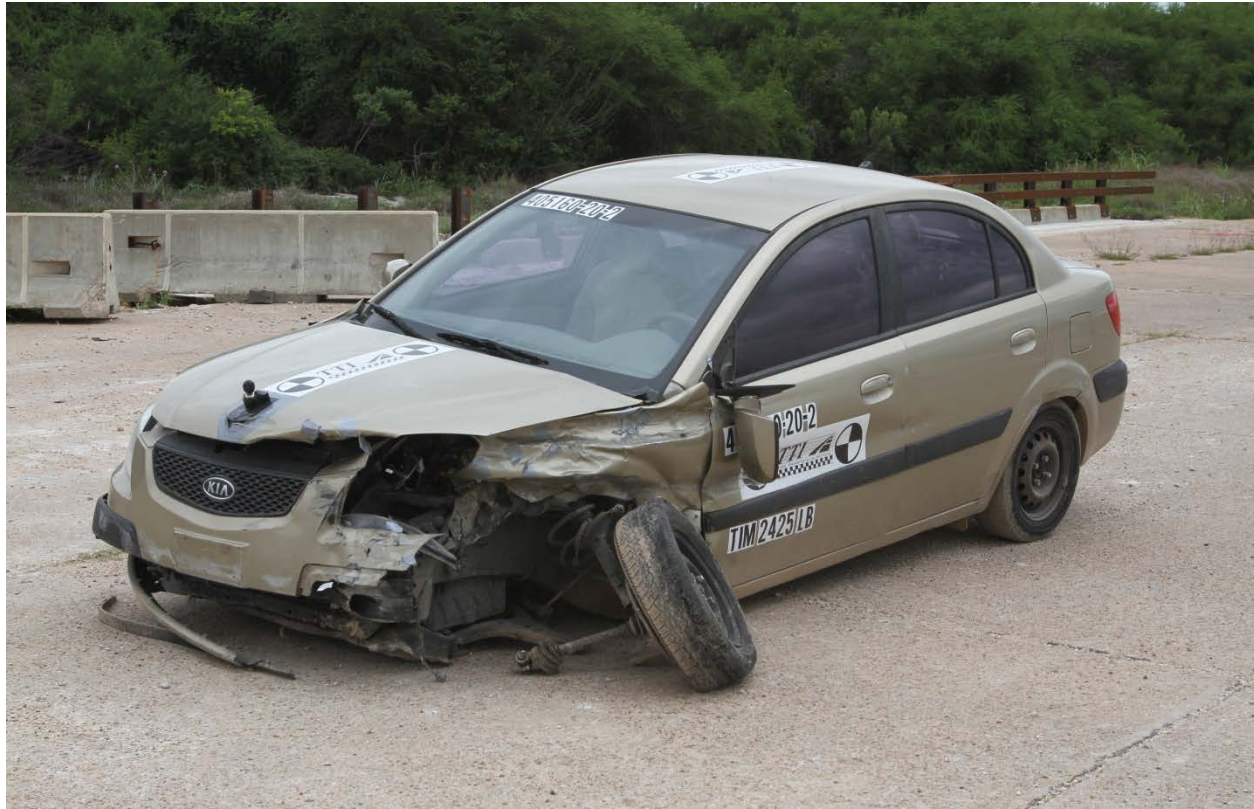
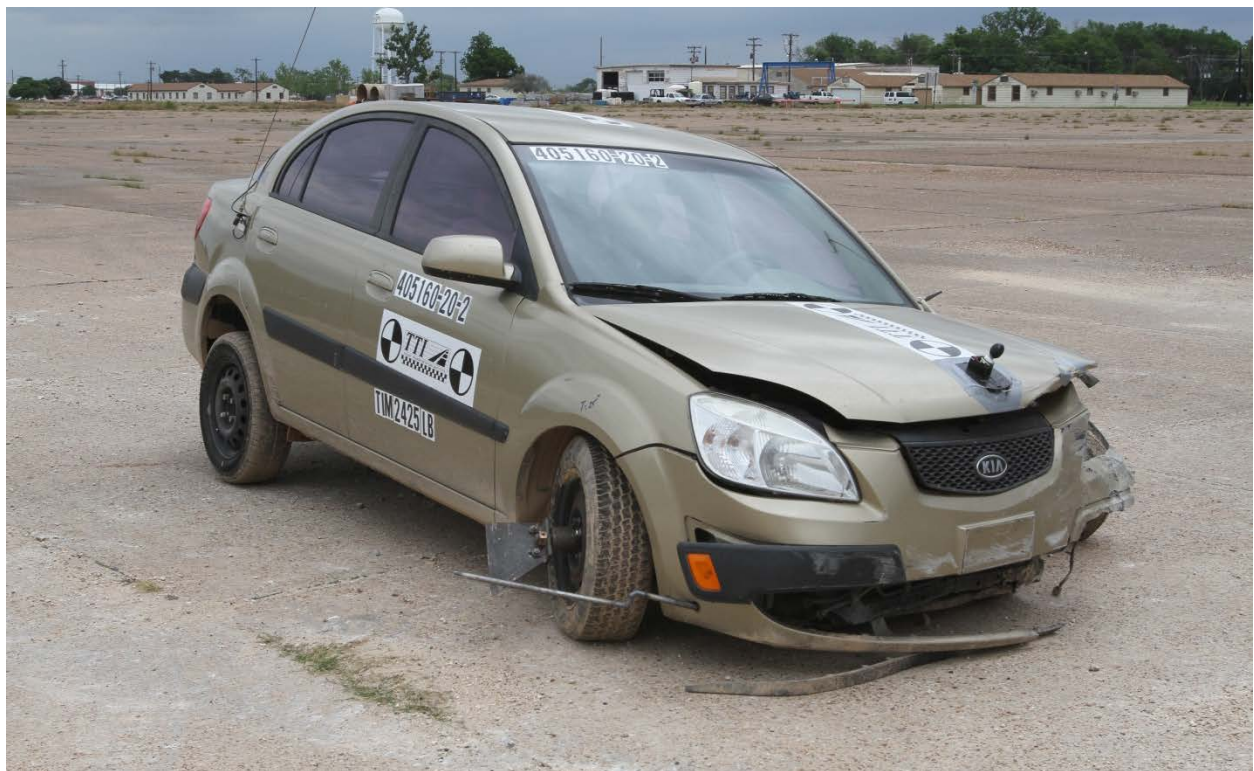
Figure 6.5. Vehicle after test 405160-20-2.

Figure 6.5 shows the damage sustained by the vehicle. The left front strut and strut tower, left inner CV joint, and left lower A-arm and ball joint were deformed. Also damaged were the front bumper, grill, hood, left front fender, left front tire and wheel rim, left front and left rear doors, and left rear quarter panel. The windshield sustained stress cracks radiating from the left lower corner. Maximum exterior crush to the vehicle was 10.5 inches in the front plane at the left front corner at bumper height. No occupant compartment deformation occurred. Photographs of the interior of the vehicle are shown in figure 6.6. Exterior vehicle crush and occupant compartment measurements are shown in appendix E, tables E2 and E3.
