TECHNICAL MEMORANDUM

Test Report No.: TM 479070-1

Project Name: Crash Testing for Hawaii DOT Typical Cement Rubble Masonry

Guardrail Walls at MASH Test Levels One and Two

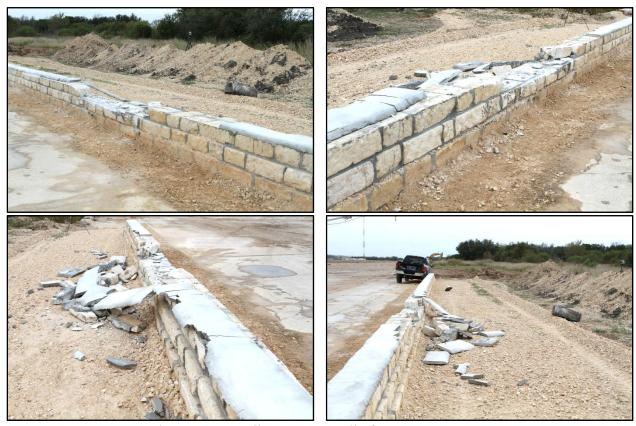
Figure 3. Hawaii Masonry Wall after test 479070-1.

A portion of the mortar cap (a length of 30 ft) and a portion of the first layer of rock (a length of 10 ft) was displaced toward the field side of the installation as shown in figure 3.
