CRASH TEST AND EVALUATION OF THE TxDOT T631 BRIDGE RAIL

Test Report 9-1002-12-10

TEXAS A&M TRANSPORTATION INSTITUTE
COLLEGE STATION, TEXAS

TEXAS DEPARTMENT OF TRANSPORTATION

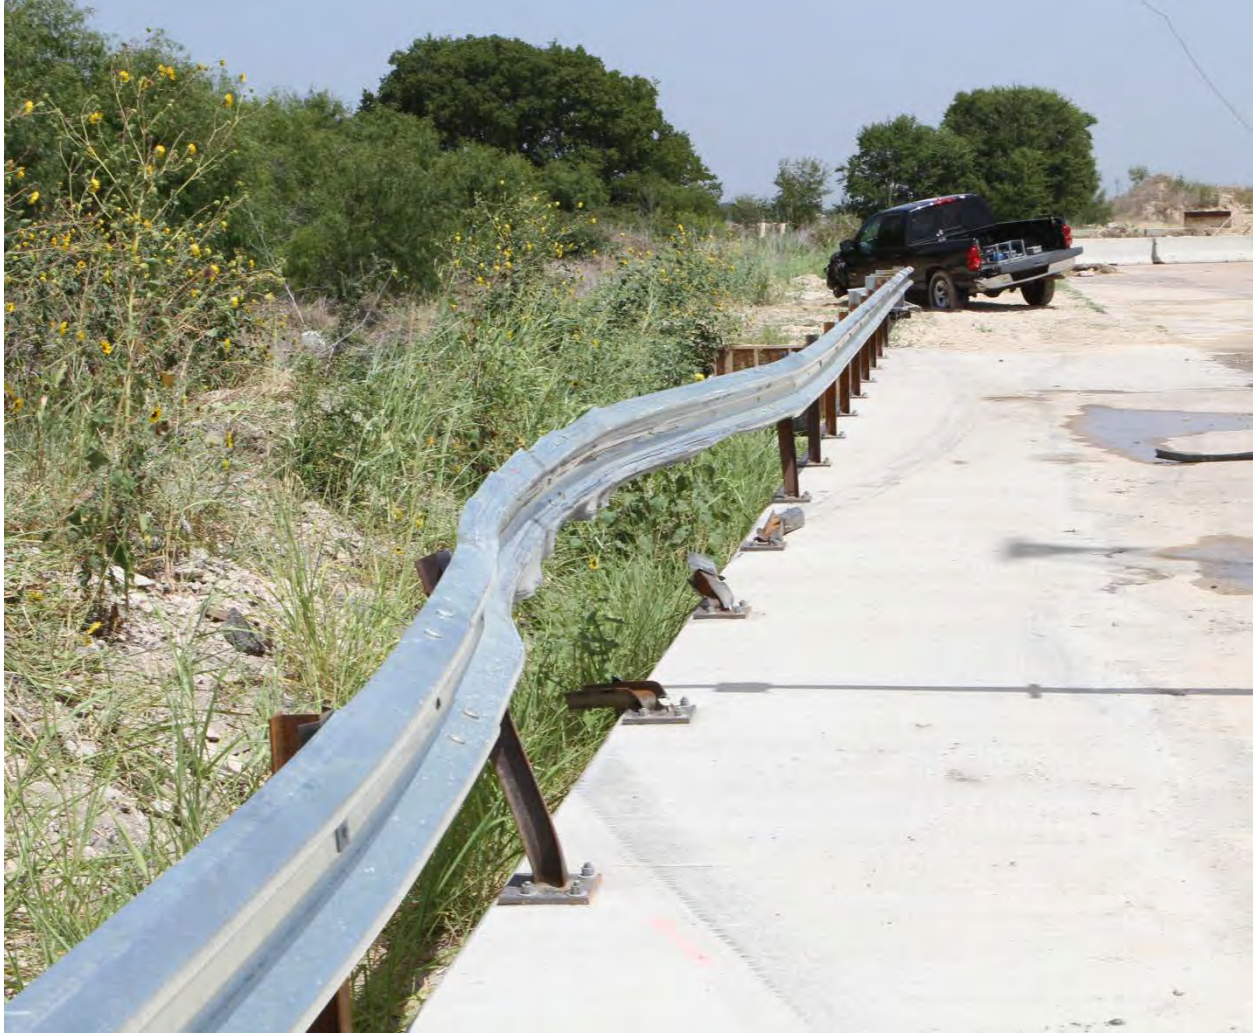
Figure 5.3. Test Article/Vehicle Positions after Test No. 490023-6-1a.

Post 1 was pulled downstream 0.25 inch, and Posts 10 and 11 were leaning toward the field side 2 degrees and 20 degrees, respectively. Posts 12 through 14 were leaning downstream 90 degrees; there was a partial tear at the base, and the rail separated from the posts. Post 15 was leaning towards the field side 5 degrees and downstream 14 degrees, and the rail separated from the post. The vehicle contacted the installation a second time at the downstream terminal post and anchor. Figures 5.3 and 5.4 show damage to the installation. The vehicle was in contact with the bridge rail 22.25 ft. Maximum dynamic deflection of the bridge rail was 25.7 inches, and permanent deformation was 21.5 inches. Working width was 30.0 inches, and vehicle intrusion was 28.8 inches.

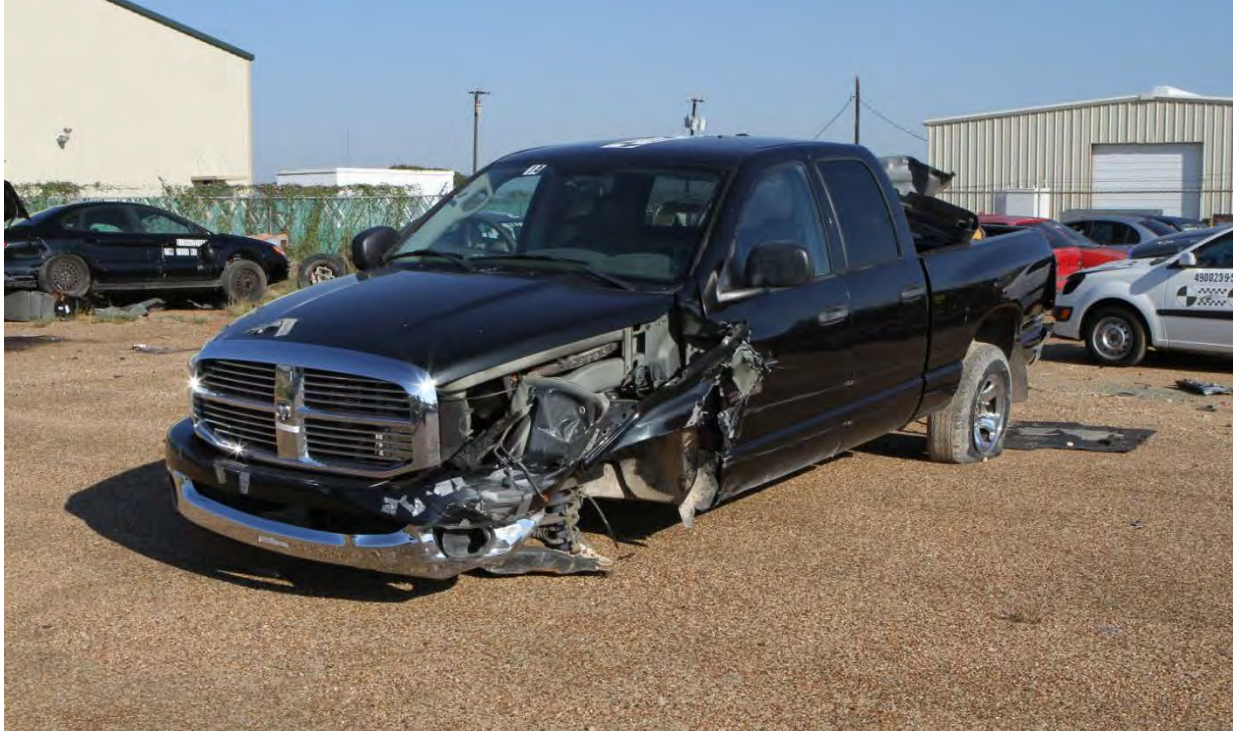
Figure 5.5. Vehicle after Test No. 490023-6-1a.

Figure 5.5 shows damage to the exterior of the vehicle. The left front wheel assembly broke from the upper and lower ball joints; the left upper and lower ball joints, A-arms, and left front tie rod end were deformed. Also damaged were the front bumper, left front fender, left front brake line, left front door, left front tire and wheel rim, left rear tire, left rear exterior bed, and the left rear bumper. Maximum exterior crush to the vehicle was 6 inches in the side plane at the left front corner at bumper height. No occupant compartment deformation or intrusion occurred. Figure 5.6 provides photographs of the interior of the vehicle. Tables C3 and C4 in Appendix C provide exterior crush and occupant compartment measurements.

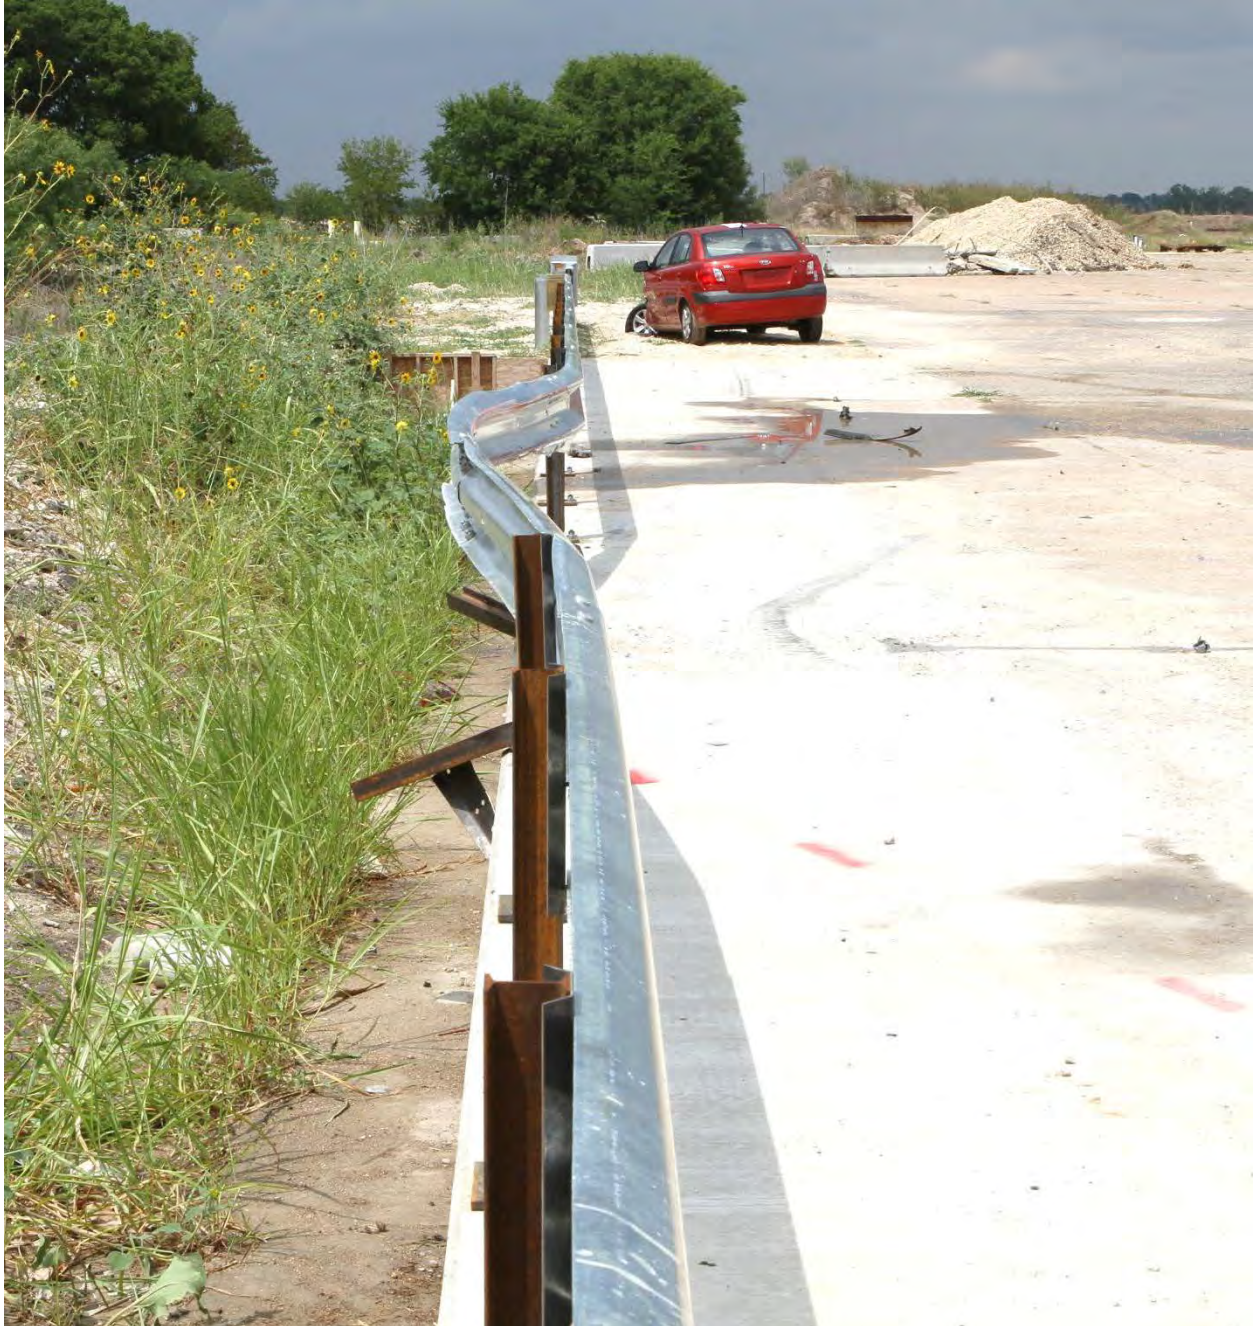
Figure 6.3. Test Article/Vehicle Positions after Test No. 490023-6-2.

Post 9 was leaning towards the field side 4 degrees. Post 10 was leaning towards the field side 95 degrees and the front flange and webbing were torn. Post 11 was leaning downstream 85 degrees and towards the field side 10 degrees; the front flange was partially torn, and the backup plate released. Post 12 was leaning downstream 85 degrees and the back flange was partially torn. Post 12 was leaning downstream 8 degrees. Figures 6.3 and 6.4 show damage to the installation. The 1100C vehicle was in contact with the bridge rail 17.8 ft. Maximum dynamic deflection of the bridge rail during the test was 22.6 inches, and maximum permanent deformation was 15.0 inches. Working width was 25.5 inches, and vehicle penetration was 30.3 inches.

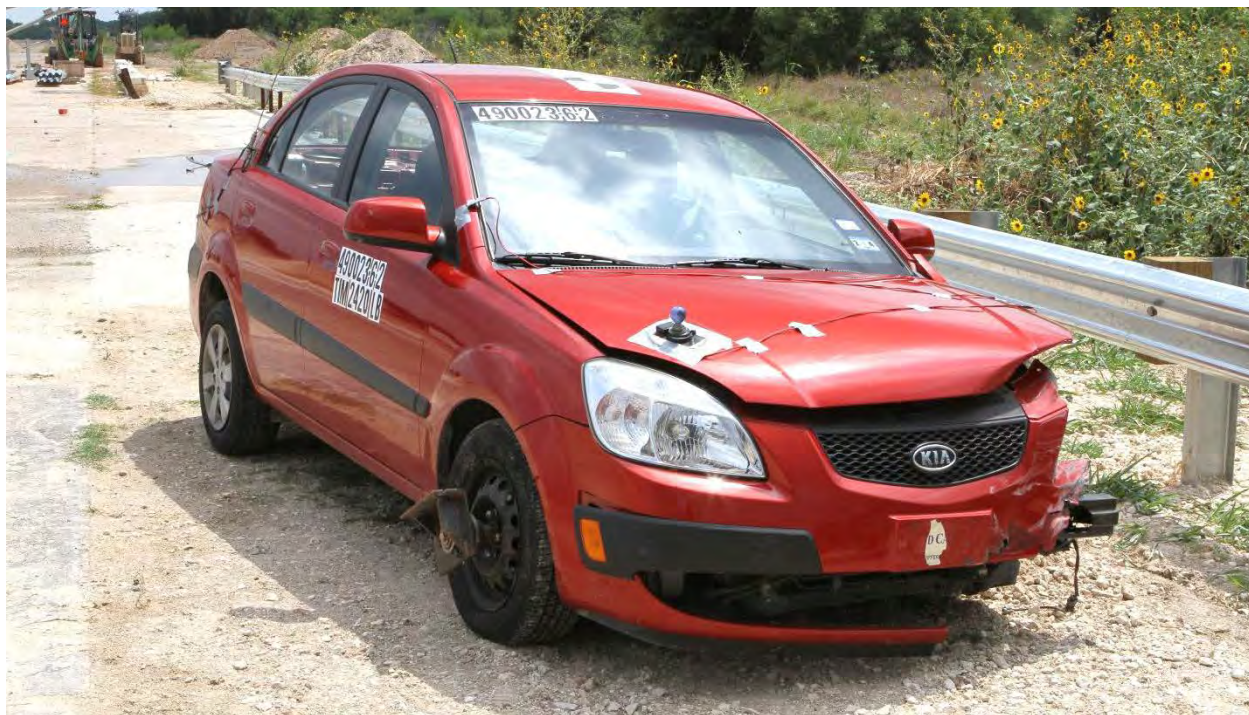
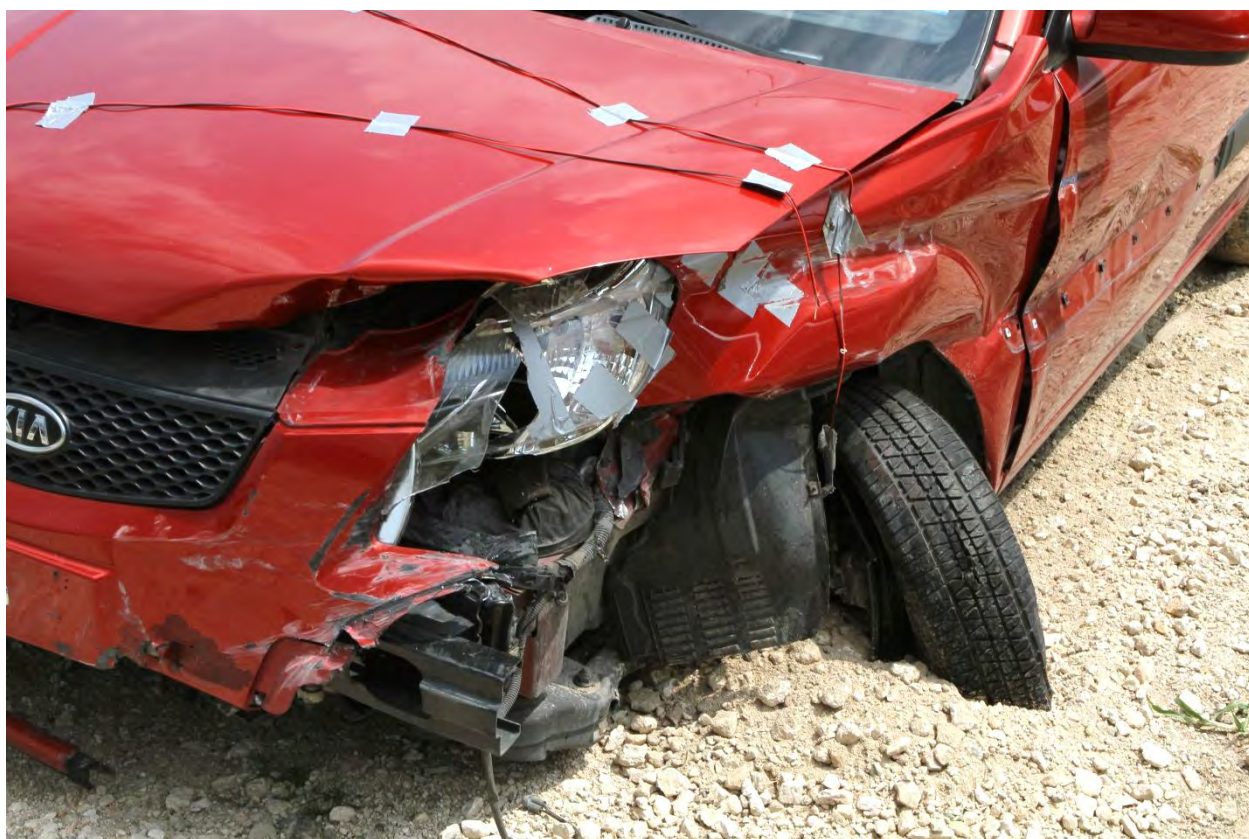
Figure 6.5. Vehicle after Test No. 490023-6-2.

Figure 6.5 shows damage to the 1100C vehicle. The left strut, strut tower, and left tie rod end were deformed. Also damaged were the front bumper, hood, left front fender, left front tire and wheel rim, and the left front door. Maximum exterior crush to the vehicle was 9.5 inches in the side plane at the left front corner at bumper height. No occupant compartment deformation or intrusion occurred. Figure 6.6 provides photographs of the interior of the vehicle. Tables D3 and D4 in Appendix D provide exterior crush and occupant compartment measurements.
