# CRASH TEST AND EVALUATION OF LOCKING ARCHITECTURAL MAILBOXES

**Test Report No. 9-1002-12-9**

**TEXAS A&M TRANSPORTATION INSTITUTE  
COLLEGE STATION, TEXAS**

**TEXAS DEPARTMENT OF TRANSPORTATION**

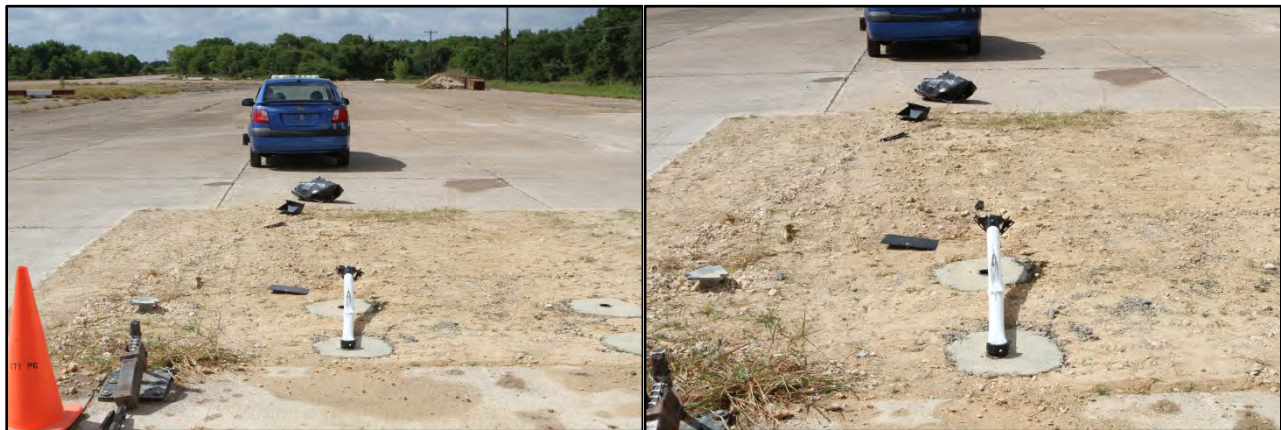
**Figure 4.6. Vehicle/Installation Positions after Test No. 490023-9-1.**

Figure 4.6 and 4.7 show damage to the locking architectural mailbox installation. The post was deformed and bent over at ground line. The connection bracket was torn from the support and the mailbox came to rest 21 ft downstream of impact. Several pieces of the mailbox became detached and lay along the path of the vehicle.

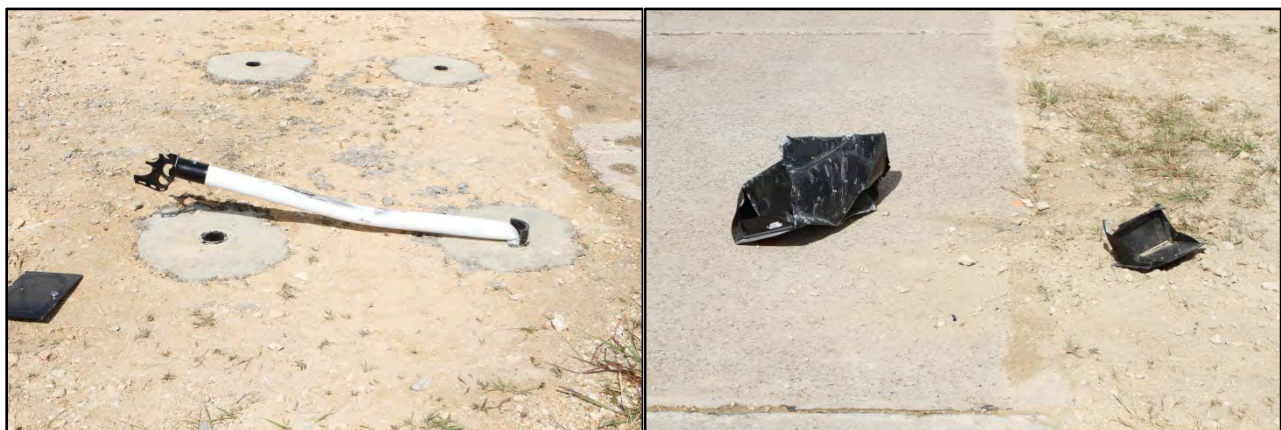
**Figure 4.7. Installation after Test No. 490023-9-1.**

Results: The locking architectural mailbox detached from the support post and separated into several pieces while being carried along beneath the vehicle. The detached pieces did not penetrate or show potential for penetrating the occupant compartment, nor present hazard to others in the area. (PASS)

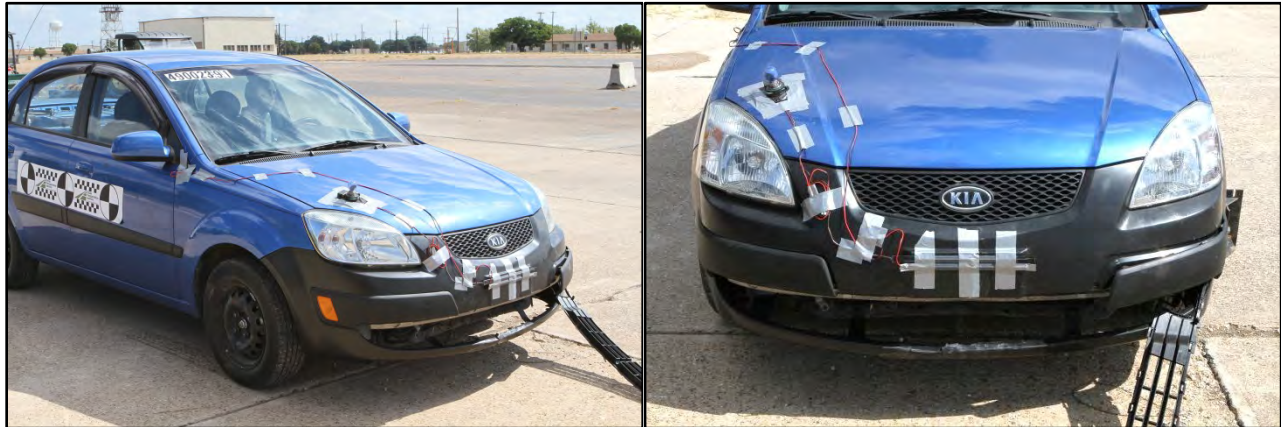
**Figure 4.8. Vehicle after Test No. 490023-9-1.**

Figure 4.8 shows damage to the exterior of the vehicle, and Figure 4.9 shows the interior of the vehicle. A very small dent was noted on the hood and bumper. There was no contact of any components of the mailbox system with the windshield. Tables A2 and A3 in Appendix A provide exterior crush and occupant compartment measurements for the vehicle.

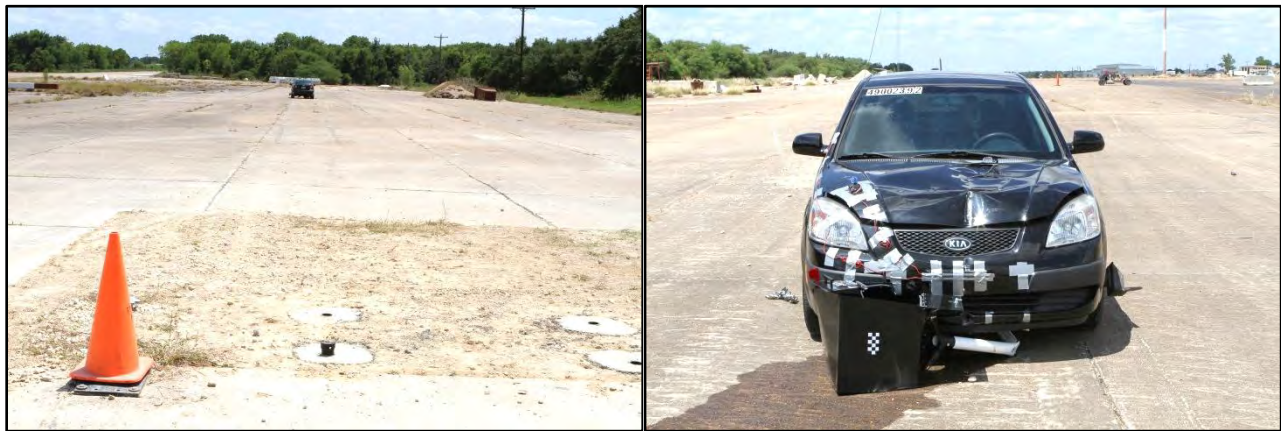
**Figure 4.13. Vehicle/Installation Positions after Test No. 490023-9-2.**

Figures 4.13 and 4.14 show damage to the mailbox installation. The support post pulled out of the socket and was deformed. The mailbox came apart at several connection seams, but all the pieces remained together and the mailbox remained attached to the support post. The mailbox and support post came to rest in front of the vehicle 245 ft downstream of impact.

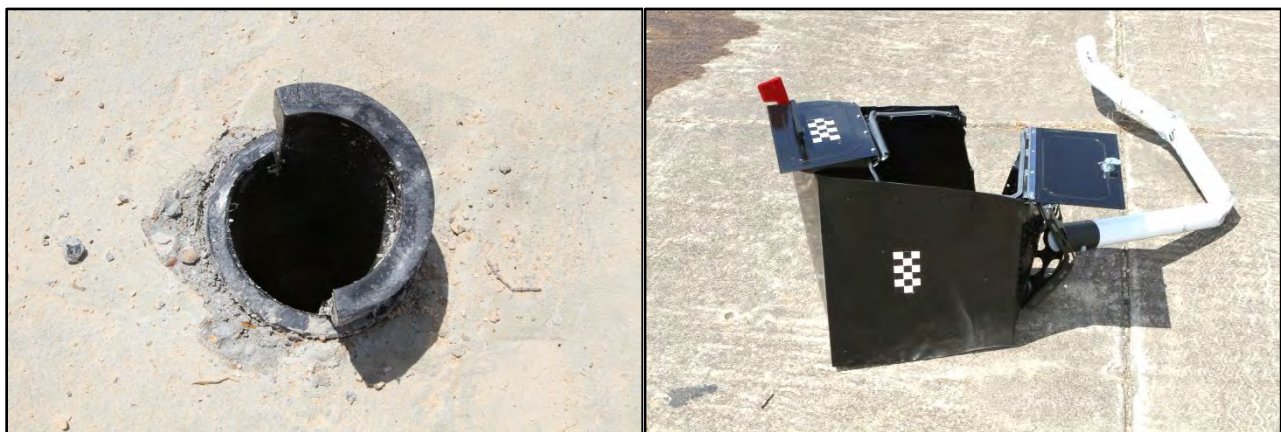
**Figure 4.14. Installation after Test No. 490023-9-2.**

Results: The locking architectural mailbox separated at several connection seams; however, the pieces remained connected and attached to the support post and traveled along the front of the vehicle. The mailbox installation did not penetrate or show potential for penetrating the occupant compartment, nor present hazard to others in the area. (PASS)

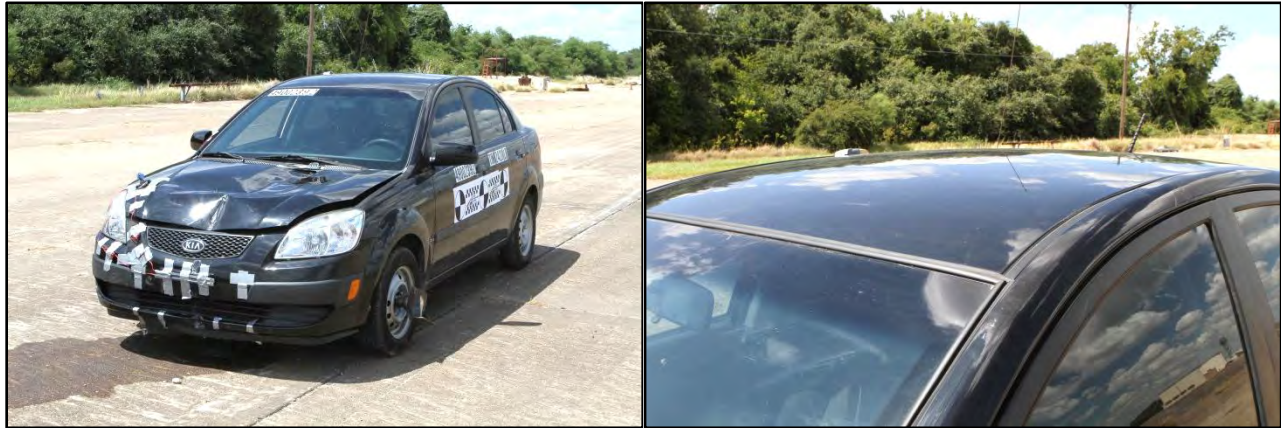
**Figure 4.15. Vehicle after Test No. 490023-9-2.**

Figure 4.15 shows damage to the exterior of the vehicle, and Figure 4.16 shows the interior of the vehicle. The vehicle sustained a small cut on the hood, and the hood was

deformed inward 1.25 inches. There was no contact of any components of the mailbox system with the windshield. Tables B2 and B3 in Appendix B provide exterior crush and occupant compartment measurements.

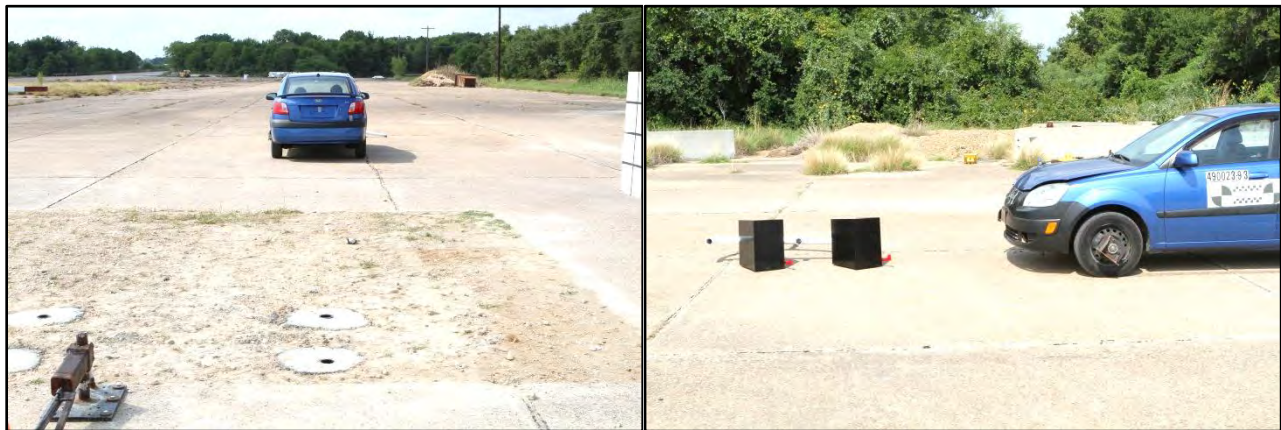
**Figure 5.6. Vehicle/Installation Positions after Test No. 490023-9-3.**

Figures 5.6 and 5.7 show damage to the locking architectural mailbox installation. The support post lifted out of the socket and was carried in front of the vehicle. The support post was deformed as well as the bracket attaching the mailboxes to the support post. The mailboxes remained attached to the support post and the assembly came to rest in front of the vehicle 58 ft downstream of impact.

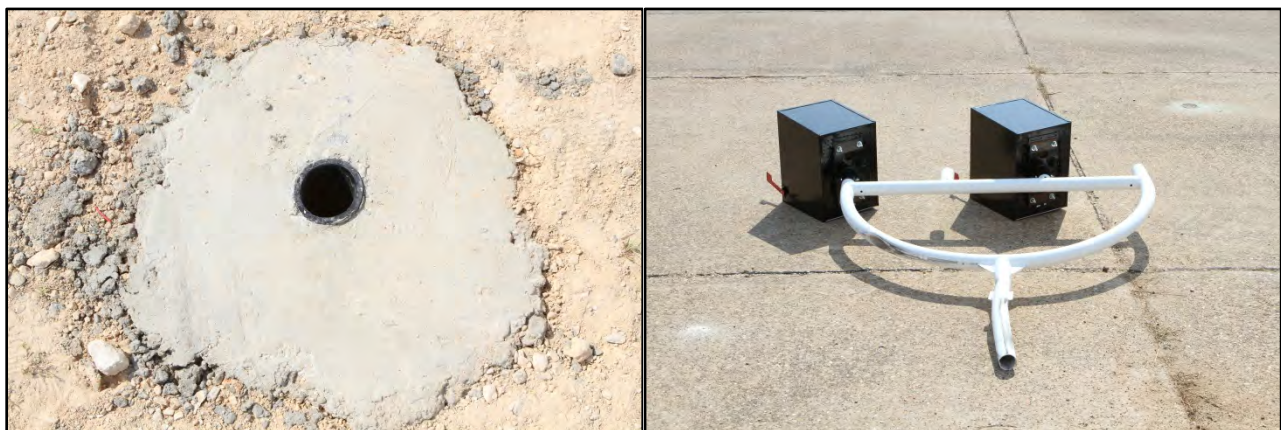
**Figure 5.7. Installation after Test No. 490023-9-3.**

Results: The locking architectural mailboxes on the SHUR-TITE® multiple-mount post activated by yielding to the vehicle and lifting out of the foundation socket. (PASS)

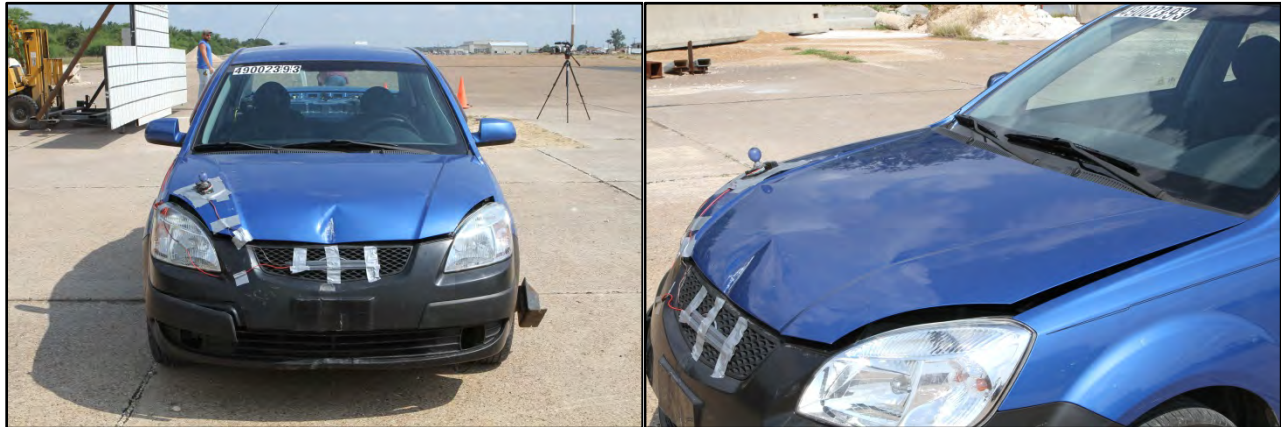
**Figure 5.8. Vehicle after Test No. 490023-9-3.**

Figure 5.8 shows damage to the exterior of the vehicle, and Figure 5.9 shows the interior of the vehicle. The hood and bumper were dented. There was no contact of any components of the mailbox system with the windshield. Tables C2 and C3 in Appendix C provide exterior crush and occupant compartment measurements.

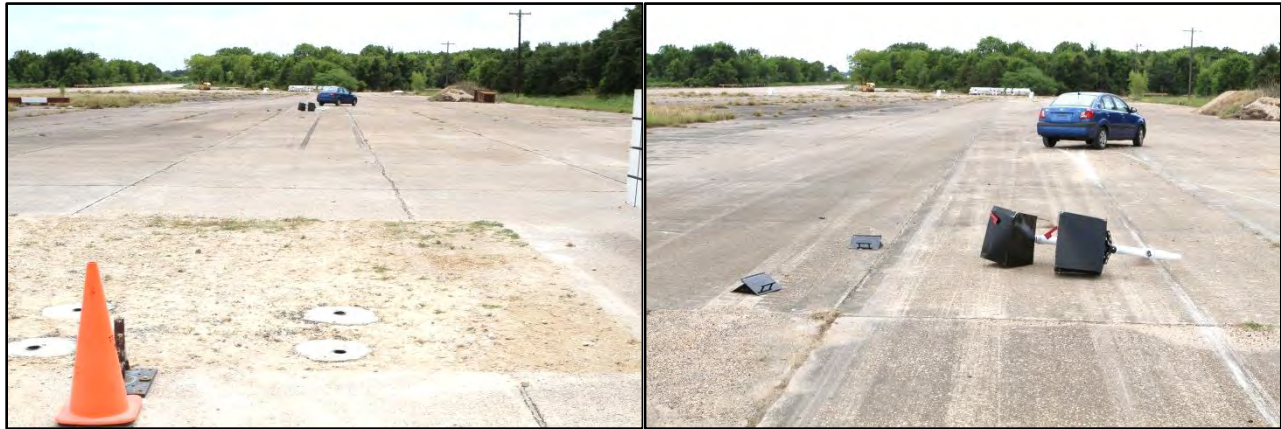
**Figure 5.13. Vehicle/Installation Positions after Test No. 490023-9-4.**

Figures 5.13 and 5.14 show damage to the mailbox installation. The support post collapsed inward and was pulled out of the socket. The mailboxes remained attached to the support post, however, the doors separated from the mailboxes. The mailboxes and support post came to rest 110 ft downstream of impact.

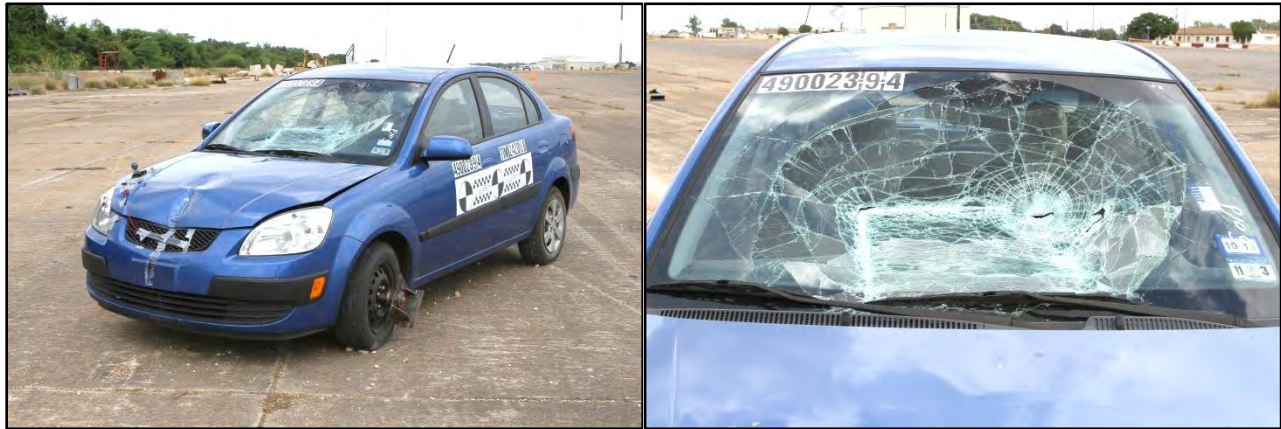
**Figure 5.15. Vehicle after Test No. 490023-9-4.**

The windshield sustained four cuts. One cut was 19 inches long, a second was 4.5 inches long, a third was 2 inches long, and the fourth was 3 inches long. The windshield was depressed 4.5 inches toward the occupant compartment over an area measuring 30 inches  $\times$  36 inches. Figure 5.15 shows damage to the exterior of the vehicle, and Figure 5.16 shows the interior of the vehicle. Tables D2 and D3 in Appendix D provide exterior crush and occupant compartment measurements.

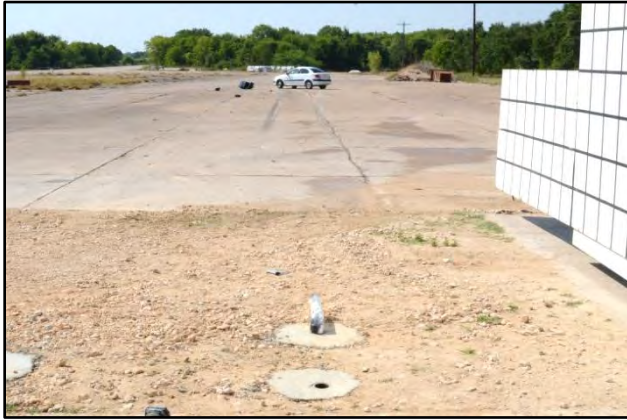
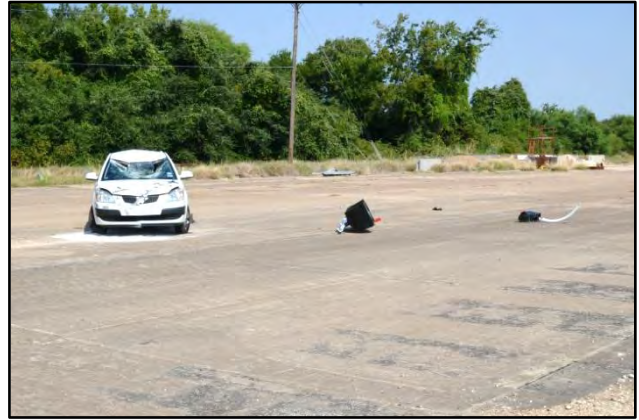
**Figure 6.7. Vehicle/Installation Positions after Test No. 490023-9-5.**

standard mailbox, and a section of the support post came to rest 192 ft downstream of impact and 10 ft to the left of centerline of the vehicle path.

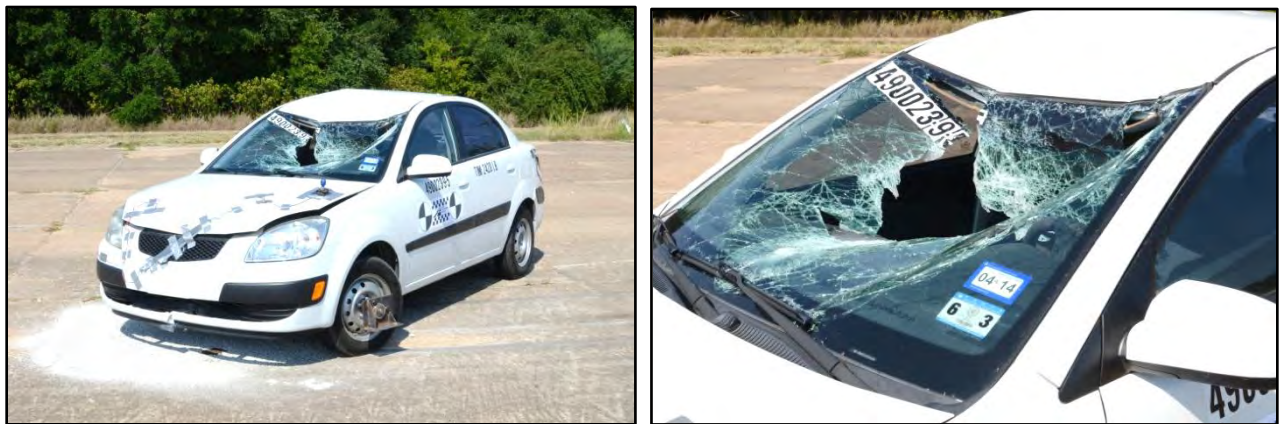
**Figure 6.9. Vehicle after Test No. 490023-9-5.**

The windshield of the vehicle sustained an open tear measuring 14 inches  $\times$  24 inches. The roof of the vehicle was deformed downward into the occupant compartment 4.75 inches. Figure 6.9 shows damage to the exterior of the vehicle, and Figure 6.10 shows the interior of the vehicle. Tables E2 and E3 in Appendix E provide exterior crush and occupant compartment measurements.

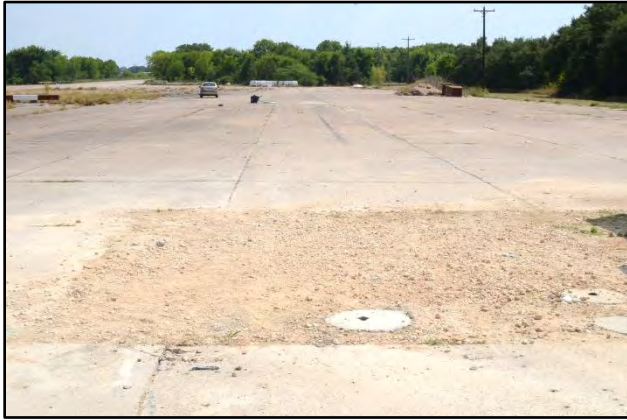
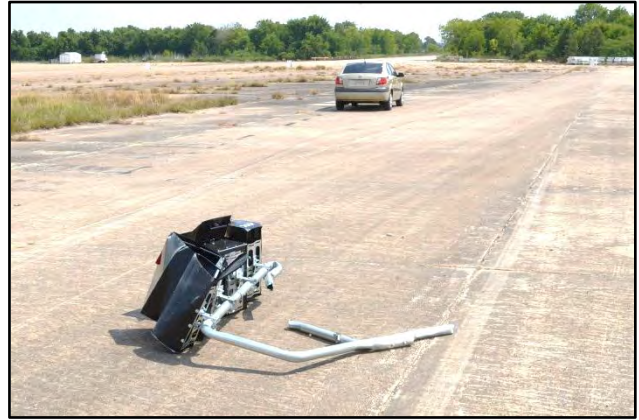
**Figure 6.20. Vehicle/Installation Positions after Test No. 490023-9-6.**

to the support post. The system came to rest 188 ft downstream of impact and 8 ft to the left of centerline of the vehicle path.

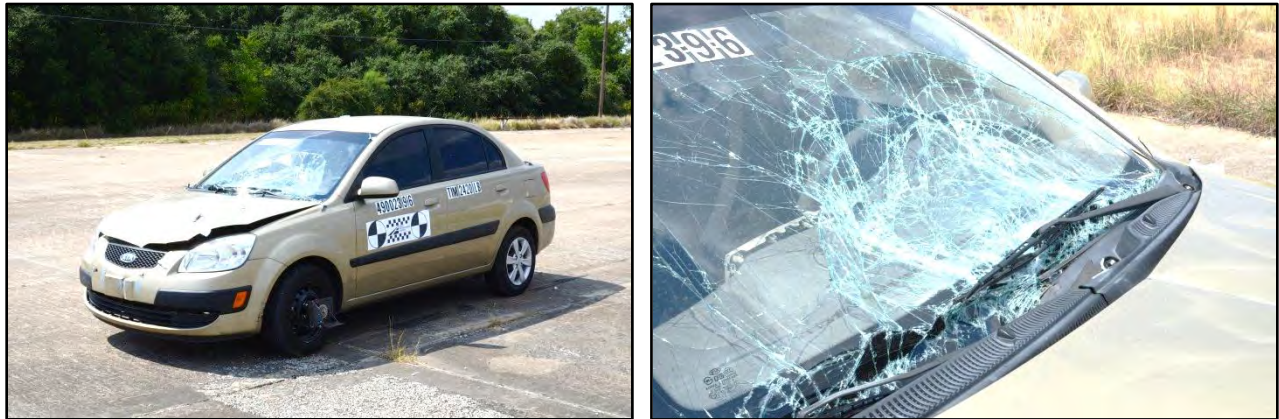
**Figure 6.22. Vehicle after Test No. 490023-9-6.**

The hood of the vehicle was dented and pushed downward. The windshield was shattered and pushed into the occupant compartment 3.5 inches and there were several small tears at the bottom edge of the windshield behind the dashboard. Figure 6.22 shows damage to the exterior of the vehicle, and Figure 6.23 shows the interior of the vehicle. Tables F2 and F3 in Appendix F provide exterior crush and occupant compartment measurements.
