Development and Evaluation of the Midwest Guardrail System Placed Adjacent to a 2:1 Fill Slope

*Midwest States Regional Pooled Fund Research Program
Fiscal Year 2004-2005 (Year 15)
Research Project Number SPR-3(017)
NDOR Sponsoring Agency Code RFPF-05-09*

DEVELOPMENT AND EVALUATION OF THE MIDWEST GUARDRAIL SYSTEM (MGS) PLACED ADJACENT TO A 2:1 FILL SLOPE

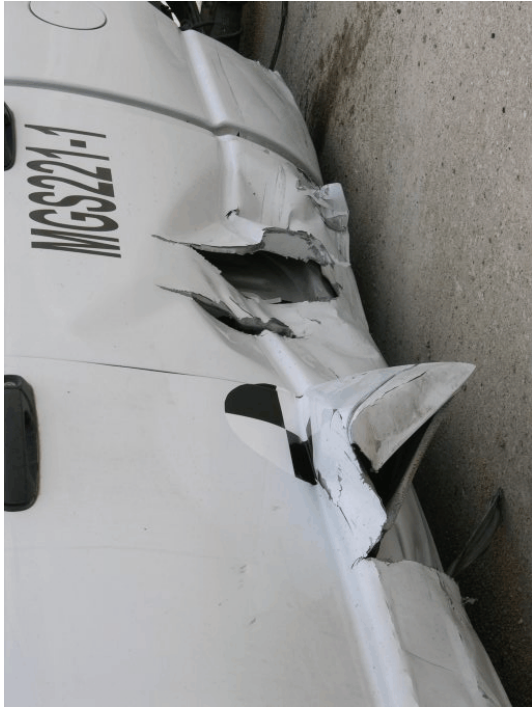
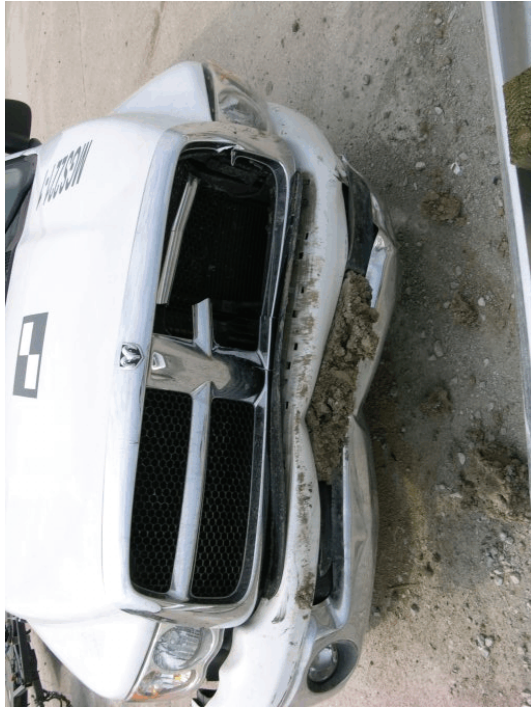
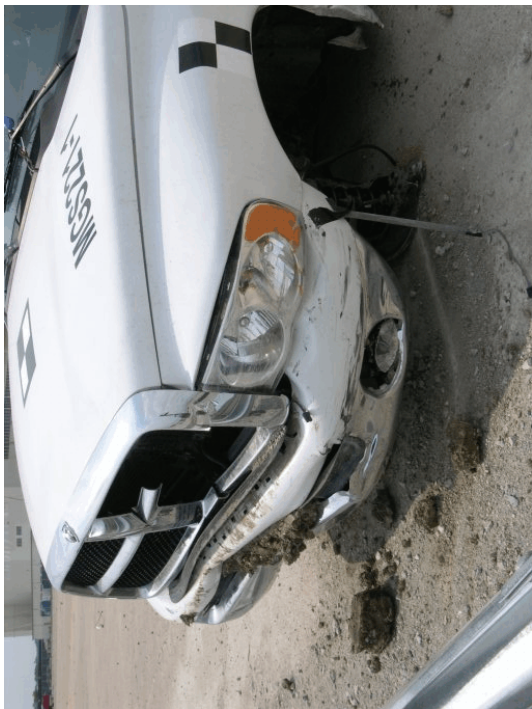
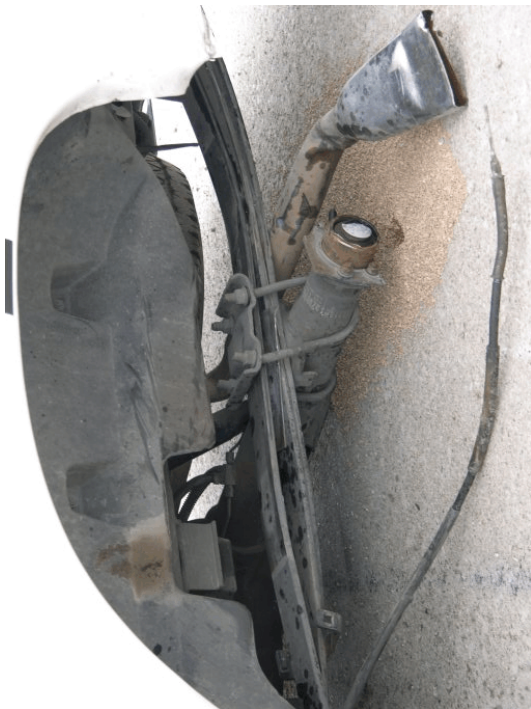
Figure 43. Vehicle Damage, Test No. MGS221-1

Damage was concentrated on the left-front corner of the vehicle. The left-front corner was deformed inward toward the engine compartment. The left side of the grill was fractured and removed. The center of the front bumper buckled. The left-front, left-rear, and right-rear tires disengaged from the vehicle. Sheet metal tearing and major deformations were found along the lower portion of the left-side doors and the left-rear fender. The left side of the rear bumper was deformed upward. The left-side taillight was fractured, while the right-side taillight was slightly dislodged. The left-front, right-front, and right-rear brake lines were severed. The left-rear and right-rear shocks were fractured. The left-front upper control arm and left-front tie rod were fractured. The drive shaft was fractured and separated at the transmission yoke. The left-front sway bar linkage was

bent. Both ends of the rear axle fractured before the brake housing. The gas tank heat shield was deformed and bent. The roof, hood, and right side of the vehicle and all window glass remained undamaged.
