EVALUATION OF BOX BEAM STIFFENING OF UNANCHORED TEMPORARY CONCRETE BARRIERS

MIDWEST ROADSIDE SAFETY FACILITY

MwRSF Research Report No. TRP-03-202-08

March 14, 2008

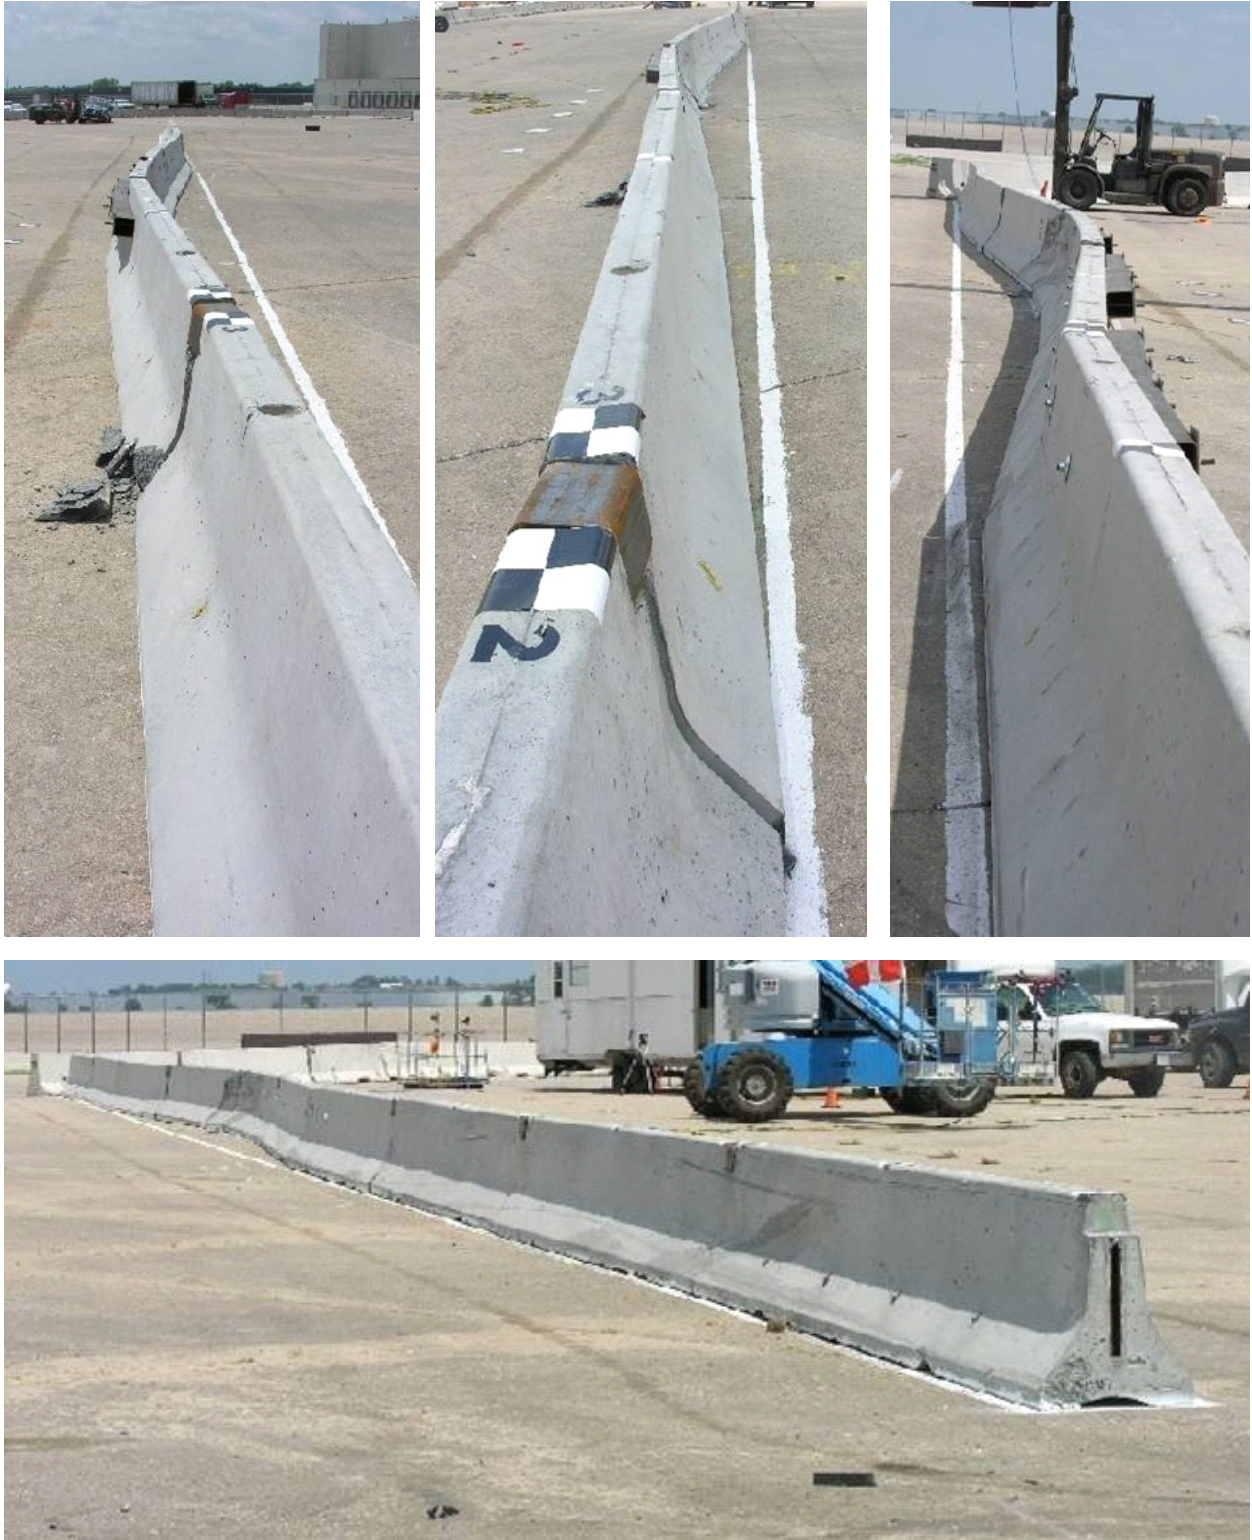
Figure 37. Temporary Barrier Damage, Test NYTCB-1

Damage to the barrier was moderate, as shown in Figures 37 through 41. Barrier damage consisted of contact marks, concrete cracking, barrier spalling, cracks, and deformed box beam sections. The length of vehicle contact along the system was approximately 38.3 m (125.8 ft), which spanned from 1.75 m (5 ft - 9 in.) upstream from the downstream end of barrier no. 4 through the downstream end of barrier no. 10.

The permanent set of the barrier system is shown in Figure 37. The maximum lateral permanent set barrier deflection was 660 mm (26 in.) at the downstream end of barrier no. 4 and the upstream end of barrier no. 5, as measured in the field. The maximum lateral dynamic barrier deflection was 700 mm (27.6 in.) at the upstream end of barrier no. 5, as determined from high-speed digital video analysis. The working width of the system was found to be 1,311 mm (51.6 in.).

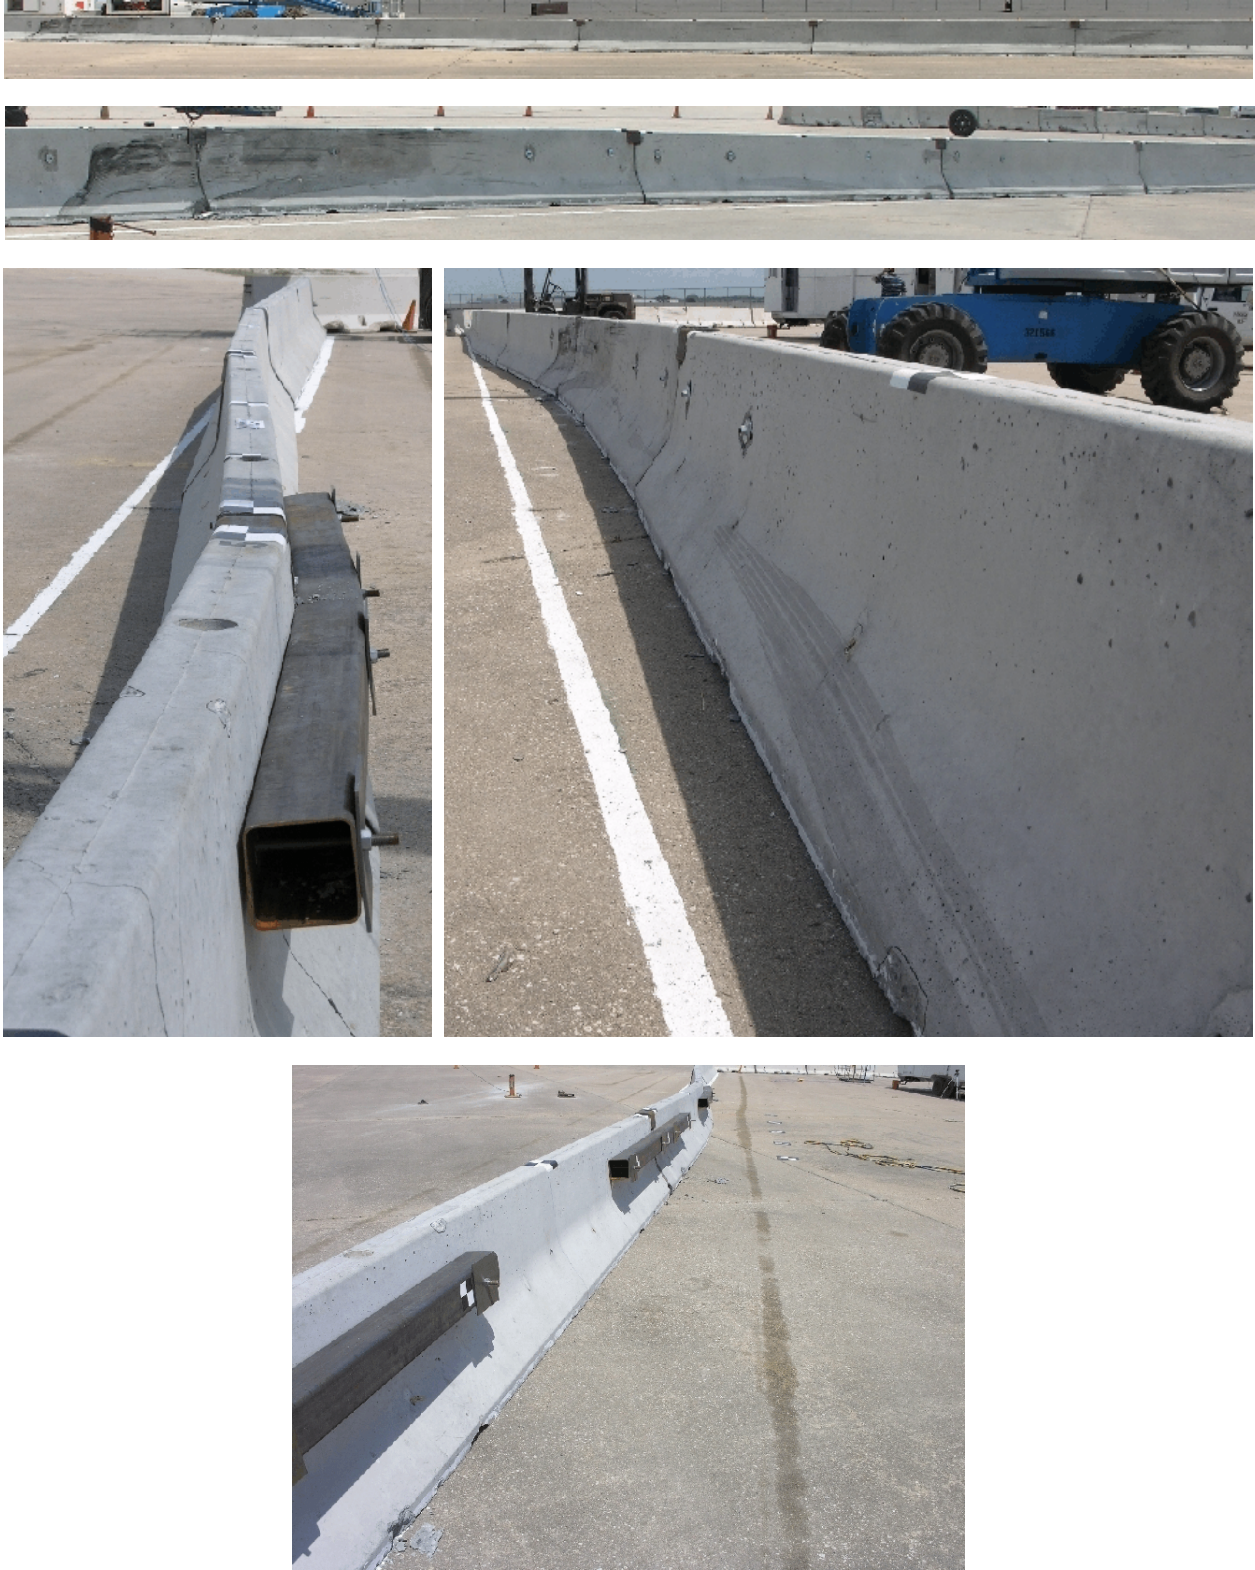
Figure 38. Temporary Barrier Damage, Test NYTCB-1

Contact and tire marks were visible on the front face of barrier nos. 4 through 10. The back side of barrier no. 3 experienced concrete spalling 152 mm (6 in.) wide and 356 mm (14 in.) in height. The back upstream end of barrier no. 4 experienced concrete spalling 584 mm (23 in.) wide and 254 mm (10 in.) tall. The front downstream edge of barrier no. 4 also experienced concrete spalling 305 mm (12 in.) wide and 178 mm (7 in.) tall. A 381-mm (15-in.) wide by 127-mm (5-in.)

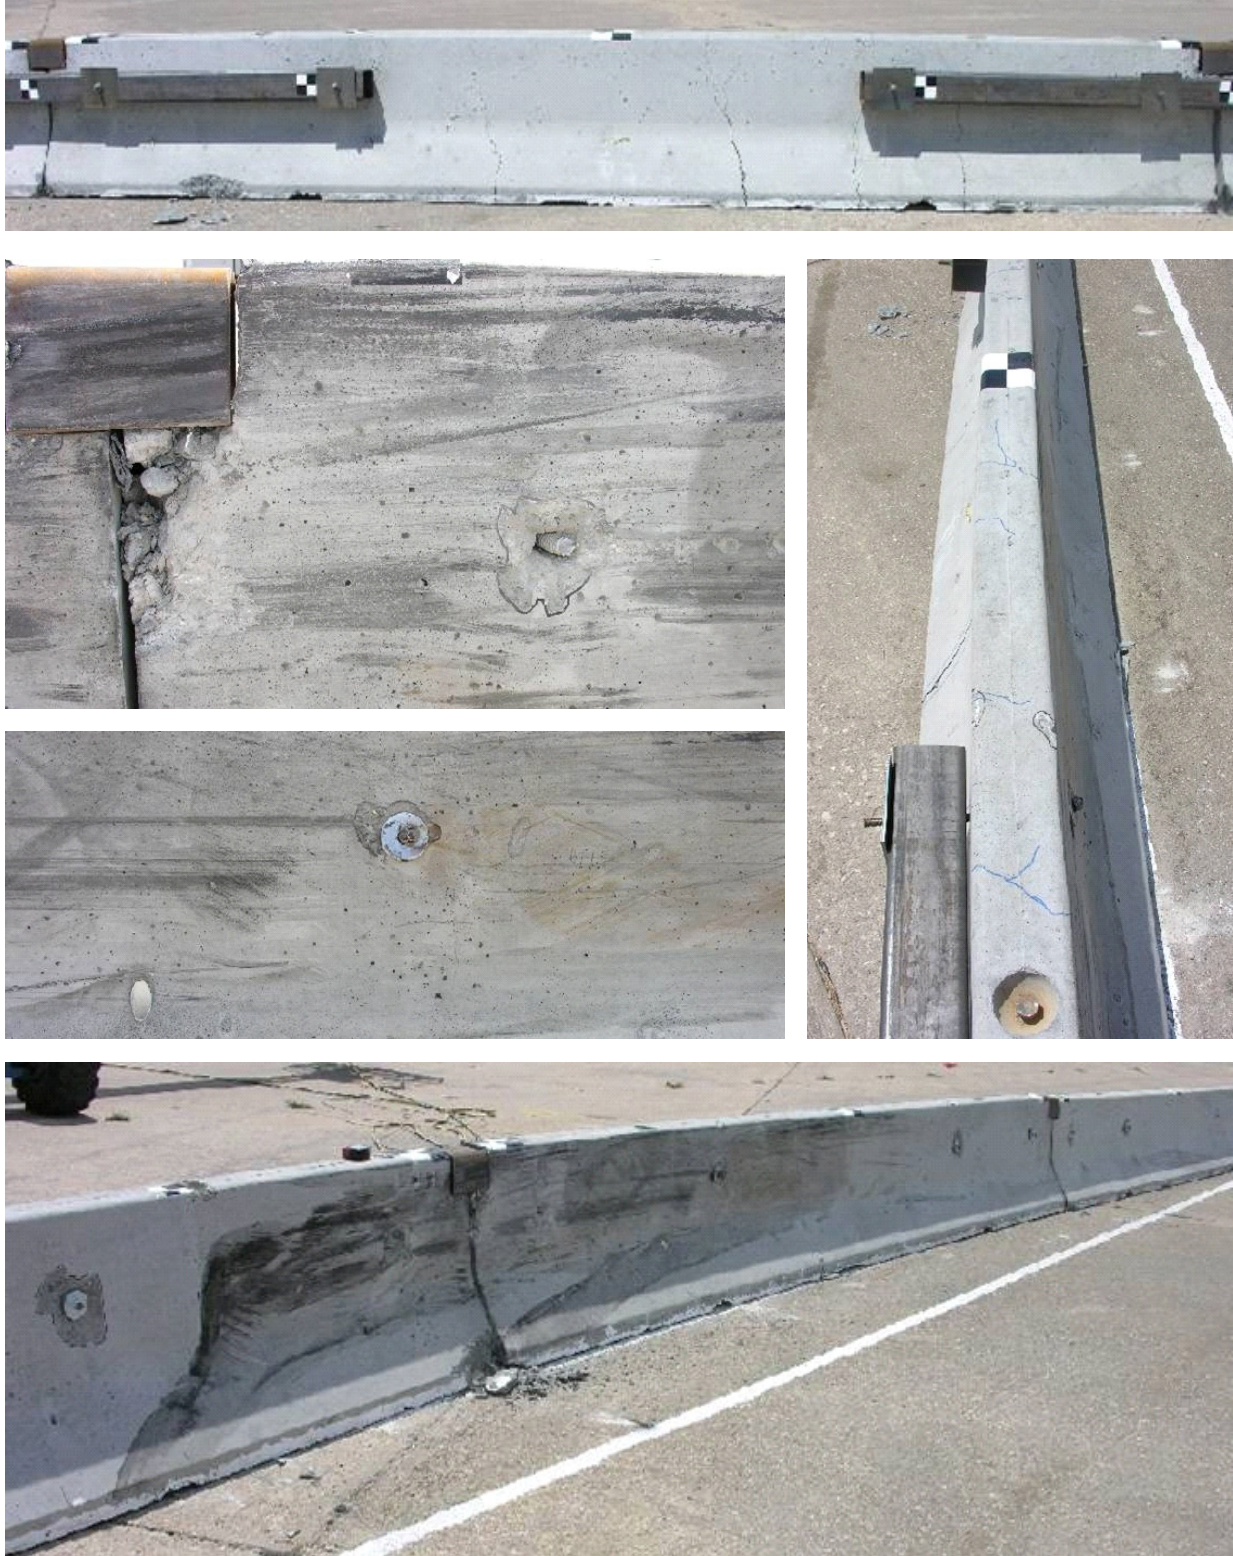
Figure 39. Barrier No. 5 Damage, Test NYTCB-1

tall area of concrete spalling was found on the back side of barrier no. 5, beginning 762 mm (30 in.) downstream from the barrier's upstream end. The front side of barrier no. 5 also experienced concrete spalling 102 mm (4 in.) wide and 178 mm (7 in.) tall. Concrete spalling occurred on the top-front upstream end of barrier no. 6, measuring 51 mm (2 in.) wide by 76 mm (3 in.) tall. The bottom-front face of barrier no. 6 also experienced concrete spalling at 1,168 mm (46 in.) downstream from the upstream end, measuring 152 mm (6 in.) wide by 76 mm (3 in.) tall. Minor concrete spalling occurred at the bottom-front face of barrier no. 6, measuring 102 mm (4 in.) tall and 1,219 mm (48 in.) long. The back side of barrier no. 6 experienced significant concrete spalling, measuring 102 mm (4 in.) wide by 76 mm (3 in.) tall at the bottom-downstream corner of the barrier. Concrete spalling on the back side of barrier no. 6, measuring 127 mm (5 in.) wide by 76 mm (3 in.) tall, occurred at 838 mm (33 in.) upstream from the downstream end of the barrier. A 178-mm (7-in.) wide by 102-mm (4-in.) tall area of concrete spalling was found on the back side 533 mm (21 in.) downstream from the upstream end of barrier no. 7.

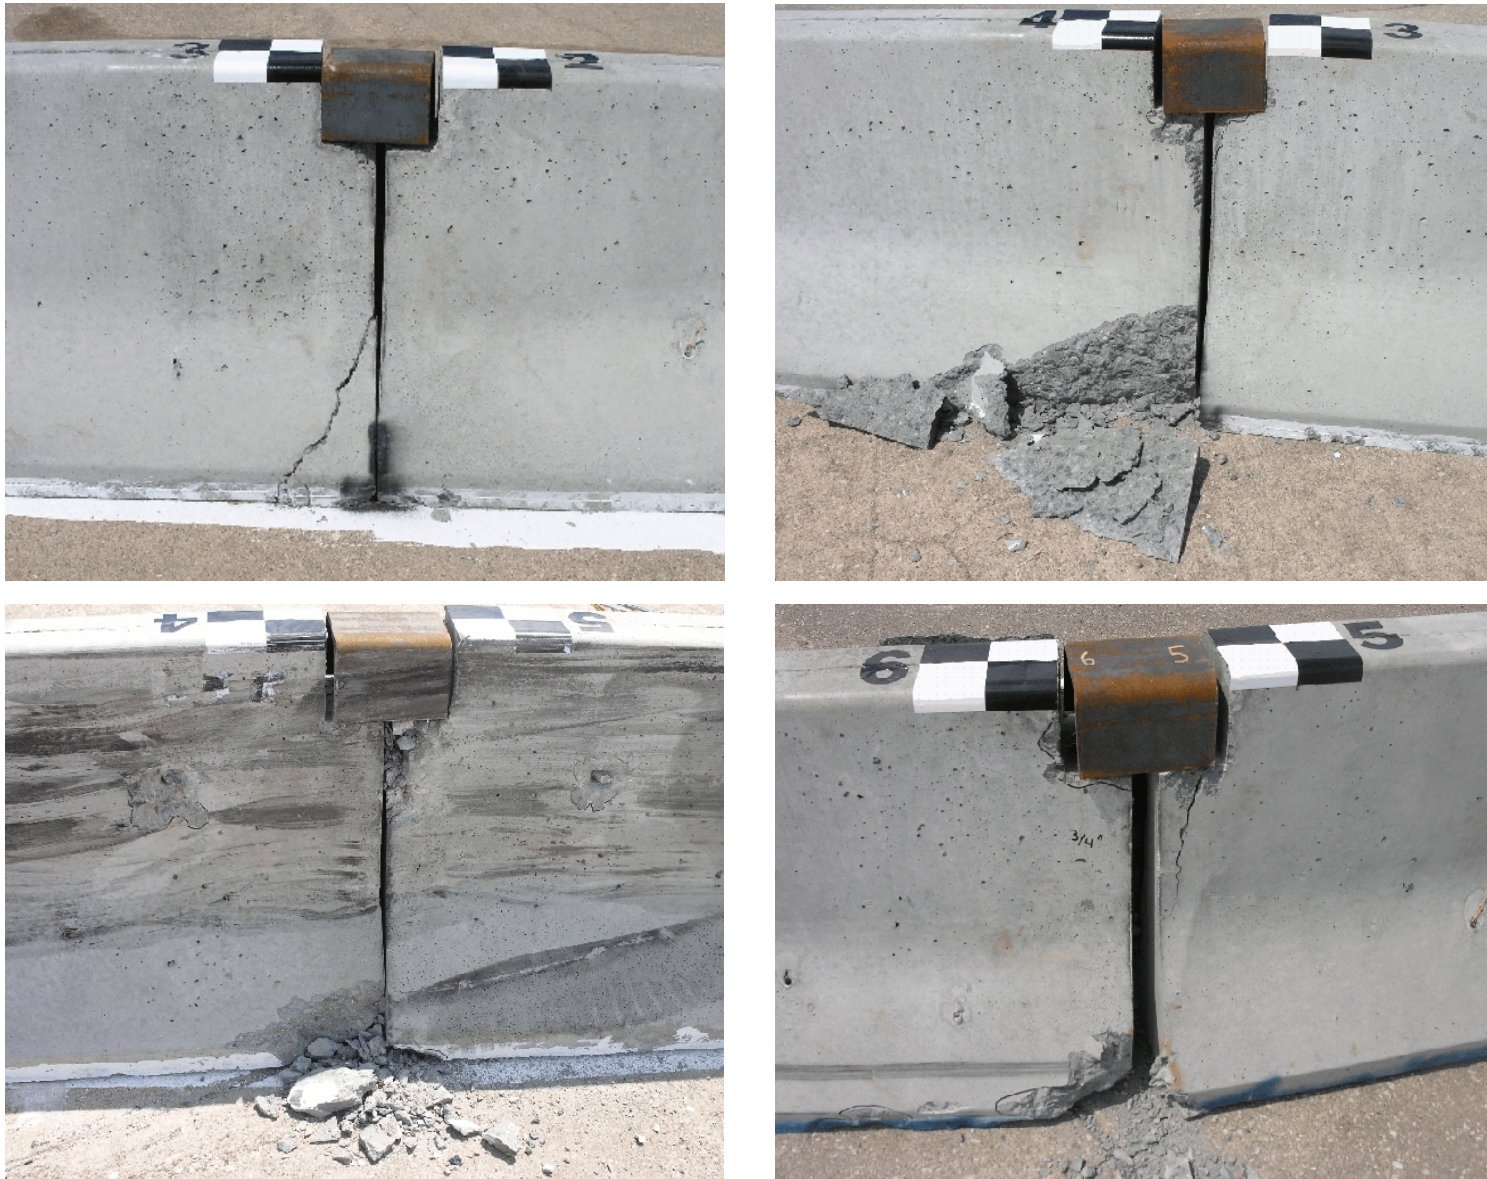
Figure 40. Joint Connection Damage - Joints 2-3, 3-4, 4-5, and 5-6, Test NYTCB-1

The joint between barrier nos. 2 and 3 was observed to have widened from its pre-test width. The joint between barrier nos. 3 and 4 rotated. The box beam stiffeners all experienced minor bending. The box beam rods at the front-downstream end of barrier no. 4 and front-upstream end of barrier no. 5 were sheared off. The downstream box beam rod was bent at the front of barrier no. 5. All connection keys remained undamaged. The anchor rods in barrier nos. 1 and 10 remained undamaged, and these barriers experienced no movement. Minor bending of the plate washers was observed. No buckling of the box beam webs nor bending of the box beam flanges was observed under the plate washers.

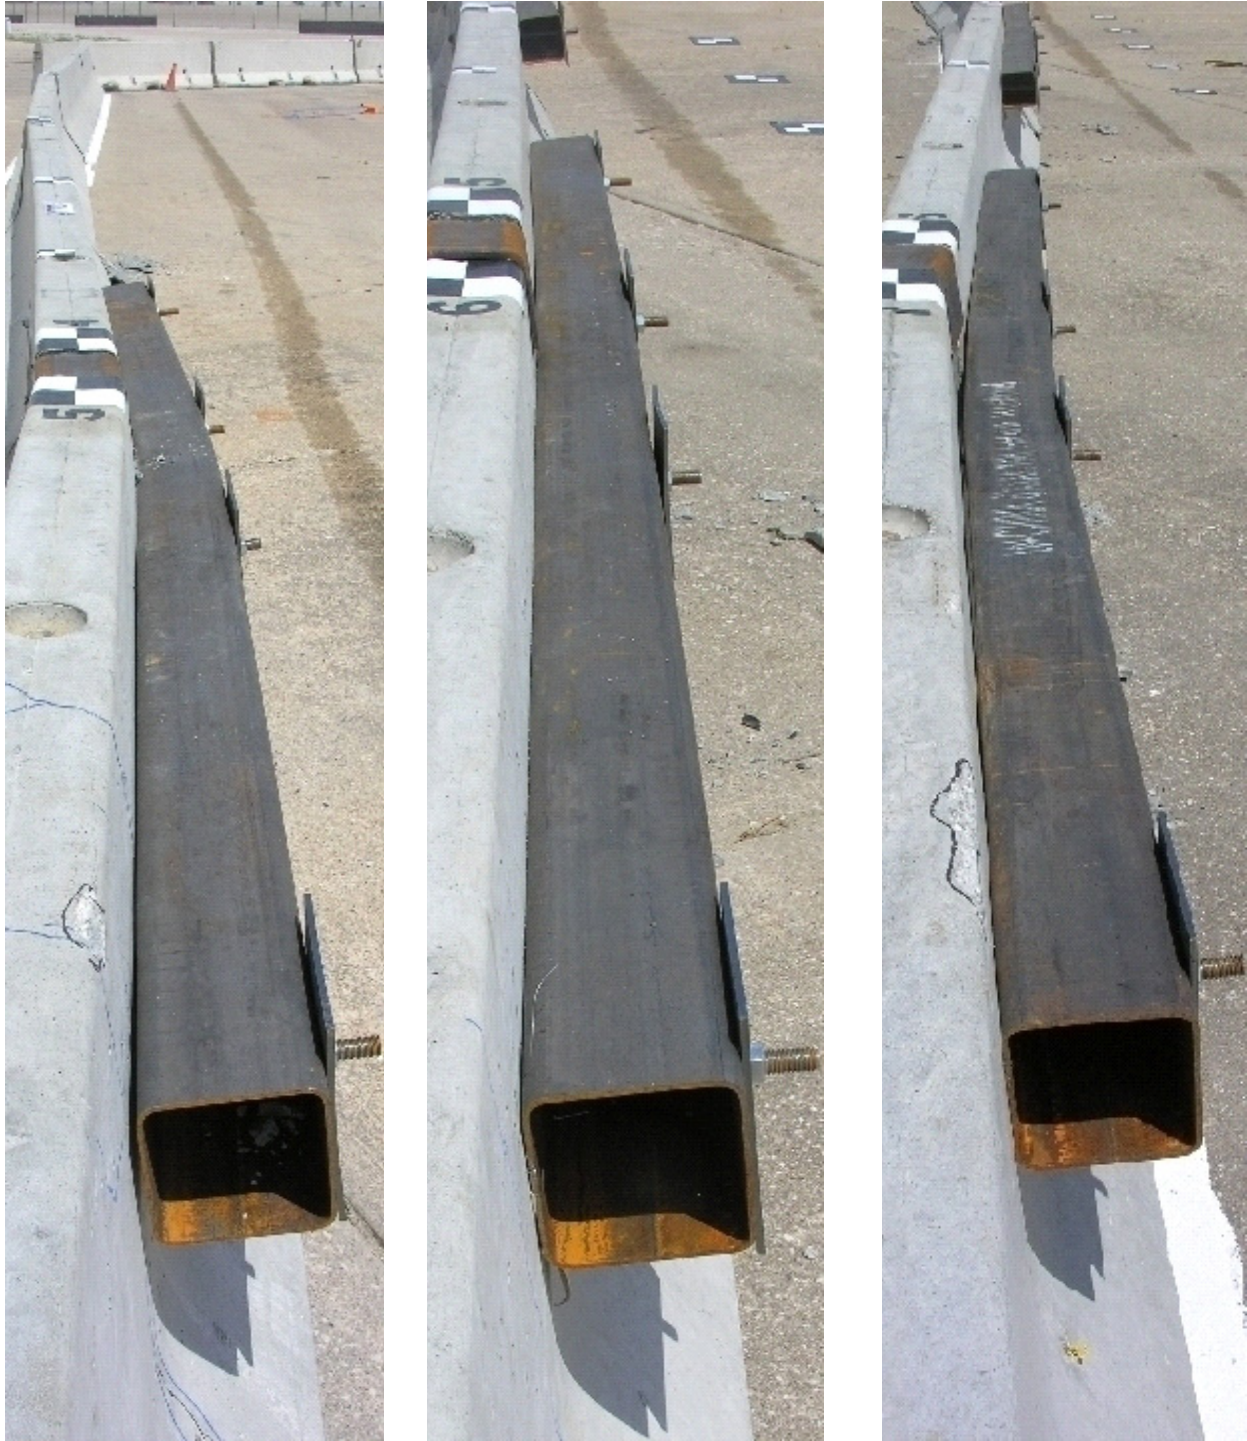
Figure 41. Temporary Barrier Box Beam Stiffener Damage, Test NYTCB-1

During the test, the anchor rods and nuts on the front-downstream end of barrier section no. 4 and the front-upstream end of barrier section no. 5, used to attach the box beam to the barrier, were sheared off. This result likely occurred as the vehicle was in contact with the barrier face and snagged on the protruding threaded rods and nuts. It should be noted that the rod and nut provide restraint for the box beam and the resulting barrier stiffening. As such, it is recommended that future design variations attempt to reduce the snag potential on the rod and nut as barrier deflections may increase with premature rod fracture. One alternative would be to incorporate dome head bolts on the traffic-side face of the barrier. This option was suggested during the construction of the barrier system.

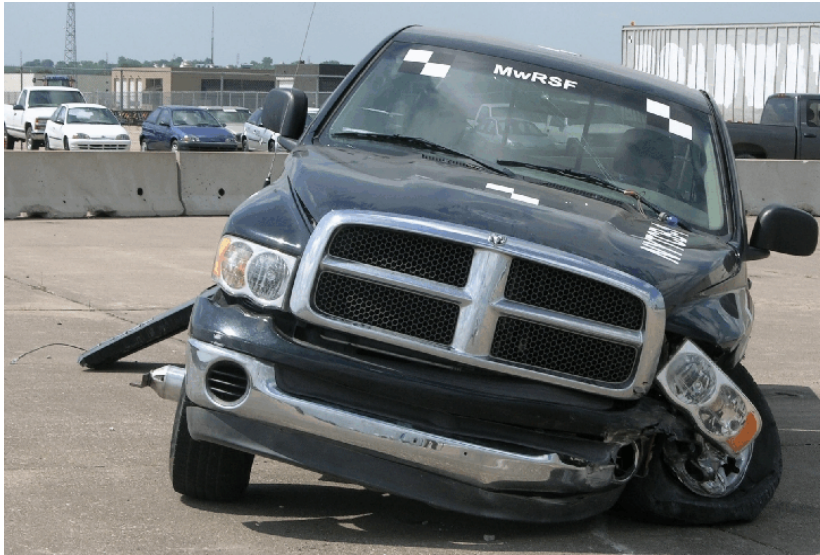
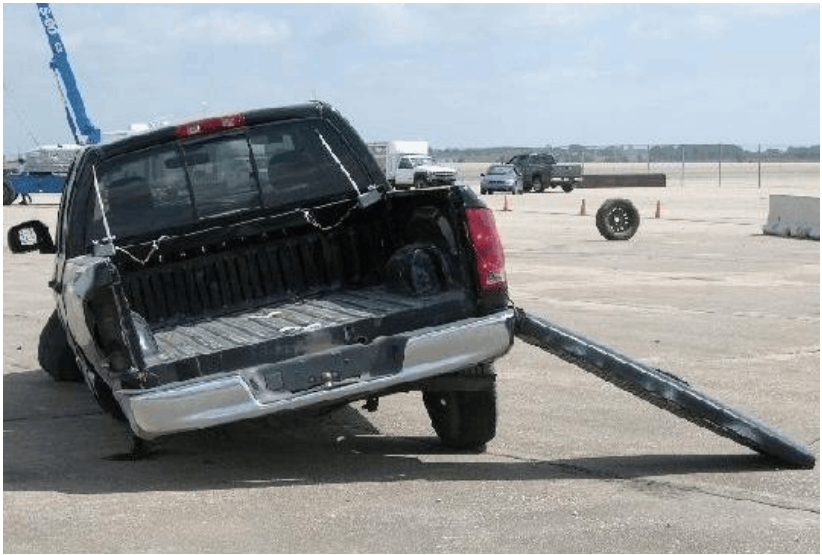
Figure 42. Vehicle Damage, Test NYTCB-1

Exterior vehicle damage was moderate, as shown in Figures 42 and 43. Occupant compartment deformations to the left side and center of the floorboard were judged insufficient to cause serious injury to the vehicle occupants. Maximum longitudinal deflections of 19 mm (0.75 in.) were located near the left-front corner of the left-side floor pan. Maximum lateral deflections of 38 mm (1.5 in.) were located near the left-front corner of the floorboard. Maximum vertical deflections of 32 mm (1.25 in.) were located near the left front of the floorboard. Complete occupant compartment deformations and the corresponding locations are provided in Appendix C.

Damage was concentrated on the left-front corner of the vehicle. The left corner of the front bumper deformed inward and the right side was detached. The left-front tire's side walls were

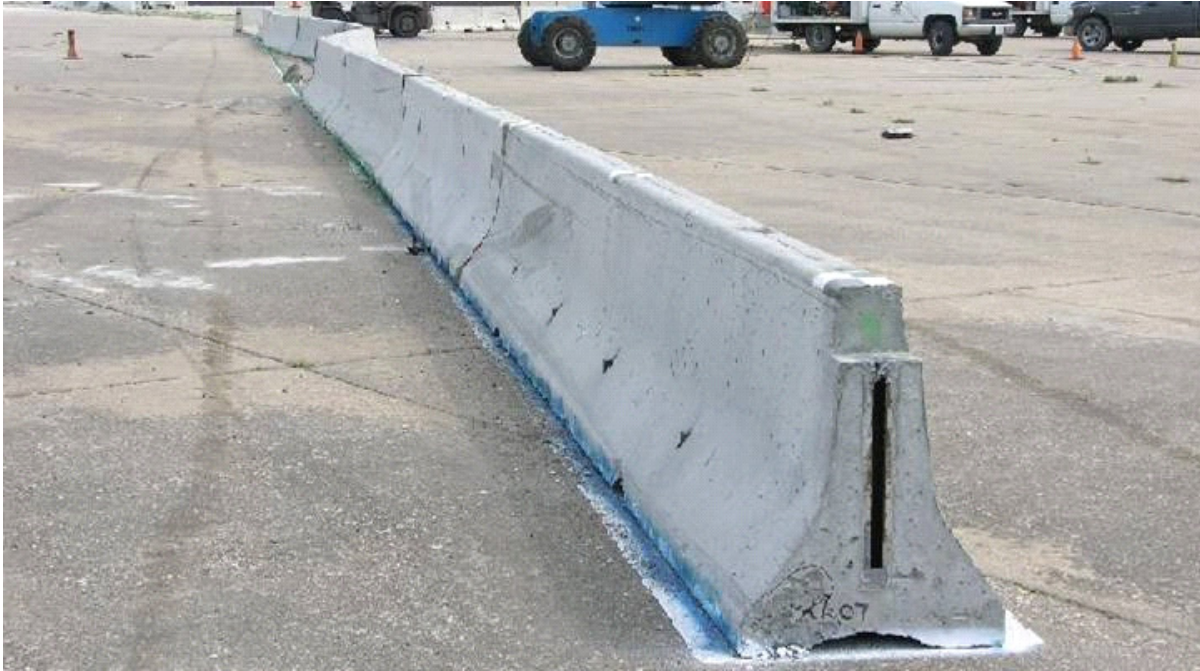
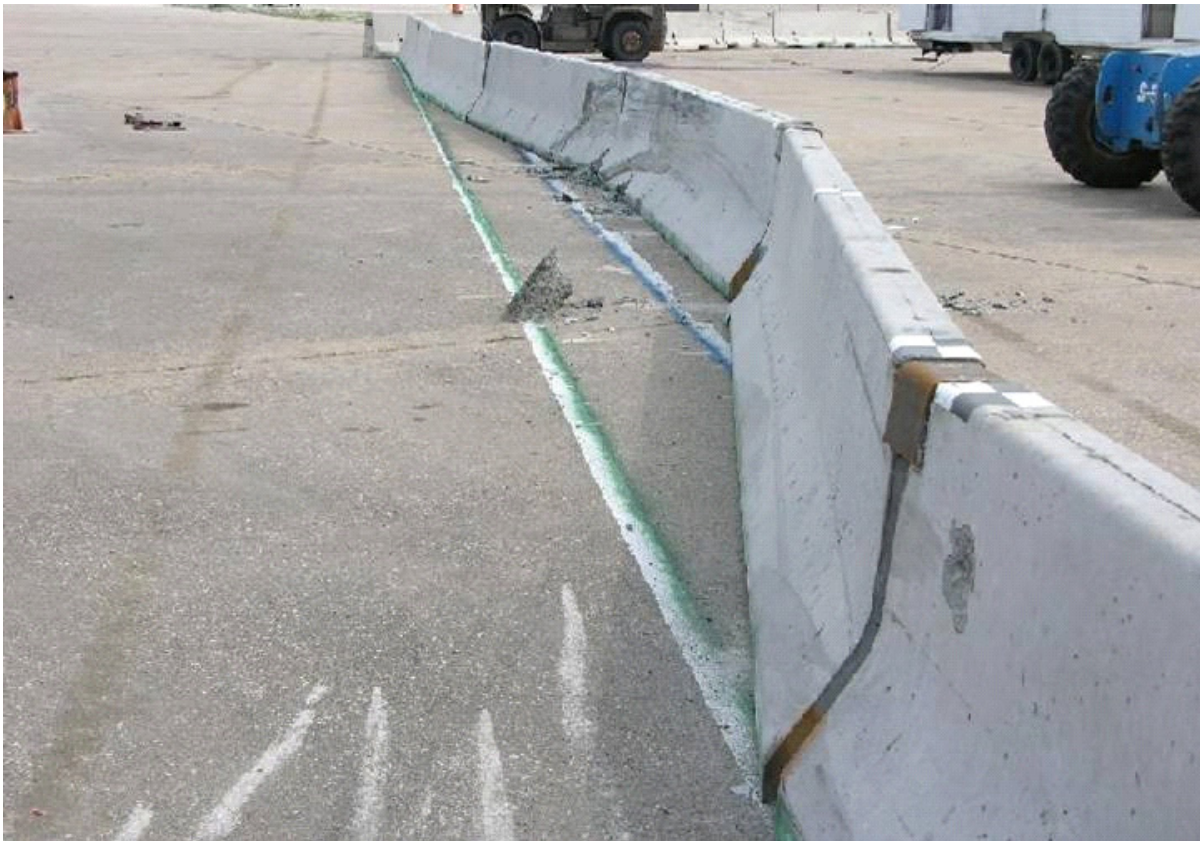
Figure 58. Temporary Barrier Damage, Test NYTCB-2

Damage to the barrier was moderate, as shown in Figures 58 through 61. Barrier damage consisted of tire and gouge marks, concrete barrier cracking, and spalling concrete. The length of the vehicle contact along the system was approximately 13.97 m (45.8 ft), which spanned from 1.78 m (70 in.) upstream from the downstream end of barrier no. 4 through the downstream end of barrier no. 6.

The permanent set of the barrier system is shown in Figures 58 and 59. The maximum lateral permanent set barrier deflection was 1,003 mm (39.5 in.) at the downstream end of barrier no. 4 and the upstream end of barrier no. 5, as measured in the field. The maximum lateral dynamic barrier deflection was 1,023 mm (40.25 in.) at the midpoint of barrier no. 5, as determined from high-speed digital video analysis. The working width of the system was found to be 1,630 mm (64.2 in.).

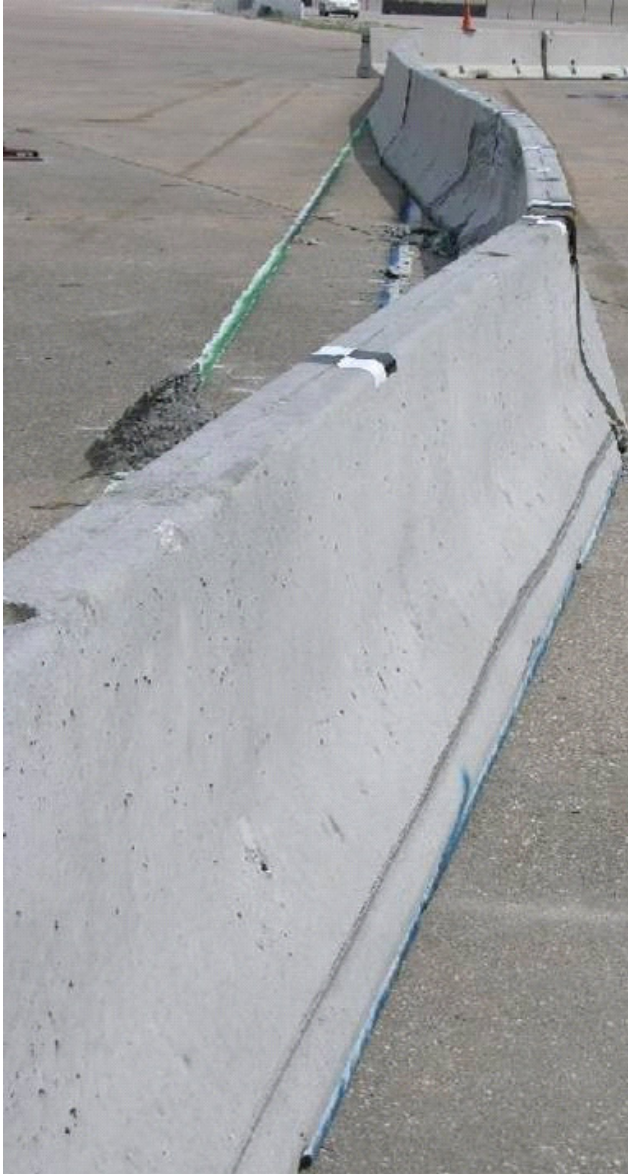
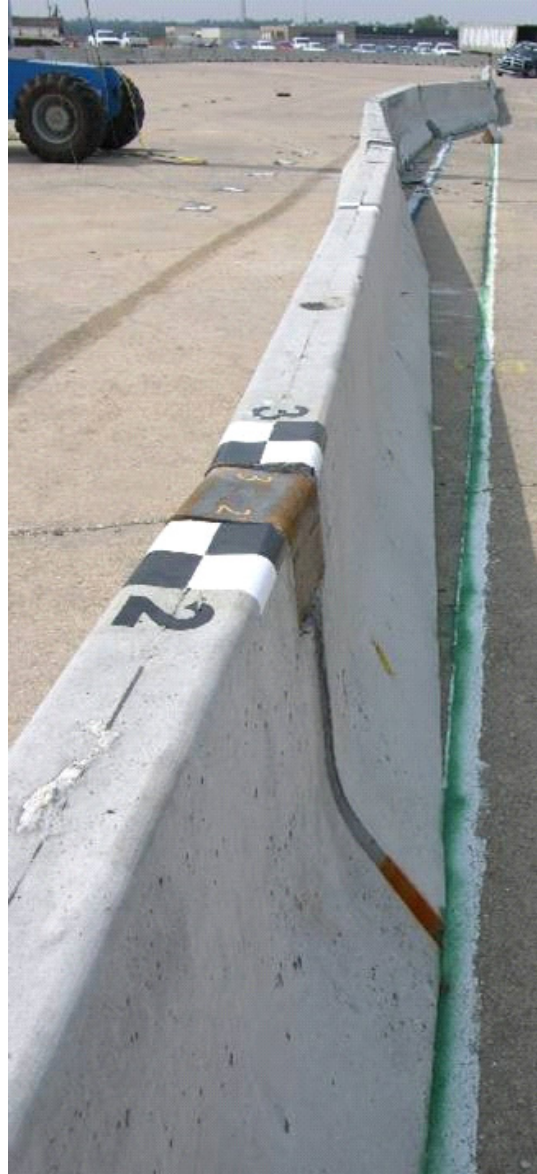
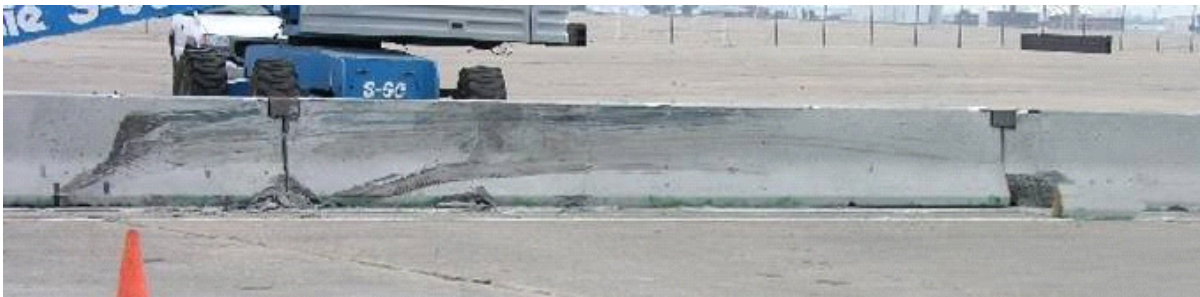
Figure 59. Temporary Barrier Damage, Test NYTCB-2

Contact marks were visible on the front face of barrier nos. 4 through 6. Tire marks were found 1,778 mm (70 in.) upstream from the downstream end of barrier no. 4 and continued through the downstream end of barrier no. 5. Tire marks were also found beginning at the midpoint of barrier no. 6 and continued through the end of barrier no. 6. Blue contact marks were found on barrier nos. 4 and 5.

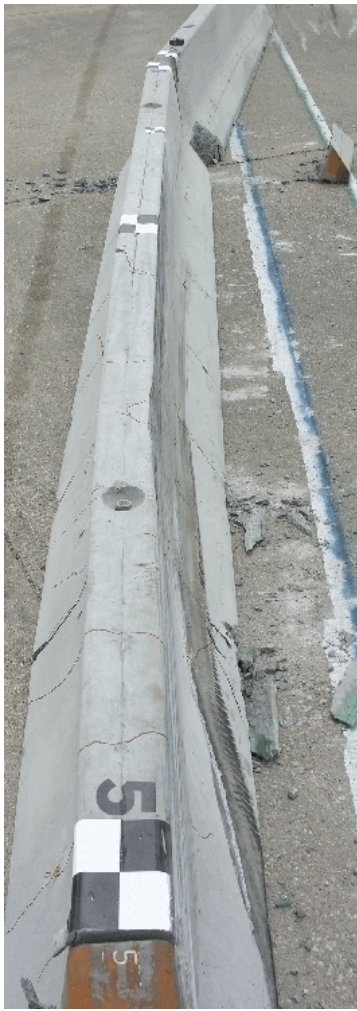
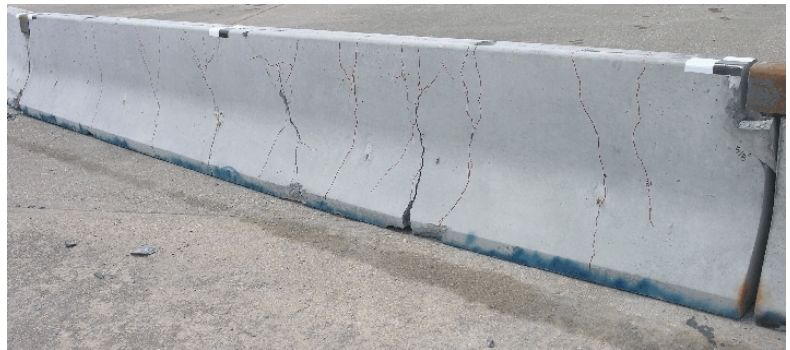
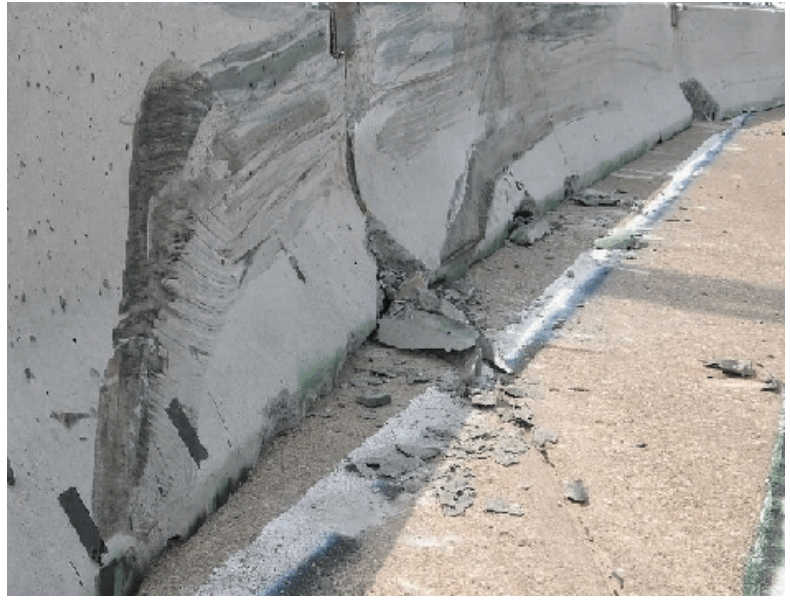
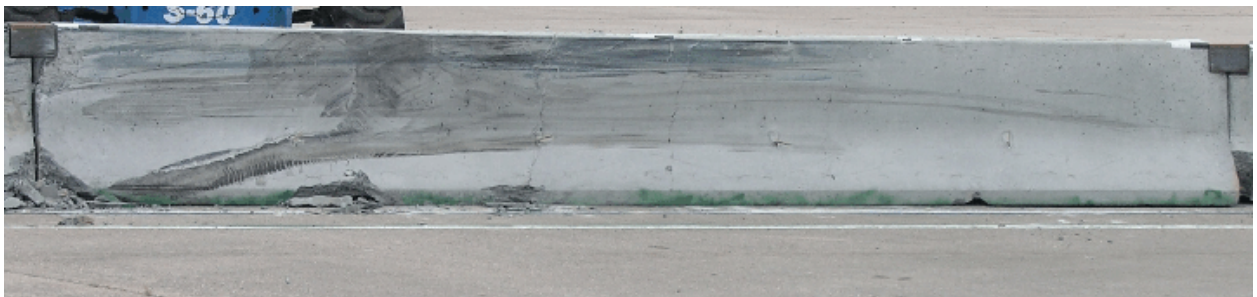
Figure 60. Barrier No. 5 Damage, Test NYTCB-2

Cracking was found on the front and back sides of barrier no. 4 from the center of the barrier to the downstream end. Major cracking was found throughout the front and back sides of barrier no. 5. Minor cracking was also found throughout the length of barrier no. 6 and on both the front and back sides.

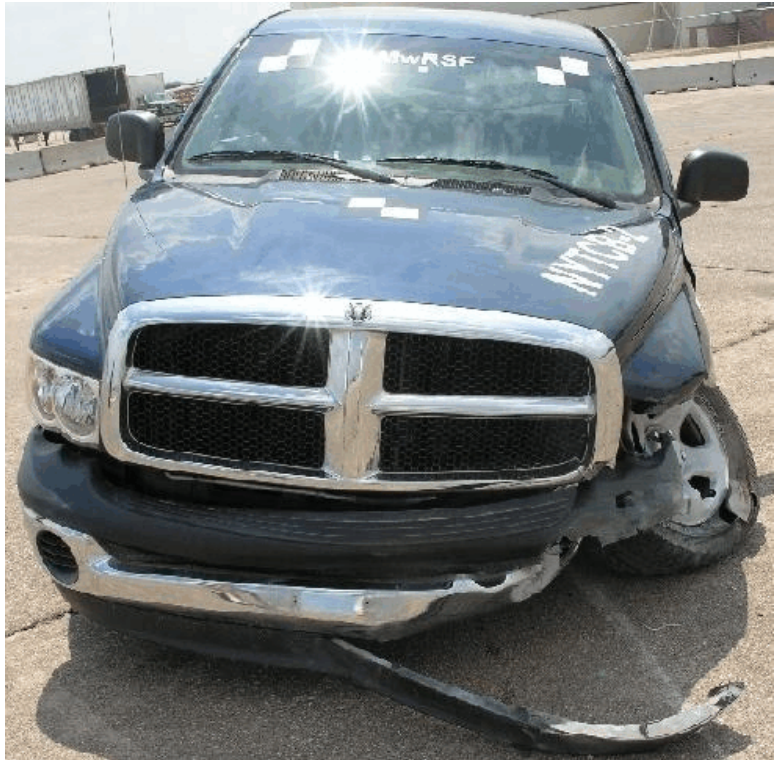
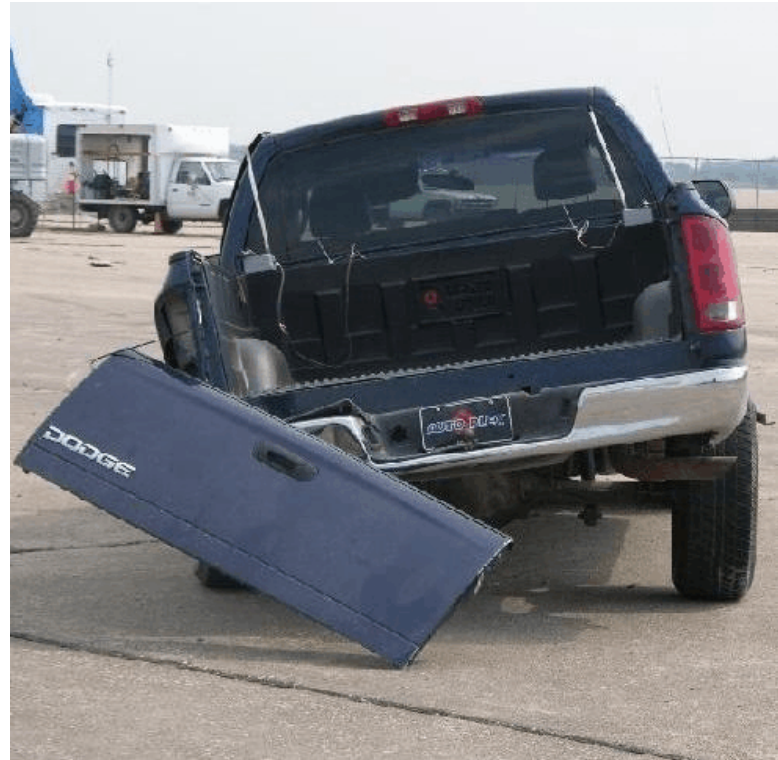
Figure 62. Vehicle Damage, Test NYTCB-2

Exterior vehicle damage was moderate, as shown in Figures 62 and 63. Occupant compartment deformations to the left side and center of the floorboard were judged insufficient to

Damage was concentrated on the left-front corner of the vehicle. The left-front and right-front quarter panels buckled inward toward the engine compartment. The left corner of the front bumper deformed and both sides were partially detached from the vehicle. The left-front tire's side wall experienced a 127-mm (5-in.) long gash, and the tire deflated. The left-front wheel assembly was deformed into the wheel well. A small gouge was found in the left-rear tire, and the tire deflated. The left-front door was ajar at the top. Scrape marks and dents were found at the bottom of the left front and left-rear doors, the left-front and right-front quarter panels, the left-rear corner of the box, and the right-rear corner of the cab. The left side of the box portion separated from the cab. The left-rear axle deformed upward. The left-side headlight and taillight disengaged from the vehicle. The left side of the rear bumper buckled inward. The tailgate disengaged, except it remained attached by the left-side cable. The front frame on the left side was deformed. The left-side upper control arm and pin were bent and scraped. All window glass in the vehicle remained undamaged.

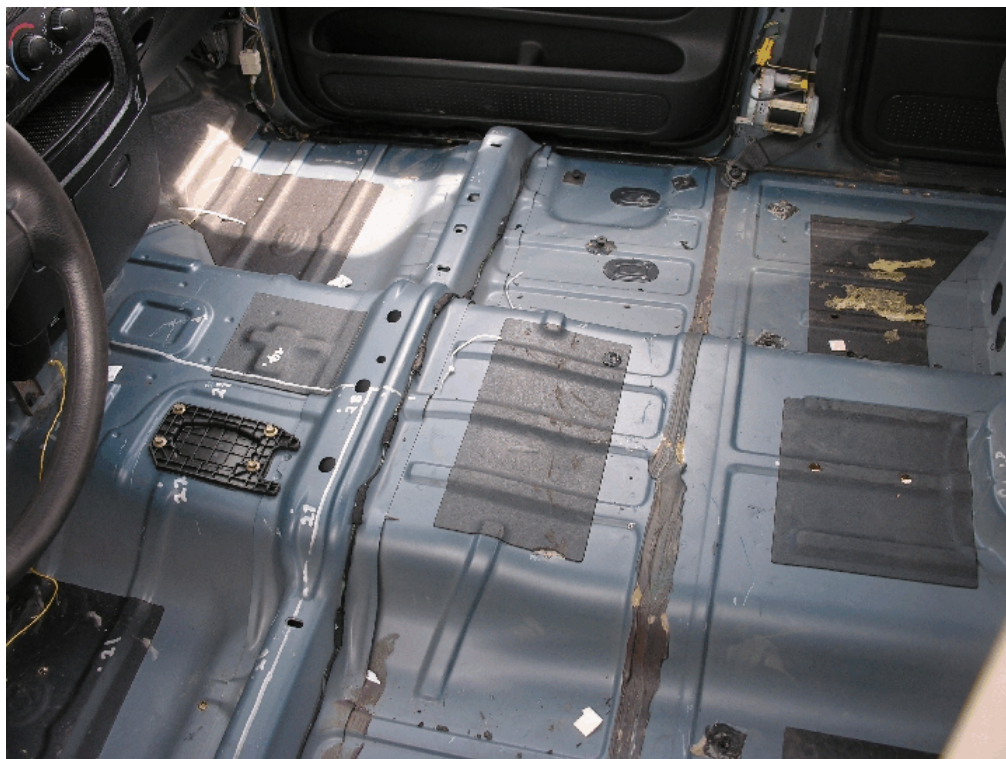
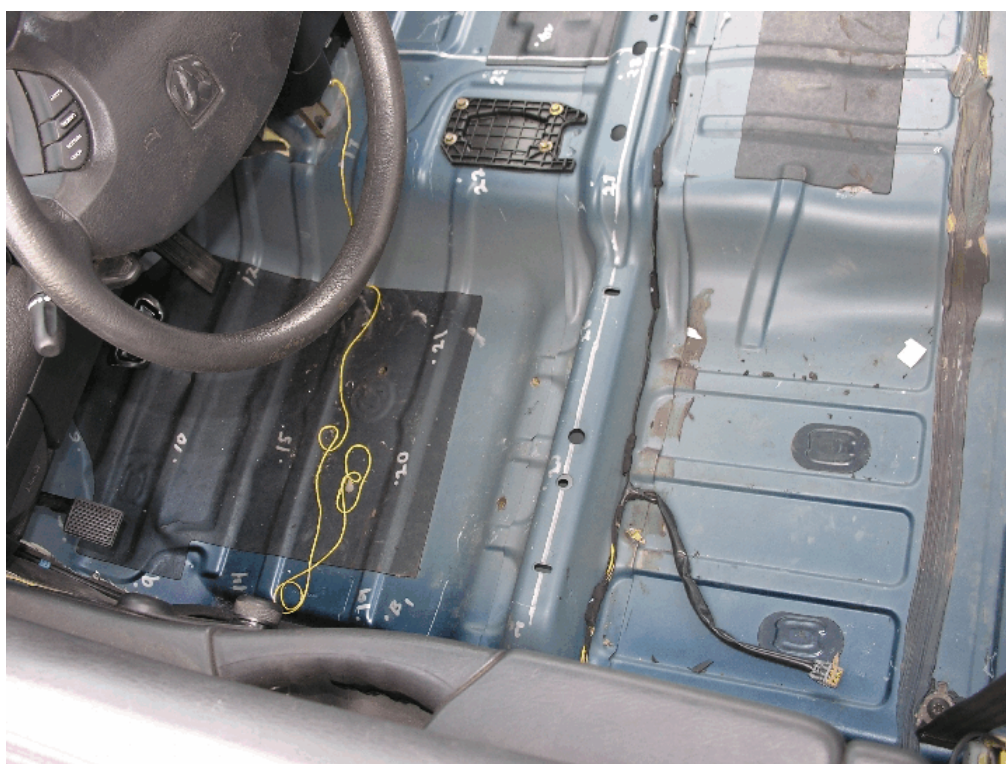
Figure 64. Occupant Compartment Deformation, Test NYTCB-2

cause serious injury to the vehicle occupants, as shown in Figure 64. Maximum longitudinal deflections of 76 mm (3 in.) were located near the left-front corner of the left-side floor pan. Maximum lateral deflections of 25 mm (1 in.) were located near the front center of the left-side floor pan. Maximum vertical deflections of 70 mm (2.75 in.) were located near the middle-front area of the left-side floor pan. Complete occupant compartment deformations and the corresponding locations are provided in Appendix C.

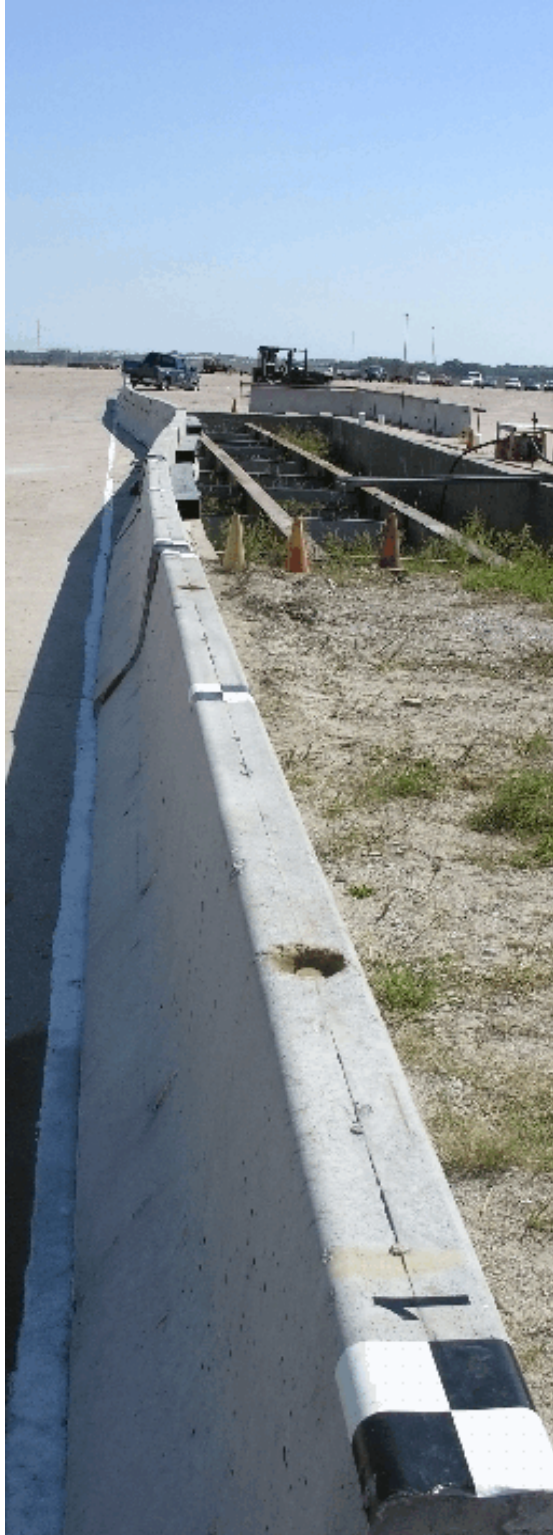
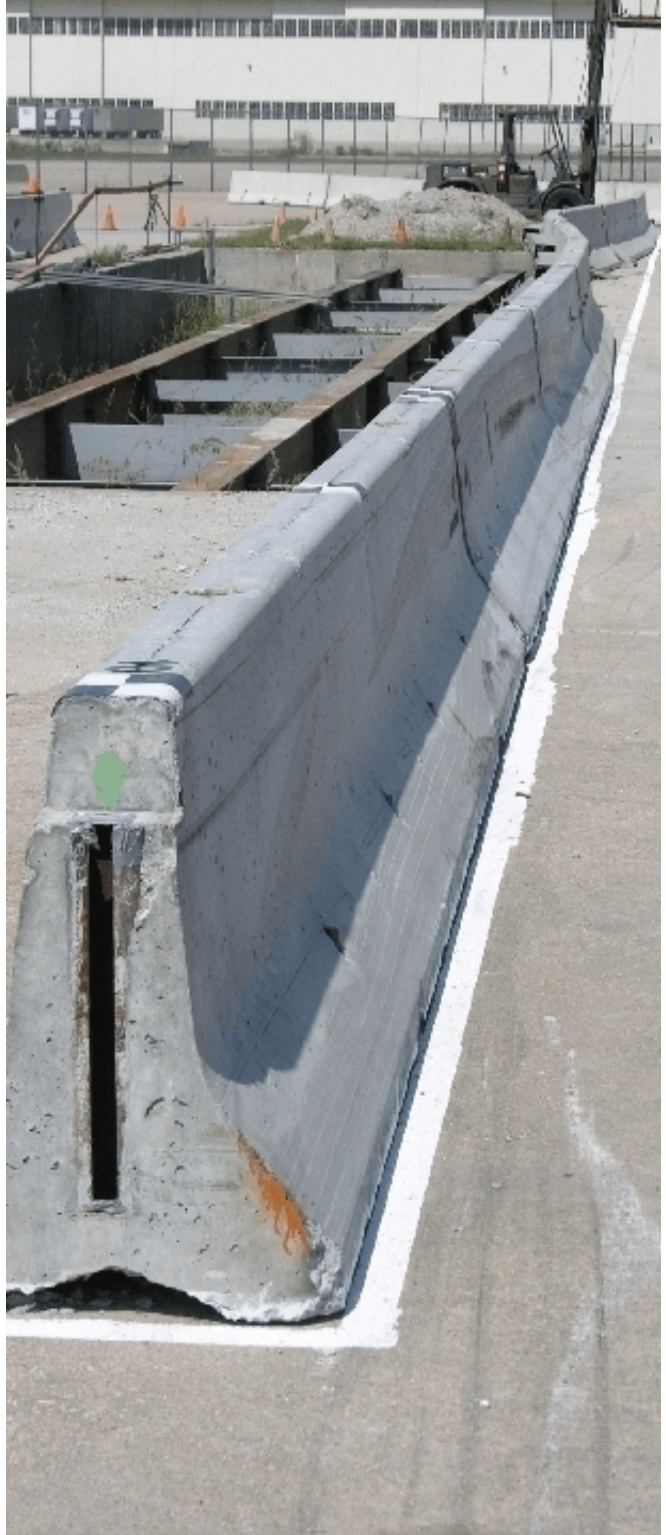
Figure 78. Box Beam Stiffened Temporary Barrier Damage, Test NYTCB-3

Damage to the barrier was moderate, as shown in Figures 78 through 84. Barrier damage consisted of contact and gouge marks, concrete barrier cracking, spalling of the concrete, and deformed box beam sections. The length of vehicle contact along the temporary barrier system was approximately 31.7 m (104 ft), which spanned from 1,783 mm (70.2 in.) upstream from the downstream end of barrier no. 4 through 3,785 mm (149 in.) downstream from the upstream end of barrier no. 5 and from 1,753 mm (69 in.) downstream from the upstream end of barrier no. 6 through the downstream end of barrier no. 10.

Tire marks were visible on the front face of barrier nos. 4 through 10. Gouge marks were found on the upstream front face of barrier no. 5.
