EVALUATION OF BOX BEAM STIFFENING OF UNANCHORED TEMPORARY CONCRETE BARRIERS

MIDWEST ROADSIDE SAFETY FACILITY

MwRSF Research Report No. TRP-03-202-08

March 14, 2008

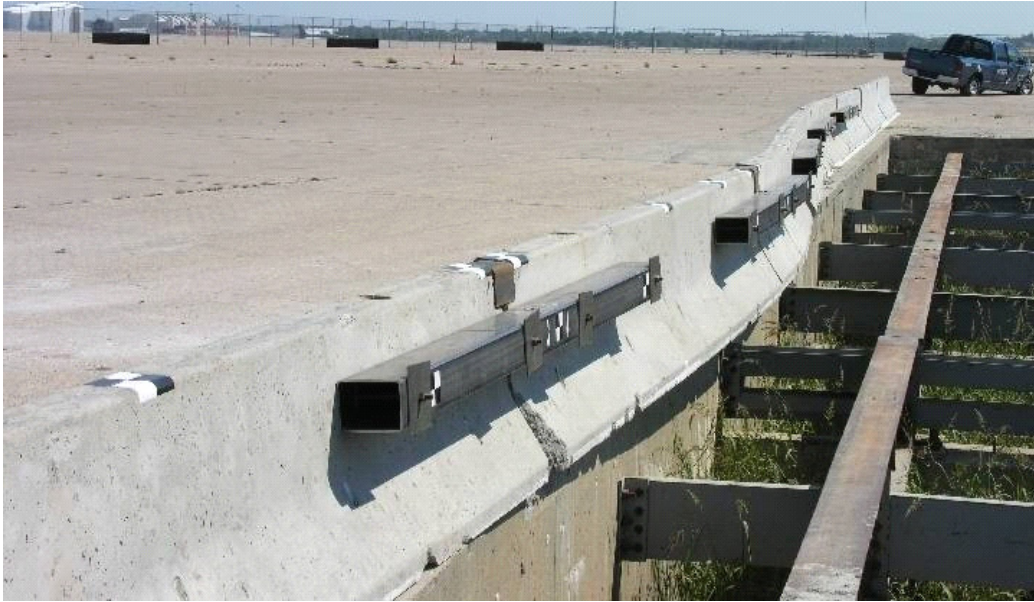
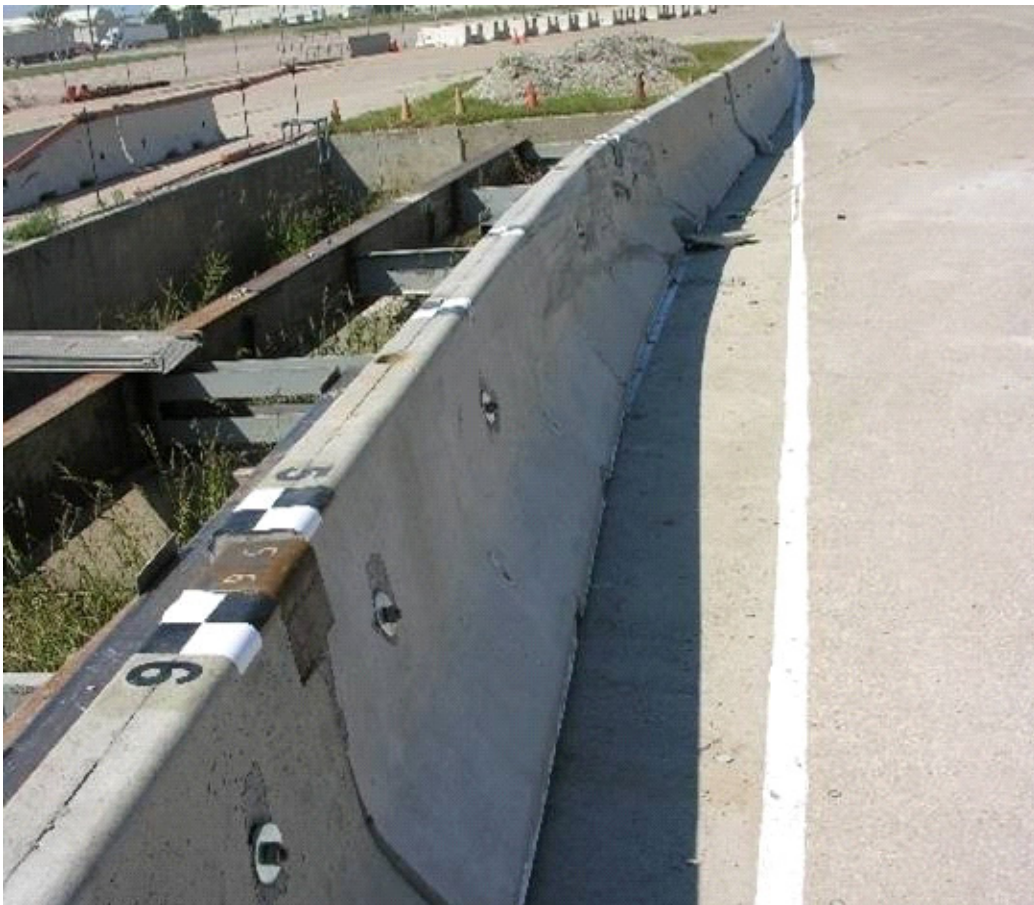
Figure 79. Box Beam Stiffened Temporary Barrier Damage, Test NYTCB-3

Cracking was found on the front and back sides of barrier no. 3. One 3.2-mm (0.125 in.) wide crack was found on the back side of barrier no. 3 and began 1,016 mm (40 in.) downstream from the upstream end of the barrier. Three hairline cracks were found on the front side of barrier no. 3 and began 1,676 mm (66 in.), 2,388 mm (94 in.), and 3,658 mm (144 in.) downstream from the upstream end of the barrier and traveled from the top to the bottom of the barrier. Major cracking was found throughout the front and back sides of barrier nos. 4 and 5. Hairline cracks were located on the back side of barrier no. 4 at 1,499 mm (59 in.), 2,413 mm (95 in.), 4,826 mm (190 in.), and 5,486 mm (216 in.) downstream from the upstream end of barrier no. 4. Two 1.6-mm (0.06-in.) wide cracks were located 3,048 mm (120 in.) and 3,607 mm (142 in.) downstream from the upstream end of the barrier with the front side experiencing hairline cracks at the same locations. A 3.2-mm (0.13-in.) wide crack was located on the back side of barrier no. 4 at 4,242 mm (167 in.) downstream from the upstream end of the barrier with the front side experiencing hairline cracking at the same location.

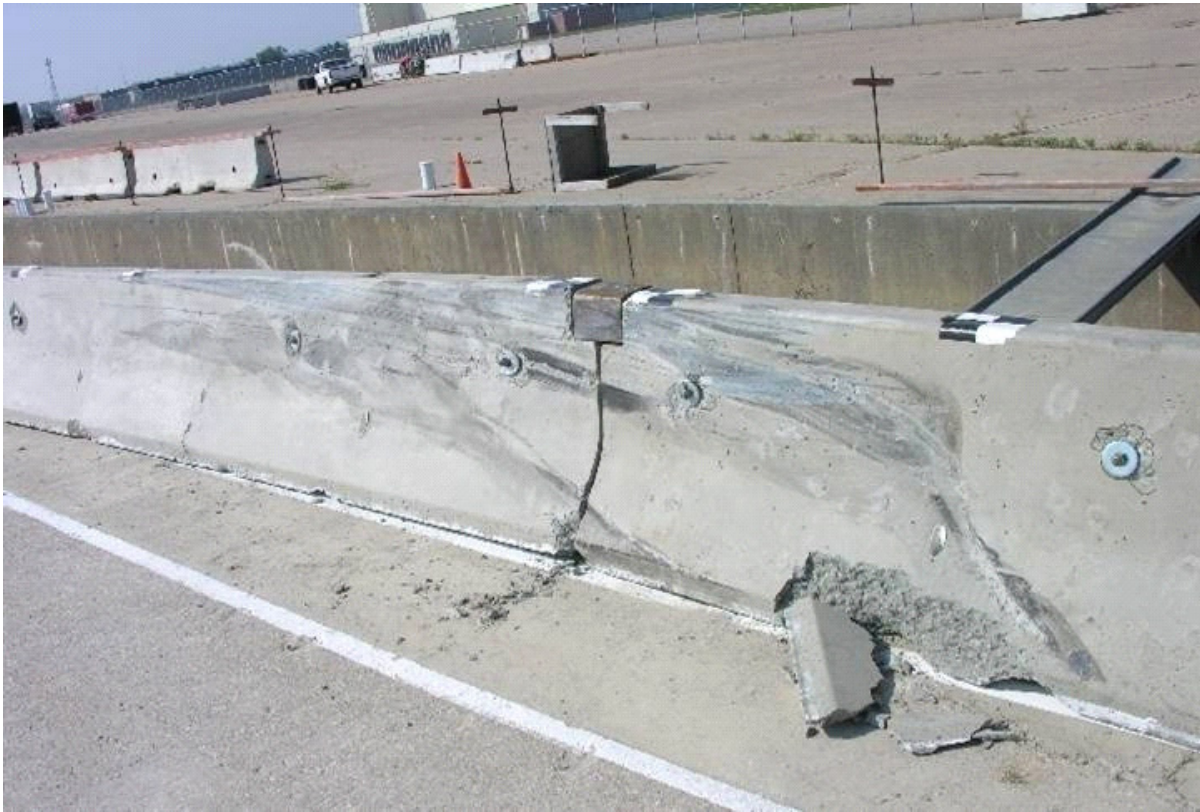
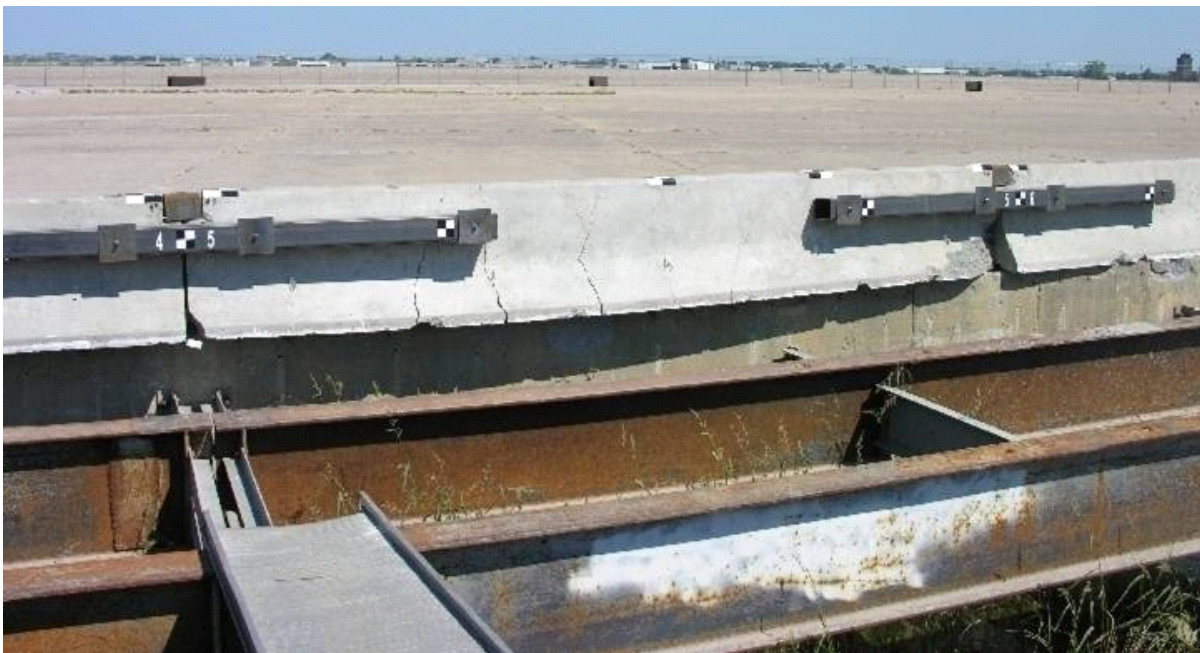
Figure 80. Box Beam Stiffened Temporary Barrier Damage, Test NYTCB-3

A 1.6-mm (0.06-in.) wide crack was located on the back side at 3,073 mm (121 in.) downstream from the upstream end of barrier no. 5. Three 6.4-mm (0.25-in.) cracks were found on the back side of barrier no. 5 at 1,422 mm (56 in.), 1,829 mm (72 in.), and 2,515 mm (99 in.) downstream from the upstream end of the barrier with hairline cracks on the front side at these same locations. A 3.2-mm (0.13-in.) wide crack was also found on the back side of barrier no. 5 at 3,759 mm (148 in.) downstream from the upstream end of the barrier with a hairline crack on the front side at this location. A hairline crack was located on the front and back sides of barrier no. 5 at 4,597 mm (181 in.) downstream from the upstream end of the barrier. Minor hairline cracking was located on the front of barrier no. 6 at 1,676 mm (66 in.), 2,337 mm (92 in.), 3,302 mm (130 in.), and 4,267 mm (168 in.) downstream from the upstream end of the barrier. One 1.6-mm (0.06-in.) wide crack was found on the front and back sides of barrier no. 7 at 1,829 mm (72 in.) downstream from the upstream end of the barrier.

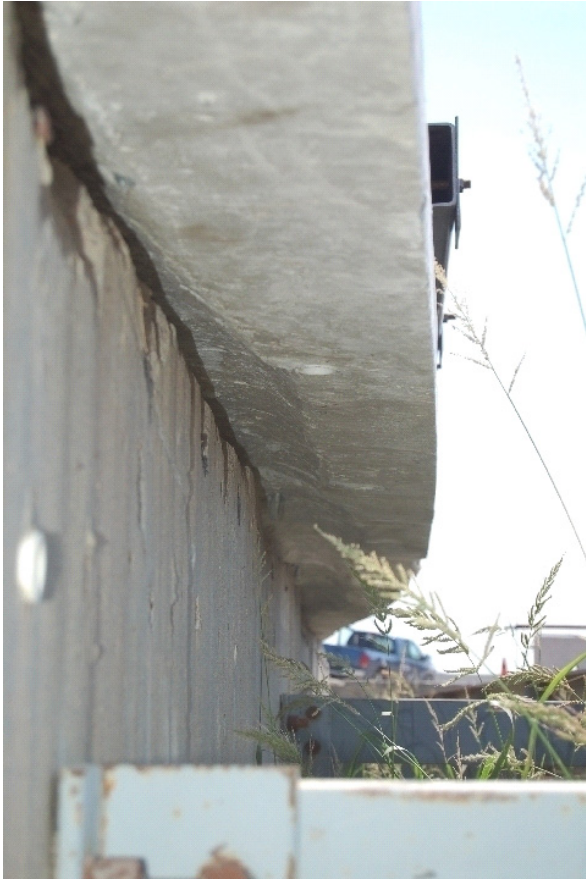
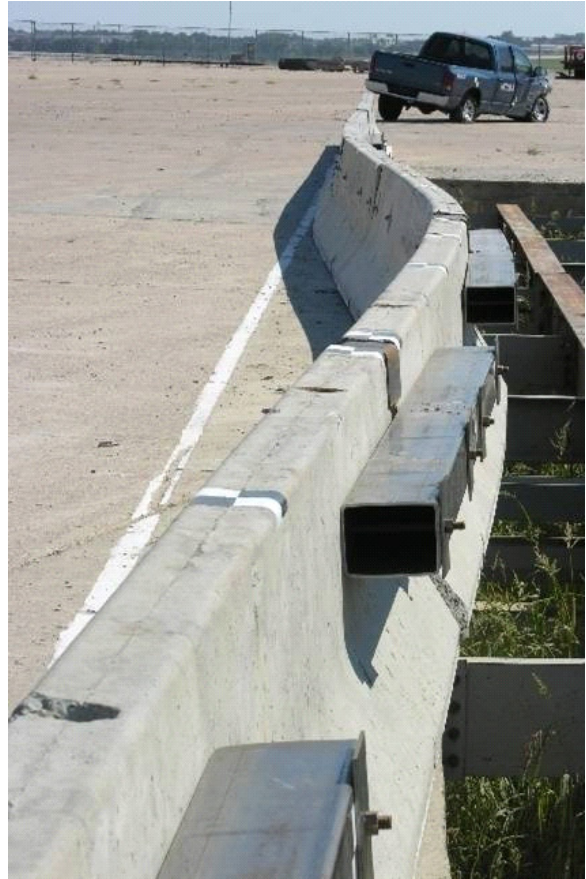
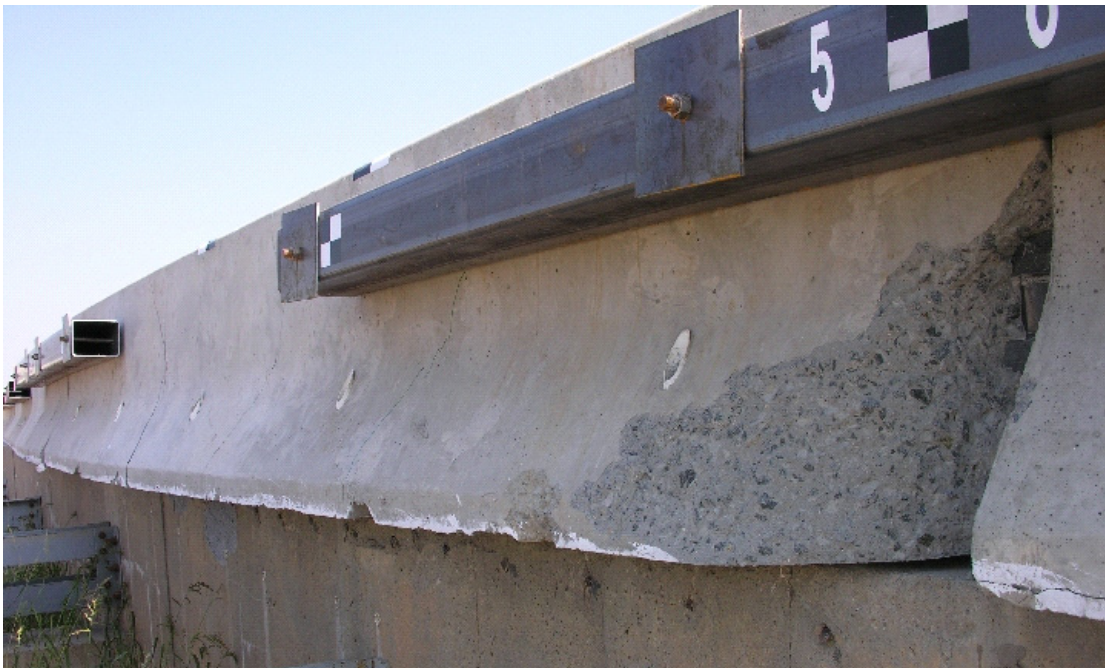
Figure 81. Box Beam Stiffened Temporary Barrier Damage, Test NYTCB-3

Concrete spalling occurred on barrier nos. 3 through 7. The downstream corner of barrier no. 3 experienced minor concrete spalling. A 737-mm (29-in.) long and 216-mm (8.5-in.) tall piece of concrete was removed from the front side of barrier no. 4 near impact. Minor concrete spalling was found on the back-upstream end of barrier no. 4, the lower-front face of barrier no. 5, and the front faces of barrier nos. 6 and 7. A 686-mm (27-in.) long by 483-mm (19-in.) tall piece of concrete was removed from the lower back-downstream corner of barrier no. 5, and exposed the steel rebar.

The box beam stiffener located across the joint between barrier nos. 4 and 5 sustained significant bending. The box beam stiffener placed across the joints between barrier nos. 2 and 3, 3 and 4, 5 and 6, and 6 and 7 experienced minor bending. The box beam rods on the front sides of barrier nos. 4 through 6 were bent, and scrape marks were found on the corresponding nuts and washers. All connection keys remained undamaged, except for minor contact marks. The anchor
