Texas Transportation Institute

NCHRP REPORT 350 TEST 3-11 OF THE LONG-SPAN GUARDRAIL WITH 5.7 M CLEAR SPAN AND NESTED W-BEAMS OVER 11.4 M

Contract No. T4541-AA
Report/Test No. 405160-1-1
Test Date: May 24, 2006

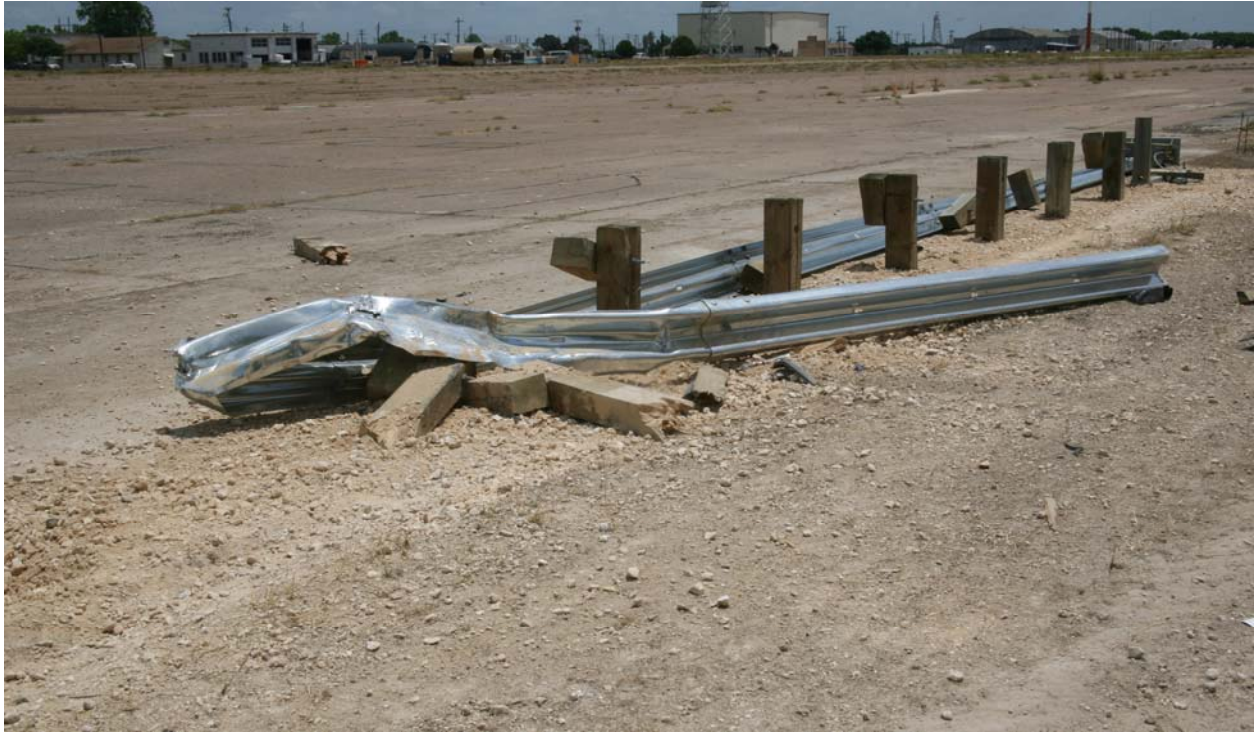
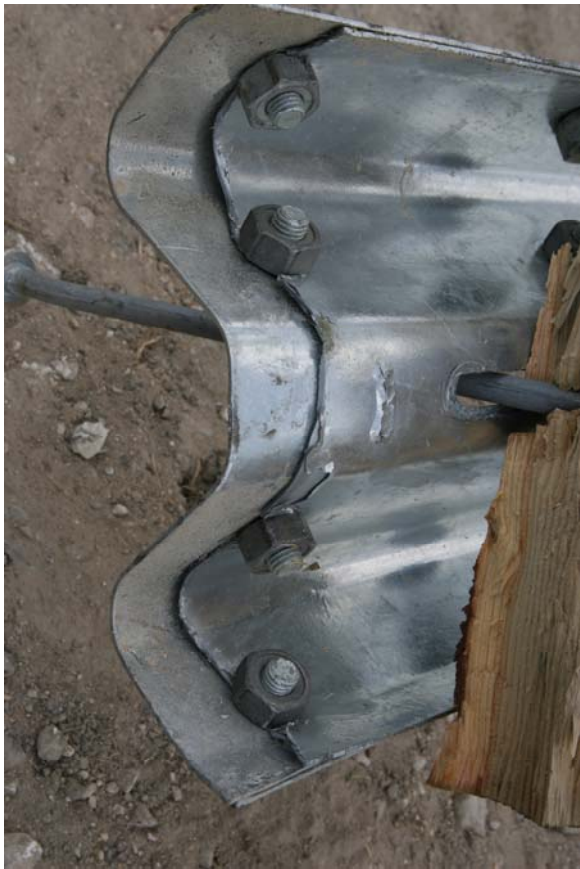
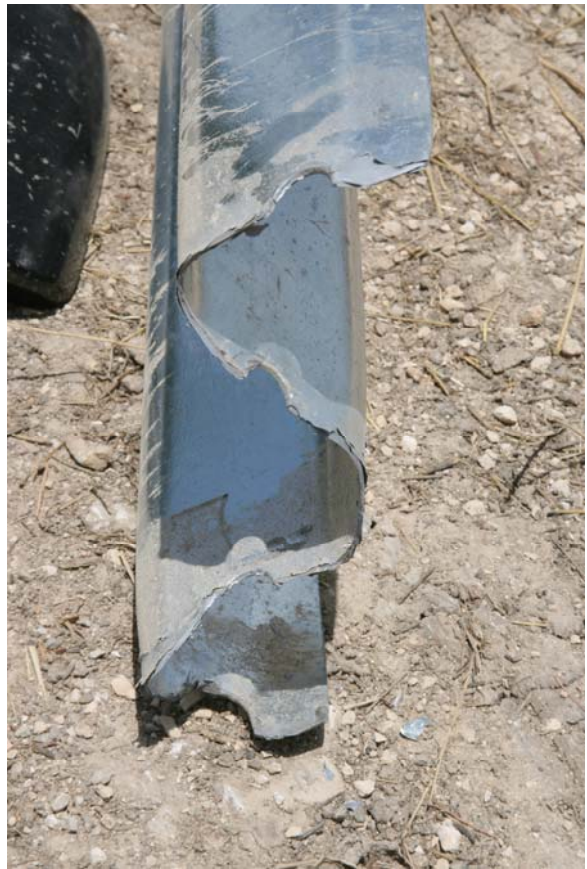
Figure 10. Installation after test 405160-1-1.

Damage to the installation is shown in figures 9 and 10. The rail ruptured at post 13, where the section changed from nested to single layer. Posts 1 and 2 were disturbed, post 3 was pulled downstream 10 mm, and posts 4-5 were disturbed. Posts 6 and 7 were pulled upstream 10 mm, and posts 8 through 10 were disturbed and post 10 was partially split longitudinally. Posts 11 and 12 were pulled toward field side 100 mm and 540 mm, respectively. Post 13 through 19 fractured at ground level and posts 14 through 18 were separated from the rail element. Post 14 was resting 3.8 m on the traffic side forward of the traffic face of the rail. The rail element was also separated from posts 20 through 25, but remained attached to post 26. The blockouts were separated from posts 21, 23 and 24. Post 25 was split longitudinally. Prior to exiting the view of the overhead camera, the working width was 4.1 m. Prior to rupture of the rail element, the maximum deflection of the rail was 1.45 m.

The rail element ruptured and allowed the vehicle to penetrate the rail system. The vehicle subsequently rolled onto its side. Therefore, the rail failed evaluation criteria for *NCHRP Report 350* test 3-11, as shown in table 1. The abrupt change in stiffness of the rail element where it changes from two layer of W-beam (nested) to a single layer may have contributed to rupture of the single layer rail element.

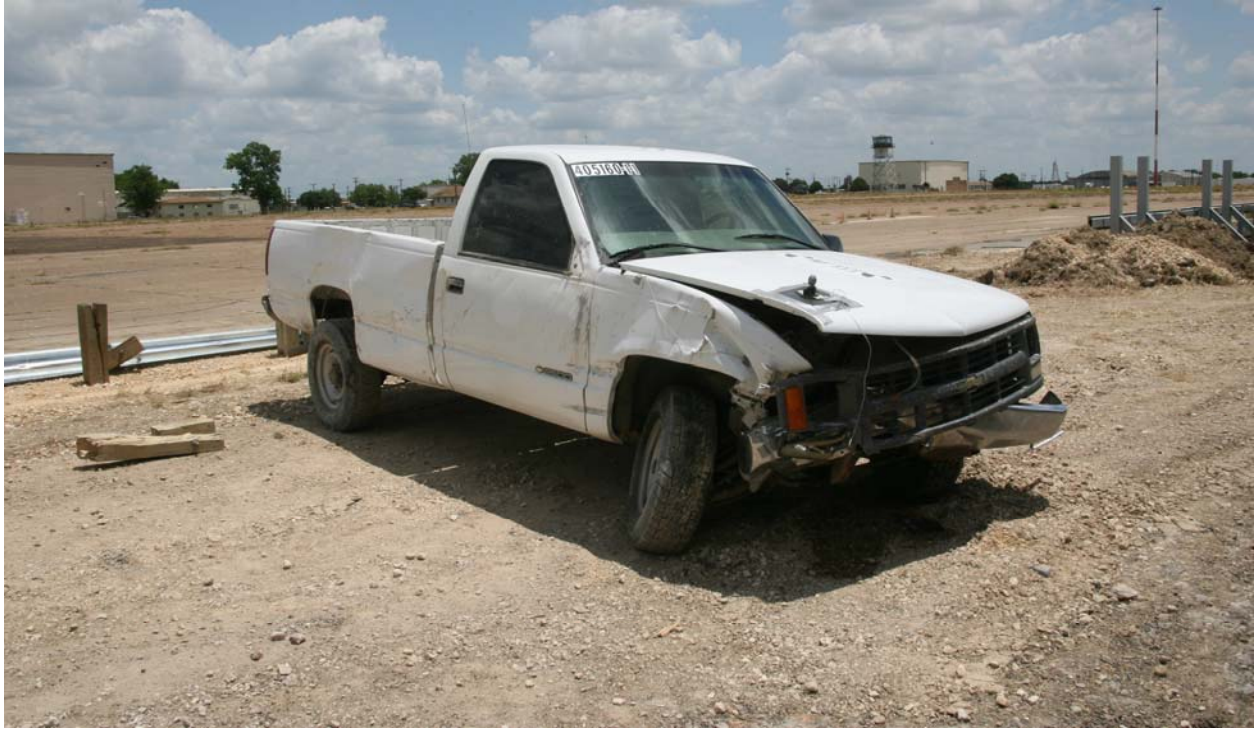
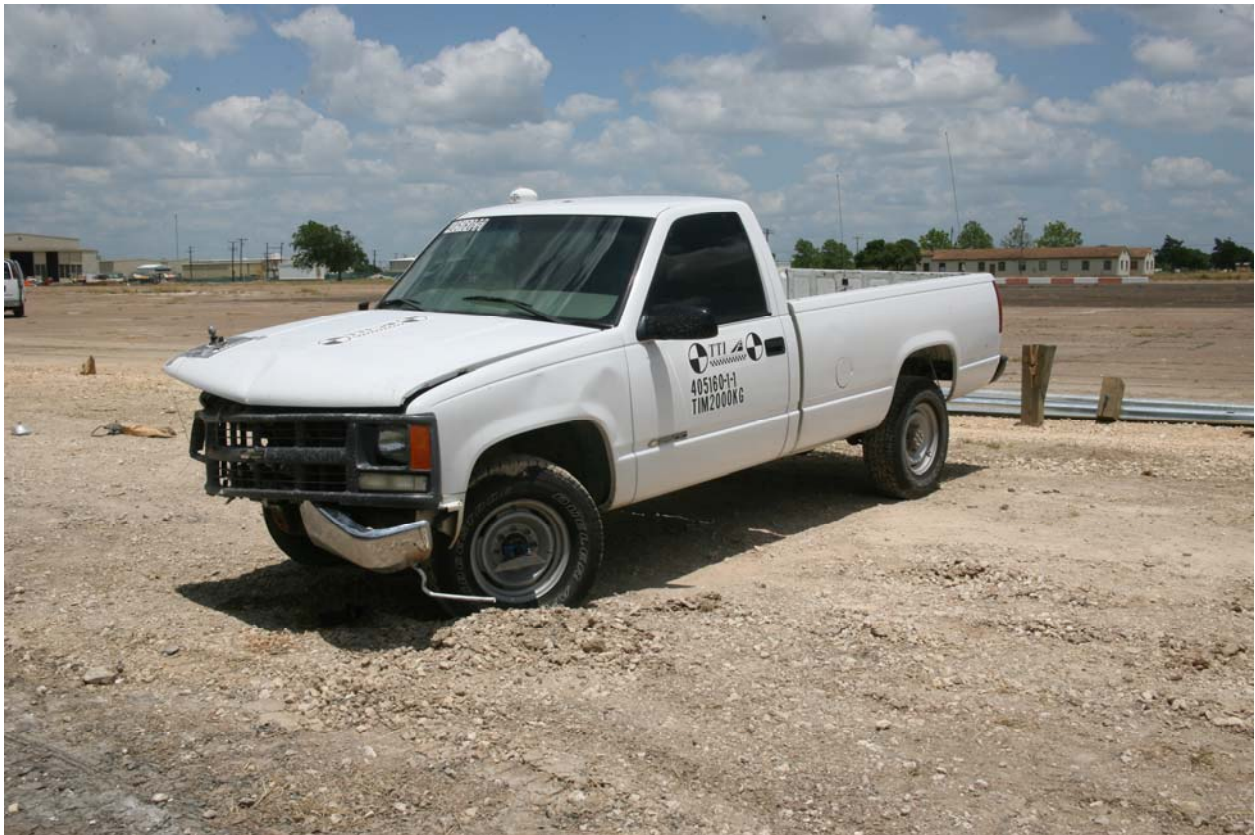
Figure 11. Vehicle after test 405160-1-1.

The vehicle sustained damage to the right side of the vehicle as shown in figure 11. The right upper and lower A-arm and right side frame rail were deformed. Also damaged were the front bumper, hood, grill, right front quarter panel, right door, right exterior bed, and right rear bumper. Maximum exterior crush to the vehicle was 540 mm in the frontal plane just to the right of centerline at bumper height. Maximum occupant compartment deformation was 16 mm in the right floor pan to instrument panel area. Photographs of the interior of the vehicle are shown in figure 12. Exterior vehicle crush and occupant compartment measurements are shown in appendix B, tables 2 and 3.

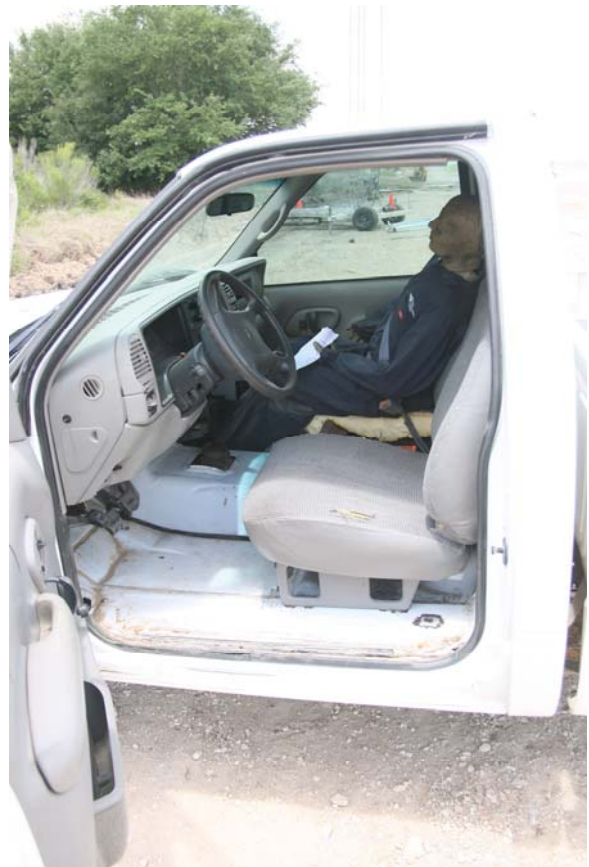
After test

Results: Some of the posts fractured and post 14 was resting 3.8 m on the traffic side of the rail. These debris did not penetrate nor show potential for penetrating the occupant compartment. Maximum occupant compartment deformation was 16 mm in the right floor pan to instrument panel area. (PASS)
