**CRASH TESTING AND EVALUATION OF THE
MODIFIED G4(1S) W-BEAM GUARDRAIL
ON 2:1 SLOPE**

Contract No. T4541-AC
Report/Test No. 405160-4-1
Test Date: 2008-04-16

NOVEMBER 2008

**TEXAS TRANSPORTATION INSTITUTE
THE TEXAS A&M UNIVERSITY SYSTEM
COLLEGE STATION, TEXAS 77843**

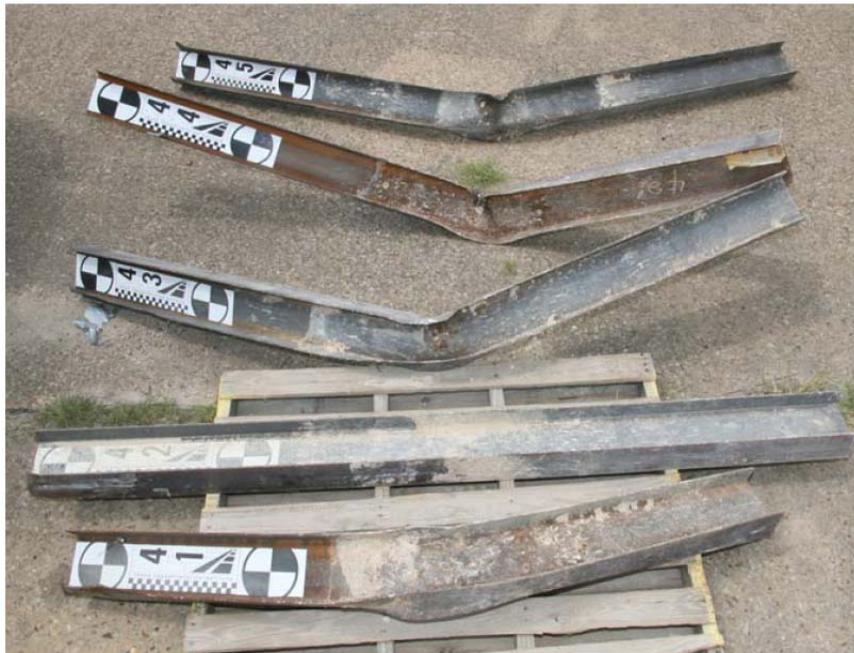
Figure 2.3. Extracted posts after first set of the bogies tests.

However, when the posts were extracted from the soil after testing, the 7-ft post did not show any sign of yielding or permanent deformation (see figure 2.3). Therefore, the 7-ft post was not considered sufficient for on slope placement, and the 8-ft post with 2H:1V slope was selected for further investigation.

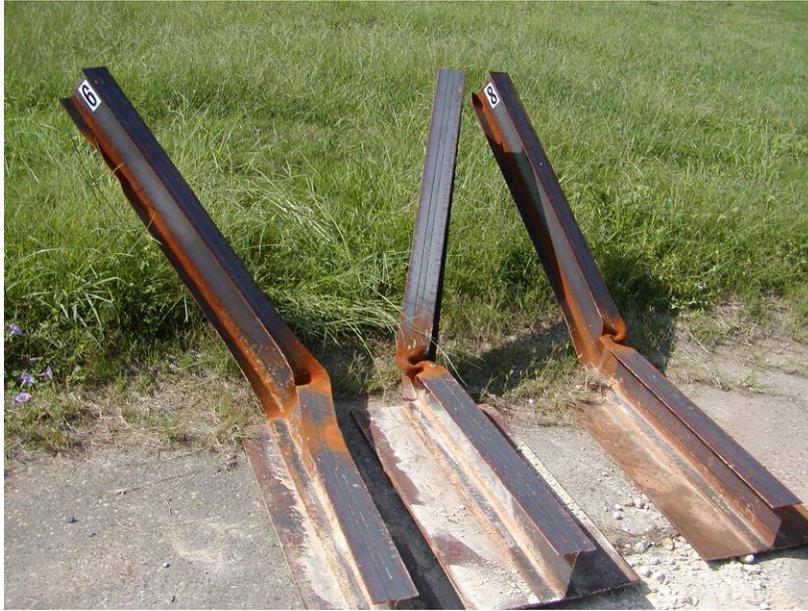
Figure 2.20. Deformed posts after test 6, 7 and 8.

However, upon inspecting the posts after the tests, all posts with soil plates yielded at the point above the soil plate top edge as shown figure 2.20. This is in contrast to the almost undeformed 7-ft post tested earlier as shown in figure 2.21.

This indicates that adding a soil plate would facilitate the creation of a plastic hinge in the post. Hence, adding the soil plate does help the interaction between the embedded depth of the post and the soil. Consequently, a model of the post with soil plate was constructed and the full scale model of the guardrail system was updated to include a 7-ft post with soil plate spaced at 6 ft-3 inches apart. The model of this configuration is shown in figure 2.22.

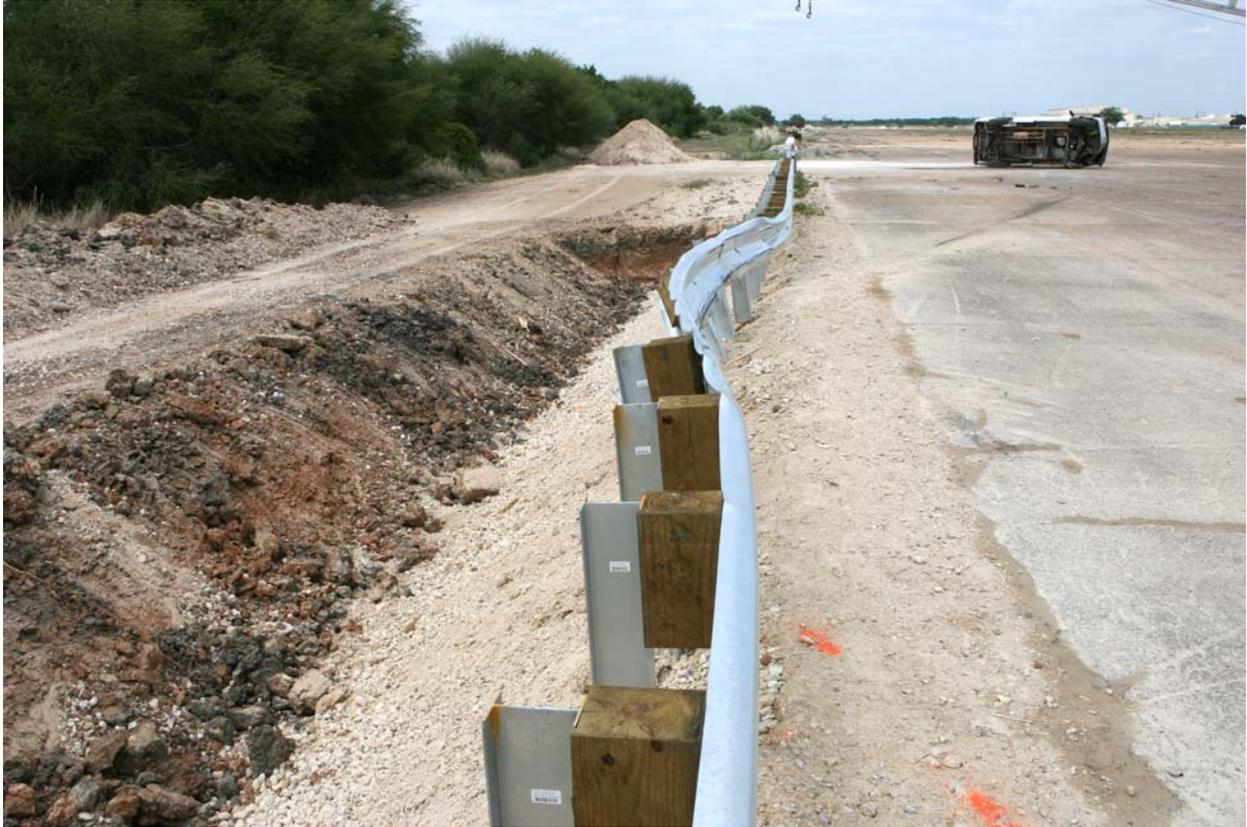
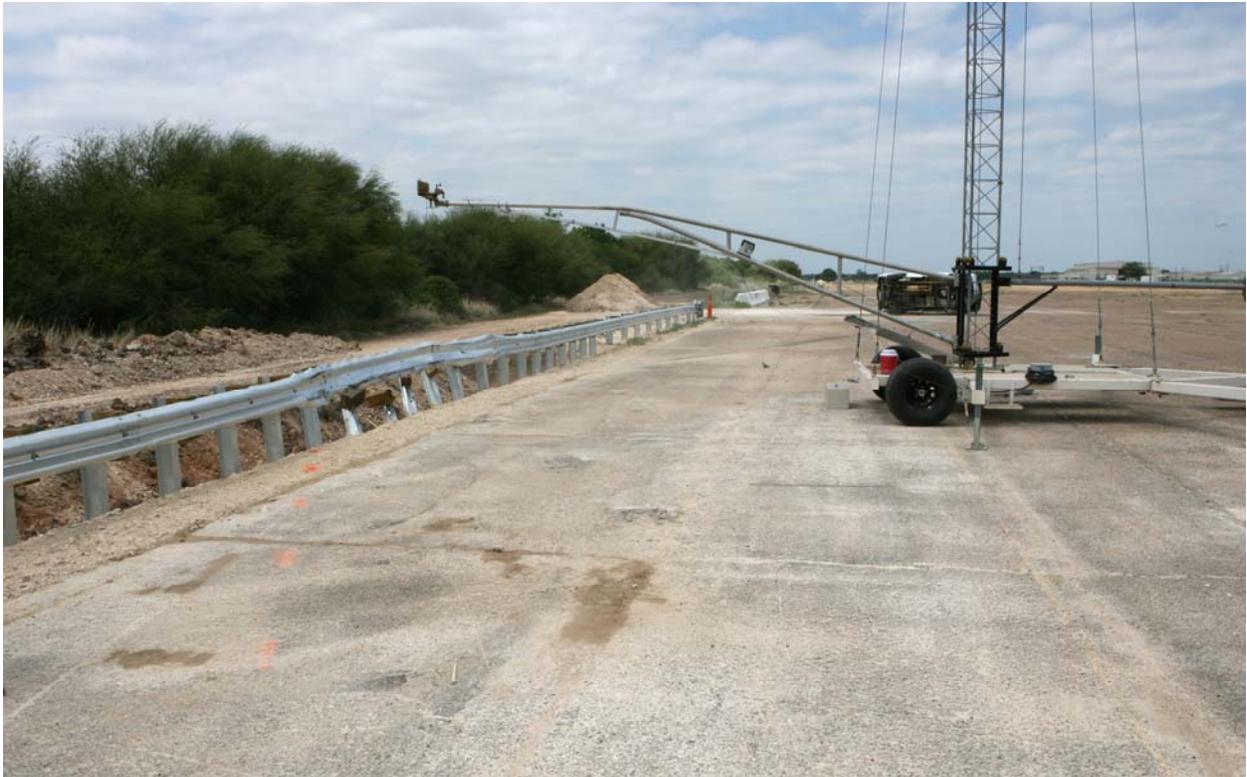
Figure 3.16. Vehicle trajectory path after test 405160-4-1.

Results: The vehicle remained upright during the initial impact period with the guardrail on 2H:1V slope. However, after exiting the installation, the vehicle rolled onto its left side. (FAIL)

Result: The vehicle intruded into adjacent traffic lanes as it came to rest on its left side 135 ft downstream of impact and 34 ft forward of the traffic face of the rail. (FAIL)

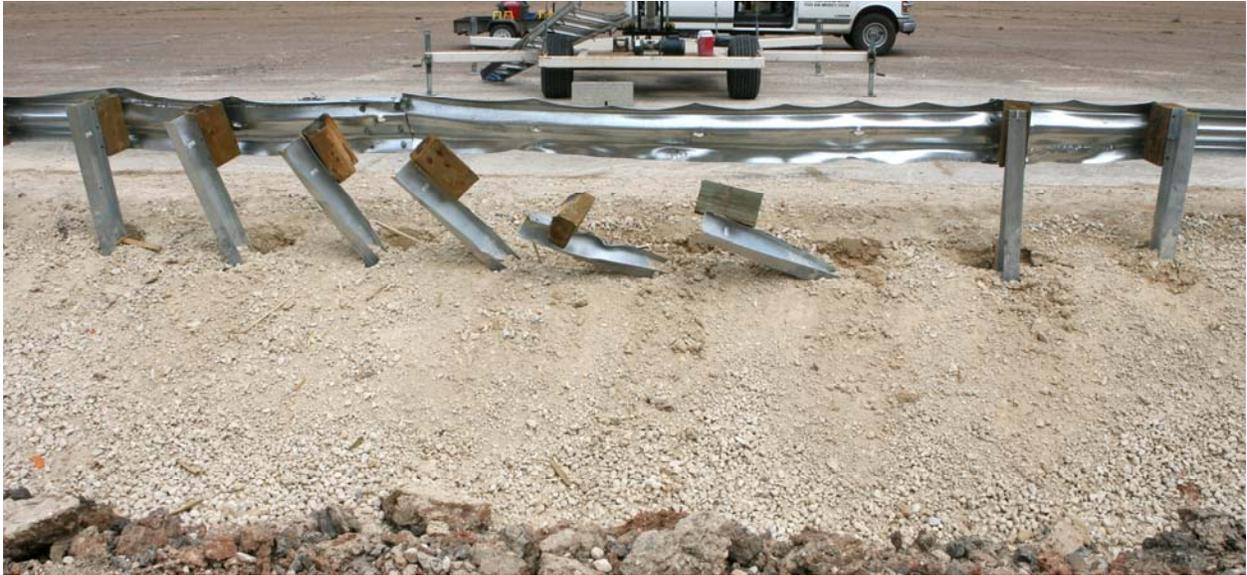
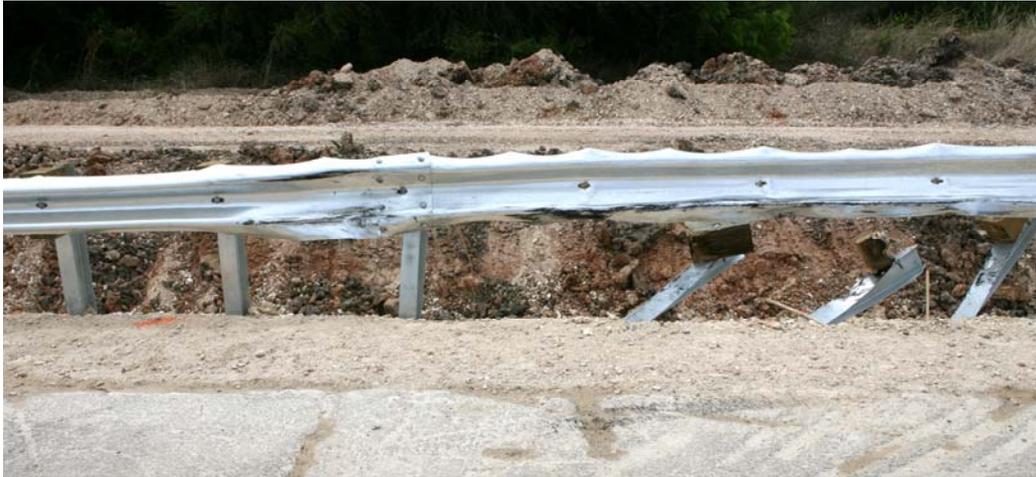
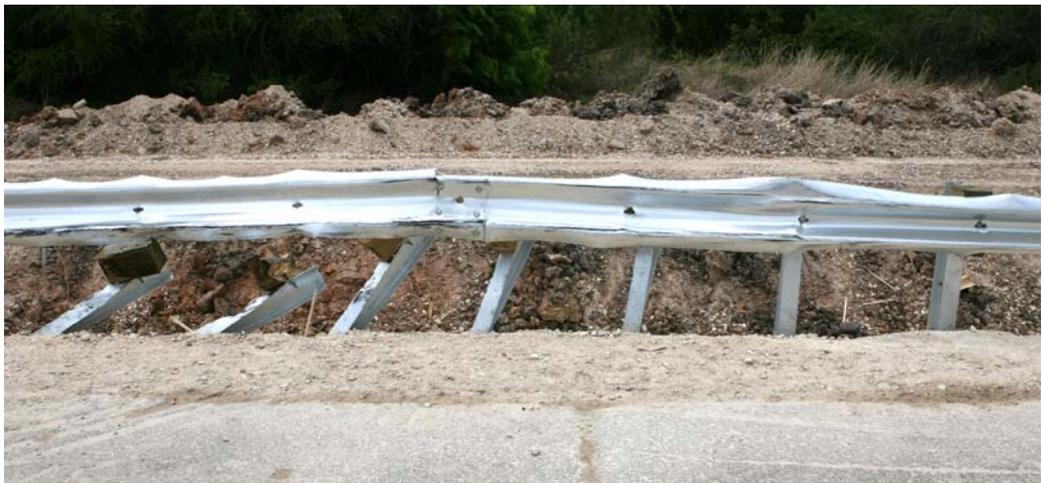
Figure 3.17. Installation after test 405160-4-1.

Damage to the guardrail on 2H:1V slope is shown in figures 3.16 and 3.17. Post 1 in the terminal was pulled downstream 0.2 inch, and no damage or movement was noted at posts 2-12. Post 13 was leaning toward the field side 88 degrees with a 0.4 inch gap in the soil on the traffic side at ground level. Post 14 was leaning toward the field side 86 degrees with a 1.1 inch gap in the soil on the traffic side at ground level. Post 15 was leaning toward the field side 85 degrees with a 2.75 inch gap in the soil on the traffic side and 0.4 inch gap on the field side at ground level. Post 16 was leaning toward the field side 78 degrees, 86 degrees downstream, rotated clockwise 25 degrees, with a 5.1 inch gap in the soil on the traffic side at ground level. The rail separated from post 17 and 18 and the posts leaned toward the field side 35 degrees, were rotated 45 degrees clockwise, with a 9.1 inch gap on the traffic side at ground level. The rail separated from post 19 and the post leaned toward the field side 50 degrees, was rotated 45 degrees clockwise, with an 11.8 inch gap on the traffic side at ground level.

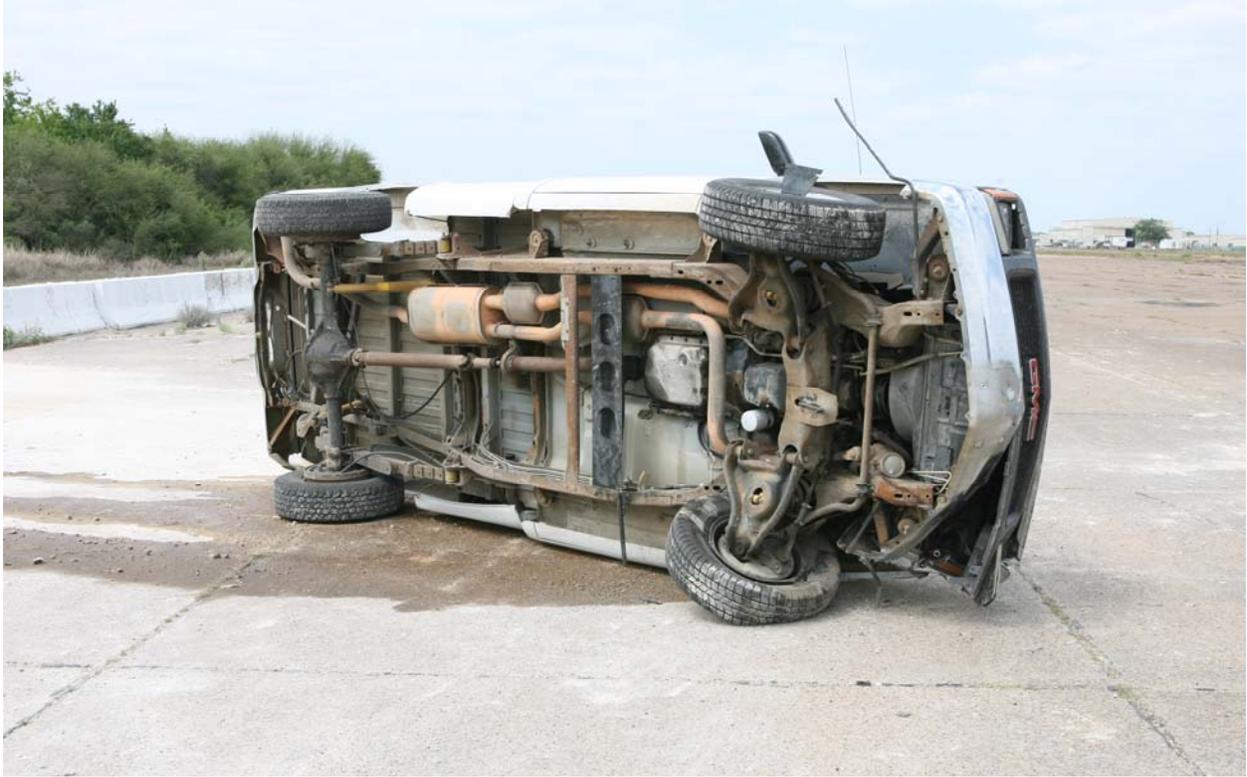
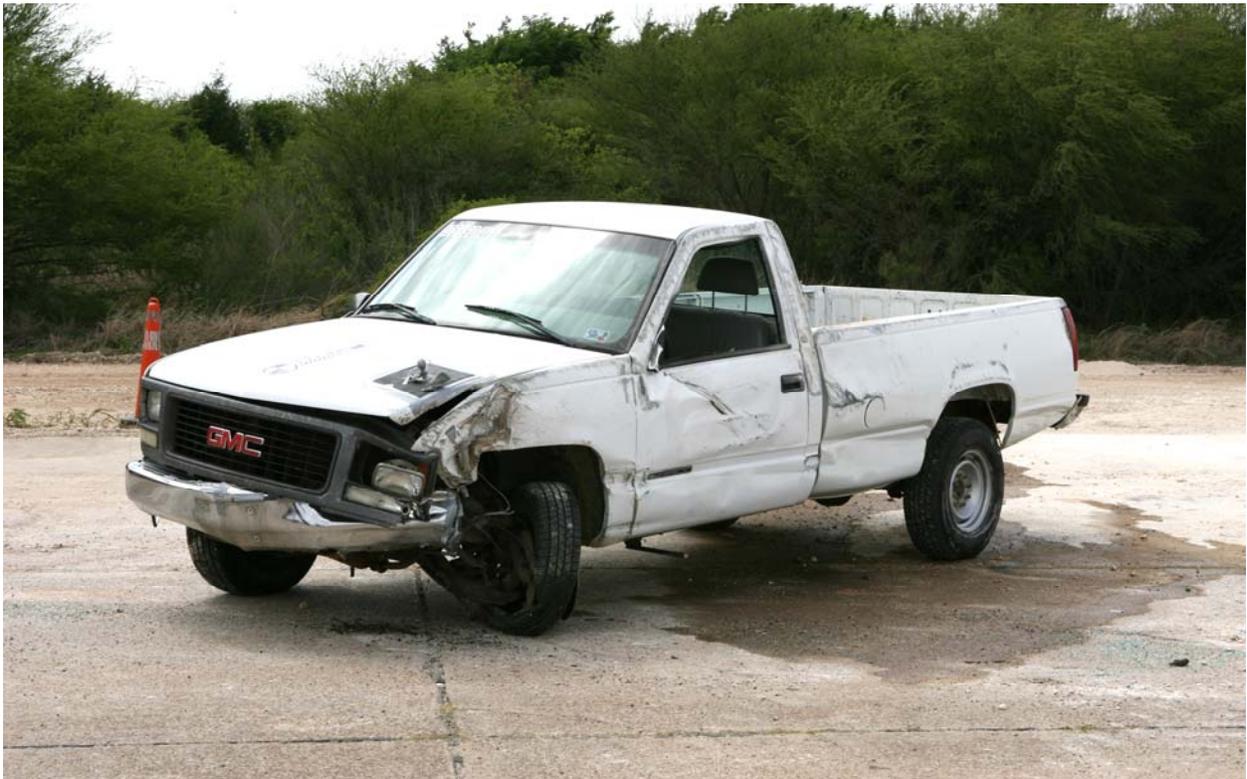
Figure 3.18. Vehicle after test 405160-4-1.

Damage to the vehicle is shown in figure 3.18. The left frame rail, left outer tie rod end, and transmission mount were deformed. Also damaged were the front bumper, grill, hood, left front fender, left door and door glass, left side of cab, left rear exterior bed, and left rear bumper. The left front wheel rim was deformed and the tire was deflated. A 15.7 inch long diagonal cut was in the door extending from just below the rear view mirror toward the lower rear corner. The upper portion of the left side of the vehicle was scuffed from rollover. Maximum exterior crush to the vehicle was 19.7 inches at the left front corner at bumper height. Maximum occupant compartment deformation was 0.8 inches in the lateral space across the floorpan from kickpanel to kickpanel. Photographs of the interior of the vehicle are shown in figure 3.19. Exterior vehicle crush and occupant compartment measurements are shown in appendix B, tables B1 and B2.

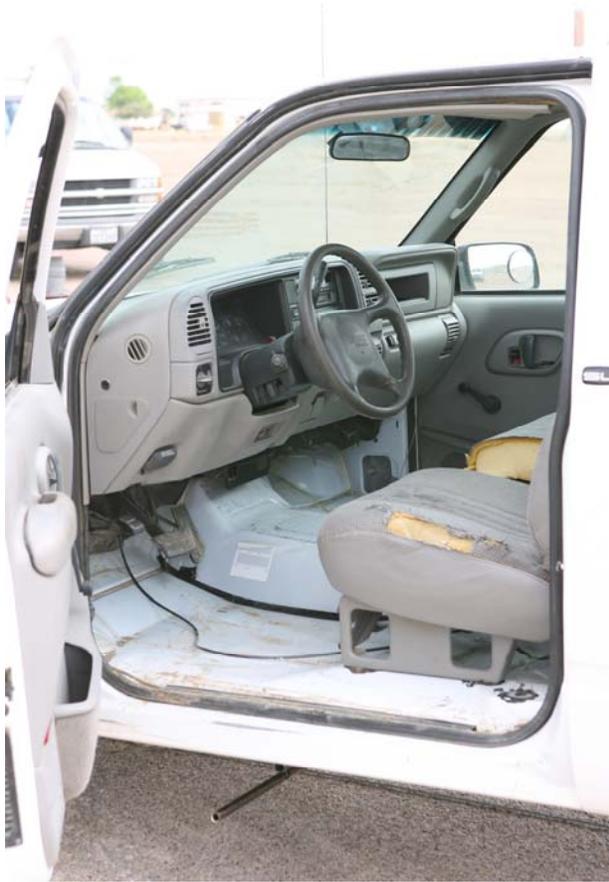
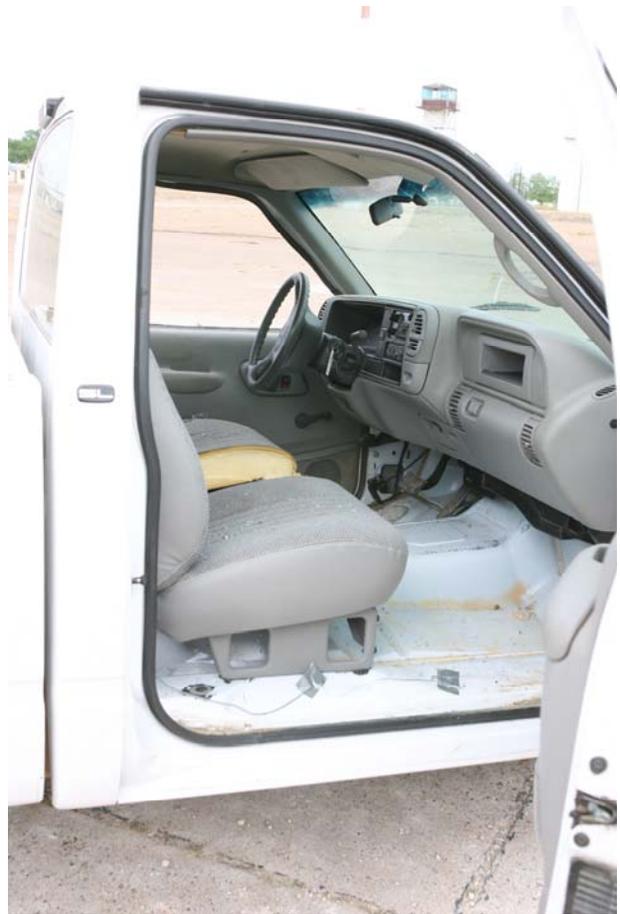
Figure 3.19. Interior of vehicle for test 405160-4-1.

Results: No detached elements, fragments, or other debris were present to penetrate, or show potential for penetrating the occupant compartment, or to present hazard to others in the area. Maximum occupant compartment deformation was 0.8 inches in the lateral space across the floorpan from kickpanel to kickpanel. (PASS)
