# ***MASH TL-3 TESTING AND EVALUATION OF A STEEL BRIDGE RAIL WITH PICKETS***

**Test Report 9-1002-12-2**

**TEXAS A&M TRANSPORTATION INSTITUTE  
THE TEXAS A&M UNIVERSITY SYSTEM  
COLLEGE STATION, TEXAS**

**TEXAS DEPARTMENT OF TRANSPORTATION**

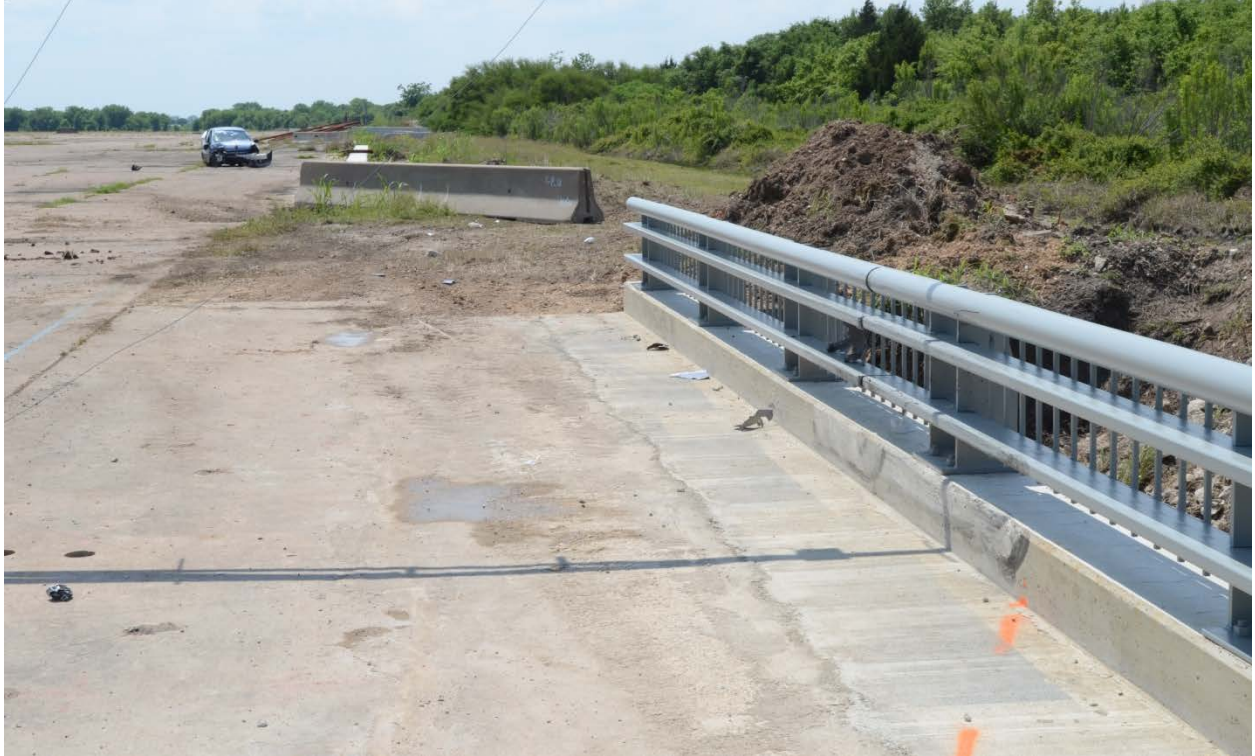
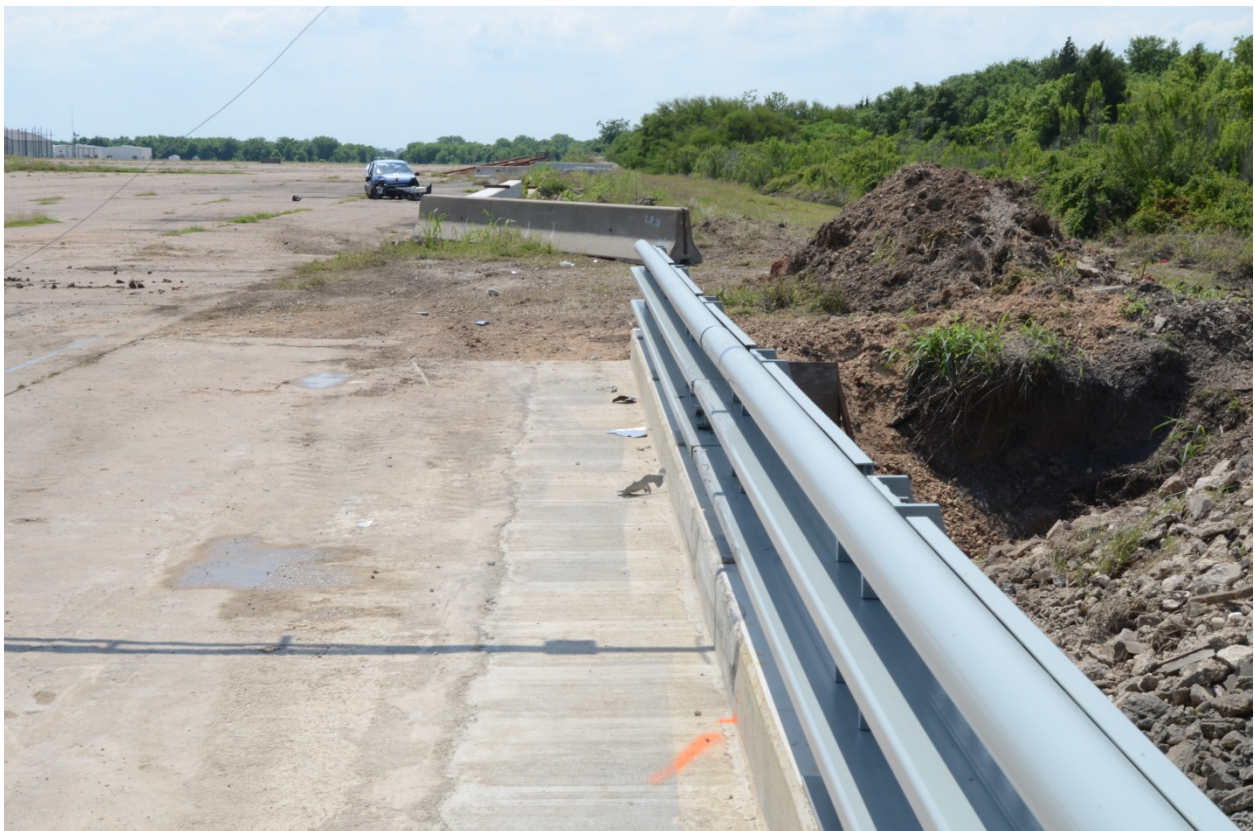
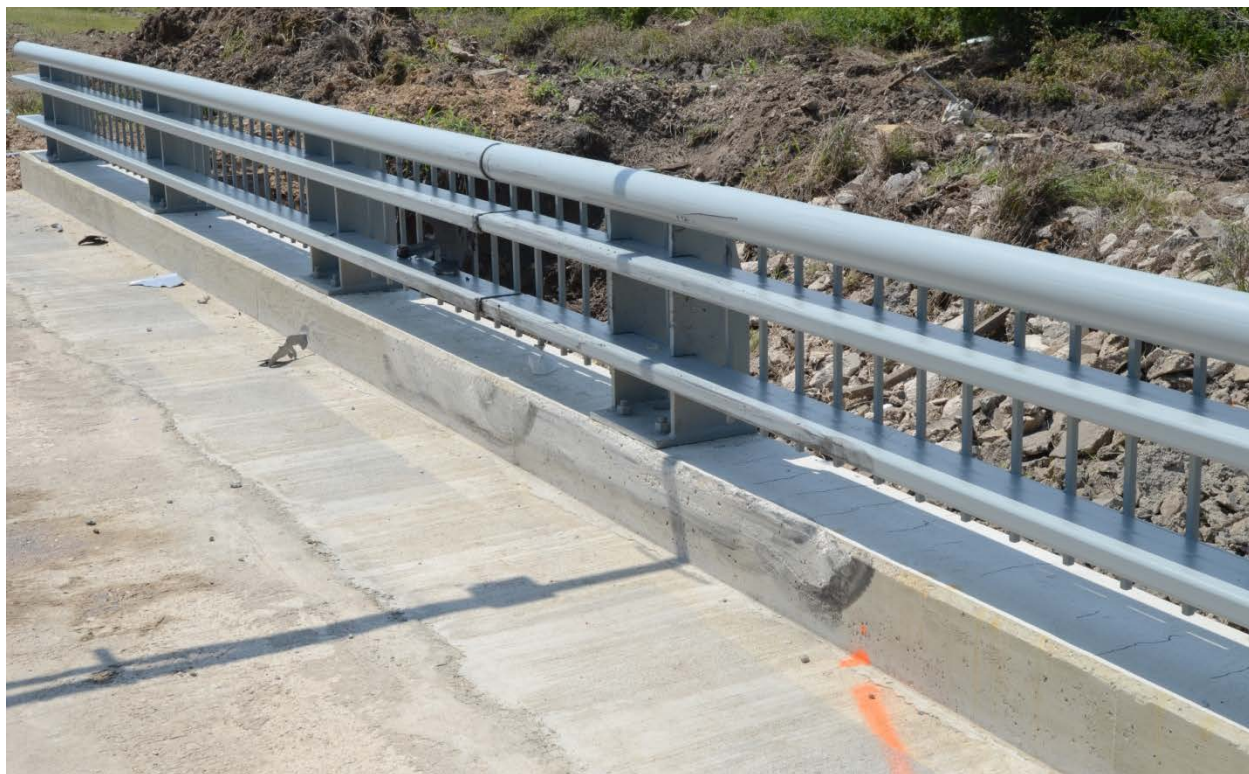
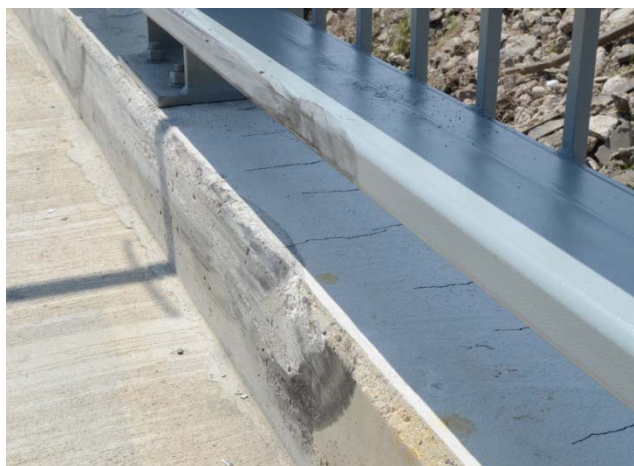
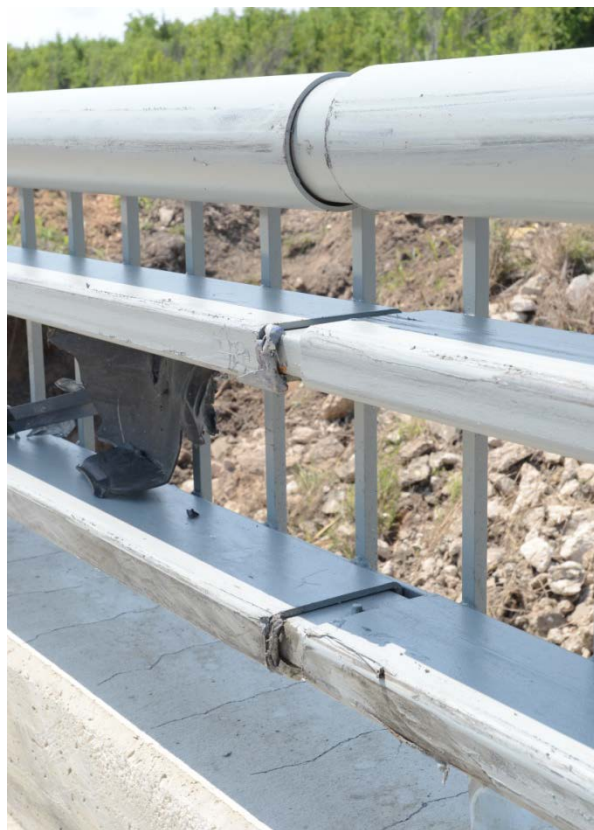
Figures 5.3 and 5.4 show damage to the TxDOT Picket Rail. Cracks in the curb radiated from the front and rear anchor bolts toward the field side at post 9, and from the rear anchor bolt on the upstream side of post 10. Tire marks were evident on the traffic face of all the horizontal metal rail elements from 3.7 ft upstream of post 9 for a length of 10.0 ft. There was no evidence of contact on the vertical pickets. Working width was 10.7 inches, and maximum dynamic deflection of the horizontal metal rail element was 0.9 inch. Residual permanent deformation was minimal and not measureable.

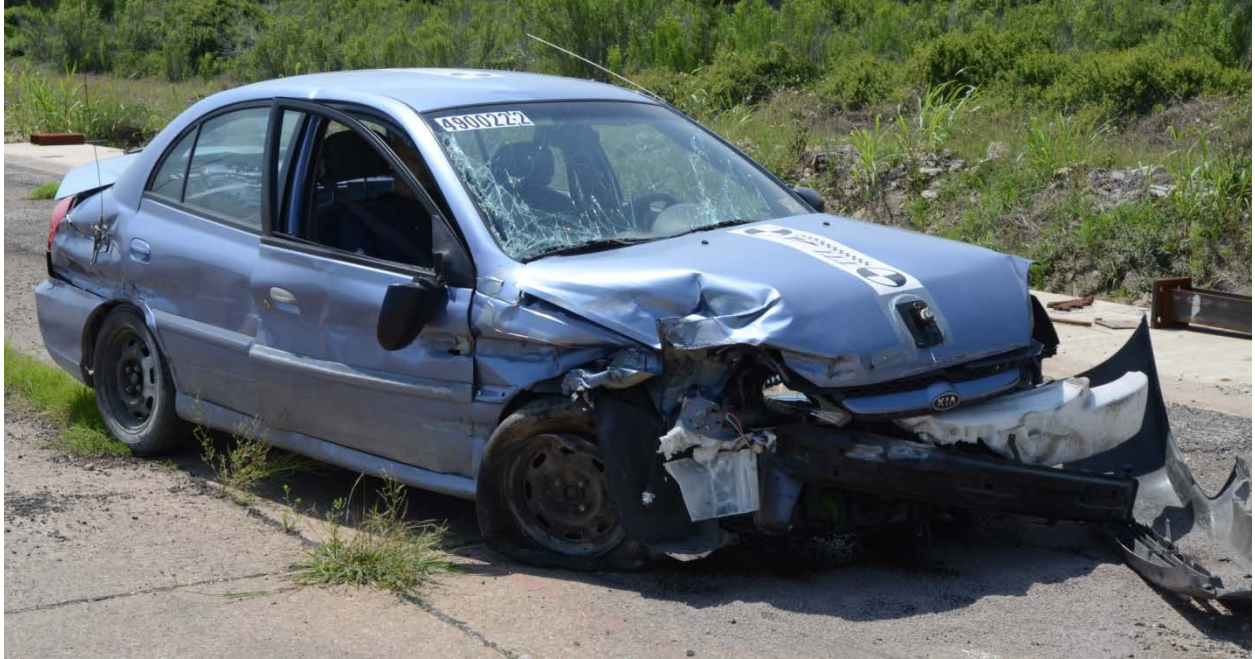
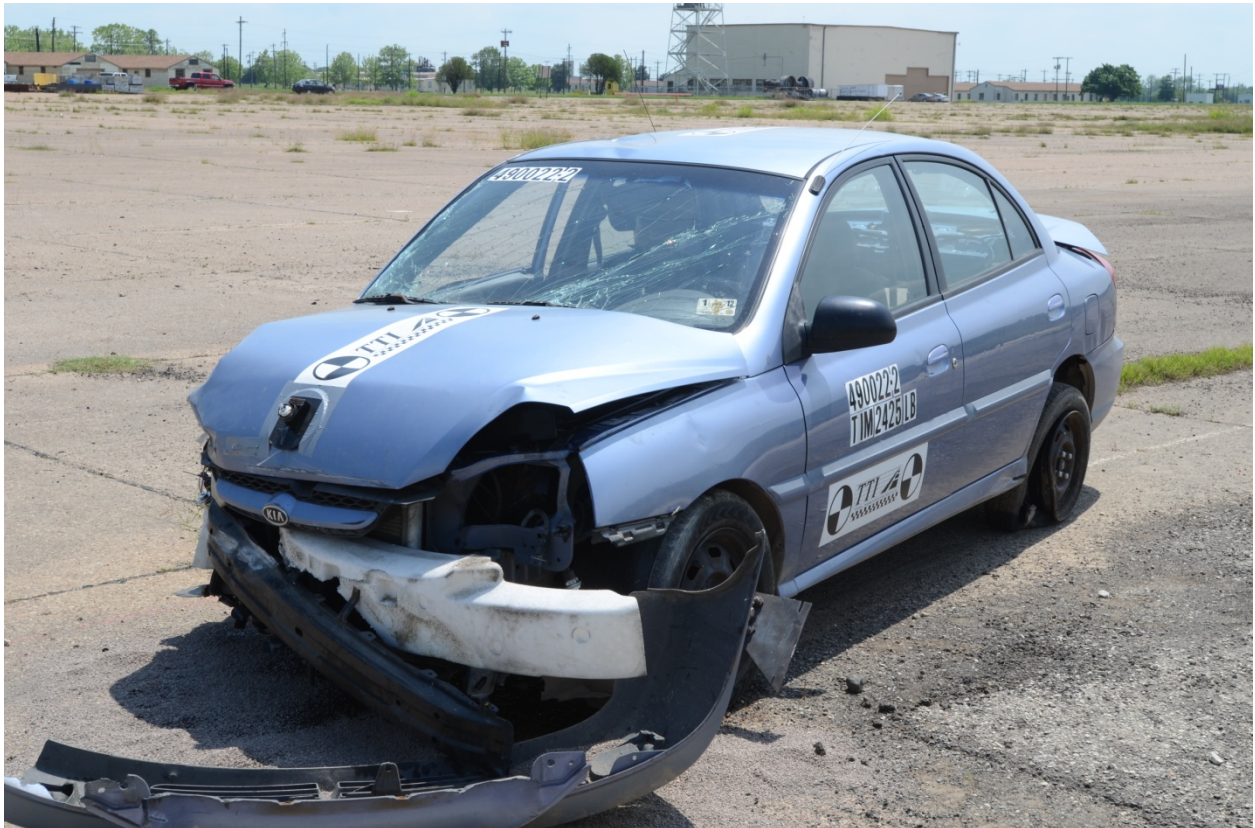
**Figure 5.5. Vehicle after Test No. 490022-2.**

Figure 5.5 shows damage to the vehicle. The right front strut and strut tower were deformed. The front bumper, hood, right front tire and wheel rim, right front fender, right front door and door glass, right rear door, right rear wheel rim, right rear quarter panel, and rear bumper were also damaged. Maximum exterior crush to the vehicle was 11.0 inches in the side plane at the right front corner at bumper height. The right side floor pan was also deformed, with a maximum occupant compartment deformation of 3.0 inches. Figure 5.6 shows the interior of the vehicle. Exterior vehicle crush and occupant compartment measurements are shown in Appendix C, Tables C2 and C3.

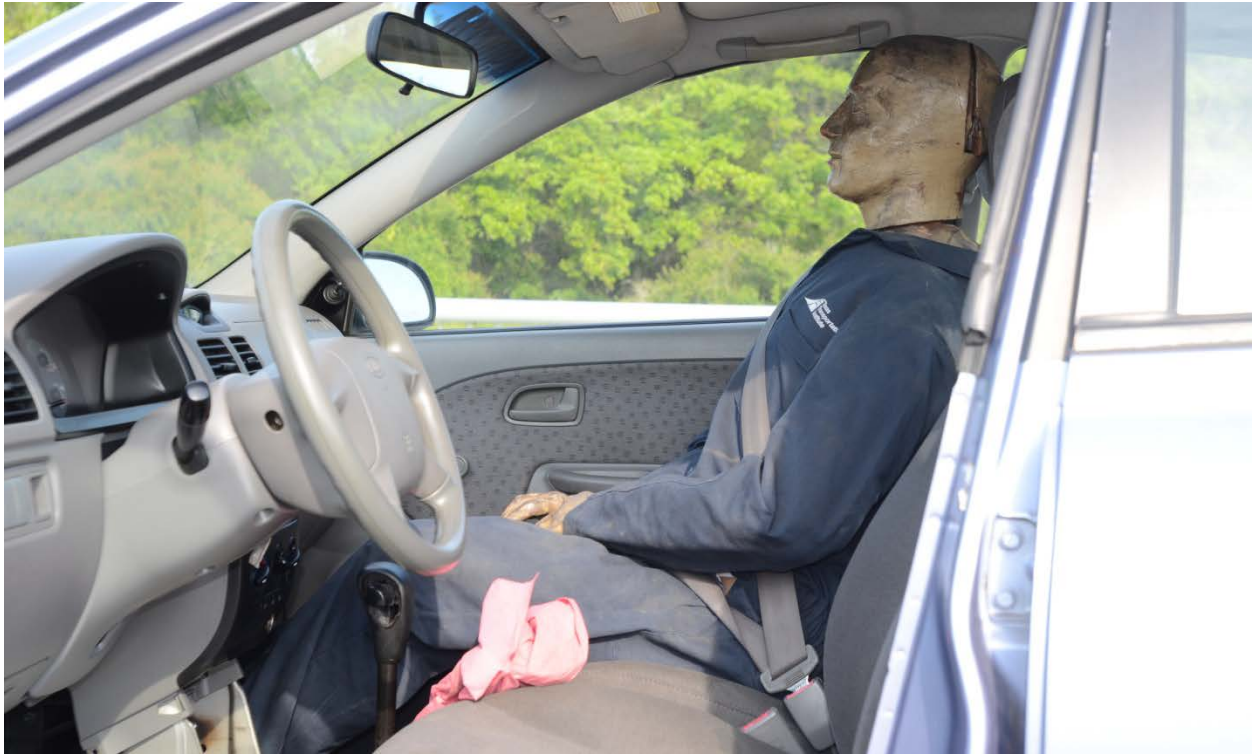
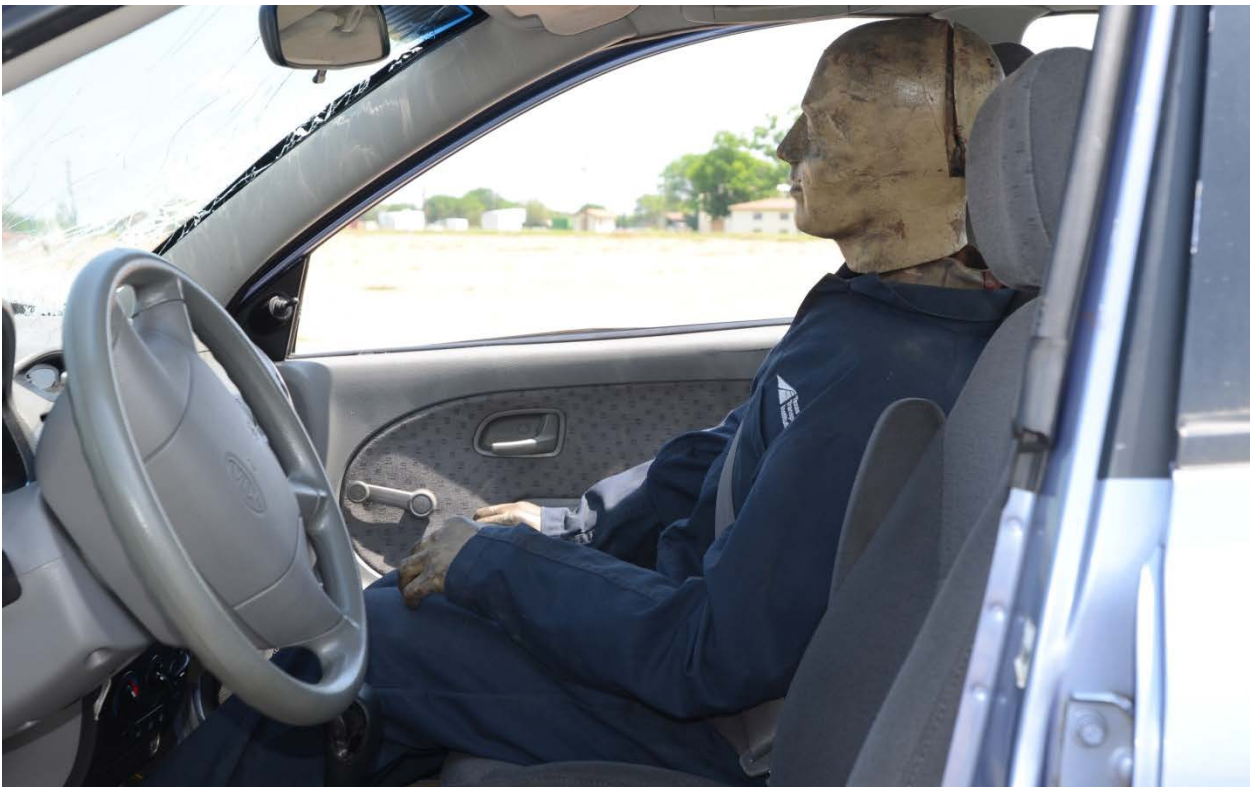
**Figure 5.6. Interior of Vehicle for Test No. 490022-2.**

Results: No detached elements, fragments, or other debris was present to penetrate or show potential for penetrating the occupant compartment, or present undue hazard to others. (PASS)  
Maximum occupant compartment deformation was 3.0 inches in the right floor pan area. (PASS)

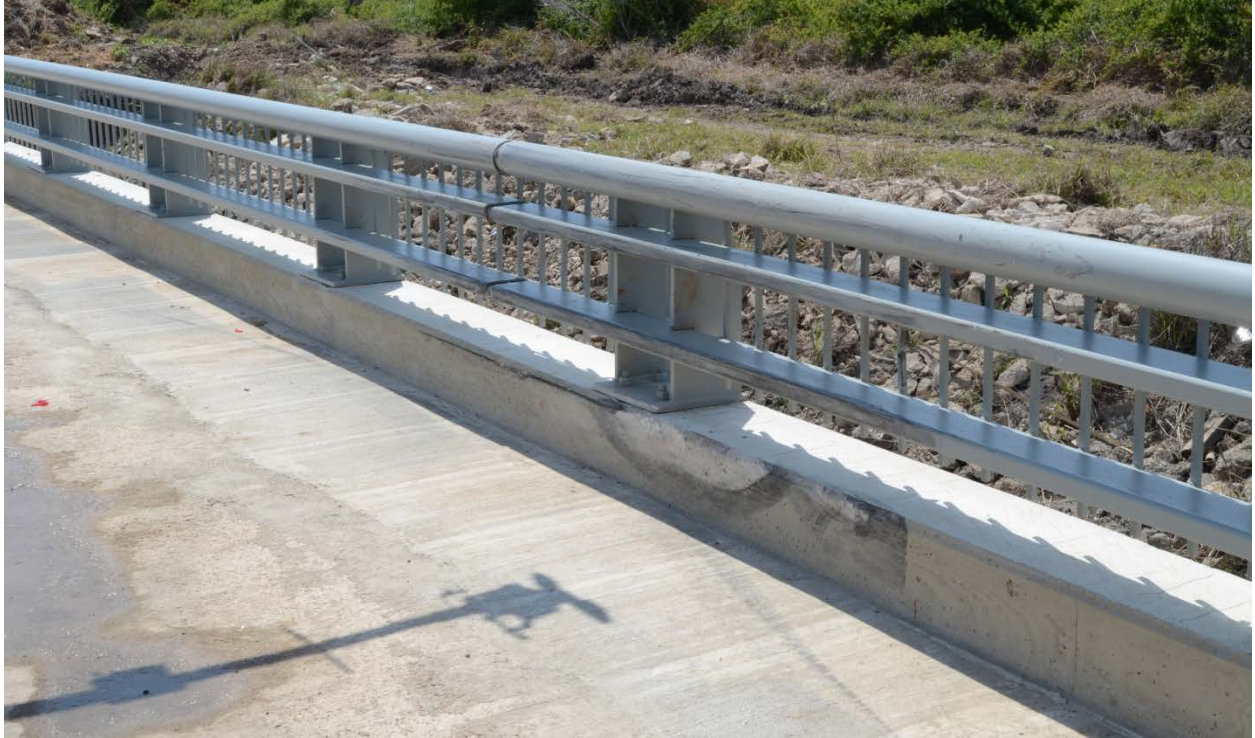
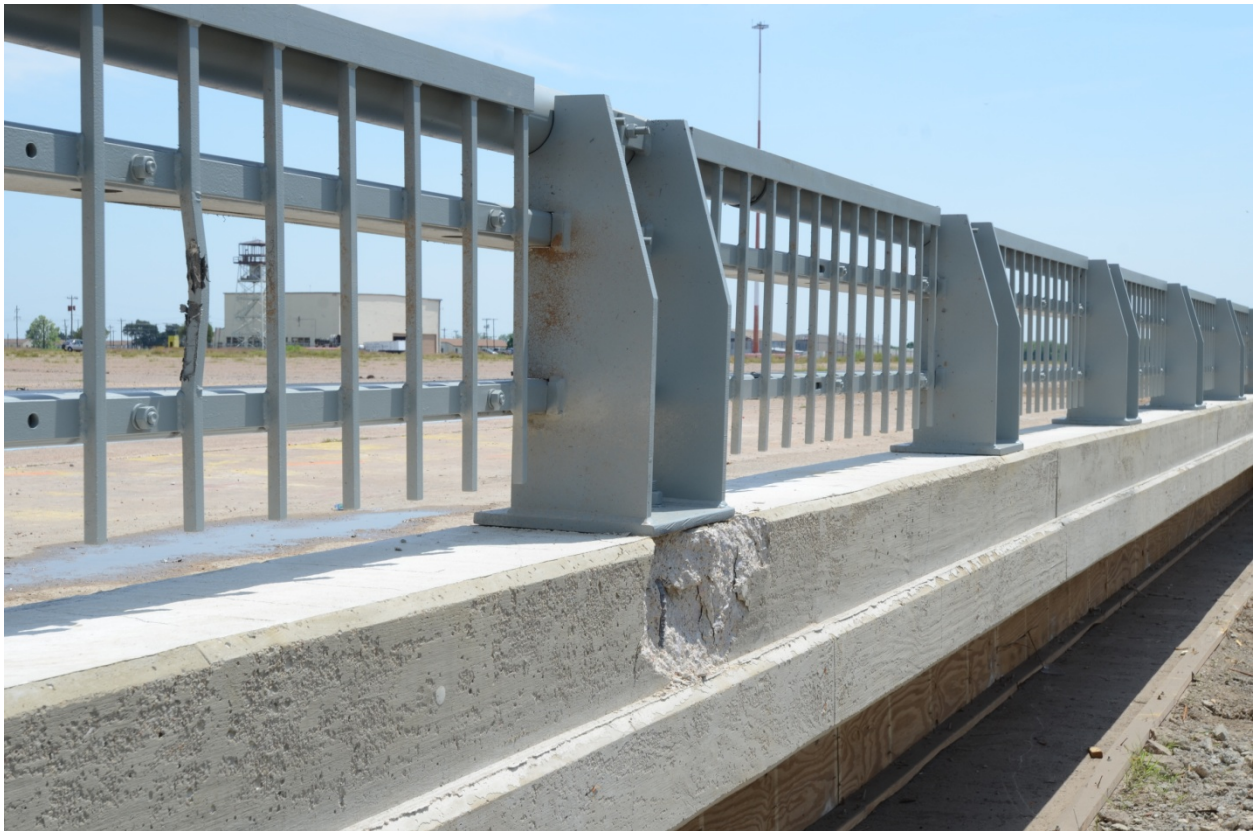
Figures 6.3 and 6.4 show damage to the TxDOT picket rail. A crack in the concrete curb radiated toward the field side from the rear anchor bolt on the impact side of post 3. Cracks in the concrete curb radiated toward the field side from the front and rear anchor bolts on both sides of post 4, and extended into the concrete deck where each radiated downward and outward on each side of the post. Working width was 10.4 inches. Maximum dynamic deflection of the top rail was 2.8 inches. Maximum permanent deformation of the rail elements was 0.8 inch on the top rail, 0.7 inch on the middle rail, and 0.9 inch on the bottom rail.

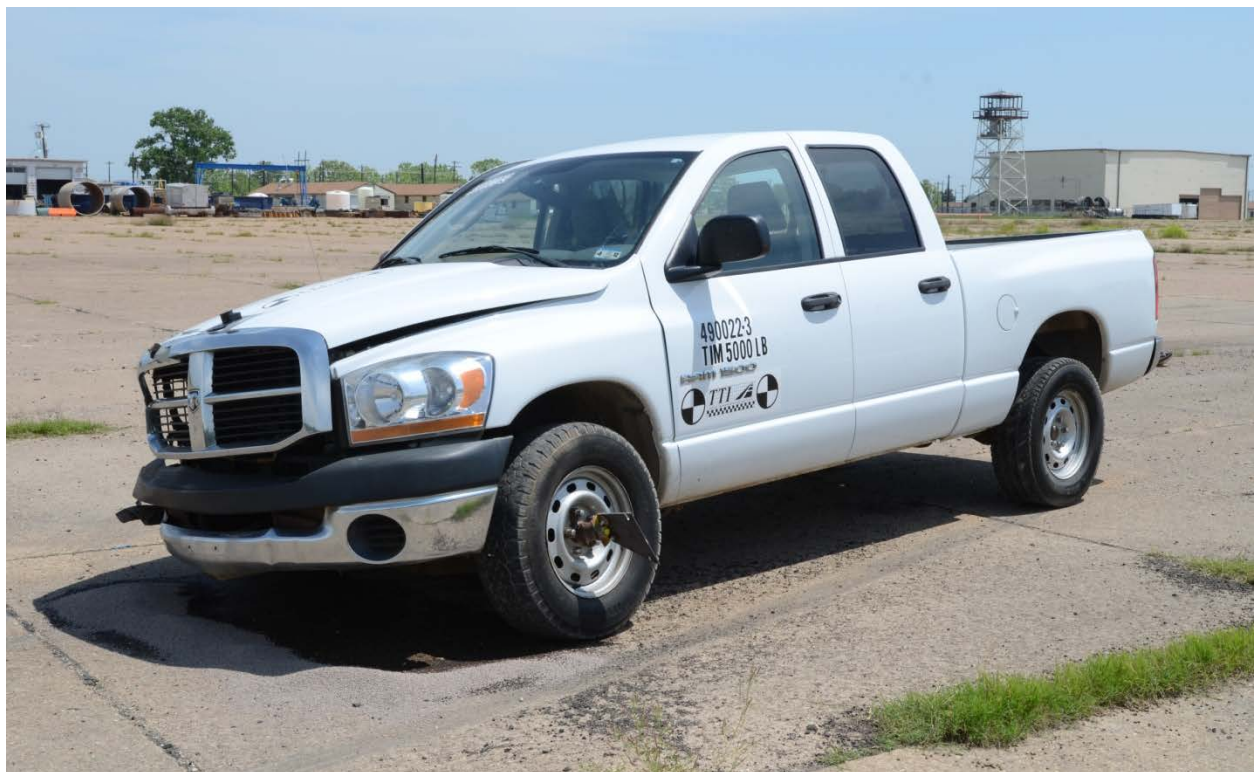
**Figure 6.5. Vehicle after Test No. 490022-3.**

Figure 6.5 shows damage to the 2270P vehicle. The right front frame rail and right front upper and lower A-arms were deformed. Also damaged were the front bumper, hood, right front tire and wheel rim, right front fender, right front and rear doors, right exterior bed, right rear tire and wheel rim and the rear bumper. The windshield sustained stress cracks in each lower corner near the hood. Maximum exterior crush to the vehicle was 11.0 inches in both the front and side planes at the right front corner at bumper height. Maximum occupant compartment deformation was 2.75 inches in the lateral area across the cab at the passenger side kickpanel. Figure 6.6 shows the interior of the vehicle, while Tables D3 and D4 in Appendix D show the exterior vehicle crush and occupant compartment measurements.

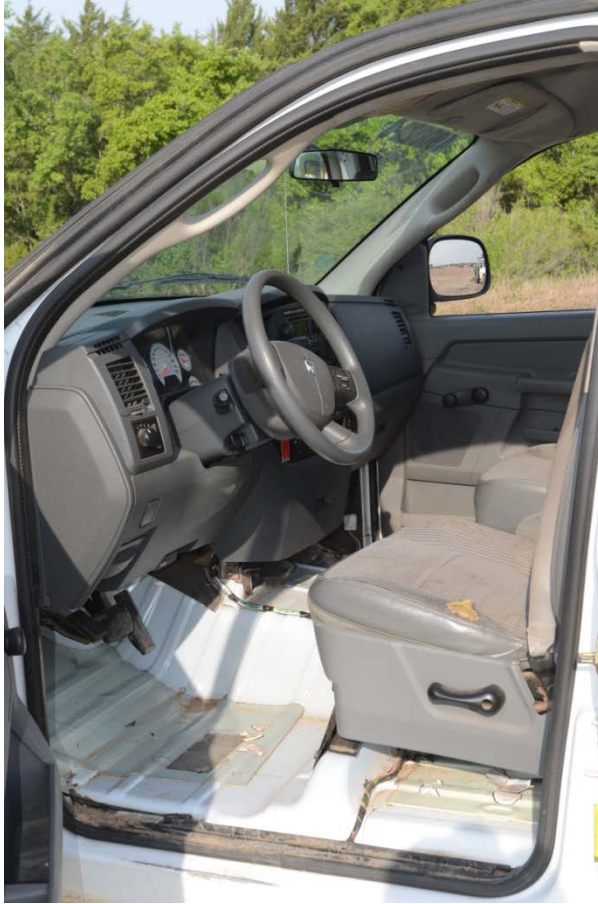
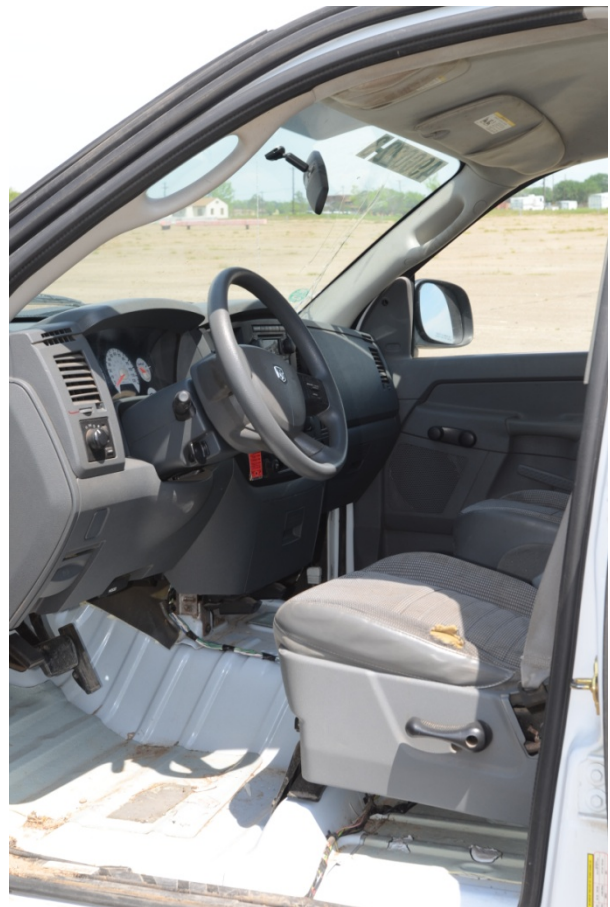
**Figure 6.6. Interior of Vehicle for Test No. 490022-3.**

Results: No detached elements, fragments, or other debris were present to penetrate or show potential for penetrating the occupant compartment, or present undue hazard to others. (PASS)  
Maximum occupant compartment deformation was 2.75 inches in the lateral area across the cab at the front passenger kick panel. (PASS)
