## CRASH TEST AND EVALUATION OF 3-FT MOUNTING HEIGHT SIGN SUPPORT SYSTEM

### Test Report 9-1002-15-1

TEXAS A&M TRANSPORTATION INSTITUTE  
COLLEGE STATION, TEXAS

TEXAS DEPARTMENT OF TRANSPORTATION

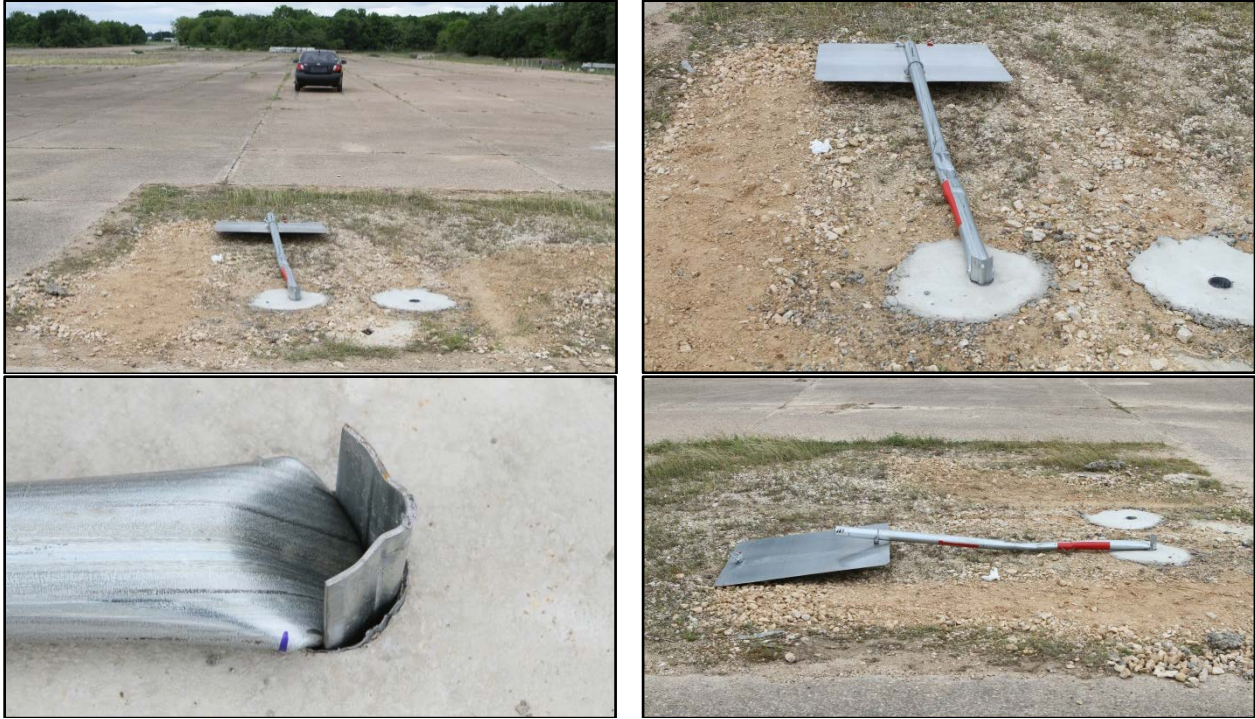
**Figure 5.3. 3-ft Mounting Height Sign Support System after Test No. 490025-7-1.**

Figure 5.3 shows damage to the sign support structure. The sign support was deformed 90 degrees at ground level. The sign panel slid 20 inches upward on the sign support but remained attached to the support.

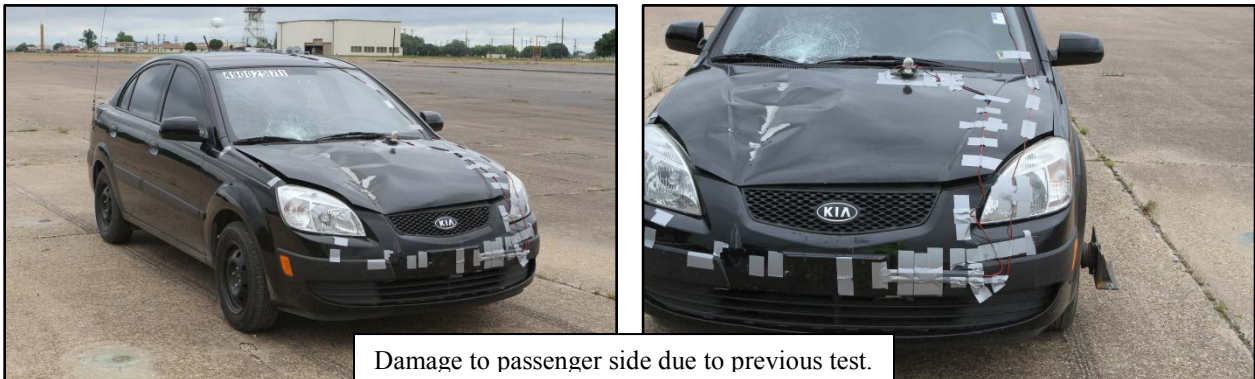
**Figure 5.4. Vehicle after Test No. 490025-7-1.**

Figure 5.4 shows minimal damage to the driver side of the vehicle after the test. The damage to the passenger side occurred during the previous high-speed test (test no. 490025-7-2), which was performed earlier that morning. Scuff marks were noted on the bumper, but no other damage was obvious. No deformation or intrusion of the occupant compartment was noted. Figure 5.5 shows the interior of the vehicle. Exterior vehicle crush and occupant compartment measurements are shown in Appendix B1, Tables B.2 and B.3, respectively.

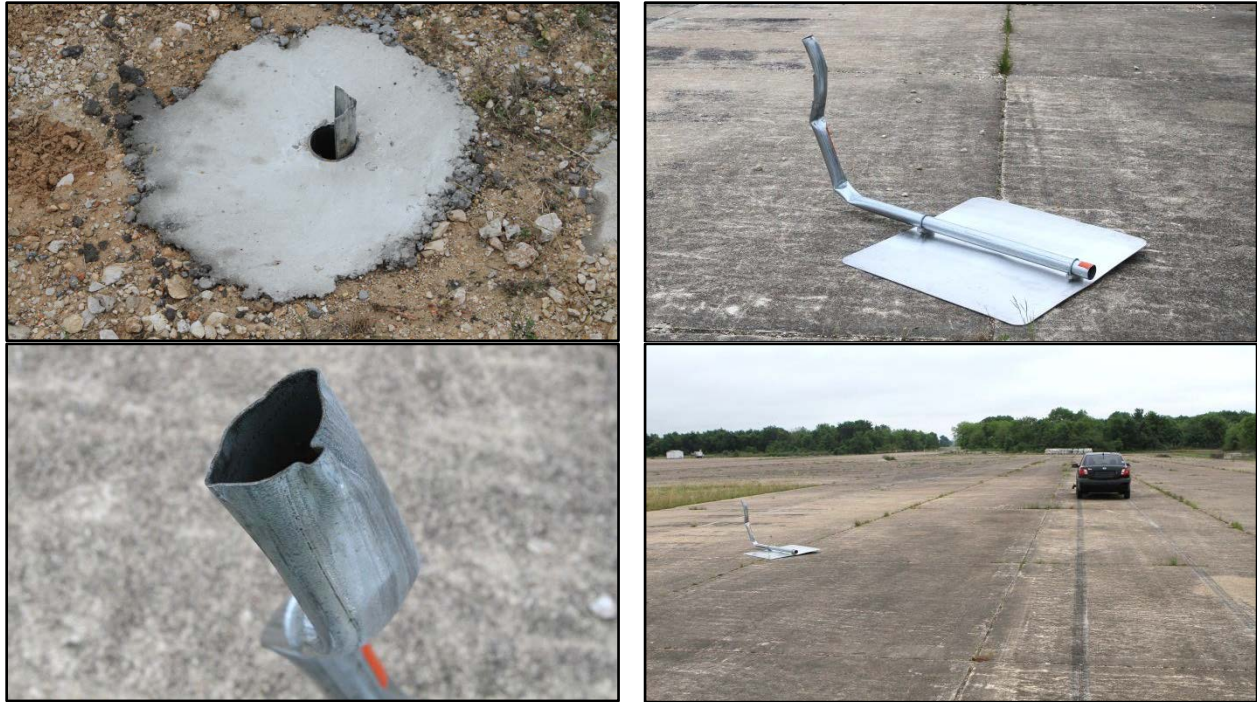
**Figure 6.3. 3-ft Mounting Height Sign Support System after Test No. 490025-7-2.**

Figure 6.3 shows damage to the sign support structure. The sign support was partially flattened from its bottom edge to a point approximately 16 inches below the bottom edge of the sign panel. The support was bent at locations corresponding to ground level and vehicle bumper height. The sign panel remained attached to the sign support and the system came to rest 207 ft downstream of impact and 18 ft to the left of centerline of its original position relative to the path of the vehicle.

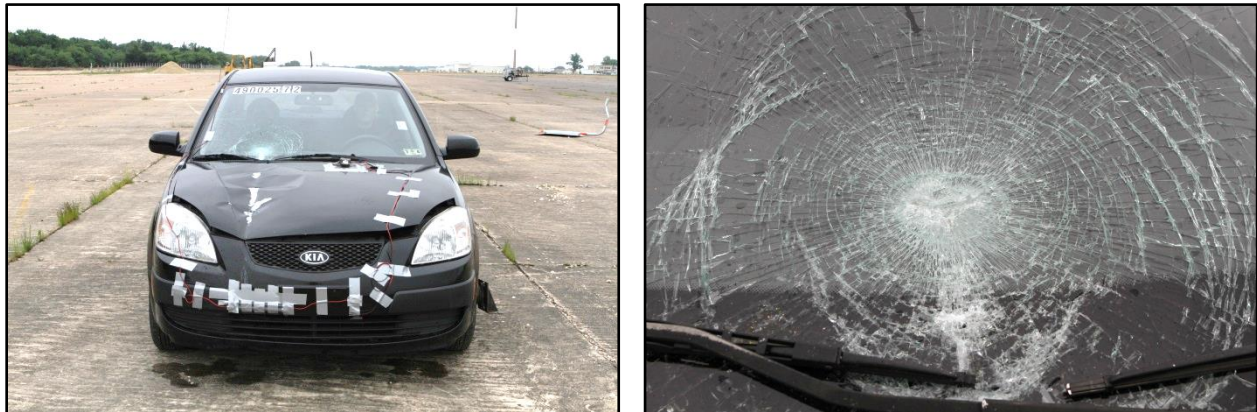
**Figure 6.4. Vehicle after Test No. 490025-7-2.**

Figure 6.4 shows damage to the vehicle after the test. There was a small indentation in the right side of the hood. The windshield was fractured in the lower right corner but remained intact. No deformation or intrusion of the occupant compartment was noted. Figure 6.5 shows the interior of the vehicle. Exterior vehicle crush and occupant compartment measurements are shown in Appendix C2, Tables C.2 and C.3.
