**PERFORMANCE EVALUATION OF THE
MIDWEST GUARDRAIL SYSTEM – UPDATE TO
NCHRP 350 TEST NO. 3-11 WITH 28" C.G.
HEIGHT (2214MG-2)**

MwRSF Research Report No. TRP-03-171-06

October 11, 2006

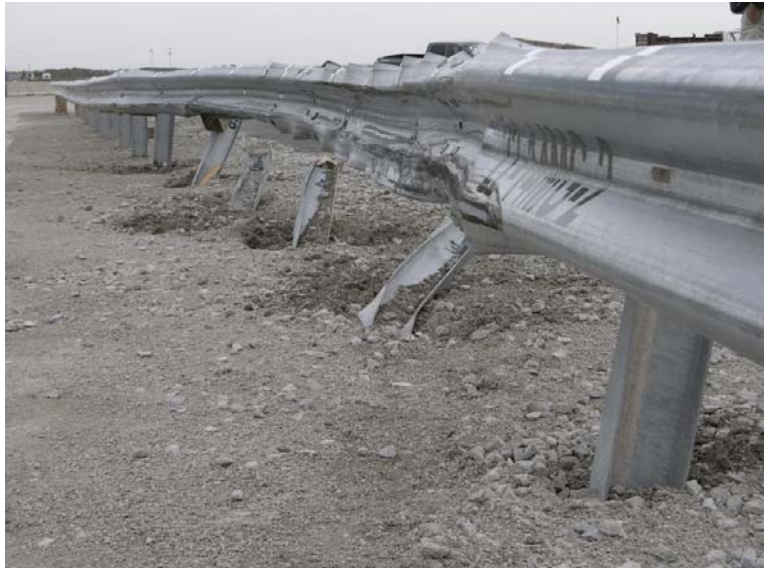
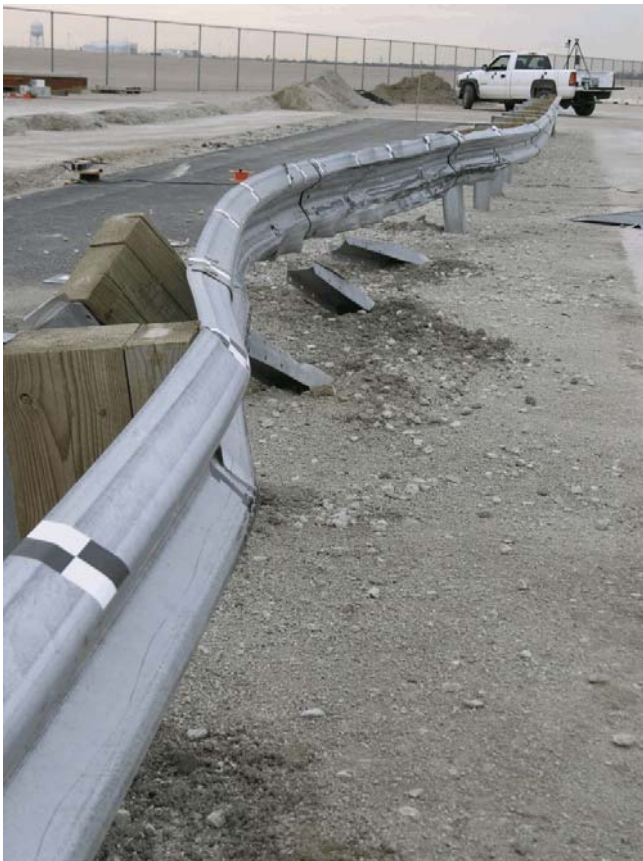
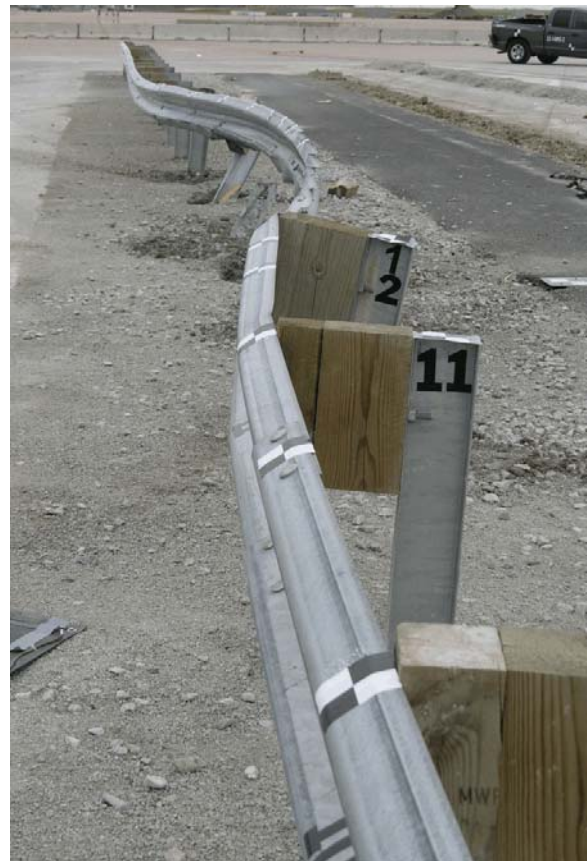
Figure 23. Midwest Guardrail System Barrier Damage, Test 2214MG-2

Damage to the barrier was moderate, as shown in Figures 23 through 25. Barrier damage consisted of deformed guardrail posts, disengaged wooden blockouts, contact marks on a guardrail section and posts, and deformed W-beam rail. The length of vehicle contact along the MGS system was approximately 10.3 m (33 ft - 8 in.), which spanned from 483 mm (19 in.) upstream from the centerline of post no. 12 through 254 mm (10 in.) downstream from the centerline of post no. 17.

The permanent set of the barrier system is shown in Figure 23. The maximum lateral permanent set rail deflections were 803 mm (31.625 in.) at the midspan between post nos. 14 and 15, as measured in the field. The maximum lateral dynamic rail and post deflections were 1,114 mm (43.9 in.) at post no. 14 and 694 mm (27.3 in.) at post no. 14, as determined from high-speed digital video analysis. The working width of the system was found to be 1,234 mm (48.6 in.).

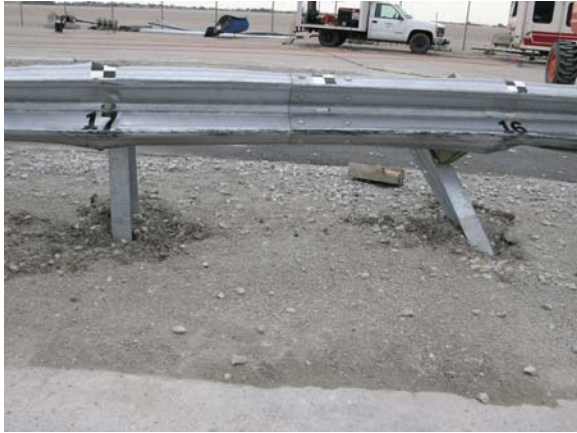
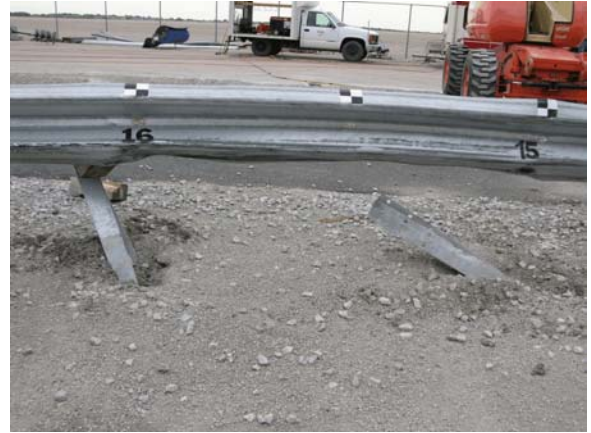
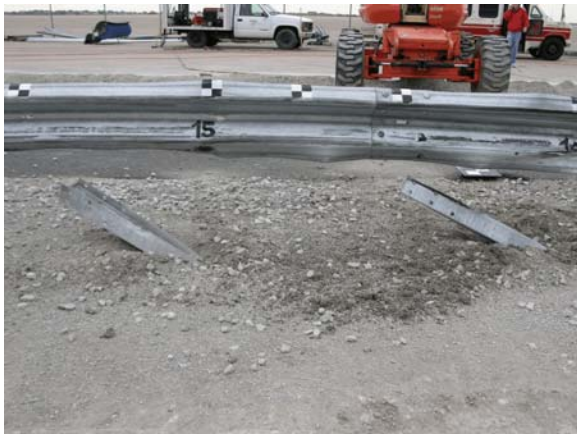
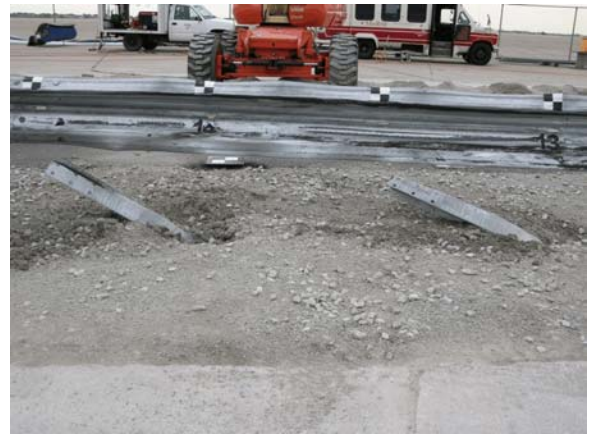
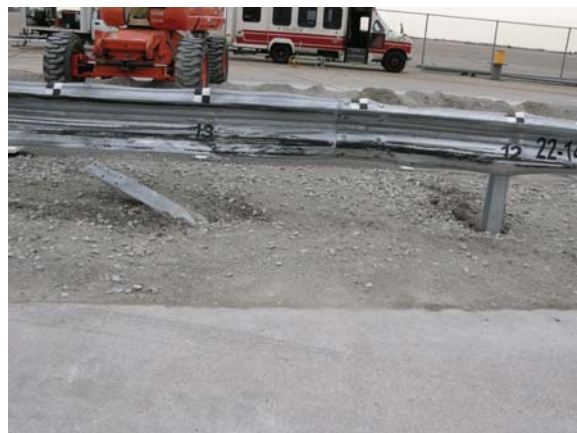
Figure 24. Guardrail Damage Between Post Nos. 12 and 17, Test 2214MG-2

Moderate deformation and flattening of the impacted section W-beam rail occurred between post nos. 12 and 15. Contact marks were found on the guardrail between post nos. 11 and 18. The guardrail buckled at the downstream edge of the blockout at post no. 11. A major buckle point in the guardrail occurred at the upstream edge of post no. 12. Another major buckle in the guardrail occurred at the downstream edge of post no. 17. The guardrail also buckled at 267 mm (10.5 in.) downstream of post no. 18. The lower corrugation of the W-beam rail between post nos. 15 and 16 was bent under. The W-beam was pulled off post nos. 13 through 16. The W-beam rail sustained tearing and significant yielding around the post bolt slots at post nos. 14 and 15, while only minor

yielding occurred around the post bolt slots at post nos. 8 through 13 and 16 through 18. No significant guardrail damage occurred downstream of post no. 19.

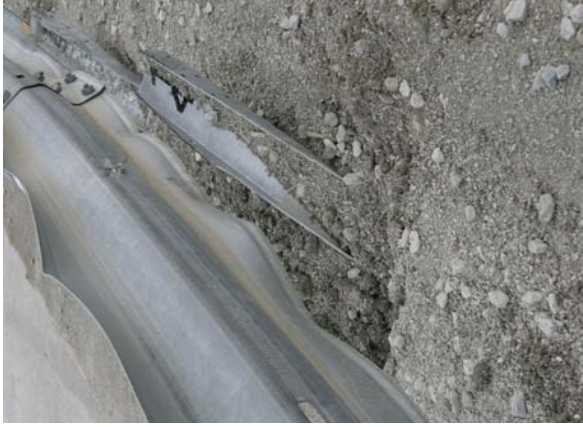
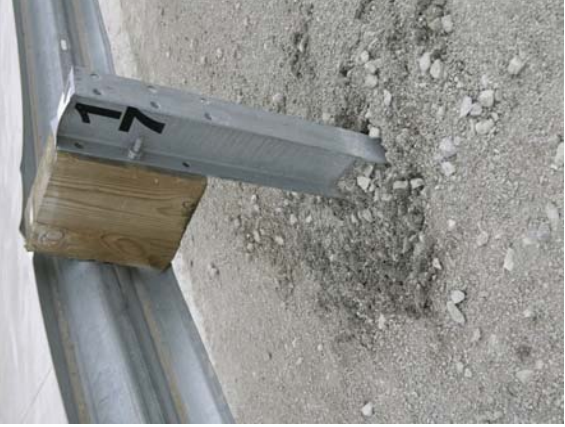
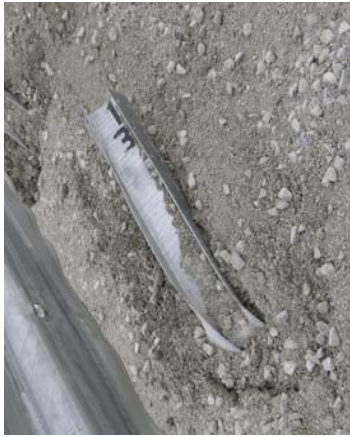
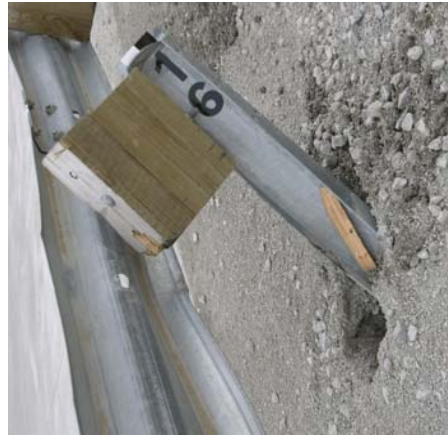
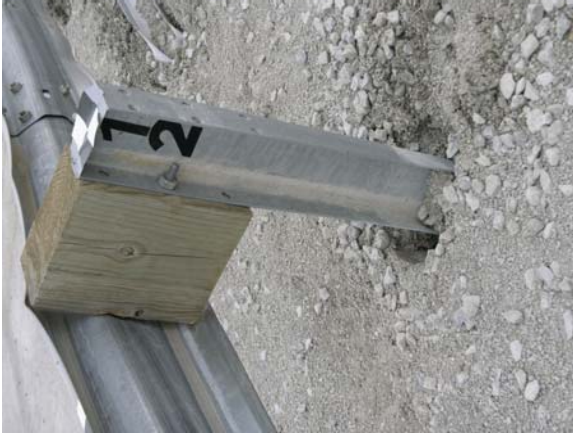
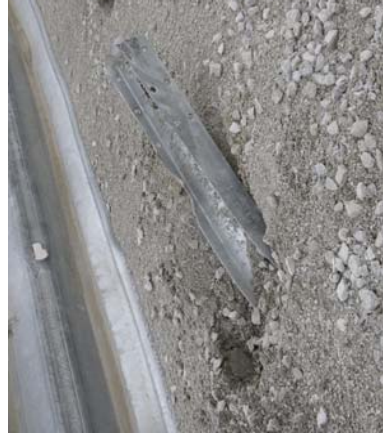
Figure 25. Post Nos. 12 through 17 Damage, Test 2214MG-2

Steel post nos. 3 through 12 encountered minor twisting. Post nos. 13 through 15 bent longitudinally downstream at ground line. Post no. 16 rotated both backward and downstream. The web of post no. 16 was also bent. Post no. 17 rotated slightly backward and downstream. Contact marks were found on the top of the front flange of post no. 13 and on the upstream edges of the front and rear flanges of post no. 14. Heavy contact marks were found on the front flange of post no. 15 causing the flange to deform toward the web. Light contact marks were also found on the upstream edges of the front and rear flanges of post no. 15. The post bolts at post nos. 14 and 15 sheared off and disengaged from the post. The upstream and downstream anchorage systems moved slightly moved longitudinally, but the posts in both anchorage systems were not damaged.

The wooden blockout at post no. 16 encountered damage on the lower front face, but remained attached. The wooden blockouts at post nos. 14, 15 were fractured and removed from the post. All the other wooden blockouts remained undamaged.

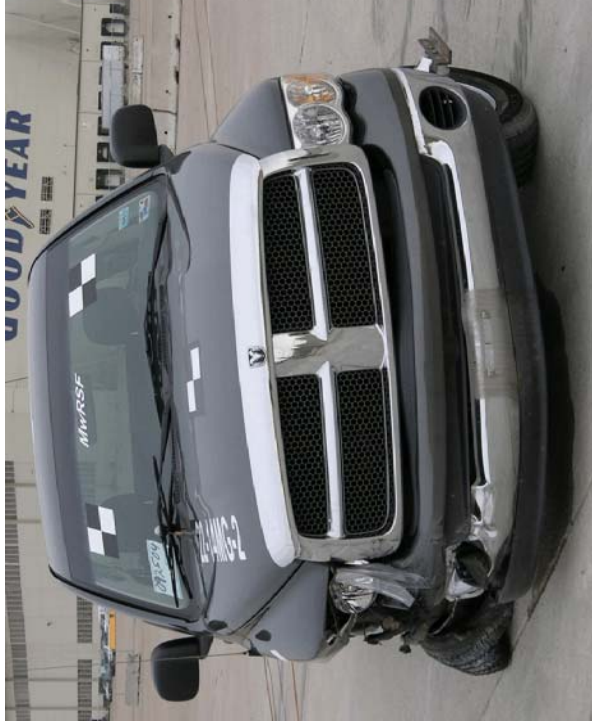
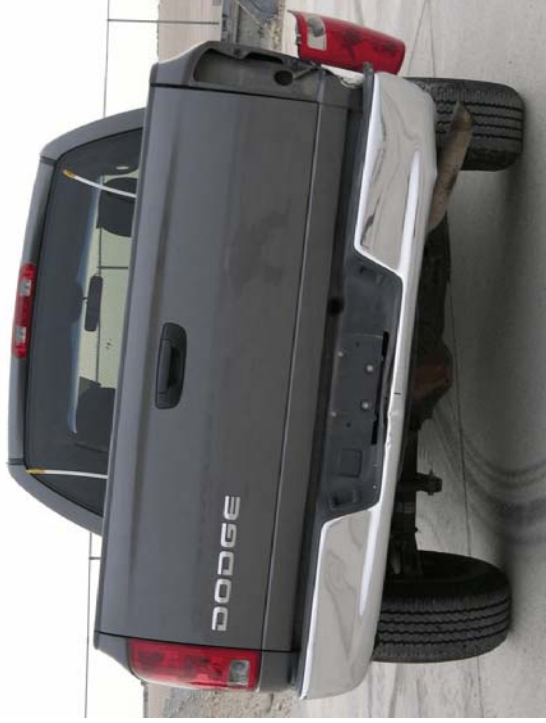
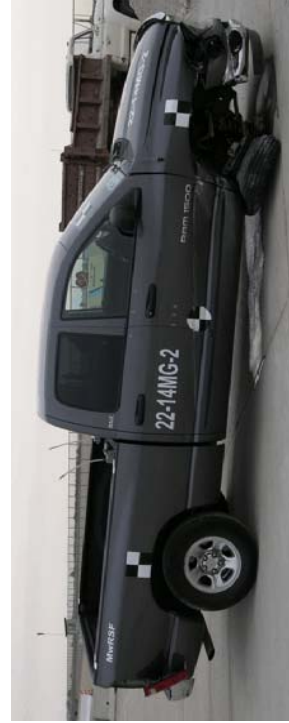
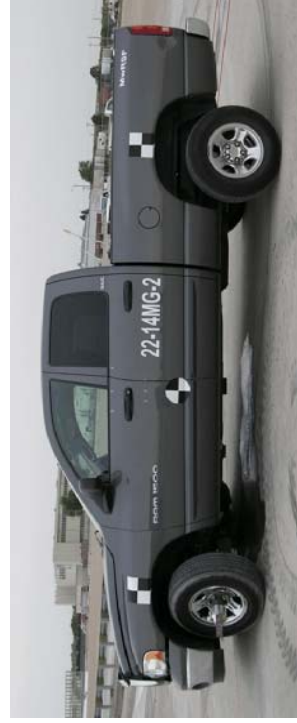
Figure 26. Vehicle Damage, Test 2214MG-2

Exterior vehicle damage was moderate, as shown in Figures 26 and 27. Occupant compartment deformations to the right side and center of the floorboard were judged insufficient to

Damage was concentrated on the right-front corner of the vehicle. The right-front quarter panel was deformed inward toward the engine compartment. The right side of the front bumper was flattened and bent back toward the engine compartment. A major gouge along the right side of the vehicle spanned from the front wheel well to the rear of the vehicle. A dent was found in the right-side door. The right-side door shifted and the top of it was ajar. The right corner of the rear bumper encountered minor scratches and dents. The right-front wheel assembly deformed and crushed inward toward the engine compartment. The right-side lower and upper ball joints were fractured. The right-side steering linkage remained attached but was bent around the sway bar to lower control arm connection. The upper control arm was bent. Minor dents were found on the right-front steel rim. The right-front tire was deformed under the vehicle. The sidewall of the right-front tire was torn, and the tire deflated. The right-side headlight, park light, and tail light fractured, and the park light disengaged from the vehicle. Minor deformations were found on the grill and plastic bumper. All window glass remained undamaged. The left-side and rear of the vehicle remained undamaged.
