# **PERFORMANCE EVALUATION OF THE MIDWEST GUARDRAIL SYSTEM – UPDATE TO NCHRP 350 TEST NO. 3-10 (2214MG-3)**

MwRSF Research Report No. TRP-03-172-06

October 11, 2006

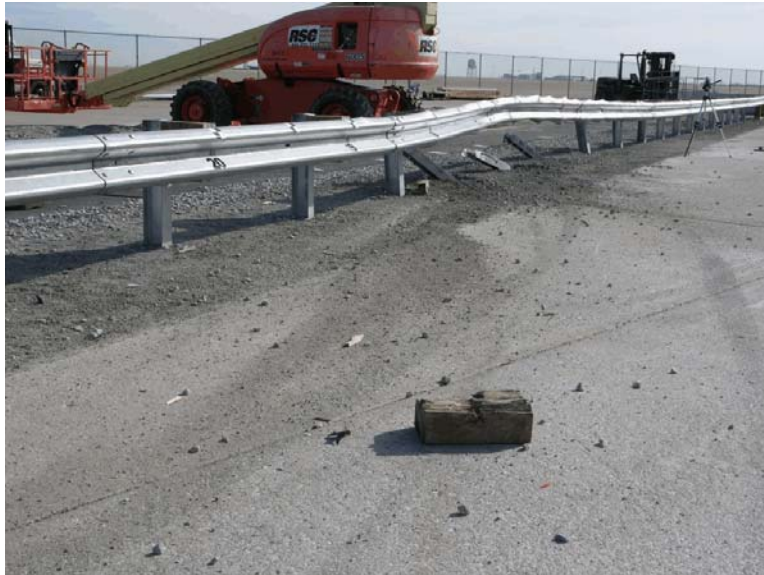
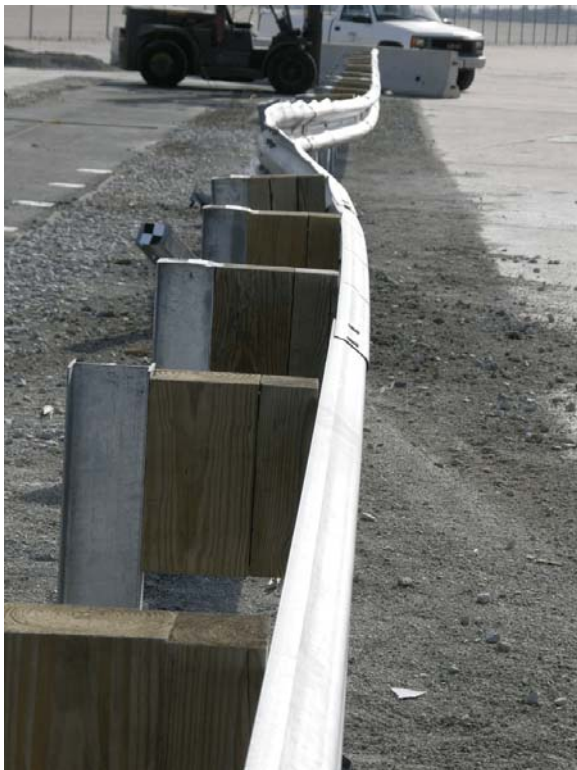
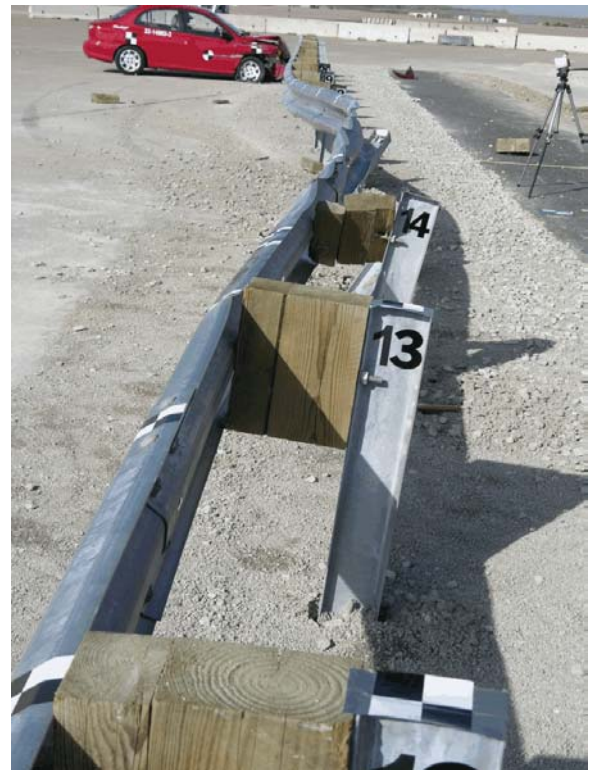
Figure 21. Midwest Guardrail System Damage, Test 2214MG-3

Damage to the barrier was moderate, as shown in Figures 21 through 25. Barrier damage consisted of deformed guardrail posts, disengaged wooden blockouts, contact marks on a guardrail section and posts, and deformed W-beam rail. The length of vehicle contact along the MGS system was approximately 8.3 m (27 ft), which spanned from 749 mm (29.5 in.) downstream from the centerline of post no. 13 through 1,822 mm (71.75 in.) downstream from the centerline of post no. 17.

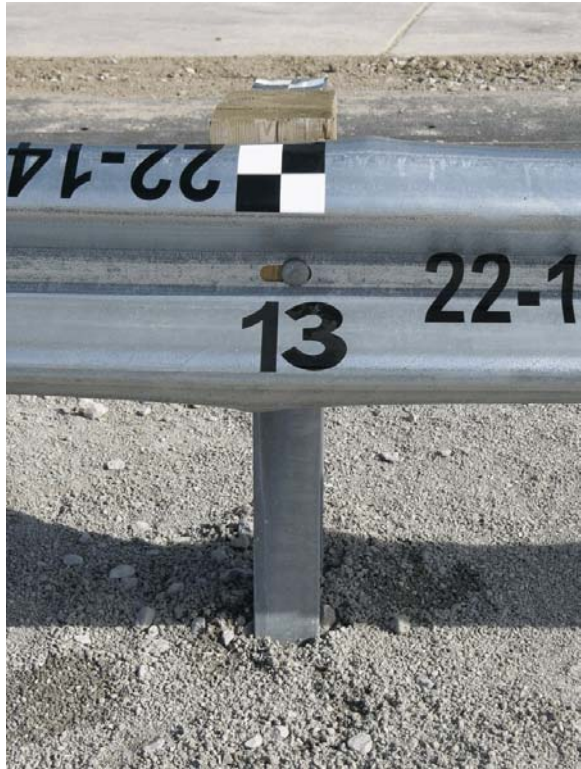
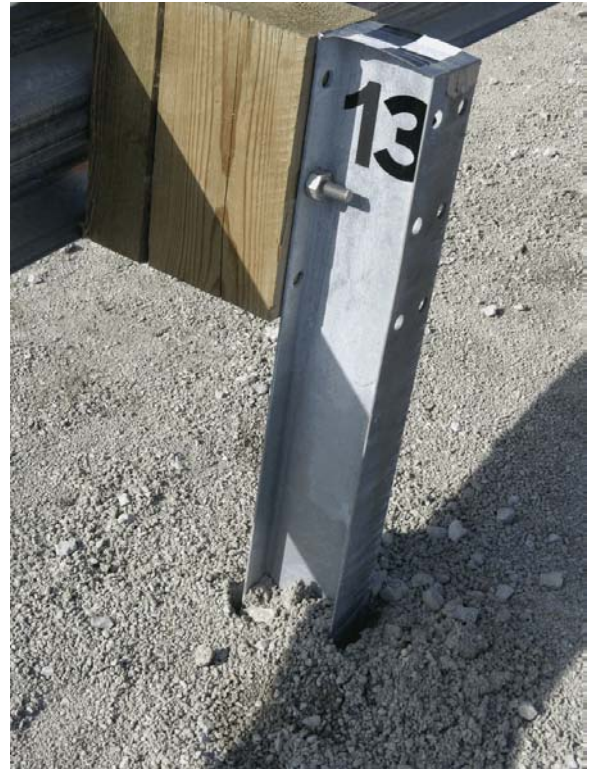
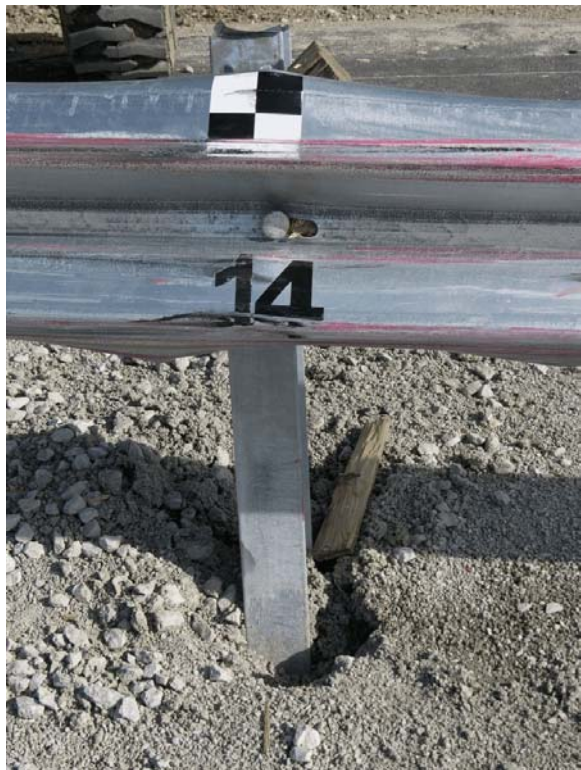
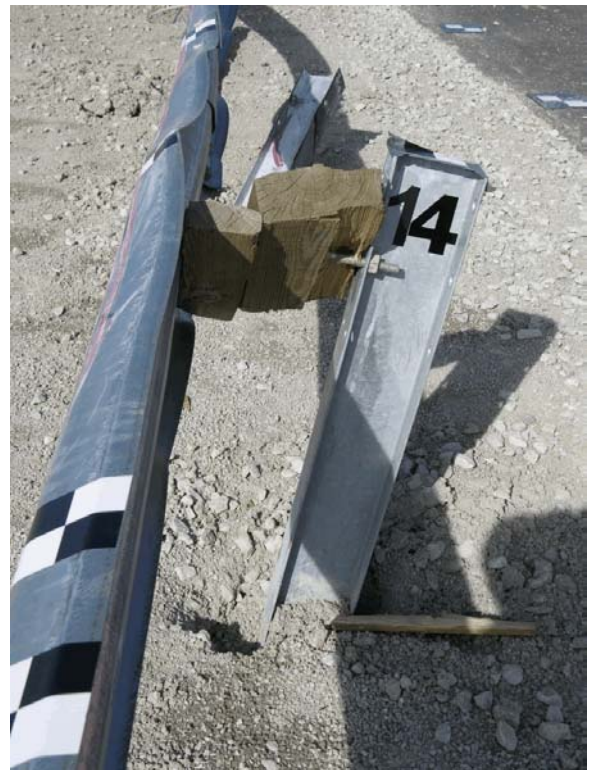
Figure 22. System Damage - Post Nos. 13 and 14, Test 2214MG-3

Moderate deformation and flattening of the impacted section W-beam rail occurred between post nos. 13 and 18. Contact marks were found on the guardrail between post nos. 13 and 18. The guardrail buckled at 105 mm (4.125 in.) upstream of post no. 13 and 254 mm (10 in.) upstream of

Steel post nos. 3 through 14 encountered minor twisting. Post no. 13 also rotated backward. Post no. 14 also rotated backward and downstream slightly. Post no. 15 rotated slightly backward and bent longitudinally downstream. Post no. 16 bent longitudinally downstream toward the ground and encountered major buckling and damage on the flanges. Post no. 17 rotated backward and bent longitudinally downstream. Post no. 18 also rotated backward slightly and bent slightly longitudinally downstream. Contact marks were found on the front and back flanges of post nos. 14 through 16. The post bolt at post no. 17 sheared off. The wooden blockouts at post nos. 14 through 17 were fractured and removed from the posts. The upstream and downstream anchorage systems moved longitudinally and the ground struts encountered plastic deformations on both ends. The upstream anchorage posts deflected downstream, while the downstream anchorage posts deflected upstream, but all four wood BCT posts remained undamaged.

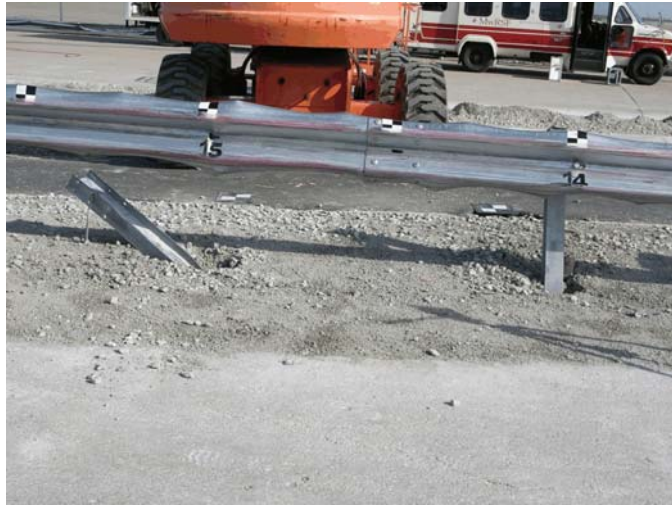
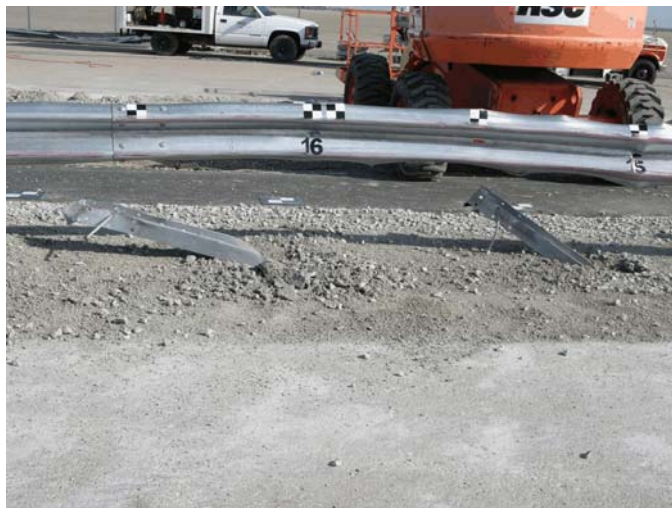
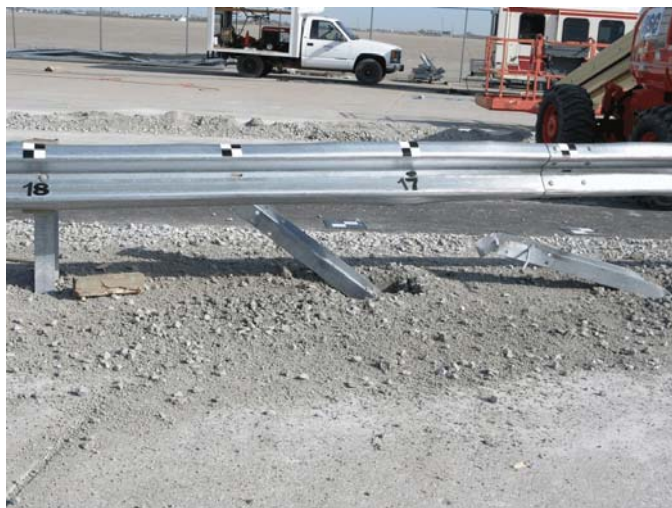
Figure 23. System Damage - Post Nos. 14 through 18, Test 2214MG-3

the post no. 19. Major buckling of the guardrail occurred at the downstream edge of the blockout at post no. 18 and at post no. 15. The W-beam was pulled off post nos. 15 through 17. The W-beam rail sustained yielding around the post bolt slots at post nos. 14 through 18. No significant guardrail damage occurred downstream of post no. 18, except for slight rail deflection and minor contact marks between post nos. 24 and 26 due to secondary vehicle contact with the system before coming to rest.

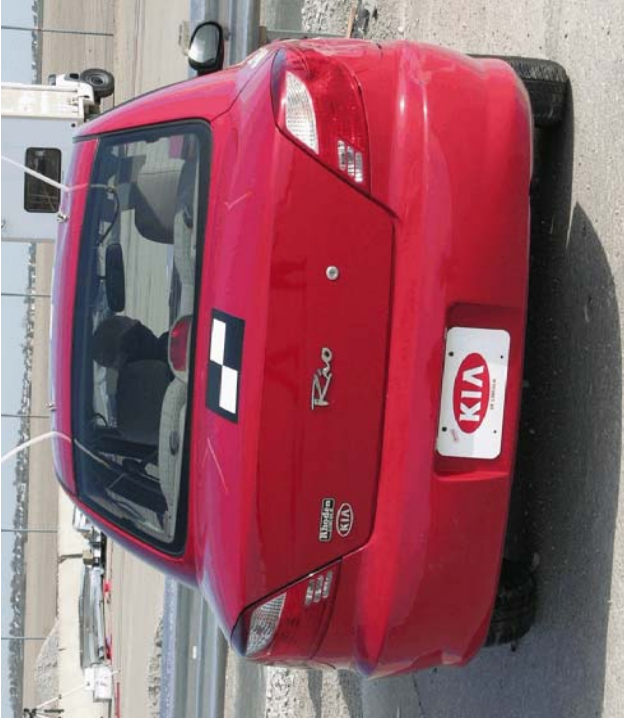
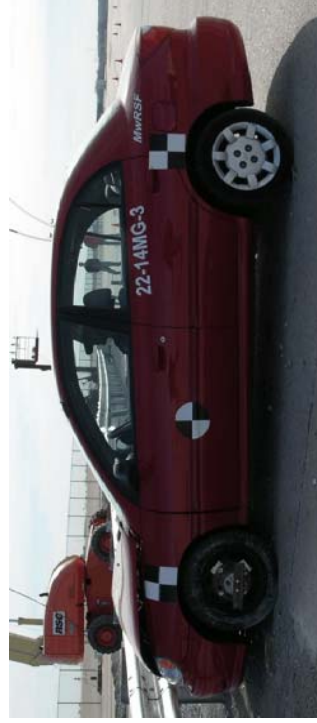
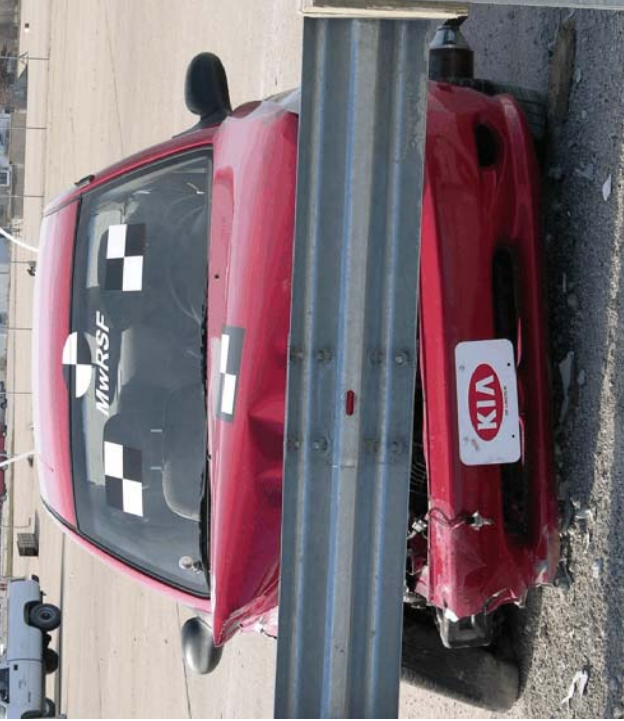
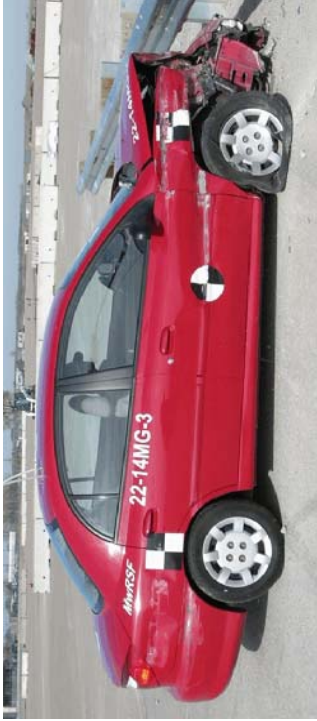
Figure 26. Vehicle Damage, Test 2214MG-3

Exterior vehicle damage was moderate, as shown in Figures 26 through 28. Occupant compartment deformations to the right side and center of the floorboard were judged insufficient to cause serious injury to the vehicle occupants. Maximum longitudinal deflections of 6 mm (0.25 in.) were located throughout the right-side floor pan. Maximum lateral deflections of 6 mm (0.25 in.) were located throughout the right-side floor pan. Maximum vertical deflections of 6 mm (0.25 in.) were located near the center of the right-side floor pan. Complete occupant compartment deformations and the corresponding locations are provided in Appendix C.

Damage was concentrated on the right-front corner of the vehicle. The right-front quarter panel was deformed inward and downward toward the engine compartment. The right side of the front bumper was flattened and crushed inward toward the frame. The front frame was bent about the centerline and the right side was bent backward and downward. The right-side frame with the connection to the wheel was bent backward also. The right-side of the hood buckled upward and crushed inward. The protective plastic molding in the right-front wheel well was fractured. The right-front wheel assembly deformed and crushed inward toward the engine compartment. The right-front steel rim was bent on both the interior and exterior sides. The right-front tire was pulled off the rim and deflated. The right-front door encountered dents and scratches and was ajar at the top. The right rear door also encountered contact marks from system interaction. The right-rear quarter panel sustained minor contact marks and denting. The right-rear bumper was scratched and dislodged slightly. The right-side headlight, park light, and brake light fractured and disengaged from the vehicle. The left-side headlight was dislodged out of its socket. All window glass remained
