MASH TL-4 EVALUATION OF THE TXDOT TYPE C2P BRIDGE RAIL

Test Report 9-1002-15-2

TEXAS DEPARTMENT OF TRANSPORTATION

1. Report No. FHWA/TX-17/9-1002-15-2	2. Government Accession No.	3. Recipient's Catalog No.	
4. Title and Subtitle MASH TL-4 EVALUATION OF THE TXDOT TYPE C2P BRIDGE RAIL		5. Report Date February 2017

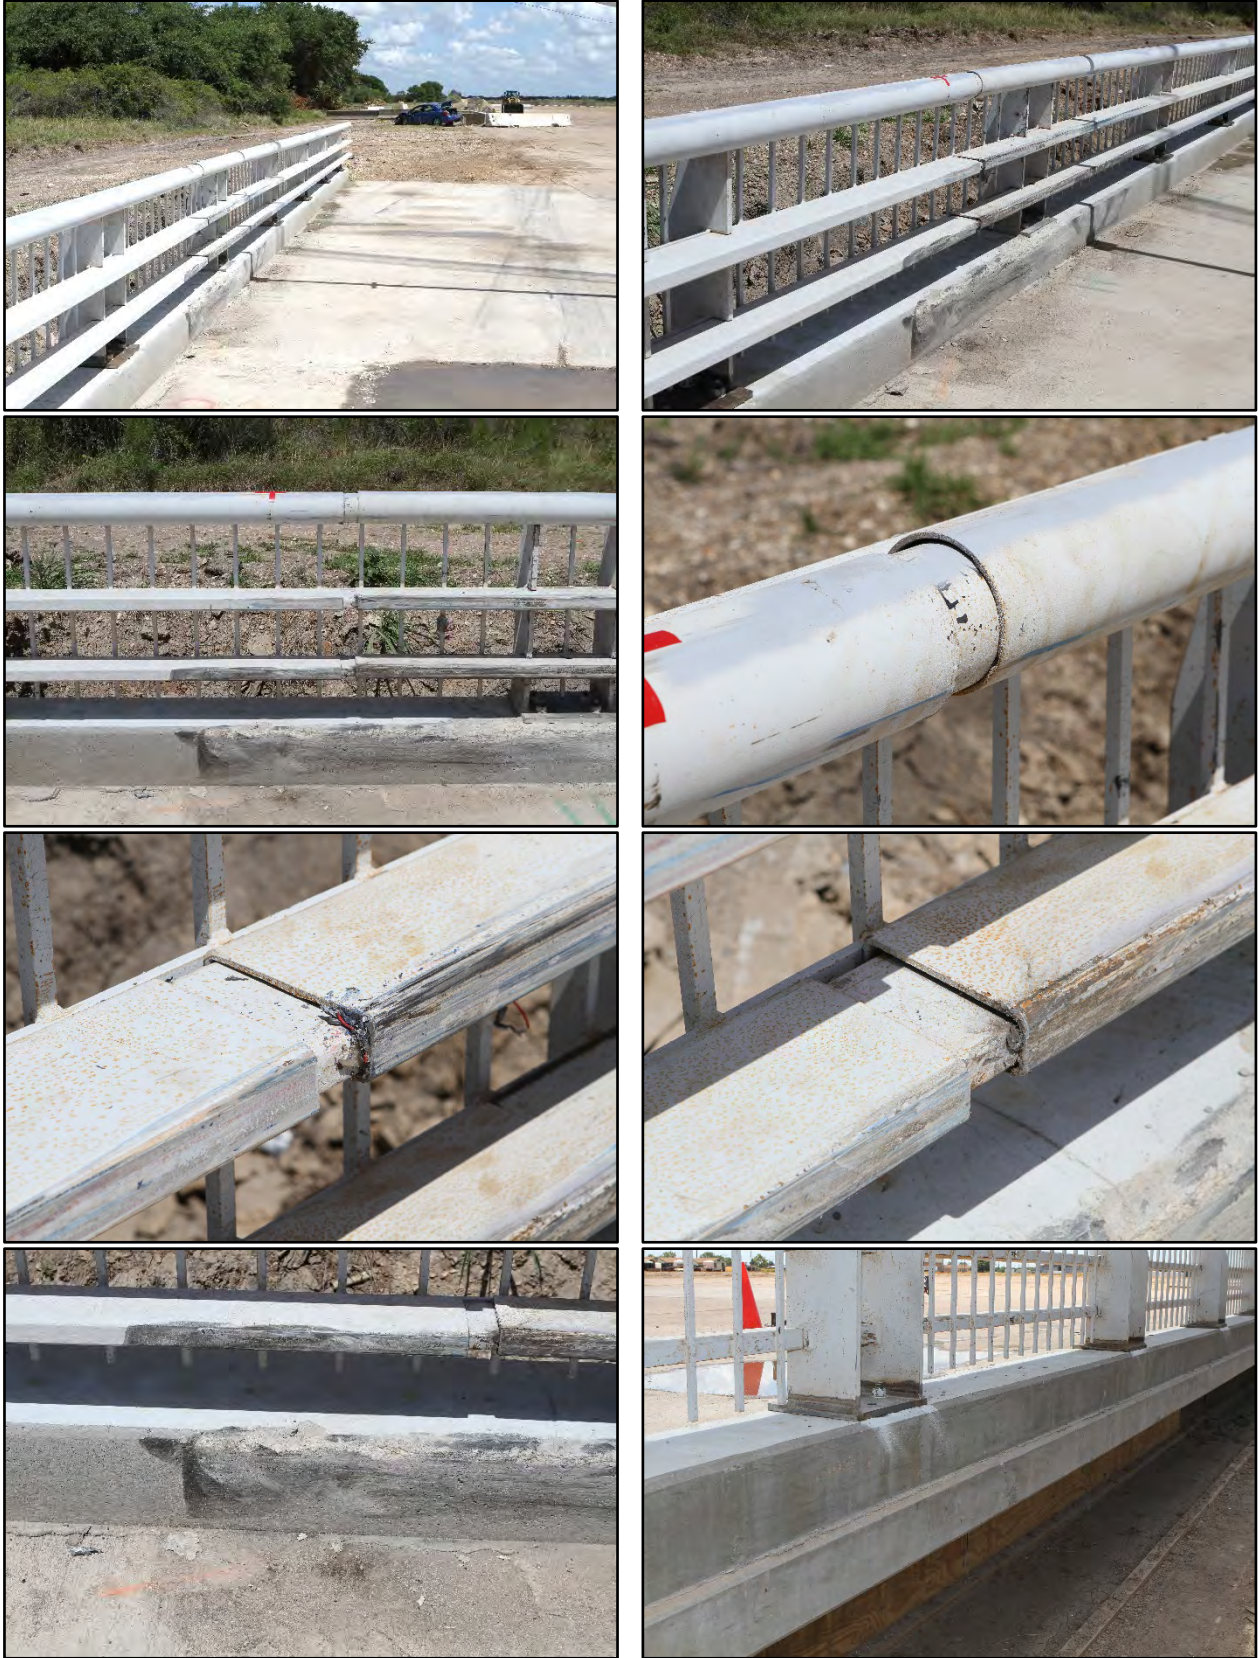
Figure 5-3. TxDOT Type C2P Bridge Rail after Test No. 490026-4-1.

Figure 5-3 shows the damage to the TxDOT Type C2P Bridge Rail. The traffic face of the bridge rail was marred and scuffed, as was the traffic face and top of the curb. Working width was 14.0 inches. Maximum dynamic deflection during the test was 0.8 inch, and there was no notable maximum permanent deformation after the test.

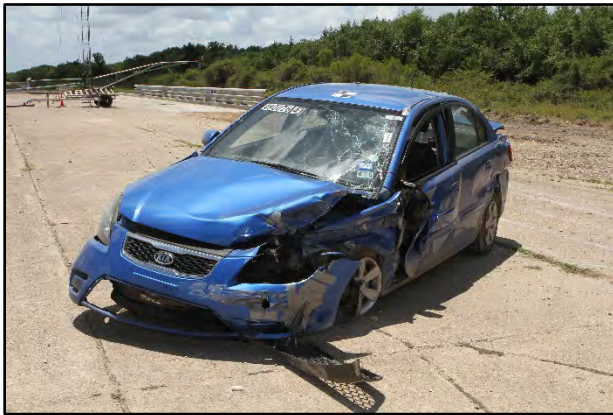
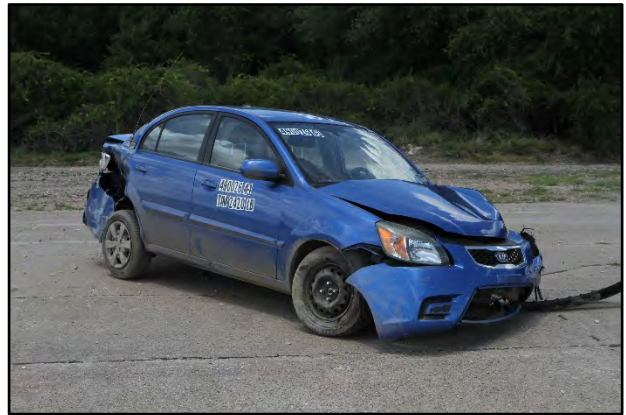
Figure 5-4. Test Vehicle after Test No. 490026-4-1.

Figure 5-4 shows the damage sustained by the vehicle. The front bumper, hood, left front tire and rim, left front strut and tower, left front fender, left front door and window glass, left rear door, left rear quarter panel, and rear bumper were damaged. The windshield was cracked in the left lower corner, and cracks radiated upward and toward the center. Maximum exterior crush to the vehicle was 13.0 inches in the side plane at the left front corner at bumper height. Maximum occupant compartment deformation was 4.0 inches in the left front firewall area near the toe pan. Figure 5-5 shows the interior of the vehicle. Tables C-2 and C-3 in Appendix D1 provide exterior crush and occupant compartment measurements.

Maximum occupant compartment deformation was 4.0 inches in the left front firewall area. (PASS)

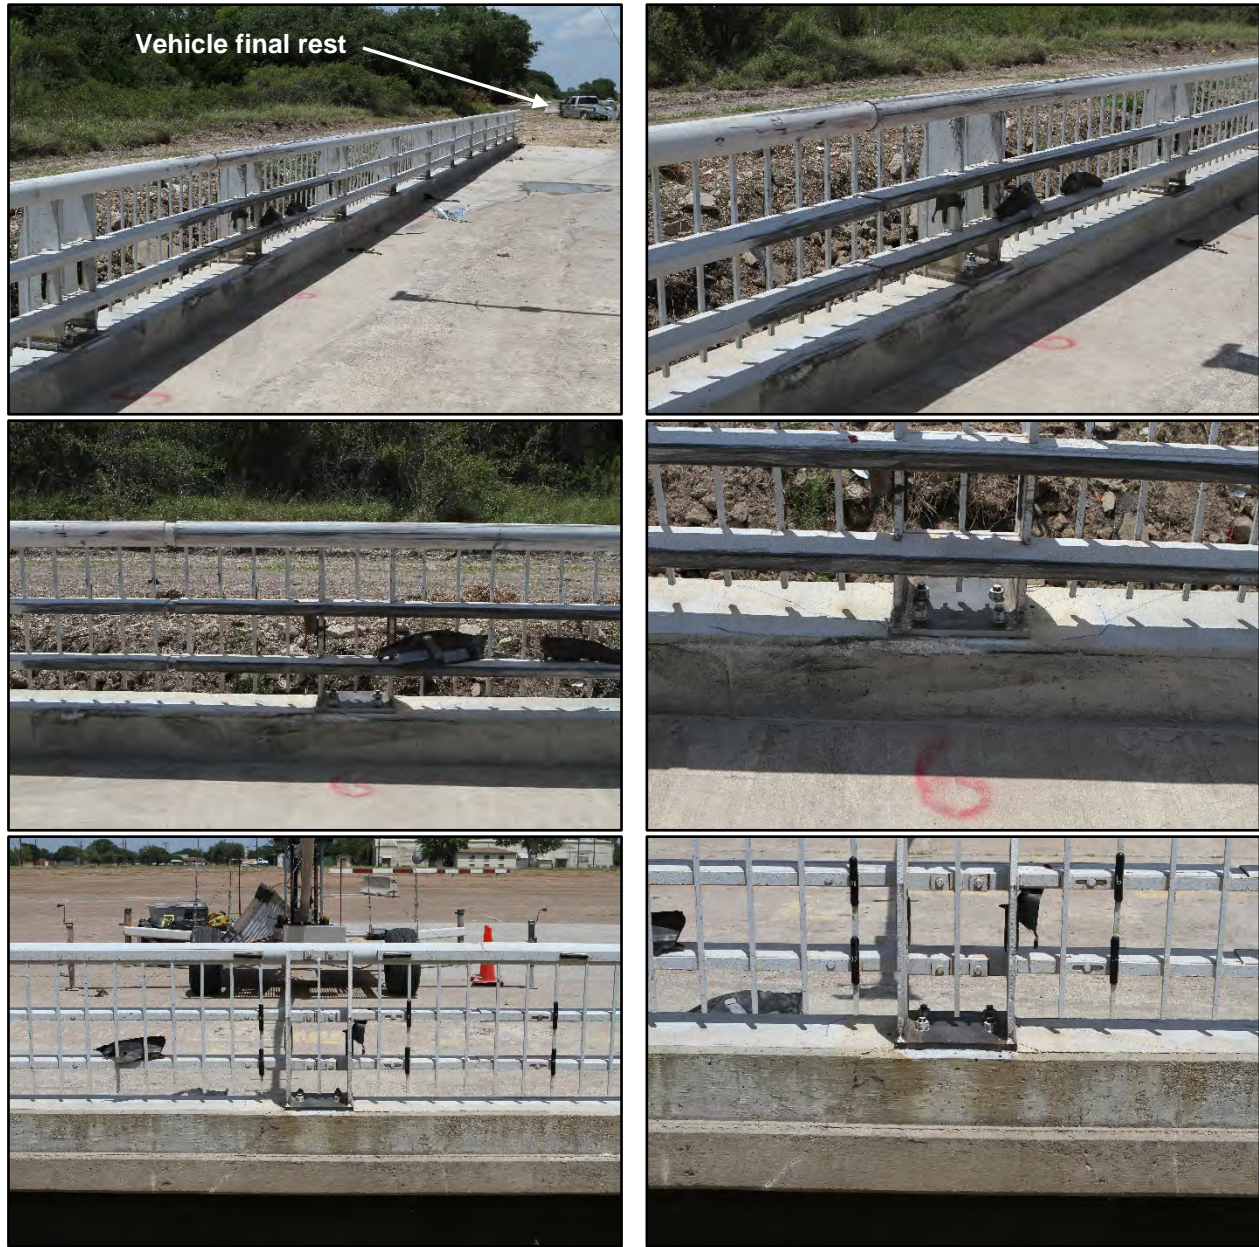
Figure 6-3. TxDOT Type C2P Bridge Rail after Test No. 490026-4-2.

Figure 6-3 shows the damage to the TxDOT Type C2P Bridge Rail. No damage to the posts was noted. Small cracks in the curb radiated from the anchor bolts at post 5, and larger cracks radiated from the anchor bolts at post 6. Working width was 14.0 inches. Maximum dynamic deflection during the test was 2.5 inches, and maximum permanent deformation was 1.4 inches.

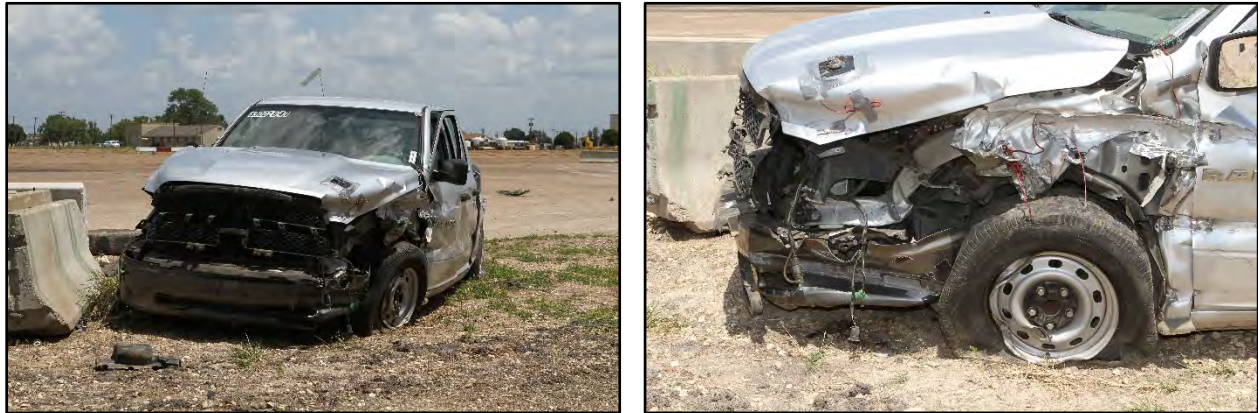
Figure 6-4. Test Vehicle after Test No. 490026-4-2.

Figure 6-4 shows the damage sustained by the vehicle. The front bumper, grill, hood, left front tire and rim, left upper and lower A-arms, left front fender, left front door and window glass, left rear door, left rear cab corner, left rear exterior bed, left rear tire and rim, left rear bumper, and left rear tailgate were damaged. The windshield sustained stress cracks radiating from the lower left corner of the A-pillar. Maximum exterior crush to the vehicle was 13.0 inches in the side plane at the left front corner at bumper height. Maximum occupant compartment deformation was 2.25 inches in the instrument panel area. Figure 6-5 shows the interior of the

vehicle. Tables E-3 and E-4 in Appendix E1 provide exterior crush and occupant compartment measurements.

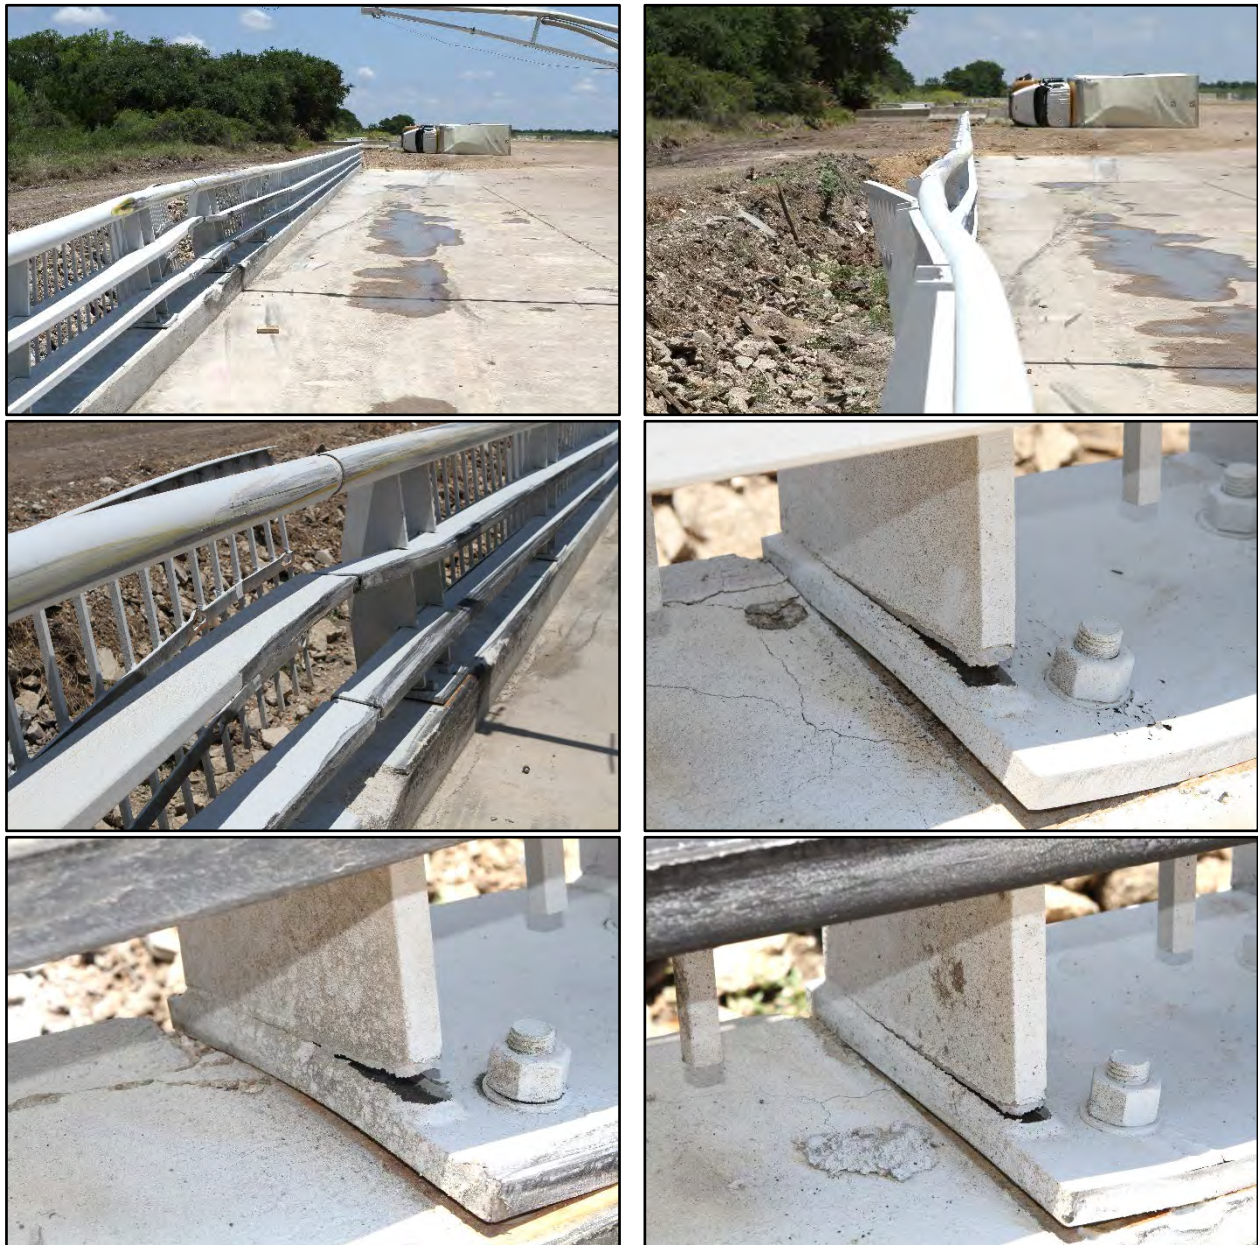
Figure 7-3. TxDOT Type C2P Bridge Rail after Test No. 490026-4-3.

Figure 7-3 shows the damage to the TxDOT Type C2P Bridge Rail. The welds failed at the base plates of post 5, 6, and 7. It was determined that the welds were not constructed correctly by the fabricator. After the welds failed at Posts 5, 6, and 7, the post plates rotated toward the field side 10 degrees, 13 degrees, and 7 degrees, respectively. The picket section between posts 5 and 6 released at the center and downstream locations but remained attached to the rail. Cracks radiated through the curb at posts 3 and 4, through the curb and deck at posts 5, 6, and 7, and through the curb at post 8. Working width was 62.3 inches. Maximum dynamic deflection during the test was 11.4 inches. Maximum permanent deformation as 7.25 inches at the joint between posts 5 and 6.

Results: The TxDOT Type C2P Bridge Rail contained and redirected the 10000S vehicle. Although the welds partially failed on several posts in the impact region (due to incorrect weldment by the fabricator), the vehicle did not penetrate, underride, or override the installation. Maximum dynamic deflection during the test was 11.4 inches. (PASS)

The first test was test 3 with the single unit truck (*MASH* 4-12), followed by test 2 with the pickup truck (*MASH* 4-11), and finally test 1 with the small car (*MASH* 4-10). During test 3, the base plate welds failed at posts 5, 6, and 7 (refer to Section 7.5). Prior to test 2, the base plates for all 15 posts used for the remaining two tests were removed and new base plates of the same design were welded to the posts.

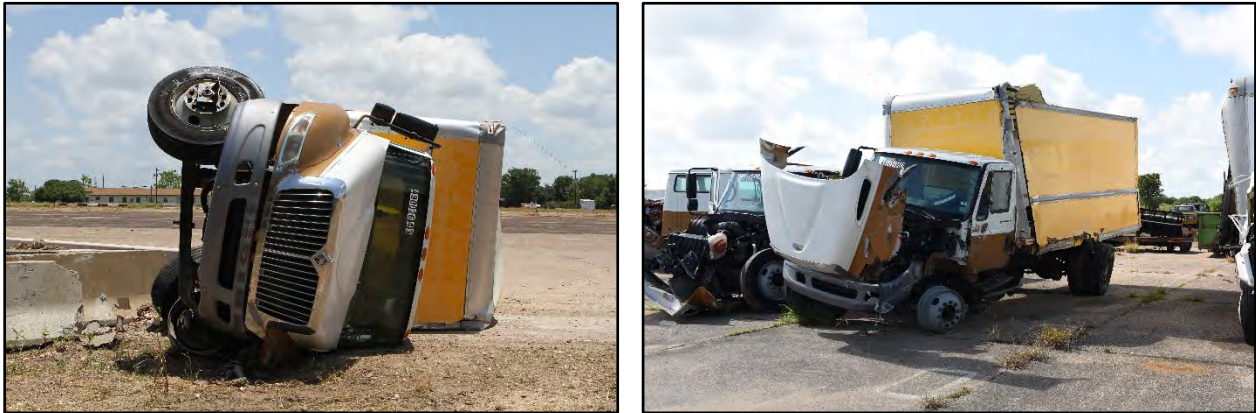
Figure 7-4. Test Vehicle after Test No. 490026-4-3.

Figure 7-4 shows the damage sustained by the vehicle. The front bumper, hood, left front tire and rim, left battery box, left steps, left door and vent glass, left side of the cargo box, left rear outer tire and rim, and roof were damaged. The windshield sustained stress cracks during the test. Maximum exterior crush to the vehicle was 14.0 inches in the side plane at the left front corner at bumper height. No occupant compartment deformation was noted. Figure 7-5 shows the interior of the vehicle.

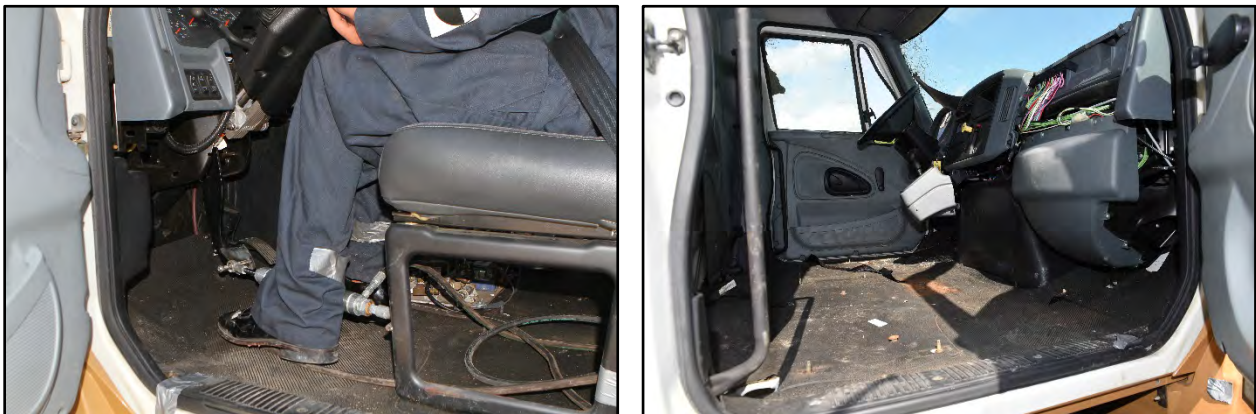
Figure 7-5. Interior of Test Vehicle for Test No. 490026-4-3.

No deformation or intrusion into the occupant compartment occurred. (PASS)
