## CRASH TEST AND EVALUATION OF THE TxDOT T224 BRIDGE RAIL

### Test Report 9-1002-15-5

TEXAS A&M TRANSPORTATION INSTITUTE  
COLLEGE STATION, TEXAS

1. Report No. FHWA/TX-15/9-1002-15-5	2. Government Accession No.	3. Recipient's Catalog No.	
4. Title and Subtitle <b>CRASH TEST AND EVALUATION OF THE TXDOT T224 BRIDGE RAIL</b>		5. Report Date December 2015

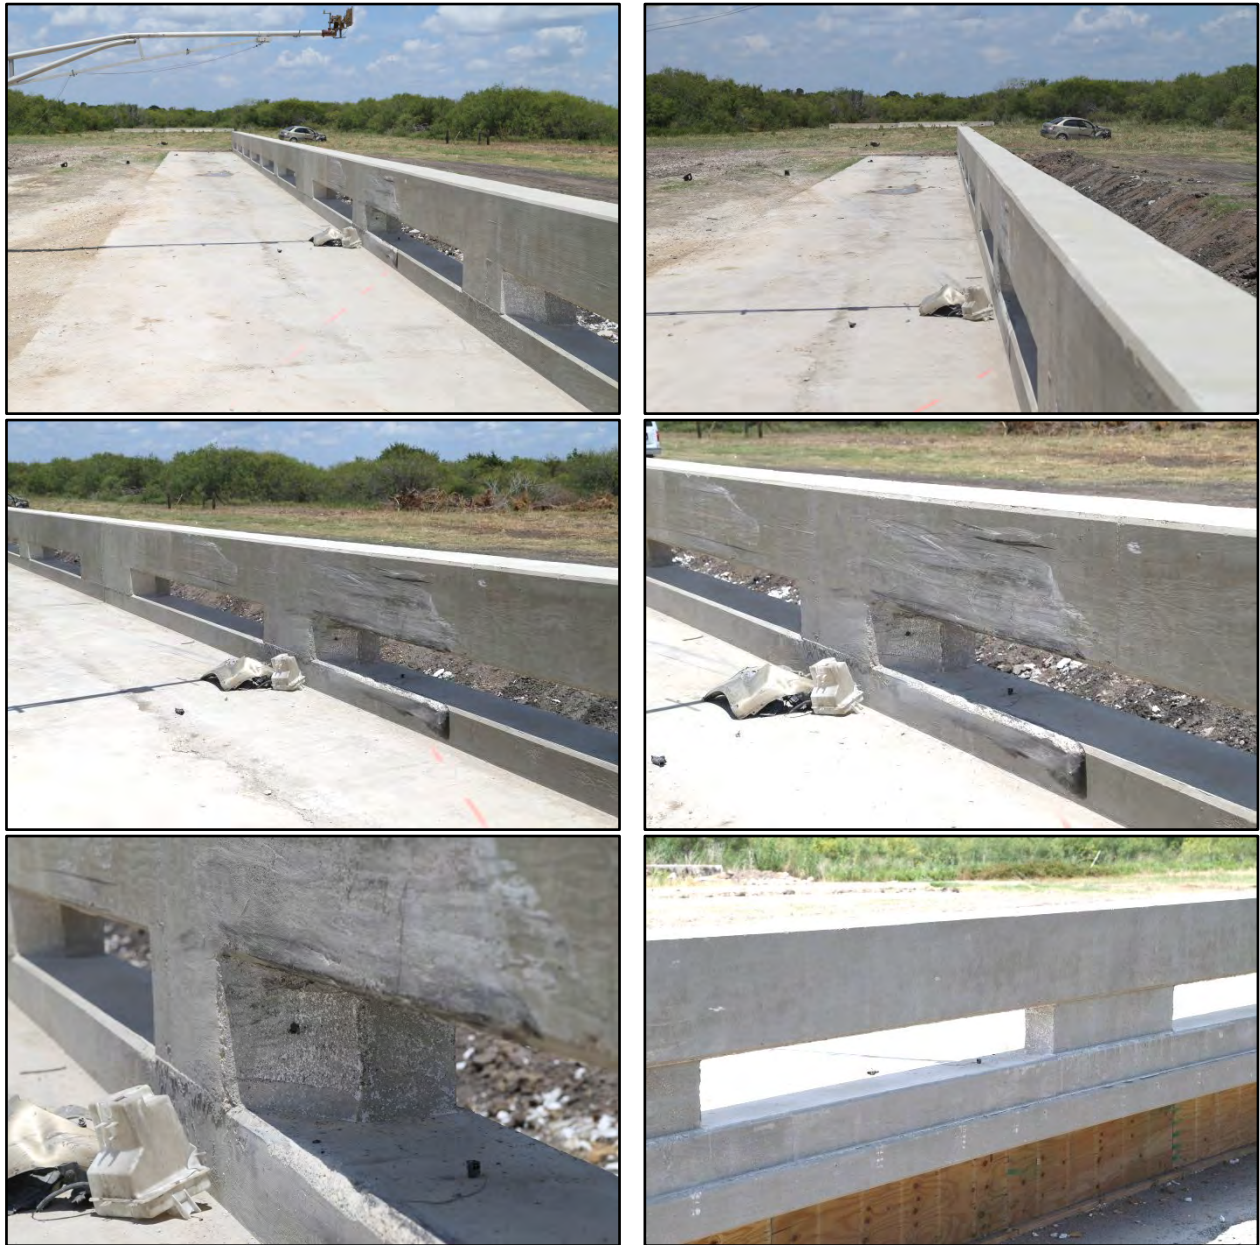
**Figure 5.3. TxDOT T224 Bridge Rail after Test No. 490025-2-2.**

Figure 5.3 shows the damage to the TxDOT T224 Bridge Rail after *MASH* Test 5-10. The traffic face of the bridge rail sustained mostly cosmetic damage in the form of scrapes and tire marks. Some concrete was scraped off the traffic side edge of the curb, and there were tire marks and gouges caused by the wheel rim on the upstream side of post 4. The 1100C vehicle was in contact with the bridge rail a total distance of 17.5 ft. Working width was 16.5 inches. Maximum dynamic deflection during the test was not obtained due to view being blocked by the vehicle and dust, and no maximum permanent deformation after the test occurred.

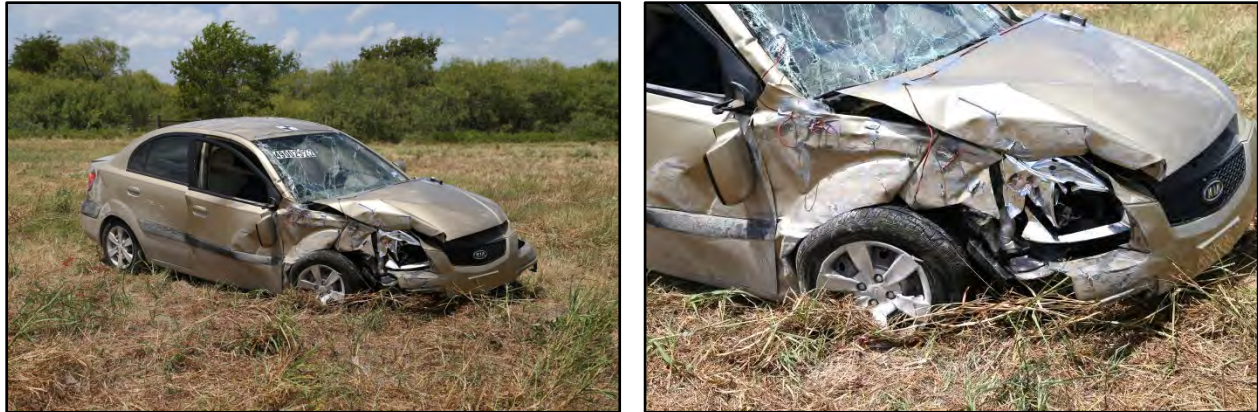
**Figure 5.4. Test Vehicle after Test No. 490025-2-2.**

Figure 5.4 shows the damage that the 1100C vehicle sustained. The right front strut and tower were deformed. The front bumper, hood, radiator, right front tire and rim, right front fender, right front door and door glass, roof, right rear door, and right rear quarter panel were damaged. The A-pillar was deformed and caused the windshield to fracture. Maximum exterior crush to the vehicle was 13.0 inches in the front plane at the right front corner at bumper height. Maximum occupant compartment deformation was 4.0 inches in the right side instrument panel.

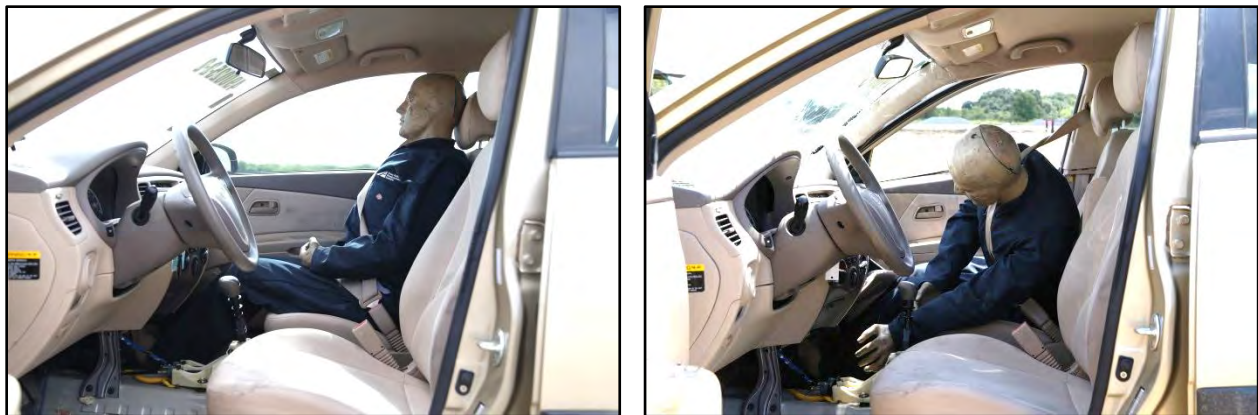
**Figure 5.5. Interior of Test Vehicle for Test No. 490025-2-2.**

Figure 5.5 shows the interior of the vehicle. Tables C.2 and C.3 in Appendix C.1 provides exterior crush and occupant compartment measurements.

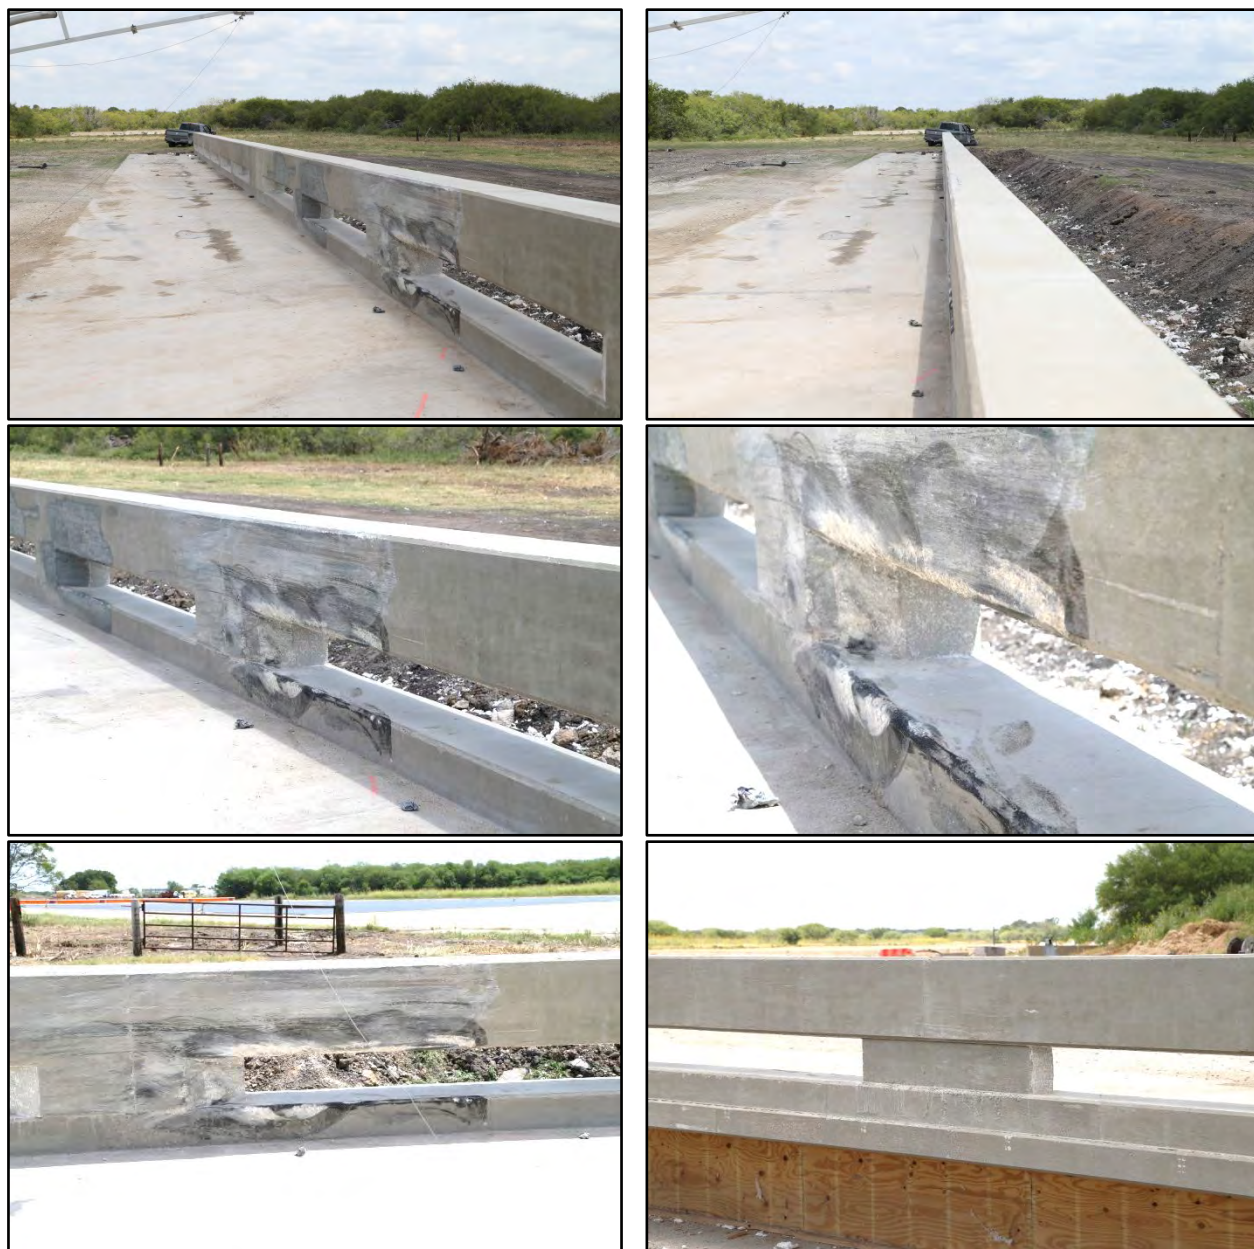
**Figure 6.3. TxDOT T224 Bridge Rail after Test No. 490025-2-3.**

Figure 6.3 shows the damage to the TxDOT T224 Bridge Rail. The traffic face of the bridge rail sustained mostly cosmetic damage in the form of scrapes and tire marks. Some concrete was scraped off the traffic side edge of the curb, and there were tire marks and gouges caused by the wheel rim on the upstream side of post 3. The 2270P vehicle was in contact with the bridge rail a distance of 14.2 ft. Working width was 16.5 inches. Maximum dynamic deflection during the test was negligible. No measureable permanent deformation was noted.

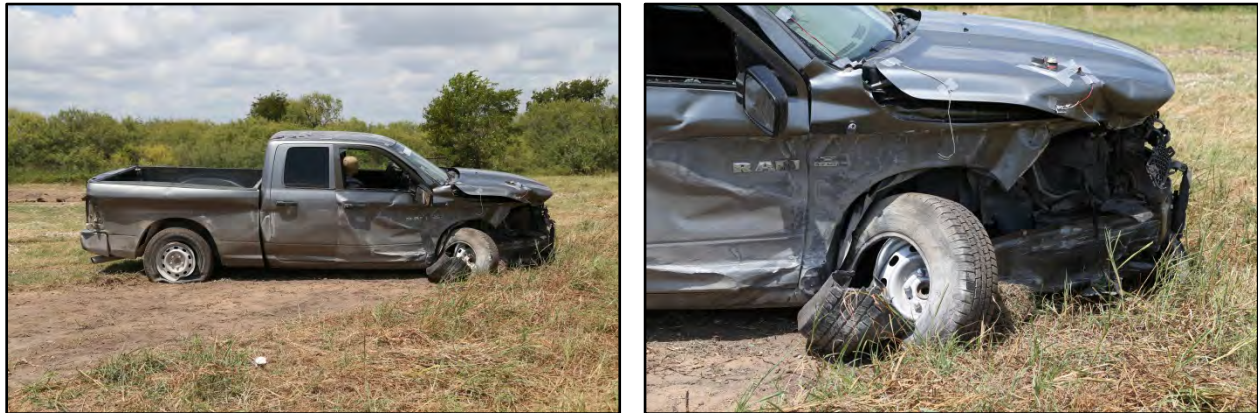
**Figure 6.4. Test Vehicle after Test No. 490025-2-3.**

Figure 6.4 shows the damage that the 2270P vehicle sustained. The right front rail, the right front upper and lower A-arms, and the right upper and lower ball joints were deformed. Also damaged were the front bumper, grill, hood, right front fender, right front tire and rim, right front door and door glass, right rear exterior bed, right rear tire and rim, and rear bumper. The A-pillar was deformed causing the windshield to fracture. Maximum exterior crush to the vehicle was 18.0 inches in the front plane at the right front corner at bumper height. Maximum occupant compartment deformation was 5.0 inches in the right firewall area. Figure 6.5 shows the interior

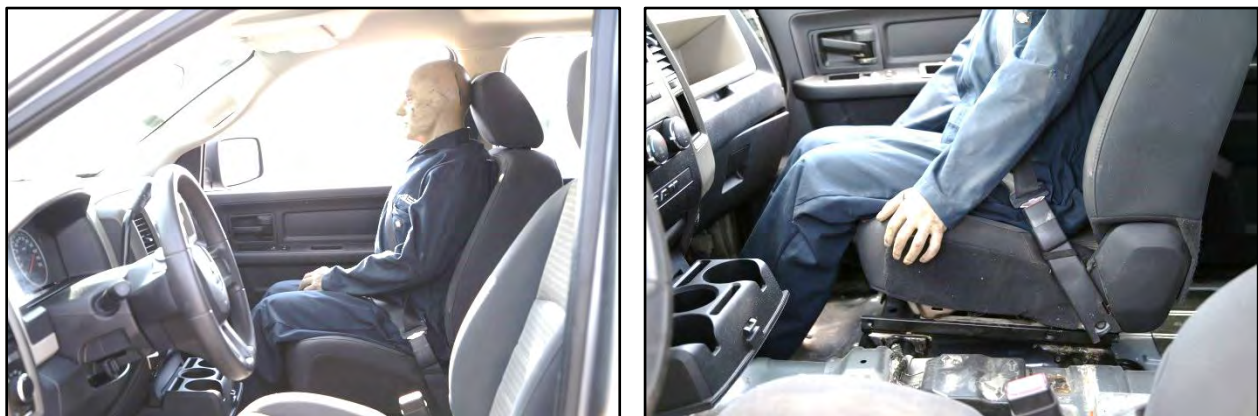
**Figure 6.5. Interior of Test Vehicle for Test No. 490025-2-3.**

of the vehicle. Tables D.3 and D.4 in Appendix D.1 provide exterior crush and occupant compartment measurements.

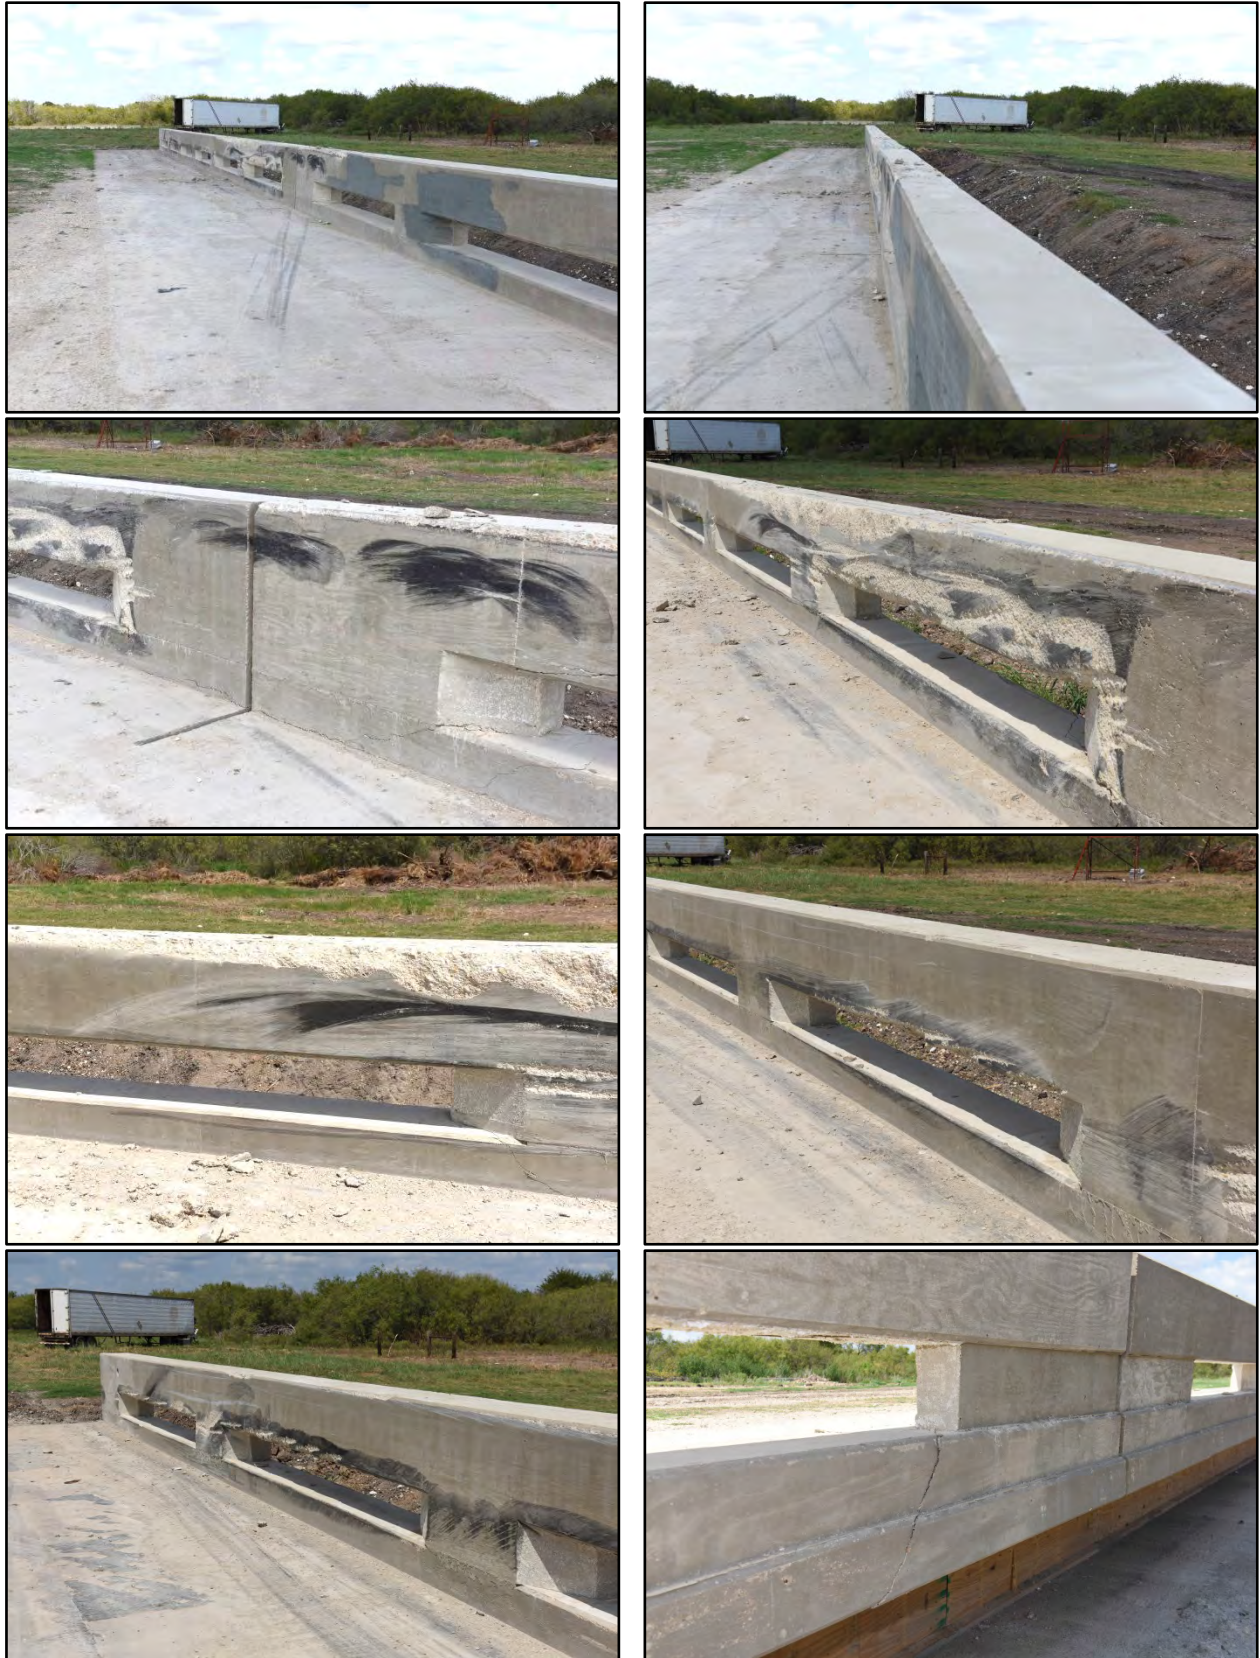
**Figure 7.3. TxDOT T224 Bridge Rail after Test No. 490025-2-1.**

Figure 7.3 shows the damage to the TxDOT T224 Bridge Rail. The curb was fractured at its connection with the deck 3.5 ft both upstream and downstream from the joint. The curb was also cracked over a length ranging from 6 ft upstream to 17 ft downstream of the joint. The upper rail was cracked from the joint extending downstream for 18 ft, and two cracks in the rail were noted from the joint extending upstream 12.5 ft (primary crack) and 17 ft 8 inches (secondary crack). The field side of the deck was cracked upstream of post 5. Working width was 38.5 inches from the traffic side of the bridge rail to the farthest extent of the vehicle. Maximum dynamic deflection during the test was 2.1 inches, and maximum permanent deformation as 1.4 inches.

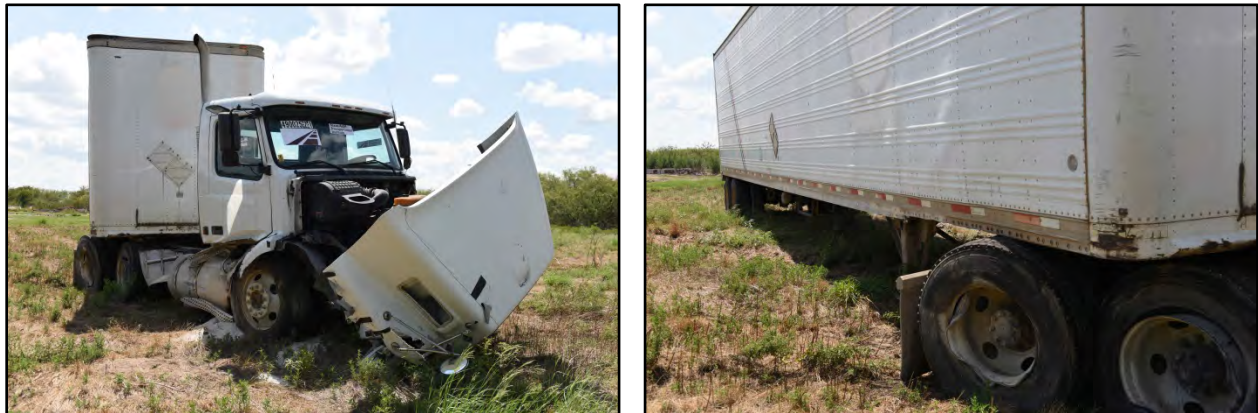
**Figure 7.4. Test Vehicle after Test No. 490025-2-1.**

Figure 7.4 shows the damage that the vehicle sustained. The front axle was pushed rearward 36 inches, and the right tie rod, right U-bolts, and right front shock and mount were deformed. Also damaged were the front bumper, hood, right front tire and rim, right front fender, right fuel tank, right side steps, and right rear outer tires and wheel rims of the tractor tandem. The right side lower edge of the trailer was also deformed and scraped. Maximum exterior crush to the vehicle was 12.0 inches in the front plane at the right front corner at bumper height. No occupant compartment deformation occurred. Figure 7.5 shows the interior of the vehicle.
