**Test Report No. 607911-1&2**

## **MASH TL-3 TESTING AND EVALUATION OF FREE-STANDING PORTABLE CONCRETE BARRIER**

**Contract No.: T4541 CN**

## **TEXAS A&M TRANSPORTATION INSTITUTE PROVING GROUND**

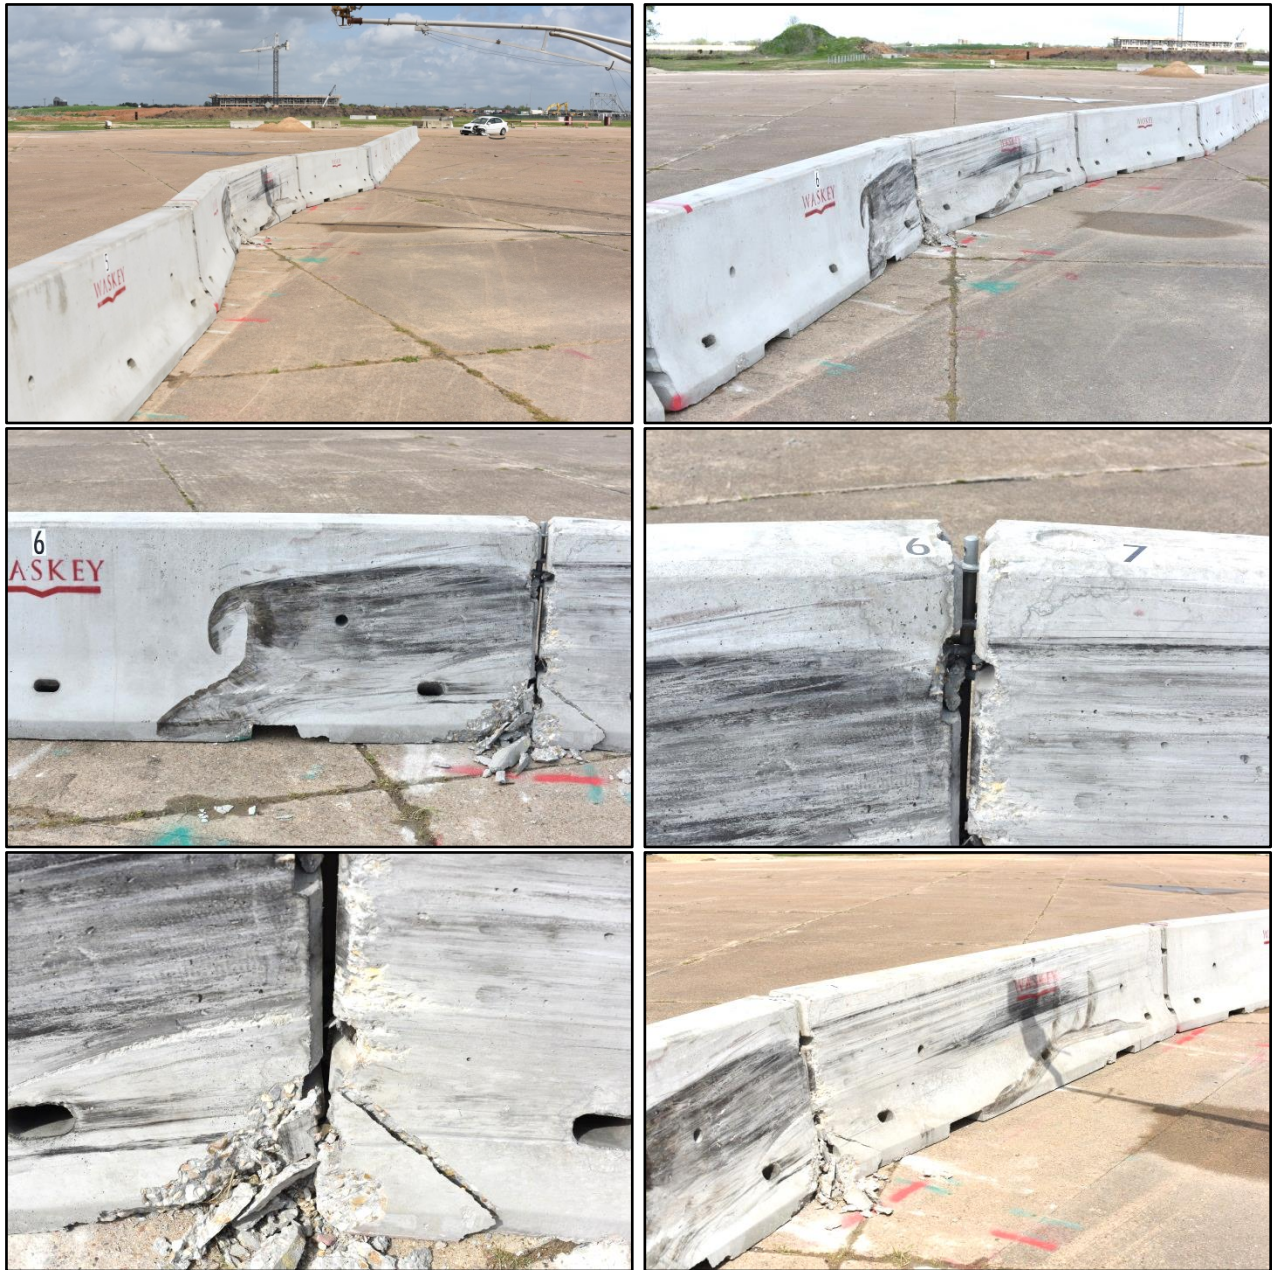
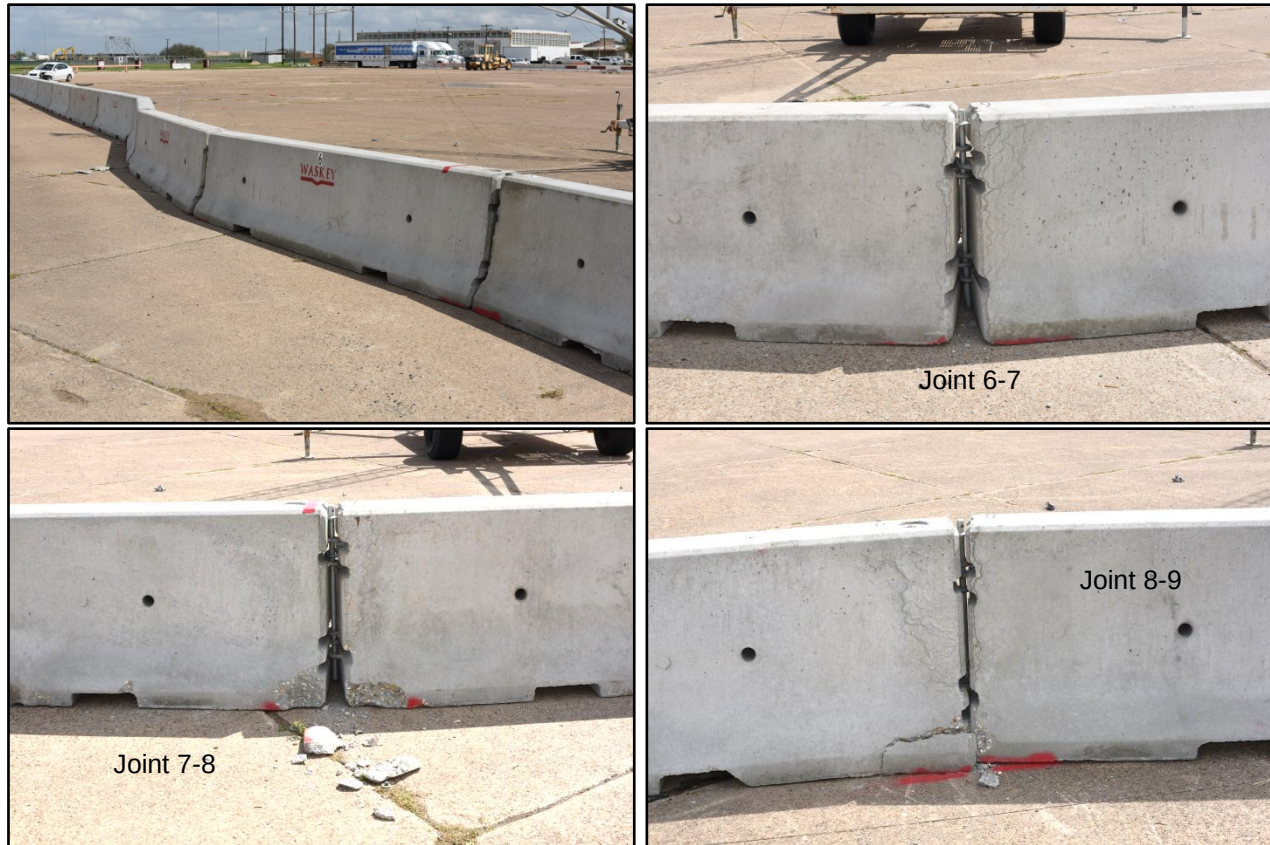
Figures 5.3 and 5.4 show the damage to the free-standing PCB. Concrete broke off at the impact side toes of segments 6 and 7 at the joint. Concrete spalled from the downstream field side toe of segment 7, from the upstream field side toe of segment 8, and from the upstream field side toe of segment 9. Tire marks and scrapes were noted along the traffic side for a distance of 16.7 ft from point of impact. Working width was 60.7 inches. Maximum dynamic deflection during the test was 36.2 inches, and maximum permanent deflection was 34.0 inches.

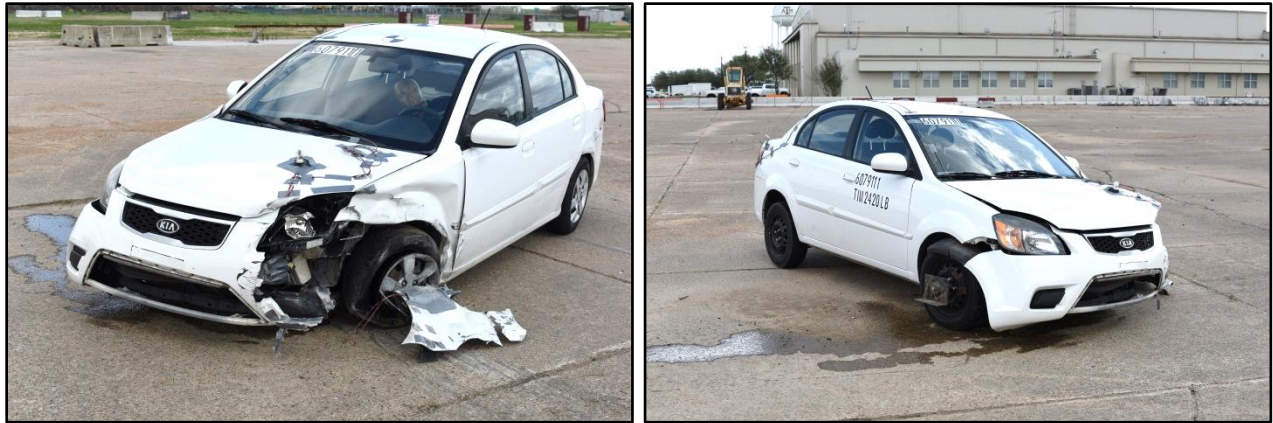
**Figure 5.5. Test Vehicle after Test No. 607911-1.**

Figure 5.5 shows the damage sustained by the vehicle. The front bumper, hood, left strut and tower, left front tire and rim, left front fender, left front and rear doors, left rear quarter panel, and rear bumper were damaged. The left side floor pan sustained light damage, and the left front door was deformed at the top near the roof/door frame, leaving a small gap. Maximum exterior crush to the vehicle was 9.5 inches in the left side plane at the left front corner at bumper height. Maximum occupant compartment deformation was 0.5 inches in the left firewall and floor pan area. Figure 5.6 shows the interior of the vehicle. Tables C.2 and C.3 in Appendix C1 provides exterior crush and occupant compartment measurements.

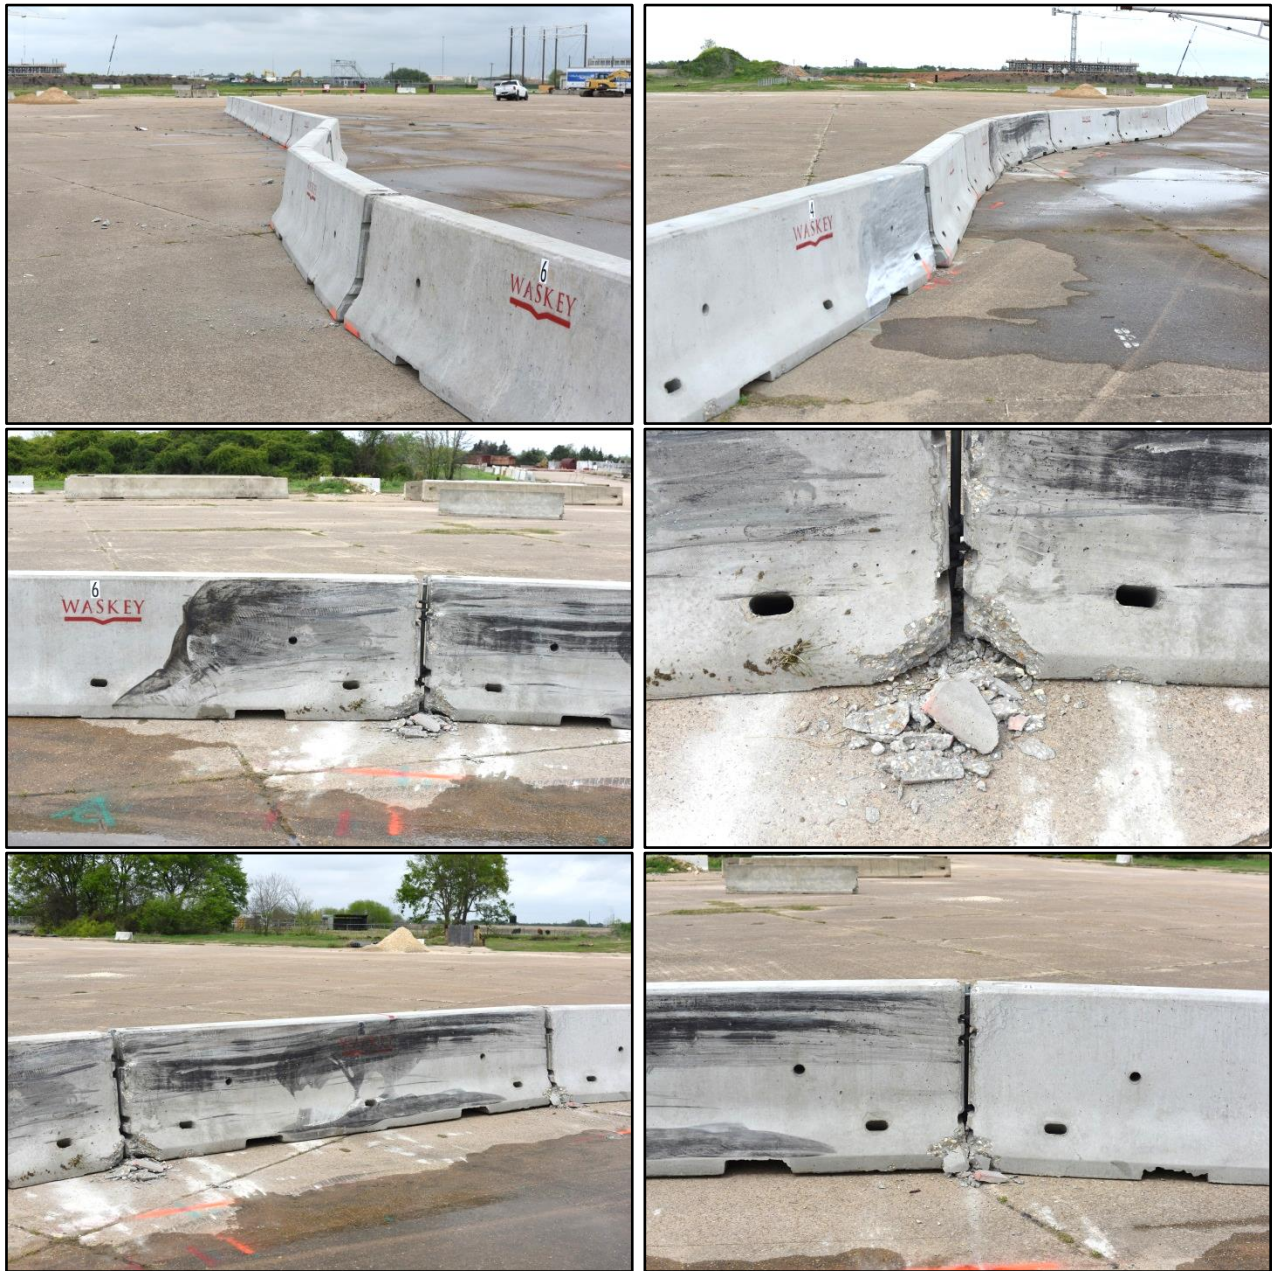
**Figure 6.3. Free-Standing PCB after Test No. 607911-2.**

Figure 5.3 shows the damage to the free-standing PCB. The field side of segment 7 was cracked near the midpoint and at the upstream quarter point. The field and impact side downstream ends of the toe of segment 4 were chipped, and both field side toes of segment 5 were chipped. Figure 5.3 shows the damage to the impact side toes of segments 6 and 7. For segments 8 and 9, the upstream non-impact and impact side toes and the downstream field side

toes were chipped. The upstream field side toe of segment 10 was also chipped. Working width was 87.5 inches. Maximum dynamic deflection during the test was 63.4 inches, and maximum permanent deflection was 61.5 inches.

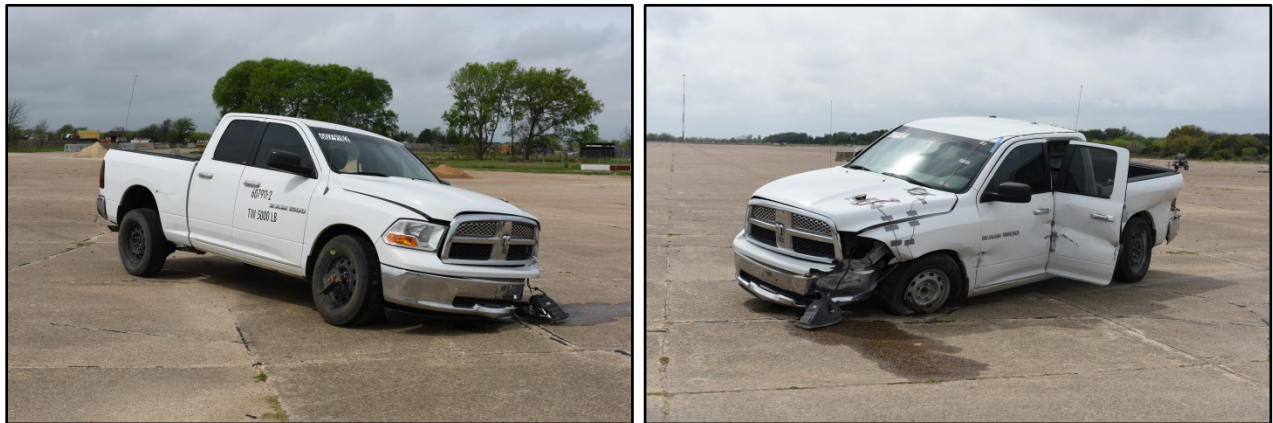
**Figure 6.7. Test Vehicle after Test No. 607911-2.**

Figure 6.7 shows the damage sustained by the vehicle. The front bumper, radiator and support, grill, left front fender, left front tire and rim, left front and rear doors, left lower corner of the cab, left exterior bed, left rear rim, and rear bumper were damaged. The right frame rail was deformed. The left front and rear doors were deformed at the top near the roof/door frame leaving a small opening. Maximum exterior crush to the vehicle was 14.0 inches in the side plane at the left front corner at bumper height. No occupant compartment deformation or intrusion occurred that reduced the size of the occupant compartment. Figure 6.8 shows the interior of the vehicle. Tables D.3 and D.4 in Appendix D1 provide exterior crush and occupant compartment measurements.
