MASH TL-4 CRASH TESTING AND EVALUATION OF THE RESTORE BARRIER

MIDWEST ROADSIDE SAFETY FACILITY

MwRSF Research Report No. TRP-03-318-15

November 3, 2015

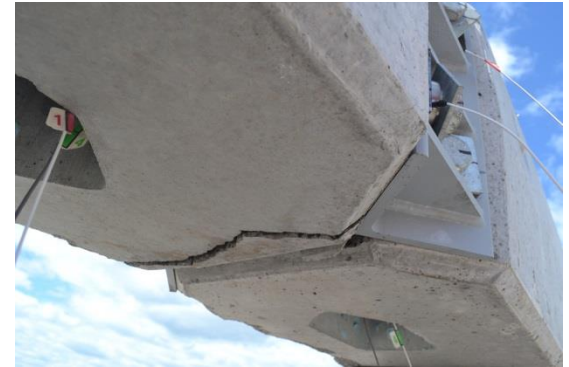
Figure 52. System Damage, Barrier Nos. 5 and 6, Test No. SFH-1

Damage to the barrier was minimal, as shown in Figures 52 and 53. Barrier damage consisted of contact marks, concrete spalling and gouges, and hairline concrete cracks. The

length of vehicle contact along the barrier was approximately 15 ft – ¼ in. (4.6 m), which spanned from 56½ in. (1,435 mm) upstream from the downstream edge of barrier no. 5 to 4 in. (102 mm) downstream from the mid-span of barrier no. 6. Gouging extended from the impact point through the end of the concrete beam along the bottom of the front face of barrier no. 5. Gouging was found along the height of barrier no. 6 located around the upstream splice on the front face. Further gouging was found along the bottom of the front face of barrier no. 6 extending 80 in. (2,032 mm) downstream from the upstream joint. Spalling occurred between barrier nos. 5 and 6 located between the front and back ACJ splices. There were hairline fractures on the back face of barrier no. 6 extending downstream from the bottom splice bolt hole approximately 5 in. (127 mm), as well as underneath the barrier beginning at the center of the upstream end of barrier no. 6 and extending downstream to the hexagonal hole. The first two posts downstream from the splice between barrier nos. 5 and 6 had contact marks along the front face and part of the upstream face.

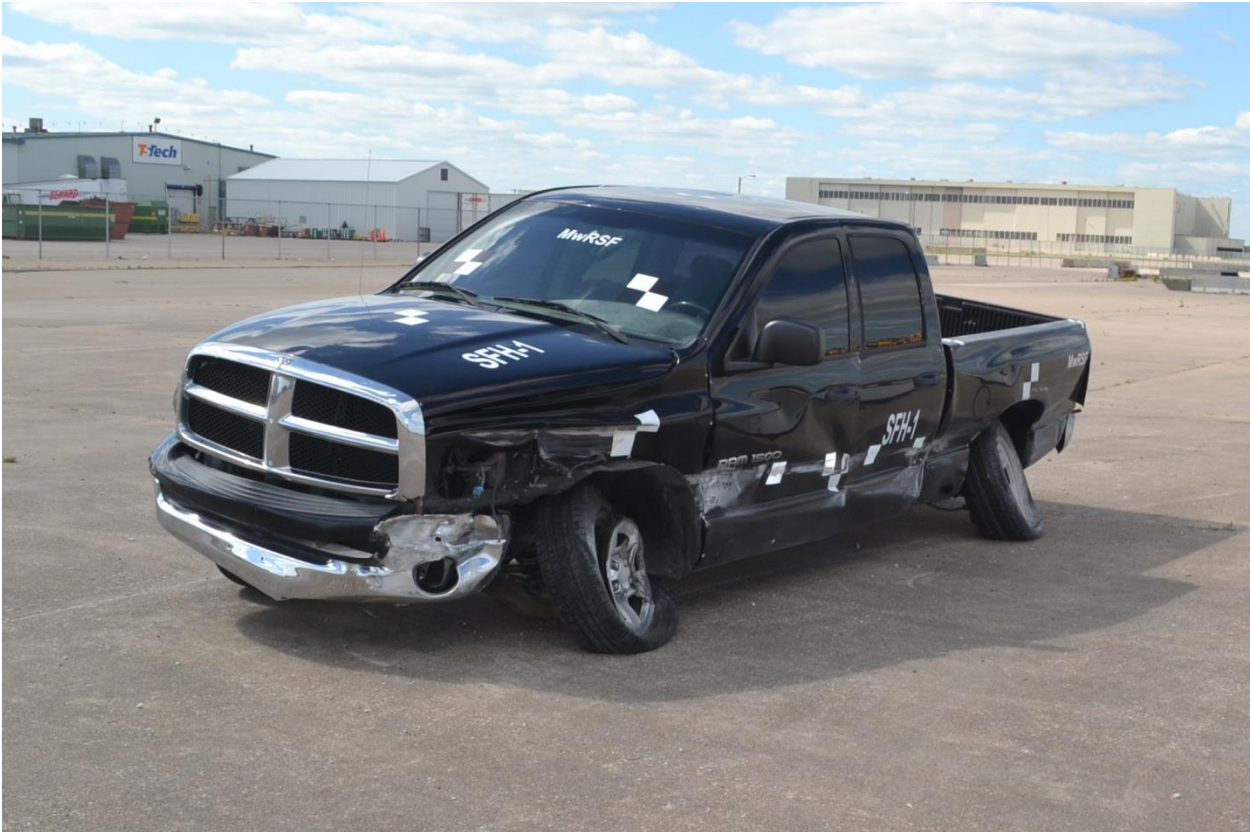
Figure 54. Vehicle Damage, Left Side, Test No. SFH-1

The damage to the vehicle was moderate, as shown in Figures 54 and 55. The maximum occupant compartment deformations are listed in Table 6 along with the deformation limits established in MASH for various areas of the occupant compartment. Note that none of the MASH-established deformation limits were violated. Complete occupant compartment and vehicle deformations and the corresponding locations are provided in Appendix C.

The majority of the damage was concentrated on the left-front corner and left side of the vehicle where the impact occurred. A 3-in. (76-mm) buckle was found in the center of the front bumper surrounded by 3 in. (76 mm) of scraping. A kink was located in the bottom of the front bumper, located 5 in. (127 mm) left of center. Both the left and right fog lights were disengaged. The left headlight was disengaged. The left-front bumper had an 8-in. (203-mm) vertical tear. The left-front bumper was deformed inward below the light fixture.

The entire left side of the vehicle had scrapes. Multiple dents were found on the left-front door and left-rear door. A 2¼-in. (57-mm) gap was found between the hood and the left fender. The left-front fender was crushed laterally inward approximately 6 in. (152 mm). A 45-in. (1,143-mm) long dent was found in the top of the left fender below the hood. The front of the left-front door was ajar 1 in. (25 mm), while the back of the left-front door overlapped the left-rear door ½ in. (13 mm). The left-rear door was ajar 1 in. (25 mm). The left tail-light separated 1½ in. (38 mm) due to the rear end of the vehicle contacting the top corner of the concrete beam. The left-rear tire deflated with a 1½-in. (38-mm) long tear from contact with the bolts underneath the beam. The outer edge of the left-rear rim was gouged and scraped. A vertical buckle was found on the rear bumper that was 8½ in. (216 mm) tall, located 19 in. (483 mm) left of center. The damage on the right side of the vehicle was present prior to test no. SFH-1.

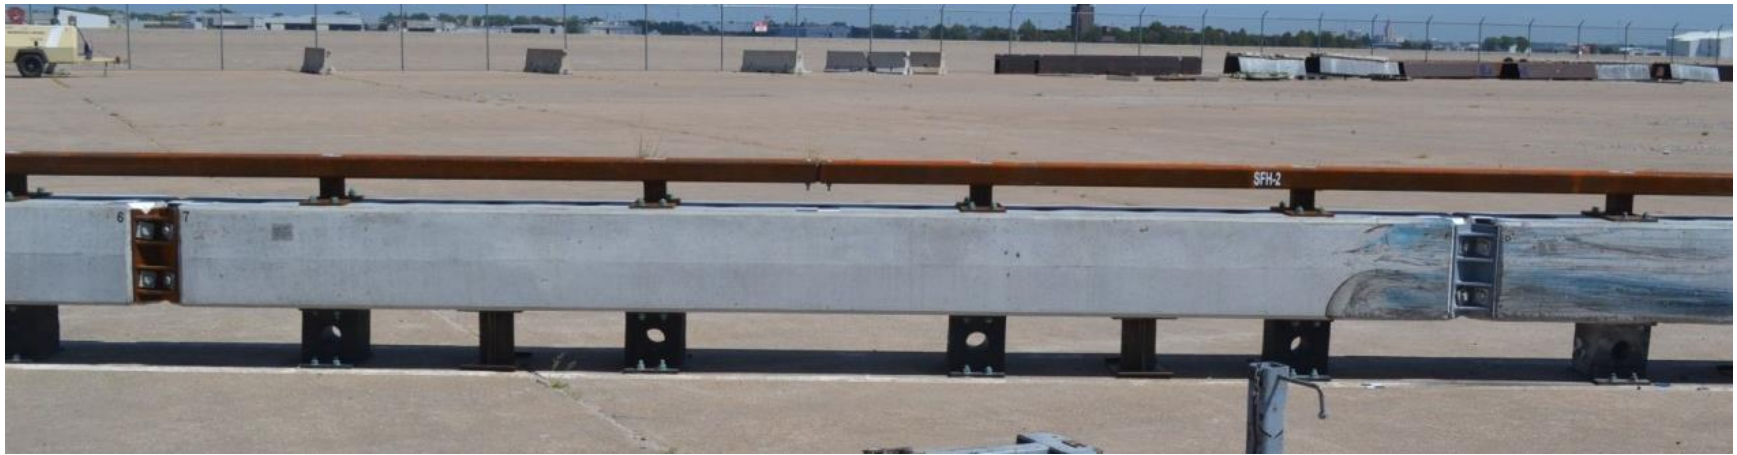
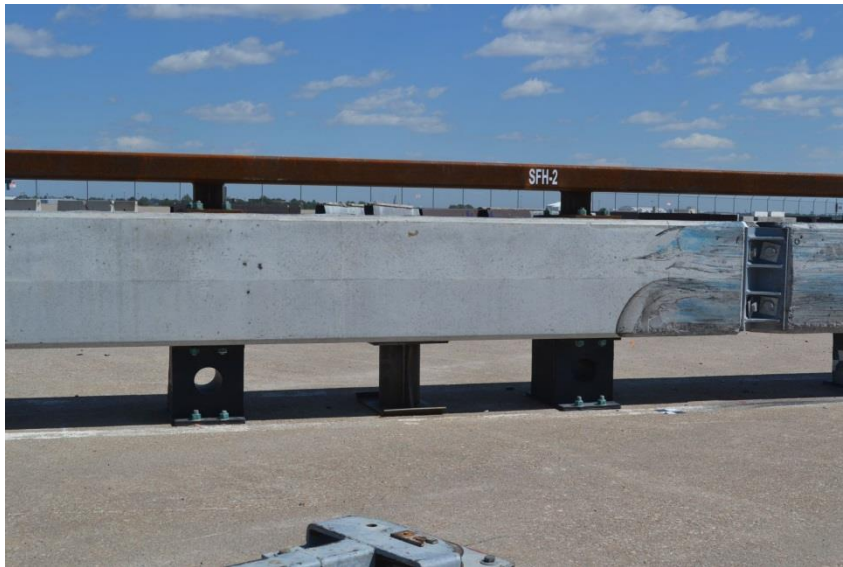
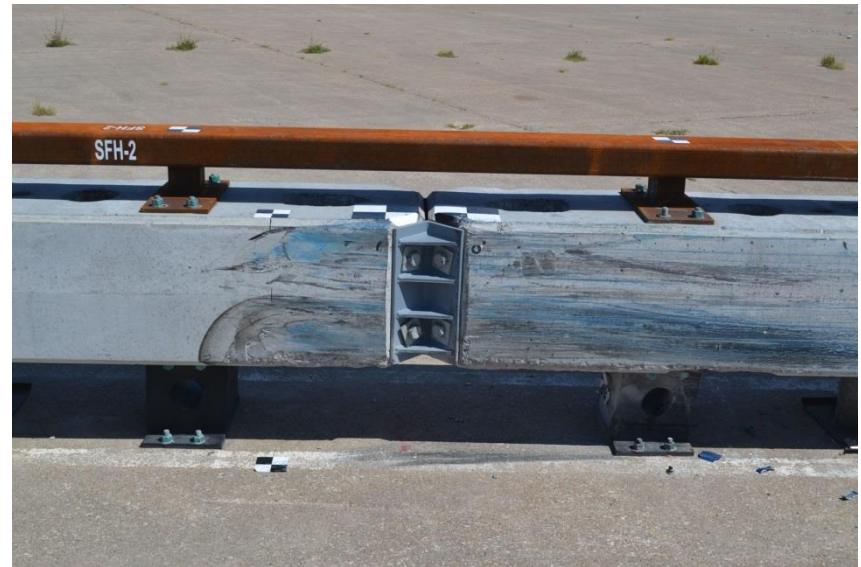
Figure 69. System Damage, Barrier No. 7, Test No. SFH-2

Damage to the barrier was minimal, as shown in Figures 69 through 72. Barrier damage consisted of gouging and contact marks on the front face of the concrete segments and cuts in the rubber posts. The length of the vehicle contact along the barrier was approximately 12 ft – 7 in. (3.8 m), which spanned from 27 in. (686 mm) upstream of the joint between barrier nos. 7 and 8

Gouging was present on the bottom of barrier no. 7 along the last 20 in. (508 mm) of the barrier at the downstream end. The gouging continued on the bottom of barrier no. 8 for 39 in. (991 mm). Tire contact marks were found on the upstream face of the first post downstream from the joint between barrier nos. 7 and 8 that were 3½ in. (89 mm) wide x 7 in. (178 mm) tall. From contact with the vehicle's rim, this same post was cut along the length of the front face 3 in. (76 mm) above the groundline that had a maximum depth of ½ in. (13 mm). The second post downstream from the joint between barrier nos. 7 and 8 was cut along the length of the front face located 4 in. (102 mm) above the groundline to a maximum depth of 2 in. (51 mm). The upstream corner of the front face had contact marks 5¼ in. (133 mm) wide x 7 in. (178 mm) tall. Contact marks were present on the upstream corner of the front face along the upper tube assembly post located just downstream from the joint between barrier nos. 7 and 8. From the second impact, the bottom of barrier no. 11 had gouges starting 93 in. (2,362 mm) upstream from the downstream end of barrier no. 11 that continued for 28 in. (711 mm).

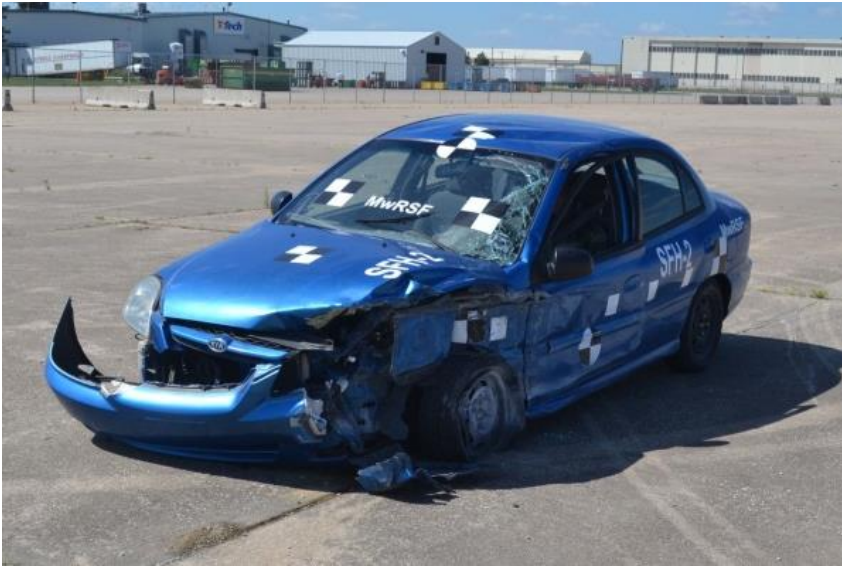
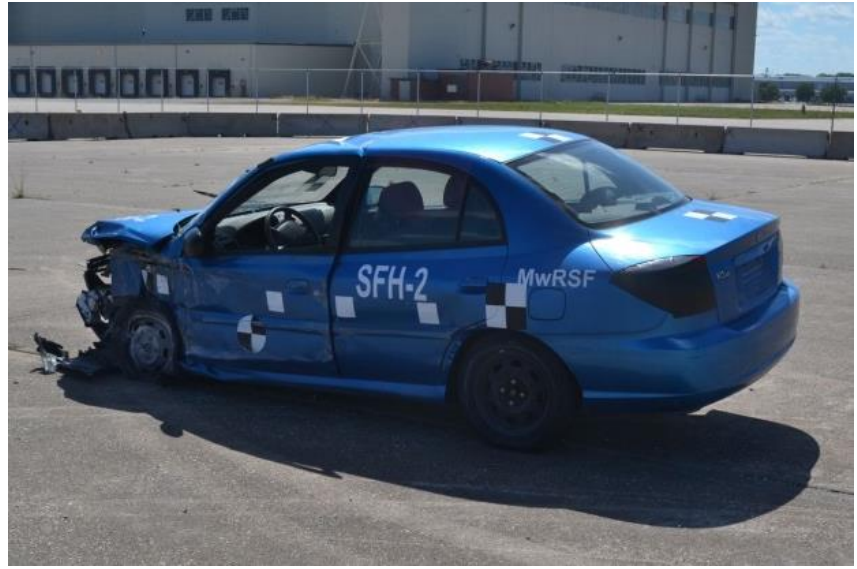
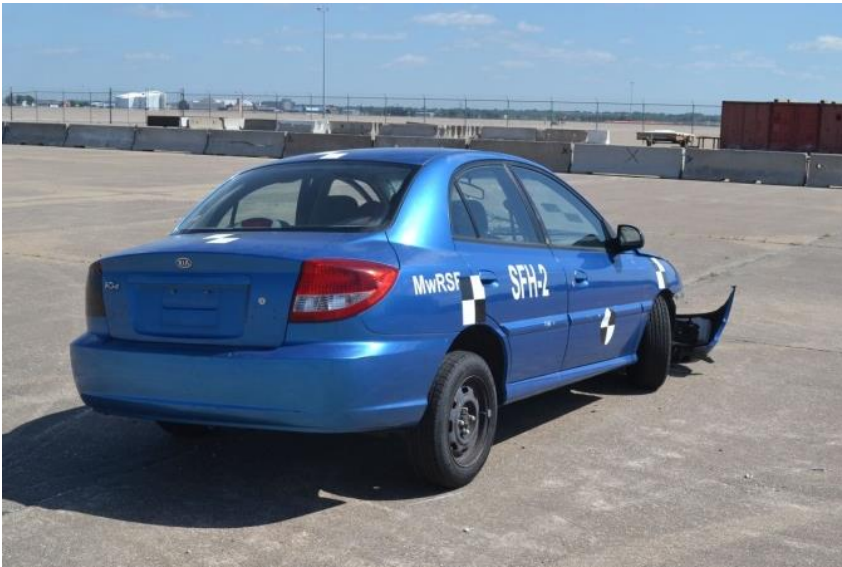
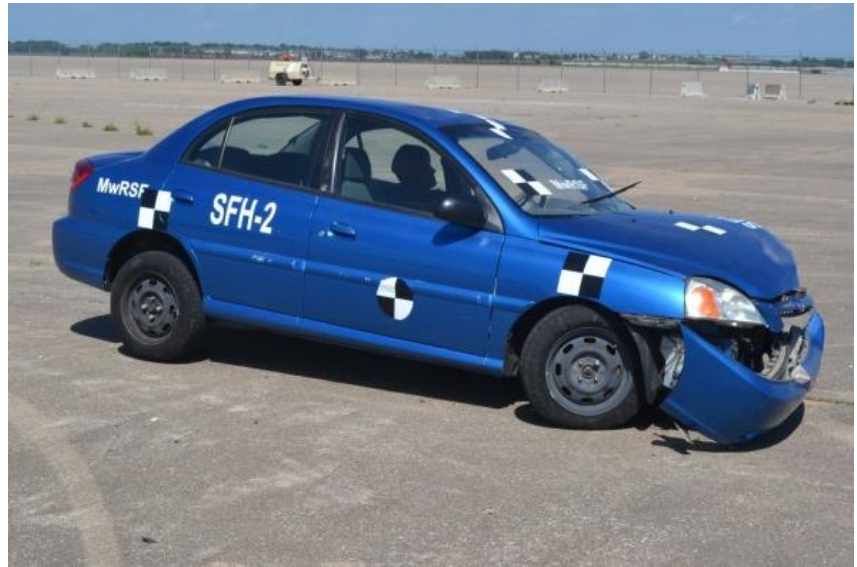
Figure 73. Vehicle Damage, Test No. SFH-2

The damage to the vehicle was moderate, as shown in Figures 73 and 74. The maximum occupant compartment deformations are listed in Table 12 along with the deformation limits established in MASH for various areas of the occupant compartment. Note that none of the MASH-established deformation limits were violated. Complete occupant compartment and vehicle deformations and the corresponding locations are provided in Appendix C.

The majority of the damage was concentrated on the left-front corner and left side of the vehicle where the impact occurred. The front bumper and the left headlight were both disengaged. The hood separated 1 in. (25 mm) near the right headlight compartment. A 5-in. (127-mm) deep x 18-in. (457-mm) long dent was found along the left edge of the hood located 5 in. (127 mm) left of center. The front windshield had cracking through the entire windshield. The left fender had a 20-in. (508-mm) long cut along the top of the fender.

A 6¾-in. (171-mm) cut was found in the left-front door located 9½ in. (241 mm) above the bodyline. The left-front tire was deflated, with gouges around the outer rim. The left fender was crushed inward approximately 6 in. (152 mm). The A-pillar had dents located 5 in. (127 mm) and 11½ in. (292 mm) from the bottom of the pillar. The left-front window shattered from contact with the dummy head. A 2½-in. (64-mm) gap was located between the left-front door and the A-pillar. The top of the B-pillar had a 2-in. (51-mm) dent. Contact marks extended from the left fender through 17 in. (432 mm) back of the center of the left-rear wheel well. The left-front roof had a dent measuring approximately 25 in. (635 mm) x 9 in. (229 mm) x 1 in. (25 mm) deep. The bottom of the left-front door was crushed inward.

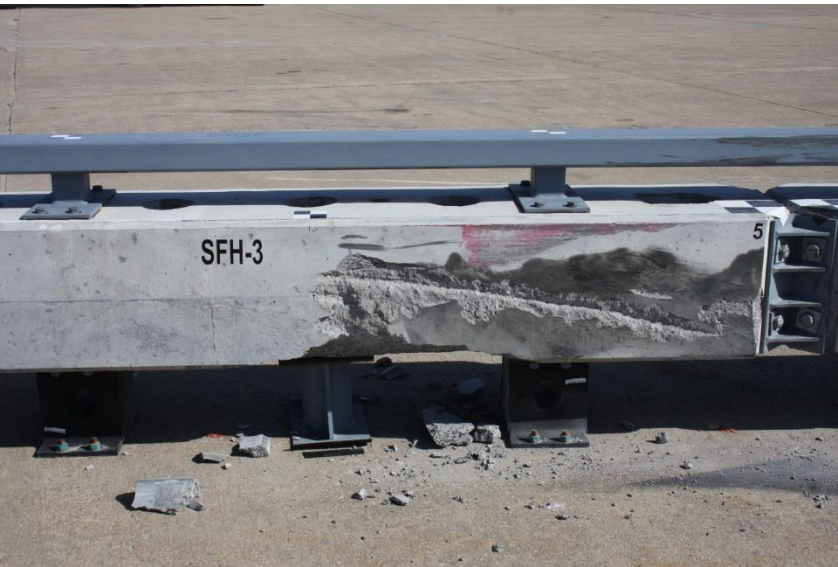
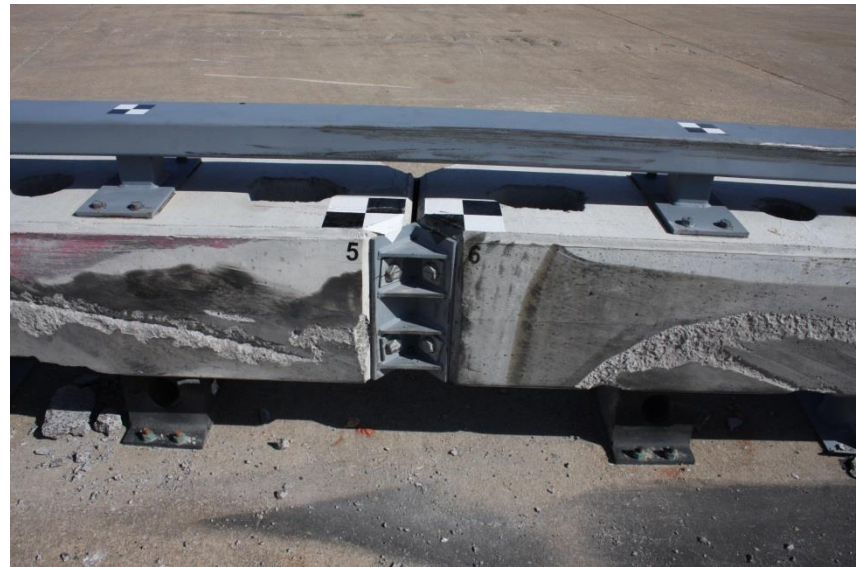
Figure 111. System Damage, Barrier No. 5 and Joint Between Barrier Nos. 5 and 6, Test No. SFH-3

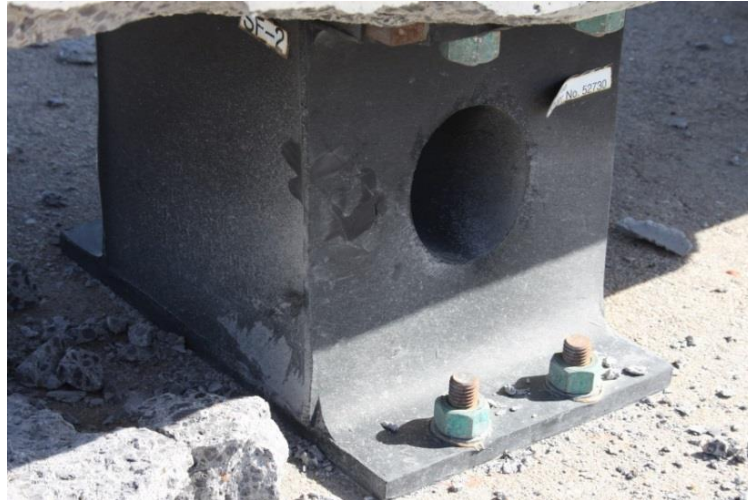
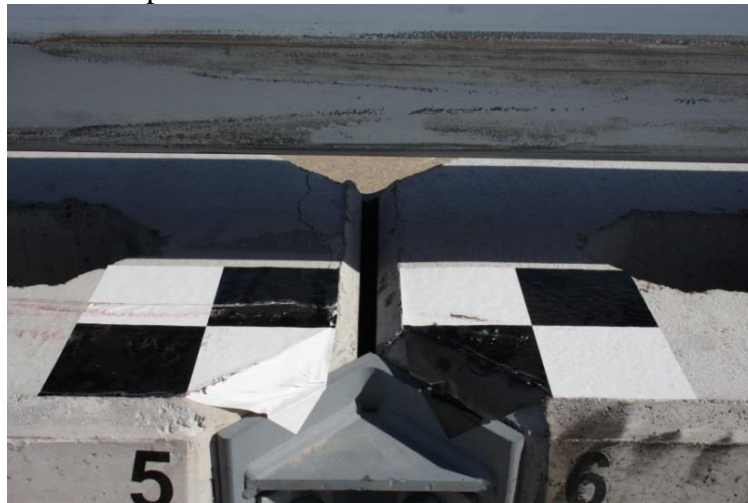
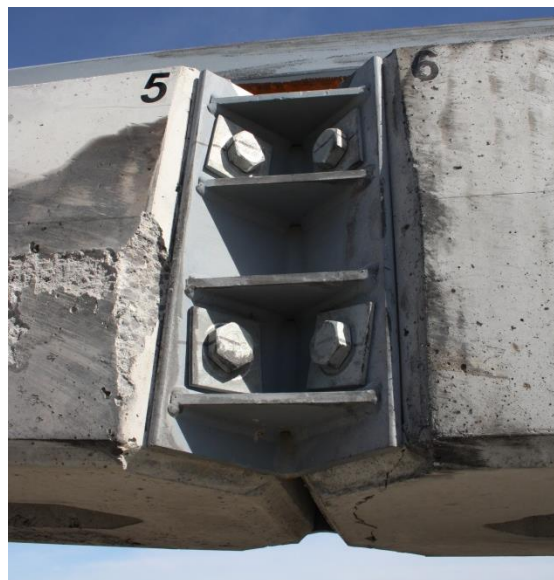
Figure 112. System Damage, Post Contact and Joint between Barrier Nos. 5 and 6, Test No. SFH-3

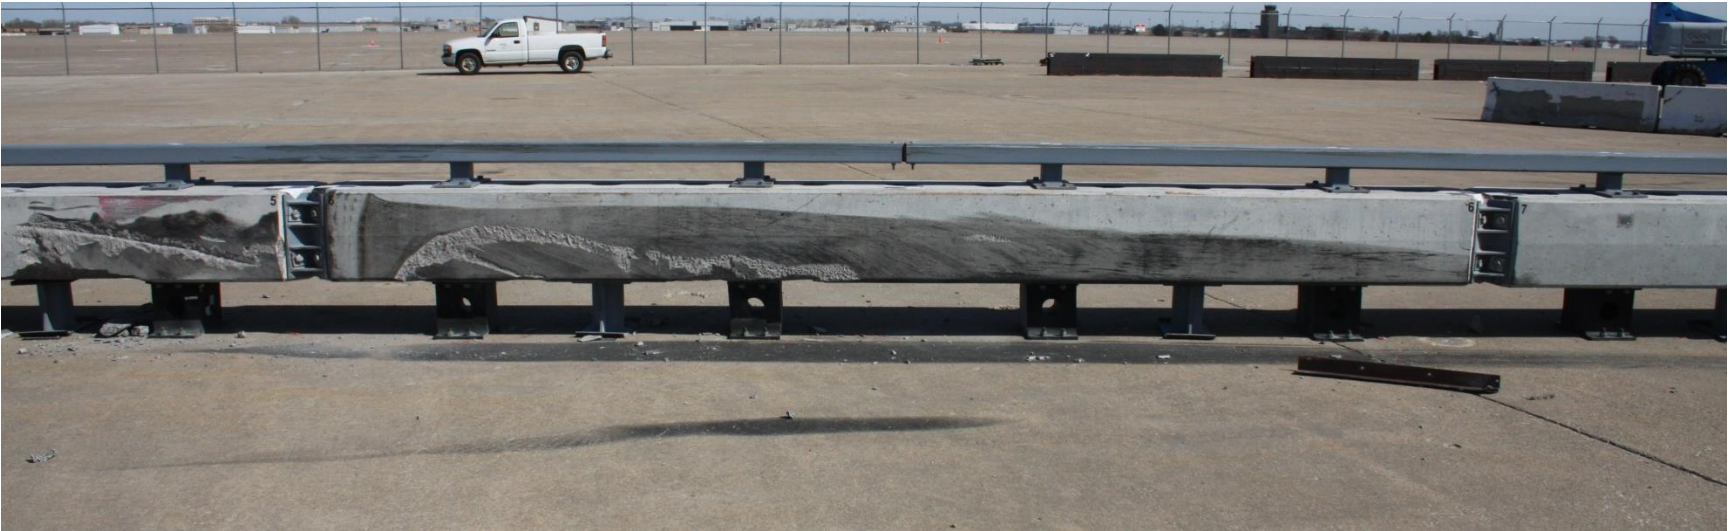
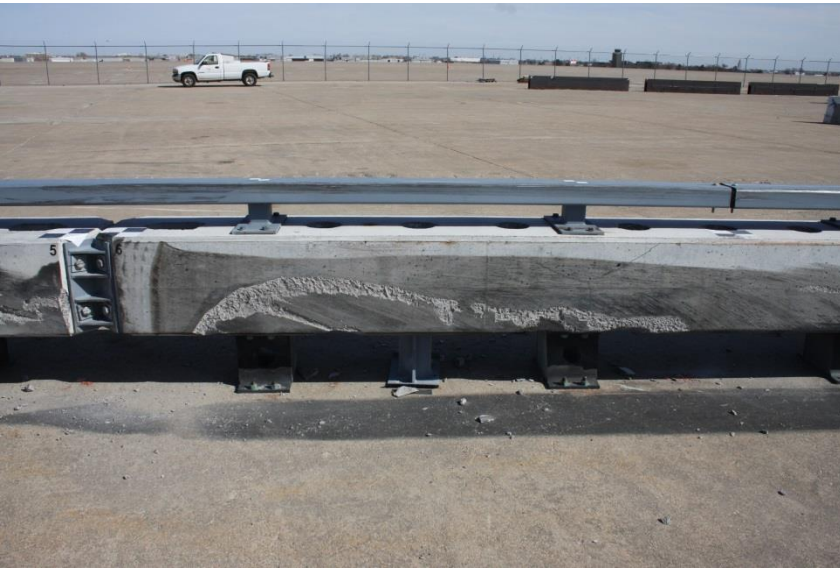
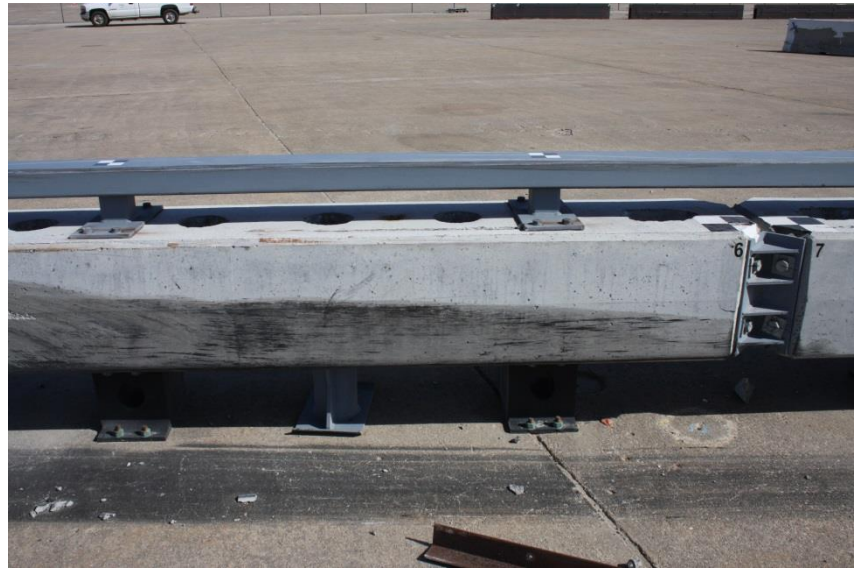
Figure 113. System Damage, Barrier No. 6, Test No. SFH-3

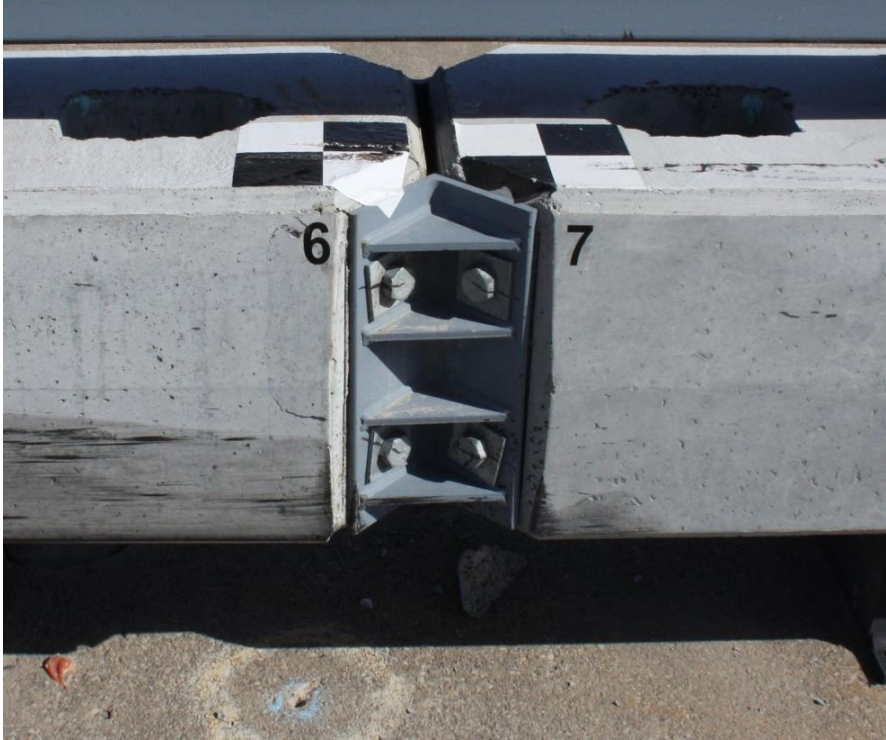
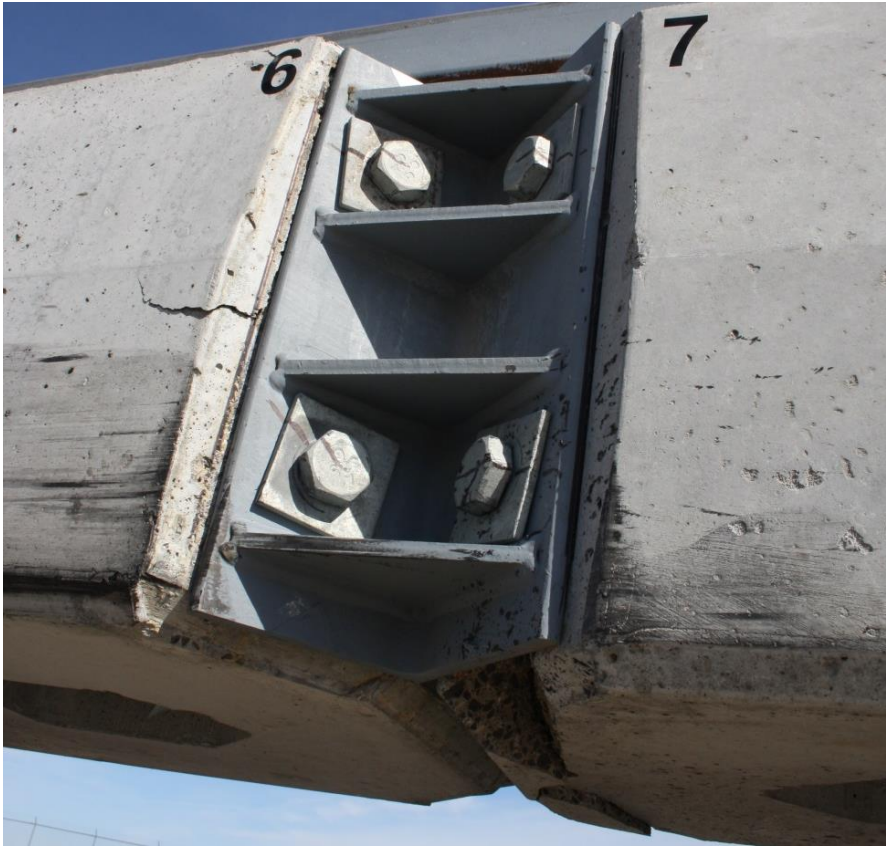
Figure 114. System Damage, Joint between Barrier Nos. 6 and 7, Test No. SFH-3

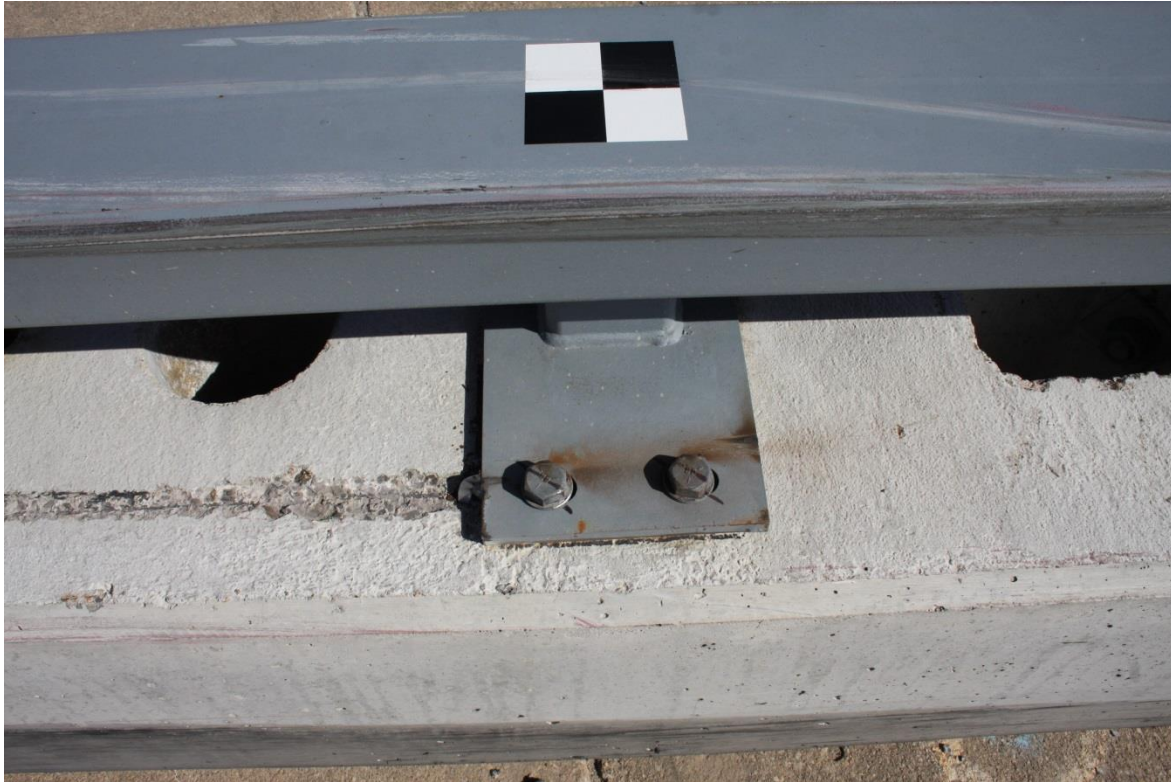
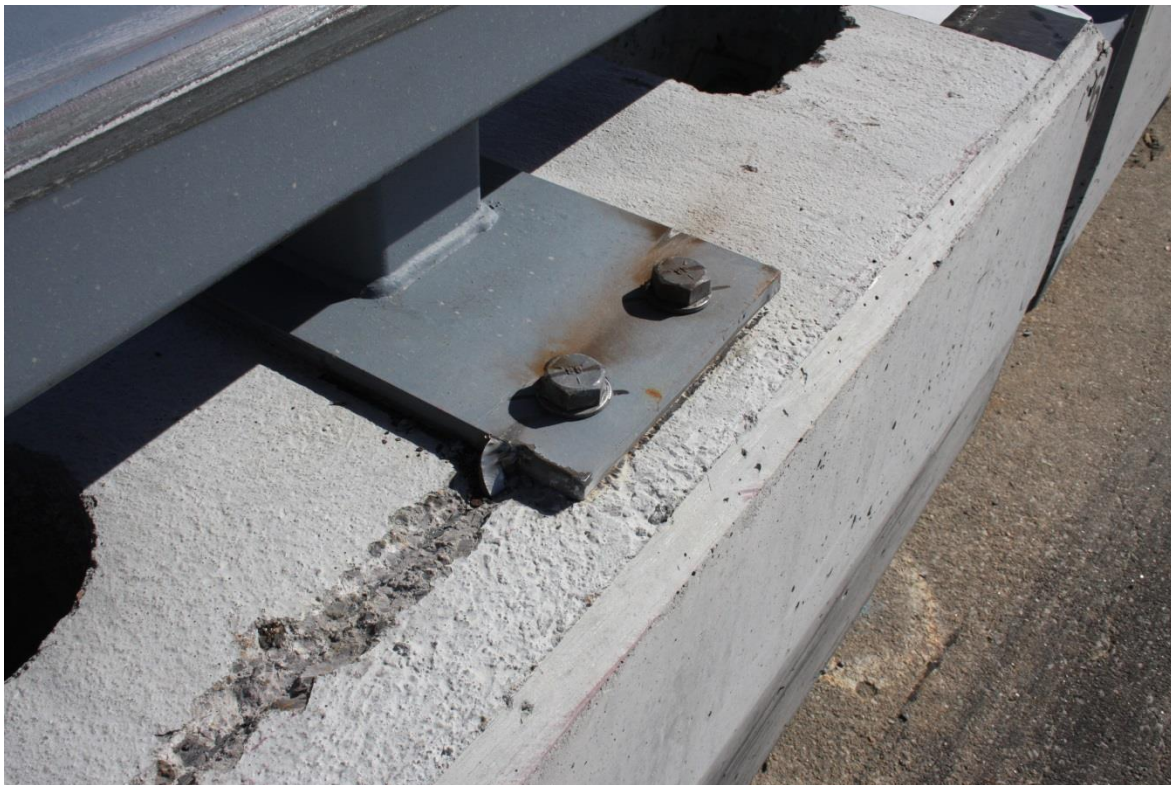
Figure 115. System Damage, First Upper Tube Assembly Connection Upstream from Joint between Barrier Nos. 6 and 7, Test No. SFH-3

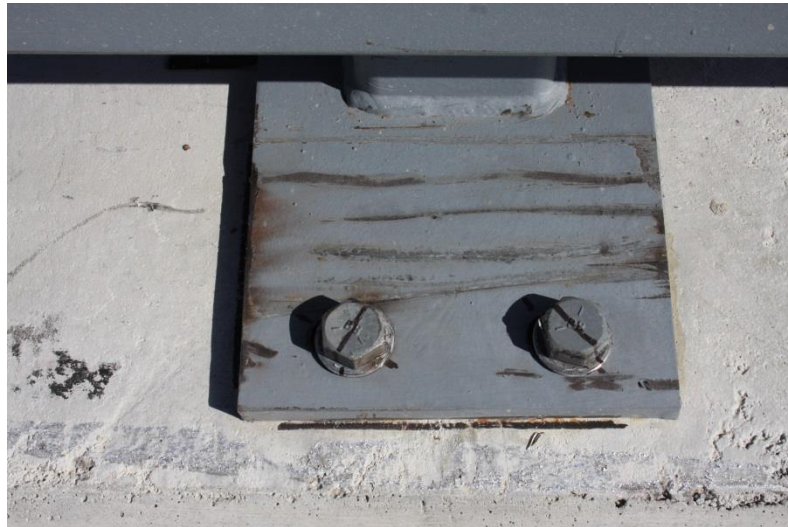
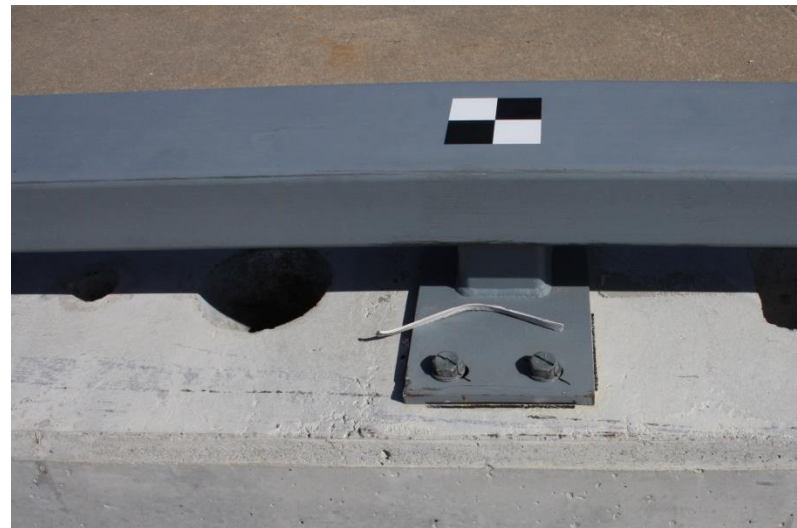
Figure 116. System Damage, Upper Tube Assembly Connection Damage, Barrier No. 7, Test No. SFH-3

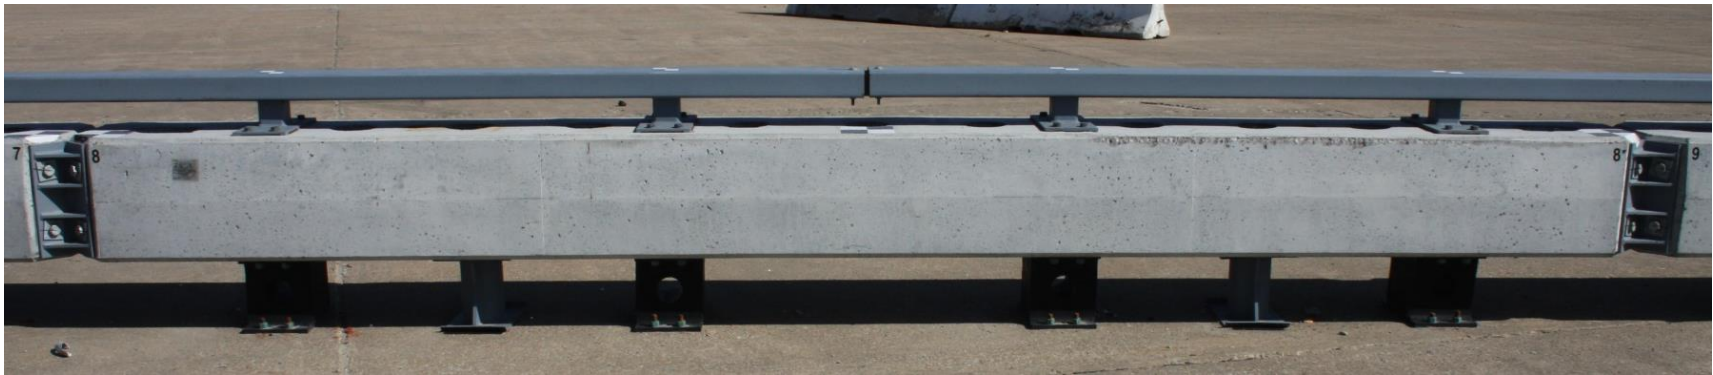
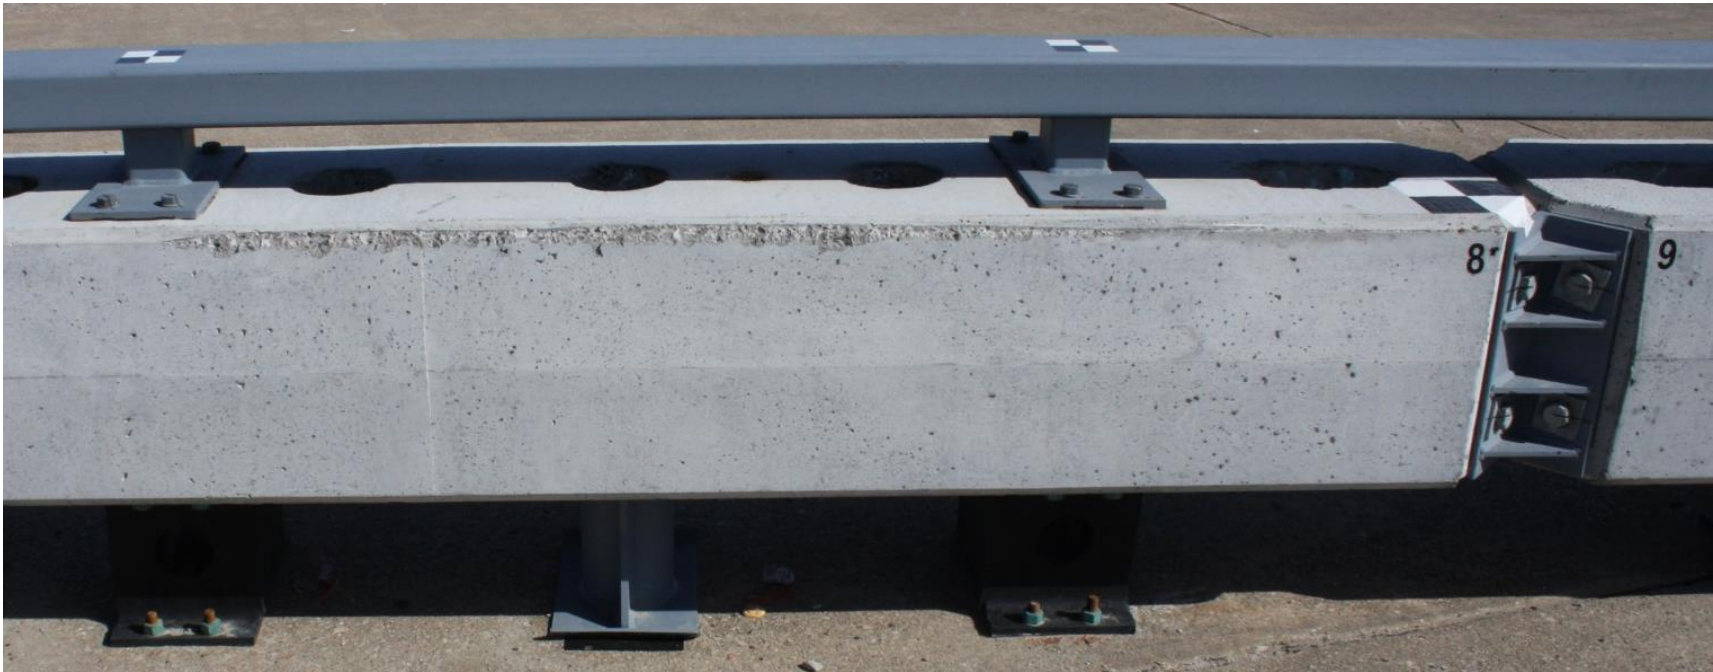
Figure 117. System Damage, Barrier No. 8, Test No. SFH-3

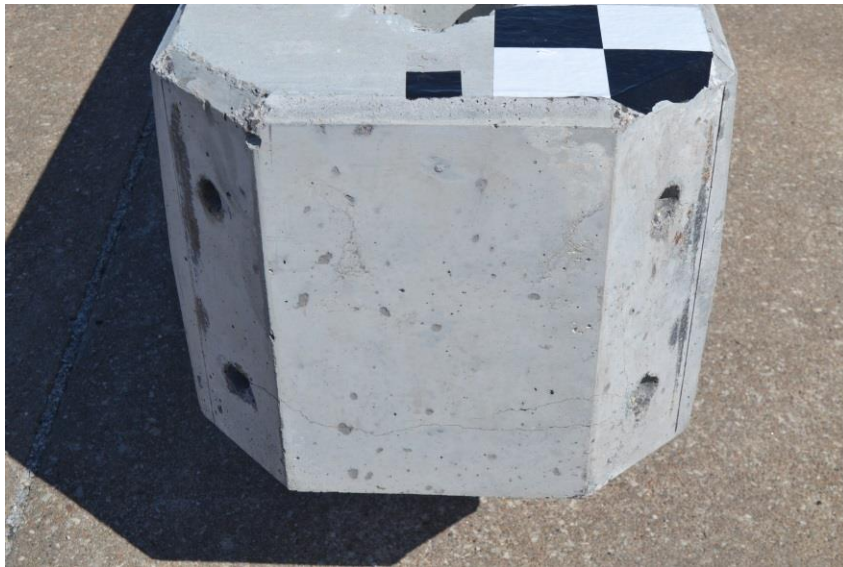
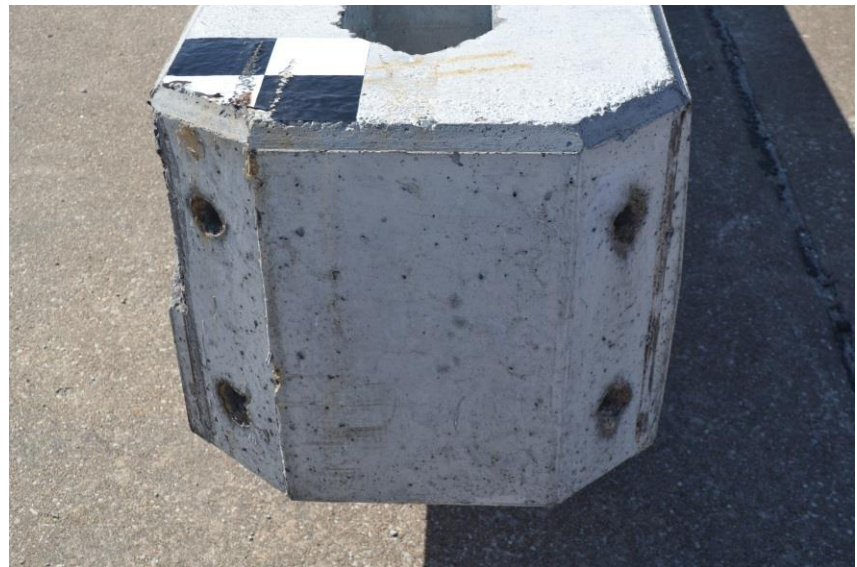
Figure 118. System Damage, Joint Damage, Barrier Nos. 5 and 6, Disassembled, Test No. SFH-3

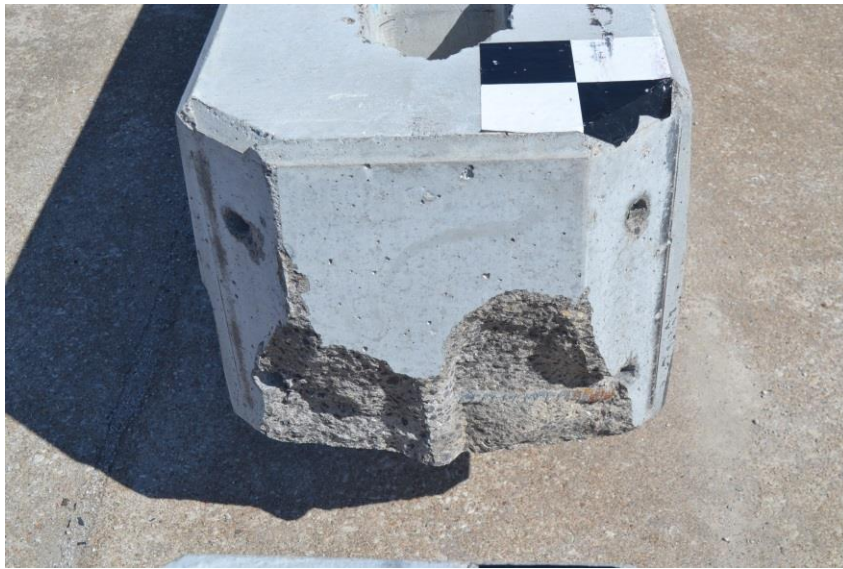
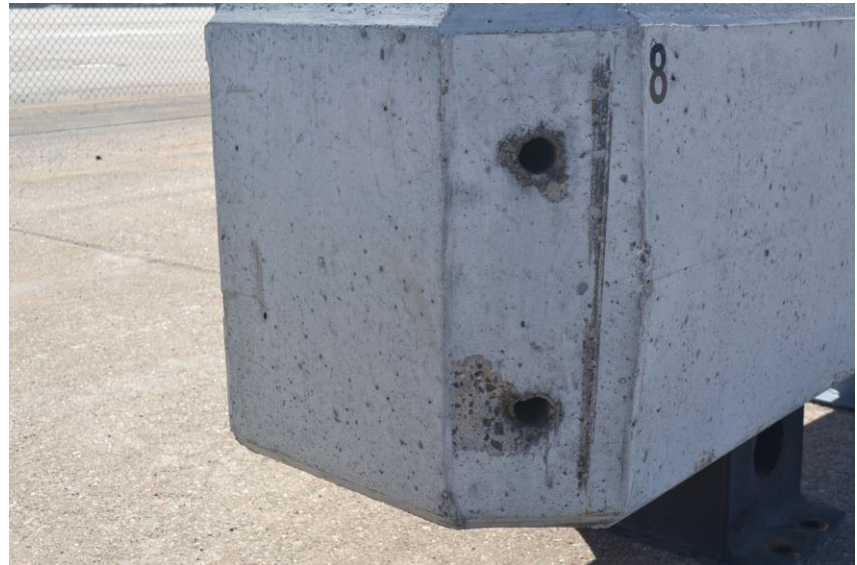
Figure 119. System Damage, Joint Damage, Barrier Nos. 7 and 8, Disassembled, Test No. SFH-3

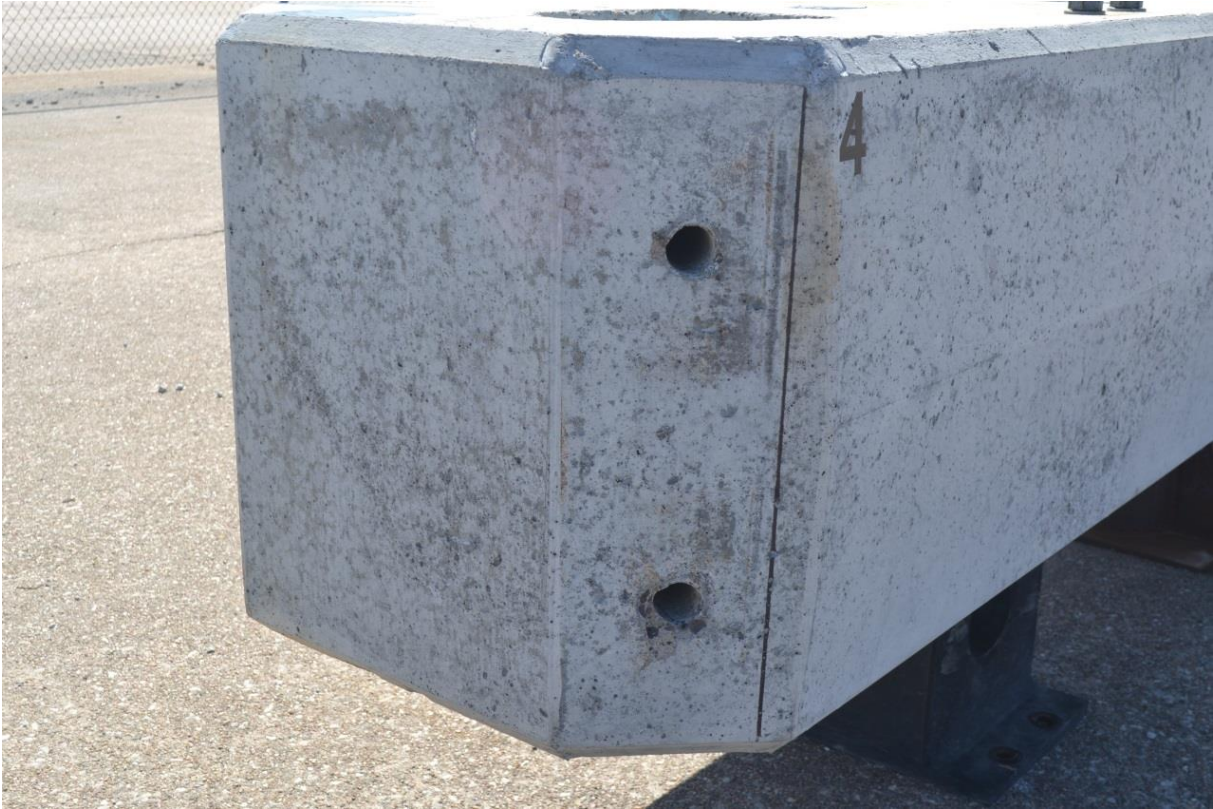
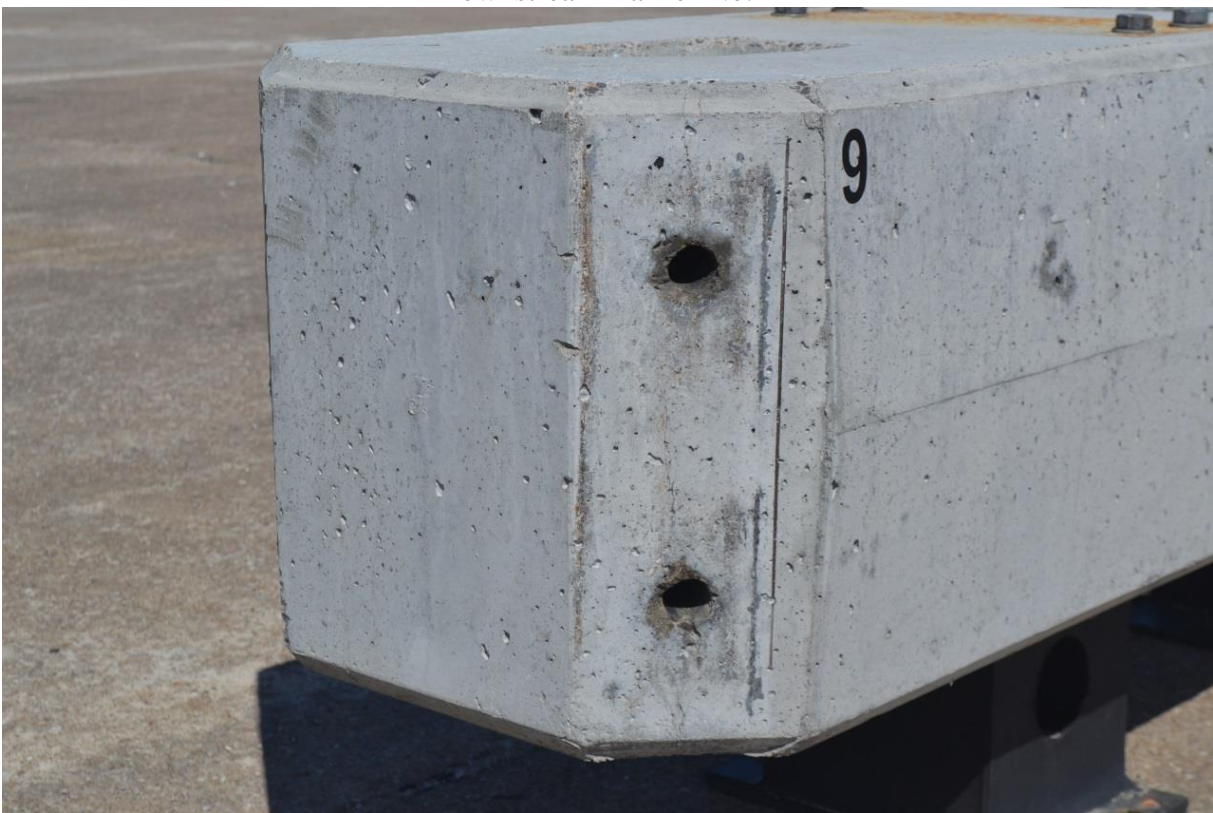
Figure 120. System Damage, Joint Damage, Barrier Nos. 4 and 9, Disassembled, Test No. SFH-3

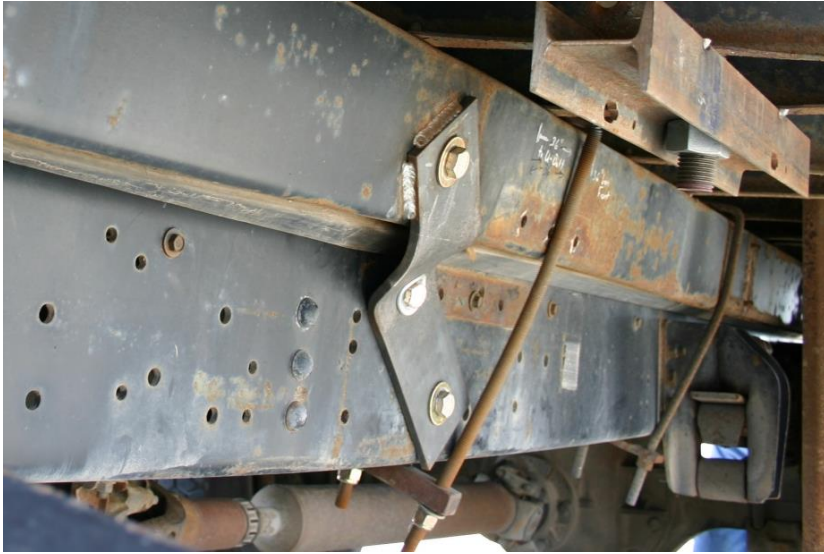
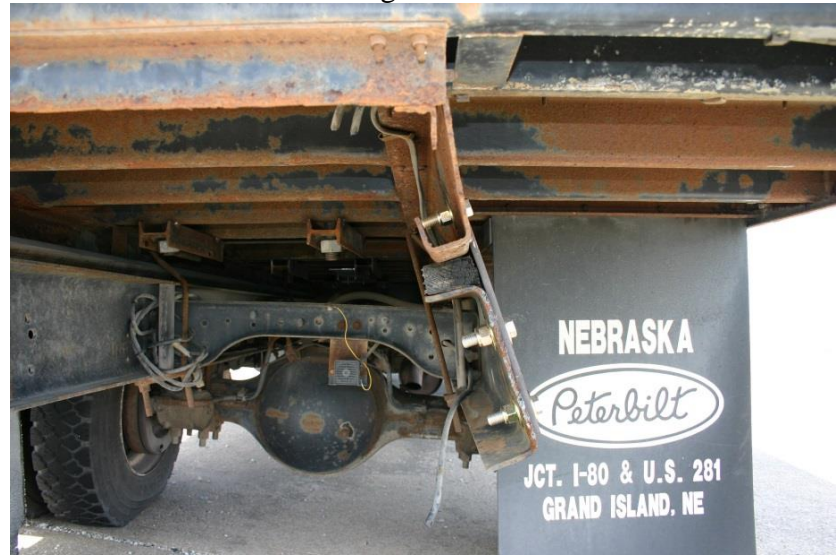
Figure 122. Vehicle Damage, Shear Plate Damage, Test No. SFH-3
