*Midwest States Regional Pooled Fund Research Program
Fiscal Year 2013 (Year 23)
Research Project Number TPF-5(193) Supplement #56
NDOR Sponsoring Agency Code RFPF-13-MGS-3*

INCREASED SPAN LENGTH FOR THE MGS LONG-SPAN GUARDRAIL SYSTEM PART II: FULL-SCALE CRASH TESTING

MwRSF Research Report No. TRP-03-339-17

April 7, 2017

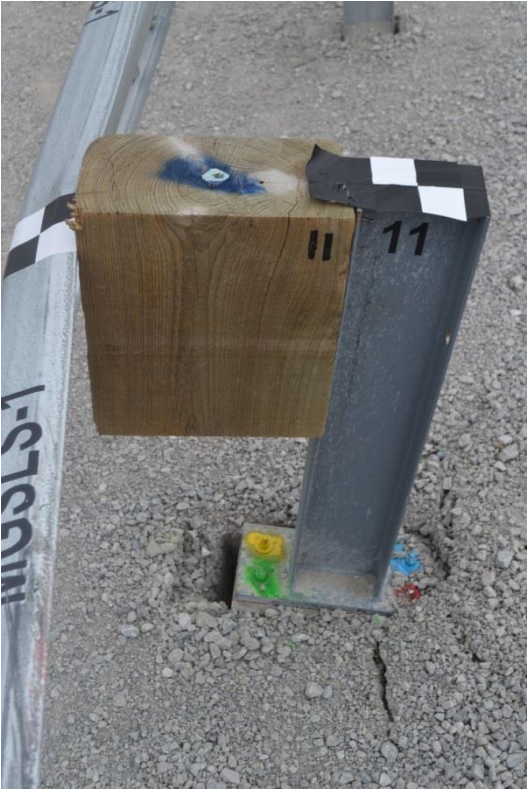
Figure 51. Damage Between Post Nos. 10 and 12, Test No. MGSL-1

Steel post damage included twisting, rotation, and detachment from the post bases. Post no. 10 twisted downstream. Post no. 11 rotated backward and twisted downstream. Post no. 15 rotated backward and downstream. Post nos. 12, 13, and 14 disengaged from the rail and the post bases. At post no. 12, the baseplate bent ¼ in. (6.4 mm) downward. At post no. 13, the lower section of the post rotated backward and was found with the two bolts on the front of the baseplate to be missing and the two bolts on the back side bent backward. Soil gaps of 1 in. (25

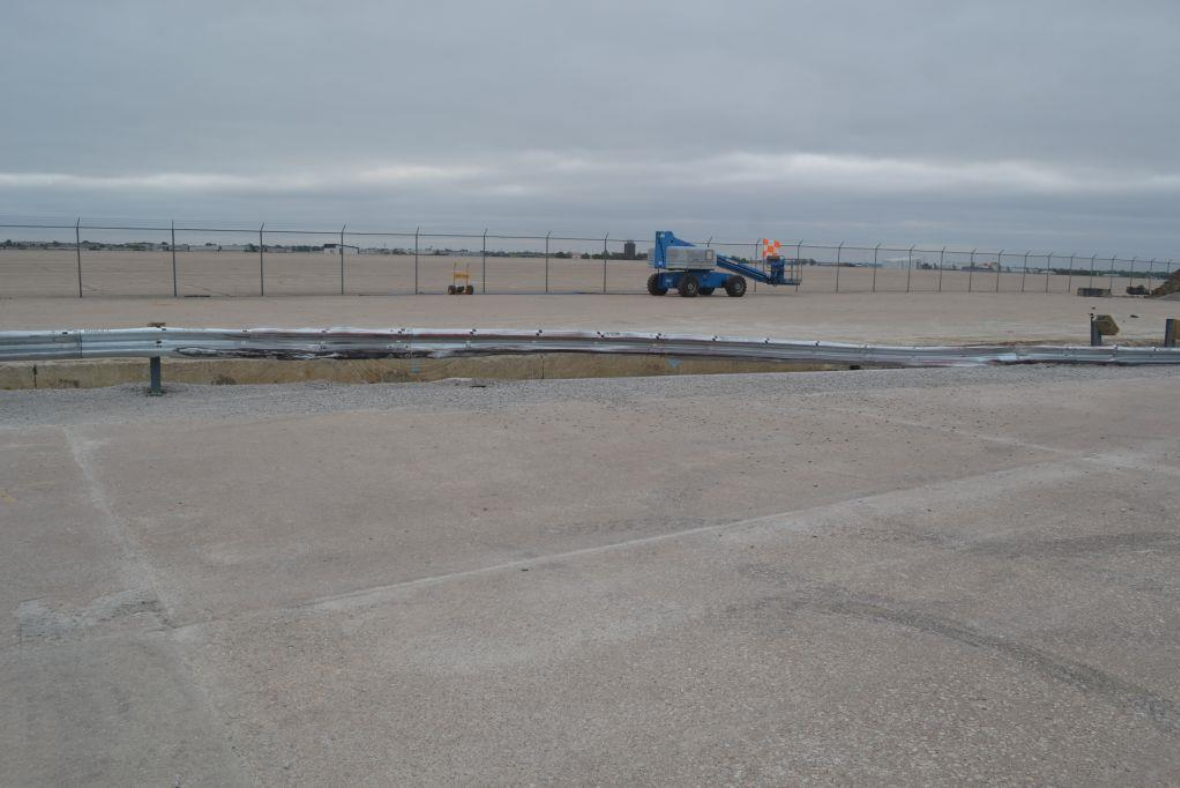
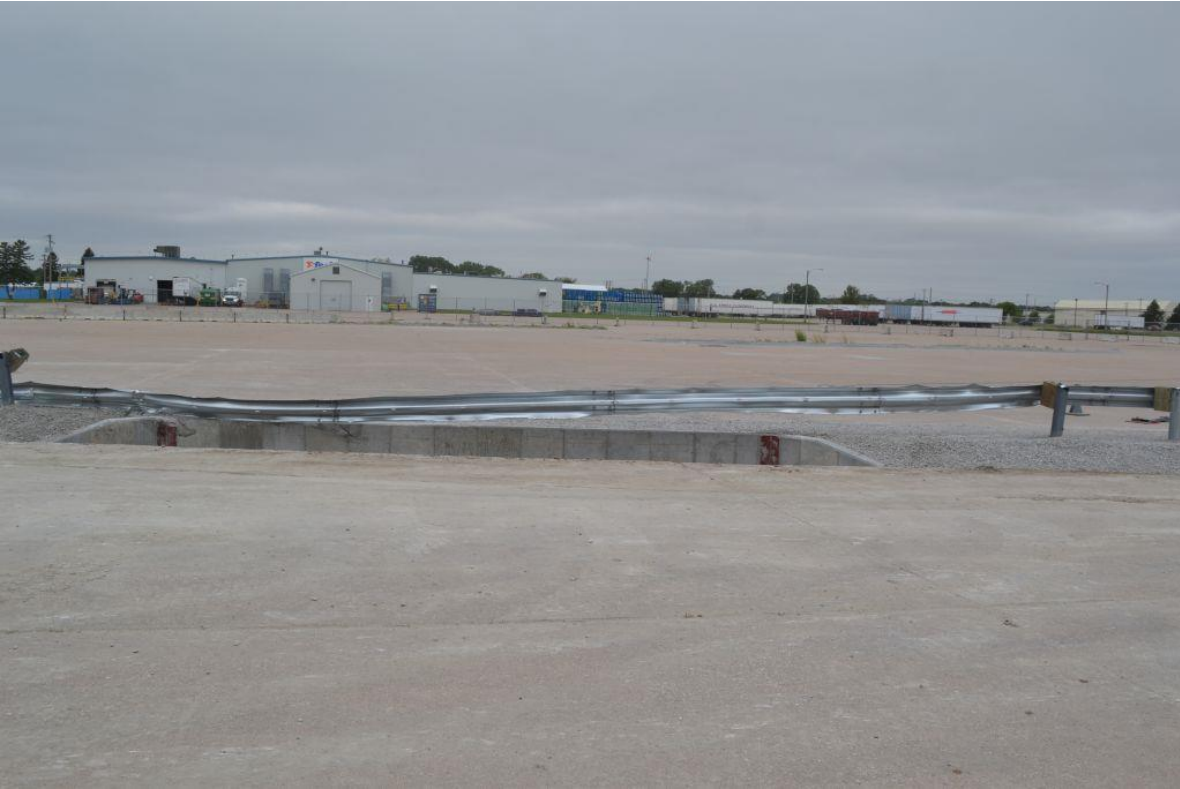
Figure 53. Damage Between Post Nos. 13 and 14, Test No. MGSLs-1

mm) or less were found at post nos. 1, 2, and 10, while soil heaves and craters were found around post nos. 11 and 13 through 15. Post no. 14 had the largest soil movement with a 40-in. (1,016-mm) diameter by 2-in. (51-mm) tall soil heave and an 18-in. (457-mm) diameter by 10-in. (254-mm) deep soil crater. Post no. 11 also had relatively-large soil movement with a 32-in. (813-mm) diameter by 4-in. (102-mm) tall soil heave and a 6-in. (152-mm) diameter by 22-in. (559-mm) deep soil crater.

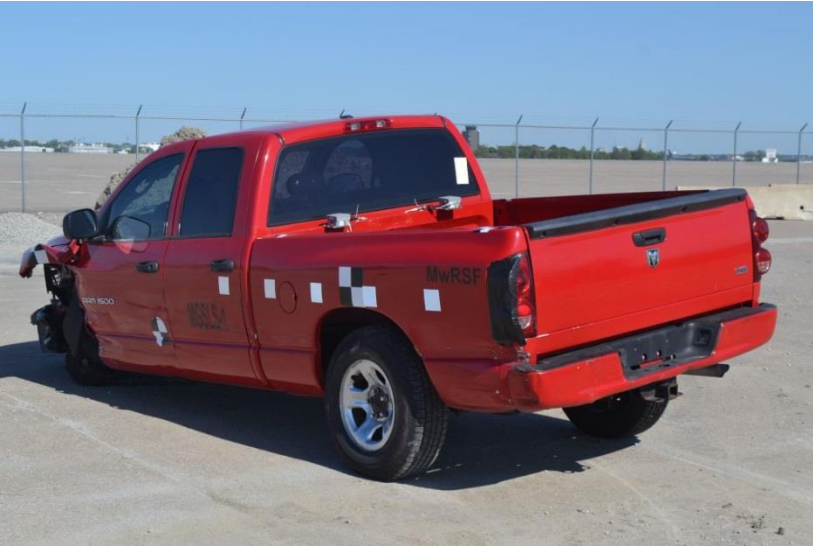
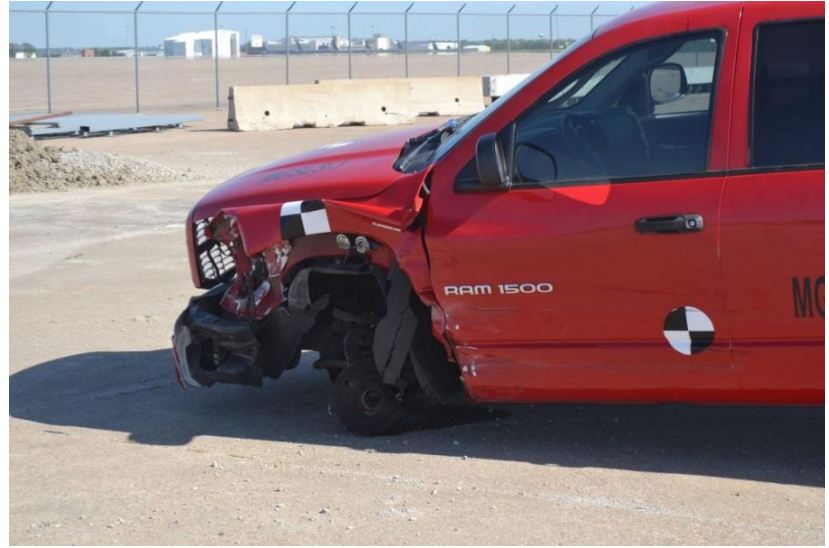
Figure 56. Vehicle Damage, Test No. MGSLS-1

The damage to the vehicle was moderate, as shown in Figures 56 through 58. The maximum occupant compartment deformations are listed in Table 5 along with the deformation limits established in MASH for various areas of the occupant compartment. Note that none of the MASH-established deformation limits were violated. Complete occupant compartment and vehicle deformations and the corresponding locations are provided in Appendix D.

The majority of the damage was concentrated on the left-front corner and left side of the vehicle where the impact occurred. The left side of the bumper fractured 23 in. (584 mm) left of center and was kinked 12 in. (305 mm) from the top. An 18-in. x 11-in. (457-mm x 279-mm) piece disengaged from the left fender starting at the hood. The left fender also had a 9-in. (229-mm) deep x 23-in. (584-mm) diameter dent. A 16-in. (406-mm) long kink occurred longitudinally in line with the base of the A-pillar, 6 in. (152 mm) down from the hood. The left fender separated 2 in. (51 mm) from the left-front door, and gouging occurred on the left fender and the left-front door. The top of the plastic wheel well on the left-front side of the vehicle had a 4-in. (102-mm) crack. The left-front rim was dented and kinked. The left-front steering knuckle cracked at the tie rod flange and the wheel bearing disengaged. The left-front wheel disengaged from the vehicle. Tears were also found on the left-front tire. Tears and gouges were found on the left side of the grill, which was partially detached from the vehicle. The left-side headlight disengaged from the vehicle. Contact marks extended the length of the left side of the vehicle. Dents were found on the left-front door near the bottom and the top of the door had separated ½ in. (13 mm). A 25-in. (635-mm) long by 4-in. (102-mm) tall by 2-in. (51-mm) deep dent

occurred on the left-rear quarter panel between the wheel well and the rear of the vehicle, 11 in. (279 mm) from the bottom of the panel. The rear bumper was slightly kinked 22 in. (559 mm) left of center. A 5-in. x 2-in. (127-mm x 51-mm) piece of the rear bumper partially disengaged. The front hood had a gap of 2 in. (51 mm) on the right side. Although the steering rack appeared to be intact, power steering fluid was found to be leaking from the vehicle. The roof and all vehicle windows remained undamaged.

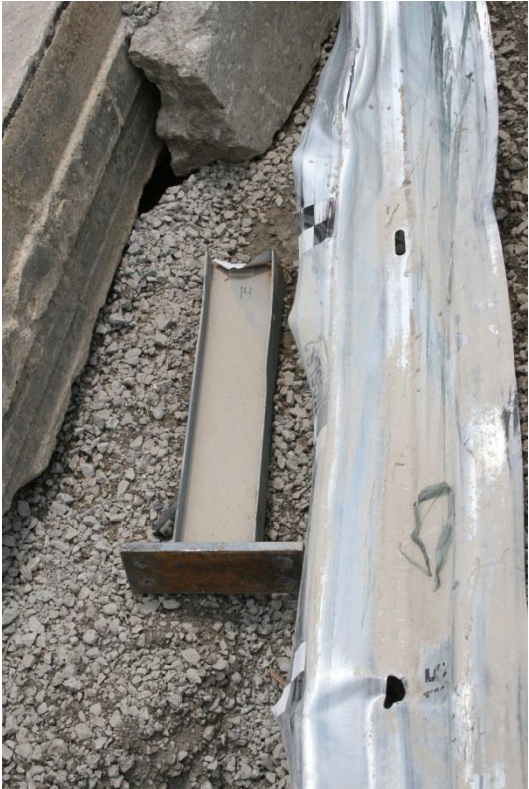
Figure 73. Damage at Post No. 14, Test No. MGSLs-2

Steel post damage included twisting, rotation, and detachment from the post bases. UBSP post nos. 14 through 16 fractured at the ground line. The baseplate for post no. 14 rotated backward, and the back-side upstream flange twisted upstream. The baseplate for post no. 14 was also dented on the back-side and the top of the downstream side. There were also contact marks on the lower 9½ in. (241 mm) of the front face of the post. The front web and flange of post no. 15 twisted upstream, and the base plate rotated backward. There were contact marks found on the top of the front flange of post no. 16 that extended 9¼ in. (235 mm) downstream. Post no. 17 bent downstream, and post no. 18 bent backward 1½ in. (38 mm) at the top of the upstream flange.
