**PERFORMANCE EVALUATION OF THE  
PERMANENT NEW JERSEY SAFETY SHAPE  
BARRIER – UPDATE TO NCHRP 350  
TEST NO. 4-12 (2214NJ-2)**

**MIDWEST ROADSIDE SAFETY FACILITY**

MwRSF Research Report No. TRP-03-178-06

October 13, 2006

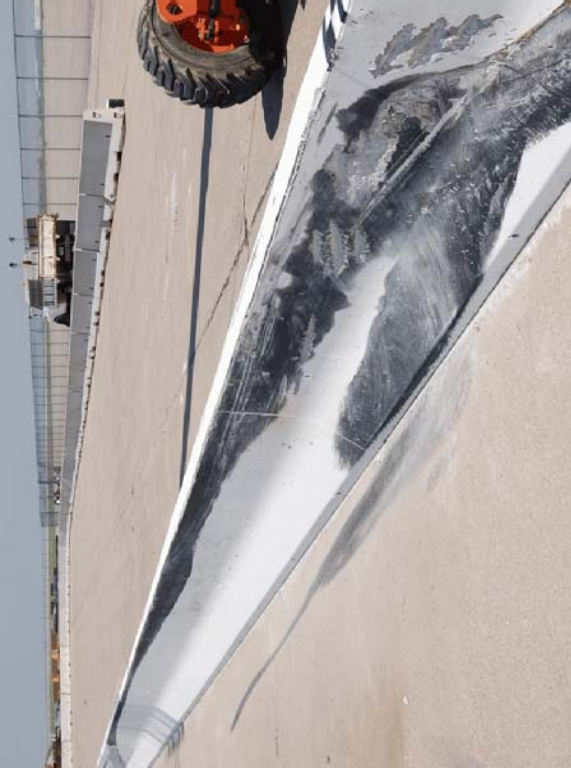
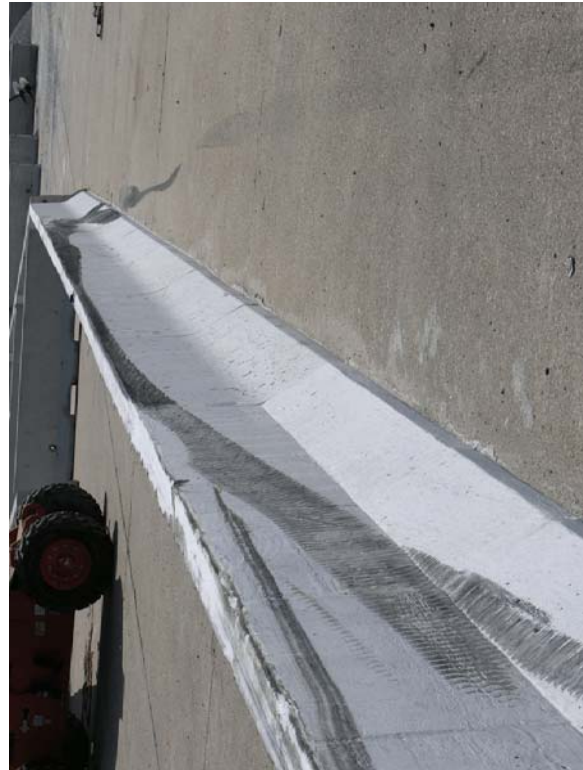
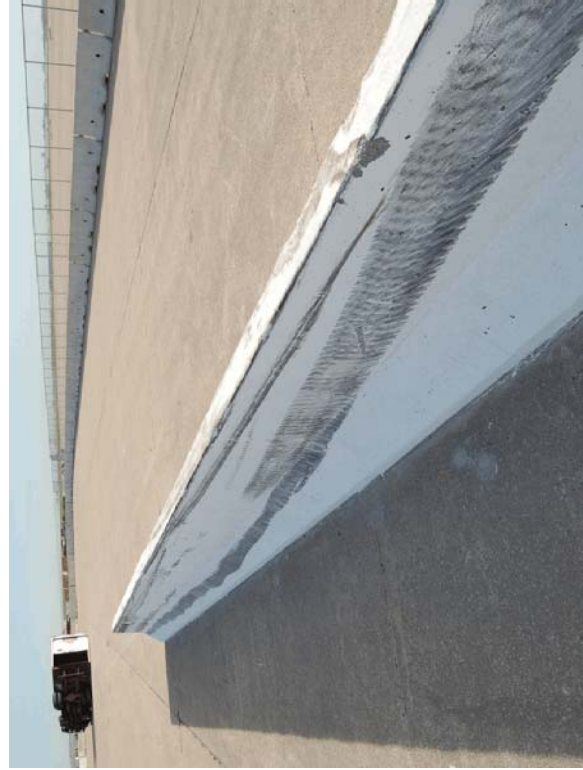
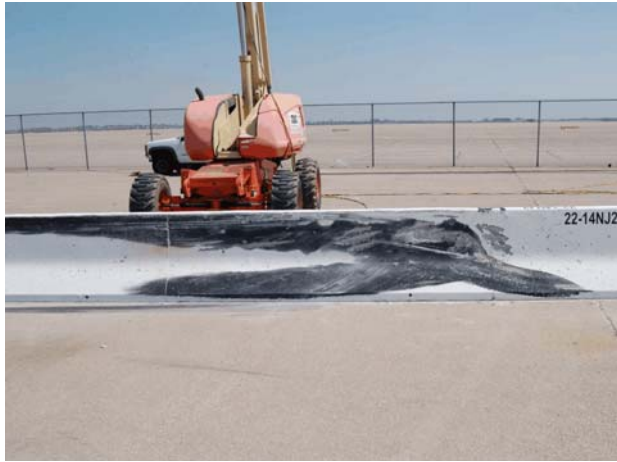
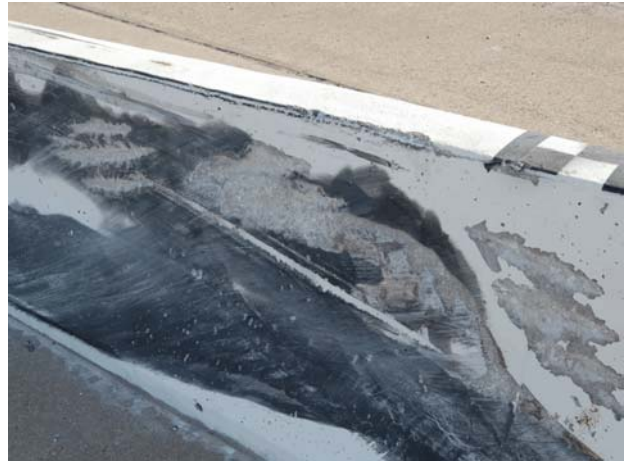
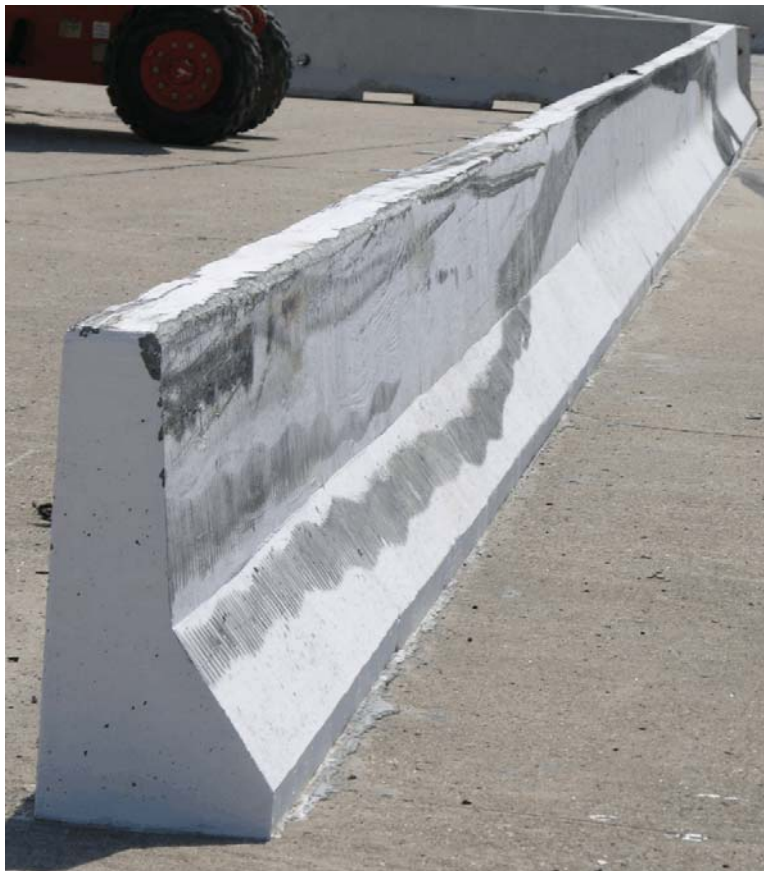
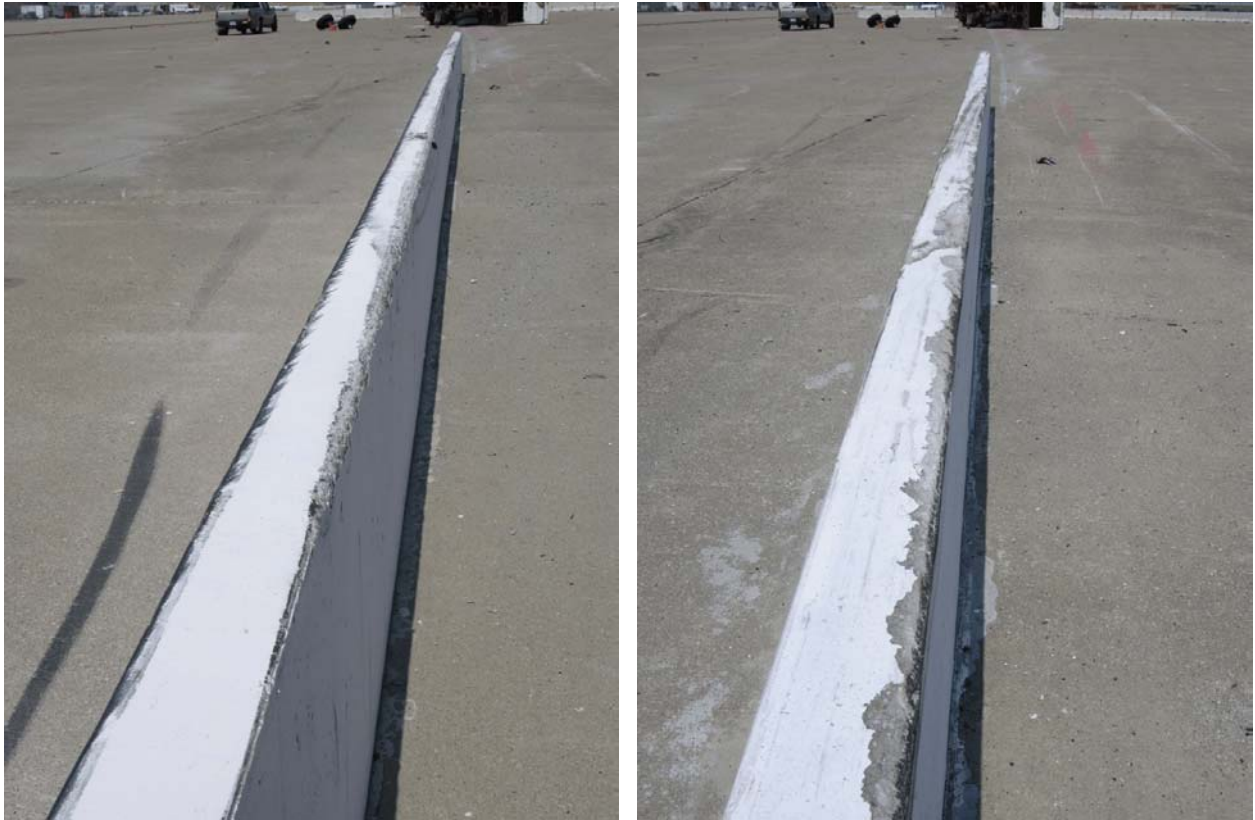
Figure 20. Permanent New Jersey Safety Shape Barrier Damage, Test 2214NJ-2

Damage to the barrier was minimal, as shown in Figures 20 through 22. Barrier damage consisted of contact and gouge marks. The length of vehicle contact along the concrete barrier system was approximately 31.29 m (102 ft - 8 in.), which spanned from 5,283 mm (208 in.) downstream from the upstream end of the barrier through the downstream end of the barrier.

A 368-mm (14.5-in.) long tire mark was found on the lower face of the barrier. Another tire mark began 9.14 m (30 ft) upstream from the downstream end of the barrier. A 279-mm (11-in.) wide by 229-mm (9-in.) high by 13-mm (0.5-in.) deep wheel gouge began at the targeted impact point. The center of a 406-mm (16-in.) wide by 203-mm (8-in.) high by 6-mm (0.25-in.) deep wheel gouge was located at 635 mm (25 in.) downstream from the targeted impact point. The center of a 356-mm (14-in.) wide by 229-mm (9-in.) high by 13-mm (0.5-in.) deep wheel gouge was located at 1,245 mm (49 in.) downstream from the targeted impact point. Spalling on the back side of the barrier began 6.71 m (22 ft) downstream from the impact point and continued to the end of the barrier. Minor spalling was located on the top front side of the barrier at 7.62 m (25 ft) downstream from the targeted impact point. The front side of the barrier also encountered spalling which began 6.10 m (20 ft) upstream from the downstream end of the barrier and continued through the end of the barrier. The permanent set of the barrier system was negligible.

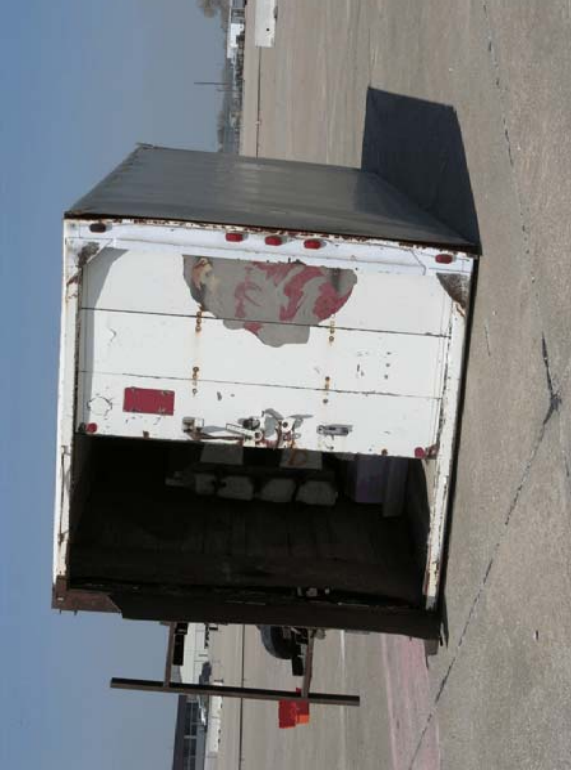
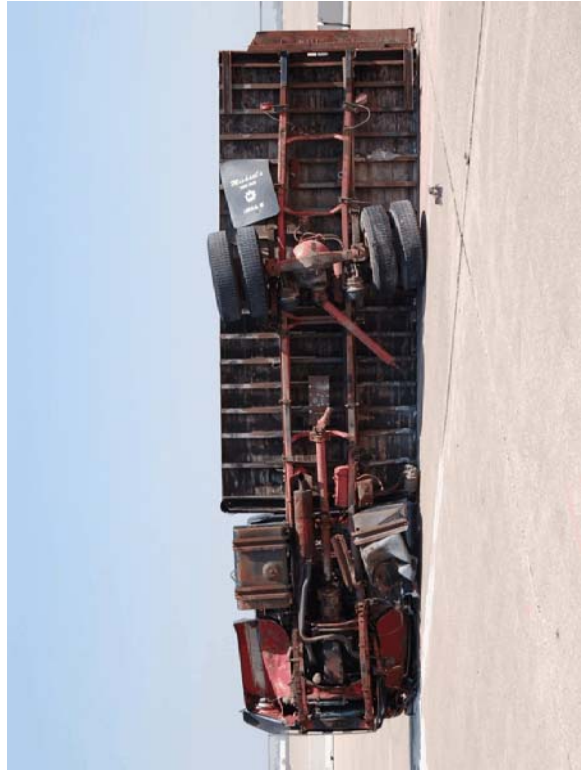
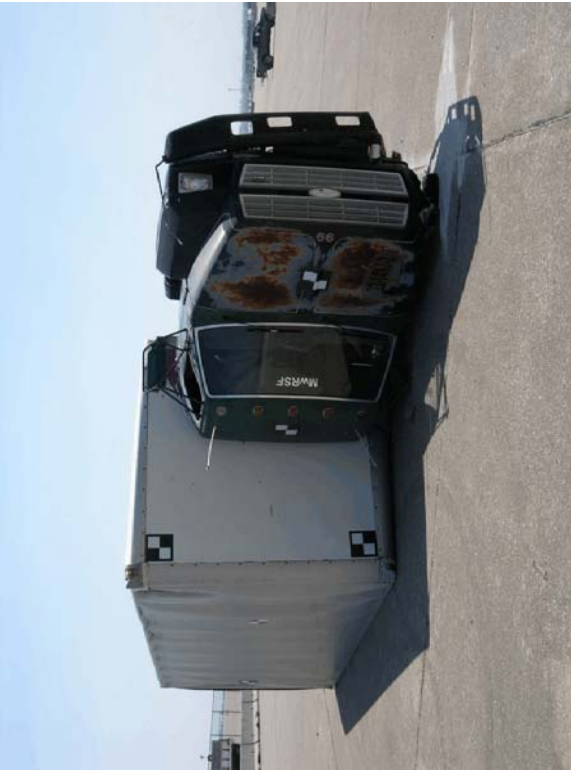
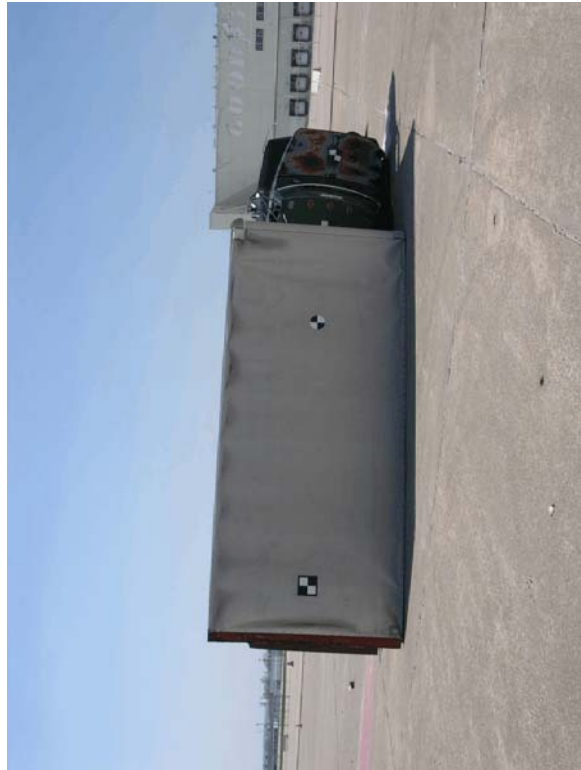
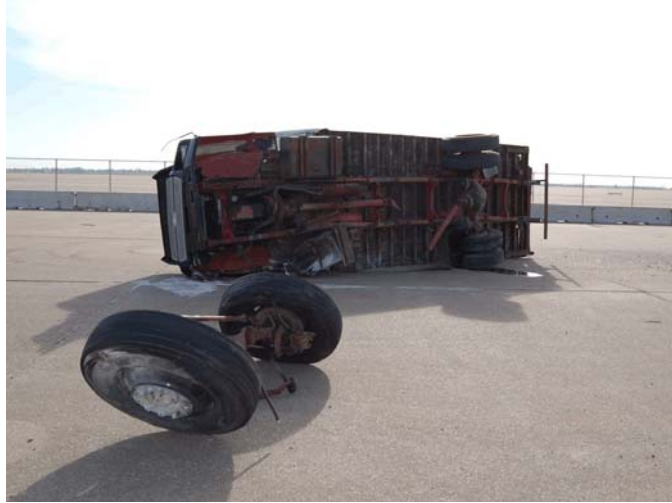
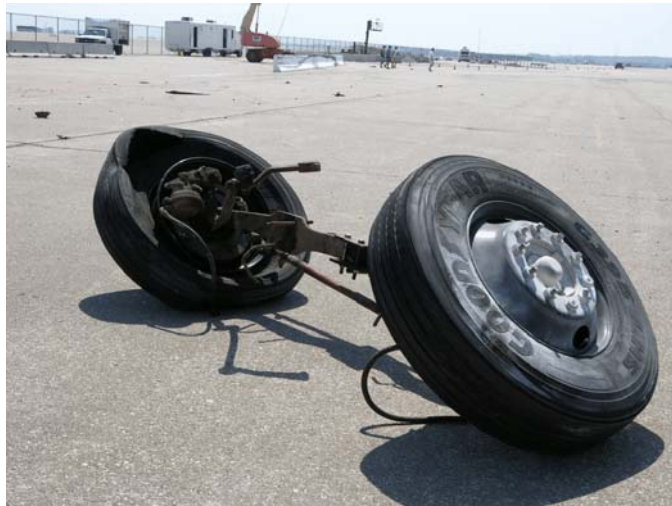
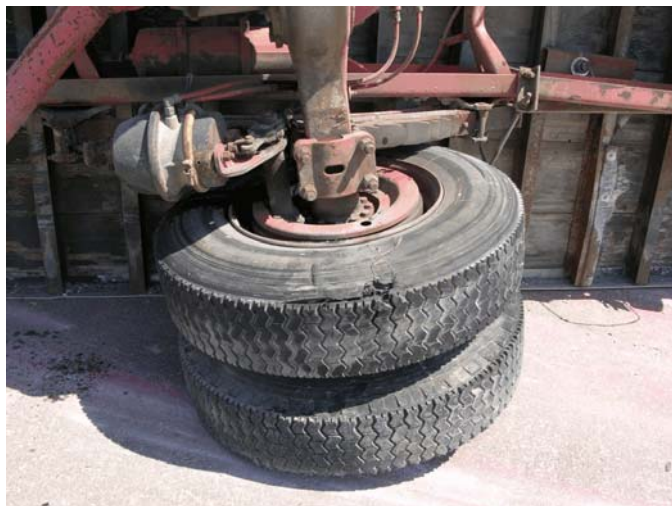
Figure 23. Vehicle Damage, Test 2214NJ-2

Exterior vehicle damage was extensive, as shown in Figures 23 through 26. Occupant compartment deformations to the right side and center of the floorboard were judged insufficient to cause serious injury to the vehicle occupants. Complete occupant compartment deformations and the corresponding locations are provided in Appendix C.

Damage was concentrated on the right side of the vehicle. The right-front quarter panel was deformed inward toward the engine compartment. The right side of the front bumper was flattened and bent back toward the engine compartment. The left side of the front bumper was also deformed inward toward the engine compartment. The right-front fuel tank was severely dented. The right-front exhaust disengaged from the truck and was dented. The bracket attaching the right-right front exhaust was bent backward 90 degrees. The right side of the frame buckled at the front flange and was bent and twisted near the rear end. The front axle and drive shaft disengaged from the truck. Scratches and contact marks were found along the entire right side. The hood deformed slightly. The third and fourth U-bolts attaching the cargo box to the frame fractured. The cargo box frame at the rear axle was bent backward. The top rear of the cargo box encountered minor buckling. Contact marks were found on the bottom of the cargo box and the steel cross beams were deformed. The right leaf spring disengage at the front of the rear tire. The right-rear inside tire encountered a severe gouge. The right-front mirror was broken. All window glass remained undamaged.
