*Midwest States Regional Pooled Fund Research Program
Fiscal Year 2009-2010 (Year 20)
Research Project Number TPF-5(193)
NDOR Sponsoring Agency Code RFPF-10-MGS*

DETERMINATION OF THE MAXIMUM MGS MOUNTING HEIGHT – PHASE I CRASH TESTING

MwRSF Research Report No. TRP-03-255-12

March 9, 2012

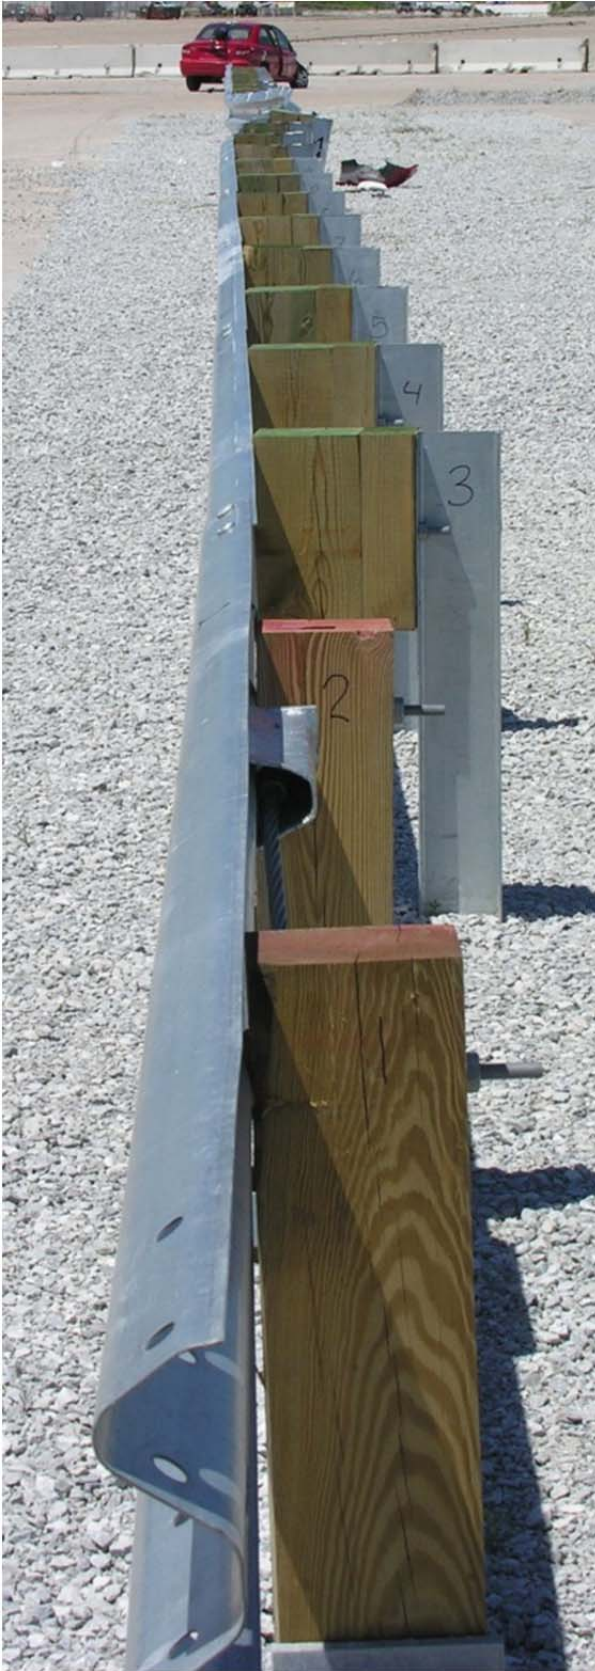
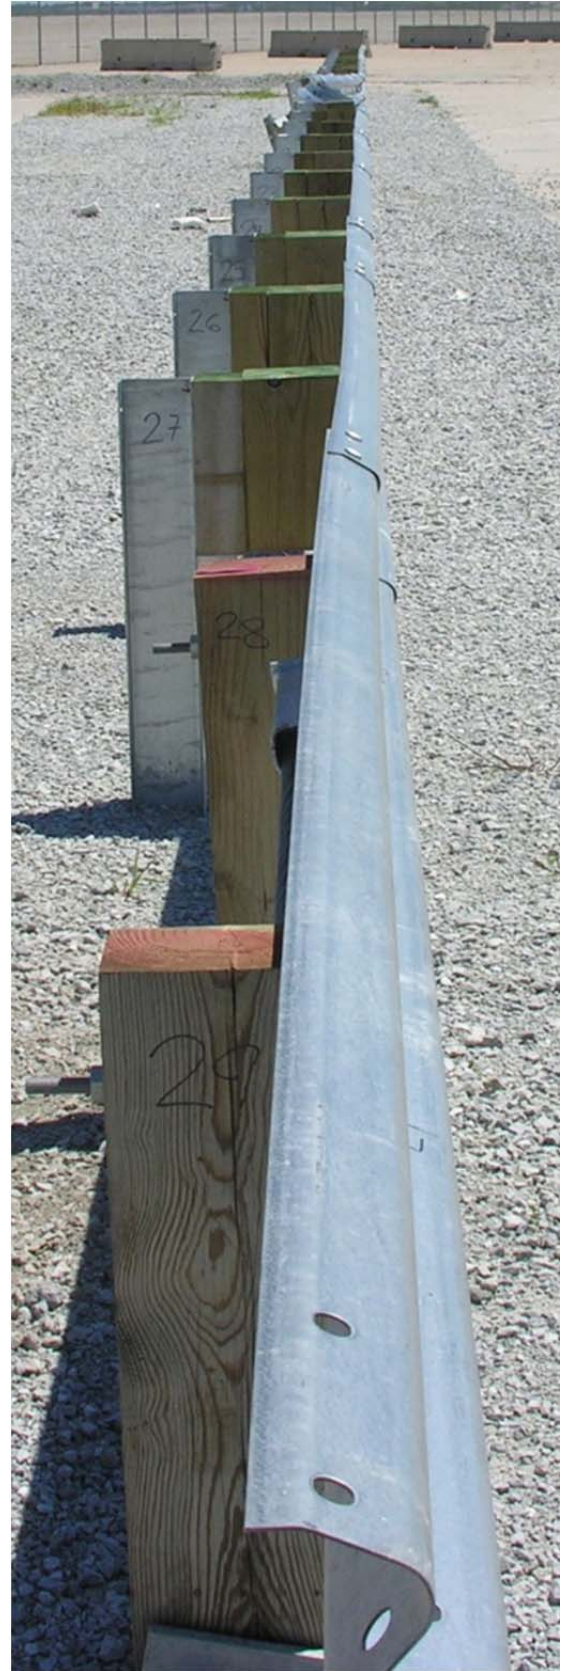
Figure 36. System Damage, Test No. MGSMRH-1

Damage to the barrier was moderate, as shown in Figures 36 through 45. Barrier damage consisted of deformed guardrail posts, disengaged wooden blockouts, contact marks on posts and guardrail, and deformed W-beam rail. The length of vehicle contact along the barrier was approximately 25 ft – 10½ in. (7.9 m) which spanned from 10 ft – 1 in. (3.1 m) upstream of the centerline of post no. 15 to 35½ in. (902 mm) upstream of post no. 18.

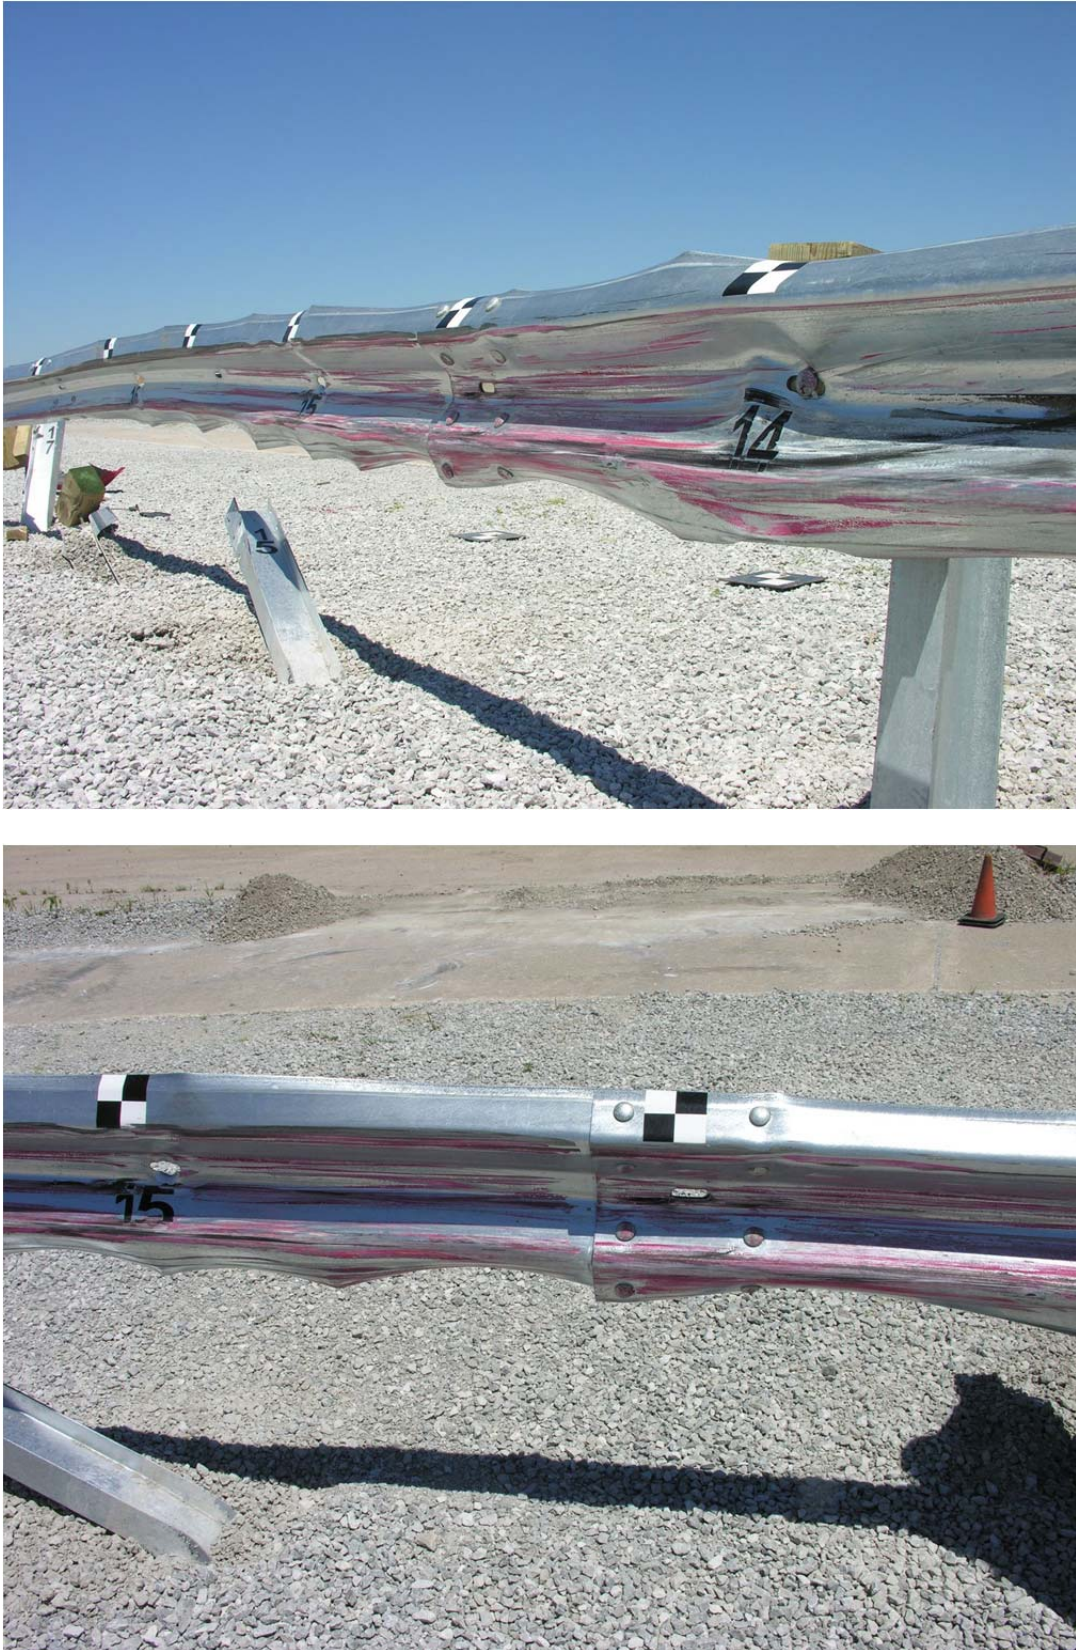
Figure 38. System Damage, Test No. MGSMRH-1

Red paint transfer was found on the rail between the impact location and post no. 18. Minor kinks in the top and bottom corrugations of the rail were found between post nos. 12 and 19, as shown in Figure 38. Flattening and deformation of the rail occurred between post nos. 13 and 18. The bottom corrugation was flattened between post nos. 14 and 16. The bottom edge of the rail was folded upward at post no. 14.

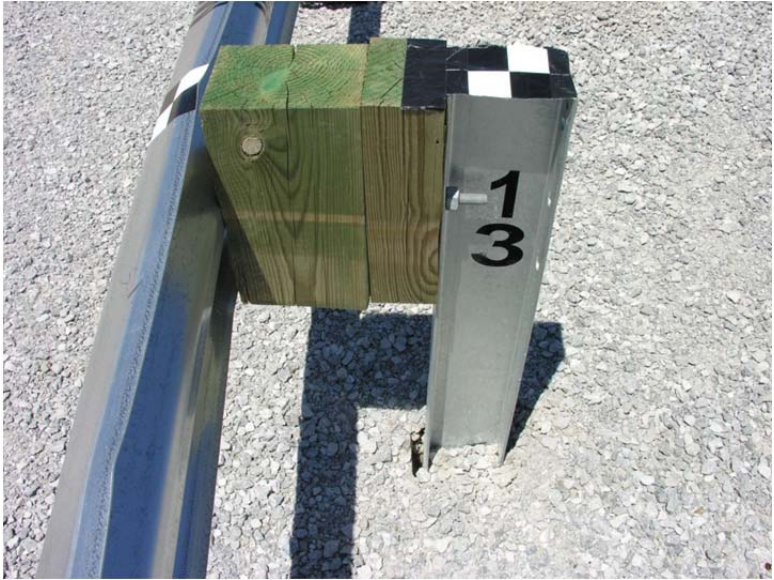
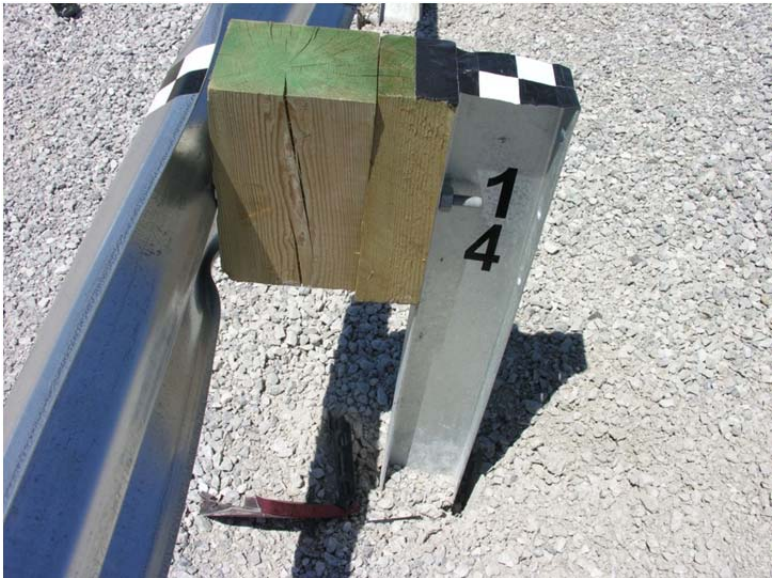
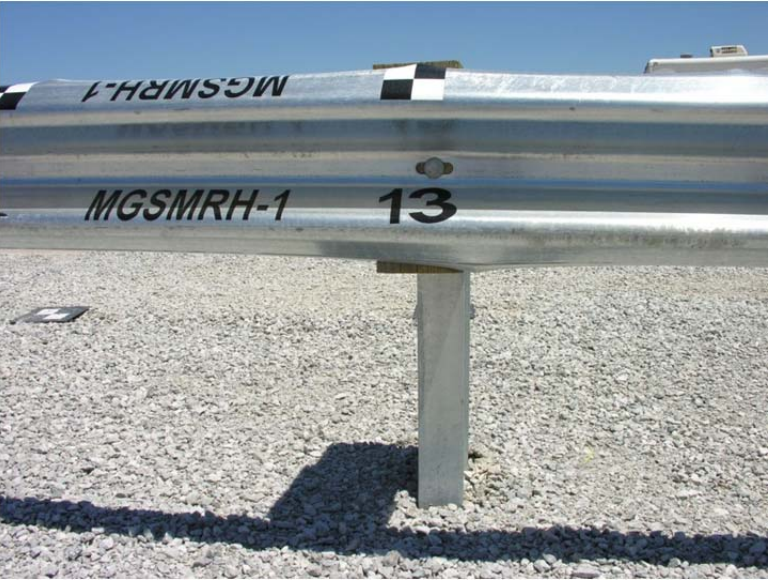
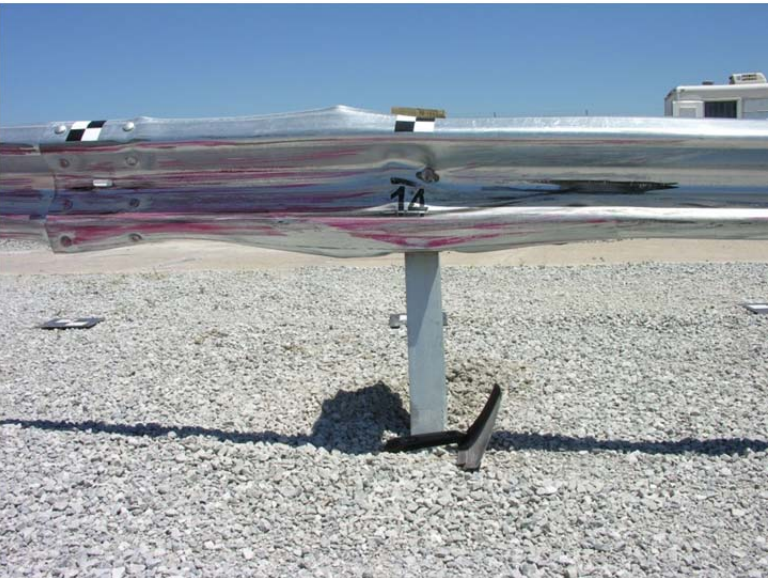
Figure 43. Post Nos. 13 and 14 Damage, Test No. MGSMRH-1

Contact marks were found on the front flange of post no. 14, on the upstream edge of the front flange and on the face of the back flange of post no. 15, on the front flange and the upstream side of the web of post no. 16 as well as on the corresponding blockout, and on both the upstream edge of the front flange on post no. 17 and the corresponding blockout.

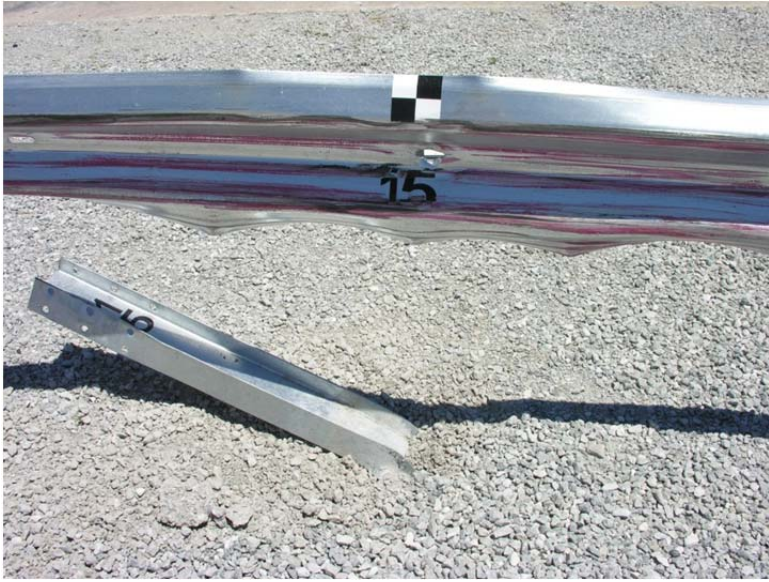
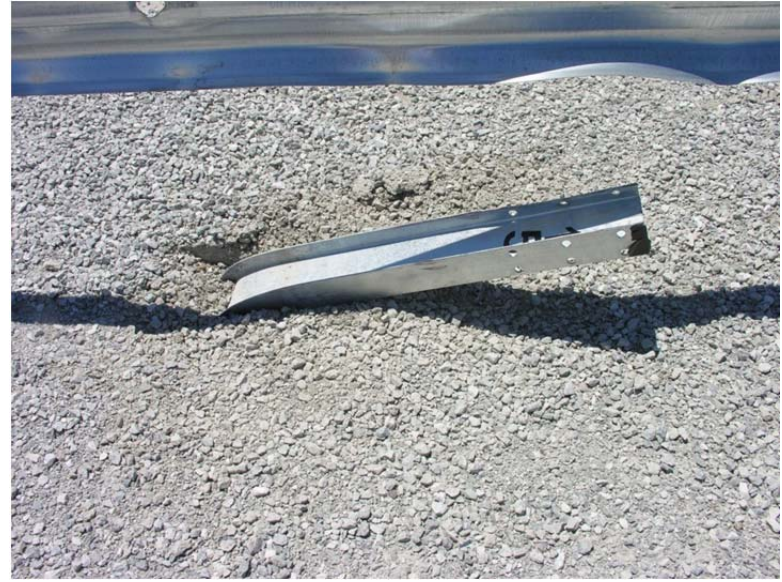
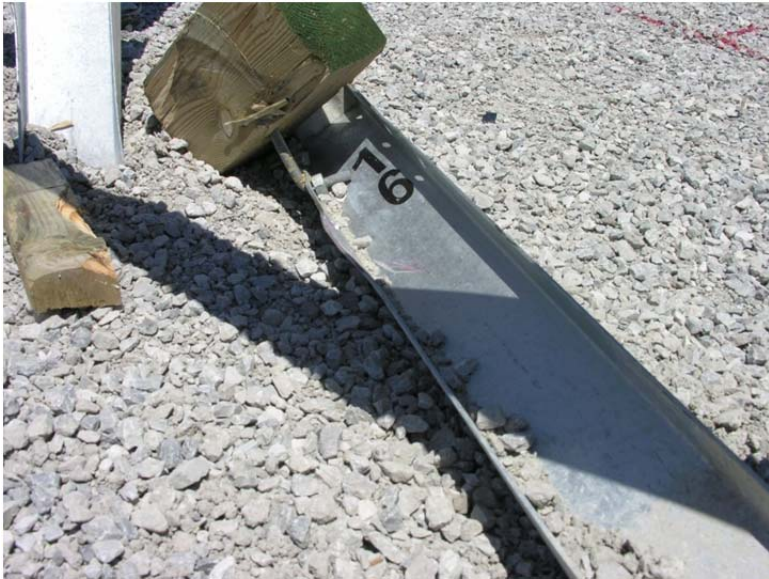
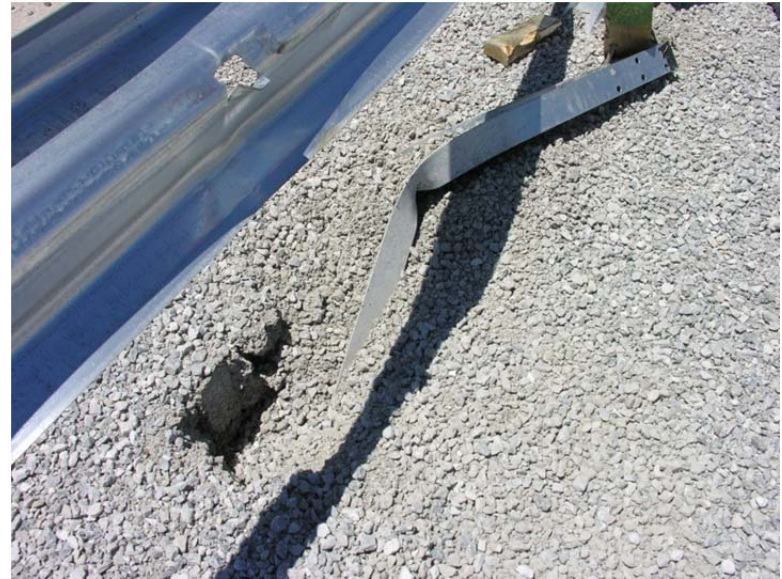
Figure 44. Post Nos. 15 and 16 Damage, Test No. MGSMRH-1

The maximum permanent set rail and post deflections of the barrier system were 18¼ in. (464 mm) at the midspan between post nos. 15 and 16 and 17 in. (432 in.) at post no. 16, respectively, as measured in the field. The maximum lateral dynamic rail and post deflections were 29.0 in. (737 mm) at the midspan between post nos. 15 and 16 and 20.2 in. (513 mm) at post no. 16, respectively, as determined from high-speed video analysis. The working width of the system was found to be 49.4 in. (1,255 mm), also determined from high-speed digital video analysis.

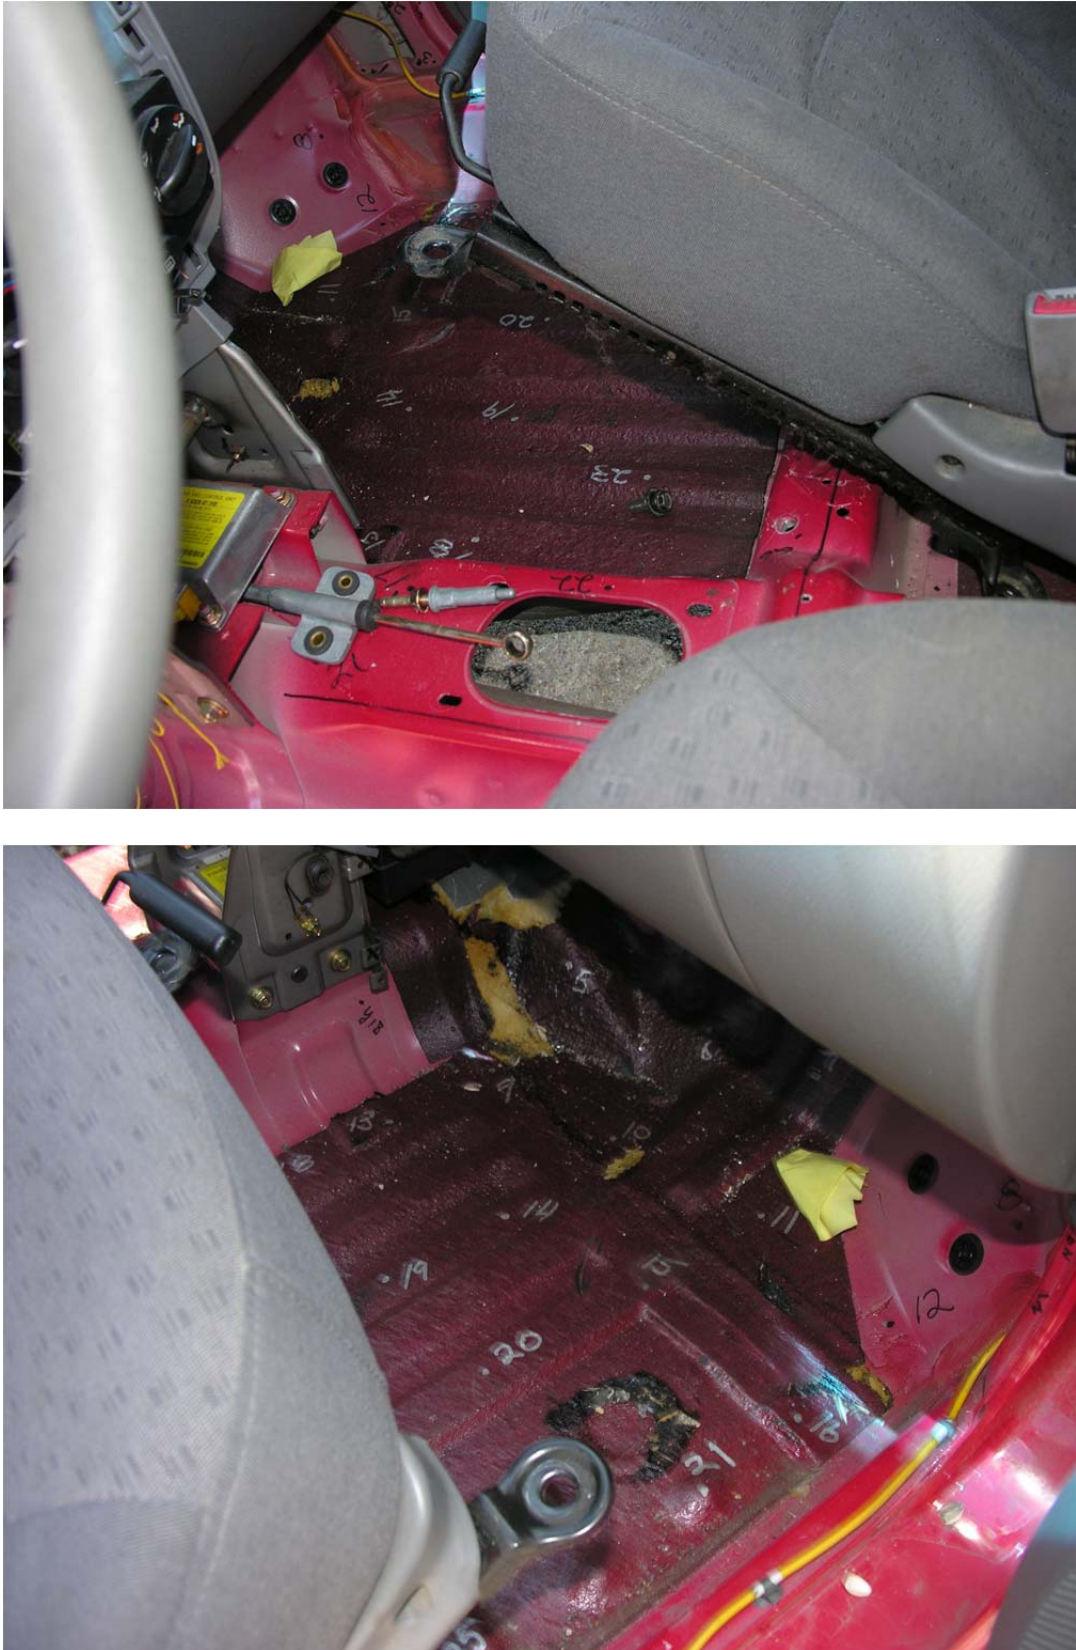
Figure 48. Occupant Compartment Damage, Test No. MGSMRH-1

The damage to the vehicle was moderate, as shown in Figures 46 through 49. The maximum occupant compartment deformations are listed in Table 7 alongside the deformation limits established in MASH for various areas of the occupant compartment. It should be noted that none of the MASH established deformation limits were violated. Complete occupant compartment and vehicle deformations and the corresponding locations are provided in Appendix D.

right-front fender. The right side mirror disengaged, and the mirror mount fractured. The base of the right-side A-pillar crushed inward. The right-front tire deflated and the rim folded inward. The upper control arm connector on the right-front wheel bent at the thread location. The right-front hood corner crushed inward. The right-side bumper cover and foam disengaged. The right-side headlight disengaged and was fractured. The bumper cover was pulled down $\frac{1}{2}$ in. (13 mm). The left side of the hood was ajar. The antenna disengaged. The windshield washer fluid container was dented, cracked, and leaking fluid. The drive linkage was leaking fluid at the transmission housing. Minor scraping was found near the bumper connection to the unibody. Minor spiderweb cracking was found at the right side of the windshield along the entire height of the windshield. All other window glass, the roof, the rear, and the left side of the vehicle were undamaged.
