# **MIDWEST GUARDRAIL SYSTEM (MGS) WITH AN OMITTED POST**

## **MIDWEST ROADSIDE SAFETY FACILITY**

MwRSF Research Report No. TRP-03-326-16

February 22, 2016

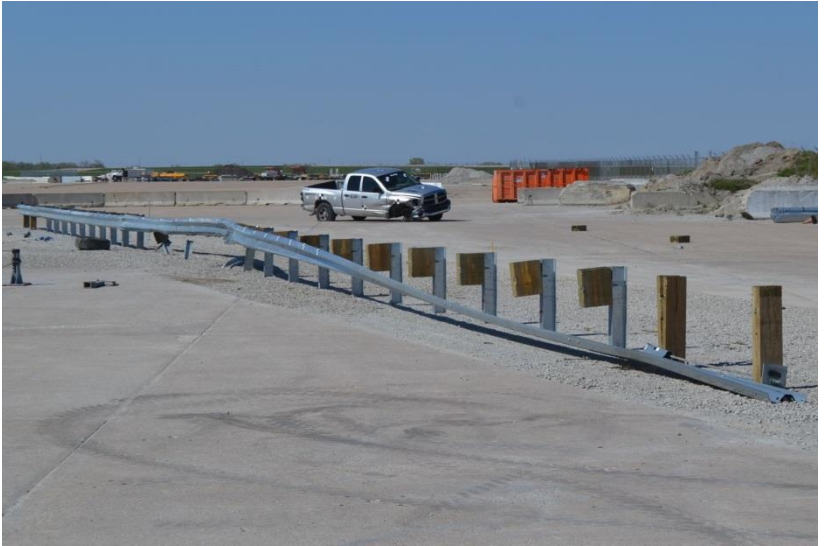
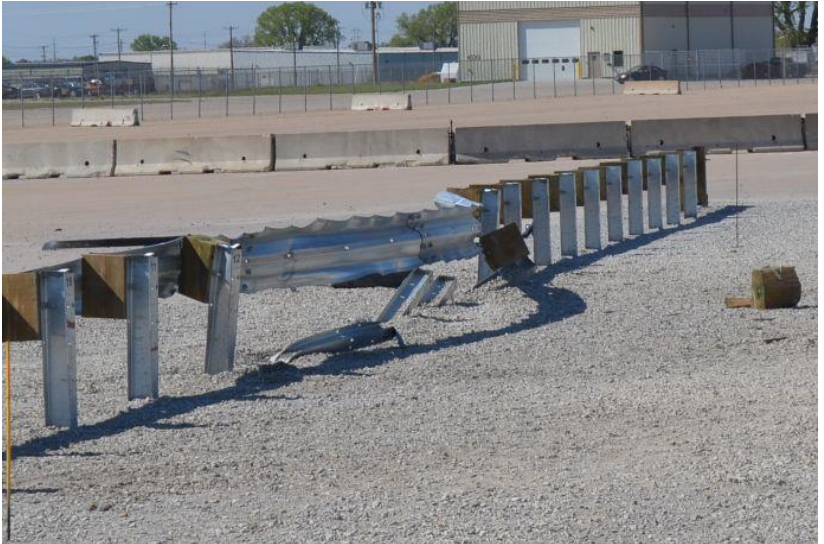
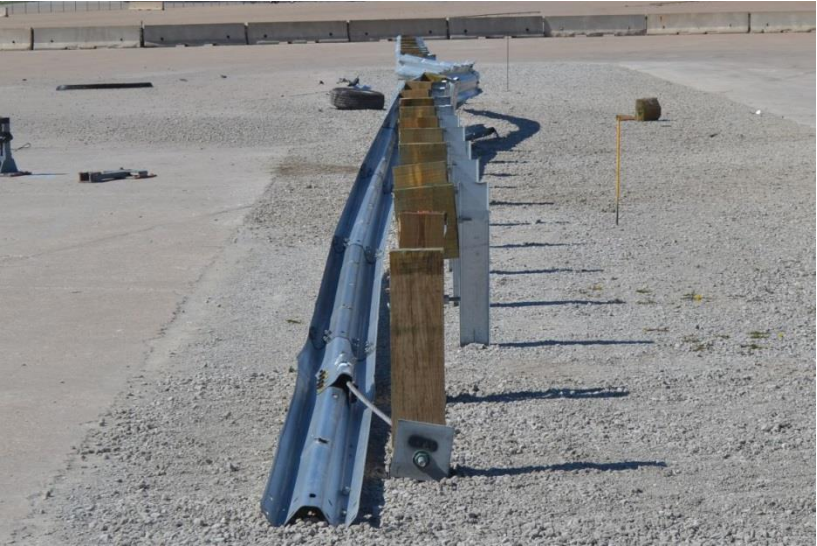
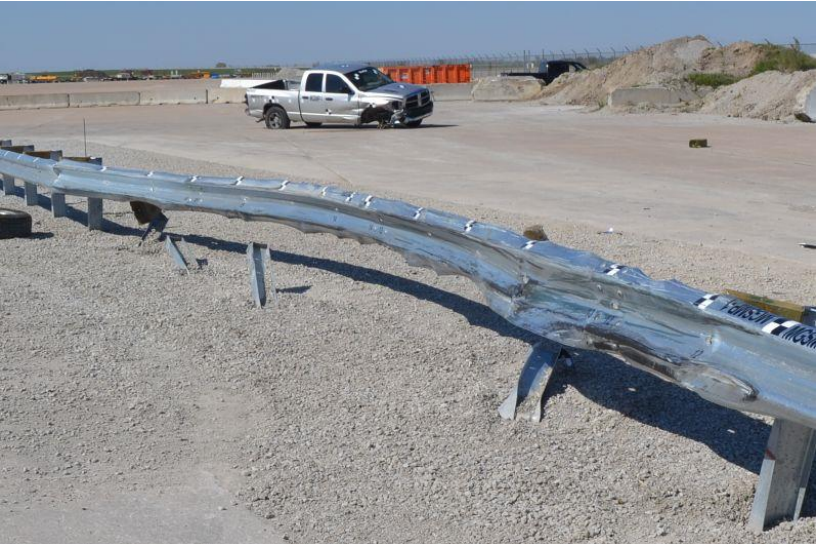
Figure 24. System Damage, Test No. MGSMP-1

Damage to the barrier was moderate, as shown in Figures 24 through 28. Barrier damage consisted of rail deformation, disengagement of the W-beam rail from the posts, bending of the steel posts, and fracture of wooded posts. The length of vehicle contact along the barrier was approximately 39 ft – 9¼ in. (12.1 m), which spanned from 18¼ in. (464 mm) upstream from the centerline of post no. 12 through 9 in. (229 mm) downstream from post no. 17.

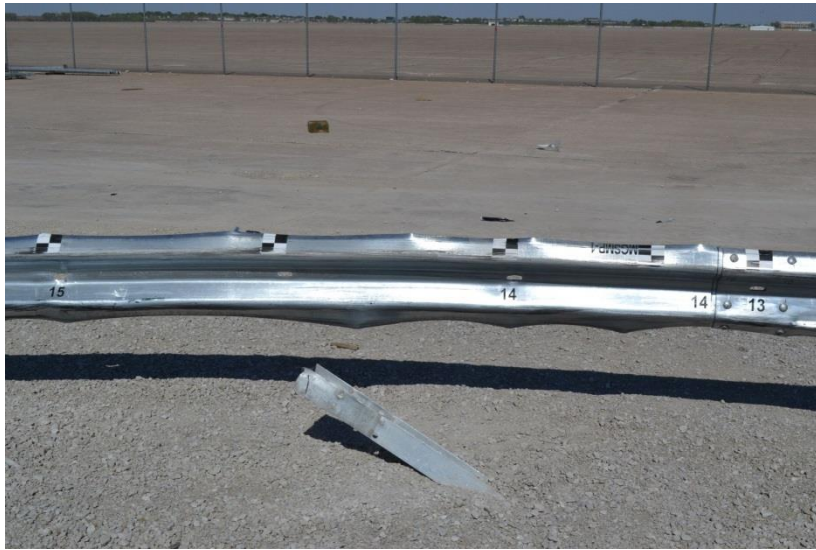
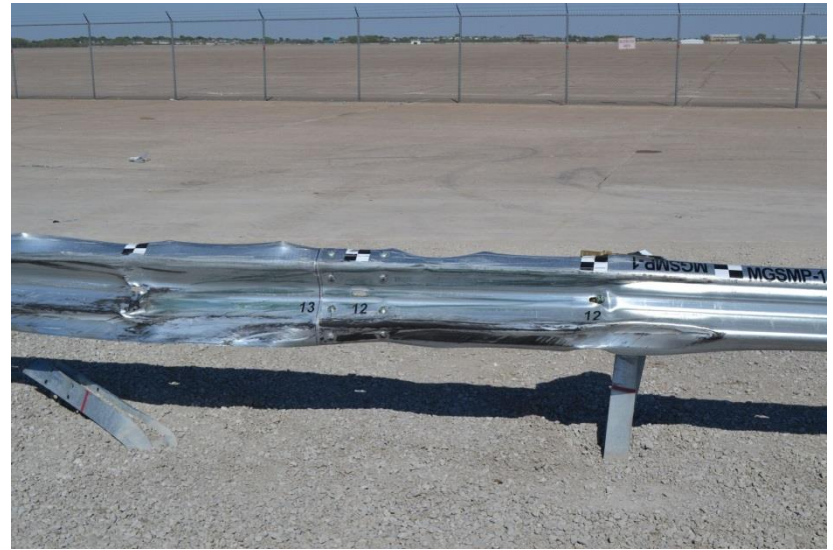
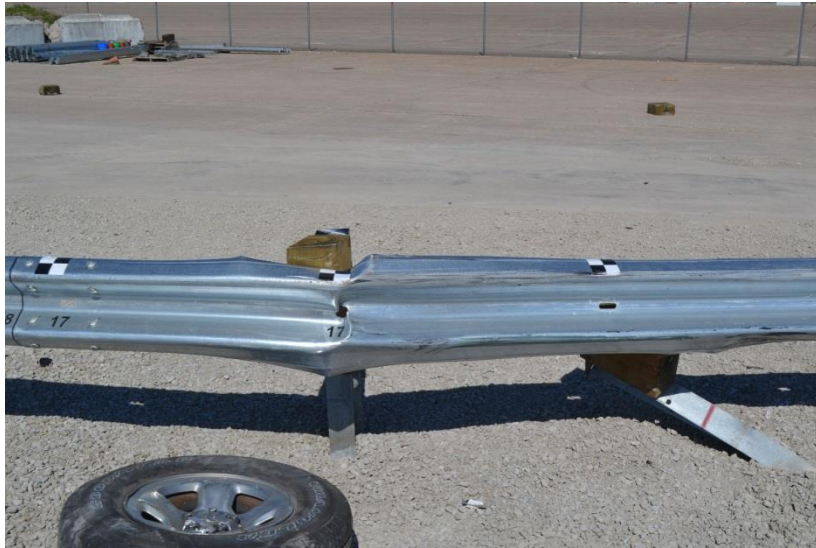
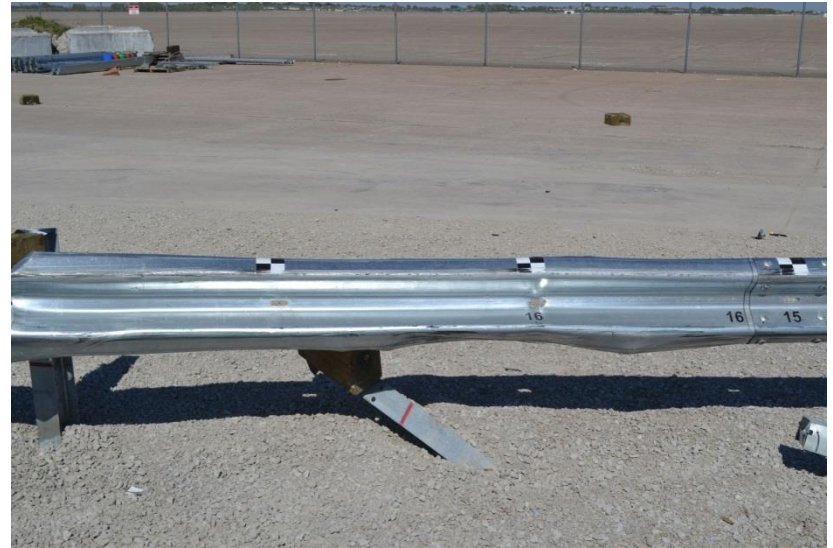
Figure 25. Rail Damage Between Post Nos. 12 and 17, Test No. MGSMP-1

Deformation of the W-beam rail occurred between post nos. 11 through 17. Flattening occurred on the bottom corrugation of the rail from the midspan between post nos. 12 and 13 to 13 in. (330 mm) upstream from the midspan between post nos. 14 and 15. A 25-in. (635-mm) long dent was found at the bottom of the rail starting 8 in. (203 mm) upstream from post no. 16. A kink was found in the rail around the blockout of post no. 17. All splice locations were measured before and after the test. A maximum splice movement of ⅝ in. (16 mm) was recorded at two adjacent splices in the contact region, which were located between post nos. 13 and 14 and between post nos. 15 and 16. The rail released from post nos. 1 through 9 and 13 through 17 where the bolt head pulled through the slots in the rail.

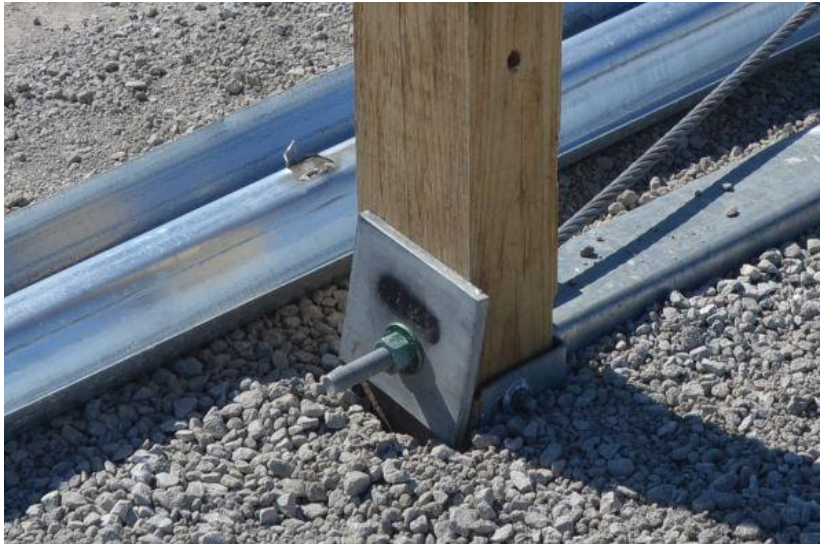
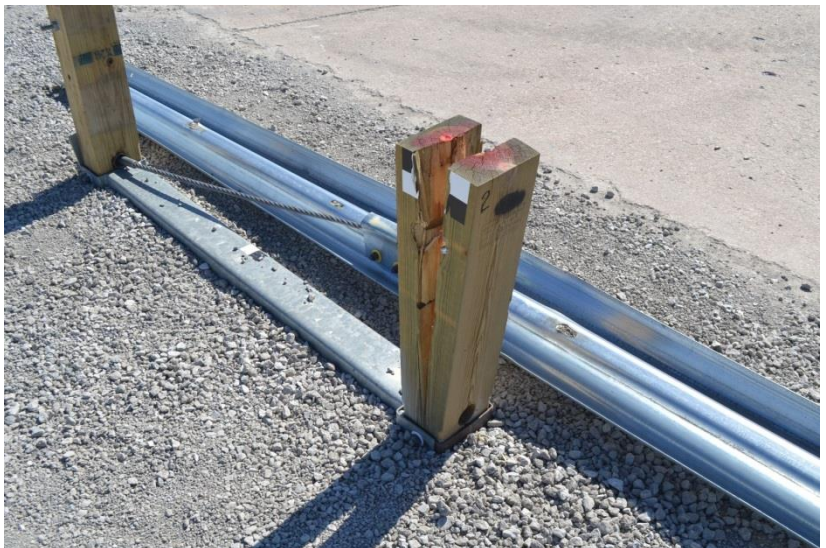
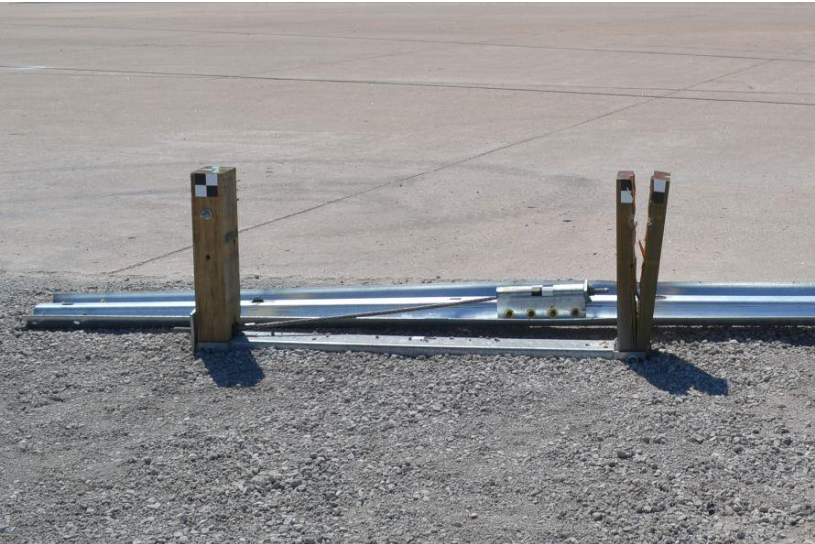
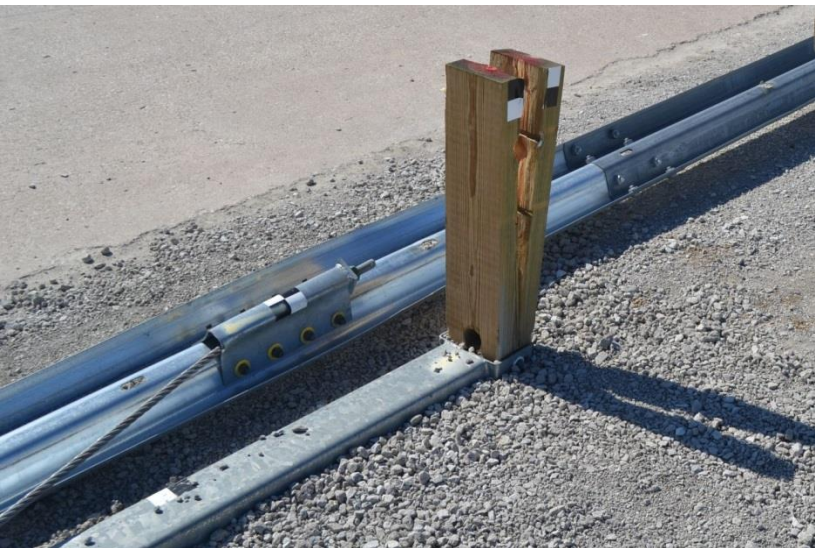
Figure 28. Upstream Anchor Damage, Test No. MGSMP-1

Although the post bolts pulled through the rail at the upstream anchor, the cable anchor remained intact between the rail and the bottom of post no. 1, as shown in Figure 28. Two tears, ¾ in. (19 mm) and ½ in. (13 mm) long, occurred in the rail at the bolt location of post no. 1. Post no. 2 was split down the center through the bolt hole. A 1-in. (25-mm) soil gap was found on the upstream side of post no. 1. The downstream anchorage was undamaged, except for a 1/16-in. (2-mm) soil gap found on the downstream side of the foundation tubes.

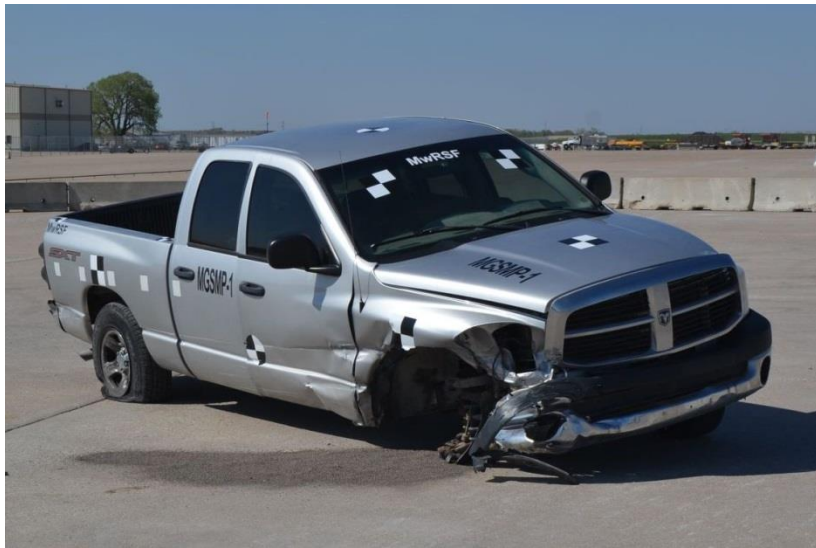
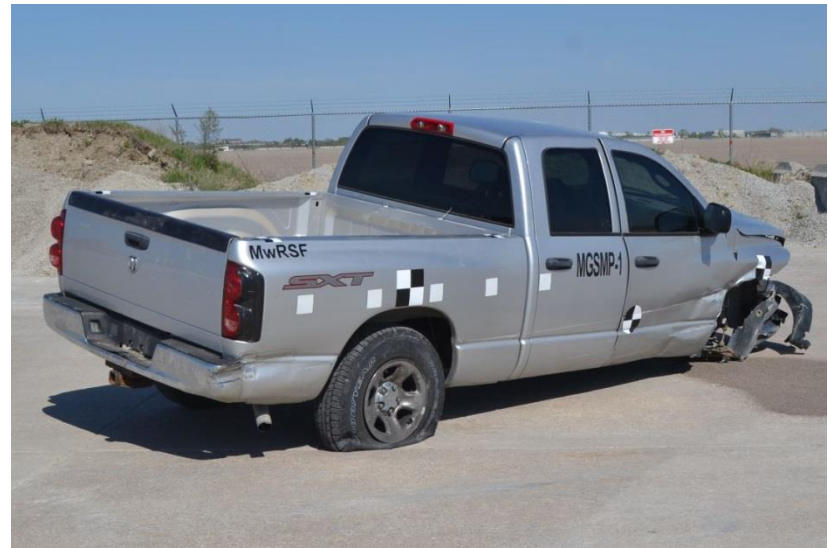
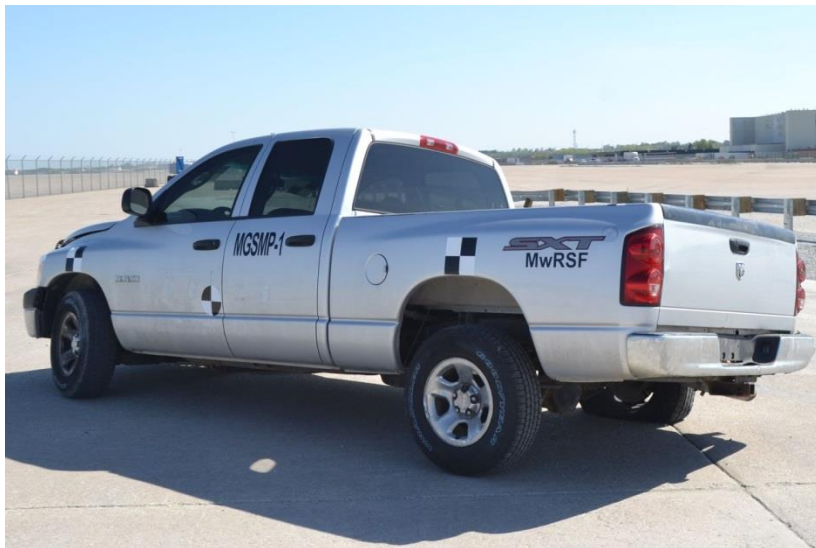
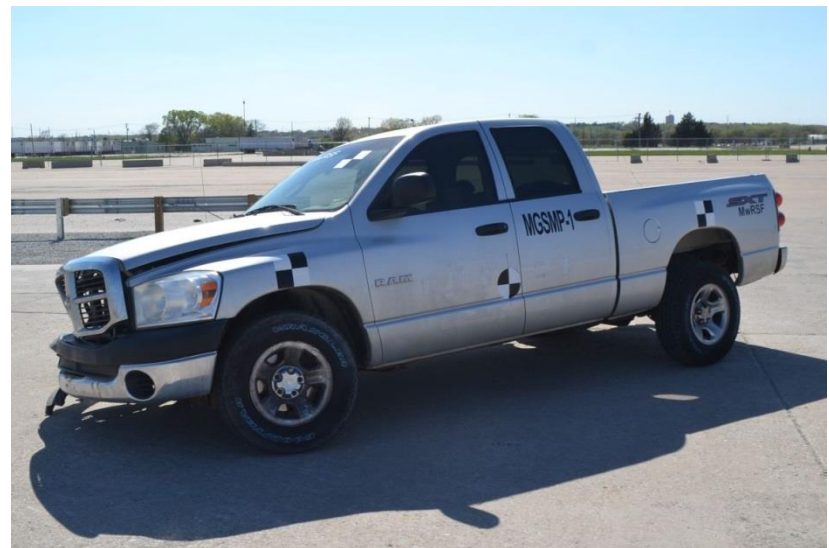
Figure 29. Vehicle Damage, Test No. MGSMP-1

The damage to the vehicle was moderate, as shown in Figures 29 and 30. The maximum occupant compartment deformations are listed in Table 6 along with the deformation limits established in MASH for various areas of the occupant compartment. Note that none of the MASH-established deformation limits were violated. Complete occupant compartment and vehicle deformations and the corresponding locations are provided in Appendix D.

The majority of the damage was concentrated on the right-front corner and right side of the vehicle where impact occurred. A 1¾-in. (44-mm) separation formed between the hood and the grill. The right-front corner of the bumper was crushed inward. The right headlight disengaged. A 5-in. (127-mm) dent formed on the fender located behind the headlight location. The right-front tire was disengaged and had a ¾-in. (19-mm) tear in its sidewall. The right-front wheel steel rim had a 1½-in. (38-mm) diameter gouge and bending around the entire edge of the rim. Additional gouges were found on the hub cap. The steering linkage broke, and the control arm was fractured. The right-front brake hose was cut. Contact marks were found on the entire length of the right side of the vehicle, starting 20 in. (508 mm) from the bottom of the right-front door and ending 9½ in. (241 mm) from the bottom of the right-rear bumper. The right-front door had a 12-in. (305-mm) long tear approximately 18 in. (457 mm) below the window. Gouges and dents were found on the right-front door. A 3-in. wide x 1-in. deep x 10-in. long (76-mm x 25-mm x 254-mm) gouge was found on the rear corner of the right-rear bumper. The right-rear tire ruptured.
