MASH EVALUATION OF TxDOT ROADSIDE SAFETY FEATURES – PHASE I

Test Report 0-6946-1

TEXAS A&M TRANSPORTATION INSTITUTE
COLLEGE STATION, TEXAS

1. Report No. FHWA/TX-17/0-6946-1		2. Government Accession No.		3. Recipient's Catalog No.	
4. Title and Subtitle MASH EVALUATION OF TXDOT ROADSIDE SAFETY FEATURES – PHASE I				5. Report Date Published: January 2018

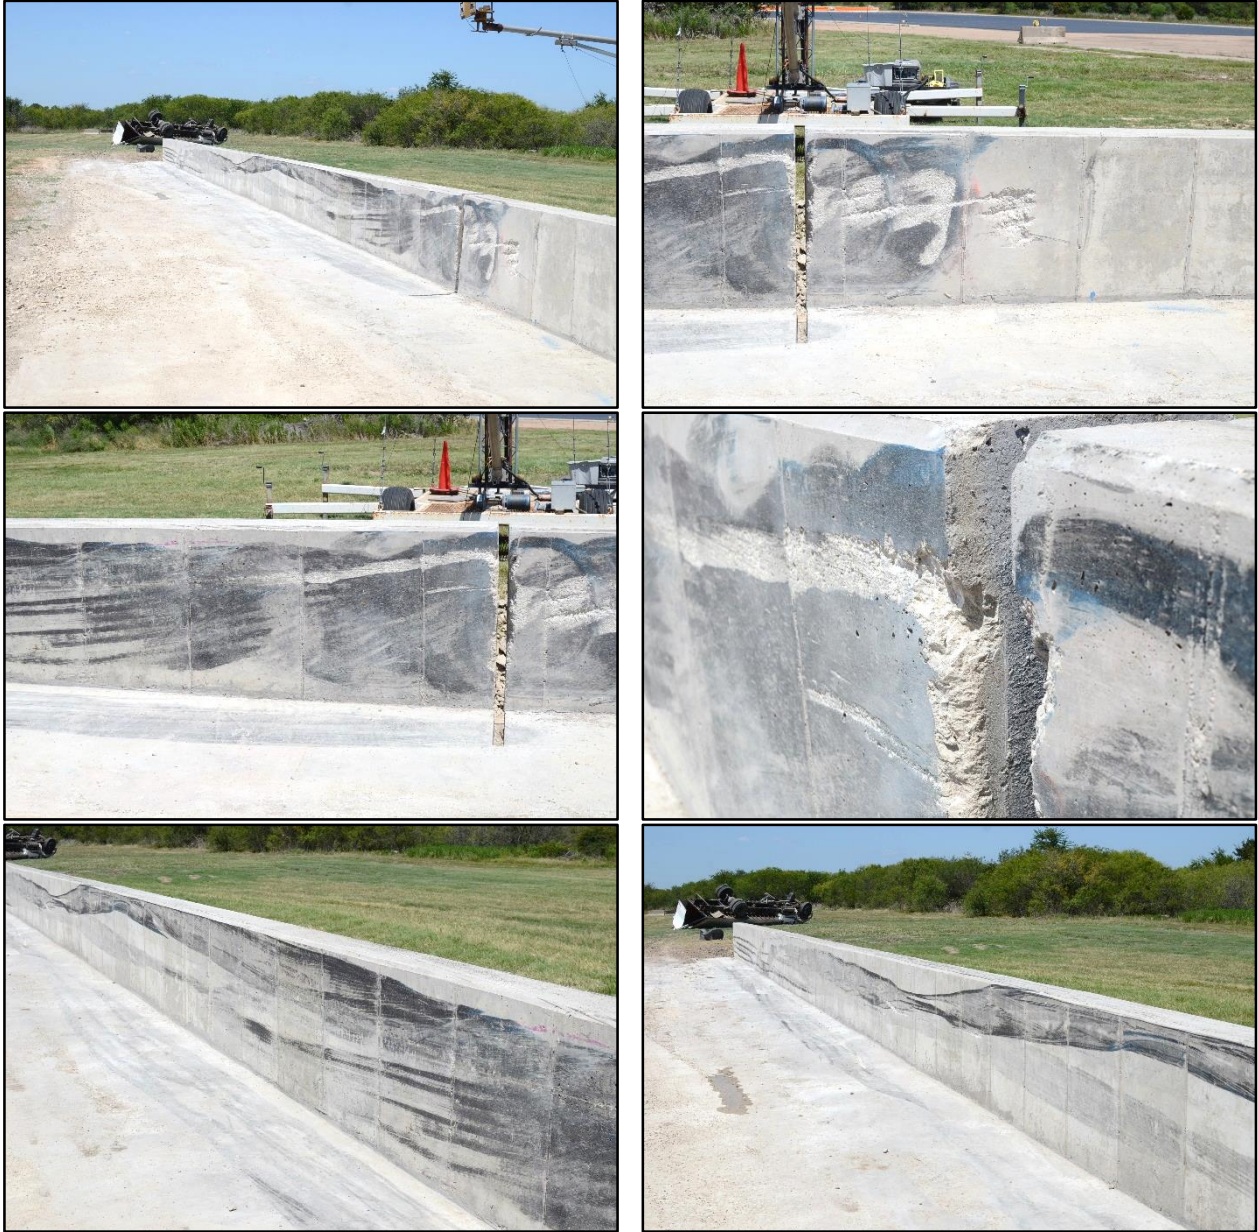
Figure 2.6. 36-inch Vertical Concrete Bridge Rail after Test No. 469467-1-1.

Figure 2.6 shows damage to the 36-inch vertical wall. Slight cracking of the concrete parapet occurred in the impact region near the expansion joint. Working width was 67 inches at a height of 104.6 inches. Maximum dynamic deflection during the test was 2.2 inches, and permanent deformation was approximately 1 inch at the top of the first section.

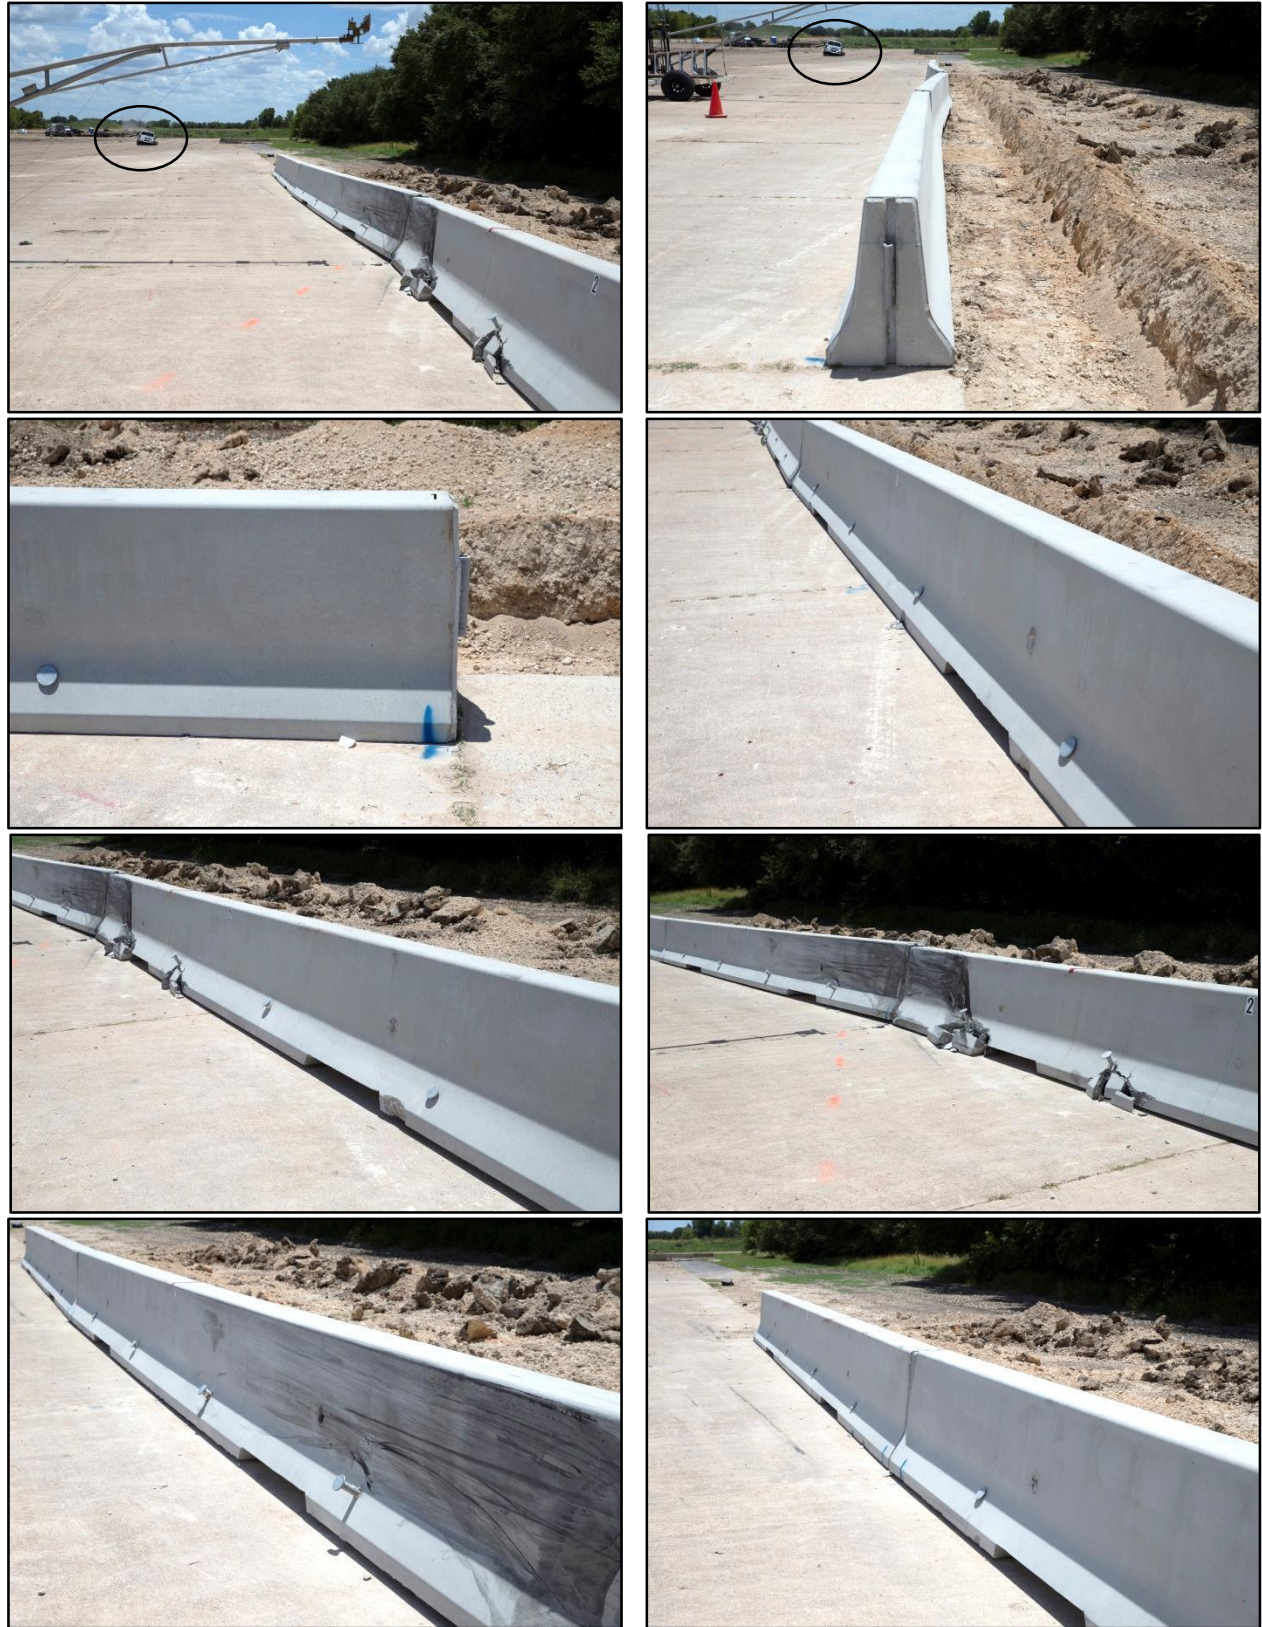
Figure 4.5. TxDOT 32-inch CSB(7)-10 Pinned to Concrete Pavement after Test No. 469467-5-1.

Figures 4.5 through 4.8 show the damage to the TxDOT 32-inch CSB(7)-10 pinned to concrete pavement. The upstream end of barrier segment 1 was pushed toward the field side 0.5 inch, and the downstream end was pushed toward traffic lanes 1.0 inch. The upstream end of barrier segment 2 was pushed toward traffic lanes 2.0 inches and was lifted upward from ground level 1.5 inches. The downstream end of barrier segment 2 was pushed 12.0 inches toward the field side and was lifted upward from ground level 0.5 inches. In barrier segment 2, pin 1 was pulled upward 0.5 inch, pin 2 was pulled up 1.0 inch, pin 3 was pulled up 3.0 inches, and pin 4 was pulled upward 4.0 inches and was deformed.

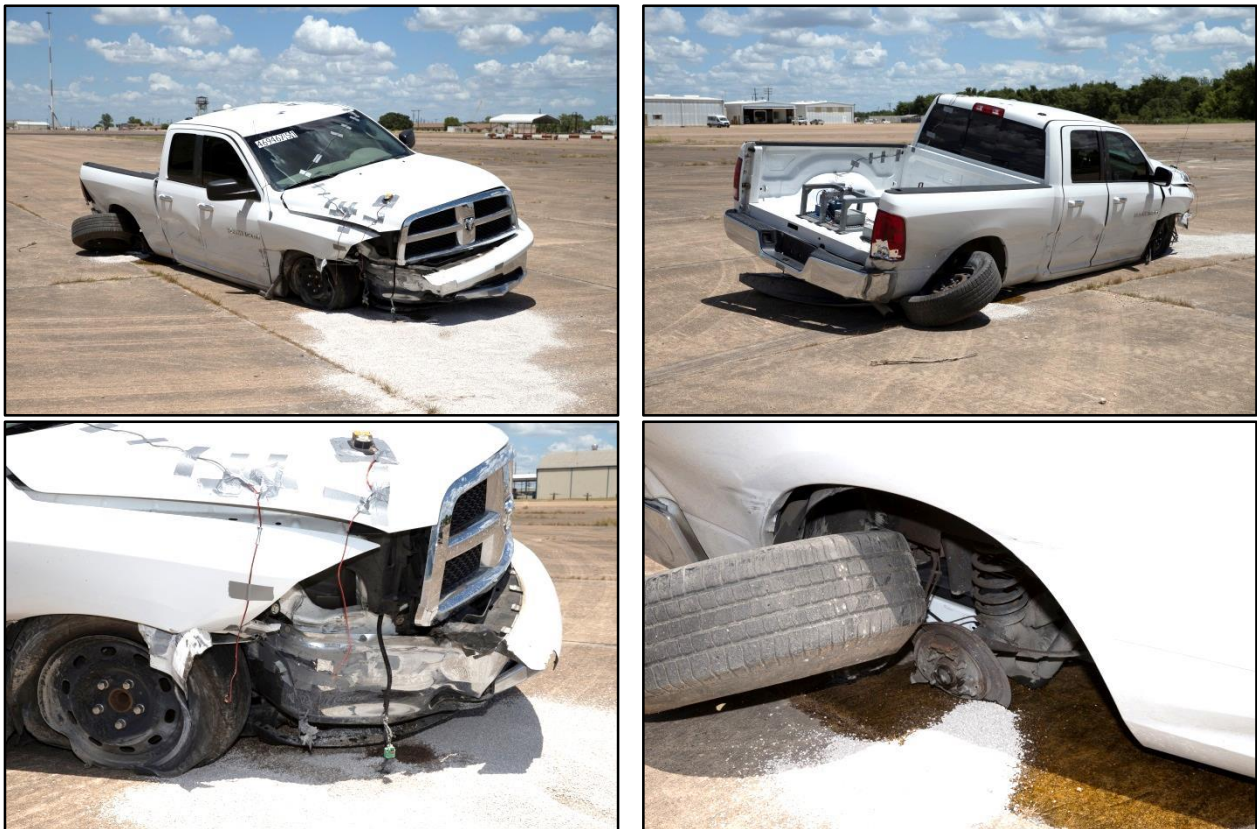
Figure 4.9. Test Vehicle after Test No. 469467-5-1.

Figure 4.9 shows the damage sustained by the test vehicle. The front bumper, grill, radiator and support, right front fender, right front tire and rim, right front and rear doors, right lower cab corner, right rear exterior bed, right rear tire and rim, right axle, rear bumper, and tailgate were damaged. Maximum exterior crush to the vehicle was 15.0 inches in the side plane at the right front corner at bumper height. No occupant compartment deformation or intrusion was noted. Figure 4.10 shows the interior of the vehicle. Tables C.3 and C.4 in Appendix C.3 provide exterior crush and occupant compartment measurements.

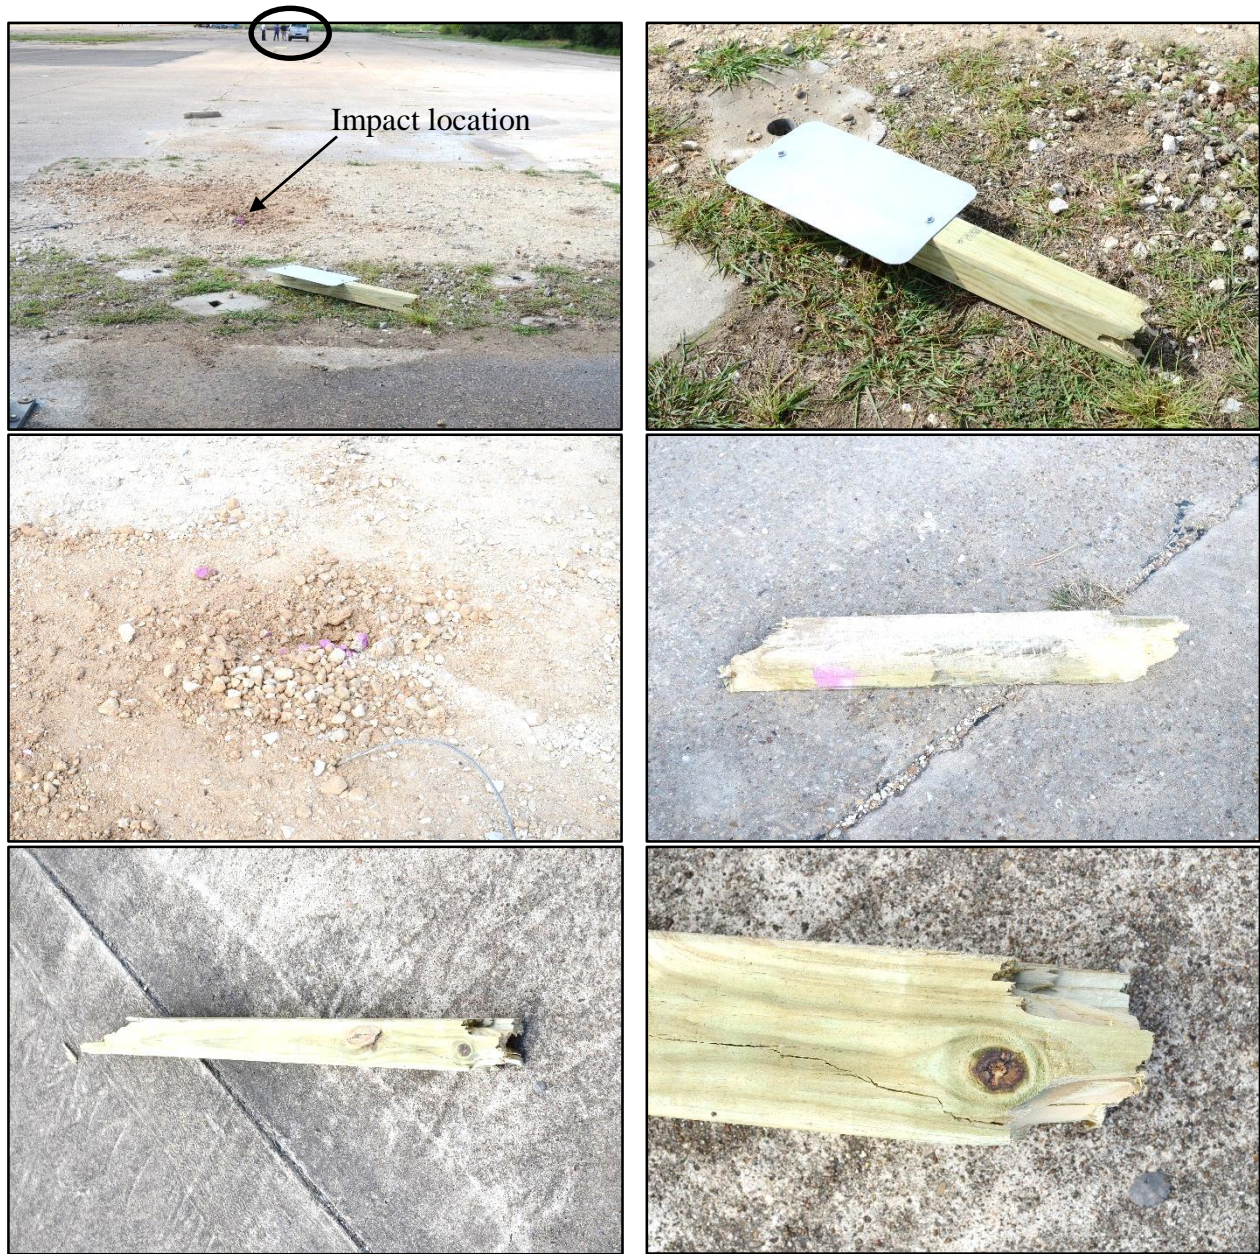
Figure 5.5. TxDOT Single Embedded Wood Post System for 0° Impact after Test No. 469467-6-1.

The support post fractured at three locations. The fracture above the vehicle hood may have been influenced by the presence of a knot on the impact face of the post. The sign panel and remaining post segment did not contact the windshield and had only minor (if any) contact with the roof. The influence of the knot on the fracture of the post may affect repeatability of the test. However, wood is a variable product with knots occurring randomly throughout. The TxDOT single embedded wood post sign system performed acceptably for *MASH* Test 3-62 at 0°.

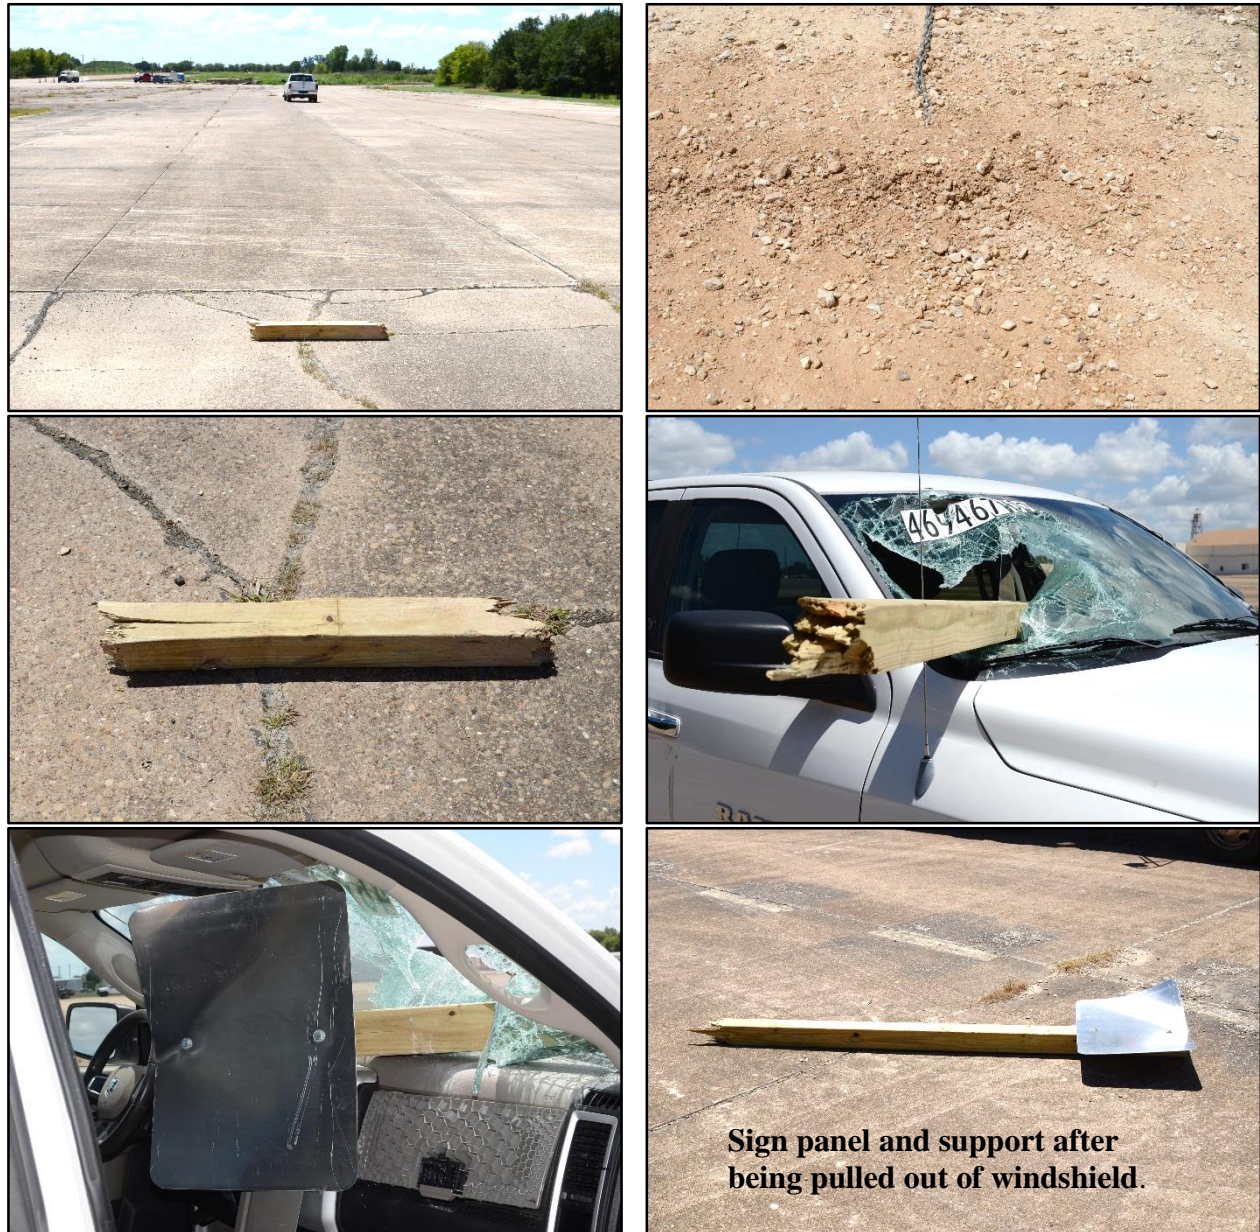
Figure 5.13. TxDOT Single Embedded Wood Post System for 90° Impact after Test No. 469467-6-3.

Figure 5.13 shows the damage to the TxDOT single embedded wood sign system. The wood post fractured in two places. A 32-inch long section was resting 155 ft upstream of impact and 11 ft to the left of centerline. An 80-inch section with the sign panel attached was embedded in the windshield of the vehicle.

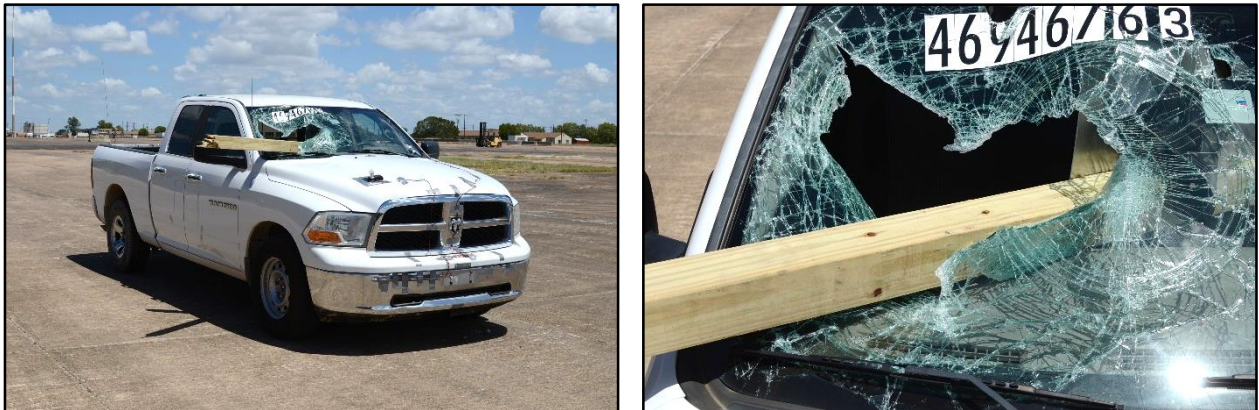
Figure 5.14. Test Vehicle after Test No. 469467-6-3.

Figure 5.14 shows damage sustained by the vehicle. The front bumper and hood had a small dent at the quarter point. The sign panel and support tore a 20 × 20-inch hole in the windshield just left of centerline. The sign panel and support also caused damage to the instrument panel, glove box, and roof. Maximum exterior crush to the vehicle was not measureable in the front plane at the left quarter point at bumper height. Penetration of the windshield occurred. Figure 5.15 shows the interior of the vehicle. Table D.6 in Appendix D.2 provides occupant compartment measurements.

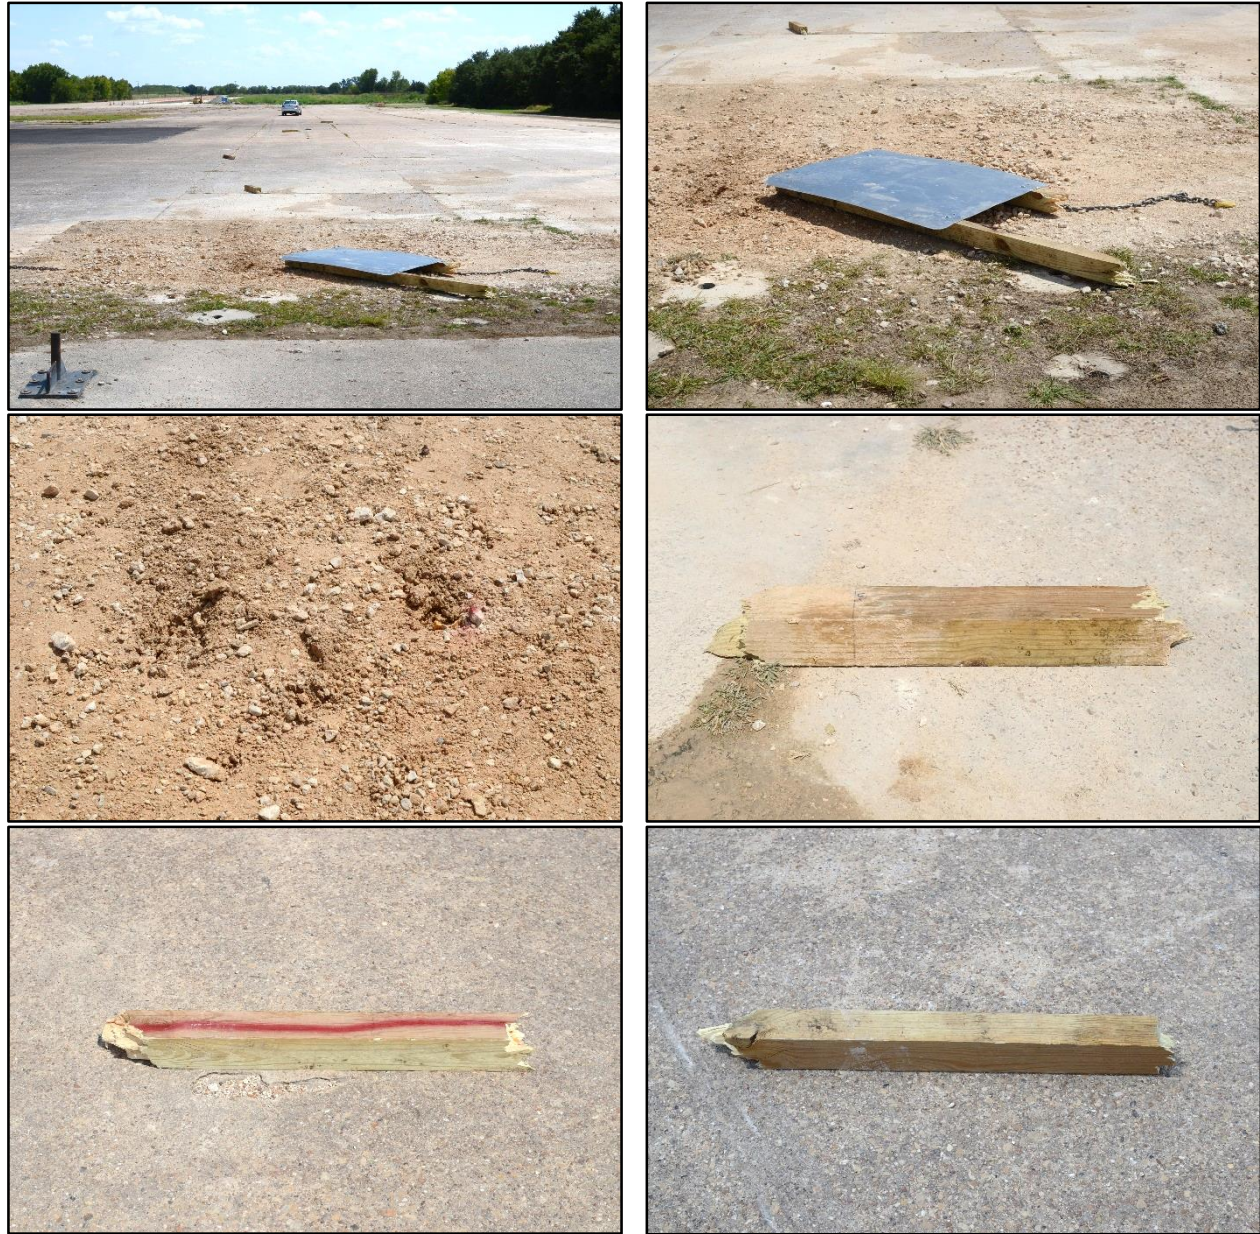
Figure 5.28. TxDOT Dual Embedded Wood Post System after Test No. 469467-6-2.

Figure 5.28 shows the damage to the TxDOT dual embedded wood sign system. The sign panel attached to an 80-inch section of the left post and a 54-inch section of the right post came to rest near impact. The left support post fractured into three pieces. An upper 80-inch long section remained attached the sign panel. A lower 24-inch long section, which included 6-inches below grade and 18 inches above grade, came to rest 25 ft downstream and 8 ft to the left of centerline. The middle 34-inch long section came to rest 121 ft downstream and 3 ft to the left of centerline. The right support post fractured into four sections. The uppermost 54-inch long section remained attached to the sign panel. The bottom 21-inch section, which included 3 inches below grade and 18 inches above grade, came to rest 55 ft downstream and 7 ft to the left of centerline. A 32-inch long section of the right post came to rest 95 ft downstream and 2 ft to the left of centerline. A 25-inch long section of the right post came to rest 175 ft downstream and 3 ft to the right of centerline.

Both support posts fractured at bumper height, and as the vehicle continued to move forward, the fractured end of the right support contacted and punctured the windshield. The TxDOT dual embedded wood post sign system did not perform acceptably for *MASH* Test 3-61 at 0° due to puncture of the windshield.
