PERFORMANCE LIMITS FOR 6-IN. (152-MM) HIGH CURBS PLACED IN ADVANCE OF THE MGS USING MASH VEHICLES PART II: FULL-SCALE CRASH TESTING

MwRSF Research Report No. TRP-03-221-09

October 30, 2009

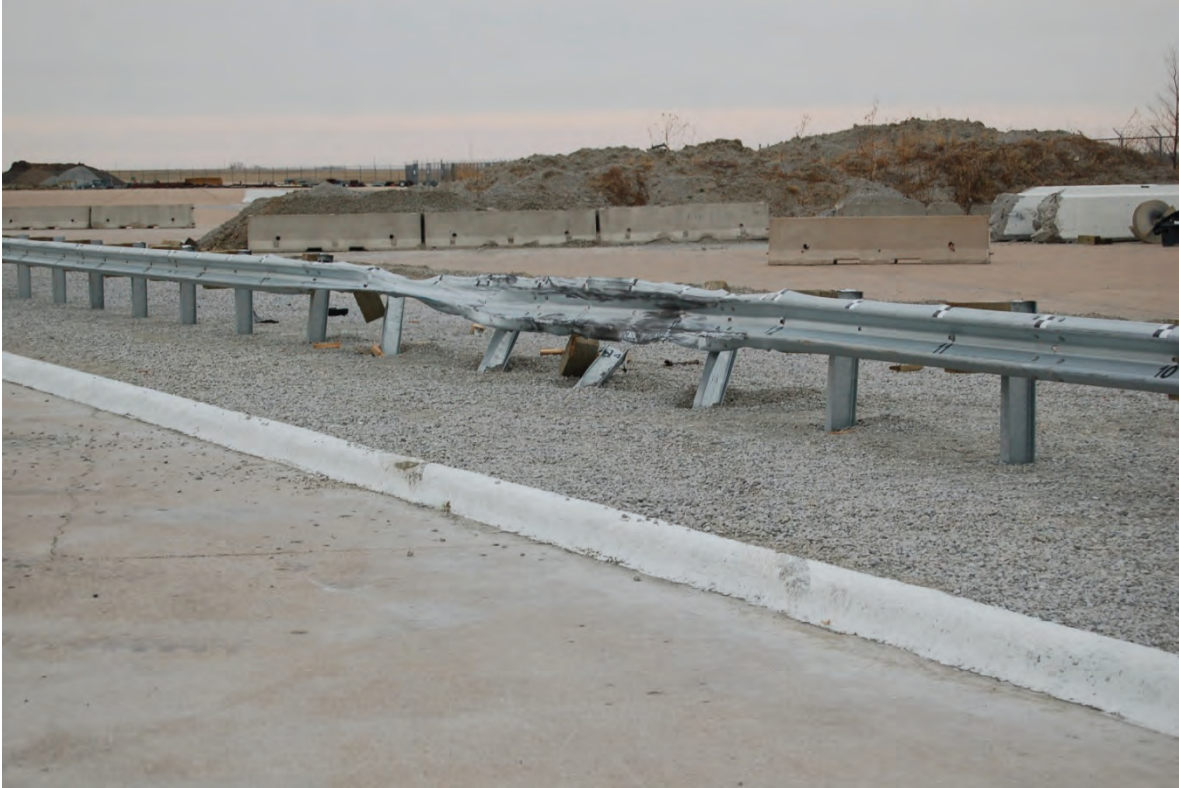
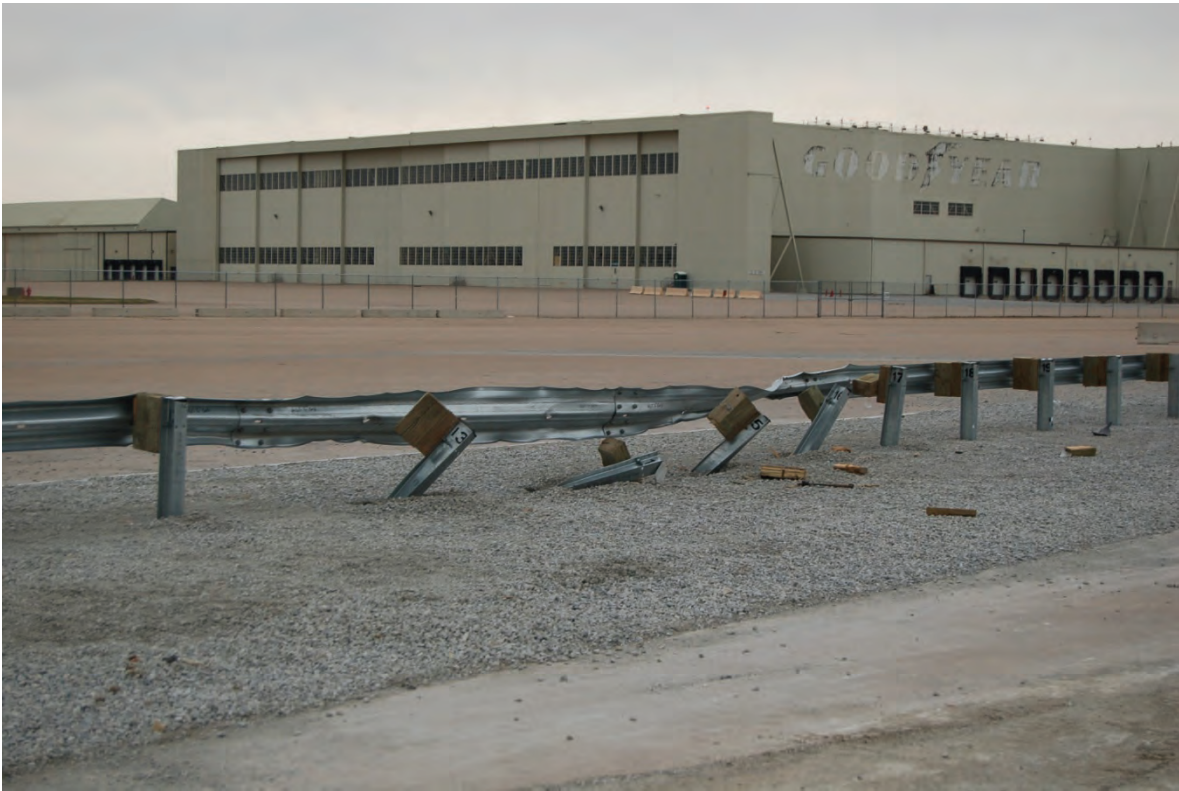
Figure 27. System Damage, Test No. MGSC-5

Damage to the barrier was moderate, as shown in Figures 27 through 38. Barrier damage consisted of deformed guardrail posts, disengaged wooden blockouts, contact marks on several sections of guardrail and the curb, and deformed W-beam rail. Five areas of contact between the vehicle and guardrail occurred, with the most substantial damage occurring at the original impact point. Three regions of light scuff marks occurred downstream of the original impact as the vehicle rolled. The final contact area occurred when the vehicle landed upside-down on the guardrail. The length of the original vehicle contact along the system was approximately 30 ft-3 in. (9.22 m), which spanned from 12 in. (305 mm) downstream of post no. 12 through the centerline of post no. 17.

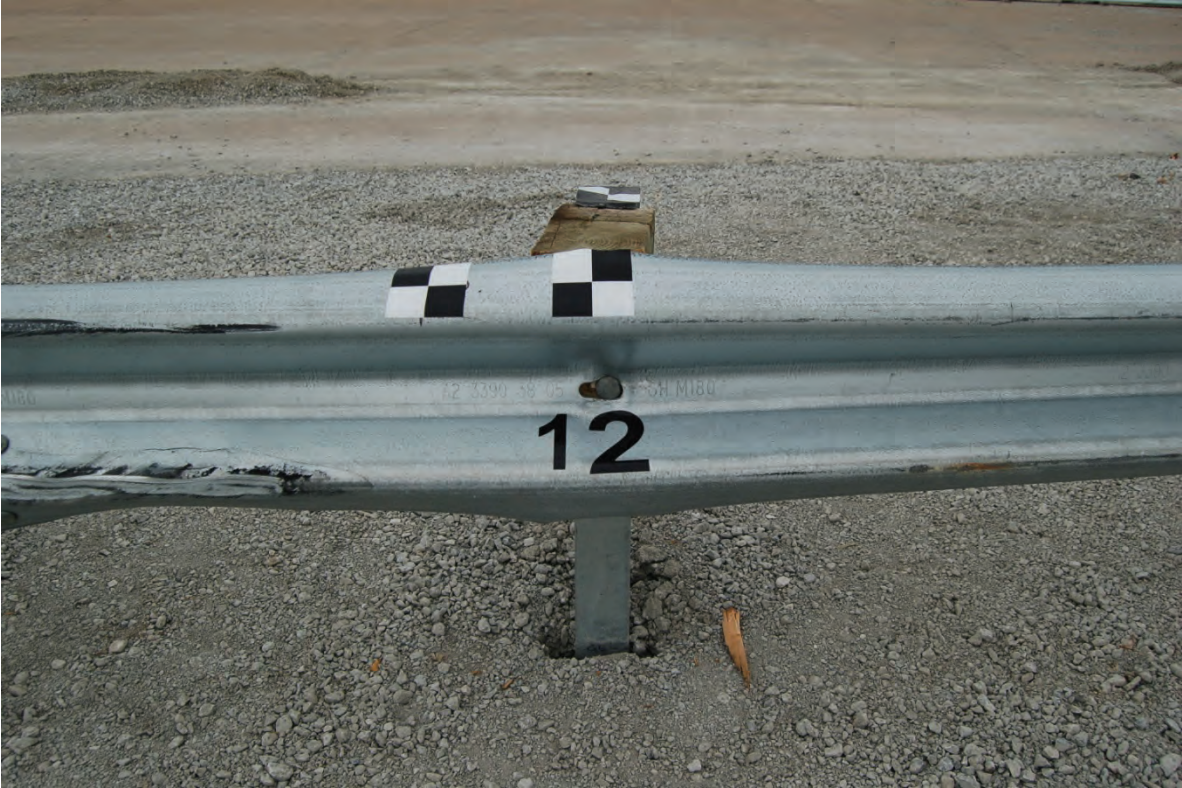
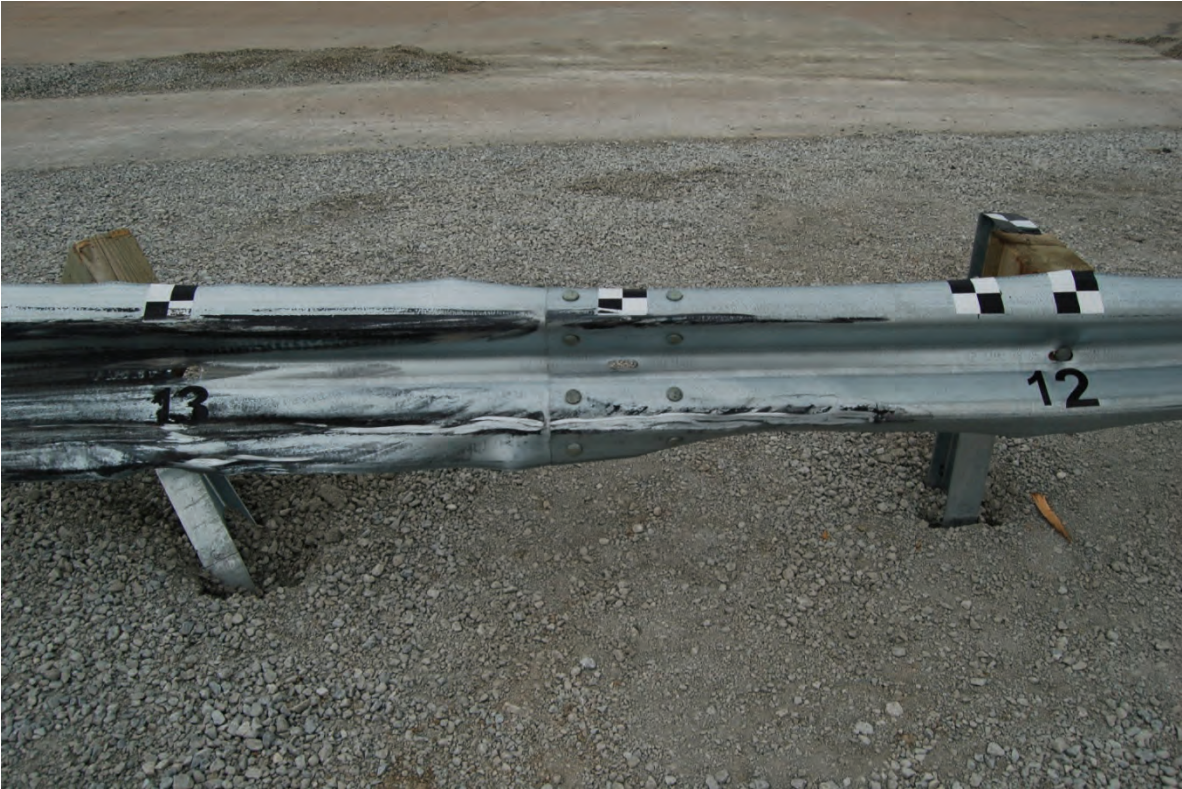
Figure 29. Rail Damage, Post Nos. 12 and 13, Test No. MGSC-5

Deformation and flattening of the W-beam guardrail occurred between post nos. 12 and 17, the primary vehicle contact region. Contact marks were visible on the guardrail beginning 12 in. (305 mm) downstream from post nos. 12 and ending at post no. 17. Additional contact marks were found on the top of the rail and included a 37-in. (940-mm) long mark beginning 25 ¾ in. (654 mm) downstream of post no. 20, a 77-in. (1,956-mm) long mark beginning 6 ½ in. (165 mm) downstream of post no. 21, an 18-in. (457-mm) long mark beginning 3 in. (76 mm) upstream of post no. 23, and a 96-in. (2,438-mm) long mark beginning 20 in. (508 mm) downstream of post no. 25.

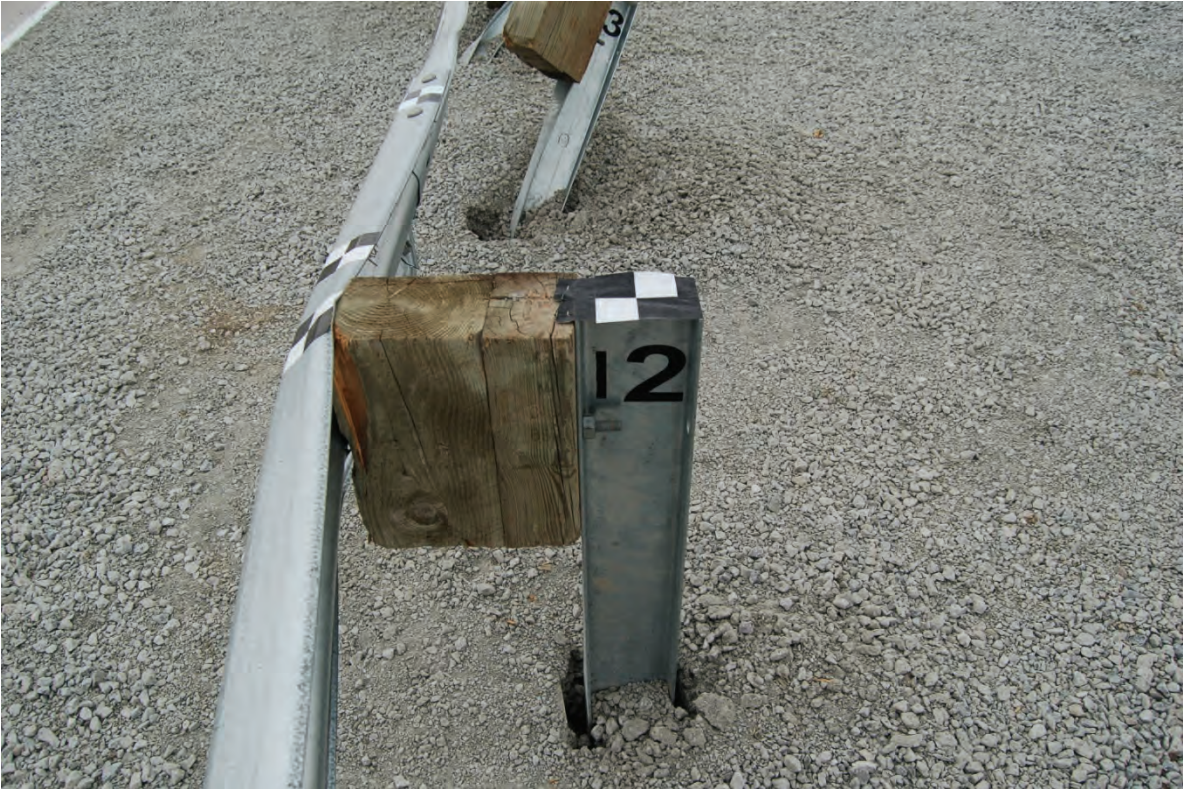
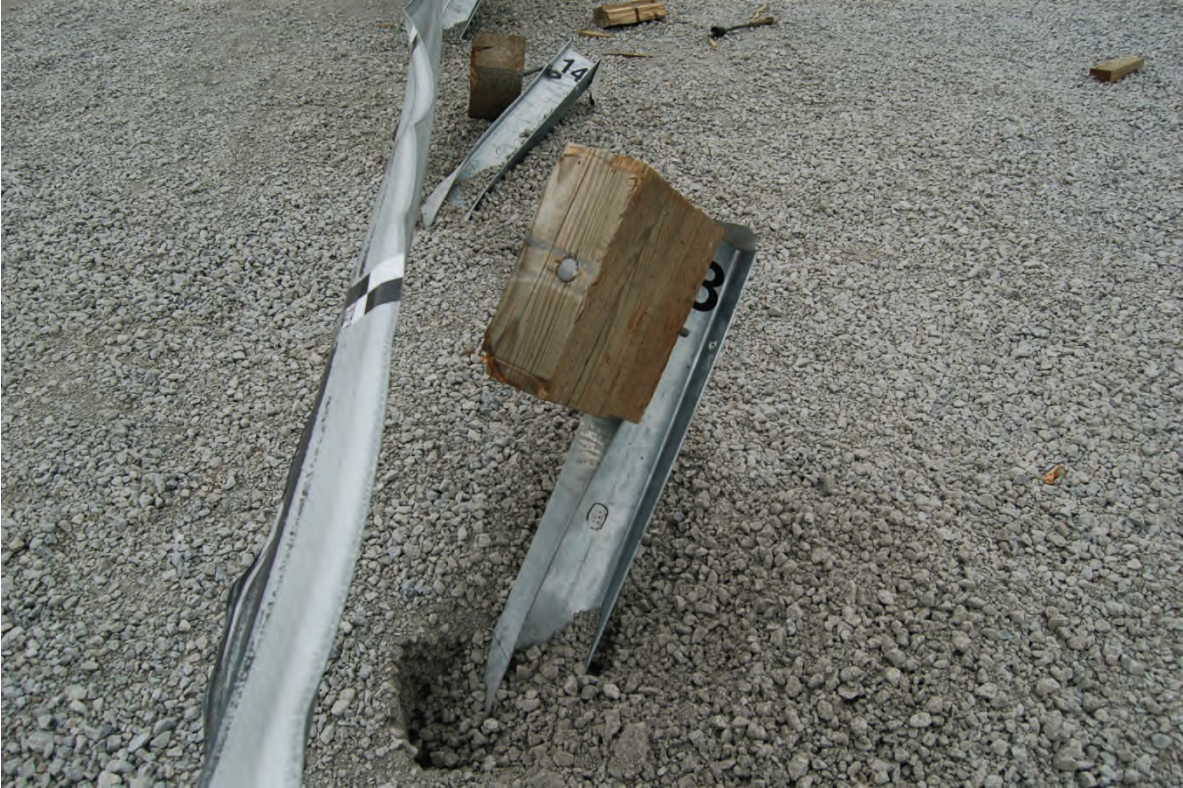
Figure 34. Post Nos. 13 and 14 Damage, Test No. MGSC-5

The blackout at post no. 13 sustained minor damage near its bottom edge due to contact with the rail. The 4-in. (102-mm) deep blackout at post no. 14 fractured and detached, while the

8-in. (203-mm) deep blockout remained attached after sustaining damage from rail contact. The blockouts at post no. 15 twisted away from the post, bending the bolt, and the 4-in. (102-mm) deep blockout sustained a small fracture at its back face. The 4-in. (102-mm) deep blockout at post no. 16 also fractured and detached, while the 8-in. (203-mm) deep blockout remained attached by the deformed guardrail bolt. The 8-in. (203-mm) deep blockout at post no. 17 twisted, but remained attached to the post. All other blockouts remained attached to the posts and undamaged.

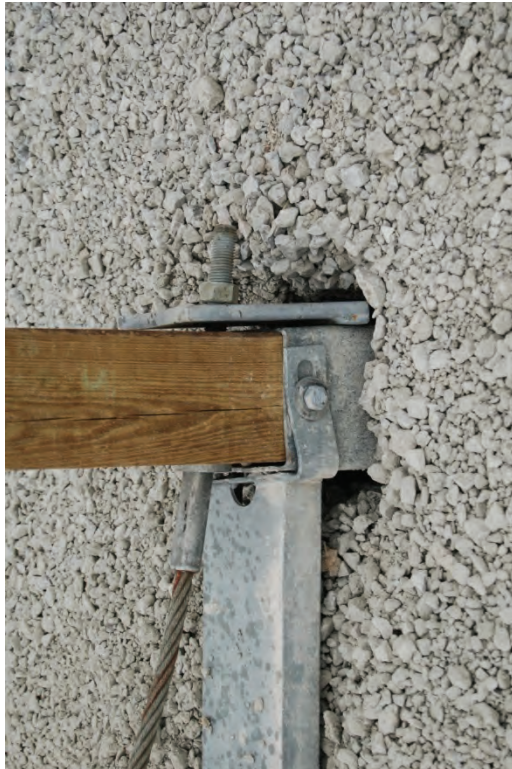
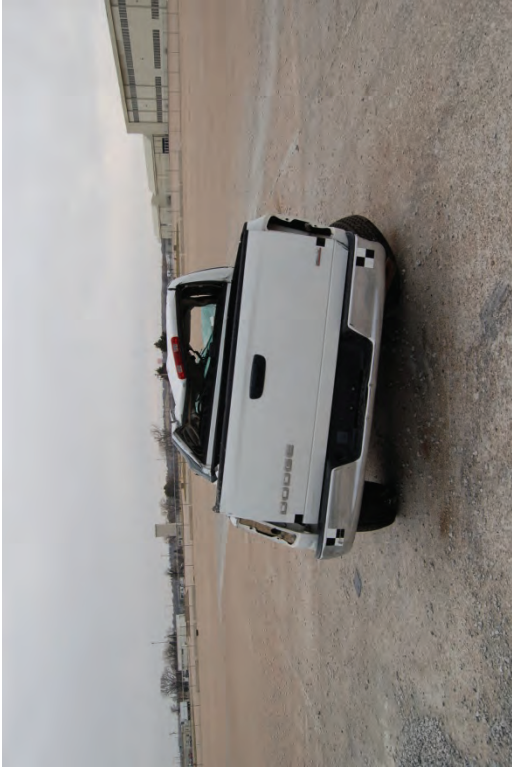
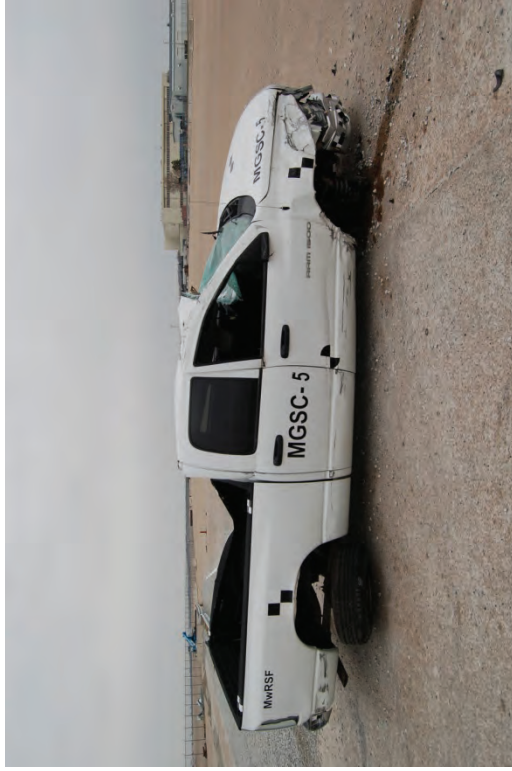
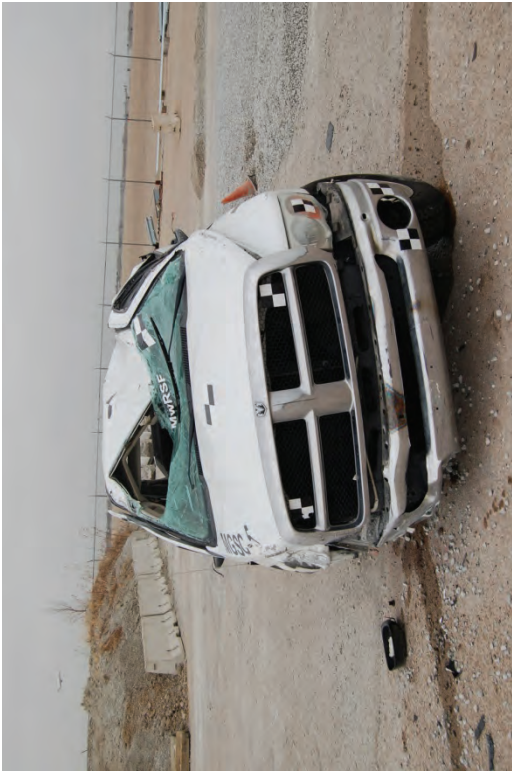
Figure 39. Vehicle Damage, Test No. MGSC-5

The damage to the vehicle was extensive, as shown in Figures 39 through 43. Occupant compartment deformations were judged to be significant to cause serious injury to vehicle occupants. Deformations to the vehicle floorboard were relatively minor, with maximum longitudinal, lateral, and vertical deflections of ¼ in. (6 mm) located throughout the right-side floorboard, ½ in. (13 mm) located along the right side of the right-side floorboard, and 2 in. (51 mm) located near the center of the vehicle's floorboard, respectively. Complete occupant compartment and vehicle deformations and the corresponding locations are provided in Appendix D.

Exterior damage was located on all portions of the vehicle. Both right-side wheel assemblies were detached from the vehicle. The right-front wheel spindle and assembly detached from the suspension control arms. The rear axle fractured at the right-rear wheel. The right-front quarter panel and bumper were deformed inward toward the engine compartment. Scrapes and gouges were found along the right-side doors and right-rear quarter panel. The right-side headlight and both rear tail lights fractured. The left side of the truck box was significantly deformed and bent away from the cab. Minor deformations occurred along the left-side doors, left-front quarter panel, and rear bumper. Both the left- and right-side mirrors disengaged from the truck. The hood and grill were slightly deformed and displaced. The roof was crushed inward, especially on the left side. The windshield was severely shattered and partially displaced. The right-front door, rear, and both left-side door window glass was fractured and removed from the vehicle. The right-rear door window glass remained undamaged.
