**Test Report No. 608431-01-1&2**  
**Test Report Date: October 2018**

**MASH TESTS 3-34 AND 3-35 ON THE 31-INCH BURIED-IN-  
BACKSLOPE TERMINAL COMPATIBLE WITH MGS GUARDRAIL**

Contract No.: T4541-CQ (1705445/C2005312.70)  
Test No.: 608431-01-1 / 608431-01-2  
Test Date: 2018-04-30 / 2018-06-01

Sponsored by  
**Roadside Safety Research Program Pooled Fund**  
**Study No. TPF-5(114)**

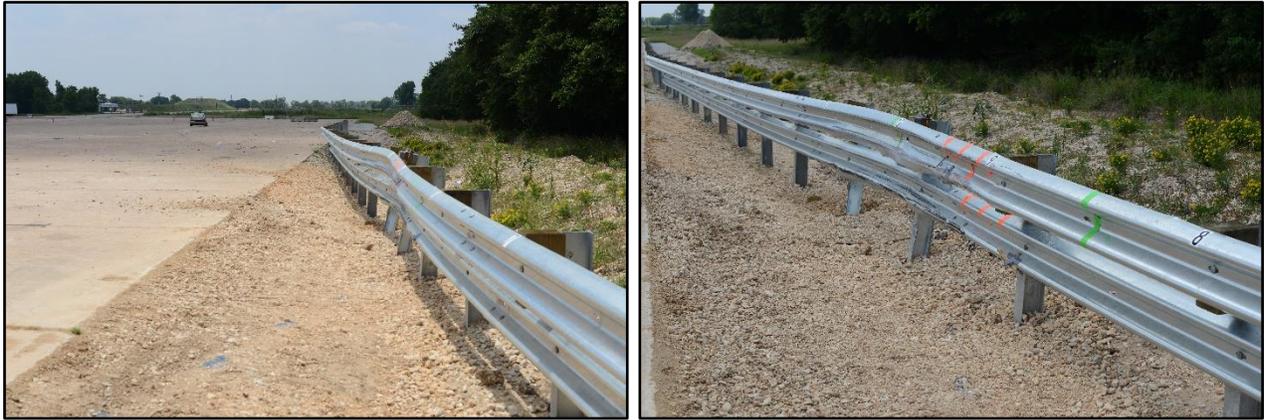
**Figure 5.3. BIB Terminal after Test No. 608431-01-2.**

Figures 5.3 through 5.5 show the damage to the BIB Terminal, and Table 5.2 lists damage. Working width was 25.3 inches at a height of 32.0 inches. Maximum dynamic deflection during the test was 19.9 inches, and maximum permanent deformation was 5.5 inches.

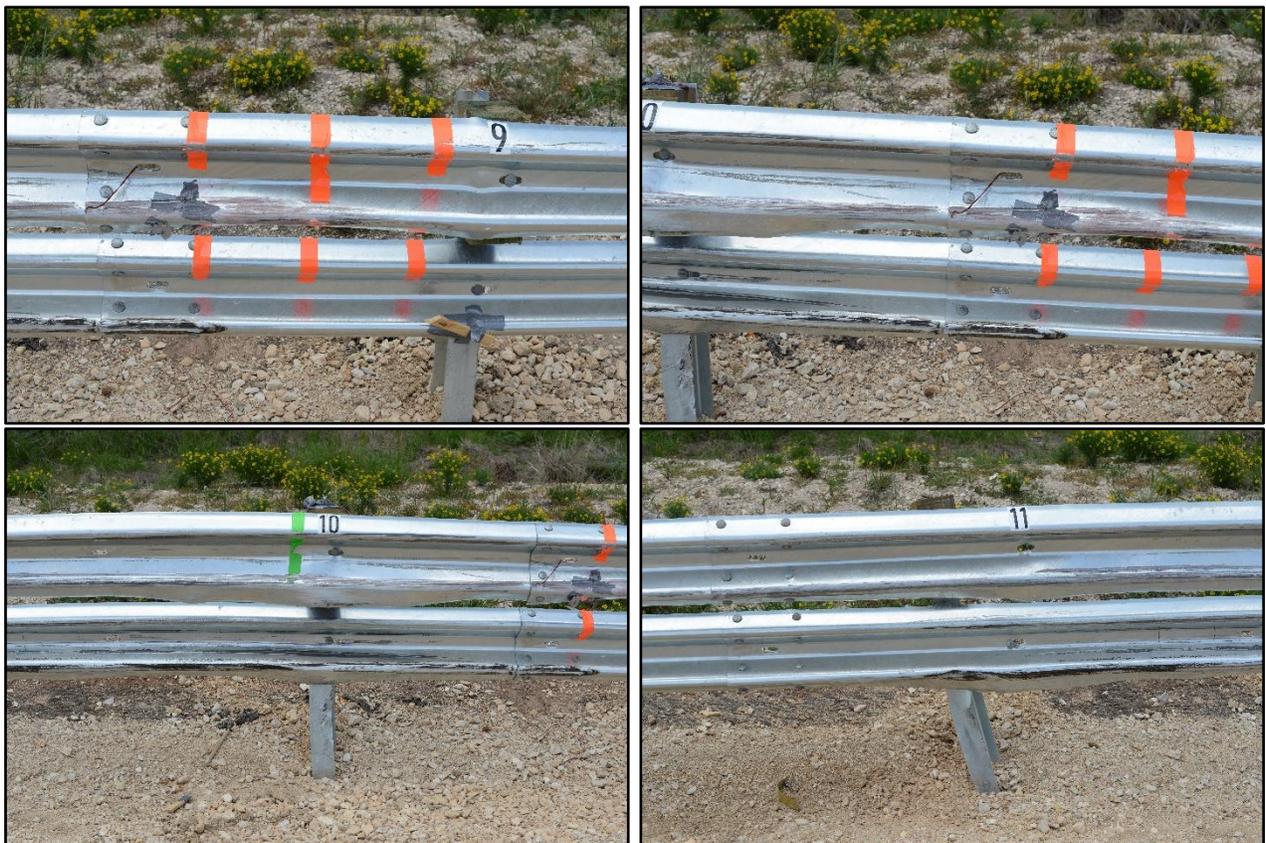
**Figure 5.4. Posts 9 through 11 after Test No. 608431-01-2.**

<b>POST NO.</b>	<b>DAMAGE</b>
1-7	No noticeable damage
8	Soil around post disturbed
9	1.5 inch gap on traffic side; 0.4 inch gap on field side; leaning 86° toward field side
10	3.0 inch gap traffic side; 1.25 inch gap field side; post leaning 79° toward field side
11	4.5 inch gap traffic side; leaning 75° toward field side & 80° downstream; rail released from blockout; rubrail bolt tore through flange
12	0.75 inch gap on traffic side; 0.5 inch gap on field side; leaning 86° toward field side
13	0.25 inch gap on traffic side; 0.5 inch gap on field side; leaning 89° toward field side
14-40	No damage

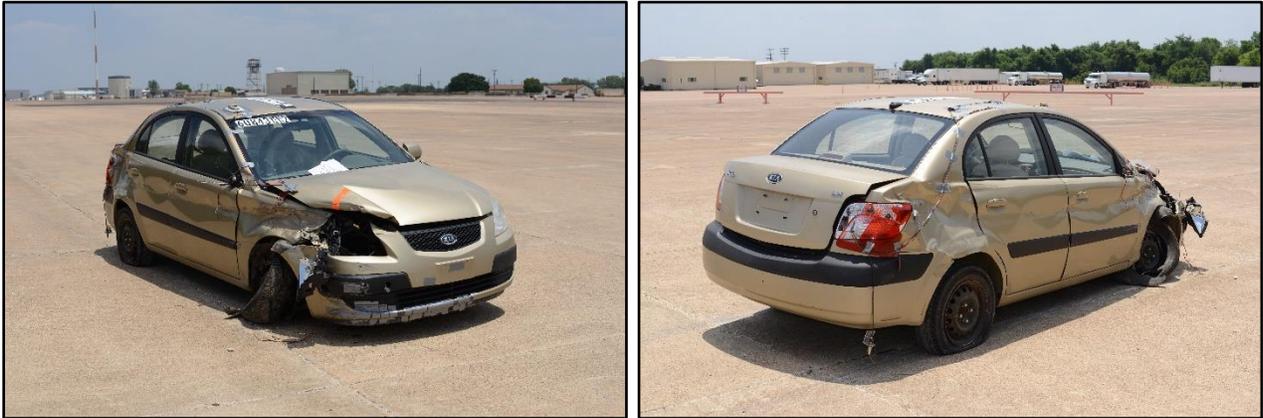
**Figure 5.6. Test Vehicle after Test No. 608431-01-2.**

Figure 5.6 shows the damage sustained by the vehicle. The front bumper, hood, right front fender, right front tire and rim, right front strut, right front and rear doors, right rear tire, right rear quarter panel, and rear bumper were damaged. The windshield sustained stress cracking at the right lower corner. Maximum exterior crush to the vehicle was 8.0 inches in the

side plane at the right front corner at bumper height. No occupant compartment deformation or intrusion was noted. Figure 5.7 shows the interior of the vehicle. Tables C.2 and C.3 in Appendix C1 provide exterior crush and occupant compartment measurements.

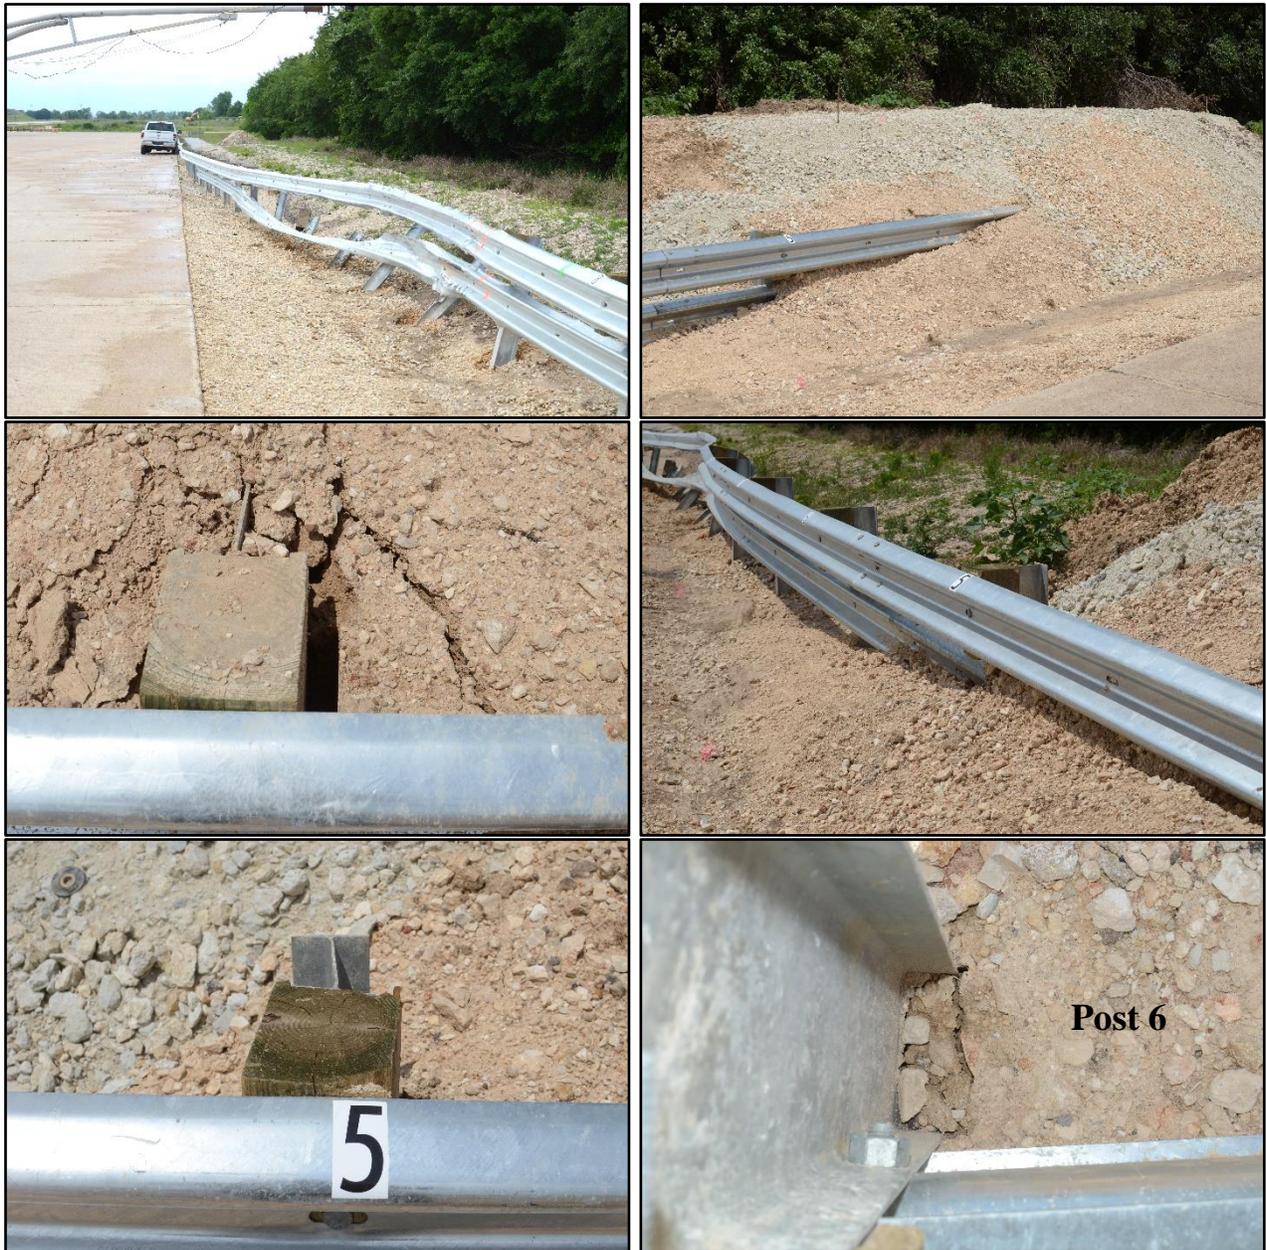
**Figure 6.3. BIB Terminal after Test No. 608431-01-1.**

Figures 6.3 through 6.5 show damage to the BIB Terminal, and Table 6.2 lists damage. Working width was 62.7 inches at a height of 54.7 inches. Maximum dynamic deflection during the test was 51.4 inches.

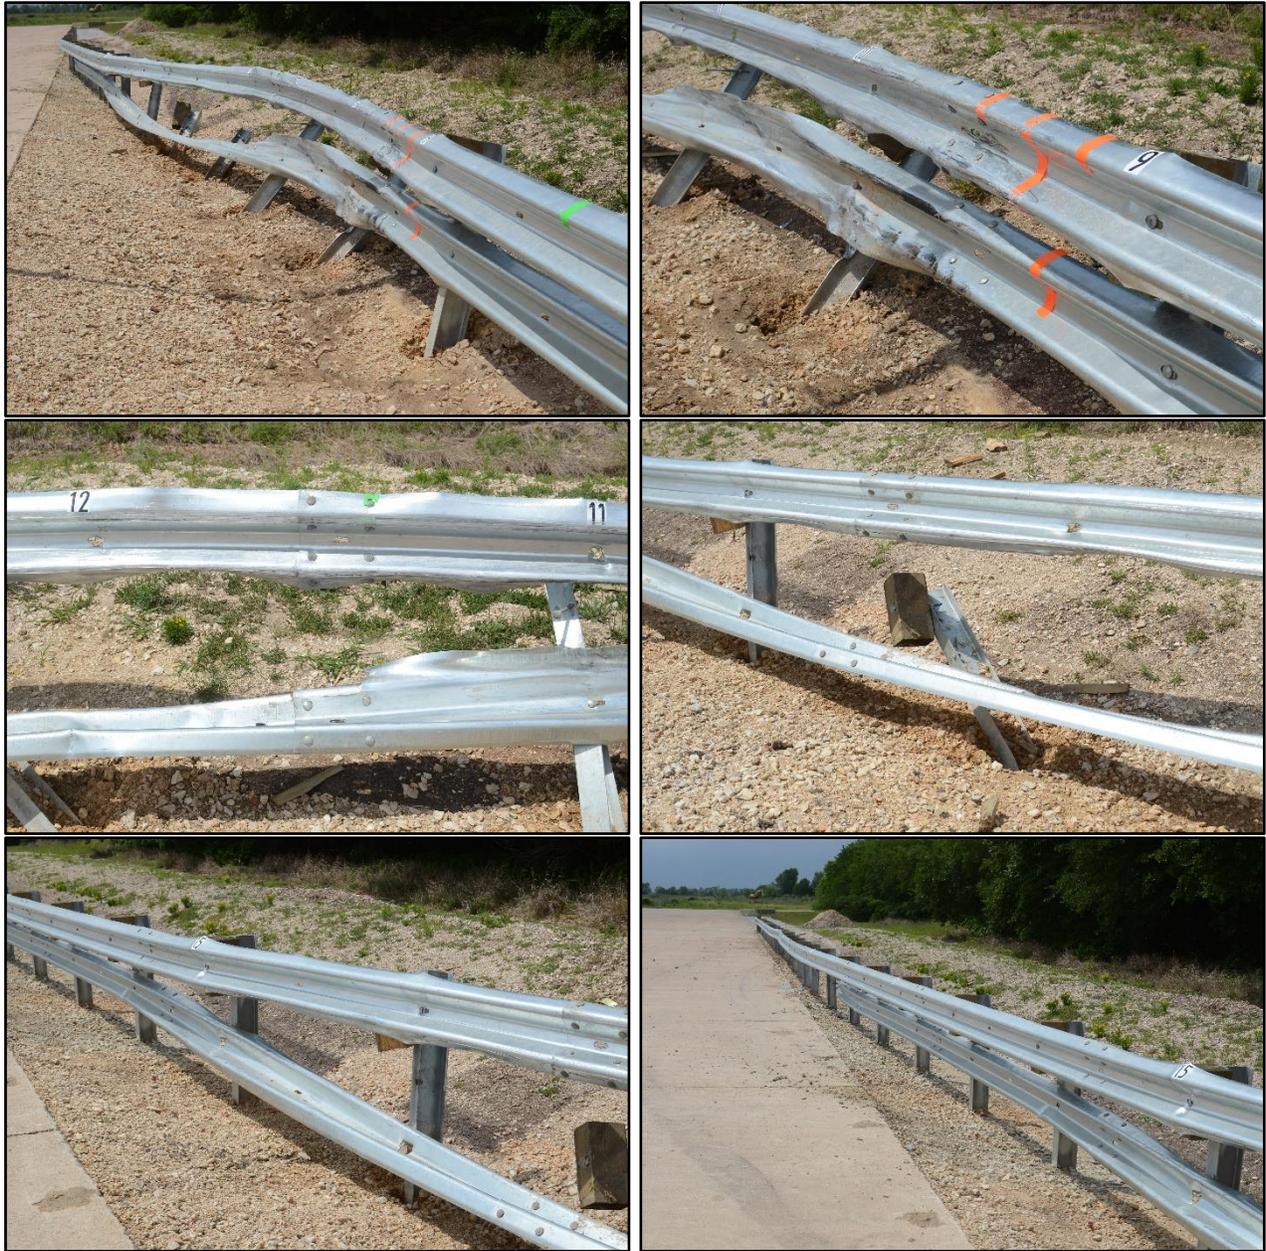
**Figure 6.4. Damage at Posts 9 through 15 after Test No. 608431-01-1.**

<b>POST NO.</b>	<b>DAMAGE</b>
1-4	No noticeable damage
5	Soil disturbed; 0.25 inch gap on downstream side; blockout rotated 5°
6	Soil disturbed
7	Soil disturbed; 0.25 inch gap on traffic side; post leaning 89° toward field side
8	1.5 inch gap traffic side; 0.5 inch gap field side; 85° toward field side
9	5.0 inch gap traffic side; 2.0 inch gap field side; post leaning 75° toward field side
10	Post released from both rail elements; post leaning 50° toward field side
11	Post released from top rail element; post leaning 48° toward field side
--	4.5-inch tear in rub rail at joint between posts 11 and 12
12	Post released from both rail elements; post leaning 85° toward field side / 45° downstream
13	Post released from both rail elements; post leaning 85° toward field side / 45° downstream
14	Post released from both rail elements; post leaning 75° toward field side / 74° downstream
15	Post released from rub rail; 1.0 inch gap on traffic side; post leaning 88° toward field side

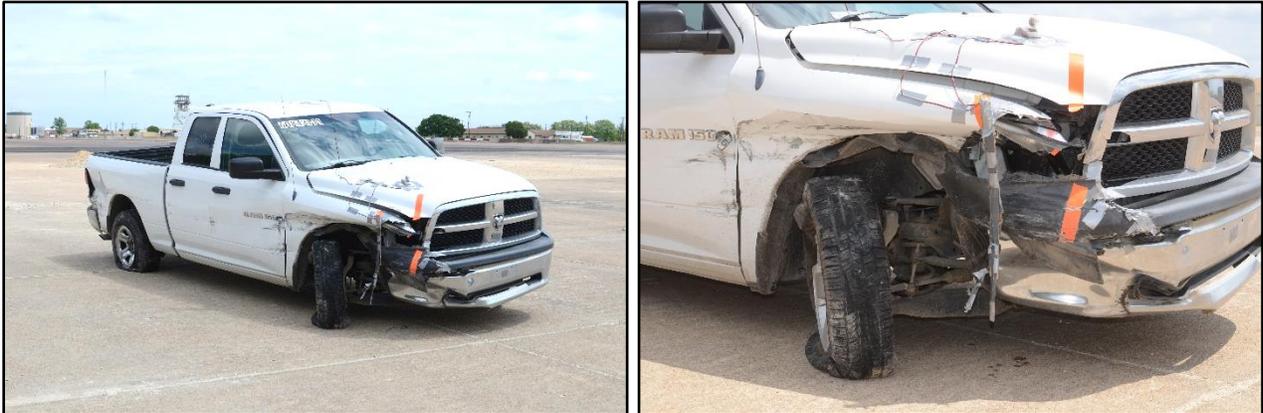
**Figure 6.6. Test Vehicle after Test No. 608431-01-1.**

Figure 6.6 shows the damage sustained by the vehicle. The front bumper grill, right front tire and rim, right front and rear doors, rear exterior bed, right rear tire and rim, and rear bumper were damaged. Maximum exterior crush to the vehicle was 10.0 inches in the front plane at the right front corner at bumper height. No occupant compartment deformation or intrusion was noted. Figure 6.7 shows the interior of the vehicle. Tables D.3 and D.4D.4 in Appendix D1 provide exterior crush and occupant compartment measurements.
