Test Report No. 608551-01-1-5

Test Report Date: April 2019

***MASH TL-3 EVALUATION OF 31-INCH W-BEAM GUARDRAIL
WITH WOOD AND STEEL POSTS IN CONCRETE MOW STRIP***

Contract No.: T4541-CS

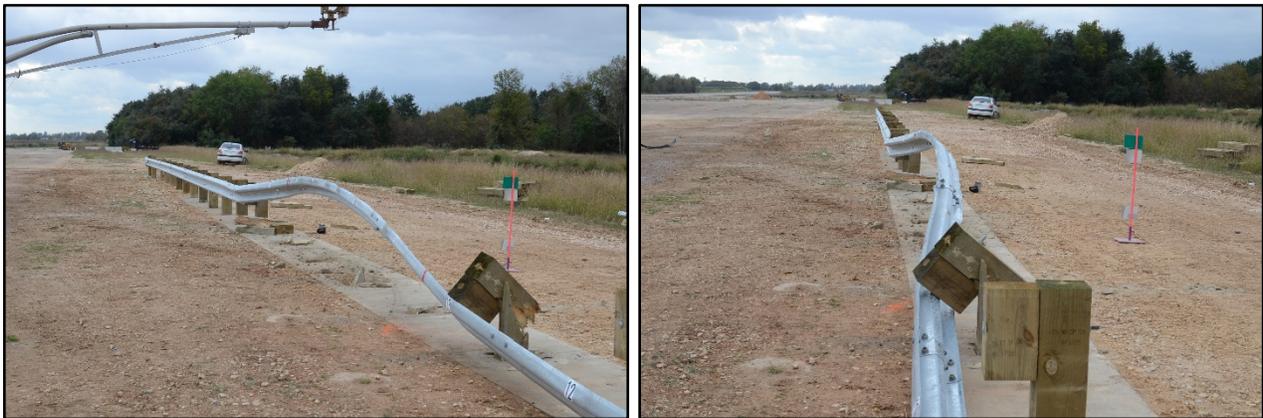
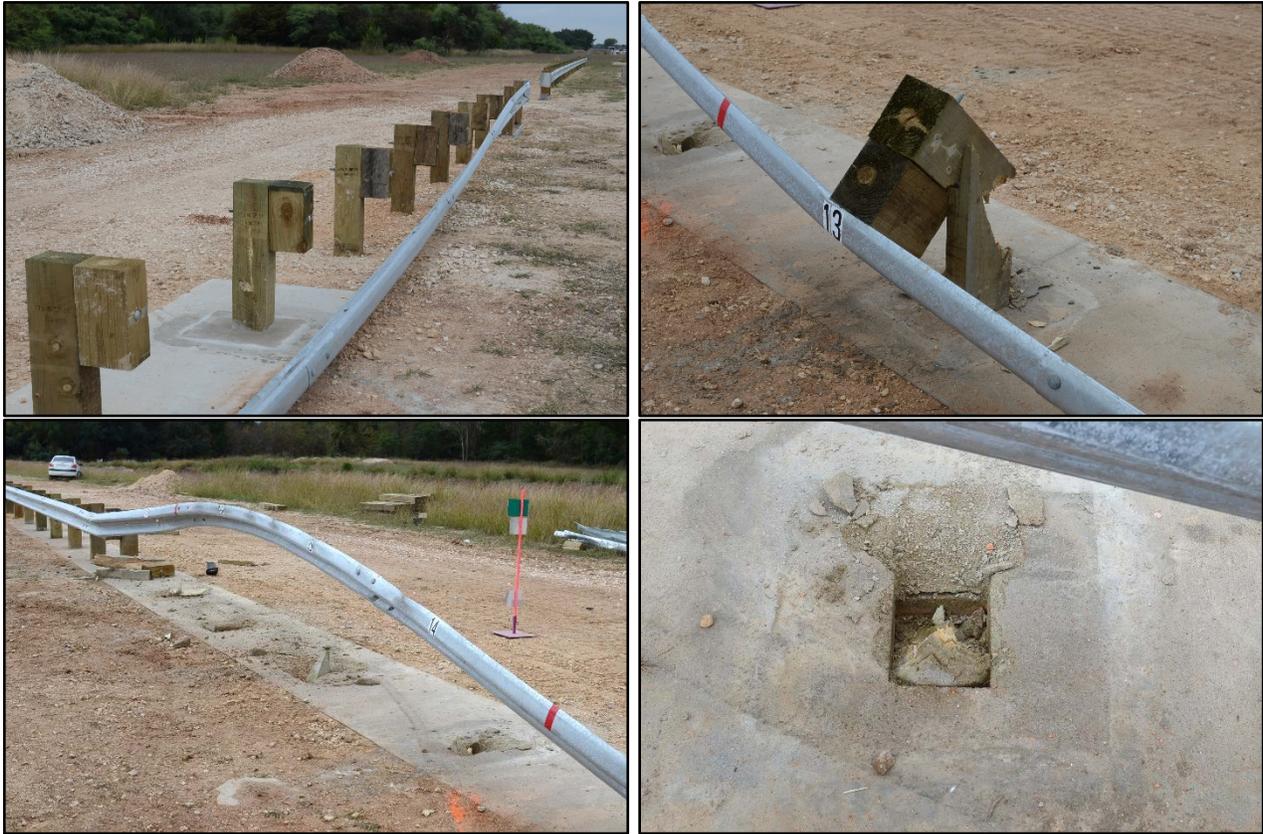
Figures 4.5 and 4.6 show the damage to the guardrail. Post 1 was pulled downstream 1.0 inch and post 2 was pulled downstream 0.25 inch at ground level. The rail element released from posts 3 through 19, and the blockouts remained attached to the top of fractured posts 10 and 13. Post 10 split through the bolt holes, post 13 broke off above grade, and posts 14-17 broke off at grade. Post 30 was pulled upstream 0.38 inch at ground level. Working width was 45.8

Figure 4.5. Guardrail in Mow Strip/Test Vehicle after Test No. 608551-1.

Figure 4.6. Guardrail in Mow Strip after Test No. 608551-1.

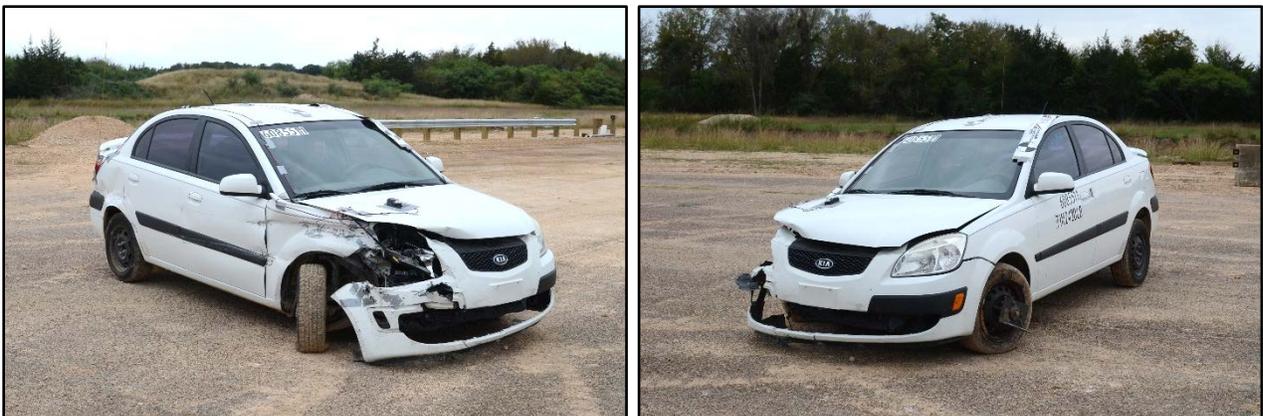
Figure 4.7 shows the damage sustained by the vehicle. The front bumper, hood, right front fender, right front tire and rim, right front and rear doors, right rear quarter panel, and the rear bumper were damaged. Maximum exterior crush to the vehicle was 10.0 inches in the side plane at the right front corner at bumper height. No occupant compartment deformation or intrusion occurred. Figure 4.8 shows the interior of the vehicle. Tables D.2 and D.3 in Appendix D1 provide exterior crush and occupant compartment measurements.

Figure 4.7. Test Vehicle after Test No. 608551-1.

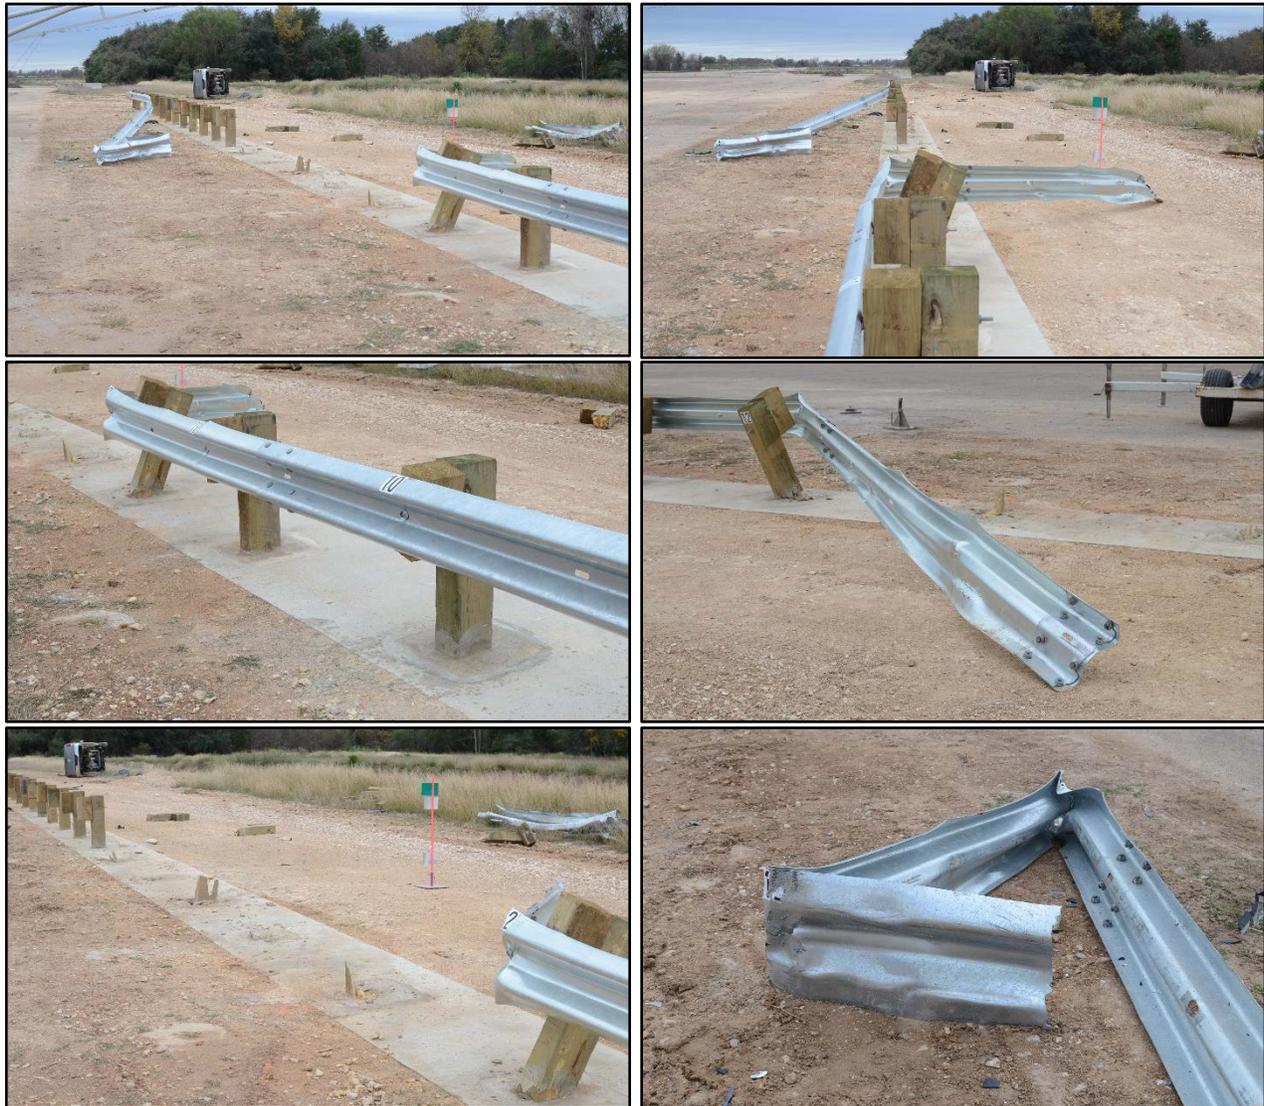
Figure 4.12 shows the damage to the guardrail. No movement was noted at post 1, and post 2 was pulled downstream 0.25 inch at ground level. Post 12 was partially fractured at ground level and was leaning 68° toward the field side. The rail element released from posts 12 through 25, and posts 13 through 17 fractured at ground level. The rail element ruptured at the downstream side of the joint between posts 14 and 15.

Figure 4.12. Guardrail in Mow Strip after Test No. 608551-2.

The 31-inch W-beam Guardrail System on wood posts in concrete mow strip performed acceptably for *MASH* Test 3-10. However, during *MASH* Test 3-11, the W-beam rail element ruptured, allowing the 2270P vehicle to penetrate the installation. The 31-inch W-beam Guardrail System on wood posts in concrete mow strip did not perform acceptably for *MASH* TL-3 longitudinal barriers.

Subsequent to the failure of the W-beam Guardrail System on wood posts in concrete mow strip in *MASH* Test 3-11 as described above, a decision was made to perform *MASH* Test 3-11 on a wood post system with reduced post embedment. This installation and test are described in Chapter 5.

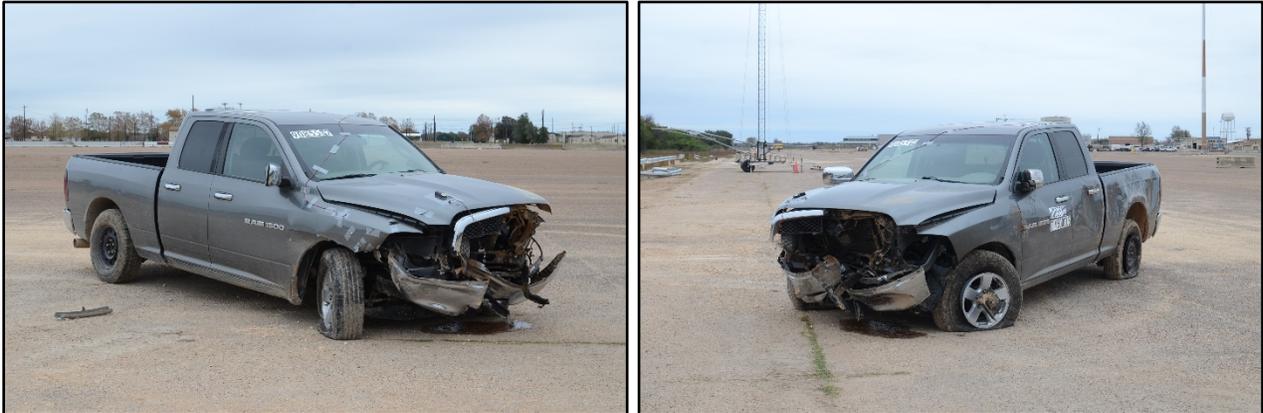
Figure 4.13 shows the damage sustained by the vehicle. The front bumper, grill, radiator, left front fender, left front and rear doors, left rear exterior bed, right front fender, and right front tire were damaged. Maximum exterior crush to the vehicle was 24.0 inches in the front plane at the right front quarter point at bumper height. No occupant compartment deformation or intrusion was noted. Figure 4.14 shows the interior of the vehicle. Tables E.3 and E.4 in Appendix E1 provide exterior crush and occupant compartment measurements.

Figure 4.13. Test Vehicle after Test No. 608551-2.

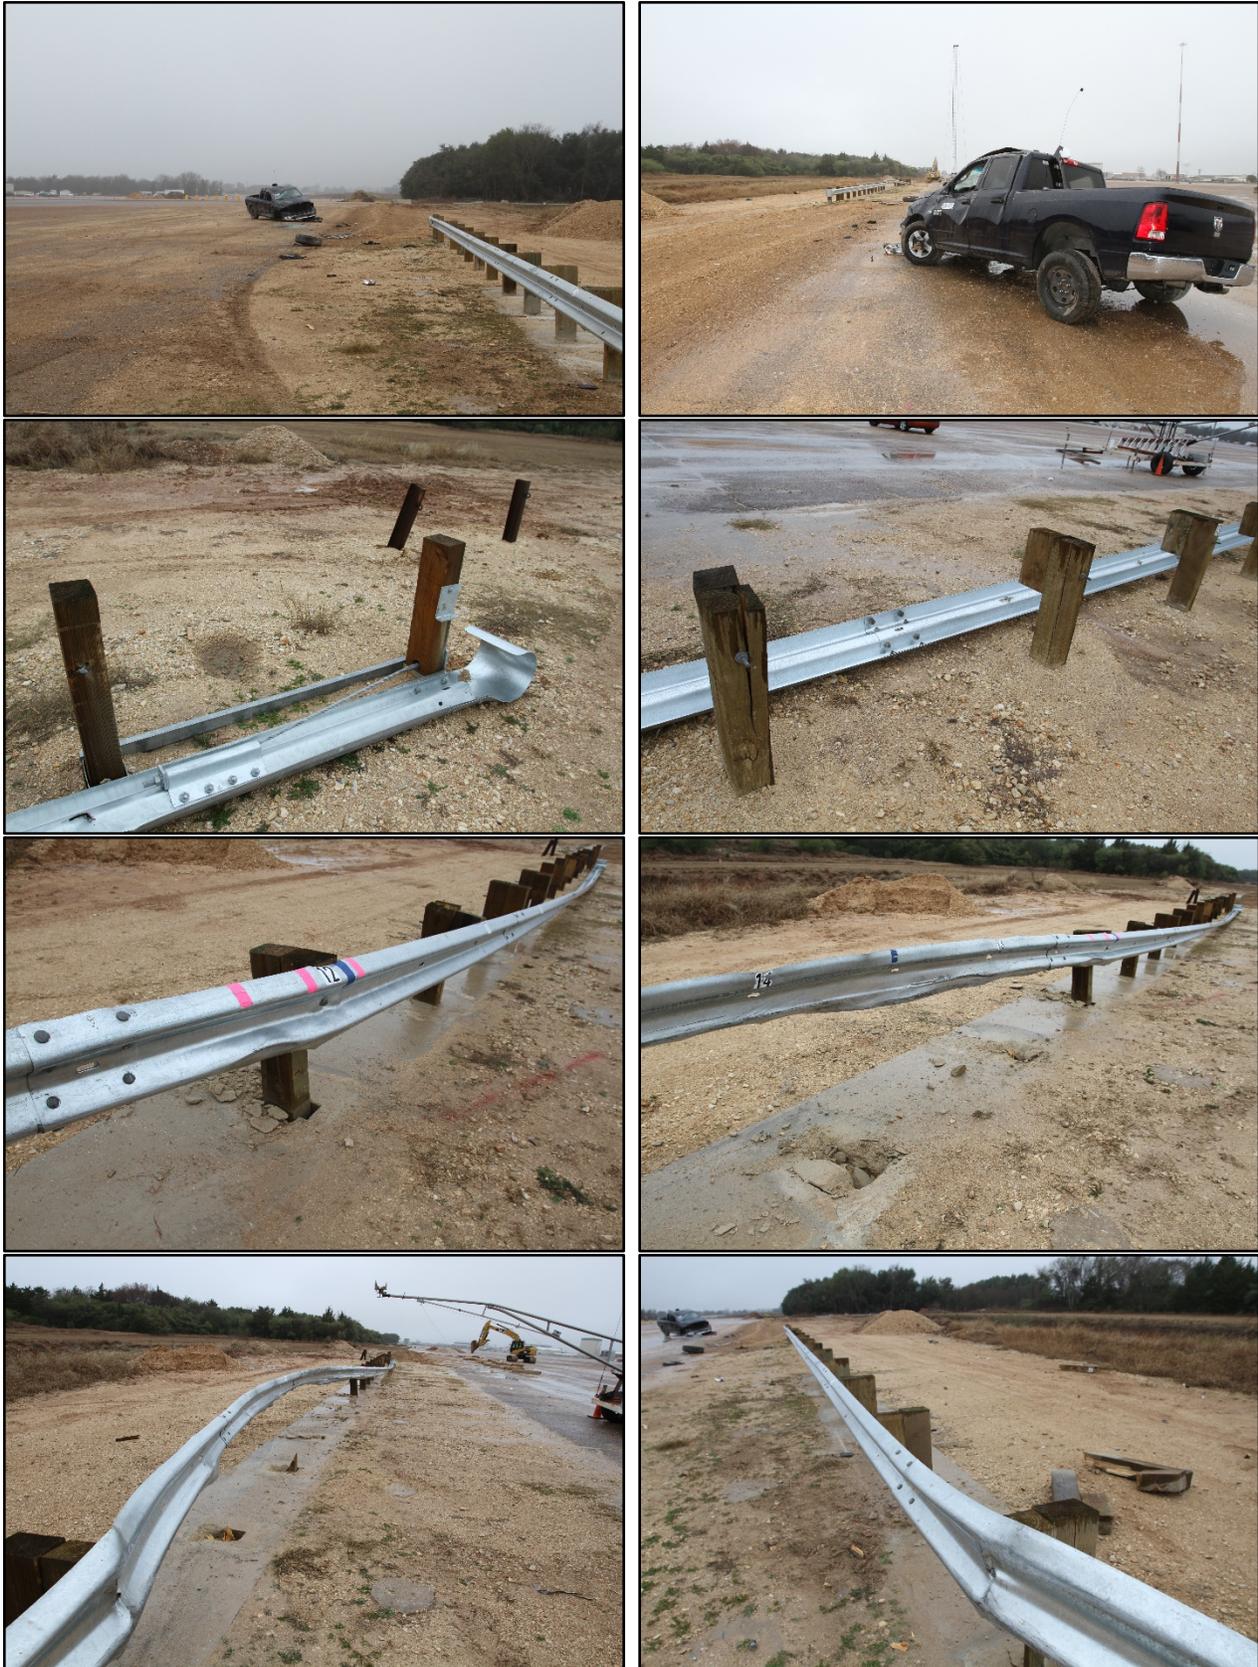
Figure 5.5 shows the damage to the guardrail. Post 1 was pulled downstream 1.0 inch. The rail element released from posts 1 through 10, 13 through 17, and 19. Post 11 split through the bolt holes. Post 12 was leaning toward the field side at 82°. Posts 13-17 broke off at grade. There were gaps of 0.25 inch on the traffic side, 0.5 inch on the downstream side, and 1.5 inch on the field side of post 18. The soil was slightly disturbed at post 30. Posts 13 to 19 came to rest 6 to 30 feet behind rail. Working width was 55.7 inches, and height of working width was 53.0 inches. Maximum dynamic deflection during the test was 49.3 inches, and maximum permanent deformation was 35.0 inches.

Figure 5.5. Guardrail in Mow Strip after Test No. 608551-5.

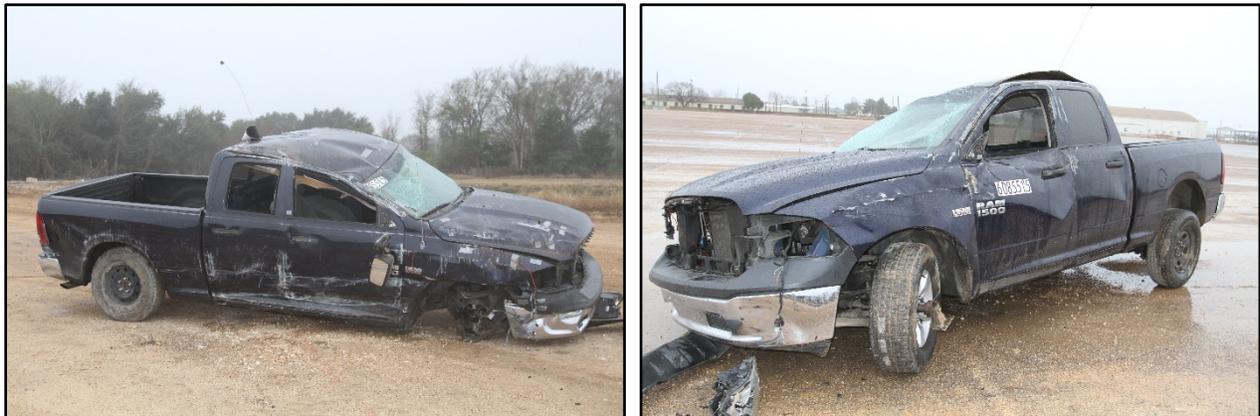
Figure 5.6 shows the damage sustained by the vehicle. The front bumper, hood, grill, upper and lower A-arms, upper and lower ball joint mounts, right front fender, right front tire and rim, right front door and window glass, right rear door, and right rear exterior bed were damaged in the initial impact. After losing contact with the guardrail, the vehicle rolled clockwise 360°, thereby damaging the roof, windshield, left front fender, left front and rear doors, left front door window glass, left rear exterior bed, right A and B posts, and right rear door window glass. Maximum exterior crush to the vehicle was 8.0 inches in the front and side planes at the right front corner at bumper height. Maximum occupant compartment deformation was 12.0 inches in the right front passenger roof area. Figure 5.7 shows the interior of the vehicle. Tables F.2 and F.3 in Appendix F1 provide exterior crush and occupant compartment measurements.

Figure 5.6. Test Vehicle after Test No. 608551-5.

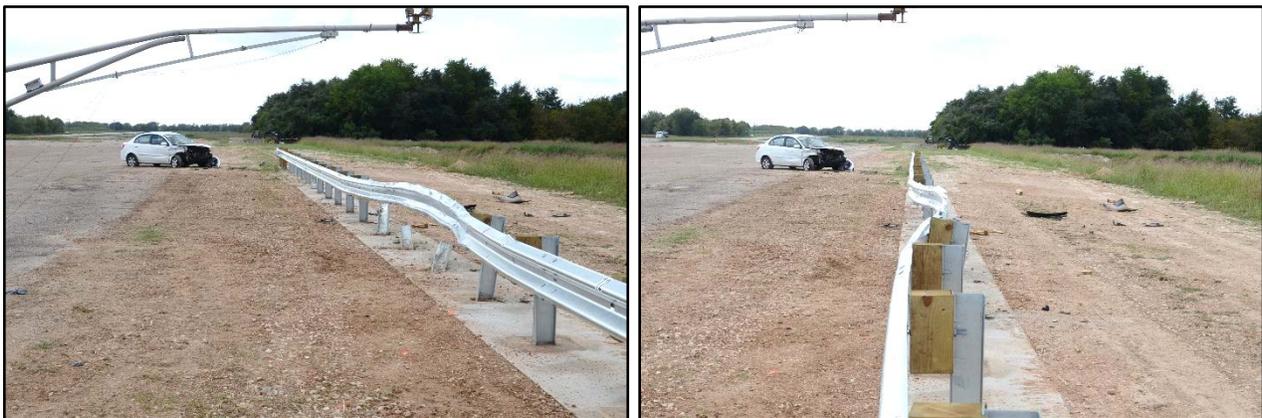
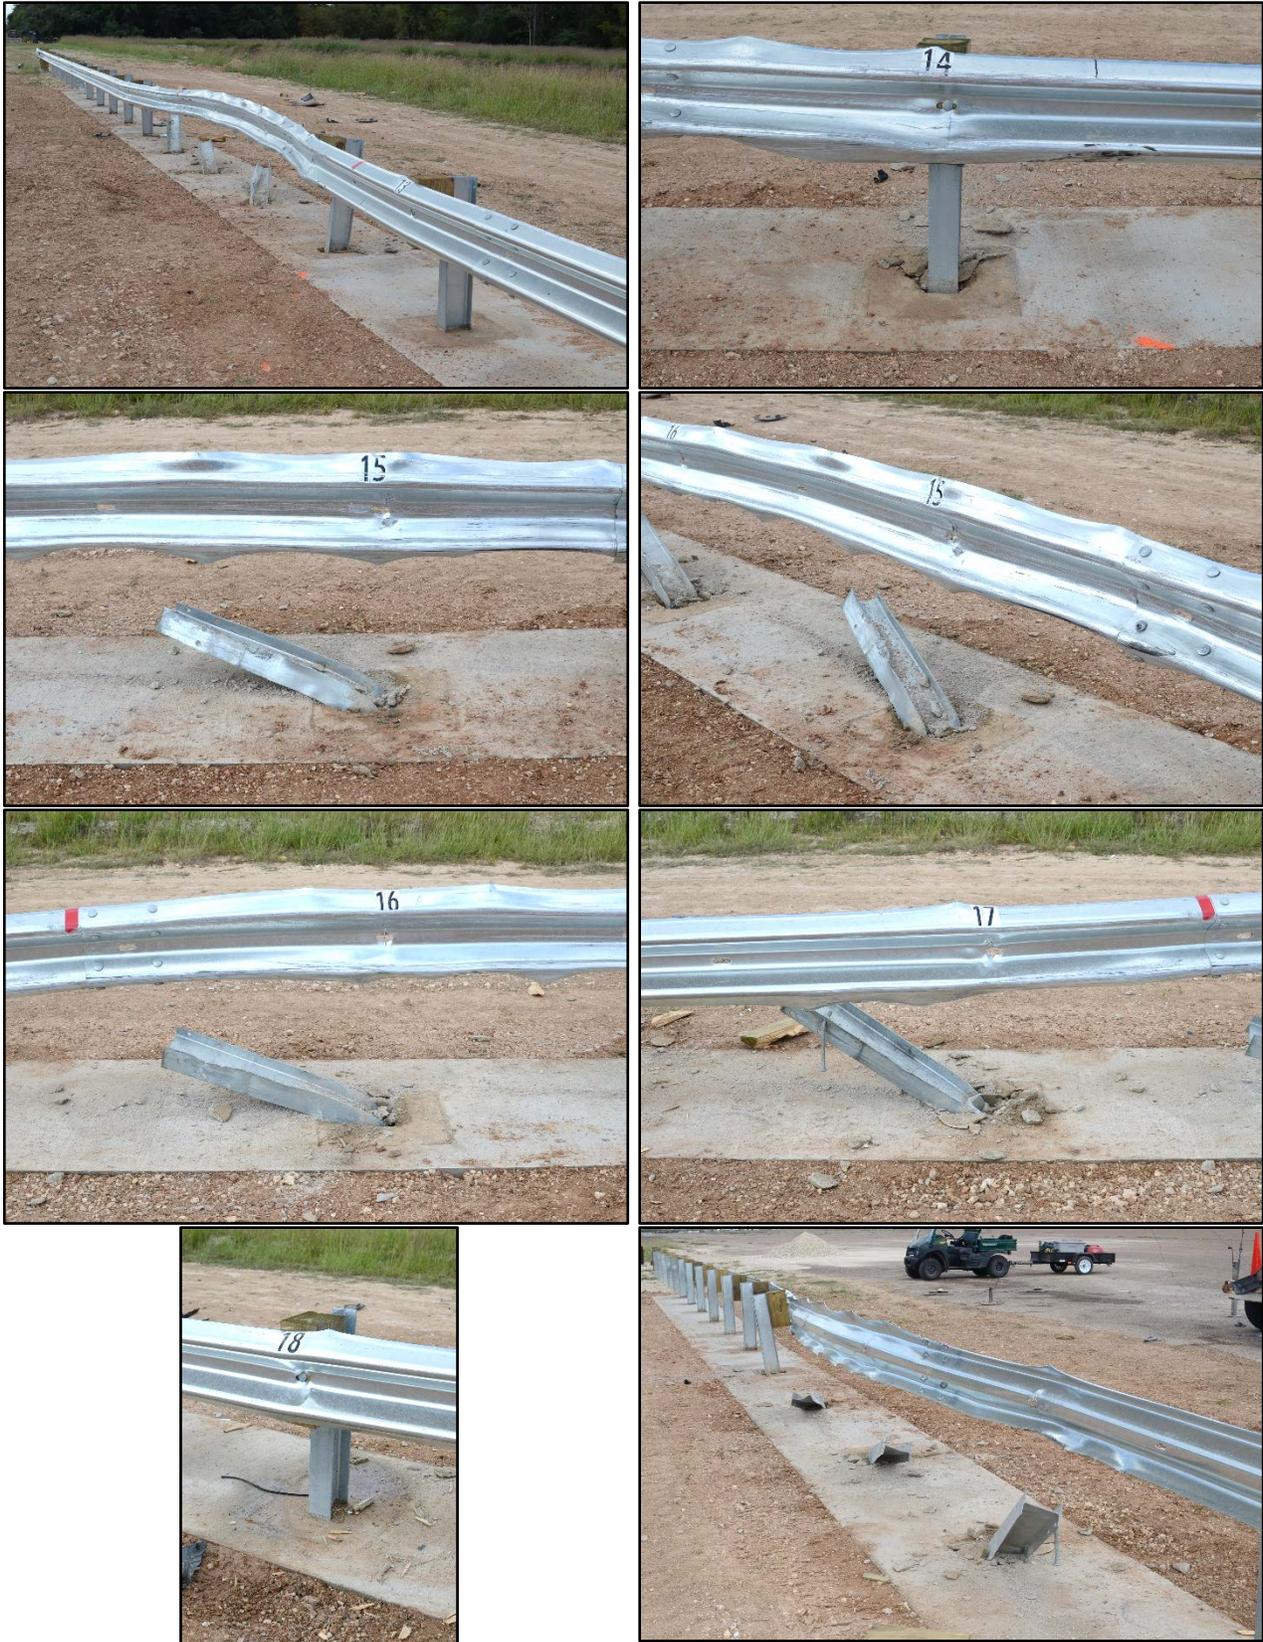
Figures 6.5 and 6.6 show the damage to the guardrail. No damage or movement was noted for posts 1 through 11. The rail element separated from post 12 and posts 15-18. Blockouts were missing from posts 15-17, and were in pieces scattered toward the field side of the installation. Post 14 deflected through the grout 2.5 inches and was leaning 82° toward the field side. Post 15 deflected through the grout 1.5 inches and was leaning downstream at 15°. Post 16 deflected through the grout 2.0 inches and was leaning downstream at 15°. Post 17 deflected through the grout 0.7 inch and was leaning downstream at 32°. No damage or movement was noted from post 18 through to the end of the guardrail. Working width was 30.7 inches, and height of working width was 45.8 inches. Maximum dynamic deflection during the test was 27.4 inches, and maximum permanent deformation was 17.0 inches.

Figure 6.5. Guardrail after Test No. 608551-3.

Figure 6.6. Posts 15-18 after Test No. 608551-3.
