Research Project Number 20180380-01-NEB

FULL-SCALE CRASH TEST OF A TWO-BAR METAL BRIDGE RAIL

MwRSF Research Report No. TRP-03-419-19

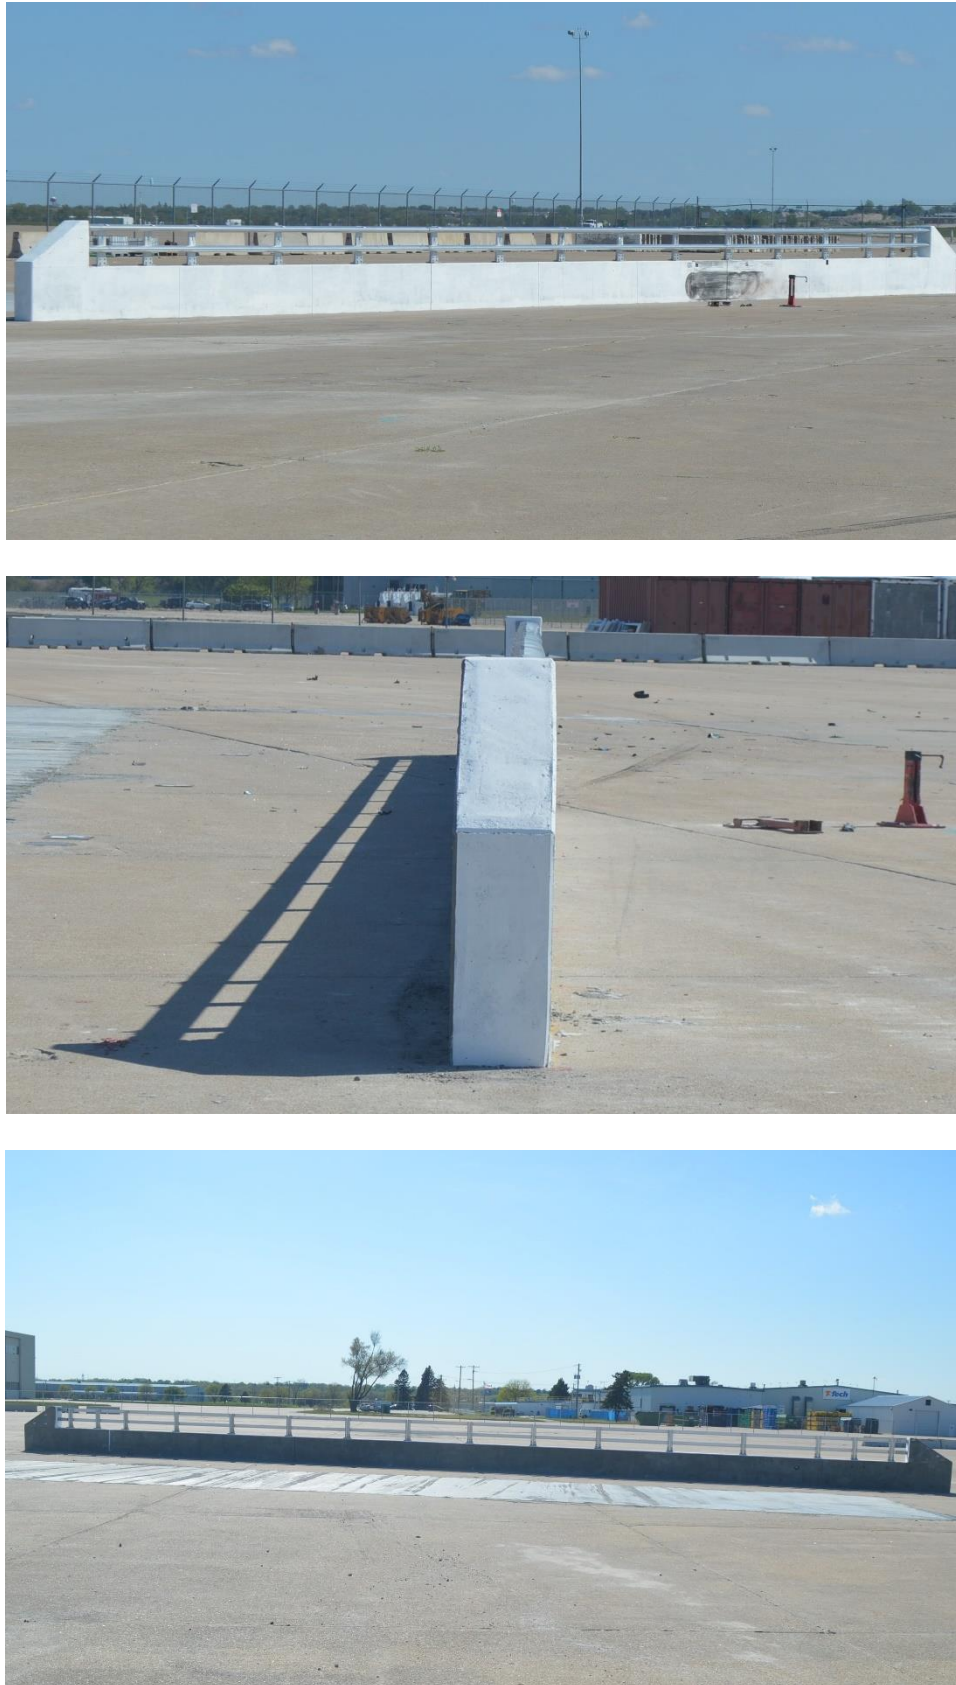
Figure 54. System Damage, Test No. NCBR-1

Damage to the barrier was minimal, as shown in Figures 54 through 57. Barrier damage consisted of contact marks and concrete gouging across the front face of the parapet. Note that all cracking visible in the system photographs was documented beforehand and not a result of test no. NCBR-1. The length of vehicle contact along the concrete parapet was $134\frac{3}{4}$ in., which spanned from $53\frac{3}{4}$ in. upstream from the splice between post nos. 10 and 11 to 71 in. downstream from the splice.

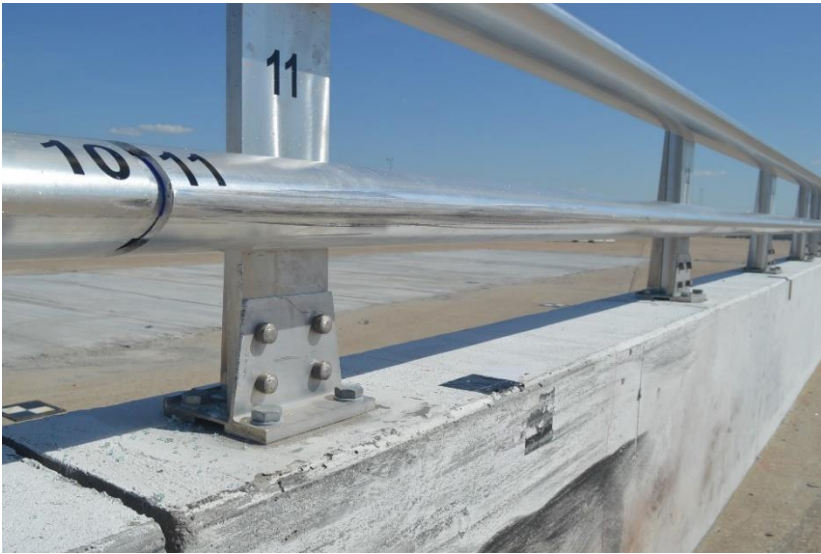
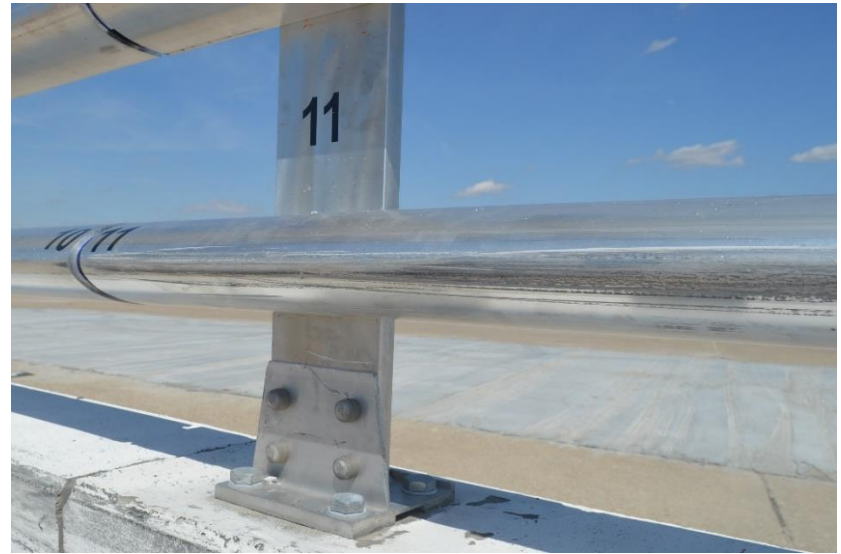
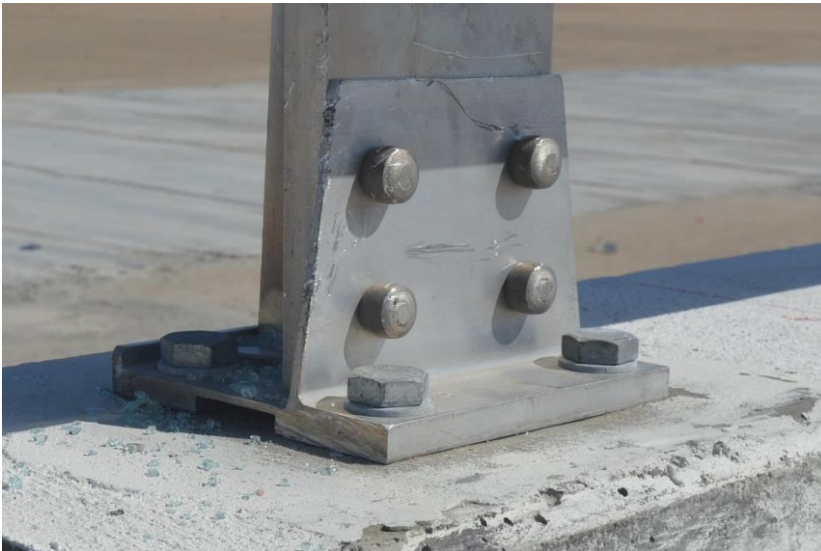
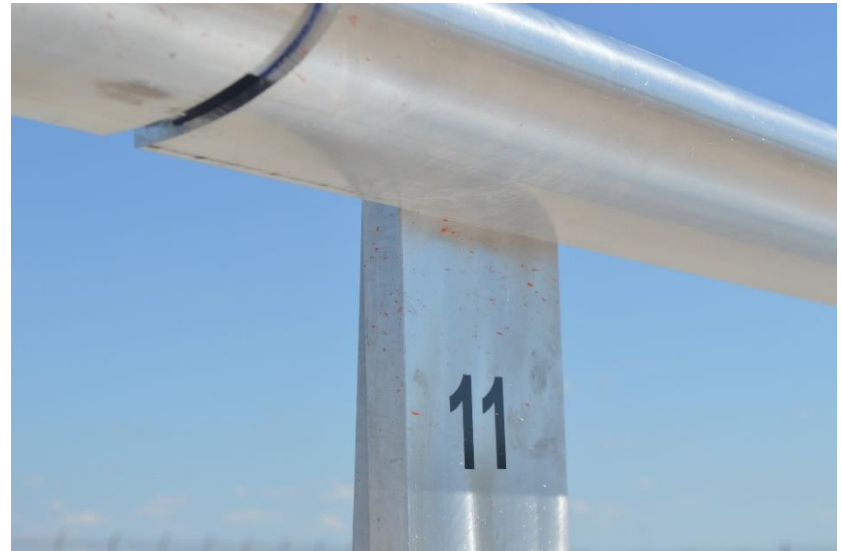
Figure 57. Rail and Post No. 11 Damage, Test No. NCBR-1

A $5\frac{1}{2}$ -in. long contact mark was observed on the upstream edge of the base plate of post no. 11, and contact was observed on the base plate and bolts extending $6\frac{1}{2}$ in. downstream along the traffic-side face. Minor splice movement was observed between post nos. 10 and 11, such that the traffic-side gap was $\frac{13}{16}$ in. and the back-side gap was $\frac{3}{4}$ in. for the lower rail. Both front- and back-side gaps were $\frac{3}{4}$ in. for the upper rail between all posts.

Orange paint splatter was observed on post no. 11 and both rails, beginning $9\frac{1}{2}$ in. upstream from the splice and extending to $16\frac{1}{2}$ in. downstream, as seen in Figure 57. Paint splatter was also found on the front face and upstream edge of post no. 11. Note that the dummy had recently been painted, and the wet paint caused splatter when the dummy's head contacted the side window. The dummy's head did not contact the system. Surface scratches were found across the entire width of the front face of post no. 11 between both rails.

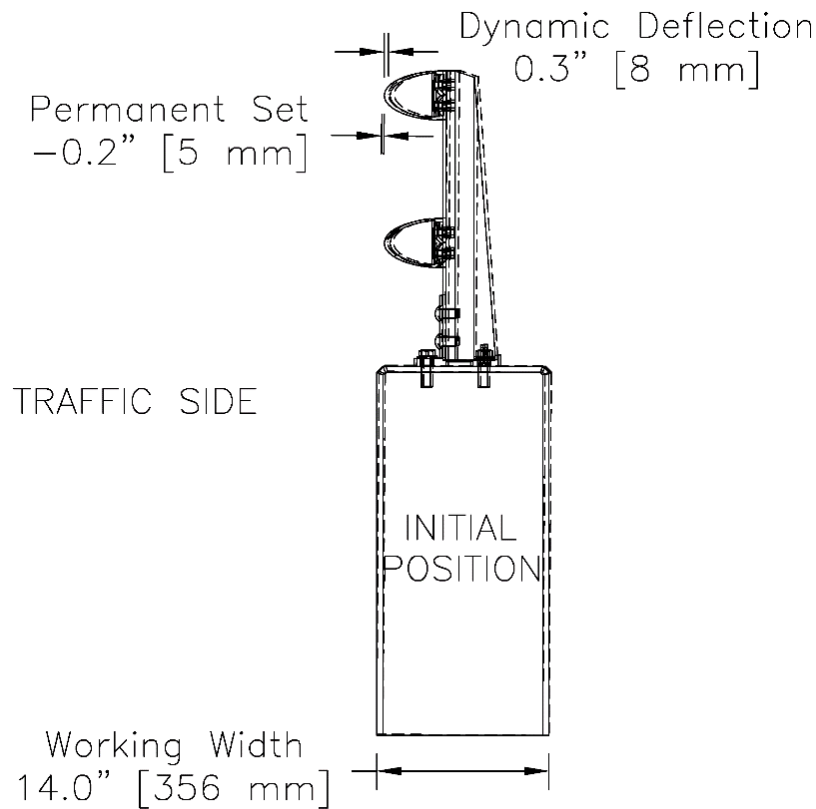
Figure 58. Barrier Deflections, Test No. NCBR-1

The maximum lateral permanent set of the barrier system was -0.2 in., as measured in the field, which was 0.2 in. forward from its initial position. The maximum lateral dynamic barrier deflection, including tipping of the barrier along the top surface, was 0.3 in. at post no. 15, as determined from high-speed digital video analysis. The working width of the system was found to be 14.0 in., also determined from high-speed digital video analysis. Barrier deflections are shown schematically in Figure 58.

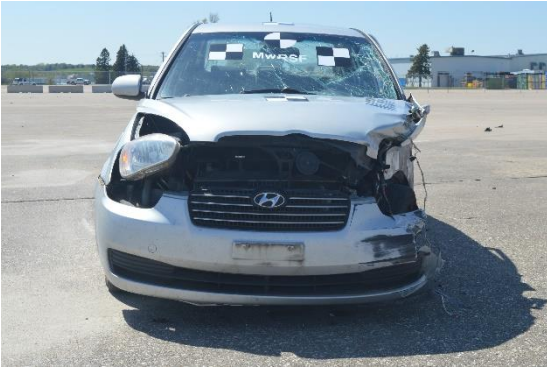
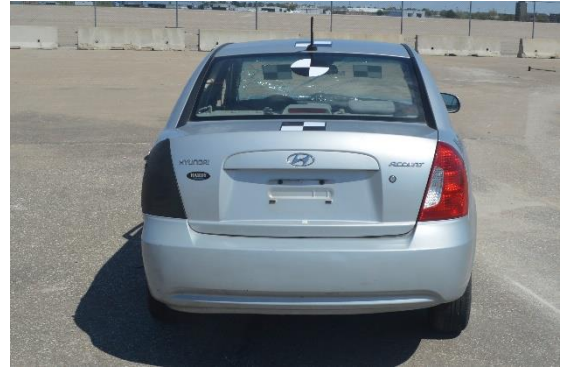
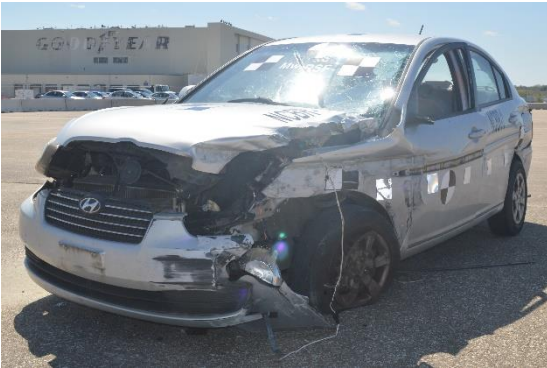
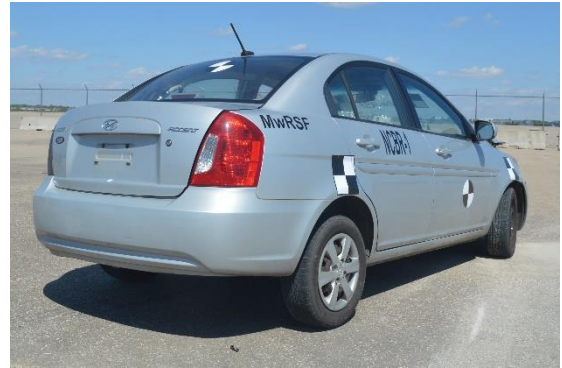
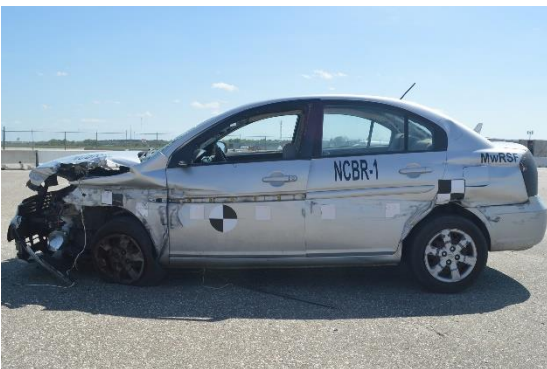
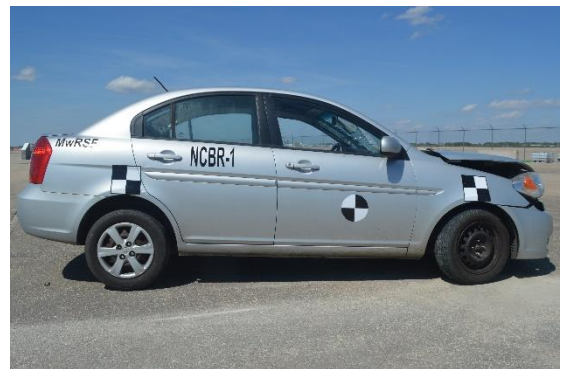
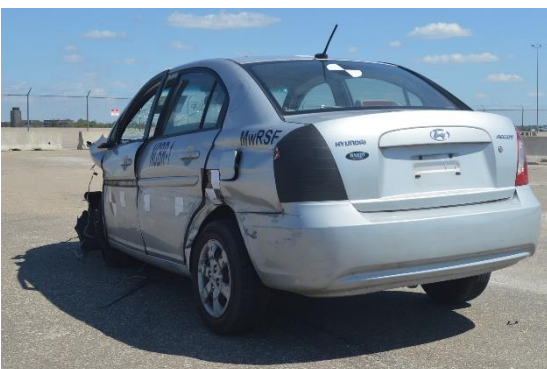
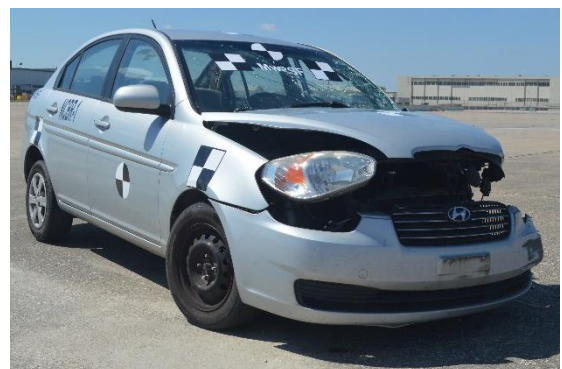
Figure 59. Vehicle Damage, Test No. NCBR-1

Damage to the vehicle was moderate, as shown in Figures 59 through 63. The majority of the damage was concentrated on the left-front corner and left side of the vehicle where impact had occurred. The left side of the bumper was deformed and torn in front of the wheel. The left-front fender was pushed inward near the door panel and torn around the left-front wheel. The left-front steel rim was deformed with tears and crushing. The left-front tire was torn and deformed. The left-side headlight and fog light were disengaged from the vehicle. The left side of the radiator was pushed backward. Denting and scraping were observed across the entire left side. The top of the left-front door was slightly ajar and the bottom was pushed inward. The bottom of the left-rear door was dented and scuffed. The fuel hatch was ajar. The left-rear wheel assembly was deformed inward. The left-rear steel rim and tire were scuffed. The left side of the rear bumper was dented and scuffed. The hood was crushed inward, separated from the bumper entirely, and the left edge was torn. The right side of the bumper was pushed downward. The left side of the windshield was cracked and deformed, and the upper-right side had minor cracking. The left-front side window

disengaged from the vehicle after contact with the dummy's head. The remaining window glass was undamaged. The spring perch on the left side was cracked. The left-side control arm was bent backward. The transmission mounts shifted toward the right side. The left-side frame rail compressed and bent upward. The rear cross member bent inward on both ends. The front cross member was bent and crushed upward. The frame horn was bent upward on the left side. The floor pan was opened at the seam across the whole left side. The front exhaust mount folded inward.

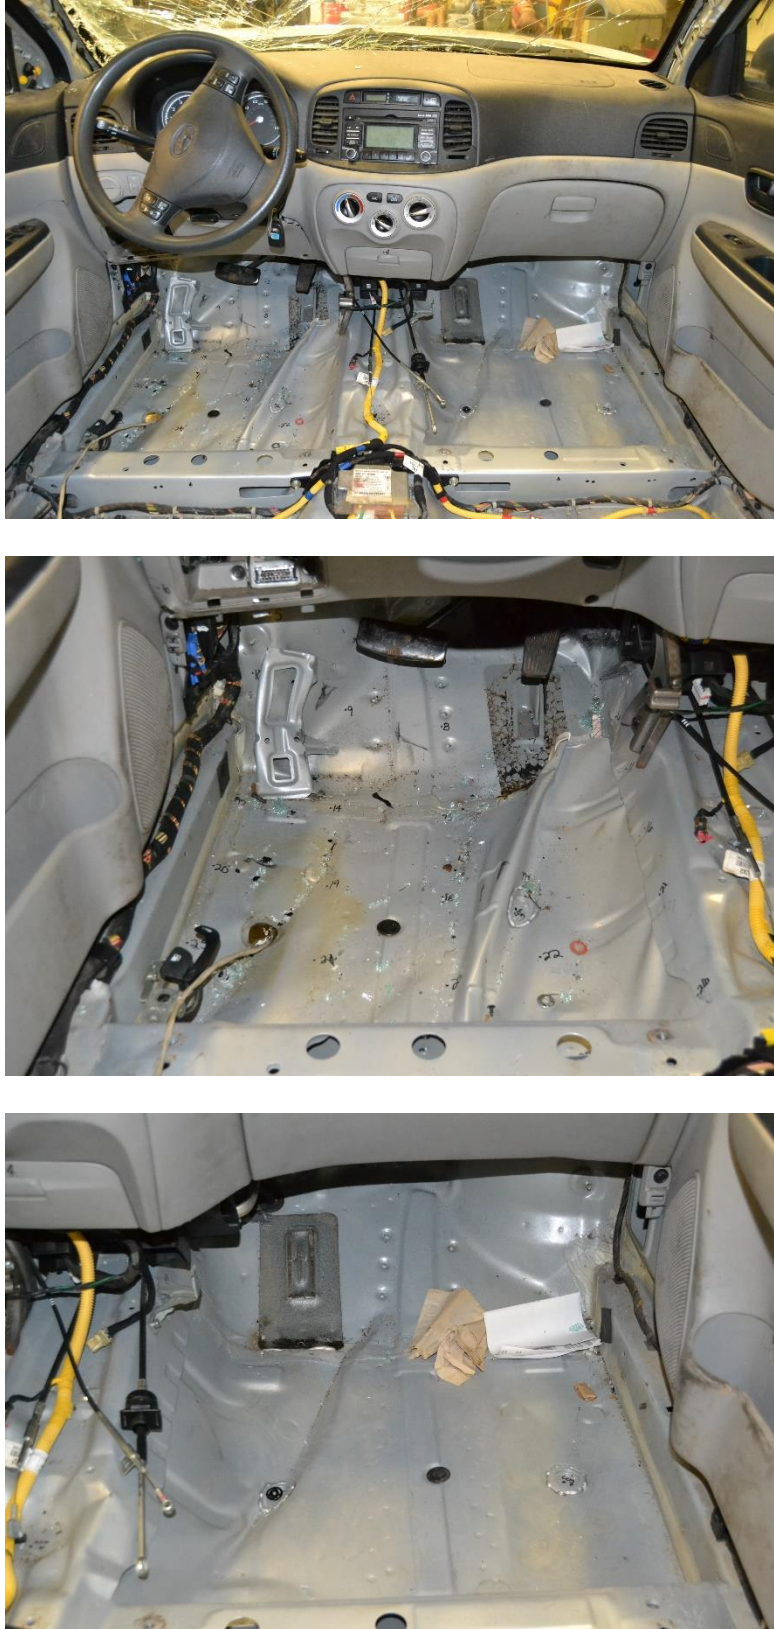
Figure 61. Occupant Compartment Damage, Test No. NCBR-1

The maximum occupant compartment intrusions are listed in Table 5, along with the intrusion limits established in MASH 2016 for various areas of the occupant compartment. MASH 2016 defines intrusion or deformation as the occupant compartment being deformed and reduced in size with no observed penetration. There were no penetrations into the occupant compartment and none of the established MASH 2016 deformation limits were violated. Complete occupant compartment and vehicle deformations and the corresponding locations are provided in Appendix D. It should be noted that a large tear was visible in the vehicle windshield. Review of the high-speed video revealed that tearing of the windshield was formed due to crushing of the back left corner of the hood, resulting in a vertical crack which propagated through the windshield to the roof. Neither the barrier nor any vehicle component contacted the windshield except at the bottom left corner. The displacement of the vehicle's "A"-pillar and hood were minimal. No deformations occurred to the roof panel. After the test, the windshield displacements were measured and compared against an exemplary vehicle. However, windshield deformations were artificially high due to settling that occurred in between testing and measurement. Therefore, windshield displacements were deemed acceptable according to MASH, and none of the MASH criteria for windshield contact, protrusion, or deformation were violated.

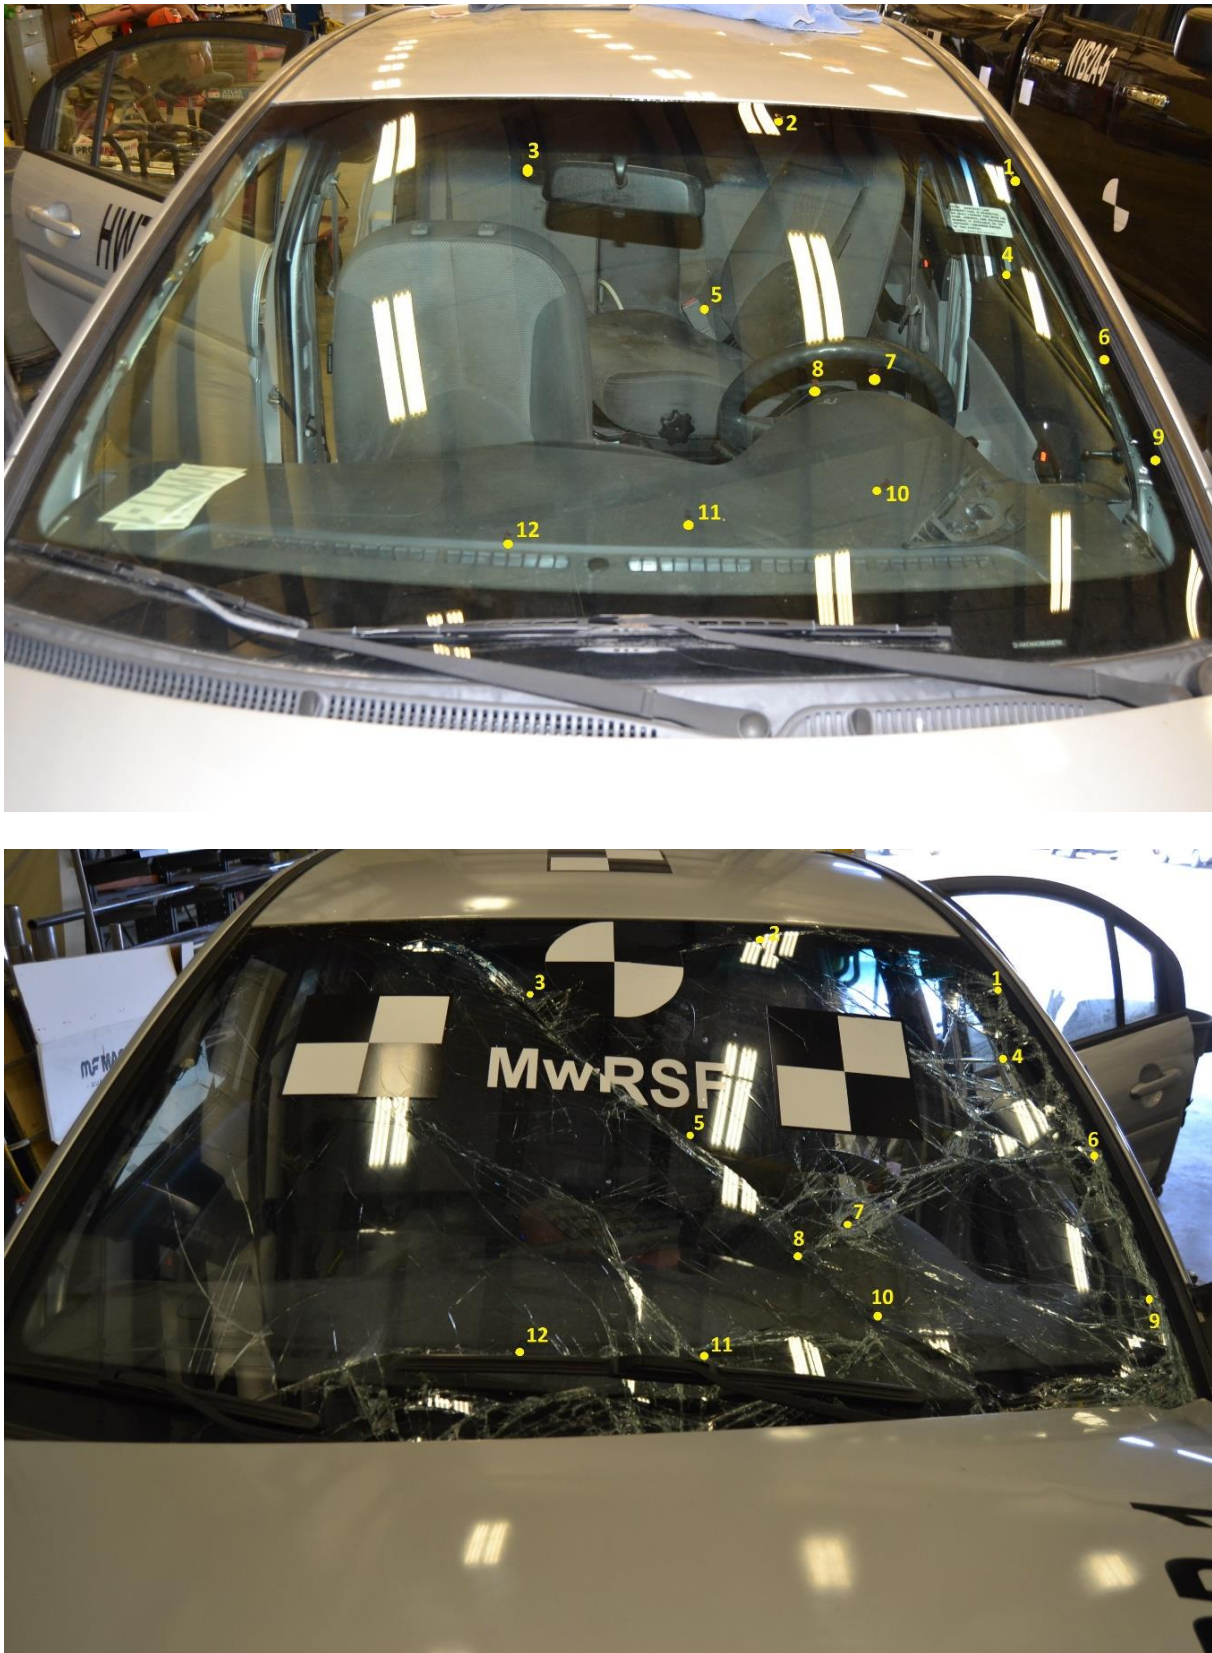
Figure 63. Windshield Damage (Pre- and Post-Test), Test No. NCBR-1

* Windshield crush was measured three days after the test and during that time frame settling of the damaged windshield occurred. Thus, the measured value is not believed to be realistic

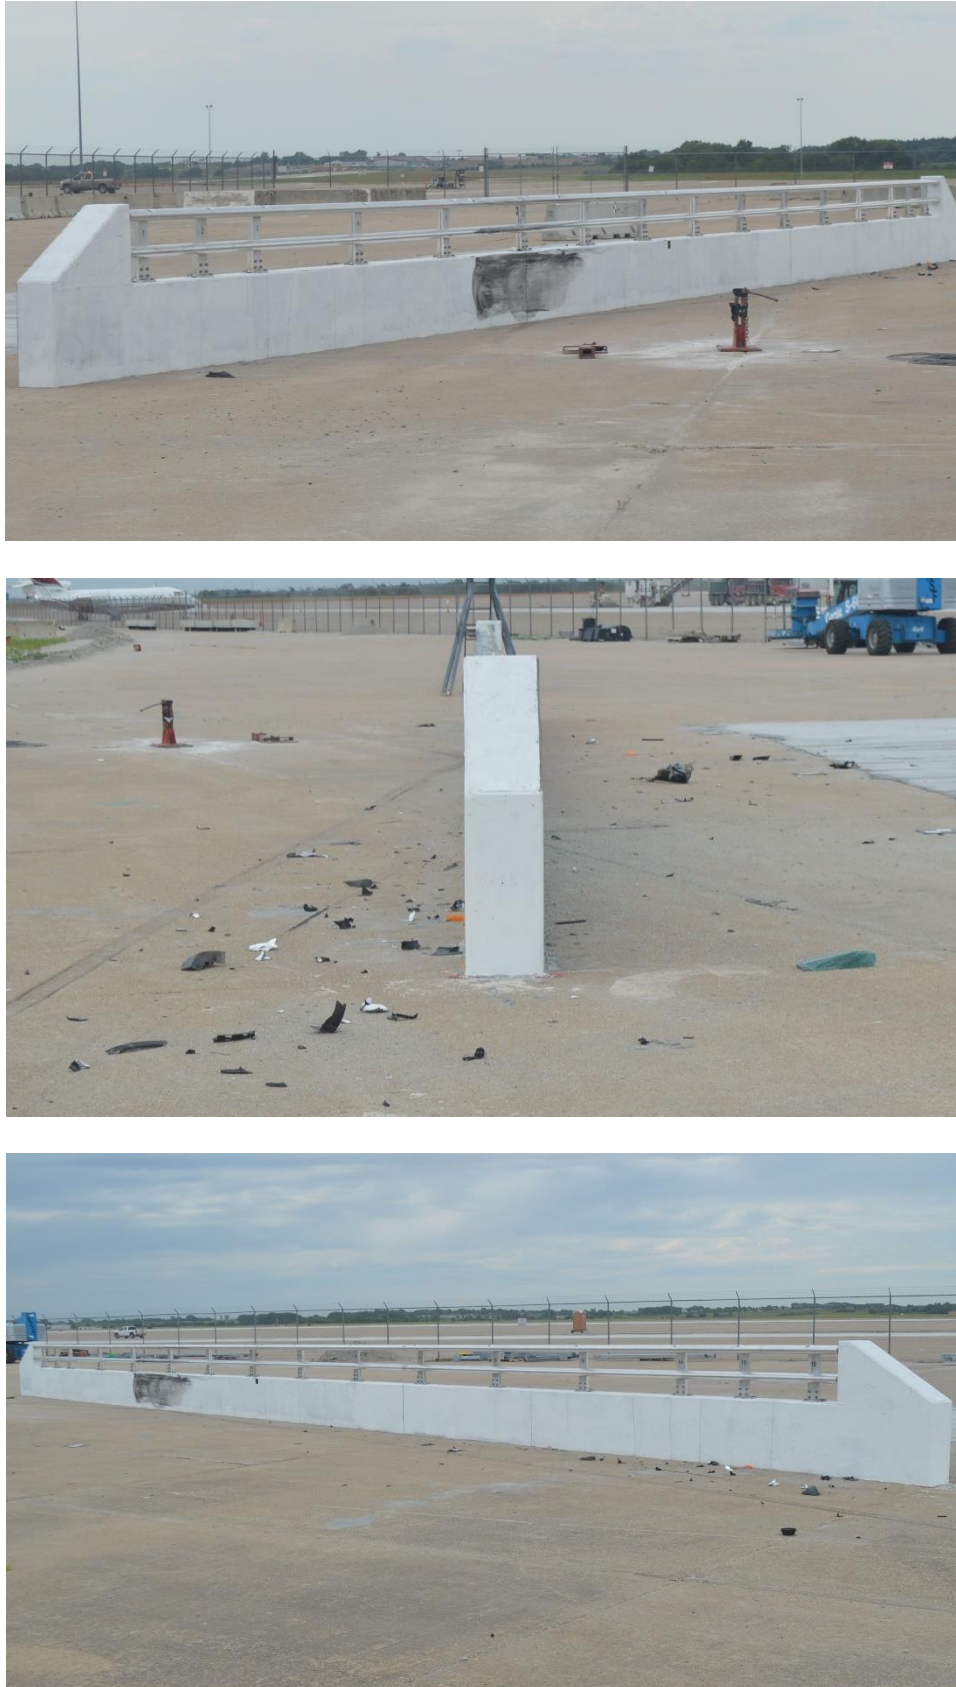
Figure 75. System Damage, Test No. NCBR-2

Damage to the barrier was minimal, as shown in Figures 75 through 79. Barrier damage consisted of contact marks and concrete gouging across the front face of the parapet, and minor concrete breakout on the upstream edge of the second parapet segment at the expansion joint. Note that any cracking visible in the system photographs was documented beforehand and not a result of test no. NCBR-2.

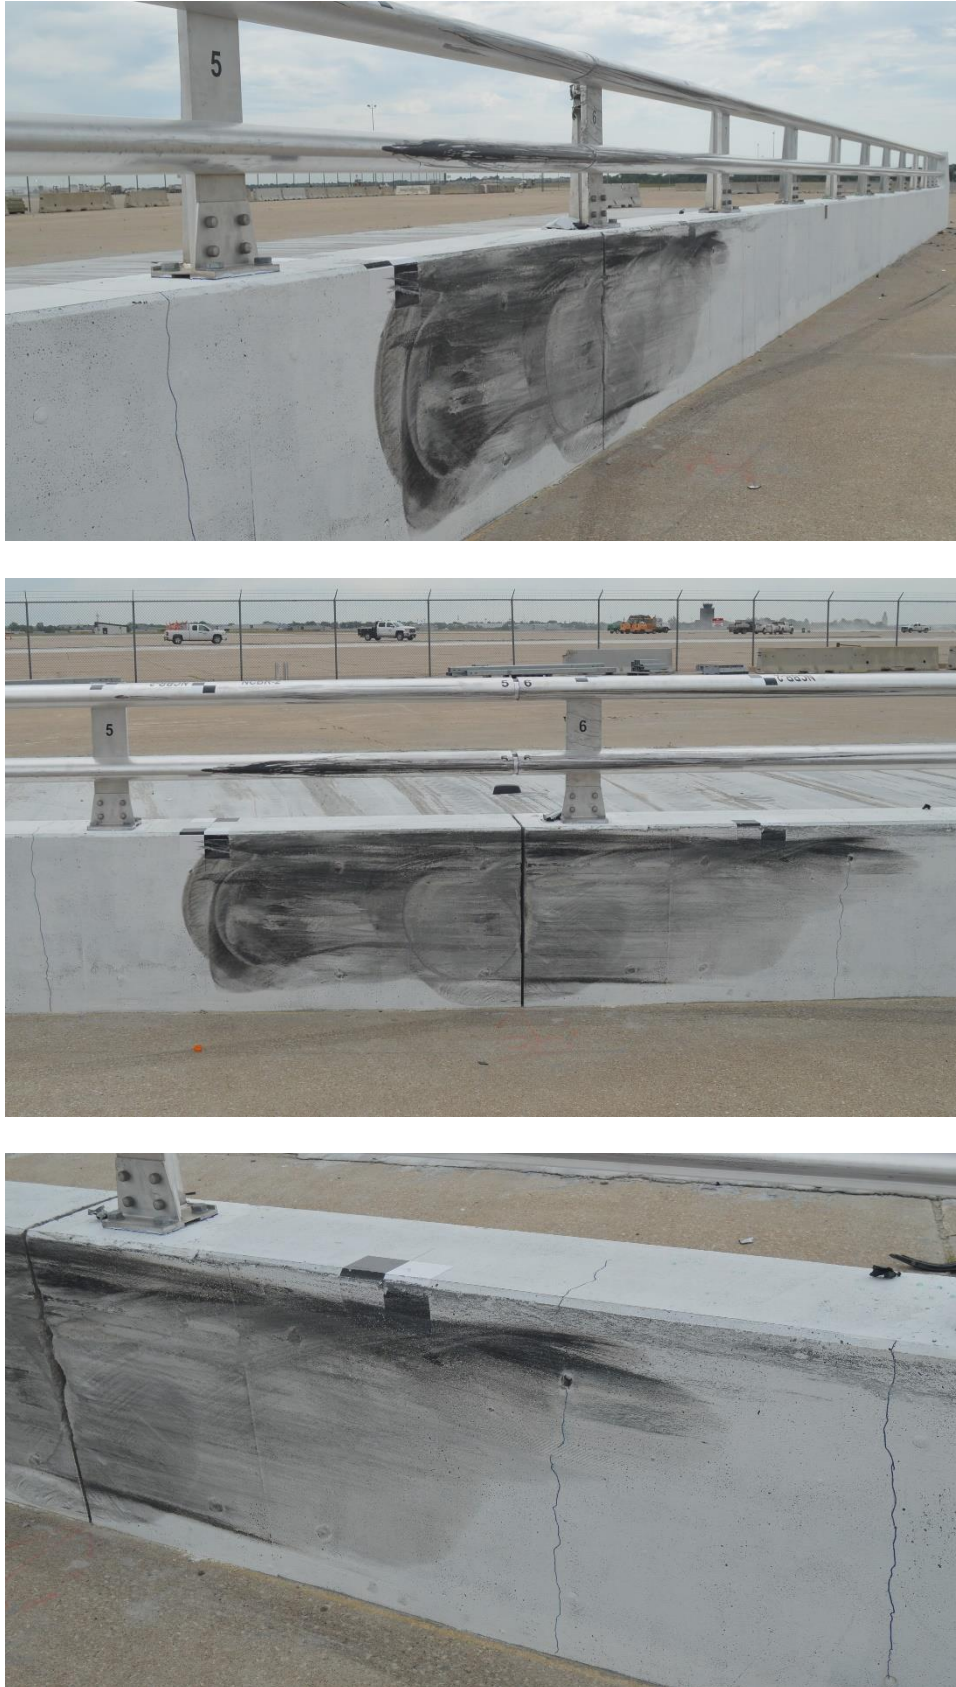
Figure 76. System Damage, Test No. NCBR-2

Contact marks on the lower rail were observed 16 in. downstream from post no. 5 and extending 150½ in. downstream. Contact marks on the upper rail were observed starting 10 in. downstream of the impact point and extending 164 in. downstream. A separate contact mark was observed on the underside of the upper rail, starting 33 in. upstream from post no. 8, measuring 21 in. long and ½ in. wide. The splices between the first and second rail segments experienced minor elongation, measuring 7/8 in. at both the front and back of both rails.

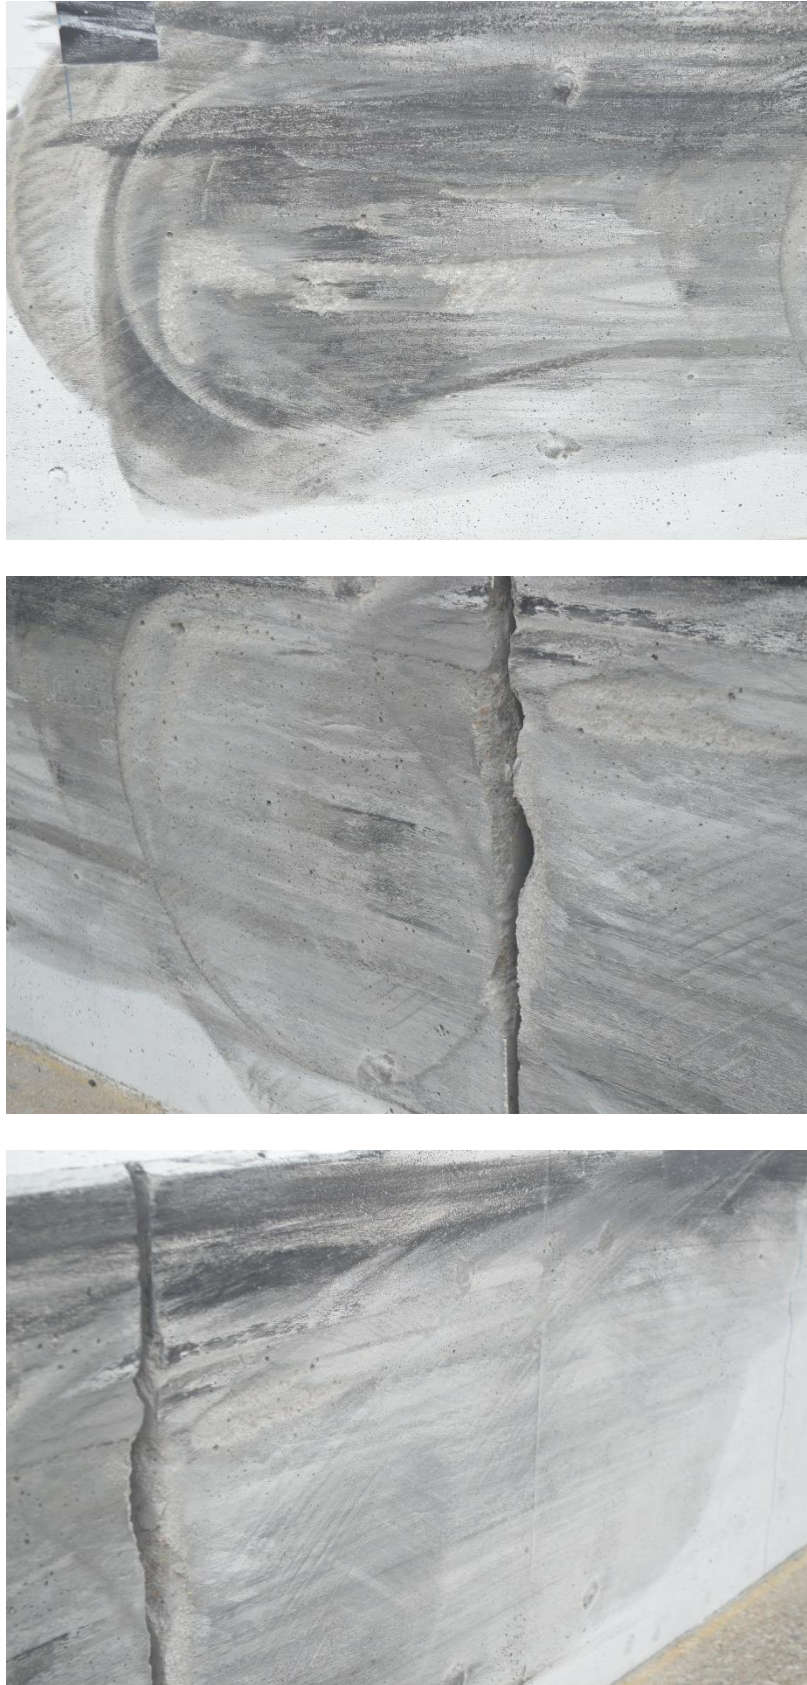
Figure 77. Concrete Gouging, Test No. NCBR-2

Minor concrete breakout measuring up to 3 in. wide x 15 in. long x 1½ in. deep, extending vertically between 9 and 24 in. above the ground line, occurred on the upstream edge of the second concrete parapet at the expansion gap between post nos. 5 and 6. Gouging was observed 20 in. downstream from post no. 5 and 14 in. below the top surface of the parapet, measuring 16 in. long and 7 in. tall. Gouging also occurred along the top edge of the front face of the parapet, located 13 in. downstream from the impact point and measuring 22 in. long and 1 in. wide. A 17-in. circular gouge occurred 17½ in. downstream from post no. 5. Small scratches were located throughout the impact region across the front face of the parapet.

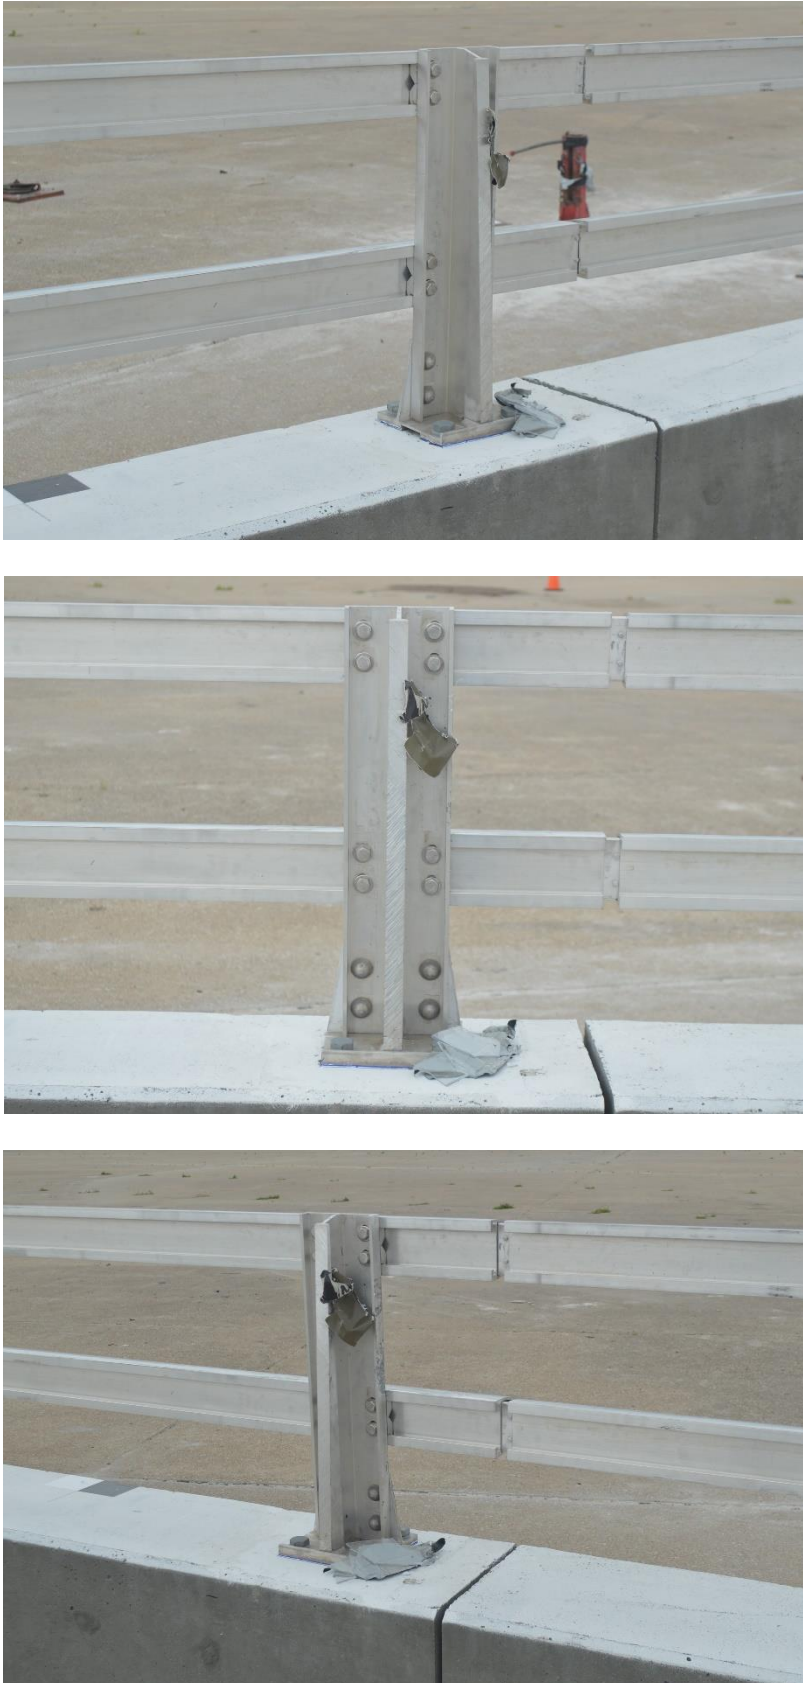
Figure 78. Post No. 6 Backside Damage, Test No. NCBR-2

An 8¼-in. contact mark began 4¼ in. from the top of post no. 6 on its upstream flange. An additional 1½-in. contact mark, beginning 5¼ in. from the bottom of post no. 6, was observed on the upstream flange. Contact marks extended 2¾ in. downstream from the upstream edge of the post-mounting bracket at post no. 6. Contact marks were observed on the back side of the upstream flange beginning 3 in. from the top of the flange and extending down 5 in. downstream. Contact marks were also observed along the entire upstream front flange edge, front post-to-parapet attachment bolts, and front edge of the base plate at post no. 6. A ¼-in. contact mark began 4¾ in. from the top of post no. 7 on its upstream flange. Minor contact marks, measuring 7 in. in height, began 2 in. from the bottom of the upstream flange of post no. 7 and along the front edge and top surface of the base plate and the front post-to-parapet attachment bolts.

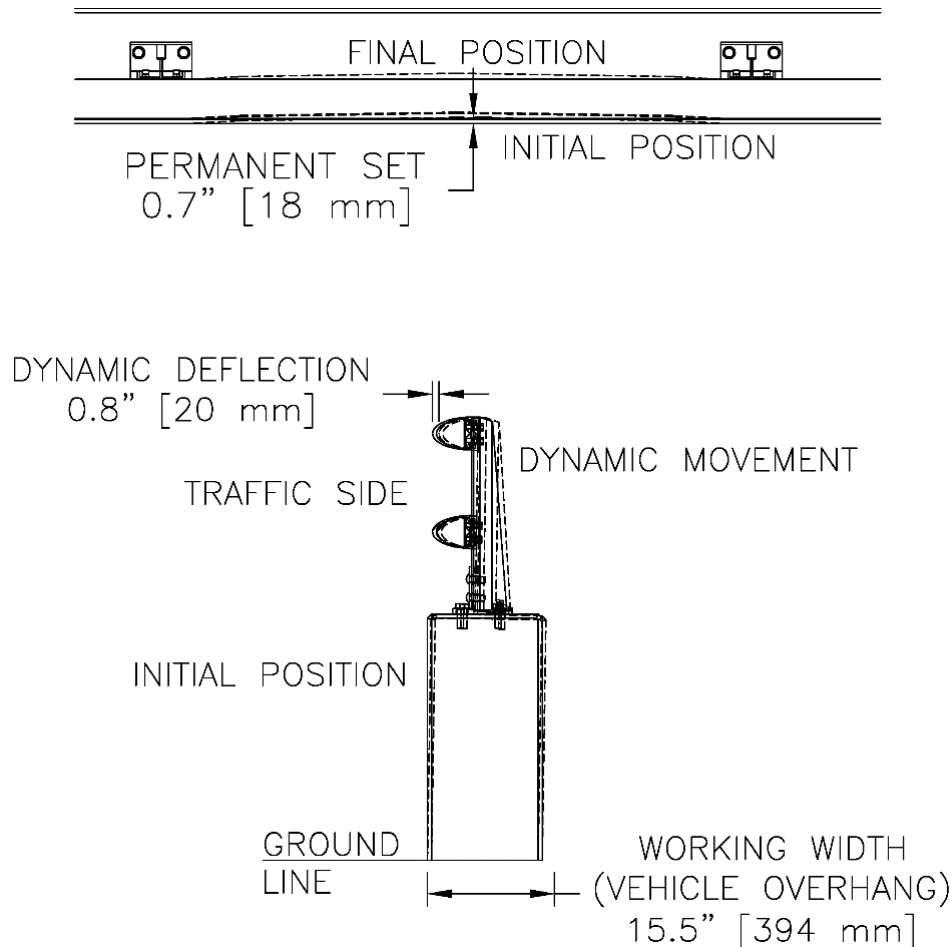
Figure 80. Barrier Deflections, Test No. NCBR-2

The maximum lateral permanent set of the barrier system was 0.7 in. between post nos. 5 and 6, as measured in the field. The maximum lateral dynamic barrier deflection, including tipping of the barrier along the top surface, was 0.8 in. on the upper rail, as determined from high-speed digital video analysis. The working width of the system was found to be 15.5 in., also determined from high-speed digital video analysis. Barrier deflections are shown schematically in Figure 80.

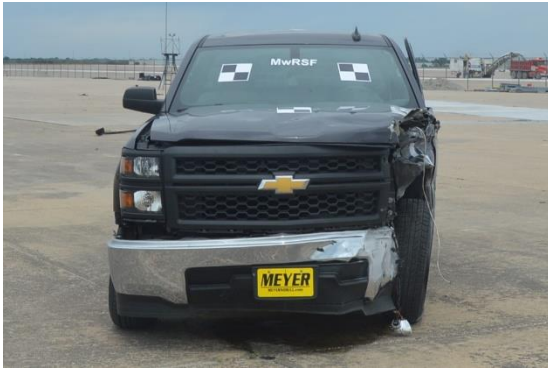
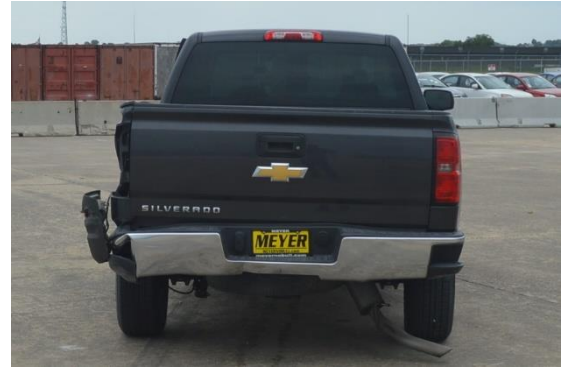
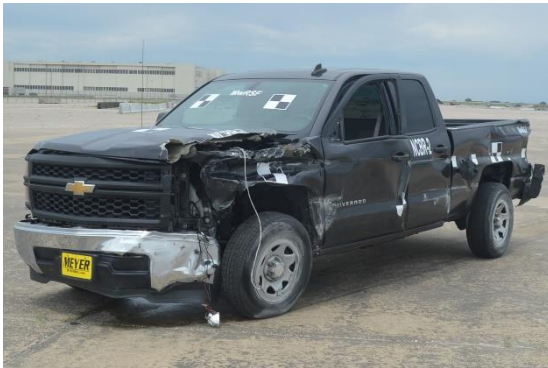
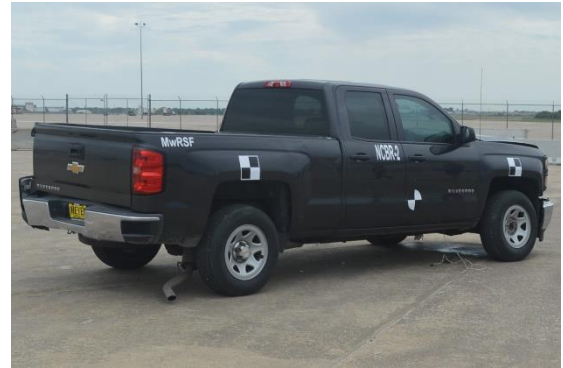
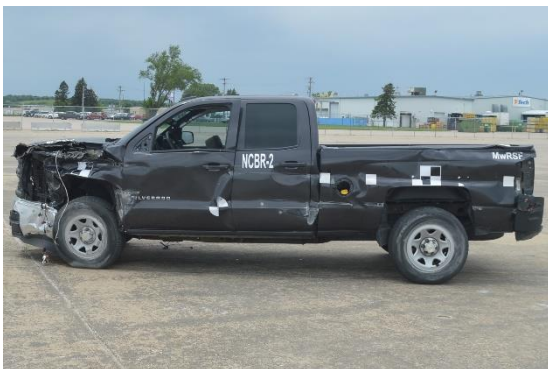
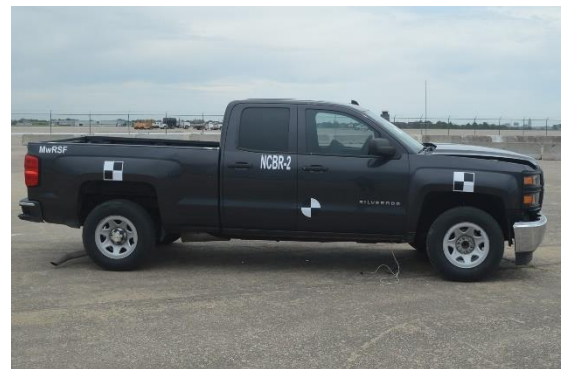
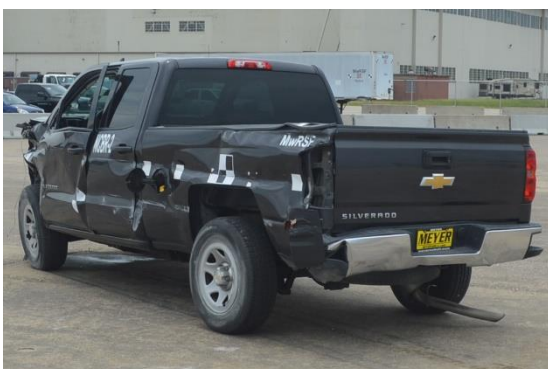
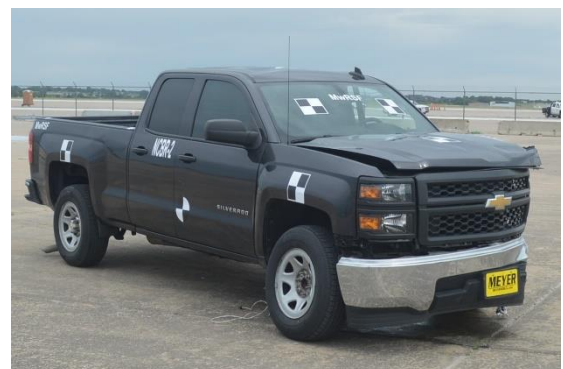
Figure 81. Vehicle Damage, Test No. NCBR-2

Damage to the vehicle was moderate, as shown in Figures 81 through 85. The majority of the damage was concentrated on the left-front corner and left side of the vehicle where the impact occurred. The left side of the bumper was crushed inward. The left-front fender was pushed upward near the door panel and dented and torn behind the left-front wheel. The left-front steel rim and tire were scuffed and deformed. The grille was pushed backward around the left-side headlight assembly. The left-side headlight and fog light were disengaged from the vehicle. Denting and scraping were observed across the entire left side. The left-front door was slightly ajar and deformed inward at the bottom. The left-rear door was dented. The left side of the truck bed was dented and the fuel hatch was ajar. The left-rear tire was scuffed. The left taillight was disengaged from the vehicle. The left side of the rear bumper was torn and pushed downward. The right side of the front bumper was pushed downward. The vehicle's aluminum hood was deformed across

its entirety and the left edge was torn from front to back. A piece of the hood was torn off the left side. The left side window was ejected from the vehicle after impact with the dummy's head. The remaining window glass remained undamaged. The anti-roll bar shifted toward the right side and the left-side end link connector was bent. The left-side bottom control arm joint was torn out of the frame. The left-side outer tie rod was bent and the left-side upper mount of the steering rack was dented. The front left side of the oil pan had a 2.5 in. x 3.5 in. puncture. The left side of the frame at the impact point was caved inward and bent at the middle of the left-front door. The right side of the frame bent inward at the midpoint of the right-front door. The middle cross member bent where it connected to the frame. The left-side frame horn bent inward. The right-front passenger cab mount was disengaged. The floor pan was wrinkled. The tail pipe came out of the rear hanging mount.

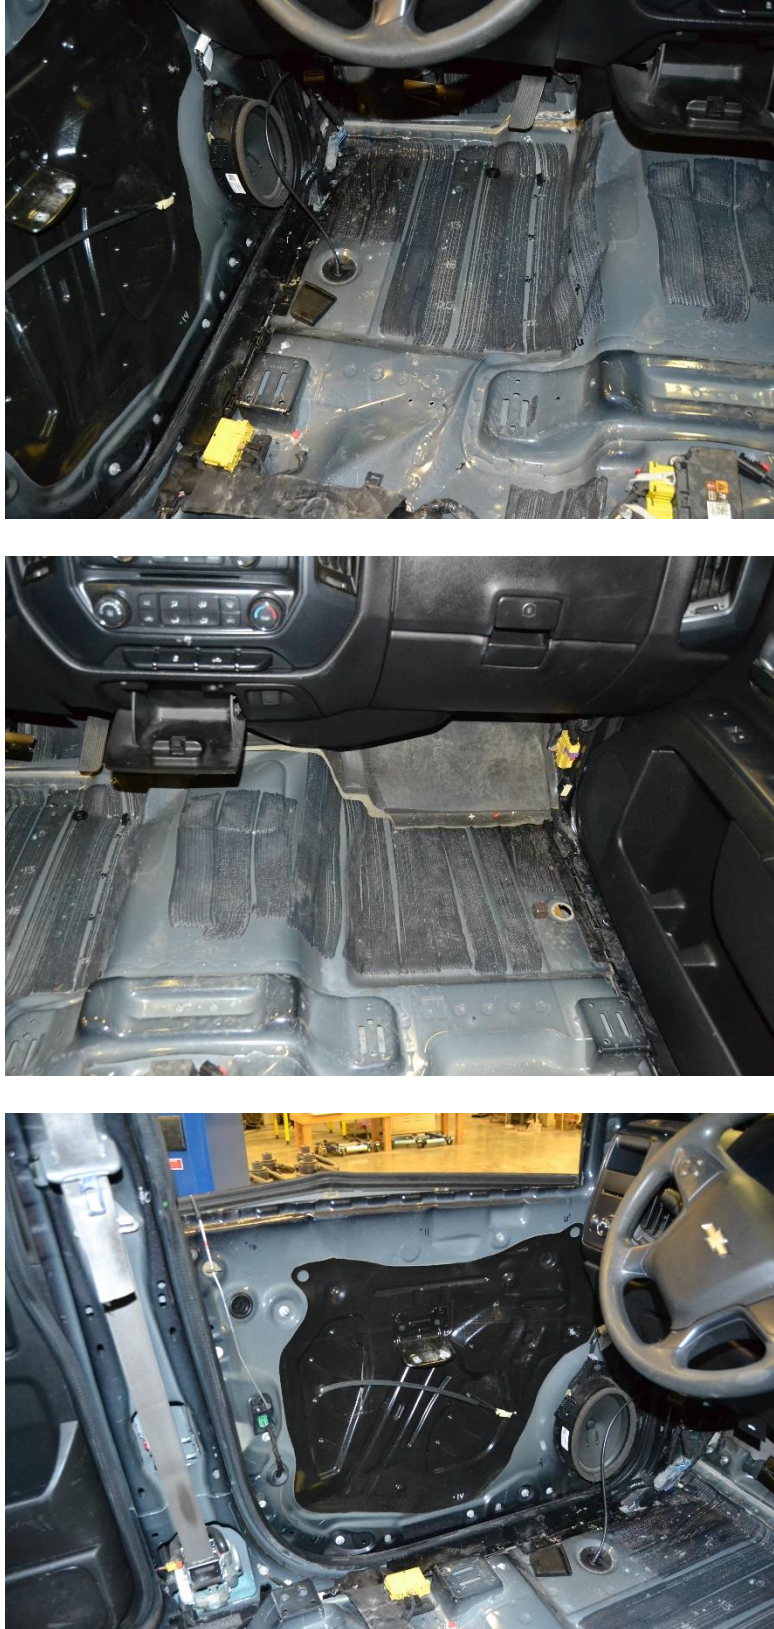
Figure 83. Occupant Compartment Damage, Test No. NCBR-2

The maximum occupant compartment intrusions are listed in Table 9 along with the intrusion limits established in MASH 2016 for various areas of the occupant compartment. MASH 2016 defines intrusion or deformation as the occupant compartment being deformed and reduced in size with no observed penetration. There were no penetrations into the occupant compartment and none of the established MASH 2016 deformation limits were violated. Complete occupant compartment and vehicle deformations and the corresponding locations are provided in Appendix D. Note that set 1 interior and floor pan deformation data was compromised and is not listed in Appendix D. Note there is no NASS crush information due to incomplete pretest profile information.
