Research Project Number 20180380-01-NEB

FULL-SCALE CRASH TEST OF A TWO-BAR METAL BRIDGE RAIL

MwRSF Research Report No. TRP-03-419-19

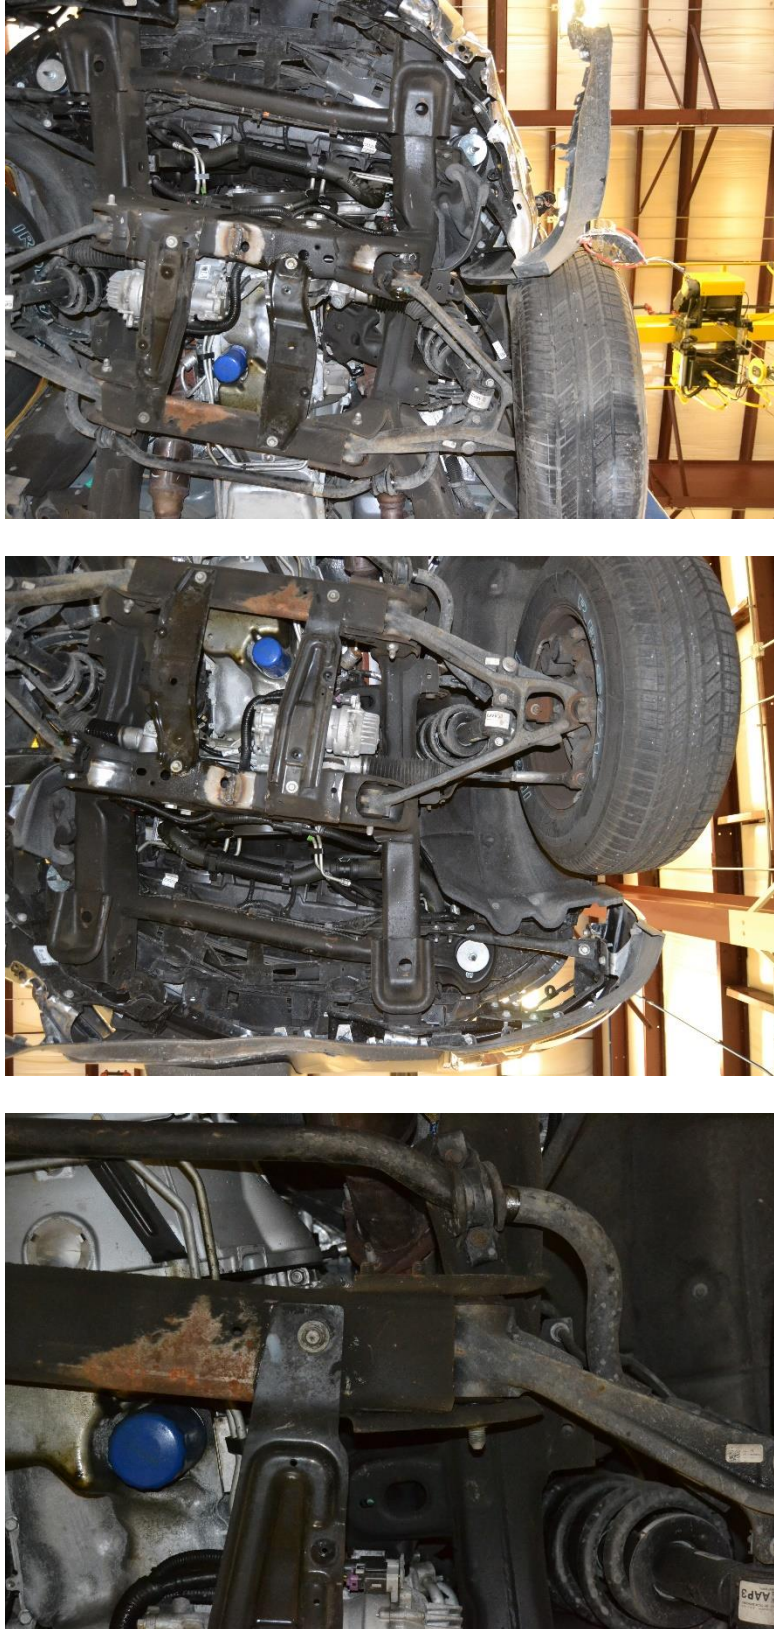
Figure 84. Undercarriage Damage, Test No. NCBR-2

its entirety and the left edge was torn from front to back. A piece of the hood was torn off the left side. The left side window was ejected from the vehicle after impact with the dummy's head. The remaining window glass remained undamaged. The anti-roll bar shifted toward the right side and the left-side end link connector was bent. The left-side bottom control arm joint was torn out of the frame. The left-side outer tie rod was bent and the left-side upper mount of the steering rack was dented. The front left side of the oil pan had a 2.5 in. x 3.5 in. puncture. The left side of the frame at the impact point was caved inward and bent at the middle of the left-front door. The right side of the frame bent inward at the midpoint of the right-front door. The middle cross member bent where it connected to the frame. The left-side frame horn bent inward. The right-front passenger cab mount was disengaged. The floor pan was wrinkled. The tail pipe came out of the rear hanging mount.

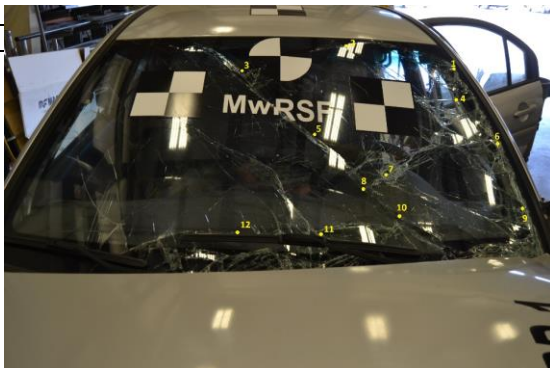
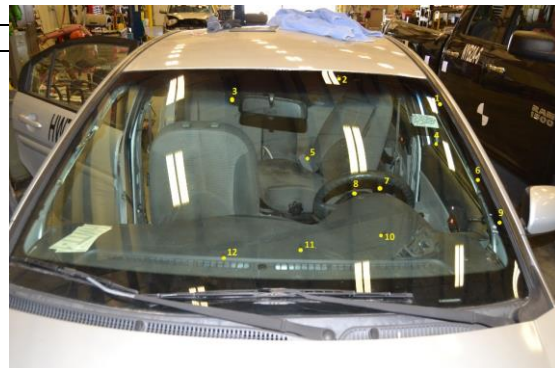
Figure D-6. Windshield Deformation, Test No. NCBR-1

The windshield deformation measurements were taken three days after the test and the windshield settled and deteriorated during this time. The values represented in these measurements do not reflect the test day values. It is likely the values were much less significant on the day of the test.
