*Research Project Number TPF-5(193) Supplement #113  
WisDOT Sponsoring Agency Code RFPF-WISC-6*

## **DYNAMIC TESTING AND EVALUATION OF CULVERT-MOUNTED, STRONG-POST MGS TO TL-3 GUIDELINES OF MASH 2016**

### **MIDWEST ROADSIDE SAFETY FACILITY**

MwRSF Research Report No. TRP-03-383-20-R1

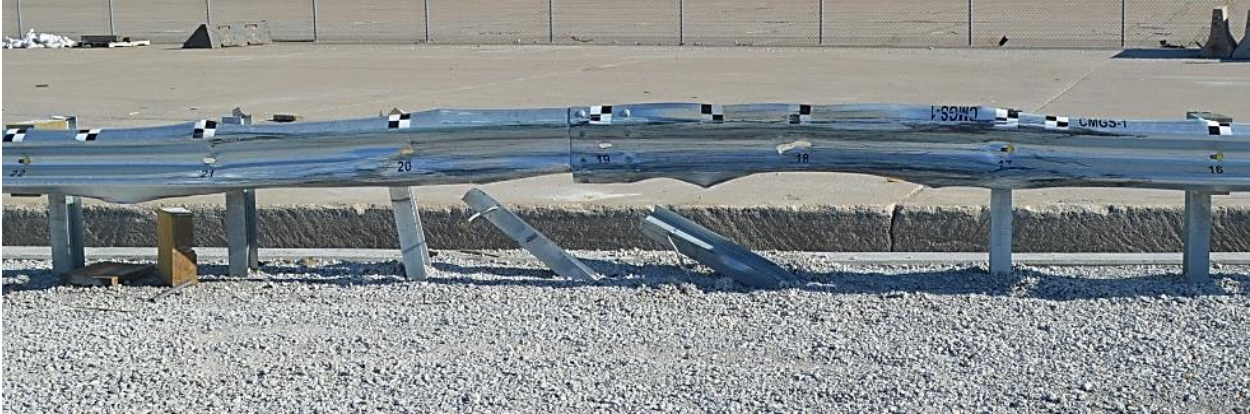
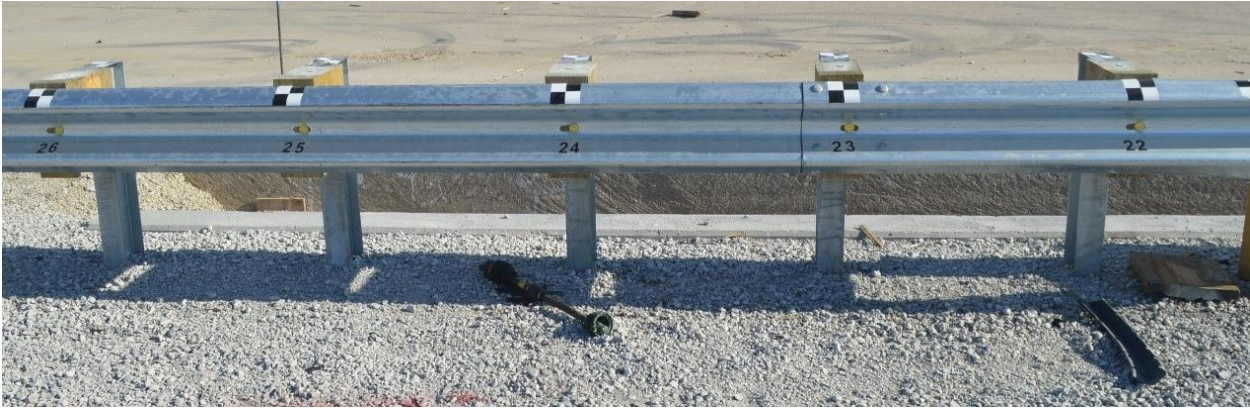
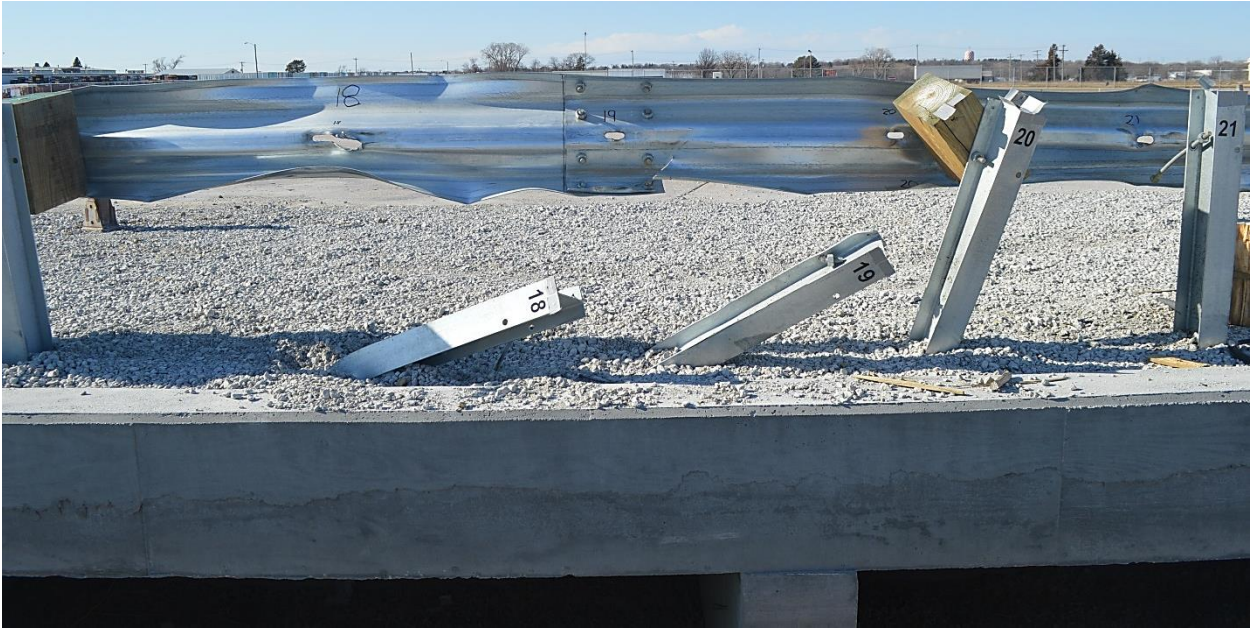
Figure 60. System Damage, Test No. CMGS-1

Damage to the barrier was moderate, as shown in Figures 60 through 66. Barrier damage consisted mostly of deformed W-beam, contact marks on the guardrail sections, and deformed posts. The length of vehicle contact along the barrier was approximately 16 ft which spanned from 12 $\frac{5}{8}$  in. (321 mm) downstream from post no. 16 to 15 $\frac{1}{2}$  in. (394 mm) downstream from post no. 21.

The guardrail damage consisted moderate deformation and flattening of the impacted section of the W-beam between post nos. 16 and 22. The W-beam was pulled out from the bolts at post nos. 18 through 21. Contact marks were found on the guardrail between post nos. 16 through 21. A partial rail tear was observed through the lower hump of the W-beam rail at the downstream end of the rail splice at post no. 19, as shown in Figures 60 and 61. No significant guardrail damage occurred upstream from post no. 16 nor downstream from post no. 22.

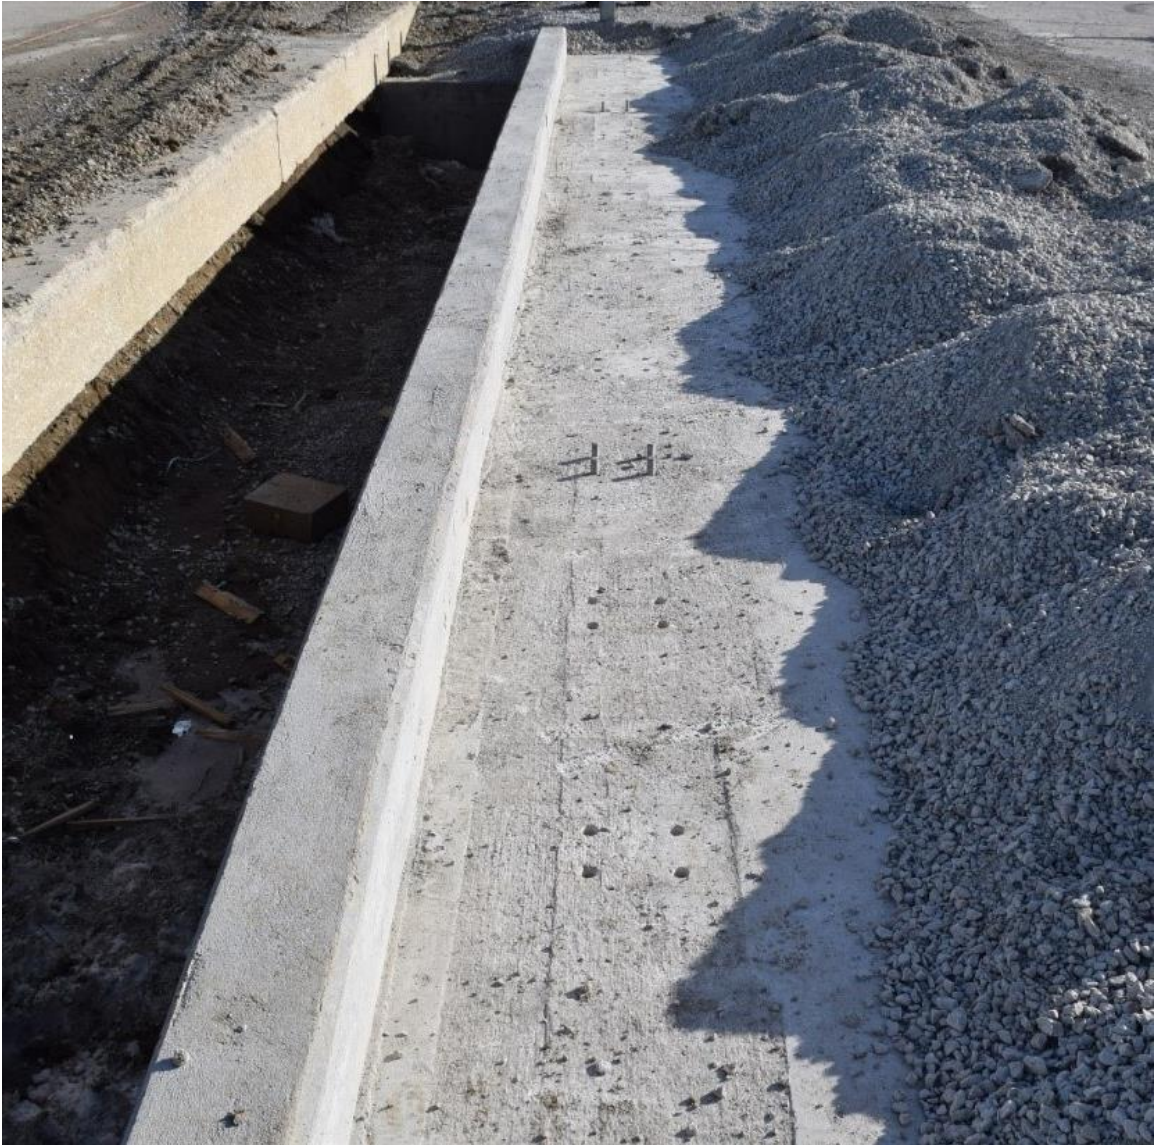
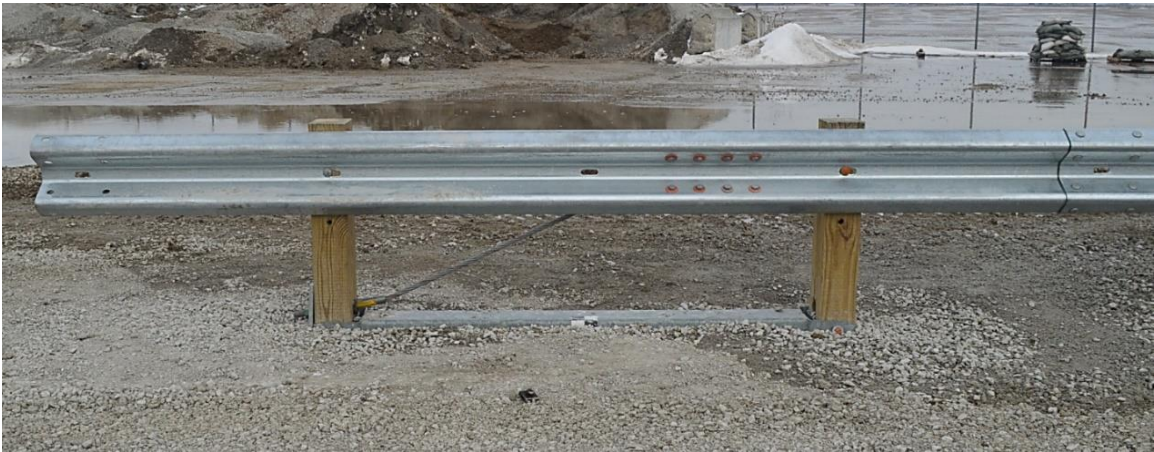
Figure 88. Culvert Deck after Removal of Soil Fill and Posts and Downstream Anchorage System Deformation, Test No. CMGS-2

Following the test, the soil on top of the culvert headwall was removed for inspection of the damage to the posts and base plates as well as to review any potential damage to the culvert. Deformation of the post base plates was observed on post nos. 16 through 22. Post nos. 17 and 18 fractured at the base of the post above the weld line at the front flange and web of the post and through the weld at the back flange of the post. The upstream side of the front flange of post nos. 20 and 21 was torn up to the web near the base plate weld. All anchorage bolts and epoxied threaded rods were intact and remained secure, although some minor deformation of the bolts and rods was observed. No damage was observed to the concrete culvert slab or the headwall.

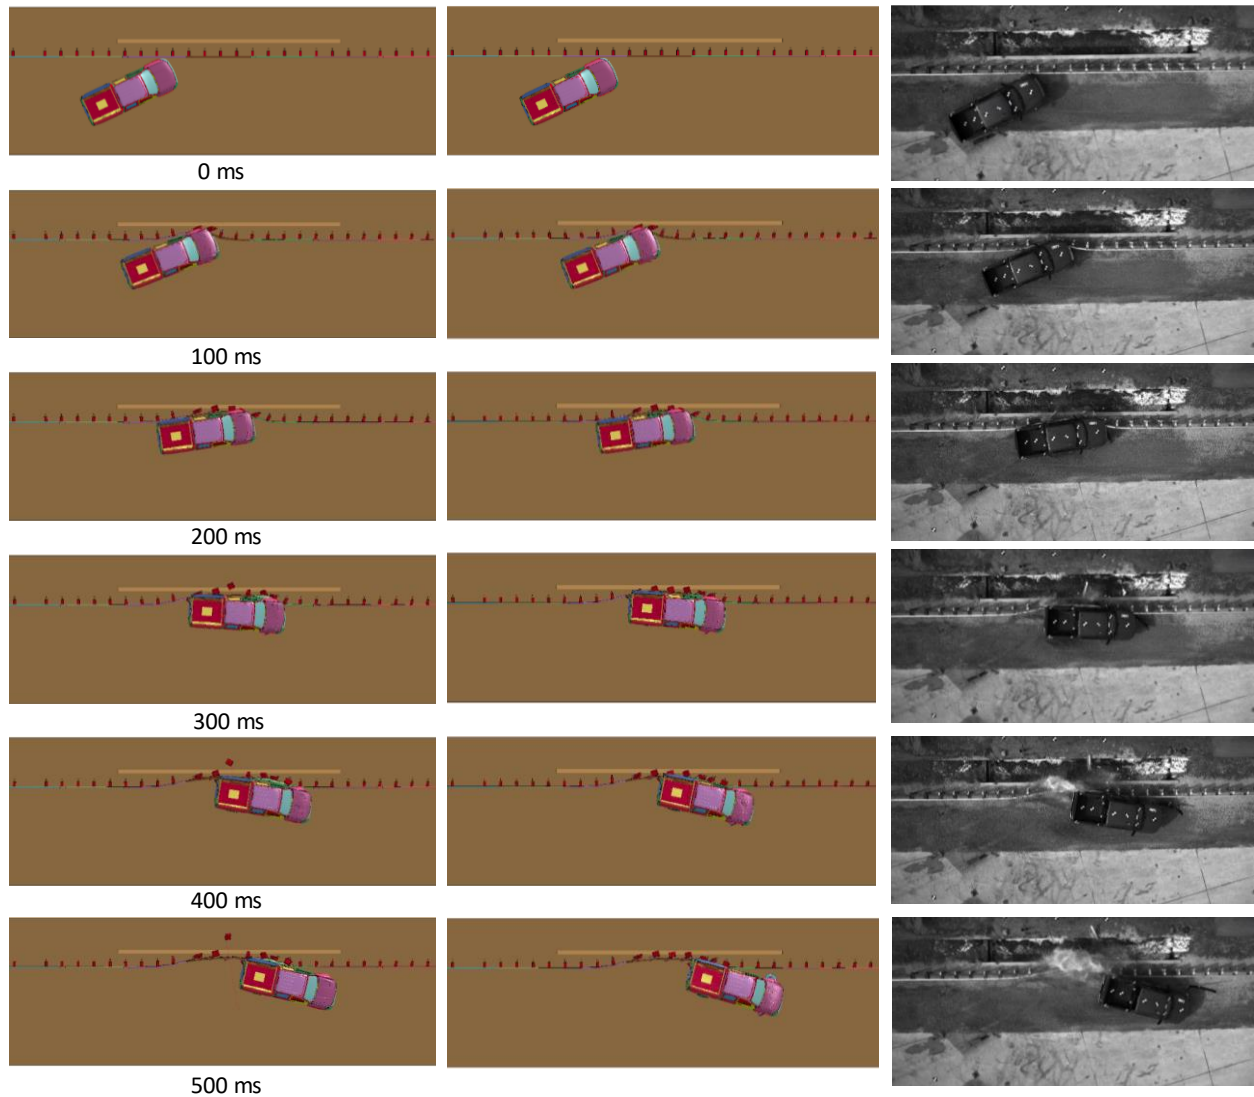
Figure 110. Simulation without Wheel Disengagement (Left), Simulation with Wheel Disengaged (Middle), and Test No. CMGS-2 (Right)

In test no. CMGS-2, the impact-side wheel of the test vehicle snagged on posts nos. 18 and 19 and was disengaged. However, the initial baseline model did not have wheel disengagement enabled. Thus, a modified model with wheel disengagement capabilities was configured. Note that failure of wheel and suspension parts cannot be reliably predicted. Thus, time-based failure was enabled in the vehicle model. This wheel disengagement model required a prescribed time to initialize the three-stage wheel disengagement process, which involves disengaging upper, lower, and steering control arms from the vehicle model. The disengagement time was estimated using test videos. Specifically, the front wheel at the guardrail side started disengaging at time 150 ms and the wheel was completely disengaged at time 160 ms. This wheel disengagement time corresponded to the approximate wheel disengagement time of 155 ms during the test. Other than the wheel disengagement, everything else in the barrier and vehicle models was kept the same with the initial baseline model. Sequential time comparisons of the baseline model without wheel disengagement, the modified model with wheel disengagement, and test no. CMGS-2 are shown in Figure 110.
