PERFORMANCE EVALUATION OF MISSOURI DOT DUAL-POST, U-CHANNEL SIGN SUPPORT ACCORDING TO MASH 2016

MIDWEST ROADSIDE SAFETY FACILITY

MwRSF Research Report No. TRP-03-426-20

December 16, 2020

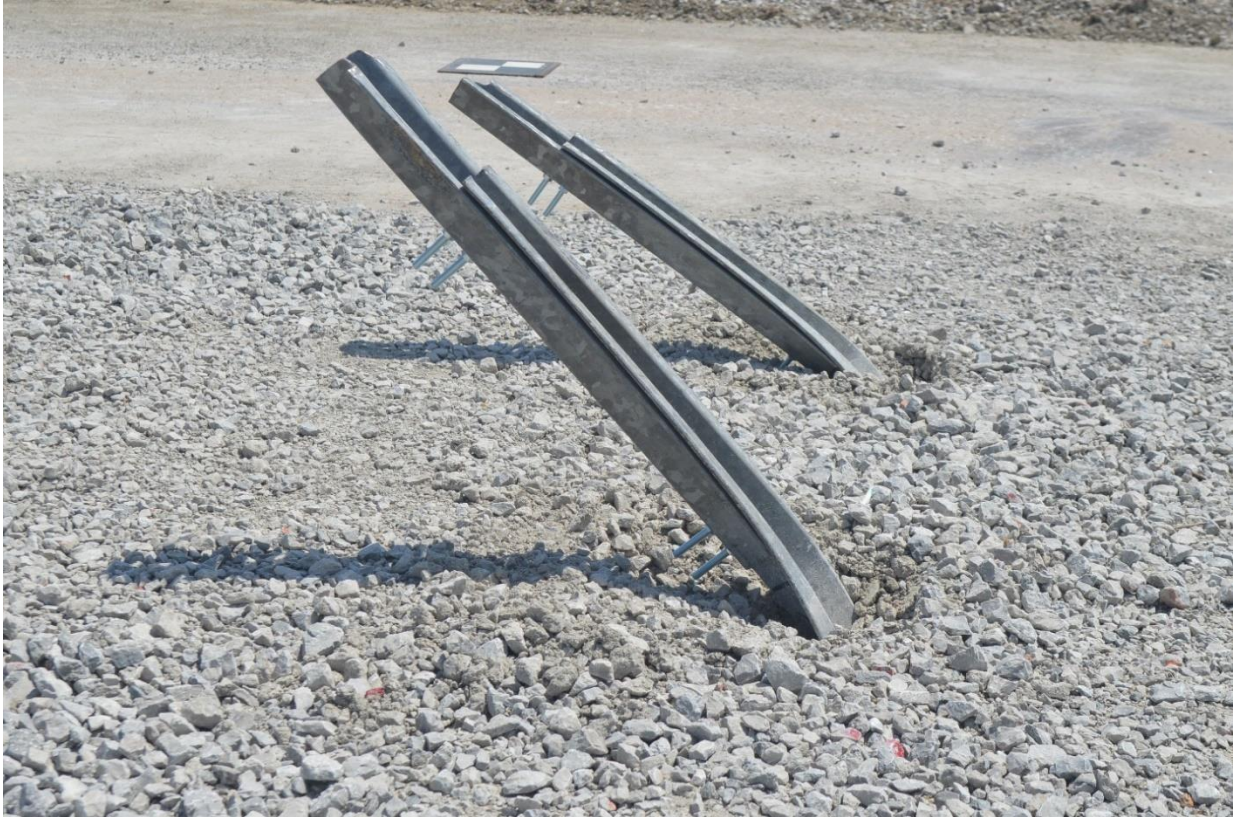
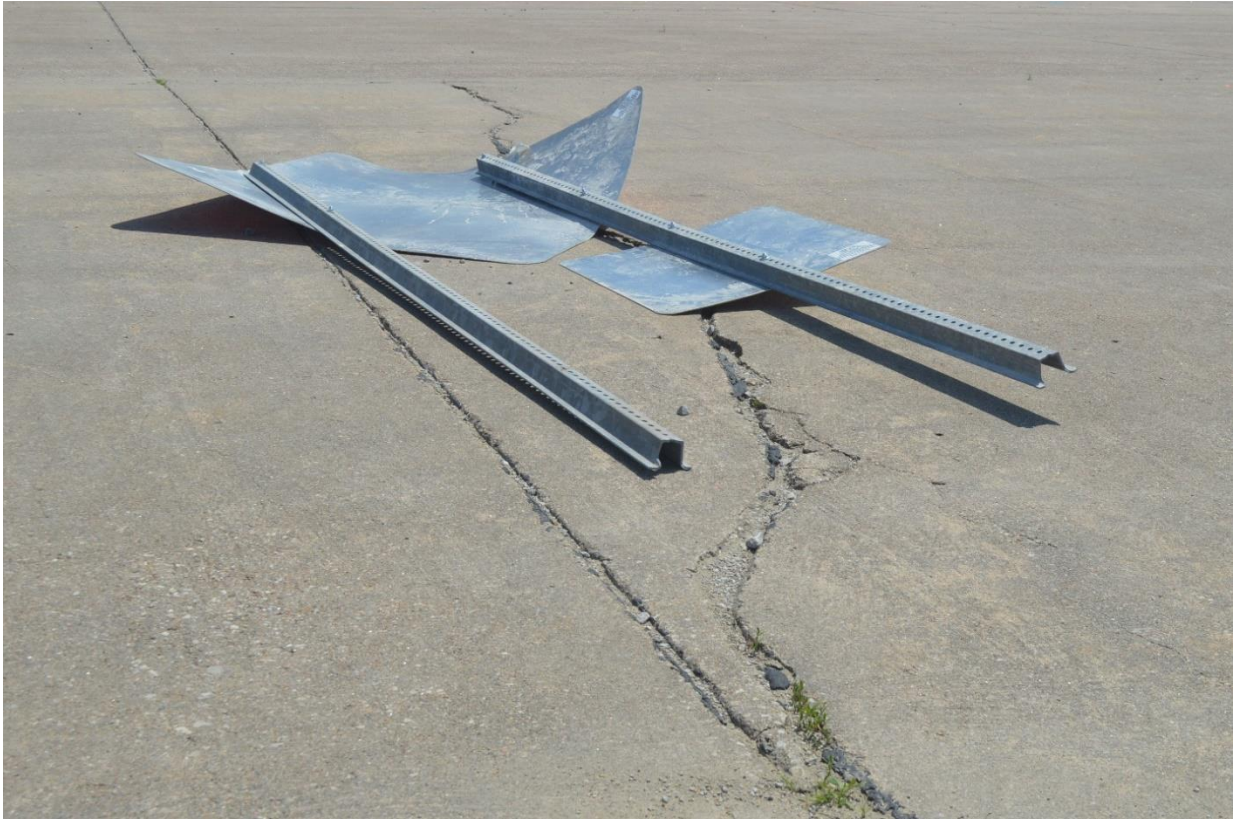
Figure 38. System Damage, Test No. MOS-5

Damage to the system was severe, as shown in Figures 38 through 42. System damage consisted of contact marks, fracture and deformation of the posts, and bending of the upper sign panel.

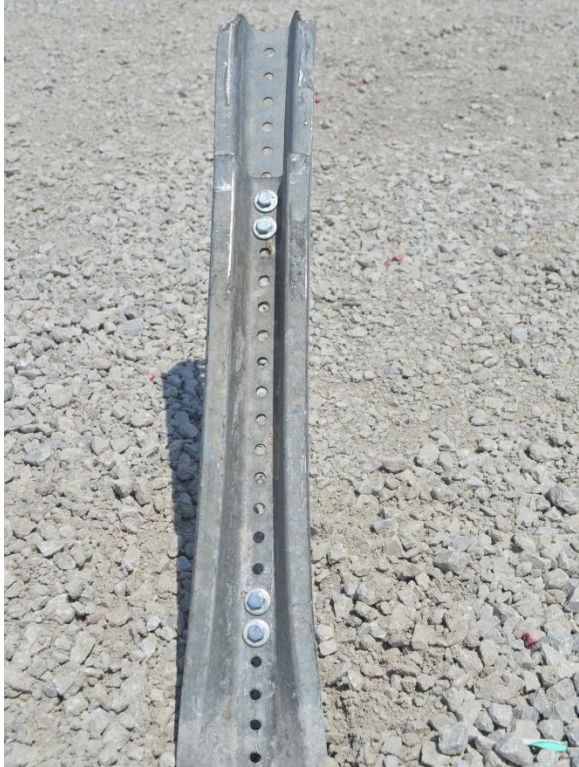
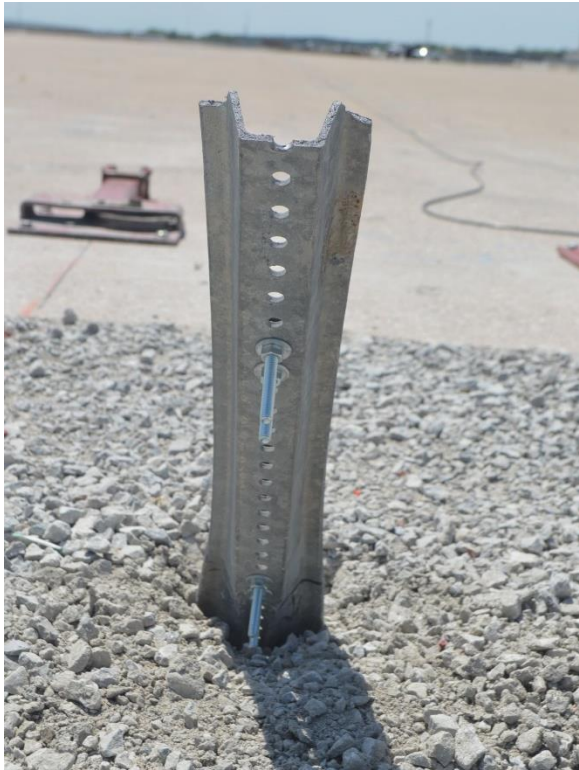
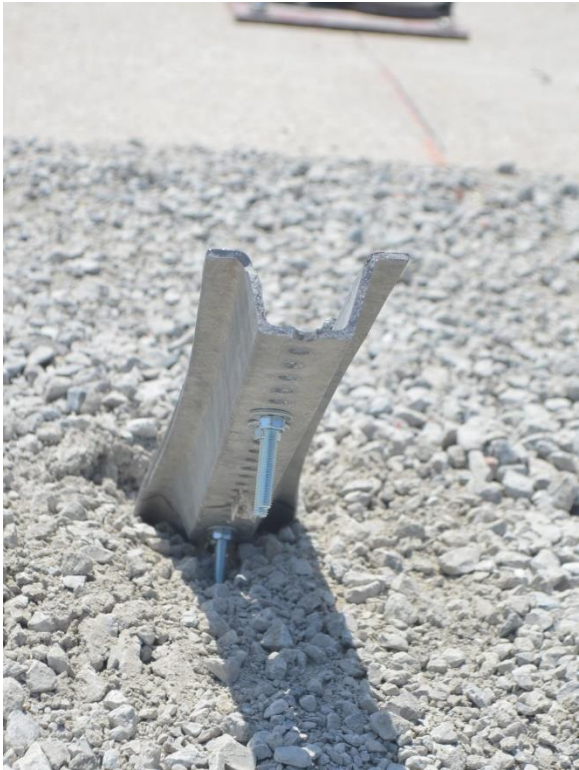
Figure 40. System Damage, U-Channel Posts, Test No. MOS-5

Both embedded stubs bent at the ground line in the downstream direction, and the bending deformed the U-channel stub cross sections to a width of 4¾ in. (121 mm). Cracking along the centerline of both U-channel stubs was visible beginning at the ground line and extending up 3¾ in. (95 mm), stopping below the bolted connection to the post. The height of the remaining stub in its deformed state was greater than 4 in. (102 mm) above the ground line. Removing the stubs from the ground revealed that the left post had fractured below the ground line. Both stubs had additional centerline cracking along the embedded portion of the stub, extending approximately 6 in. below the ground line. The bolted connections between the embedded stubs and the U-channel posts remained intact. On the right post, 11-in. (279 mm) long contact marks started at the sheared top and extended down. Contact marks on the left edge of the left post started 21¾ in. (552 mm) from the sheared top and extended down. Additional contact marks on the right edge of the left post started 22¾ in. (578 mm) from the sheared top and extended down.

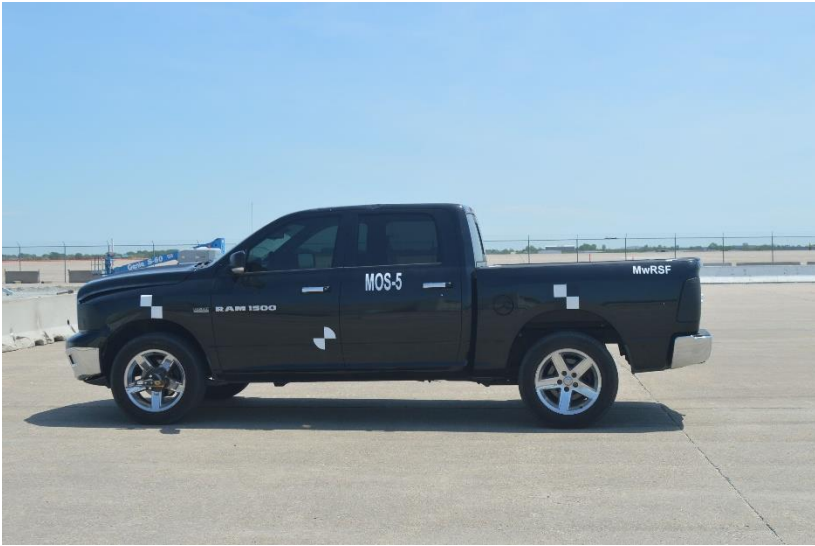
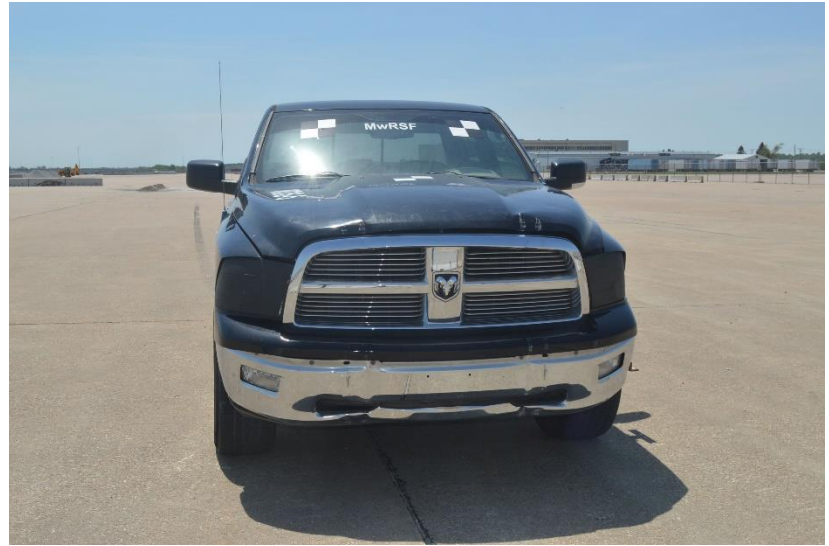
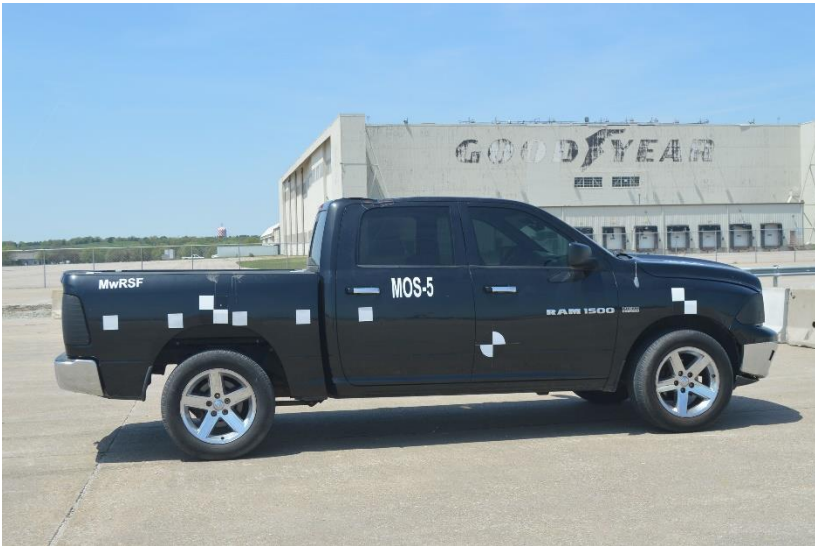
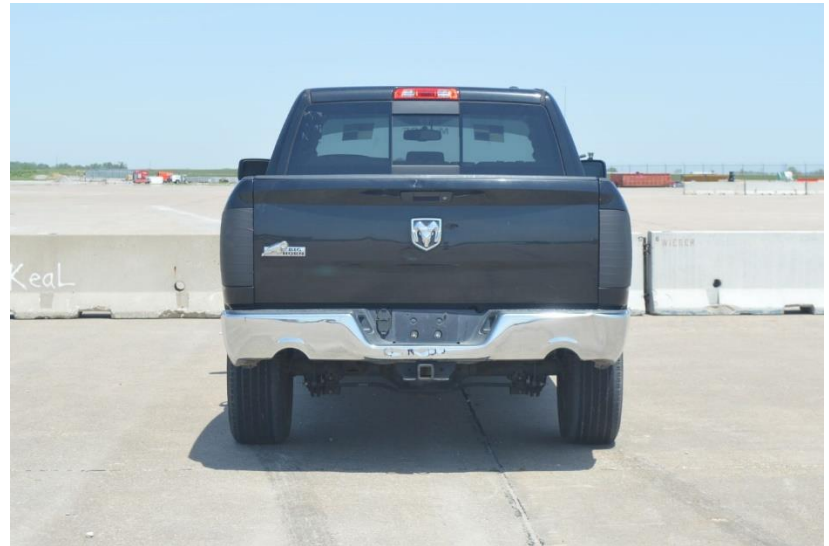
Figure 43. Vehicle Damage, Test No. MOS-5

The damage to the vehicle was minimal, as shown in Figures 43 and 44. The maximum occupant compartment intrusions are listed in Table 5 along with the intrusion limits established in MASH 2016 for various areas of the occupant compartment. Complete occupant compartment and vehicle deformations and the corresponding locations are provided in Appendix D. MASH 2016 defines intrusion or deformation as the occupant compartment being deformed and reduced in size with no observed penetration. There were no penetrations into the occupant compartment and none of the established MASH 2016 deformation limits were violated. Outward deformations, which are denoted as negative numbers in Appendix D are not considered crush toward the occupant and are not evaluated by MASH 2016 criteria.

The majority of damage was concentrated on the front of the vehicle where the impact occurred. The grille was cracked on both sides of the vehicle and was fractured on the left side. The front bumper was dented and bent downward. The hood of the vehicle was slightly ajar. Scrapes were observed along the undercarriage. The lower control arms and muffler were slightly dented. The roof was slightly dented. No damage was observed to the sides of the vehicle, and the windshield and windows remained intact.

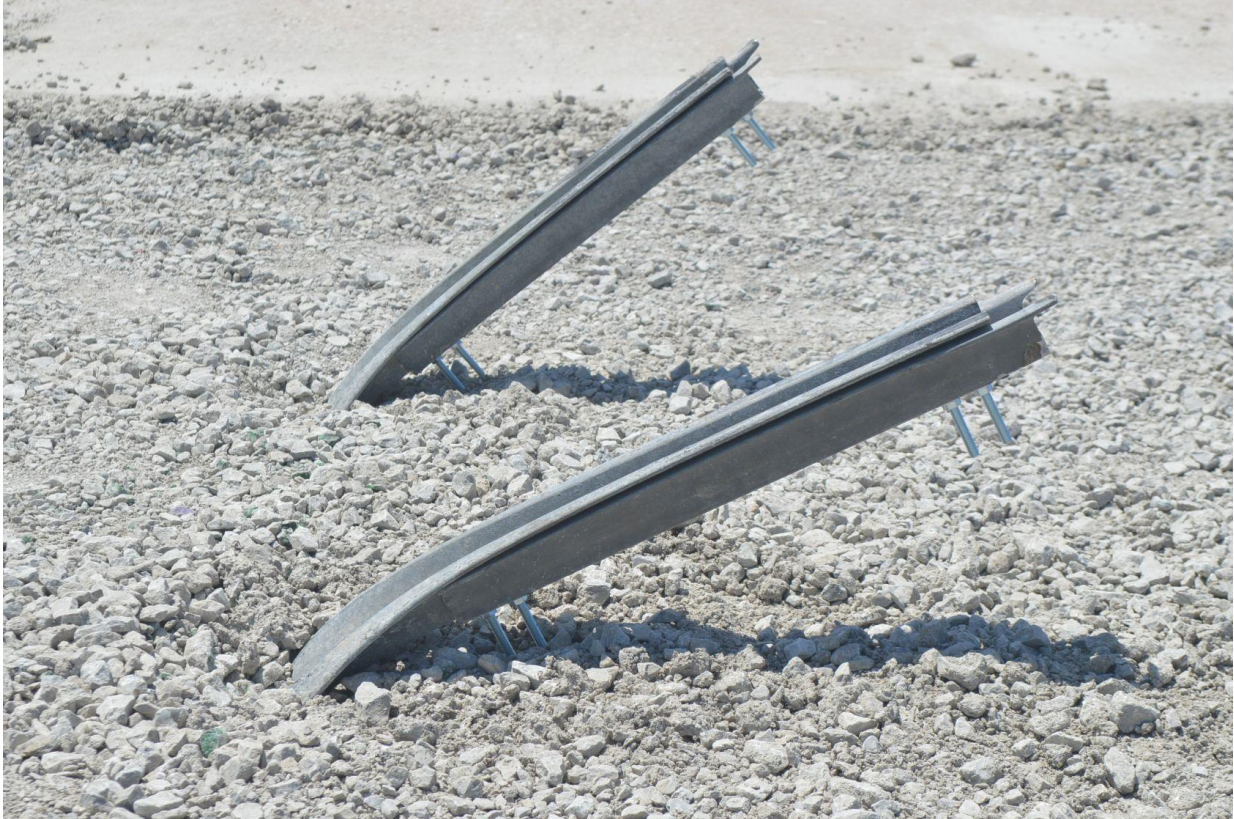
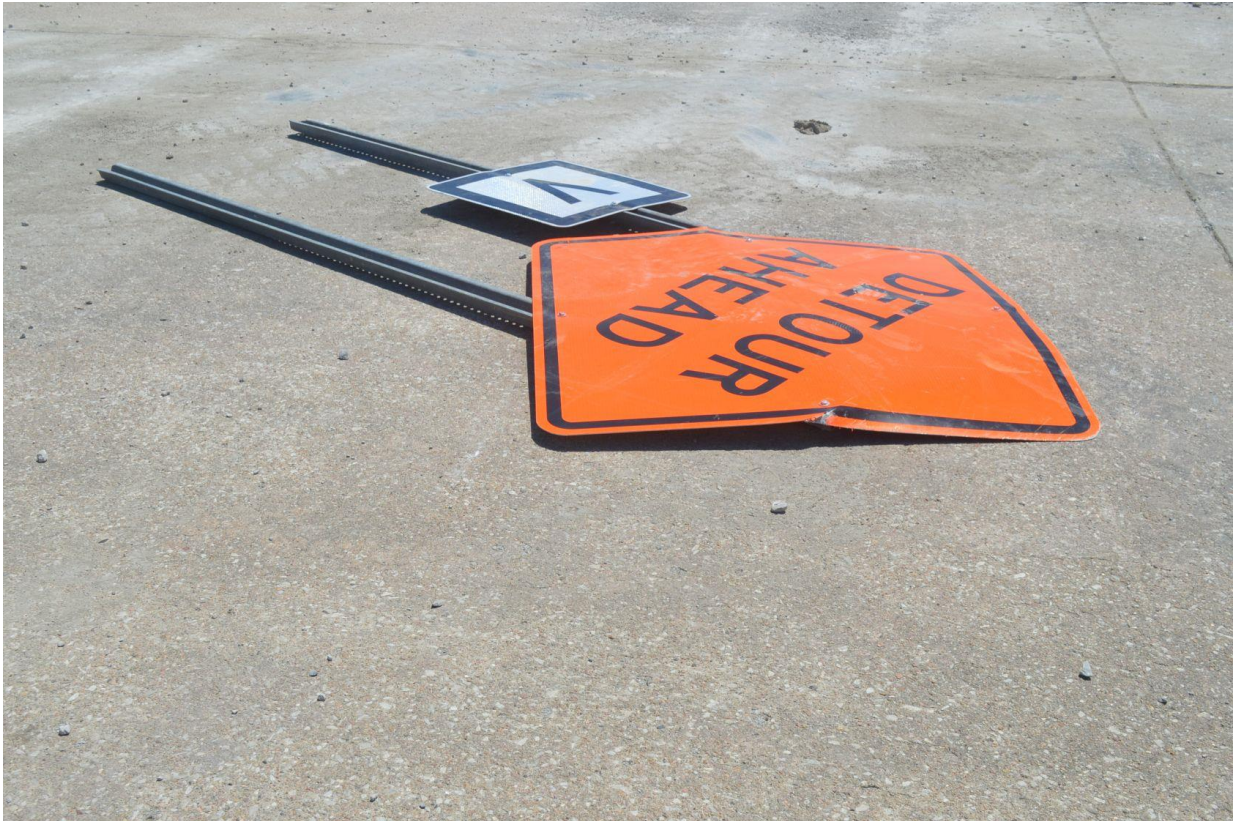
Figure 53. System Damage, Test No. MOS-6

Damage to the system was severe, as shown Figures 53 through 57. System damage consisted of contact marks, deformation, and fracture of the sign posts as well as deformation and cracking of the upper sign panel.

The left post sheared 23 in. (584 mm) above the ground line while the right post sheared 25½ in. (648 mm) above the ground line. The portion of the system above the shear plane became airborne, contacted the roof of the test vehicle, and landed upstream from the original system position. The sign panels remained attached to the posts. All four corners of the upper sign were bent slightly out of plane and a crack extended inward approximately 4 in. (102 mm) from the upper-right edge of the panel.

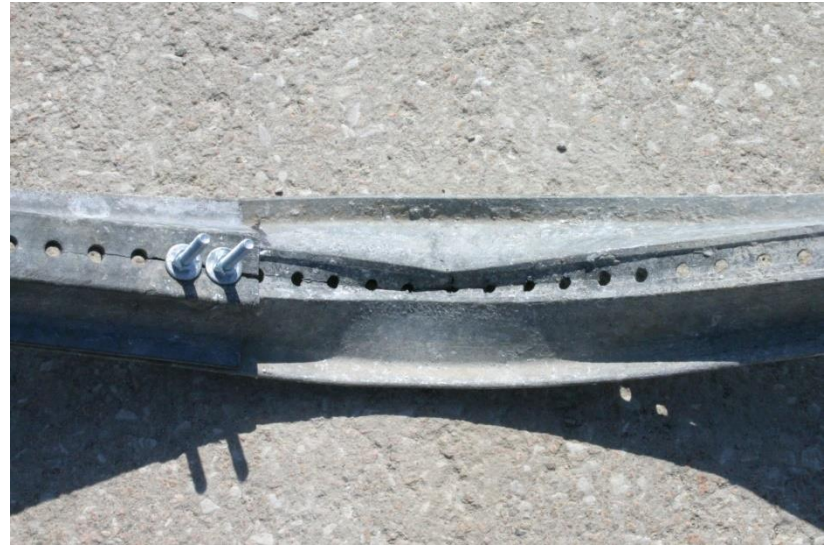
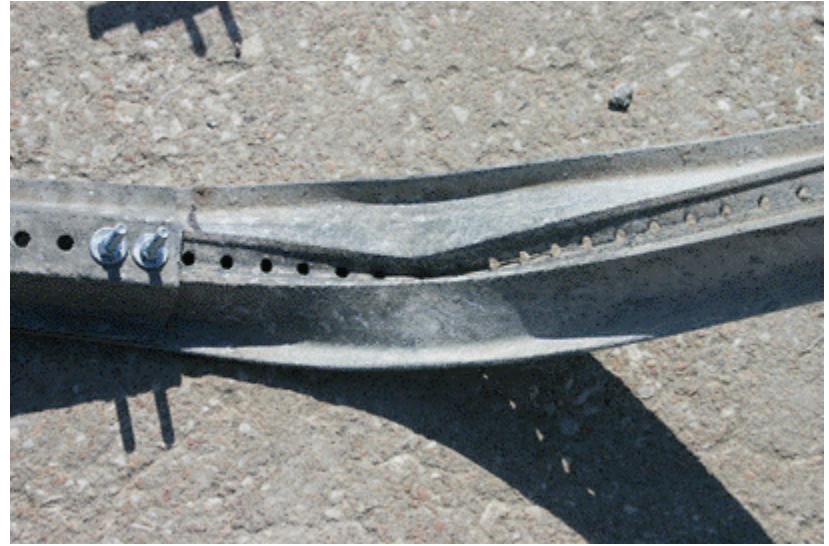
Figure 57. System Damage, Embedded Stubs, Test No. MOS-6

Both embedded stubs bent at the ground line in the downstream direction and the bending deformed the U-channel stub cross sections, increasing the section width to 5⅞ in. (149 mm) at the left stub and 5 in. (127 mm) at the right stub. Cracking along the centerline of both U-channel stubs was visible beginning at the ground line, extending 3½ in. (89 mm) up the left stub and 5½ in. (140 mm) up the right stub. In both stubs, the cracking stopped below the bolted connection to the post. The height of the remaining stub in its deformed state was greater than 4 in. (102 mm) above the ground line. Removing the stubs from the ground revealed that both stubs had additional centerline cracking along the embedded portion of the stub. The bolted connections between the embedded stubs and the U-channel posts remained intact, however, the left post had a centerline crack beginning at the bottom of the post and extending up approximately 4 in. (102 mm). The left post had contact marks on the front face starting 9 in. (229 mm) from the ground and measuring 13 in. (330 mm) long. The right post was had contact marks starting 12 in. (305 mm) above the ground that measured 12 in. (305 mm) in length.

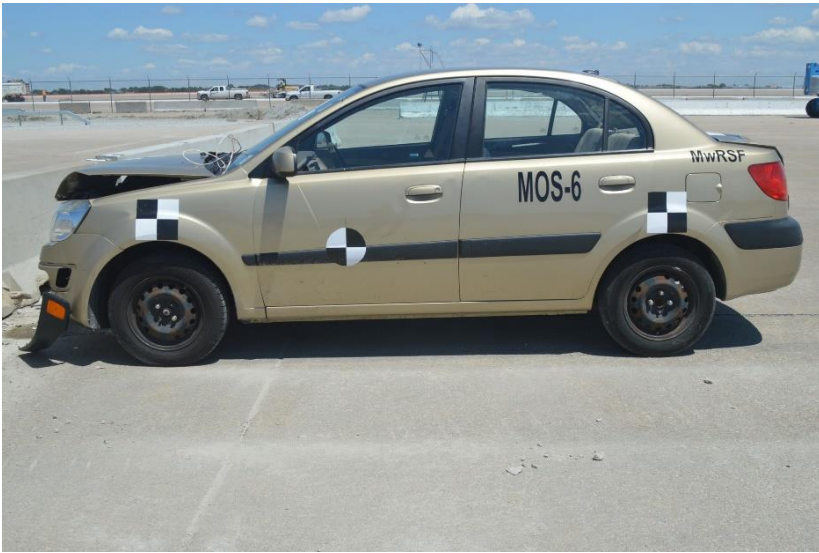
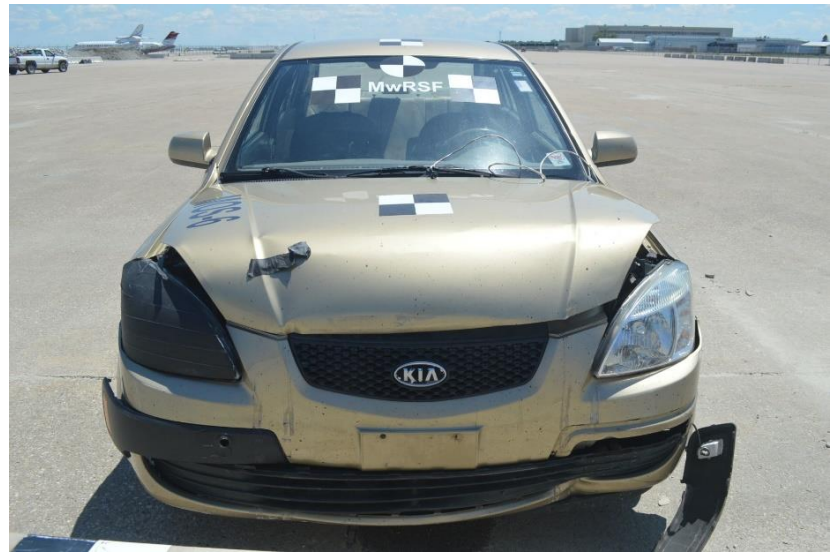
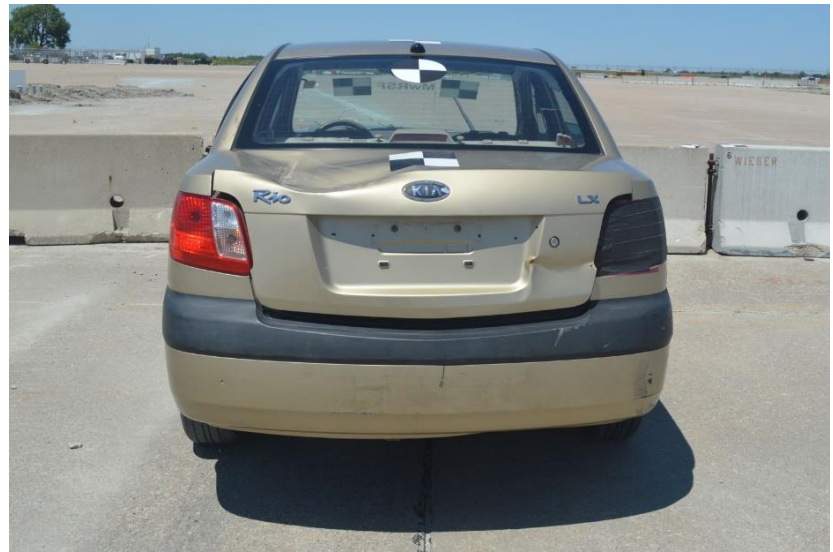
Figure 58. Vehicle Damage, Test No. MOS-6

The damage to the vehicle was minimal, as shown in Figure 58. The maximum occupant compartment intrusions are listed in Table 9 along with the intrusion limits established in MASH 2016 for various areas of the occupant compartment. Complete occupant compartment and vehicle deformations and the corresponding locations are provided in Appendix D. MASH 2016 defines intrusion or deformation as the occupant compartment being deformed and reduced in size with no observed penetration. There were no penetrations into the occupant compartment and none of the established MASH 2016 deformation limits were violated. Outward deformations, which are denoted as negative numbers in Appendix D are not considered crush toward the occupant and are not evaluated by MASH 2016 criteria.

The majority of the damage was concentrated on the front of the vehicle where the impact occurred. The grille and hood were crushed inward. The left-side running light disengaged from the vehicle. The bumper insert disengaged from the top mounts. The right fender deformed outward at the middle. The left side of the trunk was crushed downward into the trunk compartment. The right frame horn was dented inward toward the engine compartment. The floor pan and gas tank experienced minor scraping. The windshield and side windows remained intact.

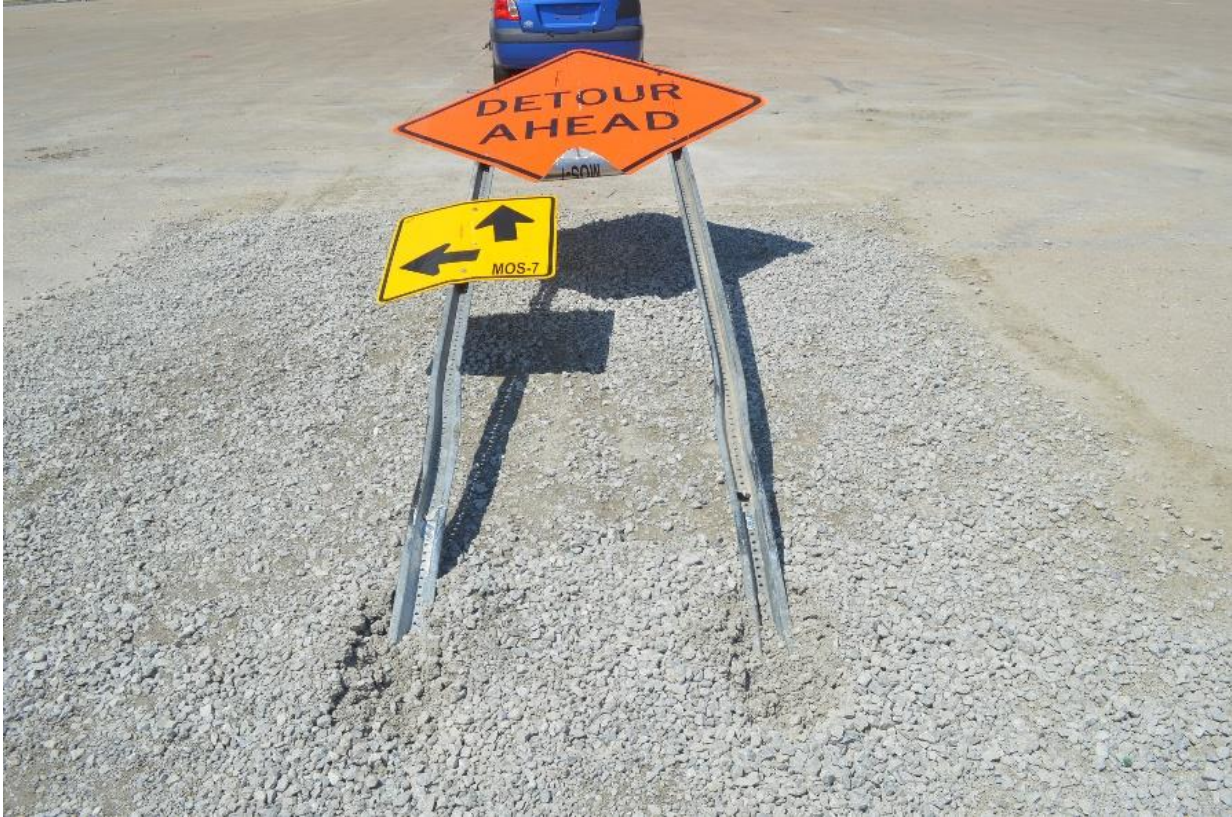
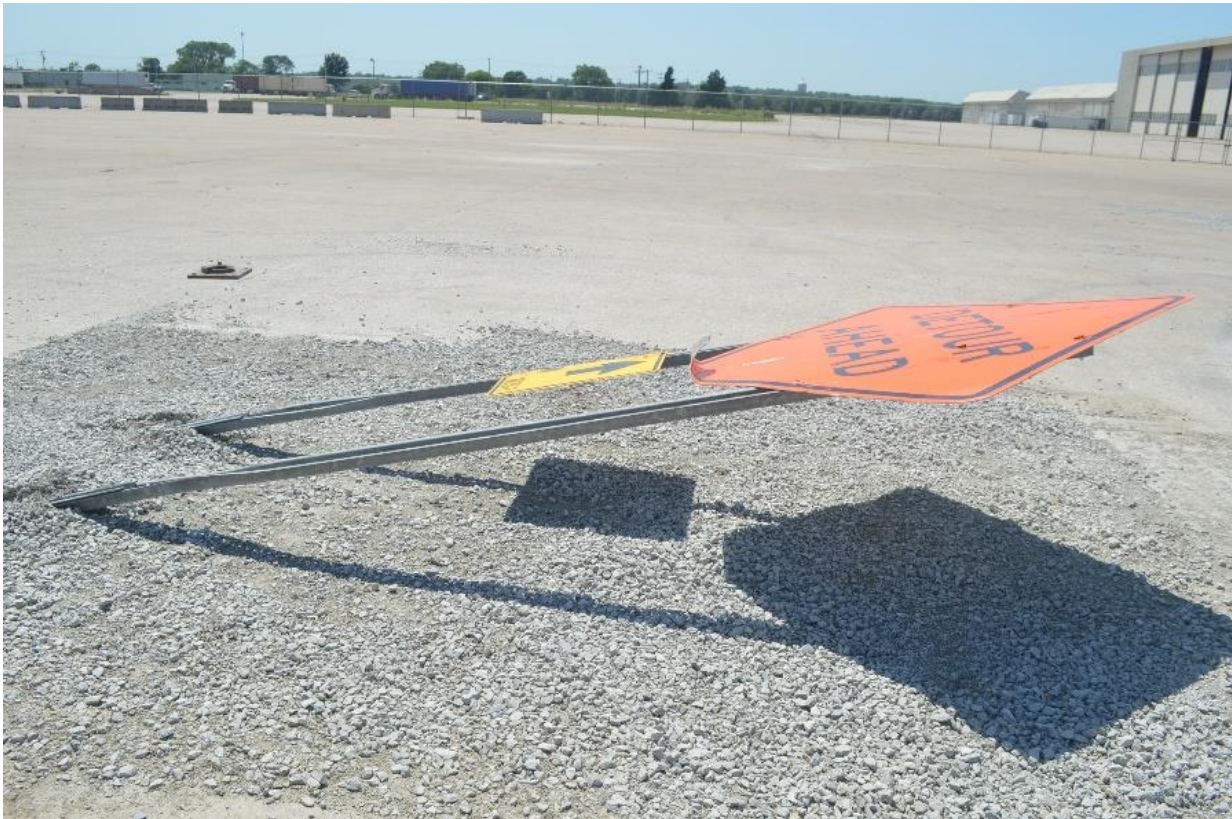
Figure 69. System Damage, Test No. MOS-7

Damage to the system was severe, as shown in Figures 69 through 72. System damage consisted of contact marks on the posts, bending of the posts, and bending of the upper sign panel.

The left and right posts bent downstream at the ground line and the bolted connections to the embedded stubs remained intact. The sign panels remained attached to the posts, and the bottom edge of the upper sign panel was bent. The system in its deformed state was greater than 4 in. (102 mm) above the ground line. Removing the embedded stubs from the ground revealed cracking along the centerline of the U-channel that extended several inches below the ground line. In addition, both embedded stubs were bent.

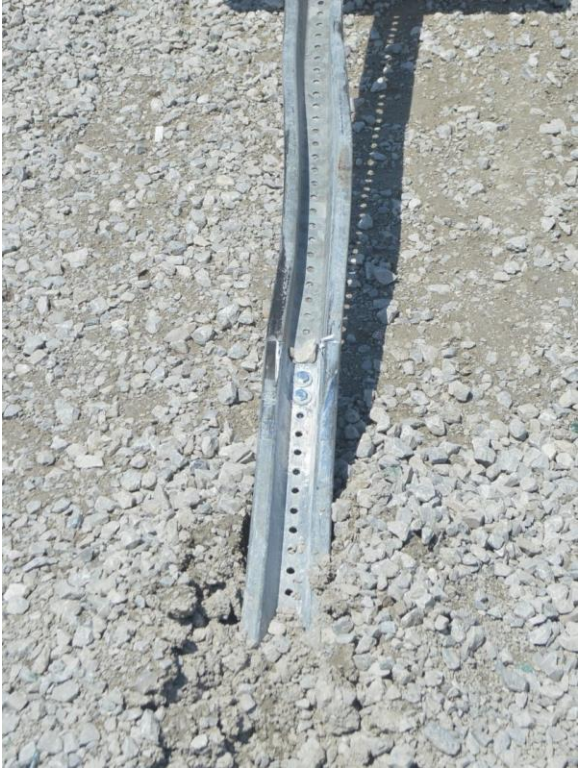
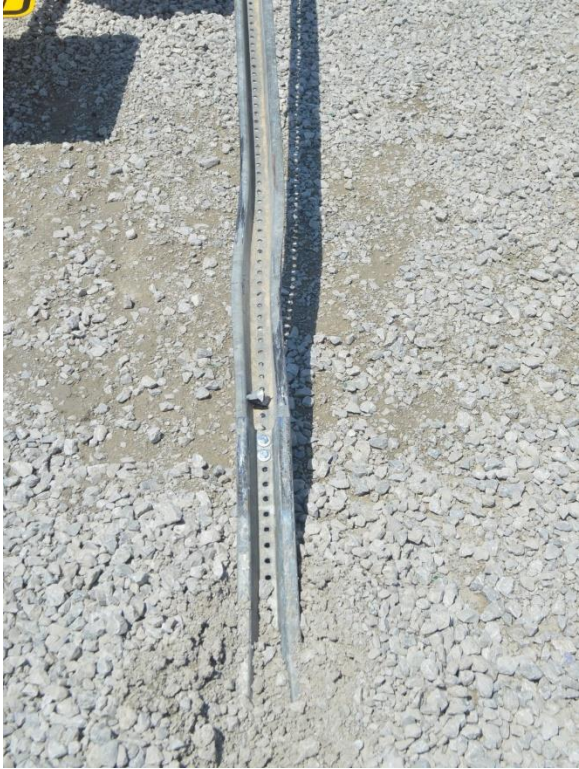
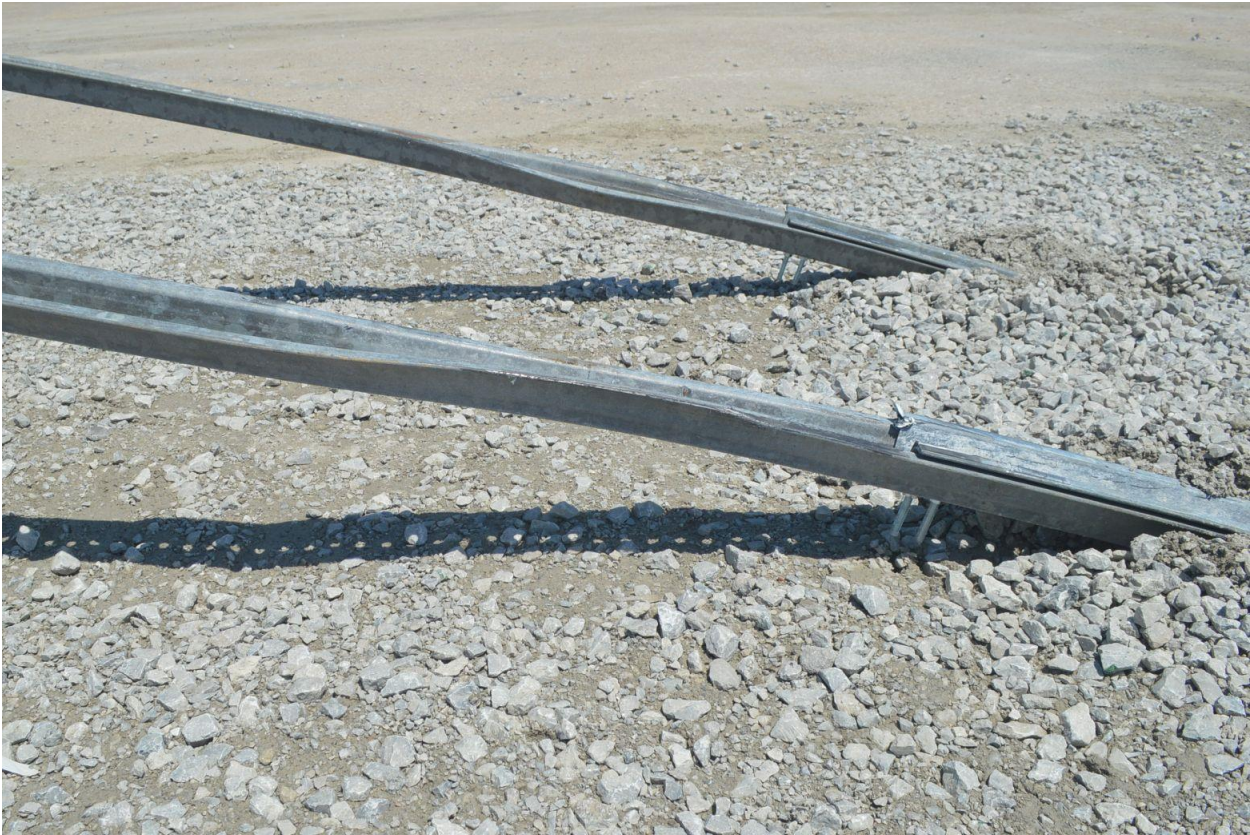
Figure 71. System Damage, U-Channel Posts, Test No. MOS-7

On the left post, a 21½-in. (546-mm) long contact mark on the left flange and a 39-½ in. (1,003-mm) long contact mark on the right flange started 10 in. (254 mm) and 7½ in. (191 mm) from the ground line, respectively. Four contact marks were found on the right post. The left flange had 37½-in. (953-mm) and 24-in. (610-mm) long contact marks that started 10½ in. (267 mm) and 53 in. (1,346 mm) from the ground line, respectively. The right flange had a 24-in. (610-mm) long contact mark that started 9 in. (229 mm) from the ground line and a 26½-in. (673-mm) long contact mark that started 66 in. (1,676 mm) from the ground line. Over the lower portion of the system, both posts exhibited lateral deformation toward the centerline of the system and deformation of the left U-channel flange.

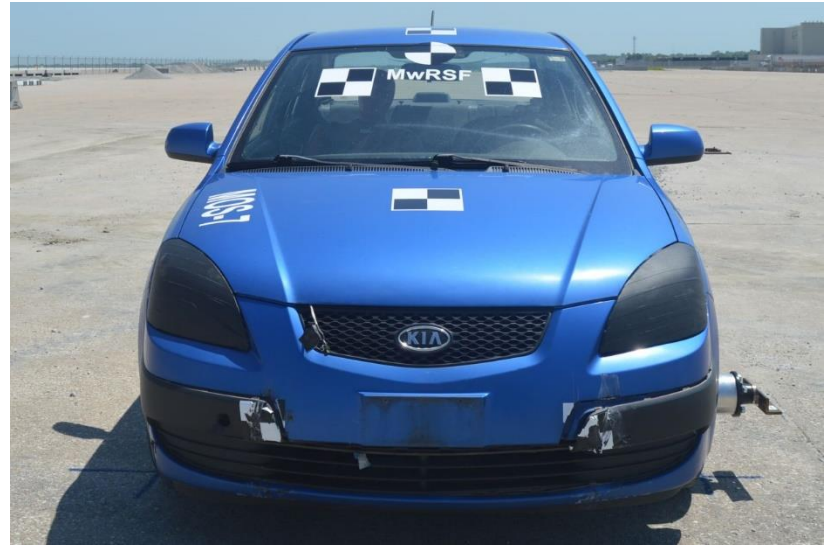
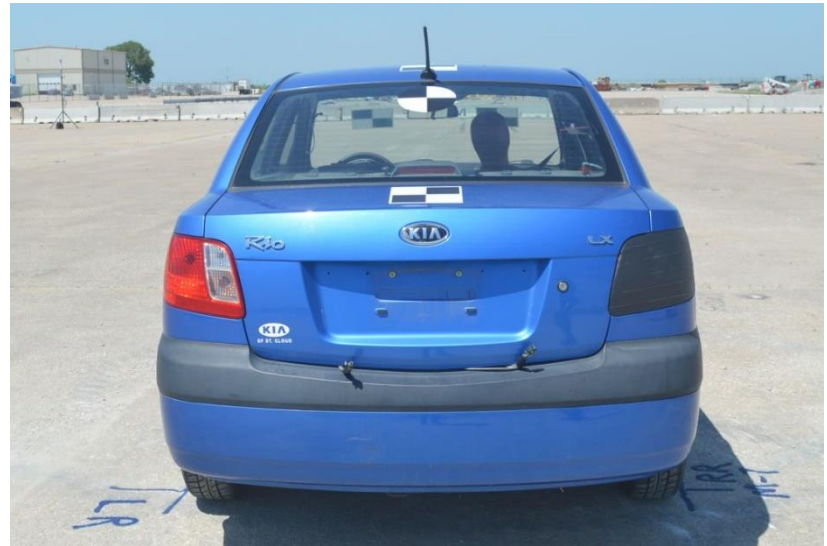
Figure 73. Vehicle Damage, Test No. MOS-7

The damage to the vehicle was minimal, as shown in Figure 73. The maximum occupant compartment intrusions are listed in Table 13 along with the intrusion limits established in MASH 2016 for various areas of the occupant compartment. Complete occupant compartment and vehicle deformations and the corresponding locations are provided in Appendix D. MASH 2016 defines intrusion or deformation as the occupant compartment being deformed and reduced in size with no observed penetration. There were no penetrations into the occupant compartment and none of the established MASH 2016 deformation limits were violated. Outward deformations, which are denoted as negative numbers in Appendix D are not considered crush toward the occupant and are not evaluated by MASH 2016 criteria.

The majority of the damage was concentrated on the front of the vehicle where the impact occurred, and on the undercarriage of the vehicle where the system contacted the vehicle. The bumper was scraped and cracked at the two points where the bumper impacted the posts of the system. Scraping occurred along a majority of the undercarriage of the vehicle. The windshield, windows, and remainder of the vehicle remained undamaged.
