MASH 2016 TEST LEVEL 3 EVALUATION OF MNDOT BICYCLE AND PEDESTRIAN RAIL

MIDWEST ROADSIDE SAFETY FACILITY

MwRSF Research Report No. TRP-03-443-20

December 11, 2020

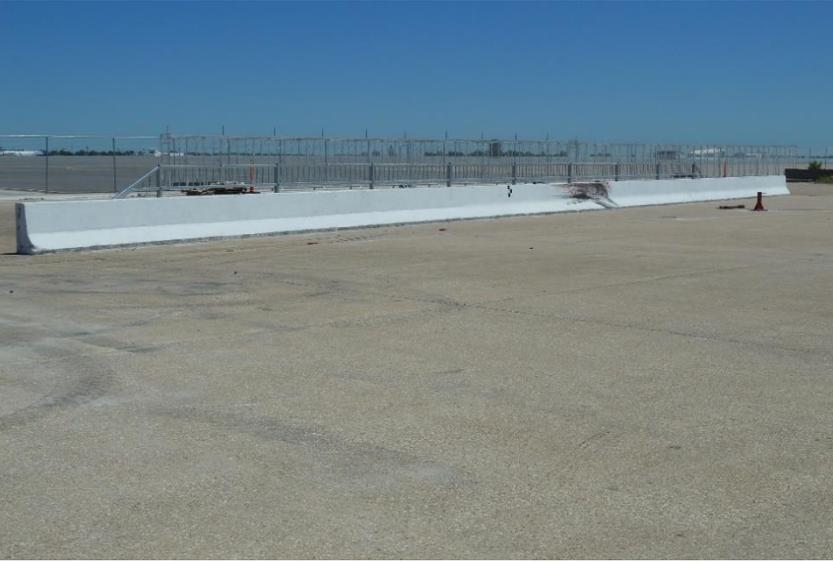
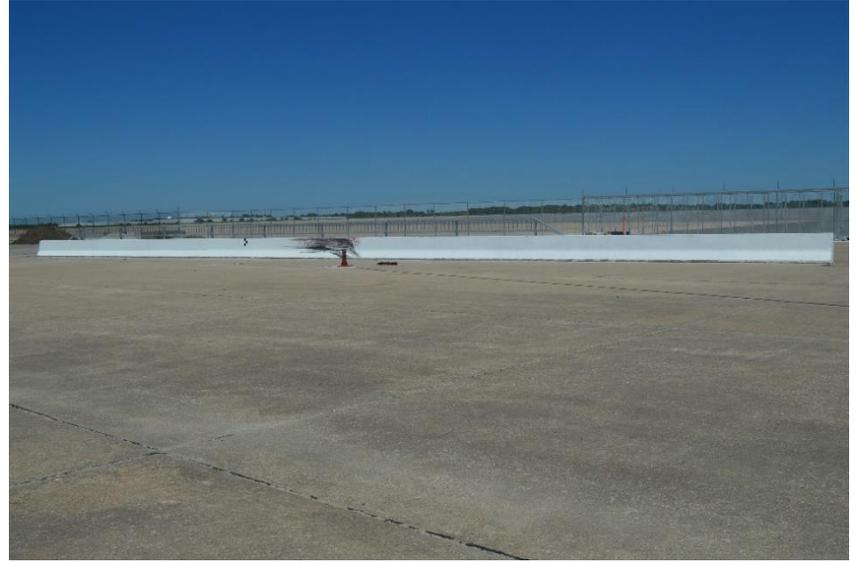
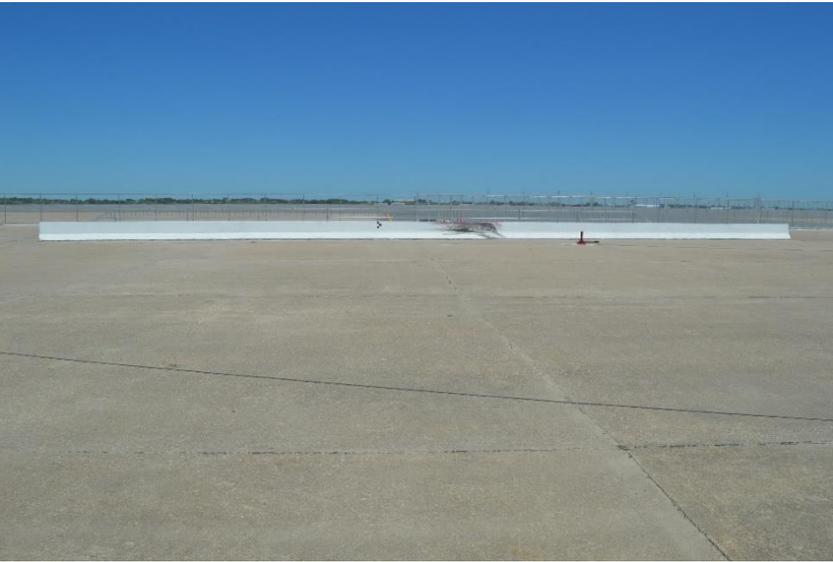
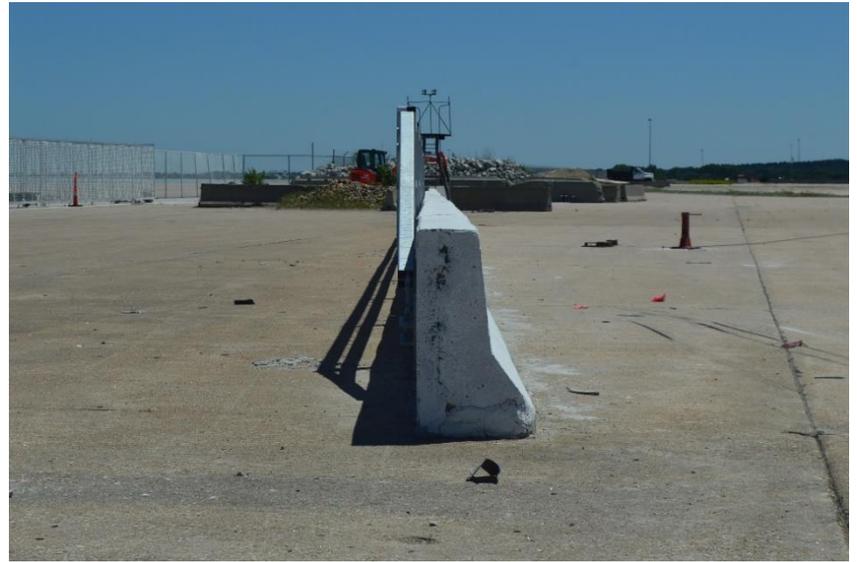
Figure 49. System Damage, Test No. MNPD-3

Damage to the barrier was minimal, as shown in Figures 49 through 58. Barrier damage largely consisted of contact marks, scraping, and gouging of the concrete barrier. The length of vehicle contact along the barrier extended downstream approximately 13 ft – 11 in., starting 14½ in. upstream from the impact point.

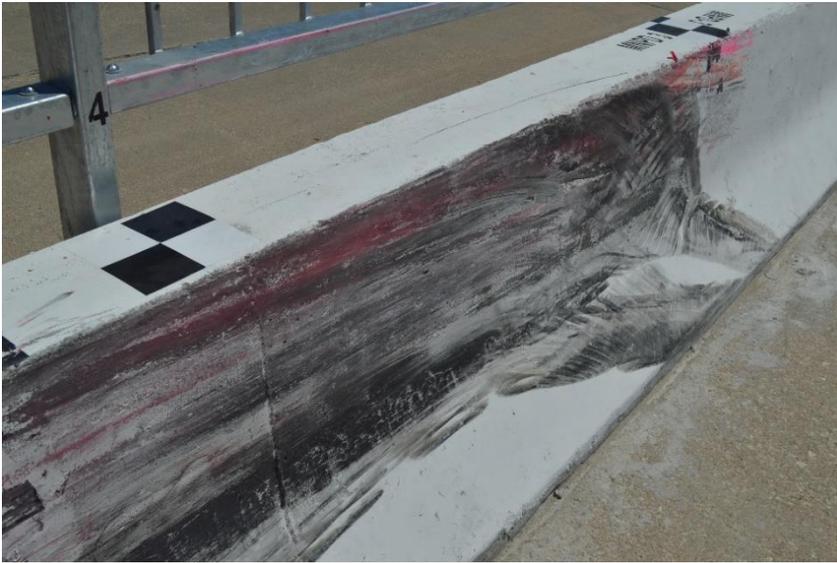
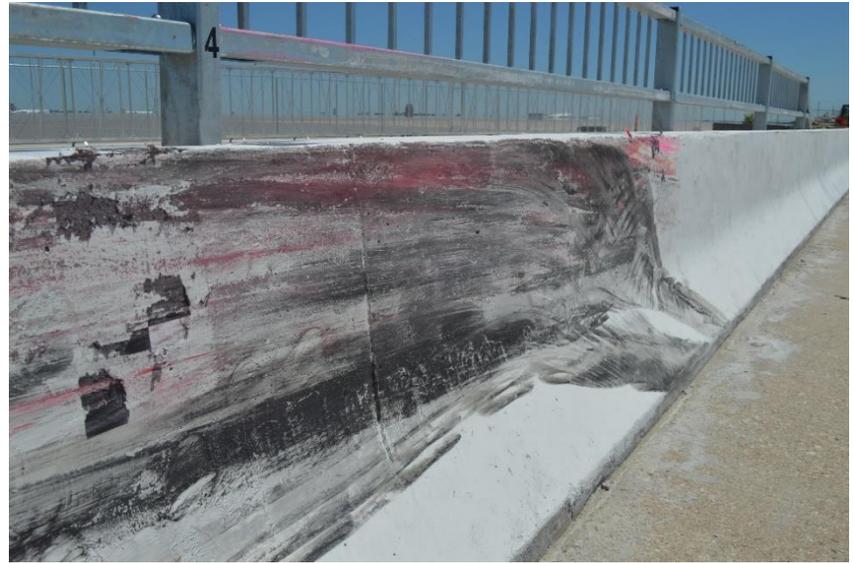
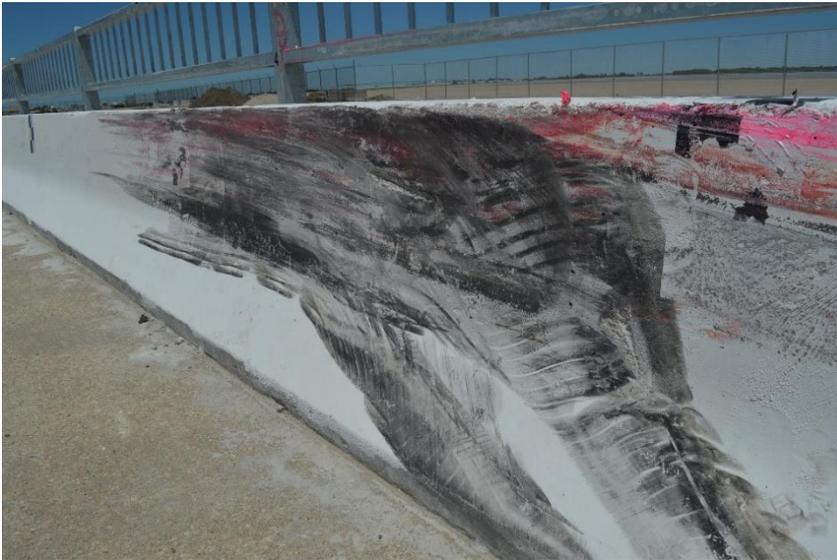
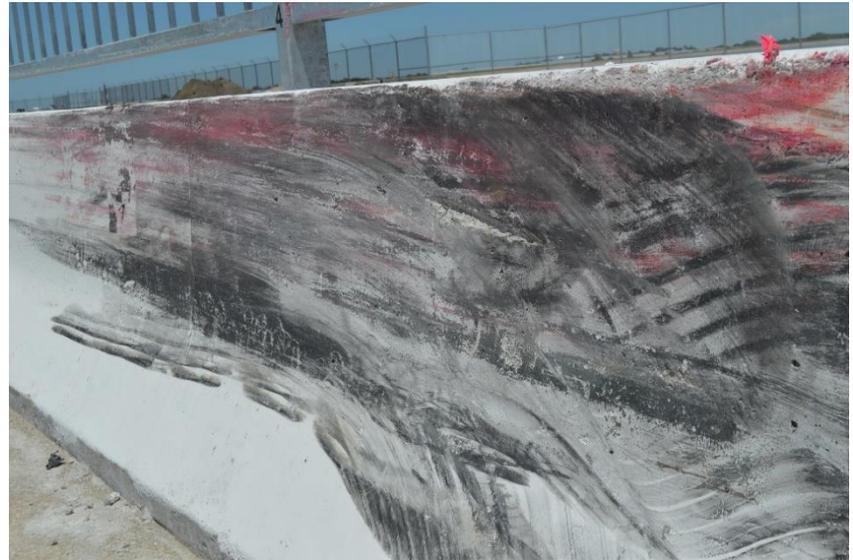
Figure 51. Tire Marks and Concrete Gouging, Test No. MNPD-3

Tire marks were visible on the front face of the J-shape concrete barrier, starting 14½ in. upstream from impact and extending 167 in. downstream across the traffic side of the barrier. Scuff marks were also found along the length of vehicle contact. Gouging was found on the front face of the barrier measuring 4½ in. long and located 15 in. from the top edge and extending 5½ in. downstream from the impact point with a height of 4 in. and a width of ¼ in. Scraping measuring 10 in. long was located 31 in. downstream from the impact point and 7 in. from the top front corner of the concrete barrier with a width of ½ in. Chipping, measuring 2½ in. long, was located 17 in. downstream from the impact point and 13¼ in. below the top front corner of the concrete barrier with a width of ¾ in. Additional chipping, measuring 11¼ in. long, was located on the top traffic-side corner of the concrete barrier 24½ in. downstream from post no. 4 with a height of ¾ in.

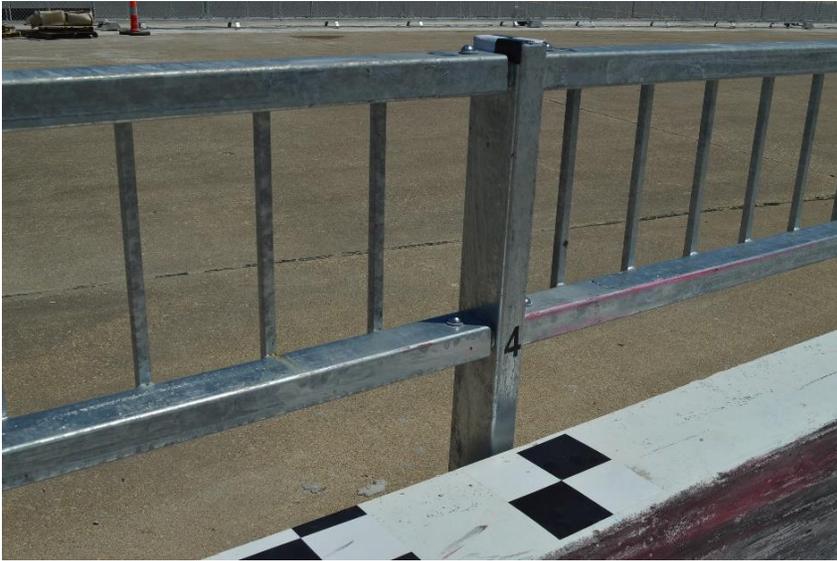
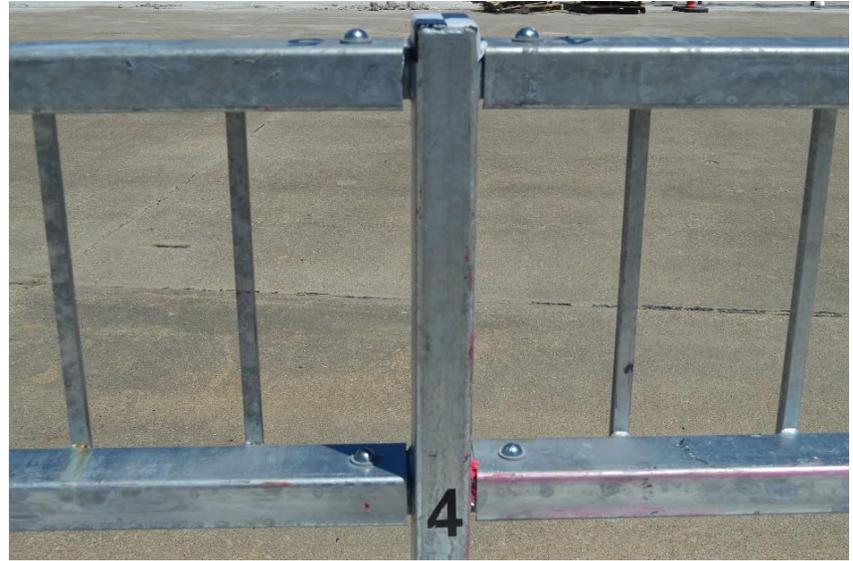
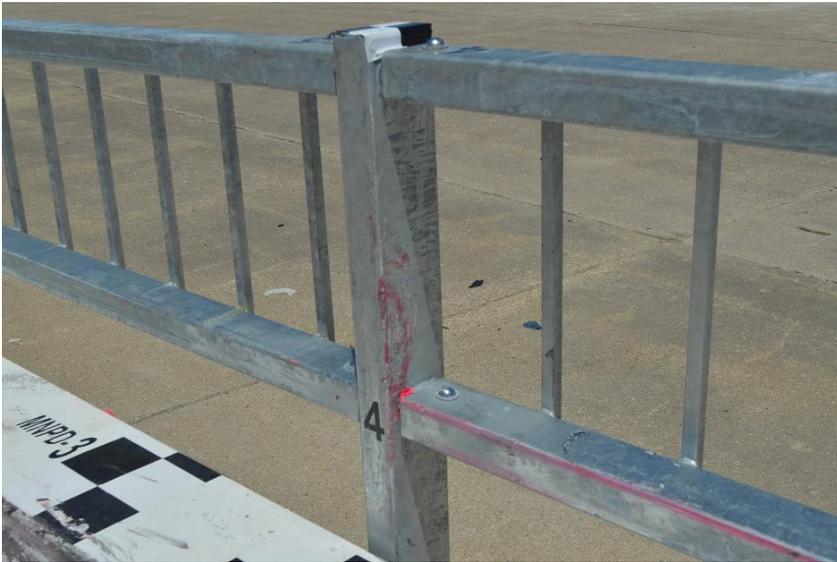
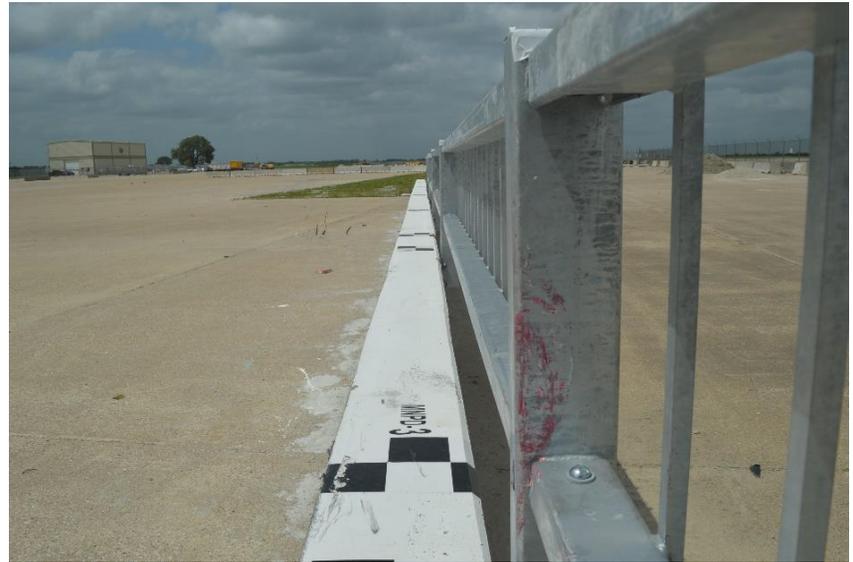
Figure 53. Rail and Post No. 4 Damage, Test No. MNPD-3

Contact marks measuring ¼ in. wide were found on the top corner of the lower rail, starting 23¼ in. upstream from post no. 4 and extending 31¾ in. downstream to the end of the rail. Contact marks ½ in. wide were found on the bottom corner of the lower rail, starting 10½ in. upstream from post no. 4 and extending 8½ in. downstream. Contact marks were found on the front face, near the top corner of the lower rail, starting 5¼ in. downstream from post no. 4 and extending 12 in. downstream. Minor vehicle contact occurred with the first vertical spindle located upstream from post no. 4, as shown in Figures 54 and 55. A small amount of vehicle debris remained on the spindle. Contact marks on the front face of the first spindle upstream from post no. 4 extended upward 7½ in. from the top face of the lower rail, as shown in Figure 53. Contact marks on the upstream face of post no. 4 began 7½ in. from the top and extended 11½ in. downward. A separate contact mark was observed on the downstream face of post no. 4, starting 4¾ in. from the top and extending 1¼ in. downward.

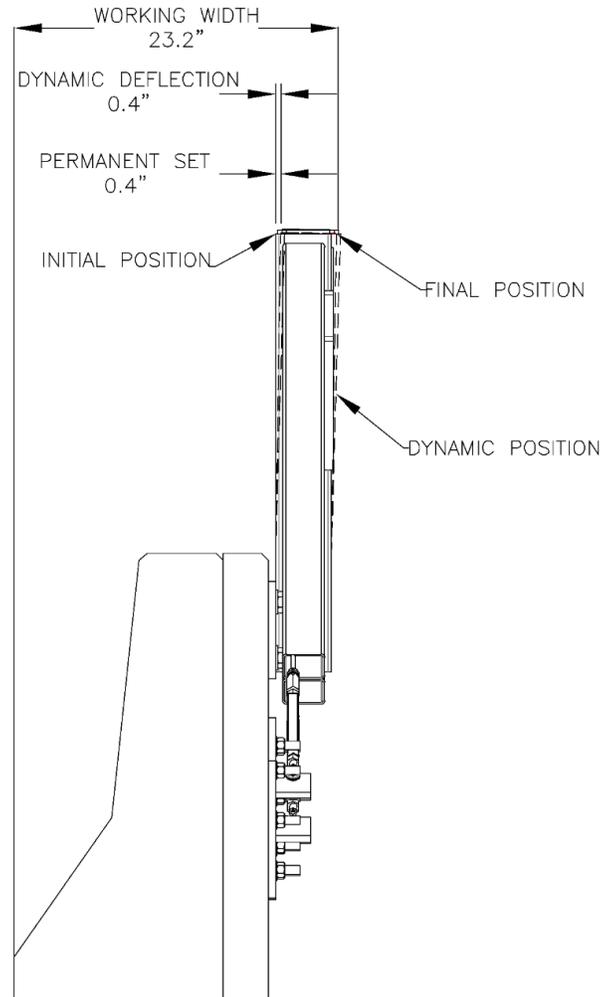
Figure 59. Permanent Set Deflection, Dynamic Deflection, and Working Width, Test No. MNPD-3

The maximum lateral permanent set of the barrier system was 0.4 in. between post nos. 5 and 6, as measured in the field. The maximum lateral dynamic barrier deflection, including rotation of the metal railing, was 0.6 in. on the upper rail at post no. 6, as determined from high-speed digital video analysis. The working width of the system was found to be 23.2 in., also determined from high-speed digital video analysis. The ZOI was 12¾ in. Barrier deflections are shown schematically in Figure 59.

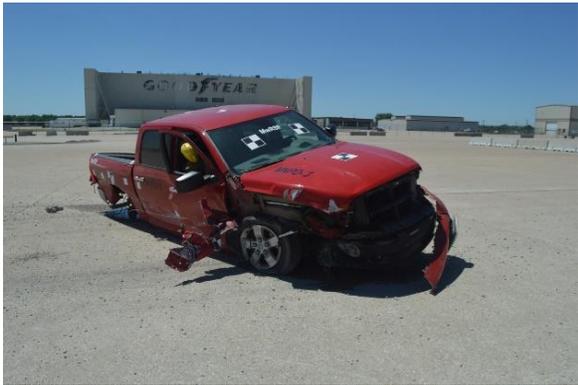
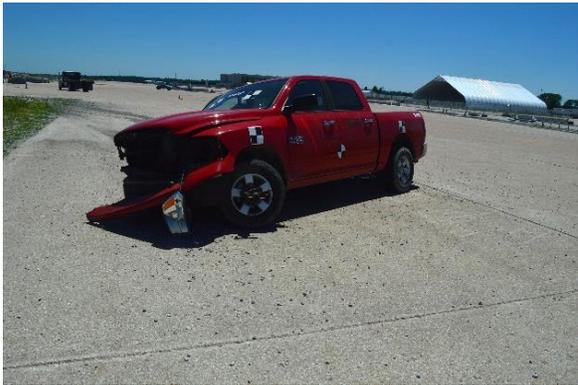
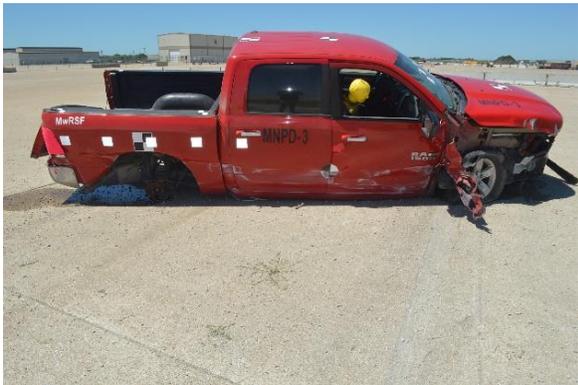
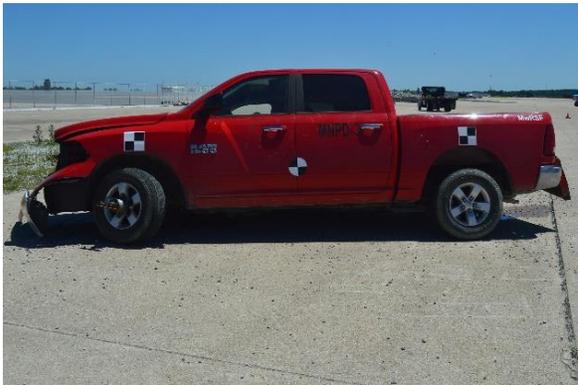
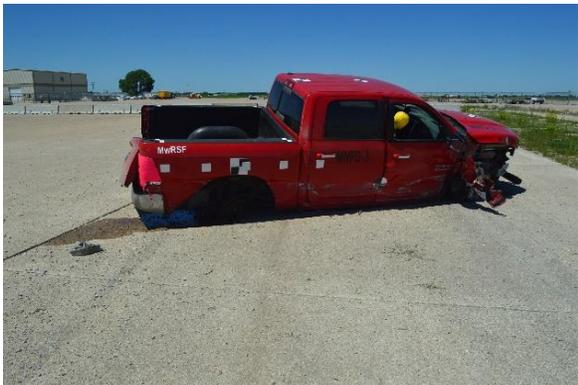
Figure 60. Vehicle Damage, Test No. MNP-3

The majority of the damage was concentrated on the right-front corner and right side of the vehicle, where impact had occurred, as shown in Figure 60. The vehicle's steel engine hood was deformed across its entirety, and the right edge was deformed inward, as shown in Figures 60, 61, and 62. The left side of the front bumper was pushed downward. The right side of the bumper was crushed inward. The right-front fender was dented, torn front to back, and pushed upward near the

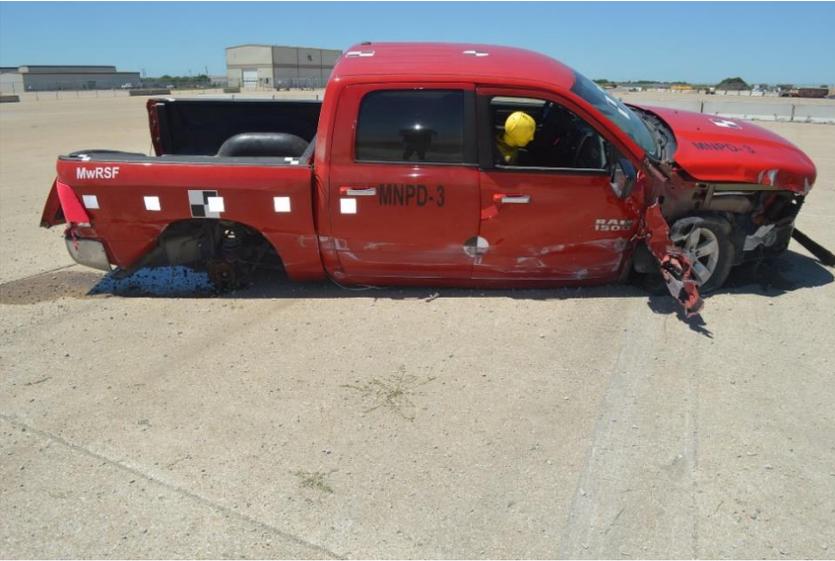
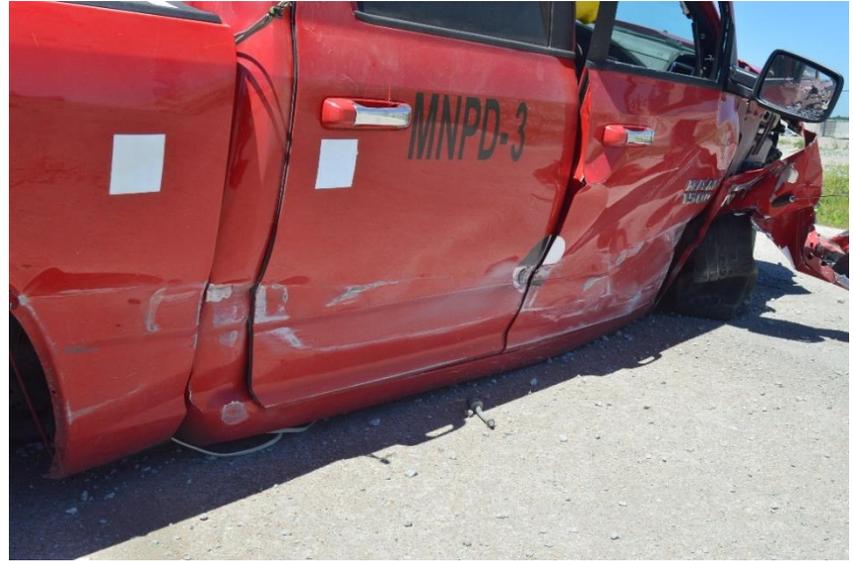
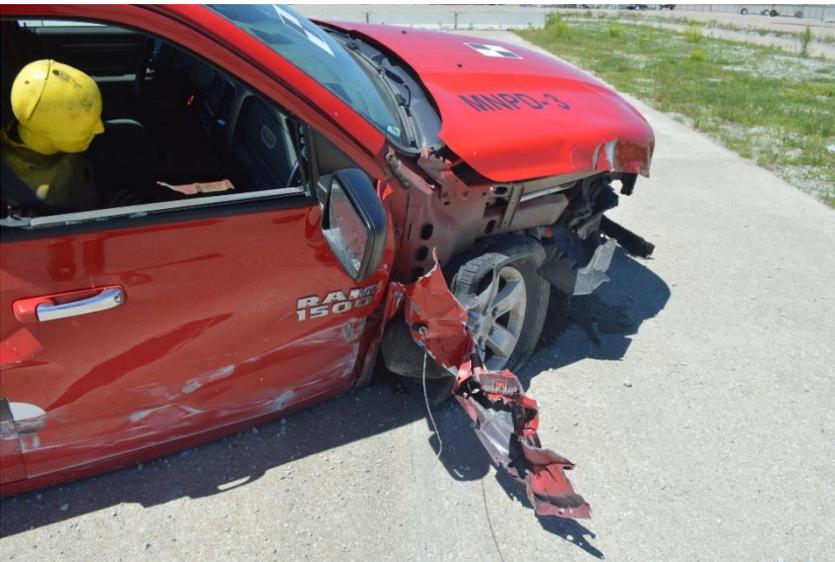
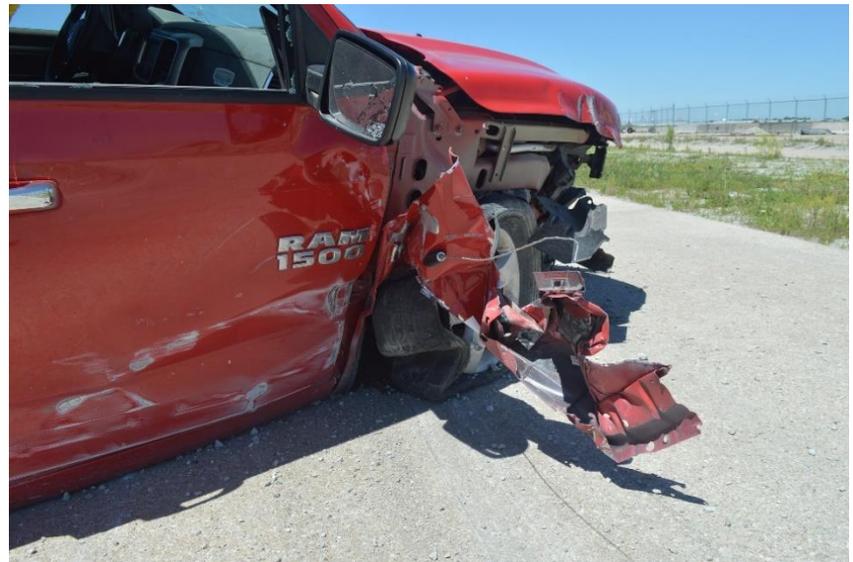
Figure 61. Vehicle Damage, Test No. MNP-3

right-front door, as shown in Figures 61 and 62. The right-front cast aluminum rim was severely deformed, fractured, and crushed, as shown in Figure 62. The grille was pushed backward and fractured around the right-side headlight assembly. The right-side headlight was disengaged from the vehicle, as shown in Figure 62. The right-side, upper control arm was fractured. The right side of the radiator was pushed backward. Denting and scraping were observed across the entire right side. The right-front door was slightly ajar, and creases were found in the door's sheet metal. The right-side window glass shattered, as shown in Figures 61, 62, and 63. The right-rear door was dented and ajar. The right side of the truck bed was dented, and the fuel hatch was ajar. The right-rear wheel detached, as shown in Figure 63. The right side of the rear bumper was torn and pushed downward. The right side of the windshield had a hairline crack, as shown in Figure 67. The roof and remaining window glass remained undamaged.
