MASH 2016 TEST LEVEL 4 EVALUATION OF MNDOT CONCRETE PARAPET WITH BRUSH CURB AND UPPER BEAM AND POST RAIL WITH NEW TAPERED END SECTION

MINNESOTA DEPARTMENT OF TRANSPORTATION

MwRSF Research Report No. TRP-03-403-21

March 26, 2021

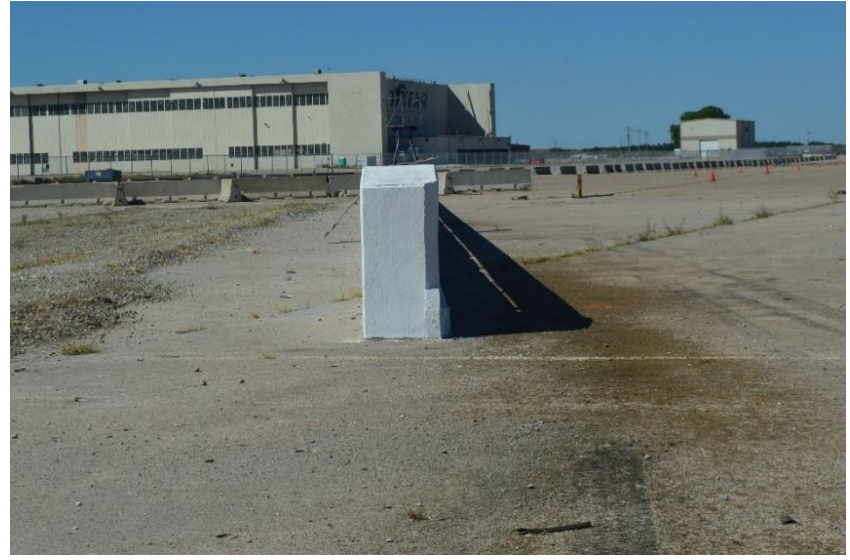
Figure 68. System Damage, Test No. MNCBR-1

Damage to the barrier was minimal, as shown in Figures 68 through 84. Barrier damage largely consisted of contact marks on the front face of the concrete barrier, gouging and spalling of the concrete, and contact marks on the upper steel rail. Note that the cracking shown in the system photographs was identified before the test and was related to shrinkage, which was not a result of test no. MNCBR-1. The length of vehicle contact along the barrier extended downstream approximately 122 ft – 3½ in., starting 8½ in. upstream from the centerline of post no. 5.

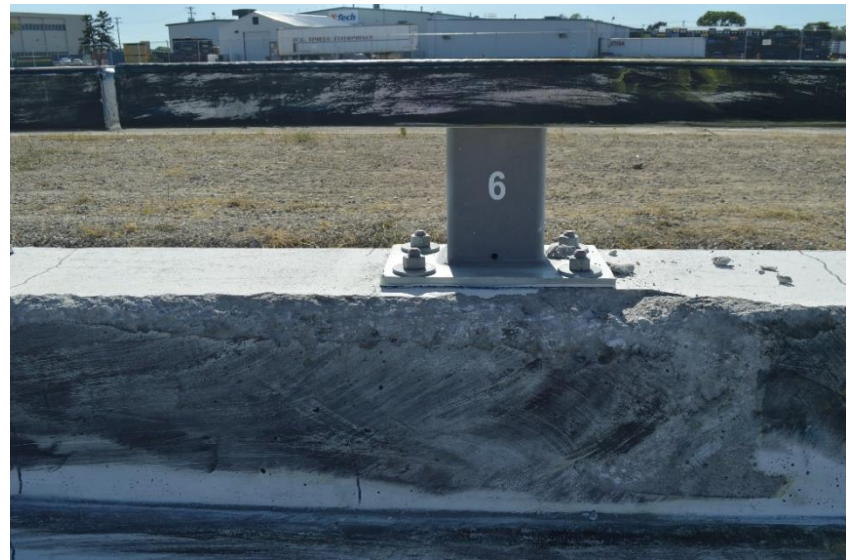
Figure 70. Concrete Gouging and Spalling, Test No. MNCBR-1

Scuff marks were also found along the length of vehicle contact. Gouging, measuring ¼ in. wide by 77 in. long, was found on the front face of the concrete parapet and located 21 in. upstream

from post no. 6 and 15 in. above the ground. Gouging, measuring 25 in. wide by 34 in. long, was located 33 in. upstream from post no. 20. Gouging, measuring 2½ in. wide by 28 in. long, was located 90 in. upstream from post no. 21. Gouging, measuring ½ in. wide by 19½ in. long, was located 46 in. upstream from post no. 21. Concrete chipping, measuring 9½ in. wide by 9 in. long, was located 36 in. upstream from the new tapered end and 26 in. above the ground.

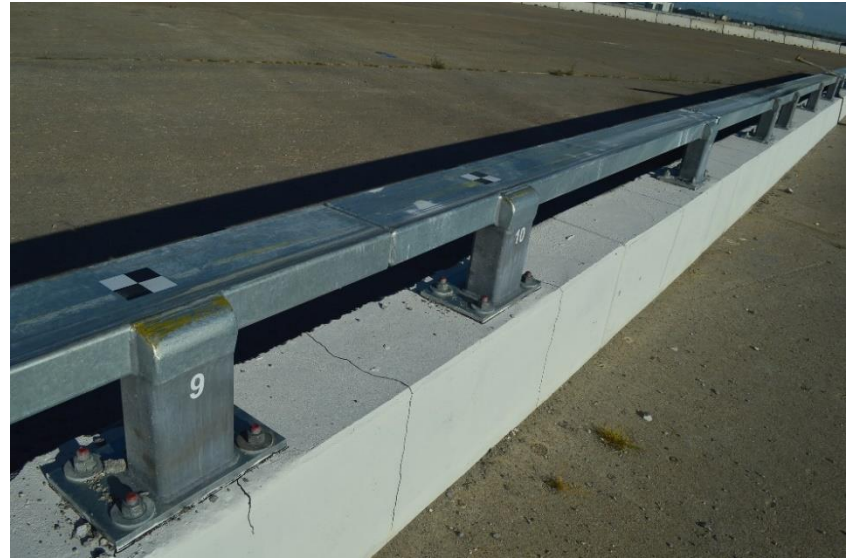
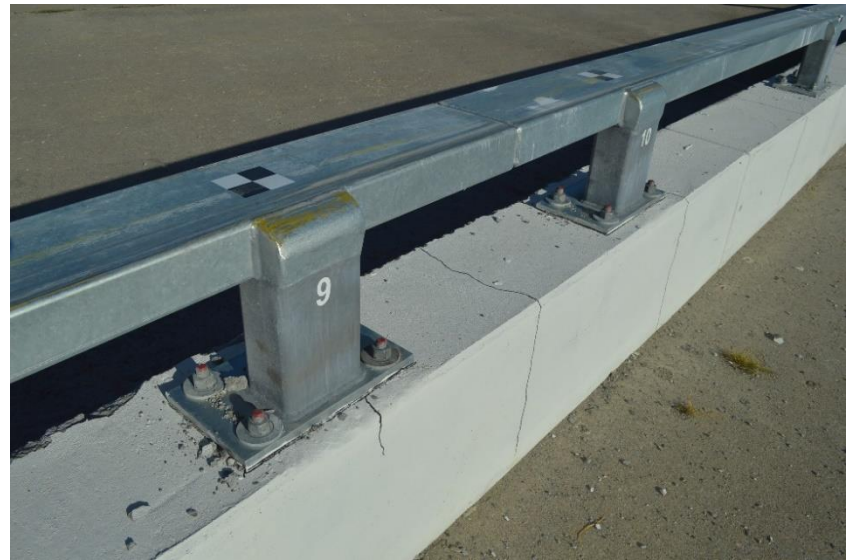
Figure 84. Rail and Post Damage, Post Nos. 10 and 9, Test No. MNCBR-1

The maximum lateral permanent set of the barrier system was 0.2 in. at post no. 9, as measured in the field. The maximum lateral dynamic barrier deflection, including tipping of the upper metal rail along the top surface, was 0.9 in., as determined from high-speed digital video analysis. The working width of the system was found to be 51.6 in., also determined from high-speed digital video analysis. The Zone of Intrusion (ZOI) was determined to be 49.6 in. Barrier deflections are shown schematically in Figure 85.

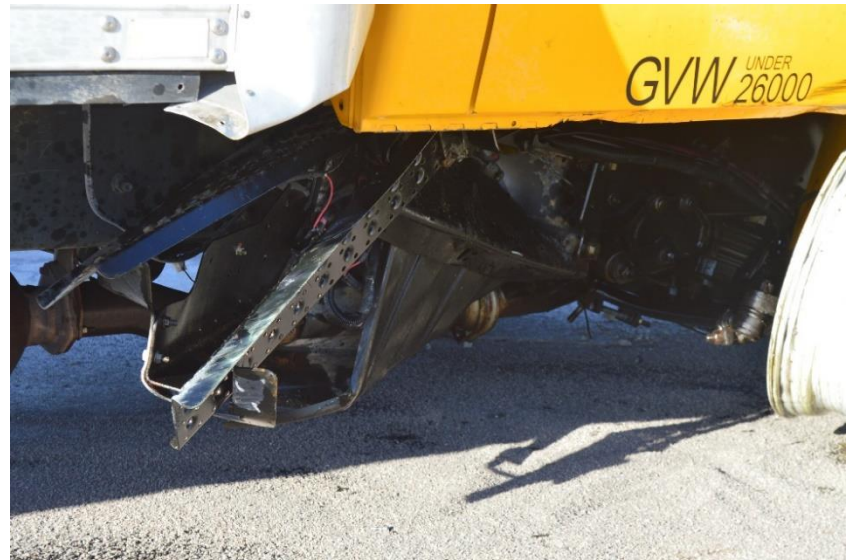
Figure 87. Vehicle Damage, Test No. MNCBR-1

The majority of the damage was concentrated on the right-front corner and right side of the vehicle, where impact had occurred, as shown in Figure 86. The left side of the front bumper was crushed inward due to the vehicle impact into a downstream portable concrete barrier far beyond the bridge railing system. The right side of the bumper was crushed inward. The right-front fender was pushed upward near the door panel and torn behind the right-front wheel, as shown in Figure 87. The right-side upper control arm was bent. The right-front steel rim was moderately deformed with concentrated crushing along the edge, as shown in Figure 87.

Denting and scraping were observed across the entire right side. The right-front door was slightly ajar, and creases were found in the door's sheet metal. The right-side window glass shattered, as shown in Figures 87 through 90. The right-rear door was dented and ajar. The right side of the truck bed was dented, and the fuel hatch was ajar. The right-rear wheel detached, as shown in Figures 87 through 90. The right side of the rear bumper was torn and pushed downward. The roof and remaining window glass remained undamaged. The undercarriage and the box were scraped, as shown in Figure 91.

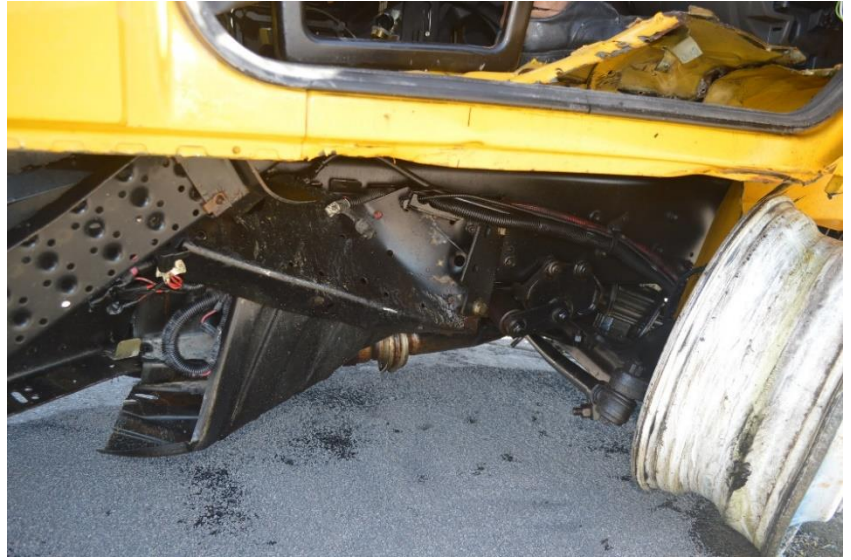
Figure 88. Undercarriage Damage, Test No. MNCBR-1

The right-side edge or seam of the floor pan released, as shown in Figures 88 and 89. The right-front wheel and/or rubber tire pushed on the supporting member and the floor pan was held in place at the edge until the partially-rusted spot welds along the seam failed. As such, the spot-weld region was pulled downward along this seam in more of a tensile loading manner, where the spot welds eventually tore out of the fabricated holes. Based on a review of the post-test results, researchers confirmed that the right-front wheel and/or rubber tire did not penetrate at the floor edge or seam since the floor did not reveal upward bending (prying up) at the edge but rather downward bending (tension down with tear out) at the edge, as shown in Figures 88 and 89. The maximum measured floor pan deformation was 5.6 in., which is within AASHTO MASH 2016 [3] occupant compartment deformation limits. The doorsill remained intact and did not show evidence of vehicle components prying through the edge opening at the doorsill region.

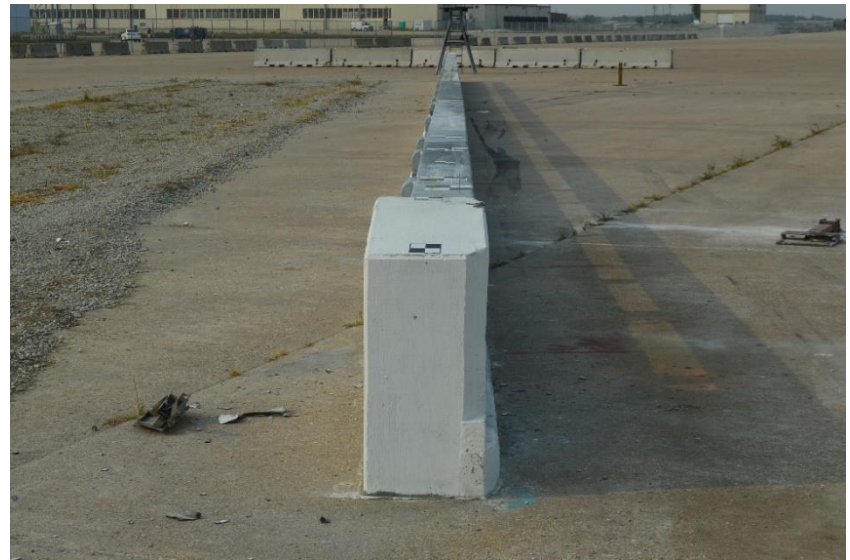
Figure 101. System Damage, Test No. MNCBR-2

Damage to the barrier was minimal, as shown in Figures 101 through 111. Barrier damage largely consisted of contact marks on the front face of the concrete barrier and spalling of the concrete. Note that the cracking shown in the system photographs was identified before the test as being related to shrinkage, and was not a result of test no. MNCBR-2. The length of vehicle contact along the barrier extended downstream approximately 12 ft – 10 in., starting at 21½ in. upstream from post no. 22.

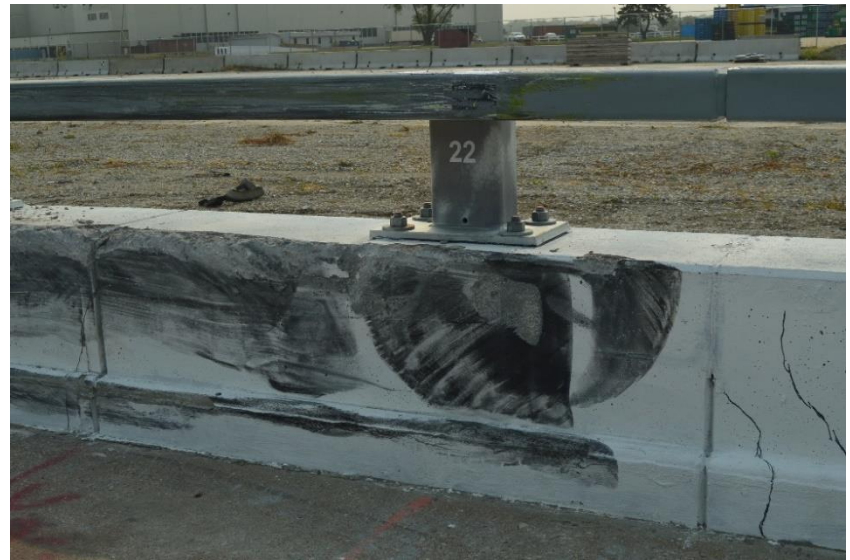
Figure 104. Concrete Gouging and Spalling, Test No. MNCBR-2

Scuff marks were also found along the length of vehicle contact. Gouging was found on the top corner of the front face of the concrete parapet, measuring 75 in. long and located 2 in. upstream from post no. 22 with a width of 7 in. Gouging with a width of 3 in. and measuring 25 in. long was located 48 in. upstream from post no. 23. Gouging was found on the upstream face of the mid horizontal tapered section measuring ¾ in. long located 8 in. from the top front corner of the upstream face. Gouging was found on the upstream face of the mid horizontal tapered section measuring ½ in. long located 3½ in. from the top front corner of the upstream face. Gouging with a width of 1½ in. and measuring 10 in. long was located 20 in. upstream from post no. 23. Gouging with a width of 1½ in. and measuring 17½ in. long was located 11½ in. upstream from post no. 23. Concrete chipping, measuring 21½ in. long, was located at upstream edge of end post with a width of 9 in.

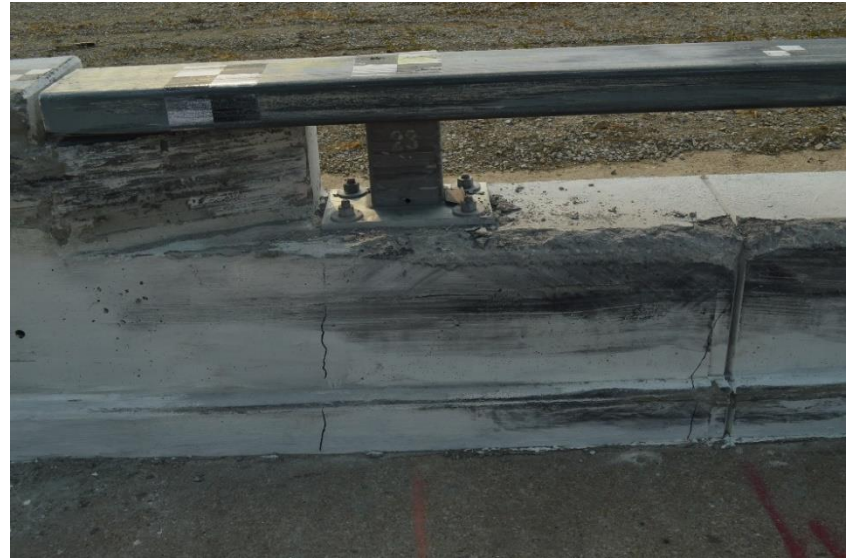
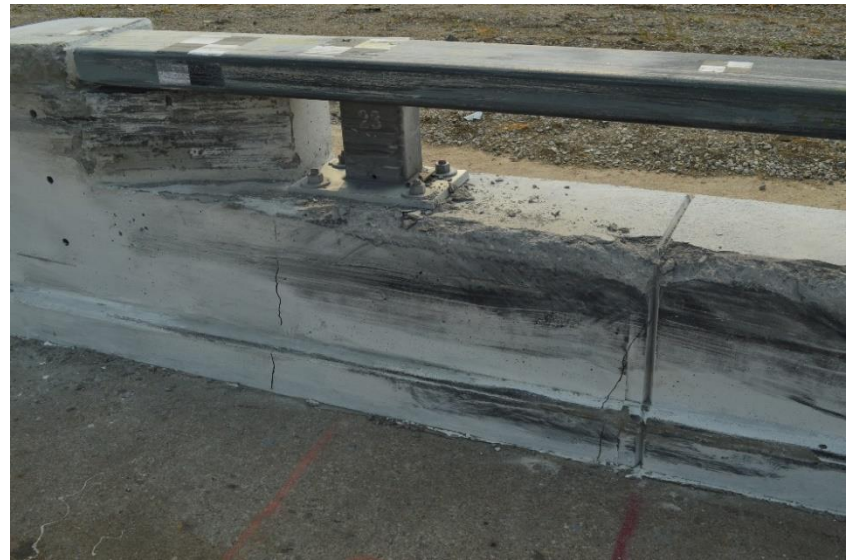
Figure 107. Rail and Post No. 23 Damage, Test No. MNCBR-2

Tire marks were visible on the front face of the 21-in. tall concrete barrier, starting 16 in. upstream from the centerline of post no. 22 and extending 9 ft – 9 in. downstream across the traffic side of the barrier. Contact marks 15 in. wide were found across the front face of the concrete barrier above the brush curb, starting 21½ in. upstream from the centerline of post no. 22 and extending 9 ft – 11 in. downstream. Contact marks 15 in. wide were found across the entire length of the front face of the end post, including the horizontal tapered end, starting 9 in. downstream from the centerline of post no. 23 and extending 56 in. downstream. Contact marks measuring 4 in. wide were found on front face of the steel upper rail, starting 6½ in. downstream from the centerline of the splice between post nos. 21 and 22 and extending 9 ft – 9 in. downstream. Contact marks measuring 8½ in. wide were found on the top face of the steel upper rail, starting 7 in. downstream from the centerline of splice between post nos. 21 and 22 and extending 9 ft – 8 in. downstream. Contact marks measuring 5½ in. wide were found on the front face of the steel upper rail, starting 13 in. downstream from the centerline of the splice between post nos. 21 and 22 and extending 8 ft – 8½ in. downstream. Contact marks measuring ⅛ in. wide were found on the upstream face of post no. 22, starting 12 in. from the top of plate and extending 1 in. downward. Contact marks measuring 1 in. wide were found on the upstream face of post no. 23, starting 6½ in. from the top of the plate and extending 2 in. upward. Contact marks measuring 6½ in. were found on the front face of post no. 23, starting ½ in. from the top of the plate and extending 8½ in. upward. Contact marks measuring ½ in. wide were found on the upstream corner of the front face of post no. 23, starting at the post base plate and extending across the entire height of the post. The vehicle's lateral overlap/contact distance at the upstream end of the tapered end section was 1 in. The vehicle's overlap/contact distance at the upstream corner of the front face of post no. 23 was ½ in.

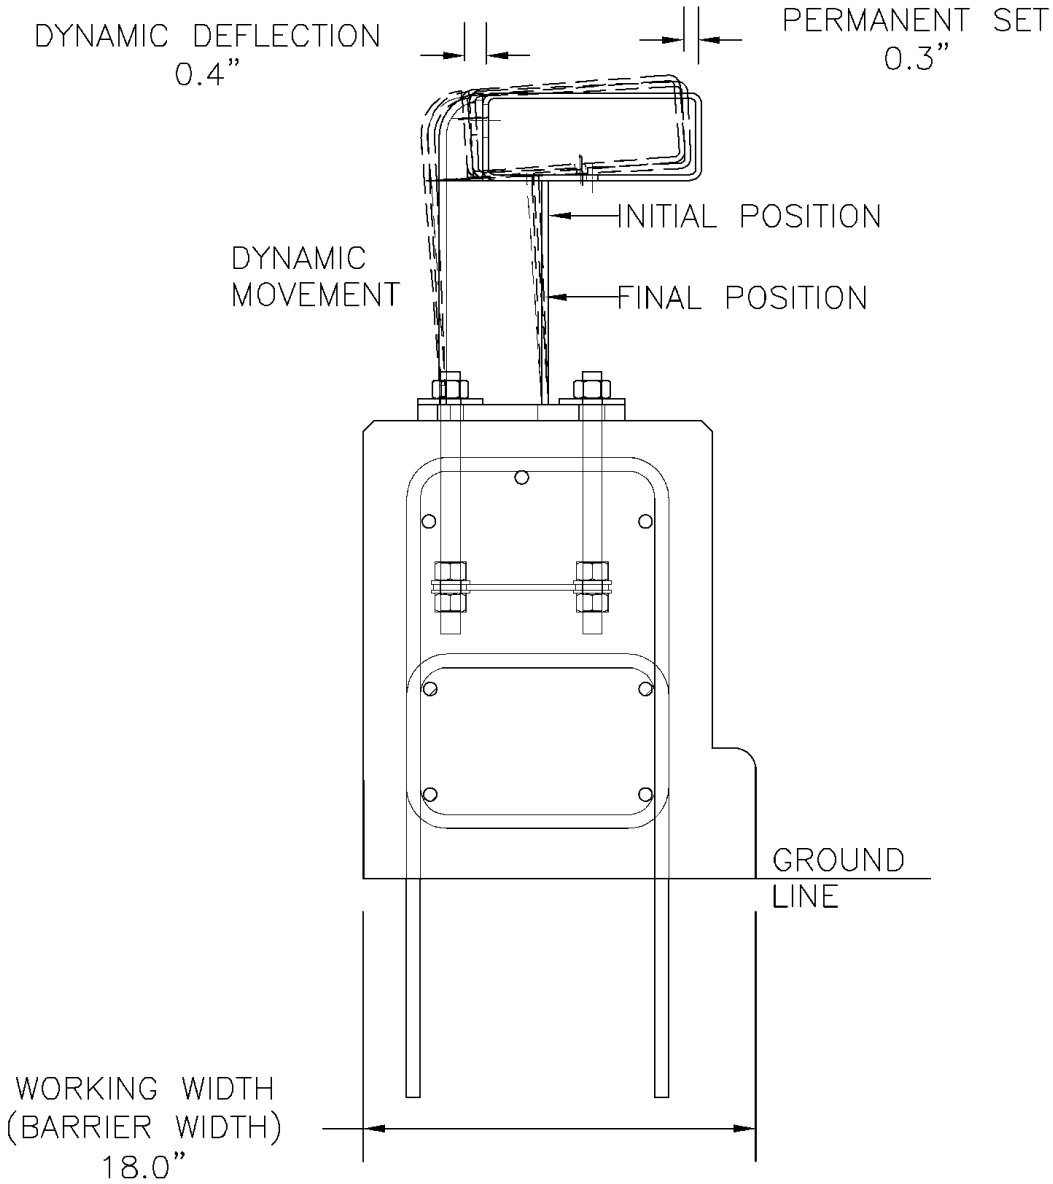
Figure 112. Permanent Set, Dynamic Deflection, and Working Width, Test No. MNCBR-2

The maximum lateral permanent set of the barrier system was 0.3 in. between post nos. 22 and 23, as measured in the field. The maximum lateral dynamic barrier deflection, including tipping of the barrier along the top surface, was 0.4 in. on the upper rail, as determined from high-speed digital video analysis. The working width of the system was found to be 18 in., also determined from high-speed digital video analysis. The ZOI was found to be 16 in. Barrier deflections are shown schematically in Figure 112.

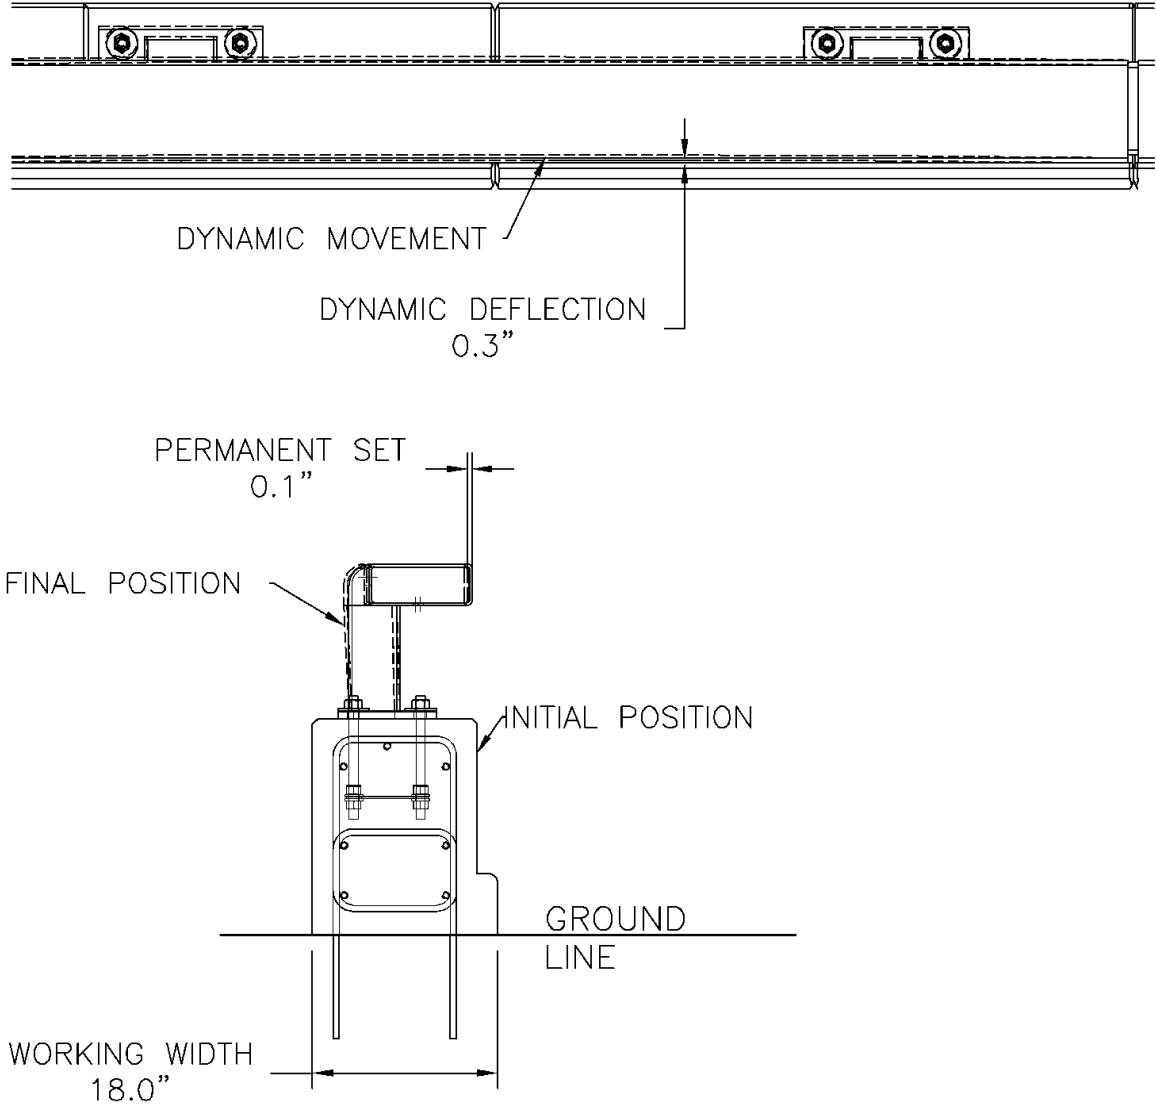
Figure 139. Permanent Set, Dynamic Deflection, and Working Width, Test No. MNCBR-3

The maximum lateral permanent set of the barrier system was 0.1 in. between post nos. 22 and 23, as measured in the field. The maximum lateral dynamic barrier deflection, including tipping of the barrier along the top surface, was 0.3 in. on the upper rail, as determined from high-speed digital video analysis. The working width of the system was found to be 18 in., also determined from high-speed digital video analysis. The ZOI was found to be 10 in. Barrier deflections are shown schematically in Figure 139.
