> **Texas A&M Transportation Institute** Proving Ground

Test Report No. 610211-01 Test Report Date: April 2022

MASH CRASH TESTING AND EVALUATION OF THE MGS WITH REDUCED POST SPACING

Contract No.: T4541-CW Test Nos.: 610211-1 / -2 / -4 / -3 / -6 / -5 Test Dates: 2018-10-04 / 2018-10-22 / 2018-11-27 / 2019-02-18 / 2021-03-0 / 2021-03-12

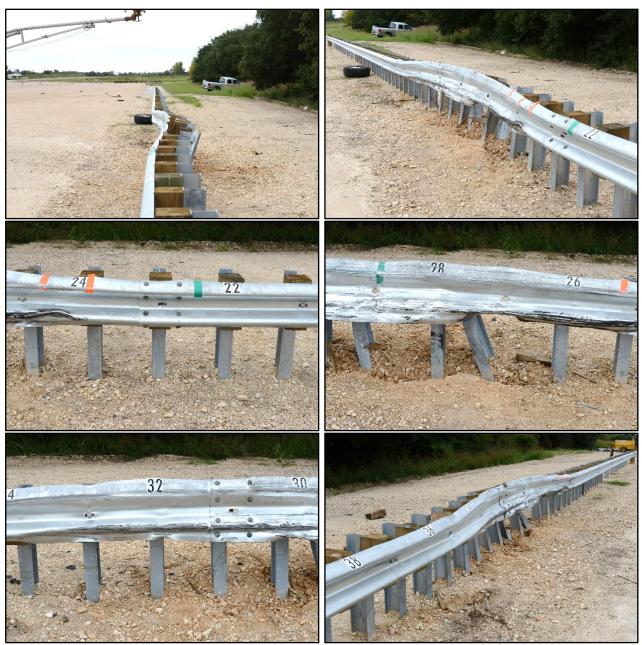
Figure 4.11. MGS System with Quarter Post Spacing after Test No. 610211-01-2.

Figure 4.11 shows the damage to the MGS with quarter post spacing. The soil around post 1 was disturbed, and the rail released from the blockouts at posts 27, 29, and 31. The soil around posts 21 and 22 was disturbed, and posts 26 through 31 were pushed downstream and toward the field side. Table 4.5 provides additional measurements. Working width was 37.1 inches, and height of working width was 27.9 inches. Maximum dynamic deflection during the test was 19.5 inches, and maximum permanent deformation of the W-beam rail was 11.0 inches.

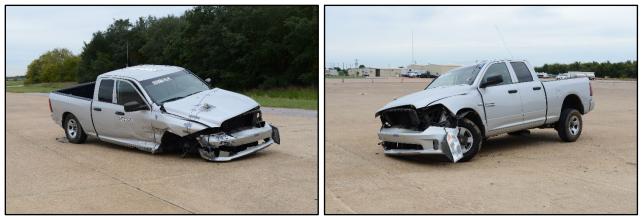
Figure 4.12. Test Vehicle after Test No. 610211-01-2.

Figure 4.12 shows the damage sustained by the vehicle. The front bumper, radiator and support, grill, right head light, right front fender, right front upper and lower A arms, right front tire and rim, right frame rail, right front door (4-inch gap at top of door), right front floor pan, right rear door, right rear fender, right rear rim, and right bumper were damaged. No damage to the fuel tank was observed. Maximum exterior crush to the vehicle was 15 inches in the front plane on the right side above the front bumper. Maximum occupant compartment deformation was 2 inches in the right front firewall area. Figure 4.13 shows the interior of the vehicle. Tables E.3 and E.4 in Appendix E1 provide exterior crush and occupant compartment measurements.

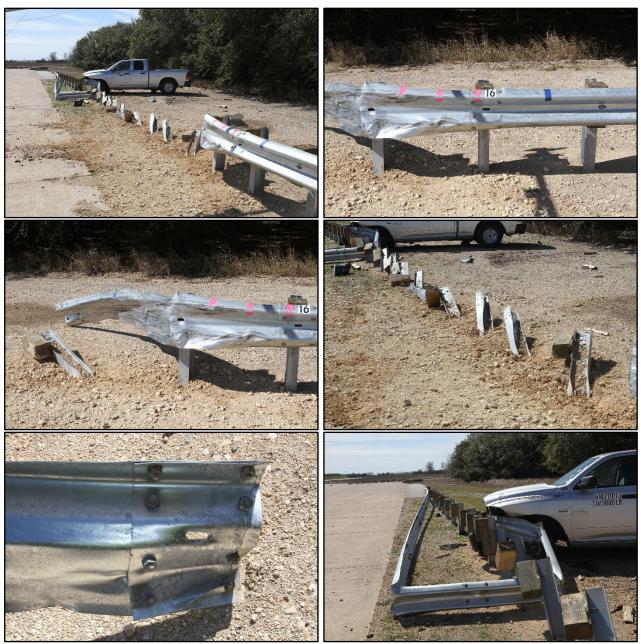
Figure 5.5. MGS with Half Post Spacing after Test No. 610211-01-3.

Figure 5.5 shows the damage to the MGS with half post spacing. The W-beam guardrail ruptured at post 20 and released from post 16 through post 39. The soil was disturbed at post 1. Table 5.2 provides additional measurements.

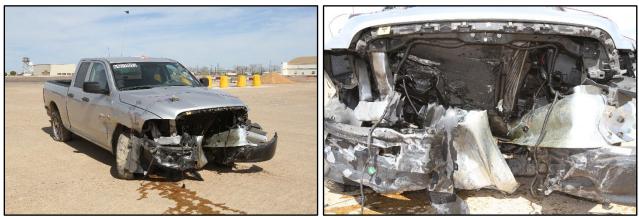
Figure 5.6. Test Vehicle after Test No. 610211-01-3.

Figure 5.6 shows the damage sustained by the vehicle. The front bumper, hood, grill, radiator and support, right and left front fenders, right front and rear doors, rear exterior bed, rear bumper, right front and rear tires and rims, and left front tire were damaged. No damage to the fuel tank was observed. Maximum exterior crush to the vehicle was 22.0 inches in the front plane at the center at bumper height. Maximum occupant compartment deformation was 0.5 inch in the right floorpan. Figure 5.7 shows the interior of the vehicle. Tables G.3 and G.4 in Appendix G1 provide exterior crush and occupant compartment measurements.

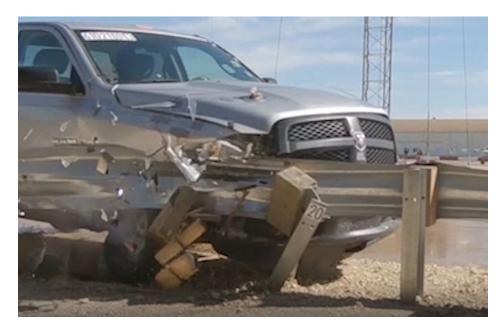
Figure 5.9. Rear View of Rail Rupture.

Following the failed *MASH* test 3-11, the research team investigated the cause of the rail rupture. After a thorough analysis of the damaged installation and the crash test video, the research team determined the rail rupture was caused by a localized interaction between the W-beam rail and the wood blockout. Figure 5.9 shows a rear view of the test installation at the approximate time of rail rupture. As the rail deflected laterally rearward and flattened with the impact of the test vehicle, the edge of the W-beam became intertwined with the wood blockout. As the wood blockout deflected and twisted, the edge of the rail deformed. This deformation caused a tear to initiate in the rail, and the continuing impact event propagated the tear through the rest of the rail cross-section.

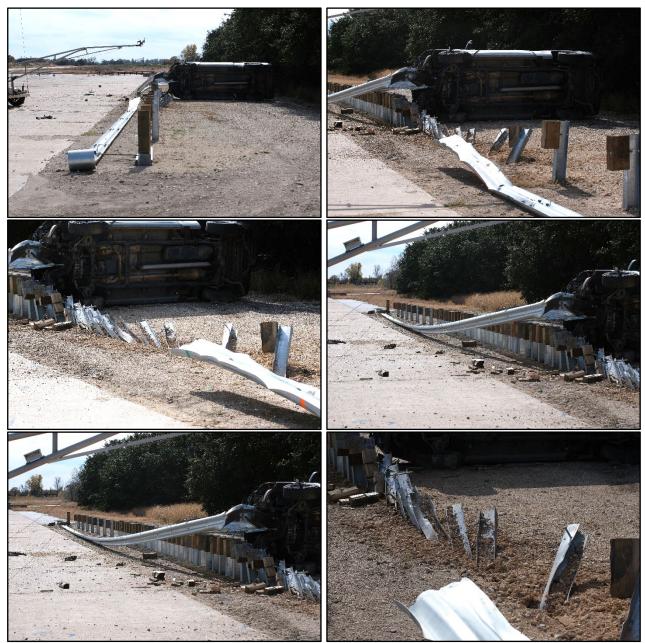
Figure 6.5. Transition from Full to Quarter Post Spacing after Test No. 610211-01-4.

showed no movement. The blockouts separated from posts 11-16, and the rail element ruptured at the splice at post 11. Table 6.2 provides additional measurements.

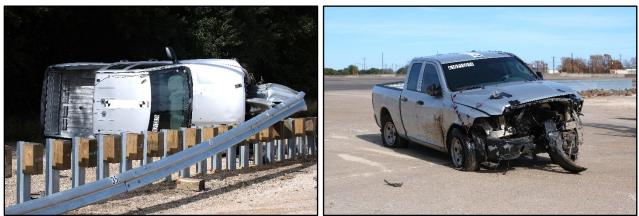
Figure 6.6. Test Vehicle after Test No. 610211-01-4.

Figure 6.6 shows the damage sustained by the vehicle. The front bumper, grill, hood, radiator and support, right front fender, right front tire and rim, right front and rear doors, right rear exterior bed, and right rear tire and rim were damaged. No damage to the fuel tank was observed. Maximum exterior crush to the vehicle was 18.0 inches in the front plane near the center at bumper height. No occupant compartment deformation or intrusion occurred. Figure 6.7 shows the interior of the vehicle. Tables K.3 and K.4 in Appendix K1 provide exterior crush and occupant compartments.
