Test Report No. 616011-01

EVALUATION OF A NON-PROPRIETARY SIGN SUPPORT SYSTEM

TEXAS A&M TRANSPORTATION INSTITUTE PROVING GROUND

15. Supplementary Notes Name of Contacting Representative: Carlos Torres		14. Sponsoring Agency Code	
16. Abstract <p>The purpose of the tests reported herein was to assess the performance of the U-Channel Sign Support System according to the safety-performance evaluation guidelines included in the second edition of the American Association of State Highway and Transportation Officials (AASHTO) <i>Manual for Assessing Safety Hardware (MASH)</i> (1). The initial objective was to evaluate the U-Channel Sign Support System according to the complete MASH Test Level 3 (TL-3) matrix. However, only MASH Test 3-62 was performed on the U-Channel Sign Support System due to excessive vehicle deformation observed during the crash test. The crash tests were performed in accordance with <i>MASH</i> Test 3-62:</p> <p style="text-align: center;">MASH Test 3-62: An 2270P vehicle weighing 5000 lb impacting the Support Structures while travelling at 62 mi/h and 0 and 90 degrees.</p> <p>This report provides details on the U-Channel Sign Support System, the crash tests and

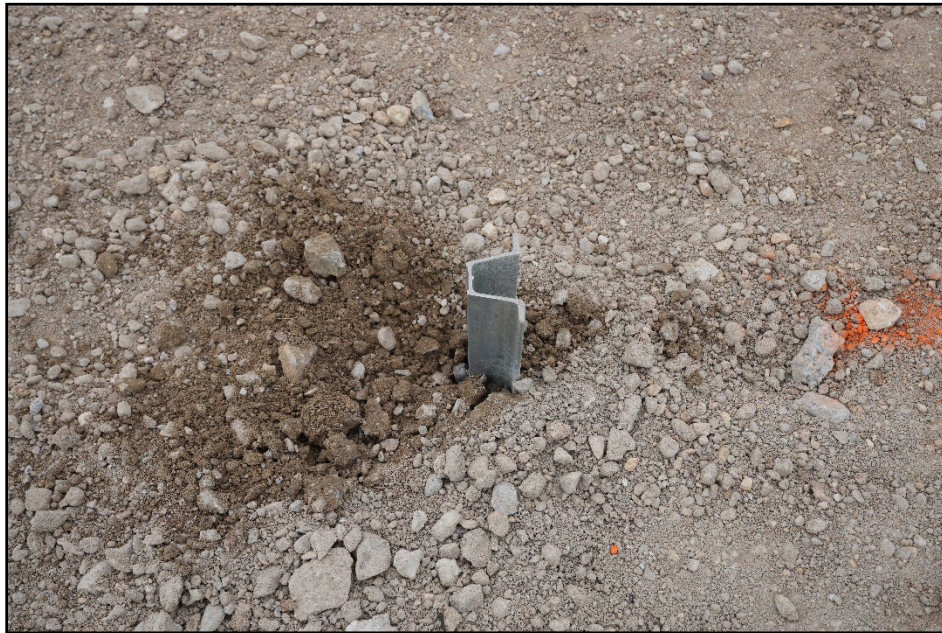
The soil was disturbed around the ground stub, but no damage was present. The sign landed 223 feet downstream and 3 feet to the right of impact. The sign panel was deformed. Figure 5.5 and Figure 5.6 show the damage to the U-Channel Sign Support System.

Figure 5.5. U-Channel Sign Support System at Impact Location after Test 616011-01-5.

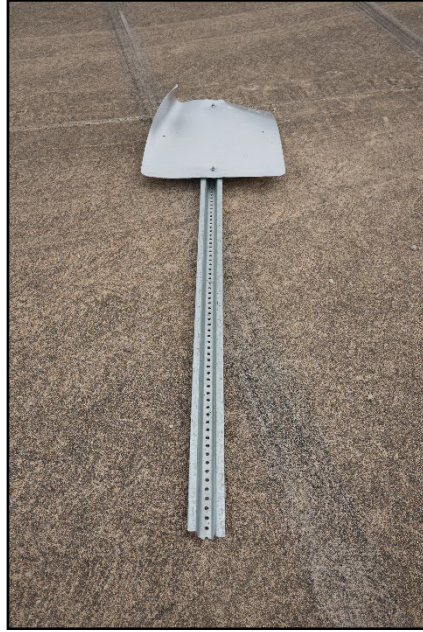
Figure 5.6. U-Channel Sign Support System at its Landing Location after Test 616011-01-5.

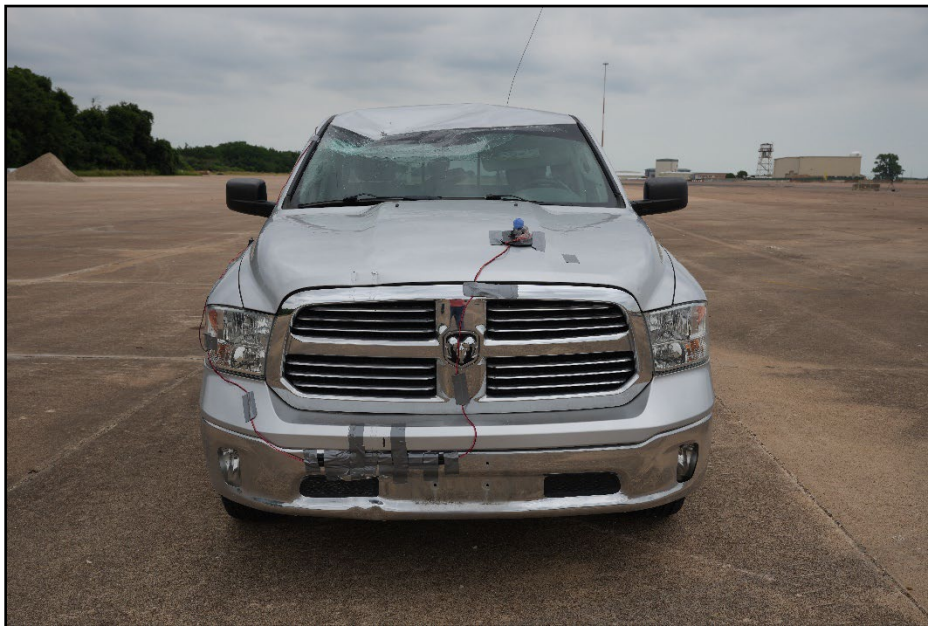
Figure 5.7. Impact Side of Test Vehicle after Test 616011-01-5.

Side Windows	The side windows remained intact
Maximum Exterior Deformation	1 inch in the front plane at bumper height
VDS	12FC2
CDC	12FCAZ3
Fuel Tank Damage	None
Description of Damage to Vehicle:	The roof, windshield, hood, and bumper were damaged. The roof had a 33-inch wide, 15-inch long, and 4.9-inch deep dent. The windshield had a 35-inch wide, 15-inch long, 3.75-inch deep dent. There was a 3.5-inch wide, 1-inch deep dent on the hood and bumper.

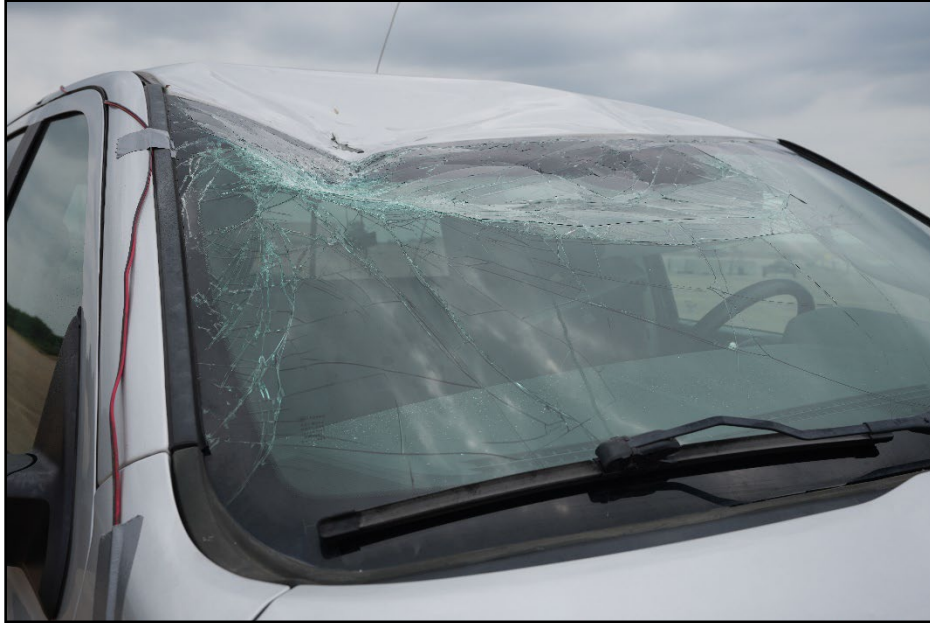
Figure 5.8. Roof and Windshield of Test Vehicle after Test 616011-01-5.

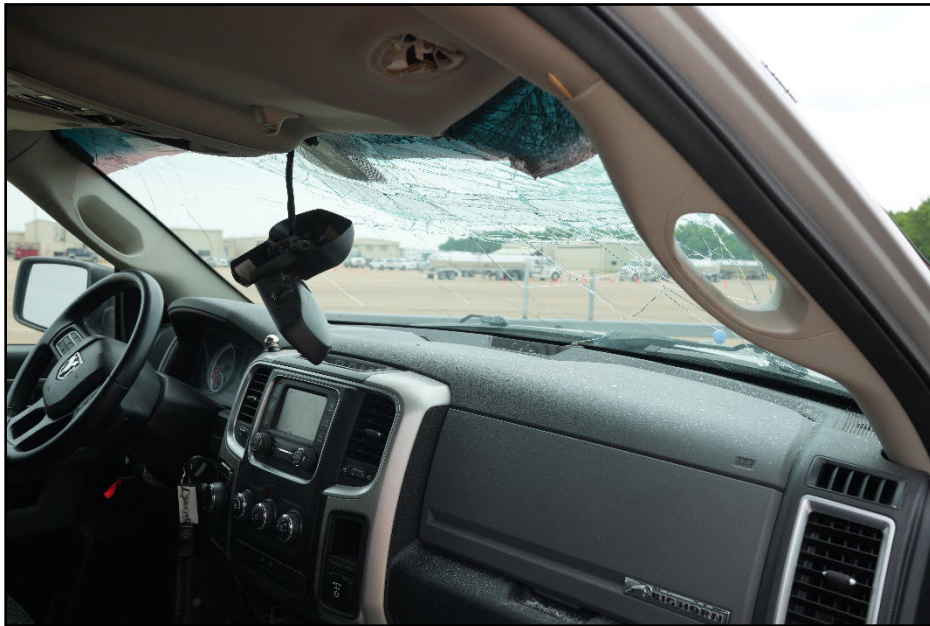
Figure 5.9. Upper Interior of Test Vehicle after Test 616011-01-5.

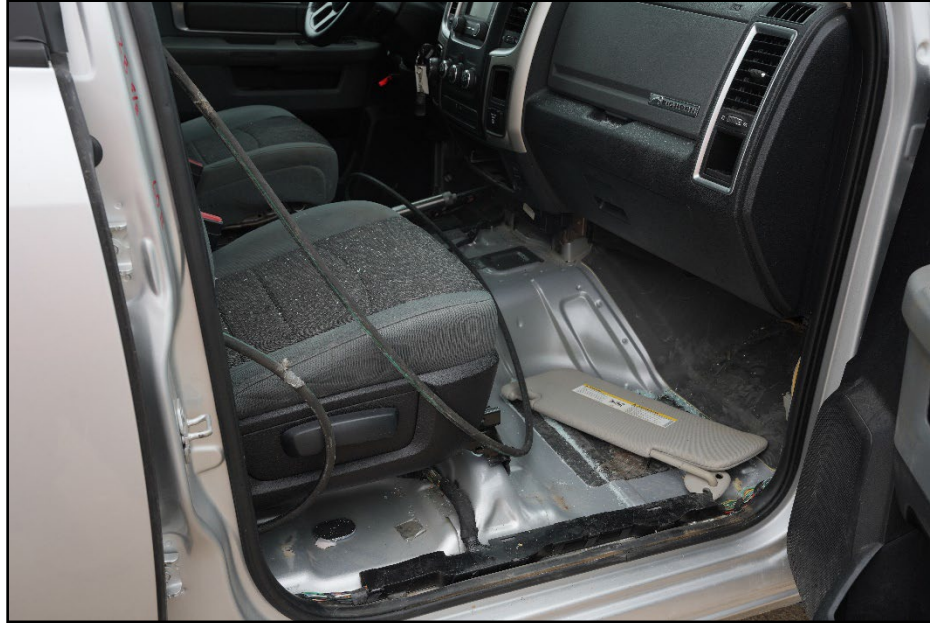
Figure 5.10. Lower Interior of Test Vehicle after Test 616011-01-5.

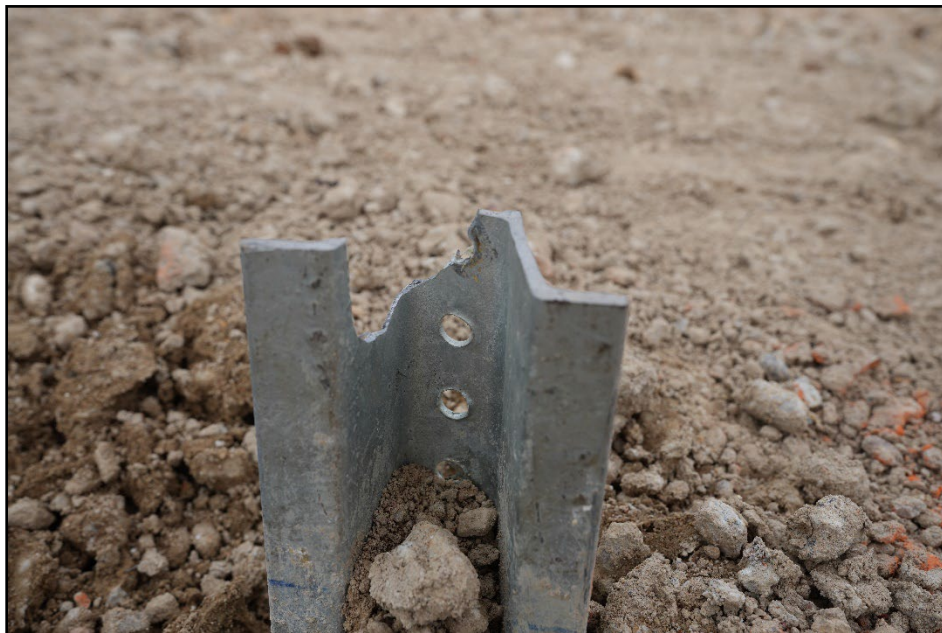
The ground stub was fractured, and the soil was disturbed around it. The sign and post landed 165 feet downstream and 36 feet to the right of impact. The post was bent but still intact, and the sign was scuffed and slightly deformed. Figure 6.5 and Figure 6.6 show the damage to the U-Channel Sign Support System.

Figure 6.5. U-Channel Sign Support System at Impact Location after Test 616011-01-6.

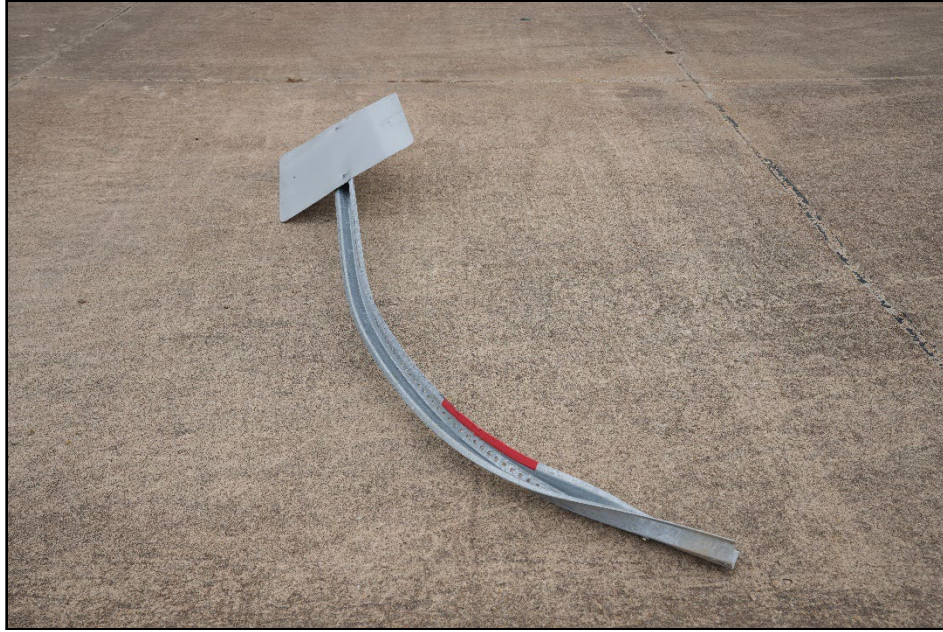
Figure 6.6. U-Channel Sign Support System at its Landing Location after Test 616011-01-6.

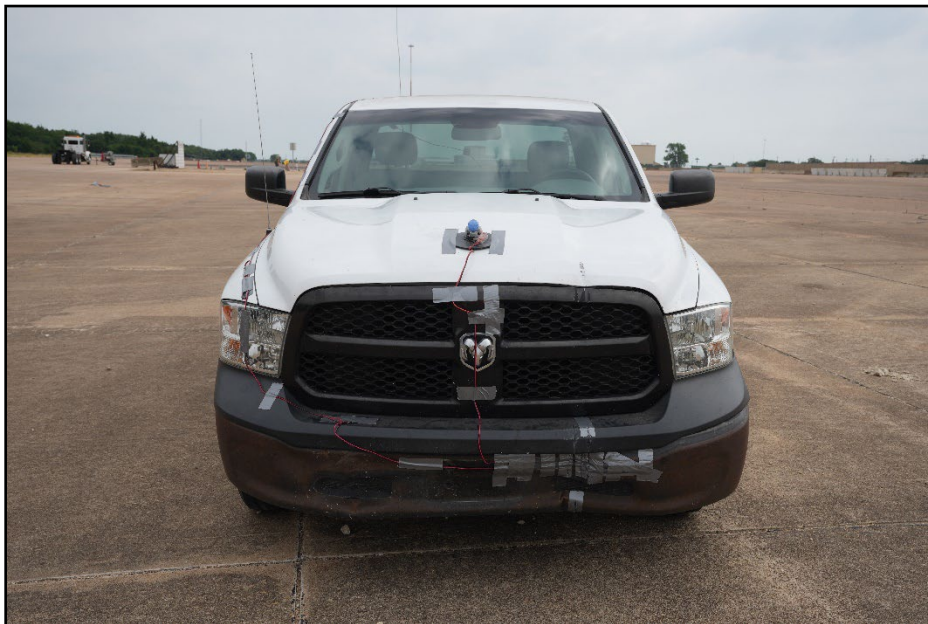
Figure 6.7. Impact Side of Test Vehicle after Test 616011-01-6.

Side Windows	The side windows remained intact
Maximum Exterior Deformation	3.25 inches in the front plane at bumper height
VDS	12FC1
CDC	12FCEL1
Fuel Tank Damage	None
Description of Damage to Vehicle:	The bumper and hood were damaged. The bumper was crushed in 3.25 inches, and the hood had a 2-inch wide, 3.5-inch long dent on the left side.

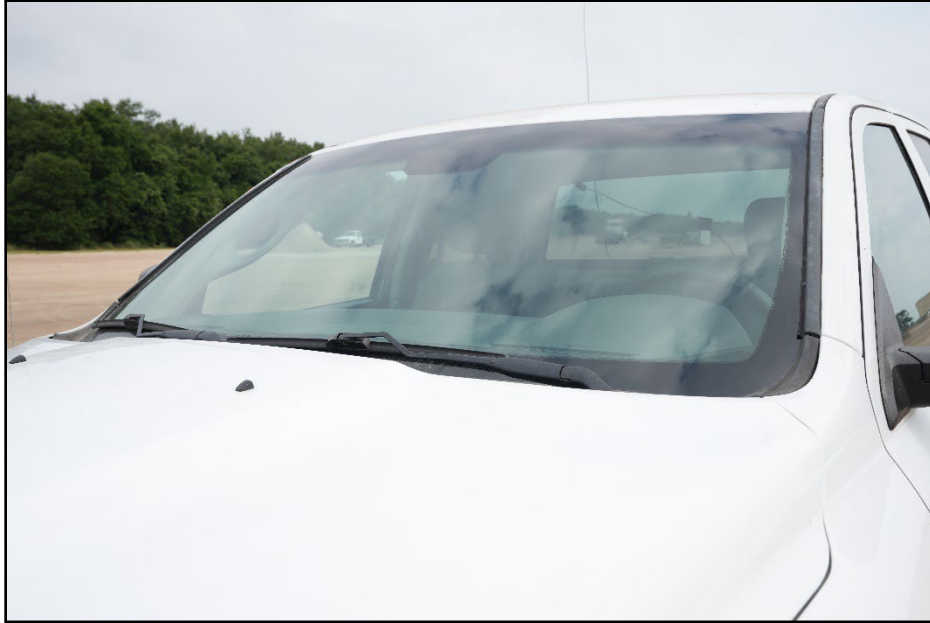
Figure 6.8. Roof and Windshield of Test Vehicle after Test 616011-01-6.

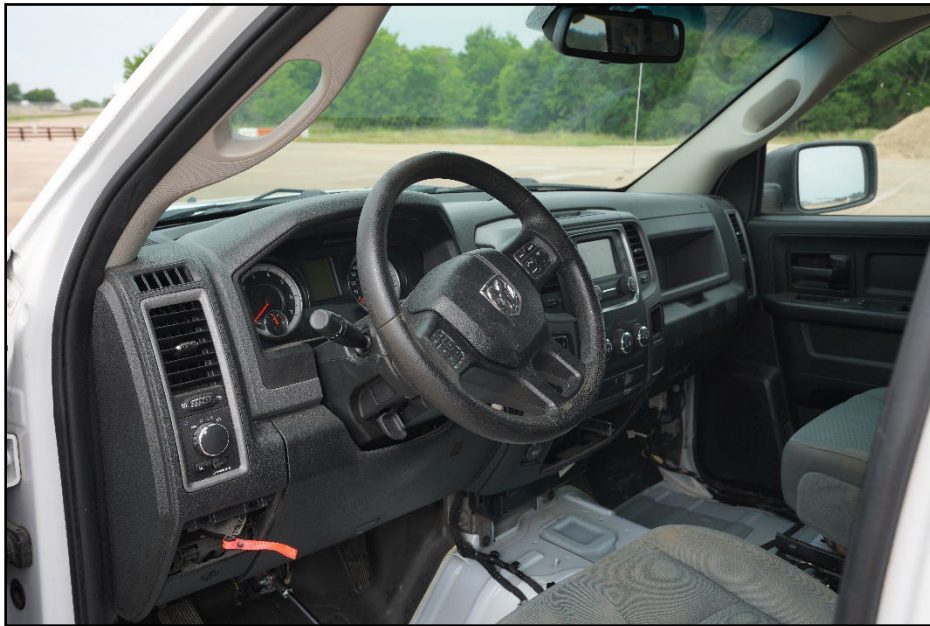
Figure 6.9. Overall Interior of Test Vehicle after Test 616011-01-6.

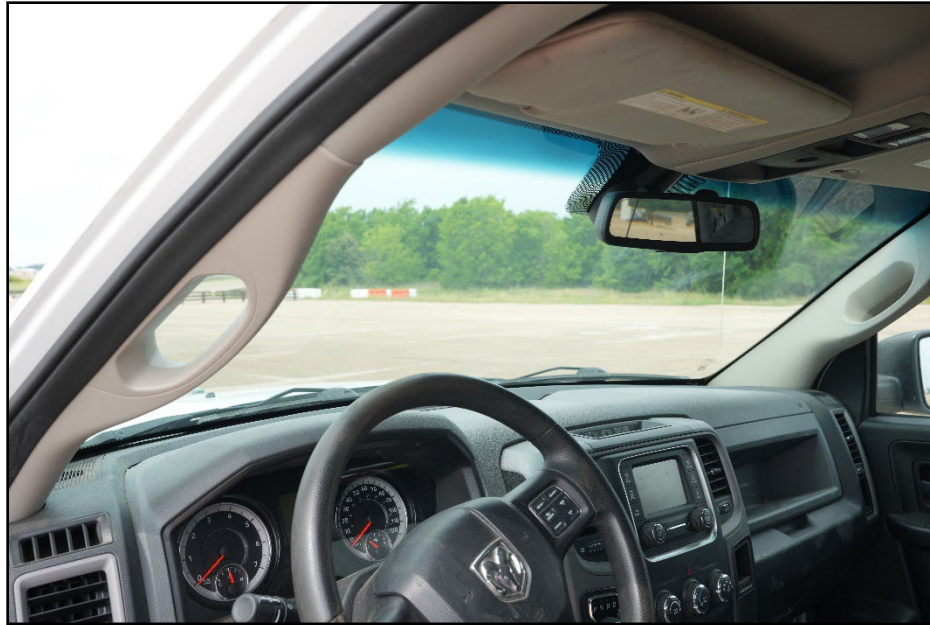
Figure 6.10. Upper Interior of Test Vehicle after Test 616011-01-6.
