**Test Report No. 616411-01**

**EVALUATION OF TYPE III BARRICADES WITH MOUNTED SIGNS**

**TEXAS A&M TRANSPORTATION INSTITUTE PROVING GROUND**

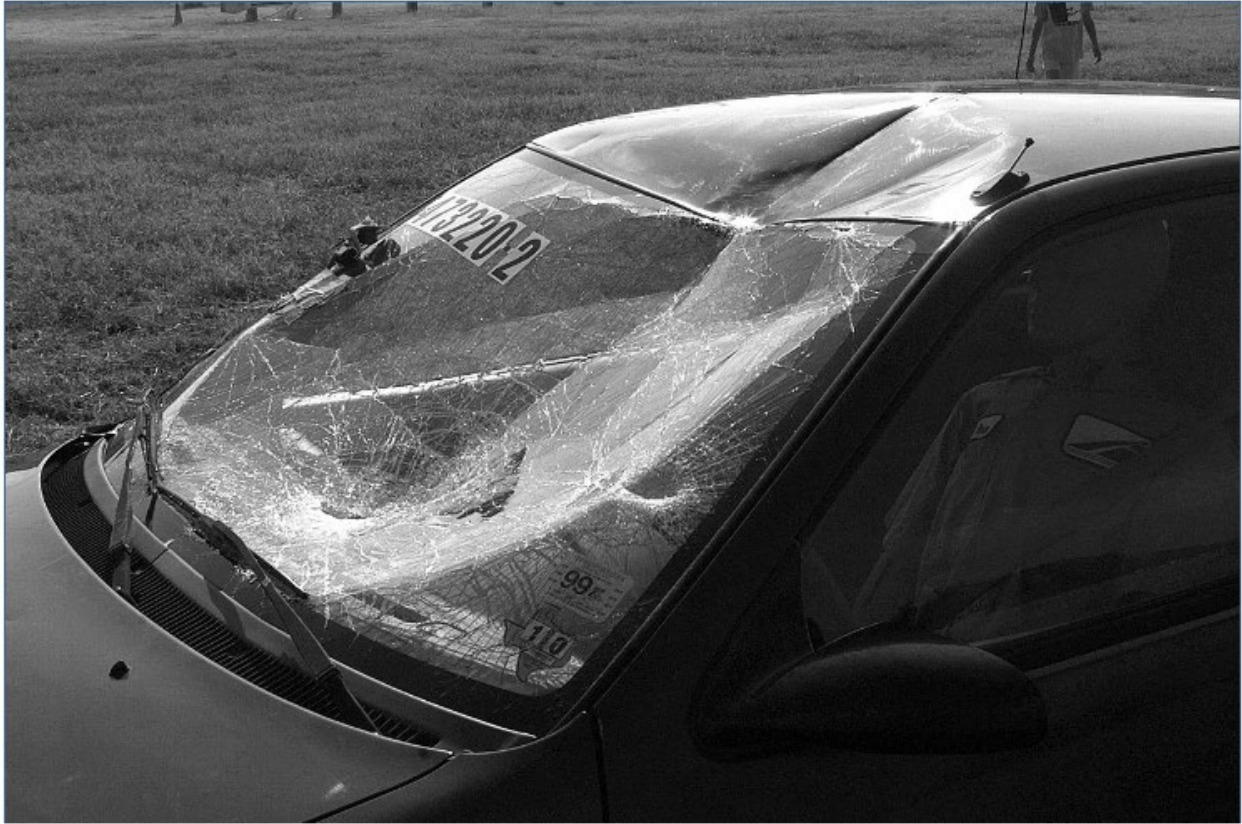
mm long and approximately 19-25 mm wide. Additionally, the maximum deformation to the occupant compartment was measured to be 44 mm. The roof deformed over an area of 800 mm x 400mm to a depth of 55 mm. This system failed to meet NCHRP Report 350 criteria because of the windshield damage caused by a cross member of the barricade. (5).

**Figure 2.11: Windshield Damage to Vehicle from New Jersey Type III PVC Barricade Testing (5)**

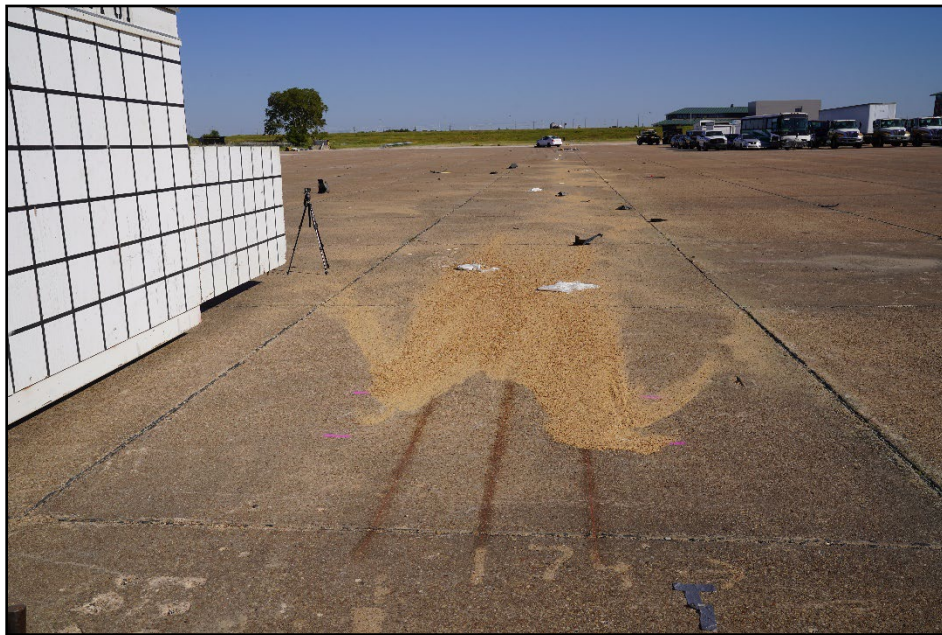
The wood debris started at 75 feet downstream and extended 42 feet to the right and 18 feet to the left of impact. The remainder of the sign was 300 feet downstream and 4 feet to the right of the installation. Figure 5.5 and Figure 5.6 show the damage to the Type III barricade with mounted sign.

**Figure 7.5. Type III Barricade with Mounted Sign after Test at Impact Location 616411-01-1.**

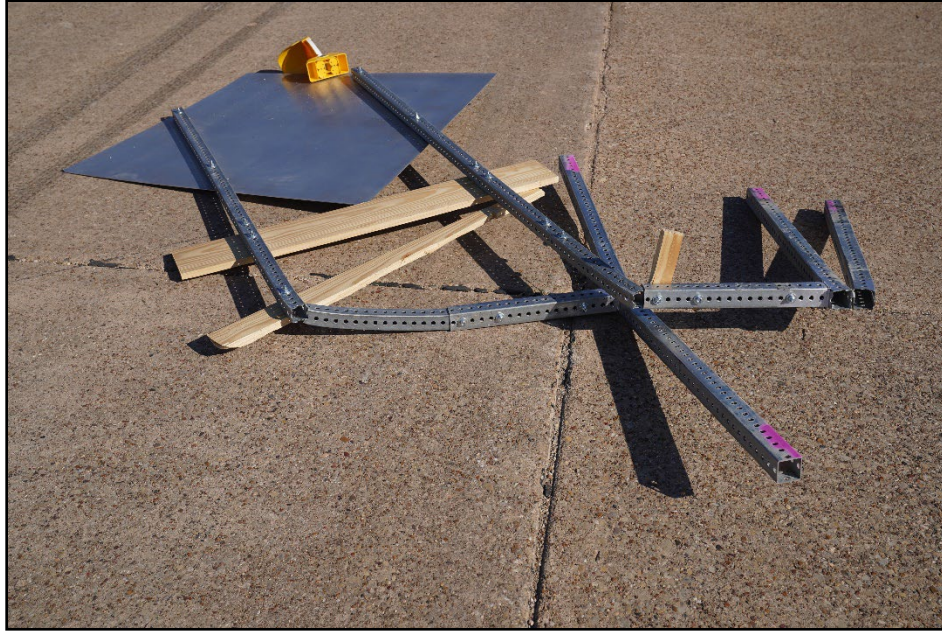
**Figure 7.6. Type III Barricade with Mounted Sign after Test at its Final Location 616411-01-1.**

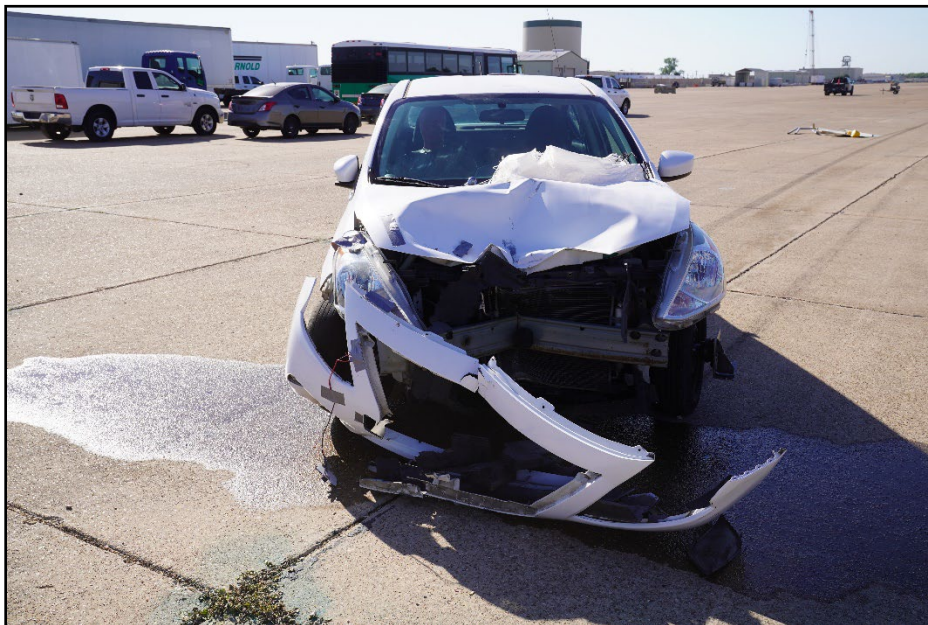
**Figure 7.7. Impact Side of Test Vehicle after Test 616411-01-1.**

Side Windows	The side windows remained intact
Maximum Exterior Deformation	12 inches in the front plane at bumper height
VDS	12FC6
CDC	12FCAN5
Fuel Tank Damage	None
Description of Damage to Vehicle:	The front bumper, hood, grill, radiator and support were damaged. The hood had a 36-inch × 20-inch × 6-inch deep dent. There were also some scuff marks on the left front center of the roof.

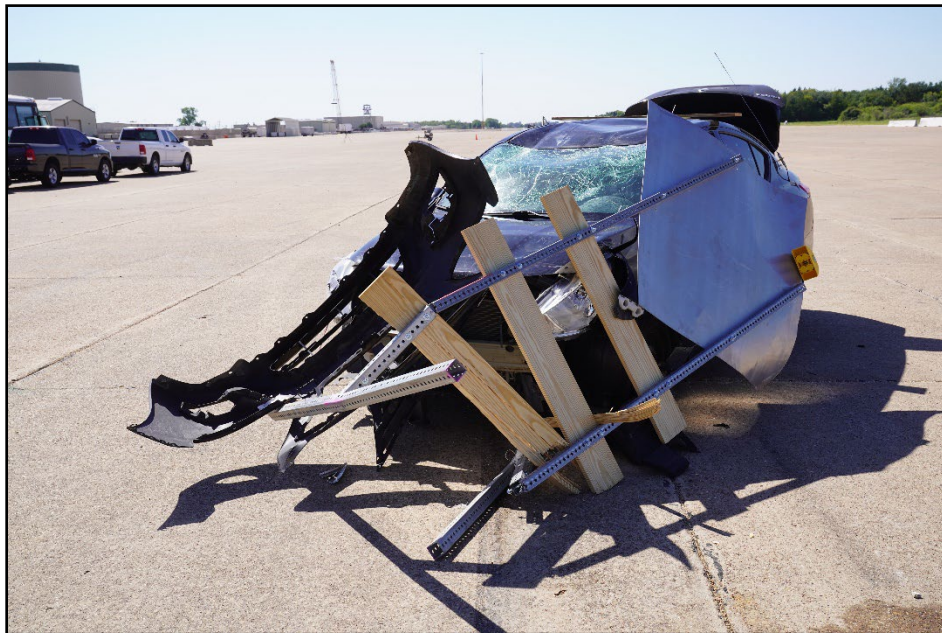
**Figure 8.5. Type III Barricade with Mounted Sign after Test 616411-01-2.**

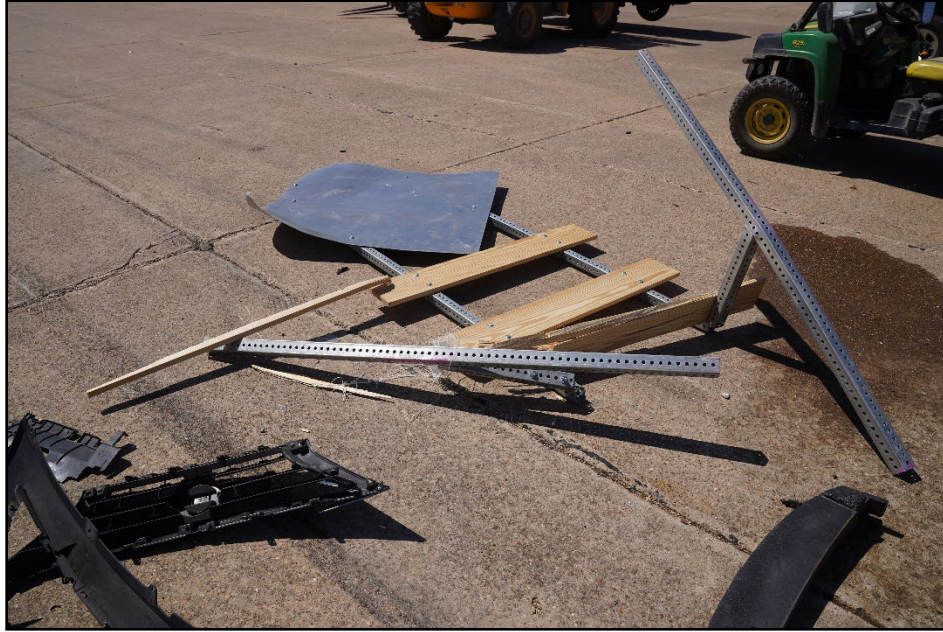
**Figure 8.6. Type III Barricade with Mounted Sign after Test After Being Removed from the Vehicle 616411-01-2.**

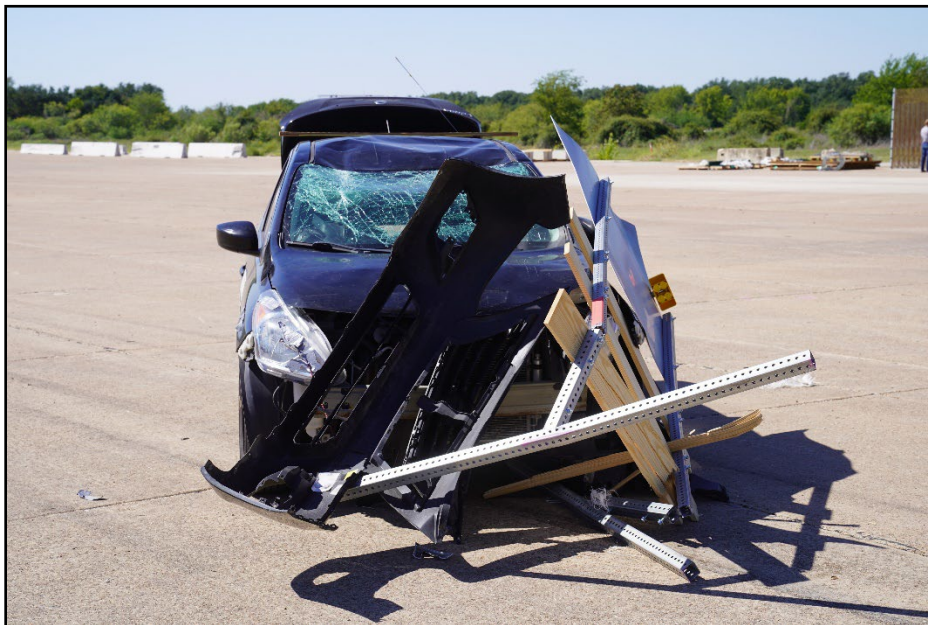
**Figure 8.7. Impact Side of Test Vehicle after Test 616411-01-2.**

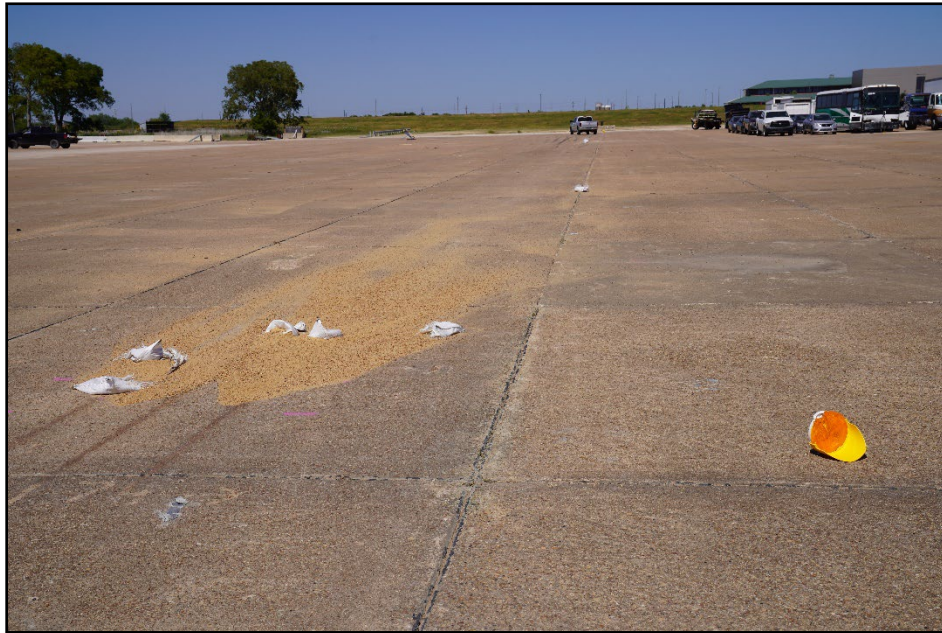
**Figure 9.5. Type III Barricade with Mounted Sign after Test at Impact Location 616411-01-3.**

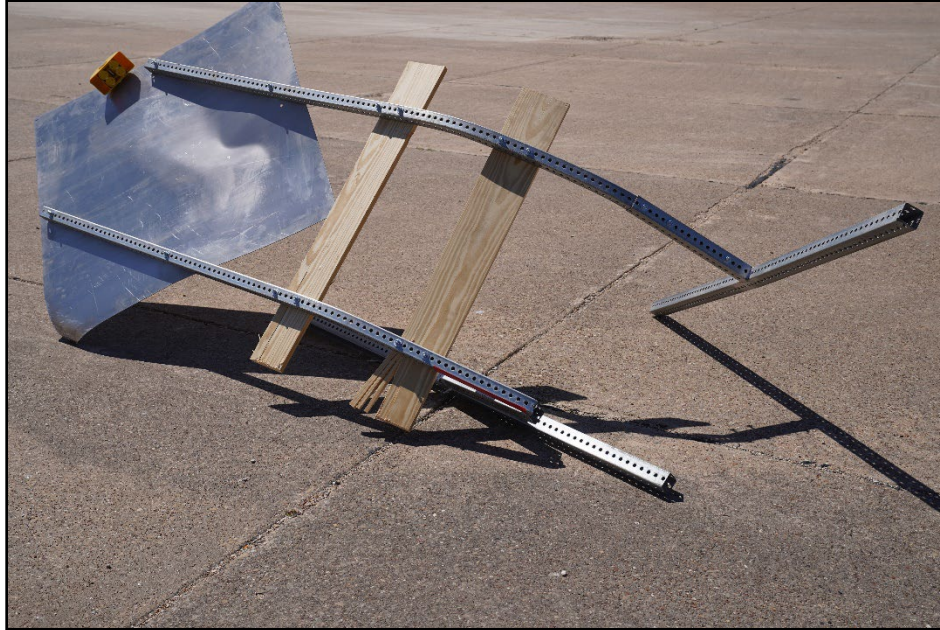
**Figure 9.6. Type III Barricade with Mounted Sign after Test at its Final Resting Location 616411-01-3.**

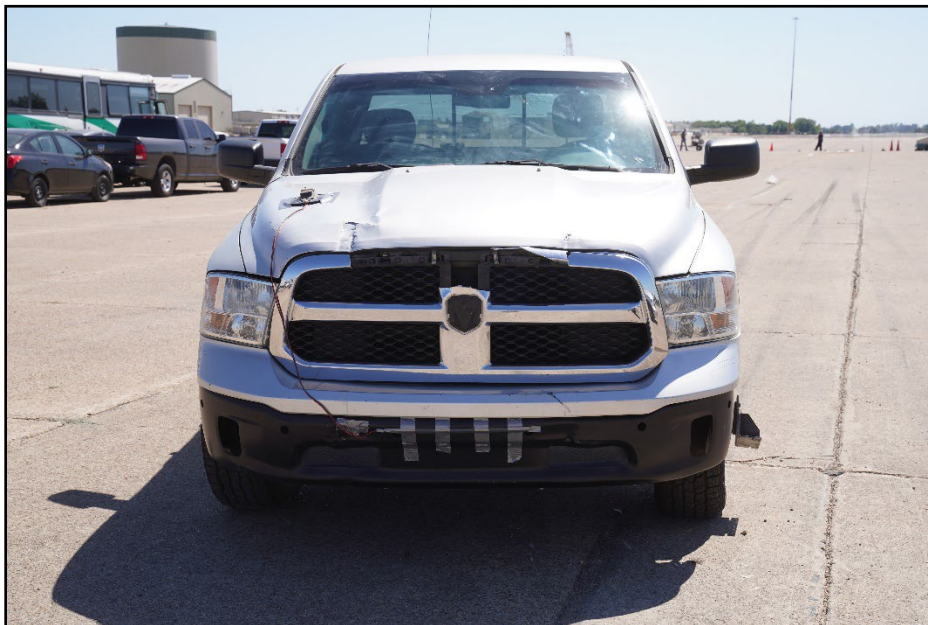
**Figure 9.7. Impact Side of Test Vehicle after Test 616411-01-3.**

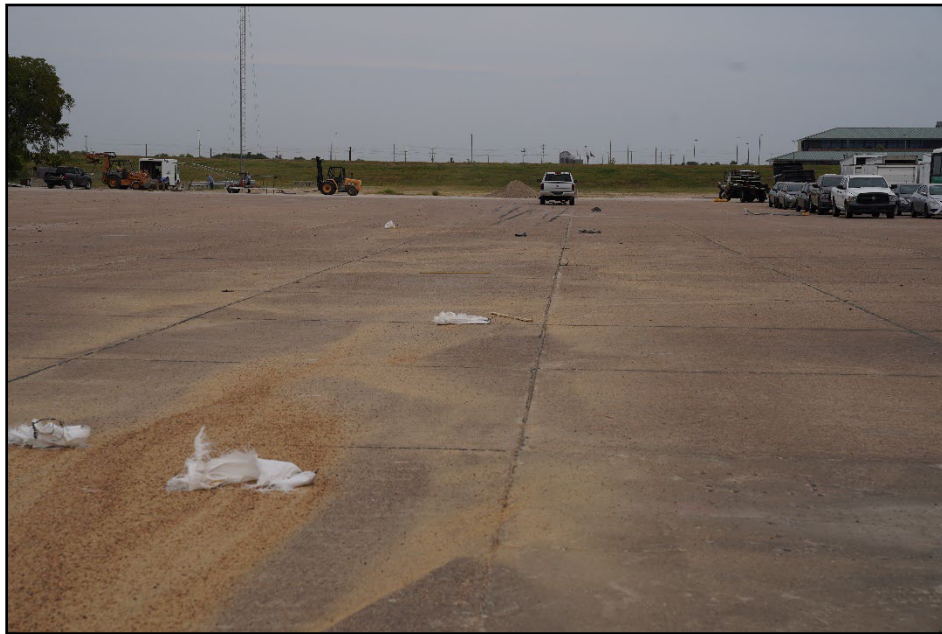
**Figure 10.5. Type III Barricade with Mounted Sign after Test at Impact Location 616411-01-4.**

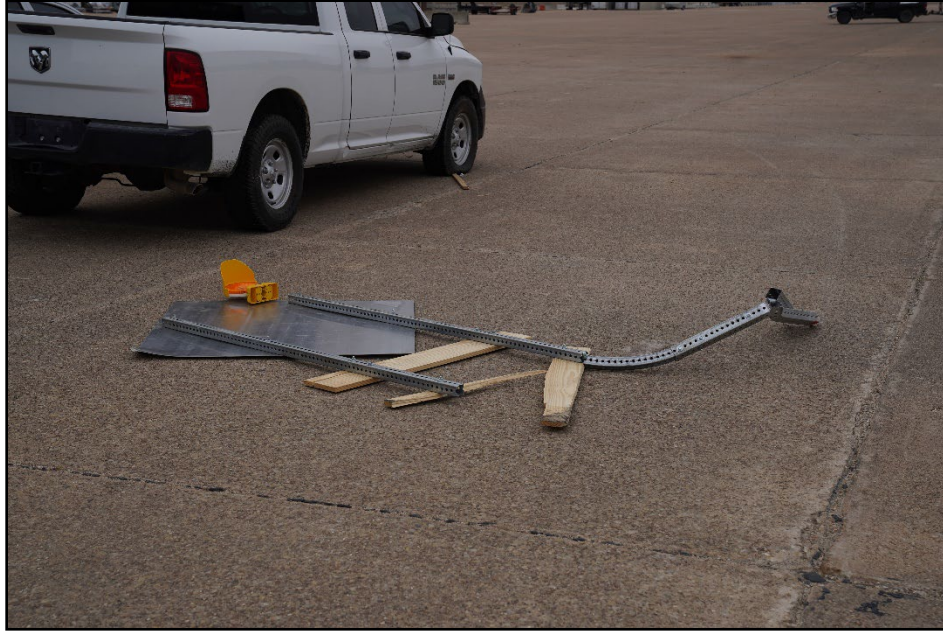
**Figure 10.6. Type III Barricade with Mounted Sign after Test at its Final Resting Location 616411-01-4.**

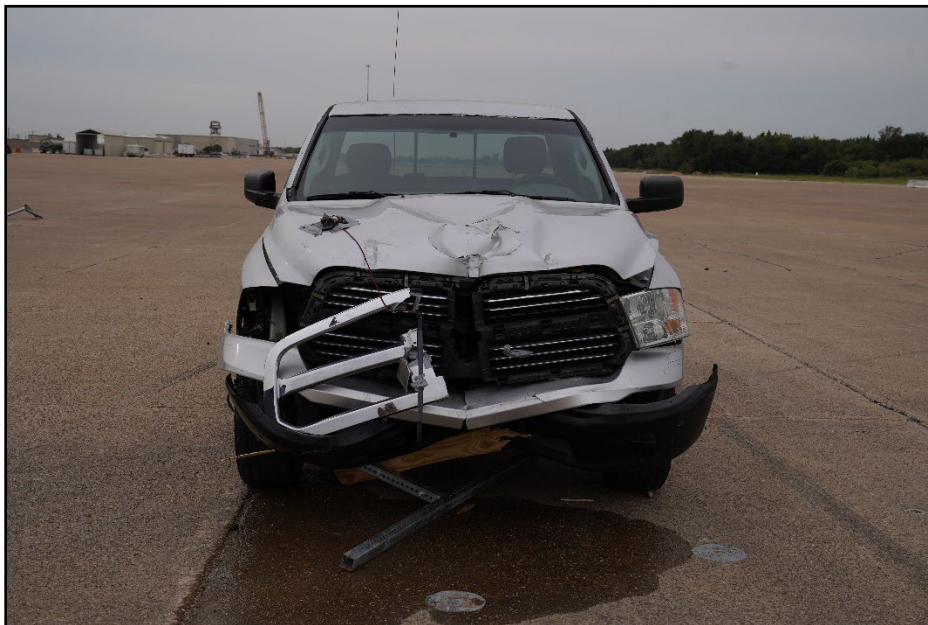
**Figure 10.7. Impact Side of Test Vehicle after Test 616411-01-4.**

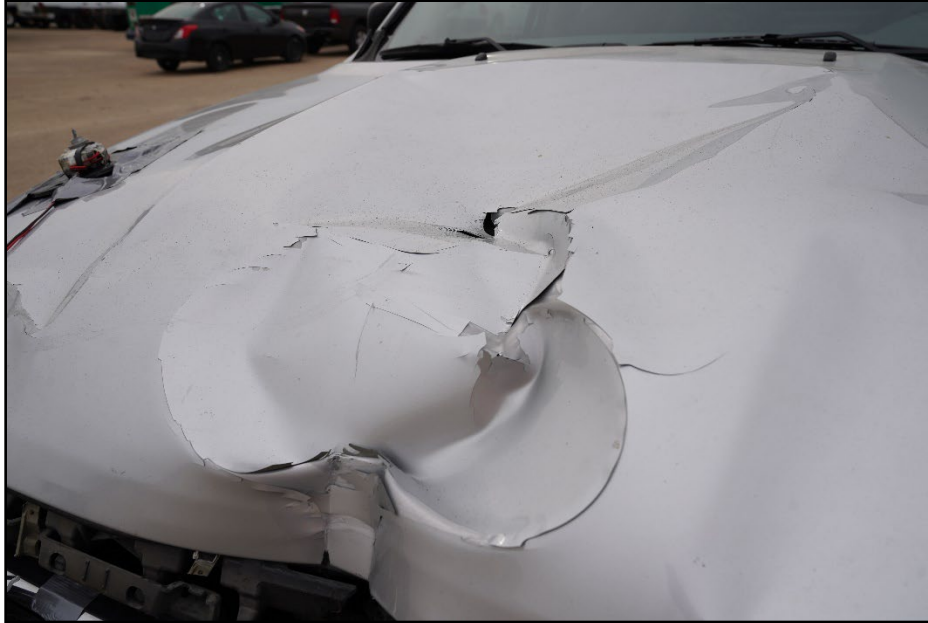
**Figure 10.8. Test Vehicle Hood Damage after Test 616411-01-4.**

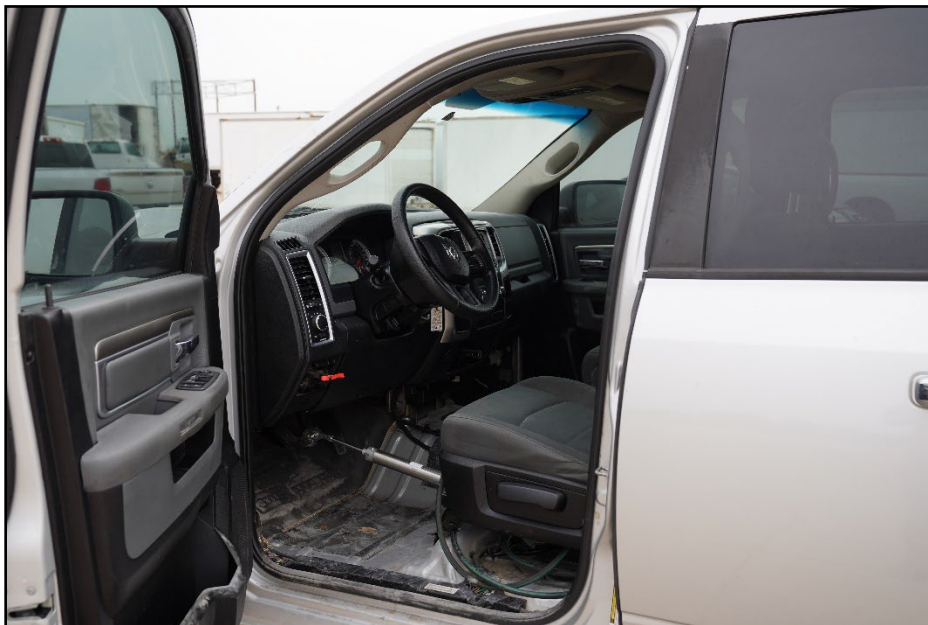
**Figure 10.9. Overall Interior of Test Vehicle after Test 616411-01-4.**
