Test Report No. 609971-01

**TESTING AND EVALUATION OF FLARED MGS SYSTEM AT
MASH TEST LEVEL 3 CONDITIONS**

Sponsored by
Washington State Department of Transportation (WsDOT)

TEXAS A&M TRANSPORTATION INSTITUTE PROVING GROUND

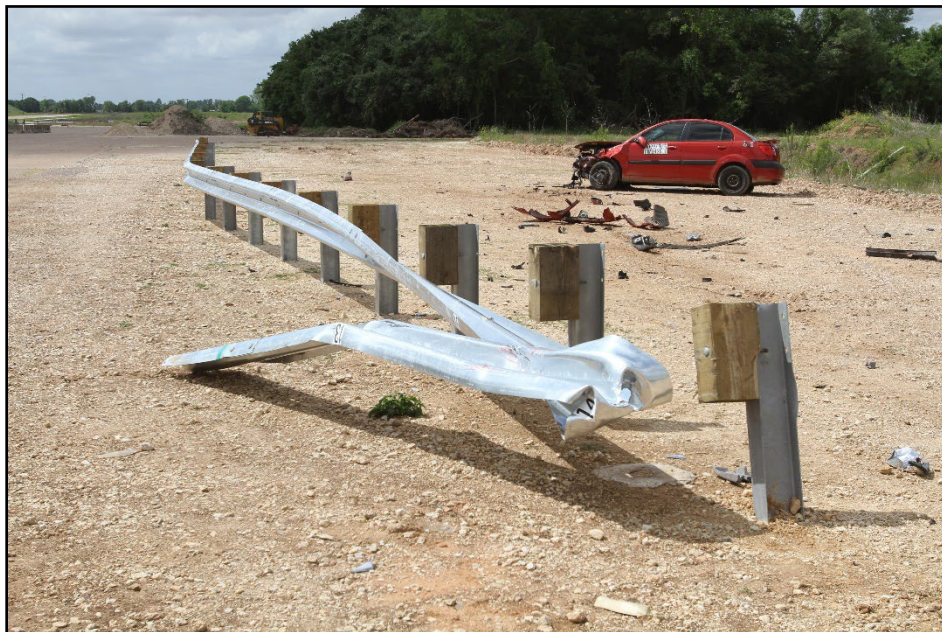
The W-beam guardrail ruptured at post 12 and released from post 11 through post 17. The soil was disturbed at posts 1 and 2, post 11 was leaning toward the field side at 2 degrees from vertical, and posts 12 and 13 were leaning toward the field side at 75 degrees from vertical and downstream at 5 degrees from vertical. Post 14 was leaning downstream at 17 degrees from vertical and toward the field side at 2 degrees from vertical. Table 5.6 describes the damage to the MGS guardrail with flare. Figure 5.5 and Figure 5.6 show the damage to the MGS guardrail with flare.

Figure 5.6. MGS Guardrail with Flare after Impact for Test 609971-01-1.

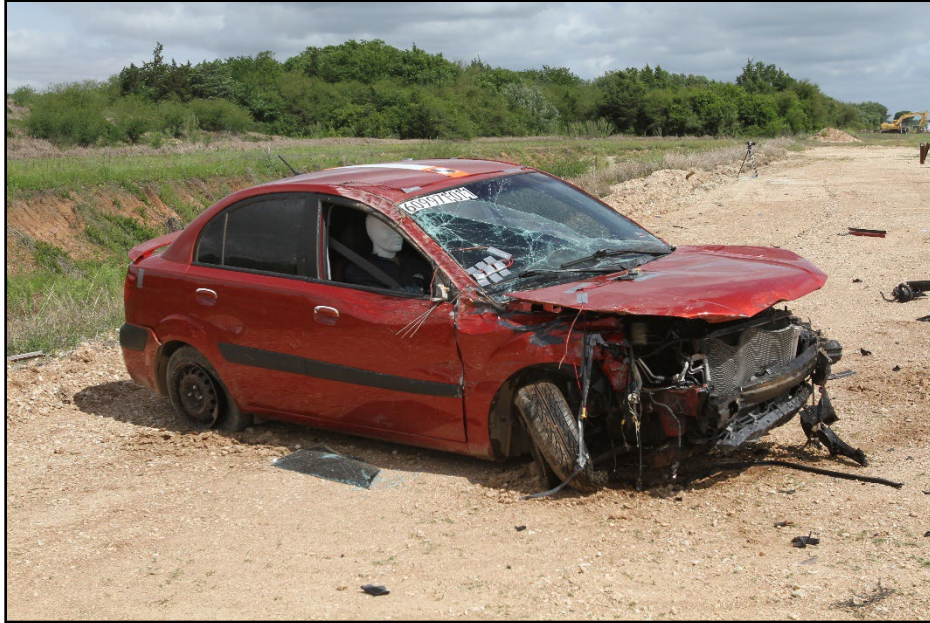
Figure 5.7. Impact Side of Test Vehicle after Test 609971-01-1.

Side Windows	Shattered due to vehicle roll
Maximum Exterior Deformation	9 inches at front bumper
VDS	1RFQ5
CDC	01FRES3
Fuel Tank Damage	None
Description of Damage to Vehicle:	The front bumper, hood, grill, radiator and support, right fender, right tire and rim, right front door and glass, right A pillar, right rear door, right rear tire and rim, and left front fender were damaged. Damage to the windshield was caused by the flexing of the vehicle body during impact, not from contact with the test article.

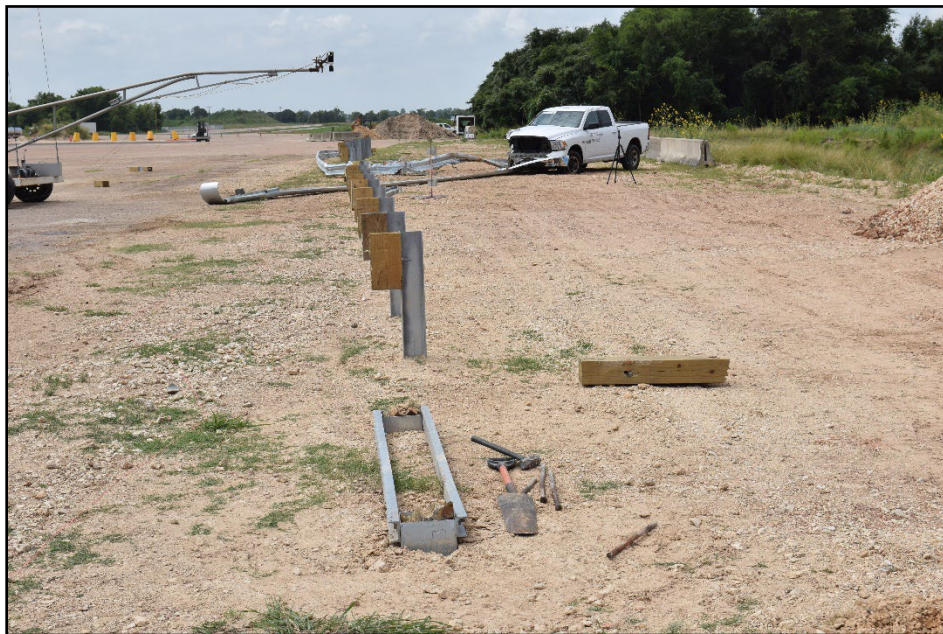
Figure 6.6. MGS Guardrail with Flare after Test 609971-03-1.

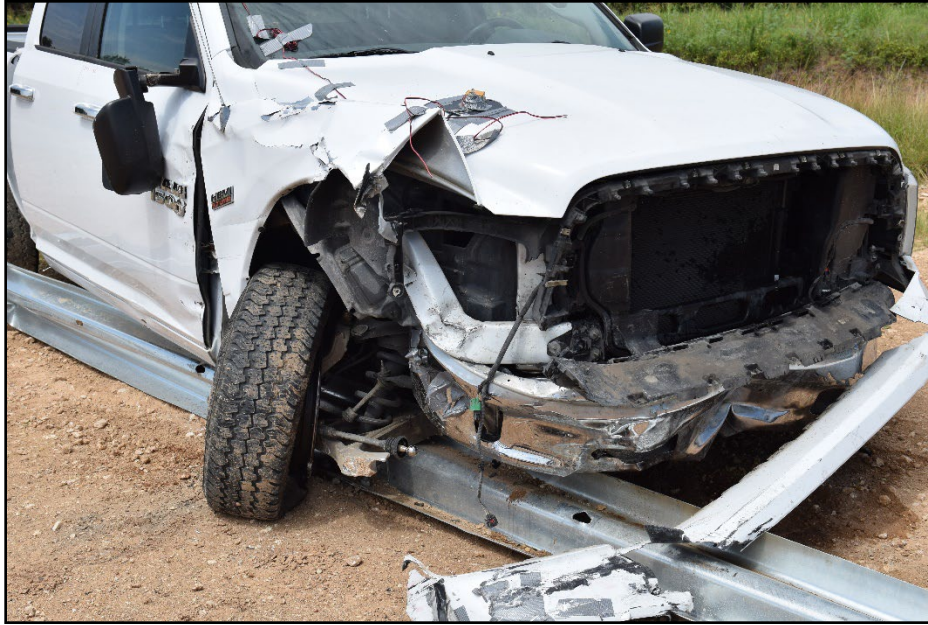
Figure 6.7. Impact Side of Test Vehicle after Test 609971-03-1.

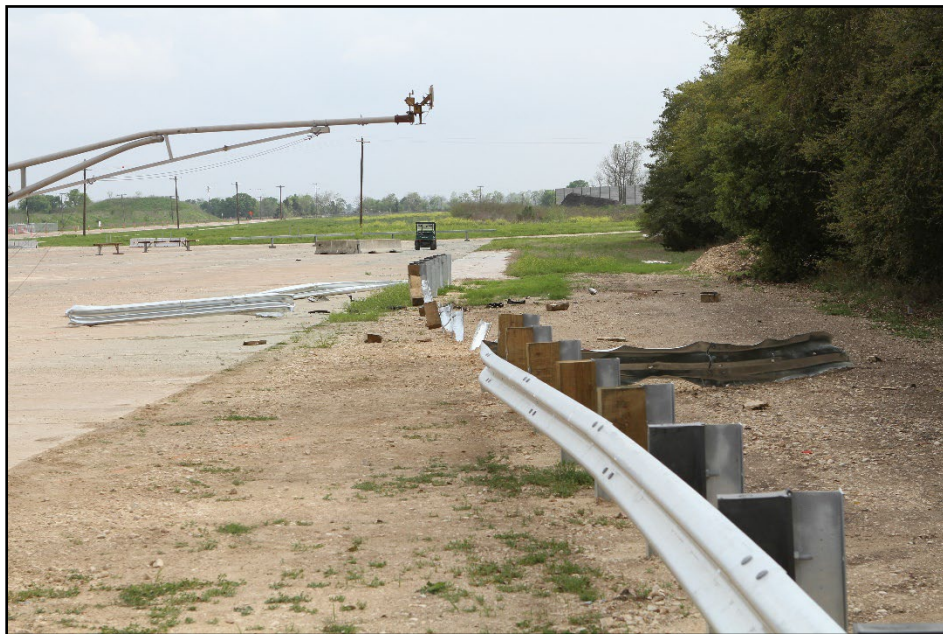
Figure 7.6. MGS Guardrail with Flare after Test 609971-03-2.

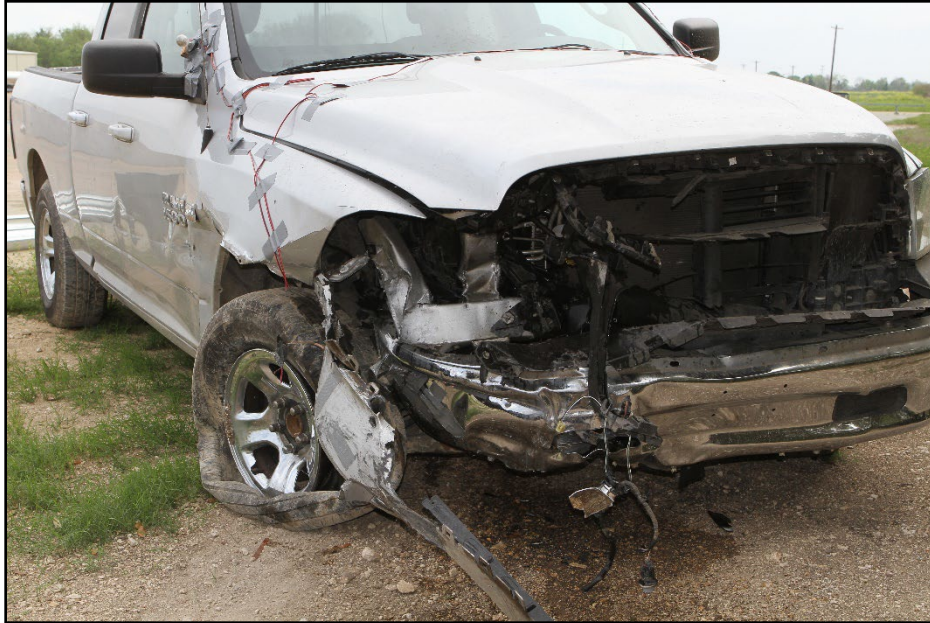
Figure 7.7. Impact Side of Test Vehicle after Test 609971-03-2.

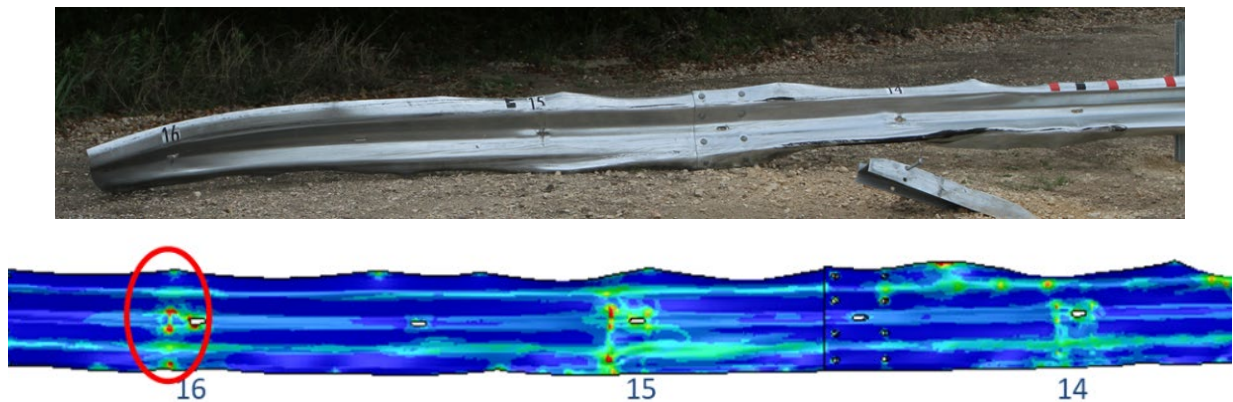
Figure 8.5. Rail Rupture Experienced in Full-Scale Testing (Top) and Rail Strains Recorded in FE Simulation (Bottom).
