## **CRASH TESTING AND EVALUATION OF THE HIGH-TENSION CABLE GUARDRAIL AT HIGH IMPACT ANGLE**

Contract No. T4541-AD  
Report/Test No. 405160-2-1  
Date of Test: 05-11-2006

**Roadside Safety Research Program Pooled Fund  
Study No. TPF-5(114)**

**TEXAS TRANSPORTATION INSTITUTE  
THE TEXAS A&M UNIVERSITY SYSTEM  
COLLEGE STATION, TEXAS 77843**

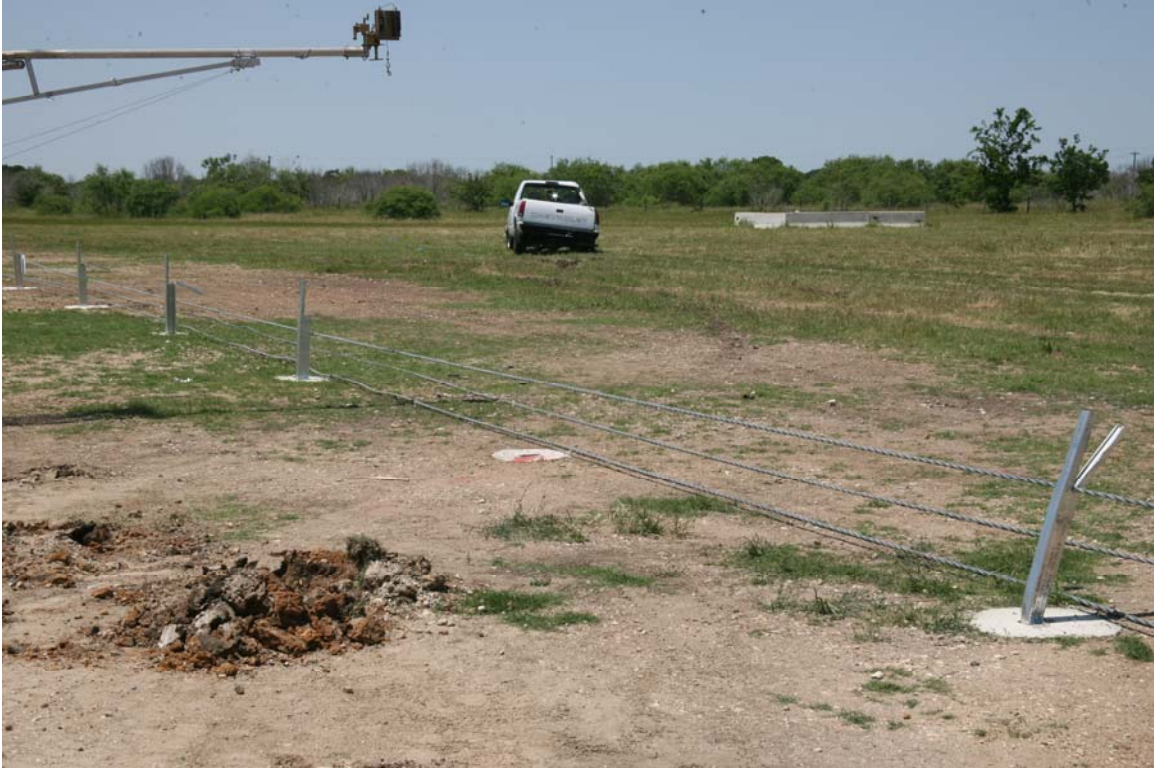
Figure 9. Vehicle trajectory path after test 405160-2-1.

Damage to the installation is shown in figures 9 and 10. All the restraining straps on the top of the wavy slot of the CASS posts failed during the test. Post 1 and 2 were disturbed, and no movement was noted at post 3. The top and bottom cables were separated from post 4 and all cables from post 5. The top cable only was separated from posts 6-9, and post 9 was leaning toward the field side 50 mm (2.0 in). The rear flange at the lower end of the wavy slot of post 10 was deformed toward the field side 90 degrees and all cables separated from the post. Post 11 was deformed toward field side about 15 degrees, the rear flange at the lower end of the wavy slot deformed 21 degrees, and the top and middle cables were separated from the post. Post 12 pulled out of the socket and was resting 19 m forward of the traffic face of the barrier. Posts 13-16 were deformed at ground line and pulled toward the field side 30 mm (1.2 in), with the rear flange at the lower end of the wavy slot deformed at 90 degrees and all cables separated from the post. Posts 17 and 18 were deformed at ground line and pulled toward the field side 30 mm (1.2 in), with the rear flange at the lower end of the wavy slot deformed at 90 degrees and the top and middle cables separated from the posts. Posts 19 and 20 were deformed at ground line and pulled toward the field side 250 mm (9.8 in) and 200 mm (7.9 in), respectively, with the rear flange at the lower end of the wavy slot deformed at 90 degrees and the top and middle cables separated from the posts. The rear flange at the lower end of the wavy slot at posts 21 and 22 was deformed 90 degrees and the top and middle cables separated from the posts. The top cable was separated from posts 23 through 27. The top and middle cable separated from post 28 and the post was pulled upstream 60 mm (2.4 in). Post 29 was disturbed only, and posts 30 and 31 were pulled upstream 20 mm (0.8 in) and 30 mm (1.2 in), respectively. Working width could not be determined. Maximum dynamic deflection of the cable barrier just prior to the vehicle exiting through the cable barrier was 6.5 m (21.3 ft).

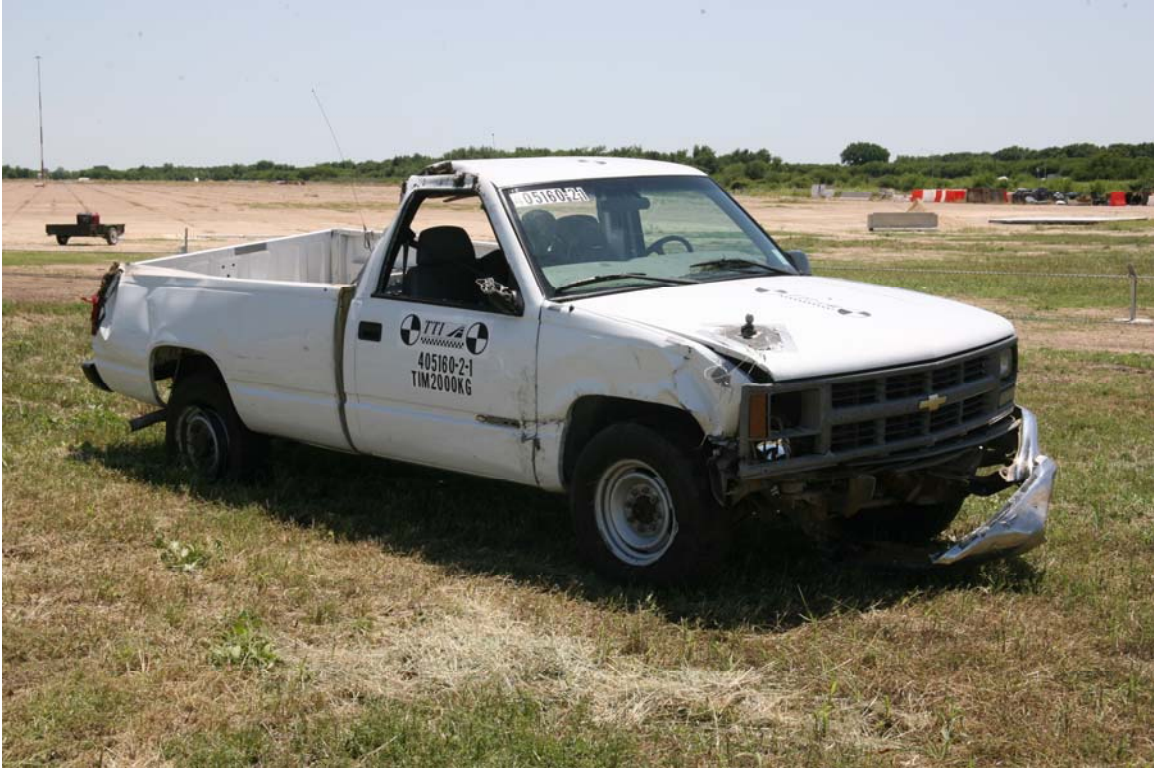
Figure 11. Vehicle after test 405160-2-1.

Damage to the vehicle is shown in figure 11. No structural damage was sustained by the pickup during the initial collision event. The front bumper, right front quarter panel, right door, right rear exterior bed were deformed and the right front tire and rim and right rear tire and rim were damaged from the initial collision event. During rollover, the left A-pillar and B-pillar and left front quarter panel deformed, and the right door glass shattered and windshield cracked. Maximum exterior crush to the vehicle was 260 mm (10.2 in) in the side plane at the right front corner at bumper height. Maximum occupant compartment deformation from the initial impact was 14 mm (0.6 in) in the lateral area across the floor pan (from kickpanel to kickpanel). Maximum occupant compartment deformation from the rollover event was 27 mm (1.1 in) in the diagonal distance between the lower edge of the A-pillar and the upper edge of the B-pillar on the left side. Photographs of the interior of the vehicle are shown in figure 12. Exterior vehicle crush and occupant compartment measurements are shown in appendix B, tables 2 and 3.

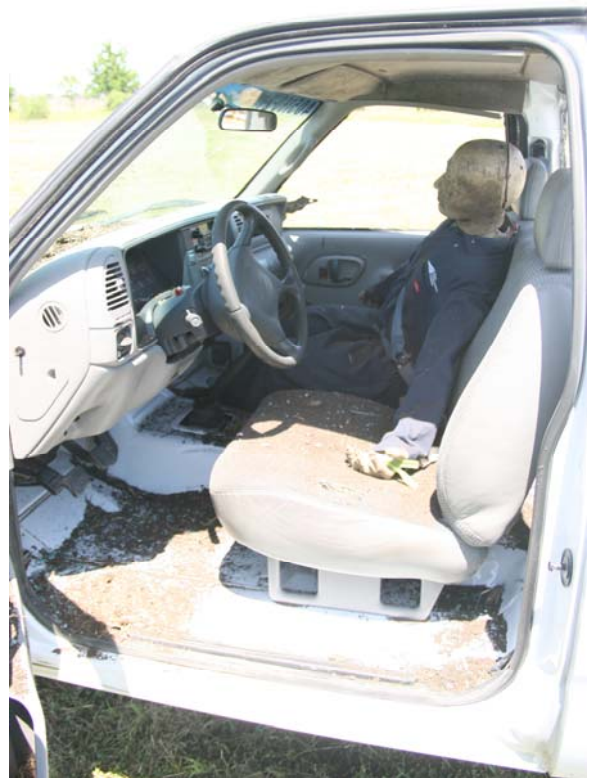
After test

Figure 12. Interior of vehicle for test 405160-2-1.
