## DEVELOPMENT GUIDANCE FOR SIGN DESIGN STANDARDS

**Test Report 0-6363-1**

TEXAS TRANSPORTATION INSTITUTE THE TEXAS A&M UNIVERSITY SYSTEM COLLEGE STATION, TEXAS

**TEXAS DEPARTMENT OF TRANSPORTATION**

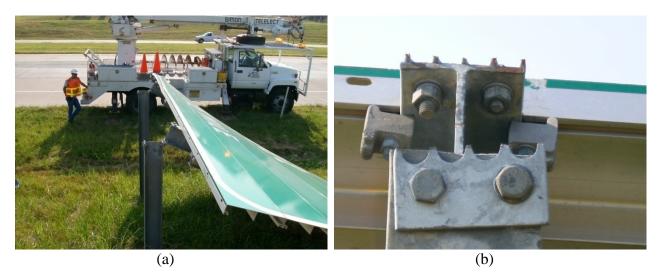
Figure 5.7. Typical Fuse Plate Failure Mode Reported by Districts.

- Localized high wind events causing fuse plate failure (high winds typically not in excess of design wind load conditions)
- Fuse plate connecting bolts were becoming loose over time (varied between a few days to a few months)
- Some sign locations were failing between two and three times a year.
- Dual fuse plate and single fuse plate designs were equally represented in failures.
- After further investigation, the W8×18 sign supports made up an abnormally large percentage of the sign installations failing under high wind loading events.

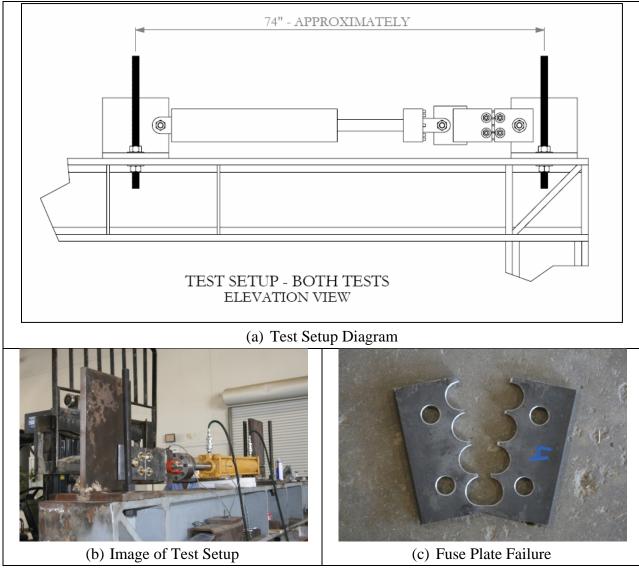
Figure 5.9. Fuse Plate Tensile Test (S12–S14).

Three of the samples were then chosen at random for testing (S12–S14). Loading was applied using a hydraulic cylinder. Care was taken to ensure bending stresses were not induced into the fuse plate during loading. This ensures that failure loads are not artificially reduced by combined stresses due to bending. Appendix B gives a recorded force-time history of the load event. Figure 5.9 (a-c) details the test setup and typical failure witnessed during the testing.

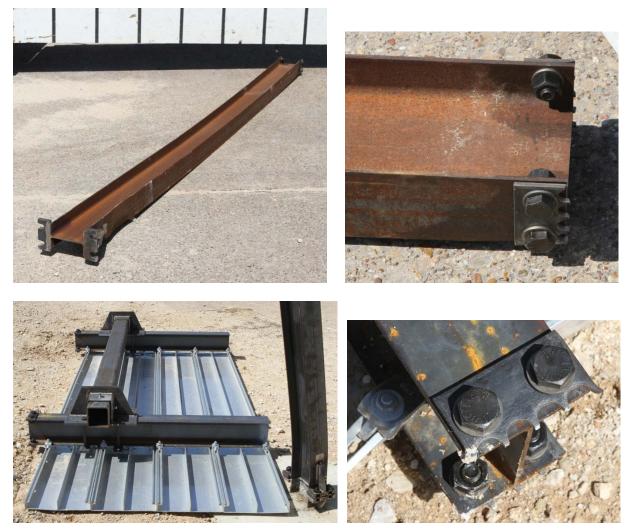
Figure 7.20. Installation after Test No. 463630-1.

- *B. The test article should readily activate in a predictable manner by breaking away, fracturing, or yielding.*
- <u>Results</u>: When impacted by the 1100C vehicle, the  $W6 \times 9.4$ -ft  $\times 10$ -ft large sign support activated by breaking away at the slipbase and at the upper hinge connections. (PASS)

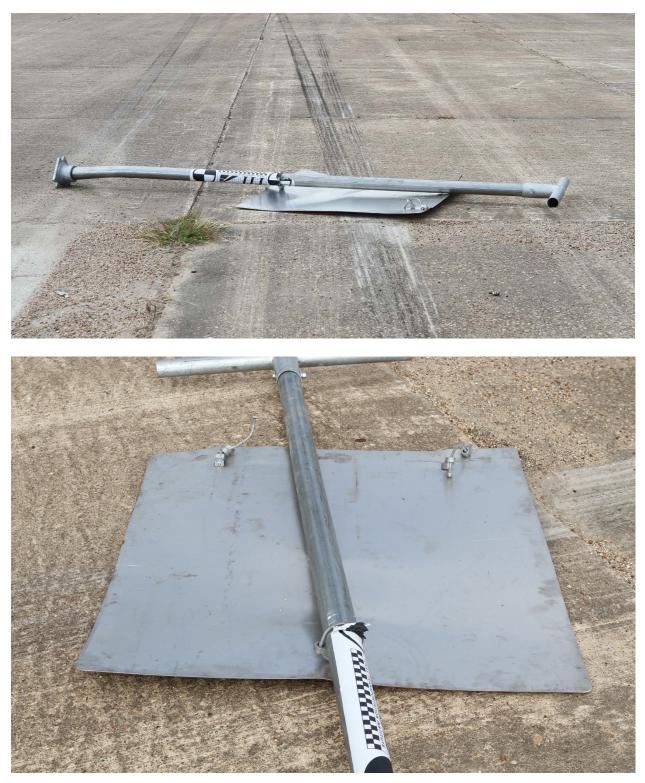
Figure 9.33. Installation after Test No. 463631-1.

Figure 9.33 shows the sign support activated as designed by slipping away at the base connection. The support was slightly deformed at bumper height of the vehicle. The sign panel clamp connections with the horizontal member failed after impact and interaction with the vehicle's roof. The support with sign panel was resting 180 ft downstream of the impact point.
