MASH EVALUATION OF TXDOT ROADSIDE SAFETY FEATURES – PHASE I

Test Report 0-6946-1

TEXAS A&M TRANSPORTATION INSTITUTE COLLEGE STATION, TEXAS

TEXAS DEPARTMENT OF TRANSPORTATION

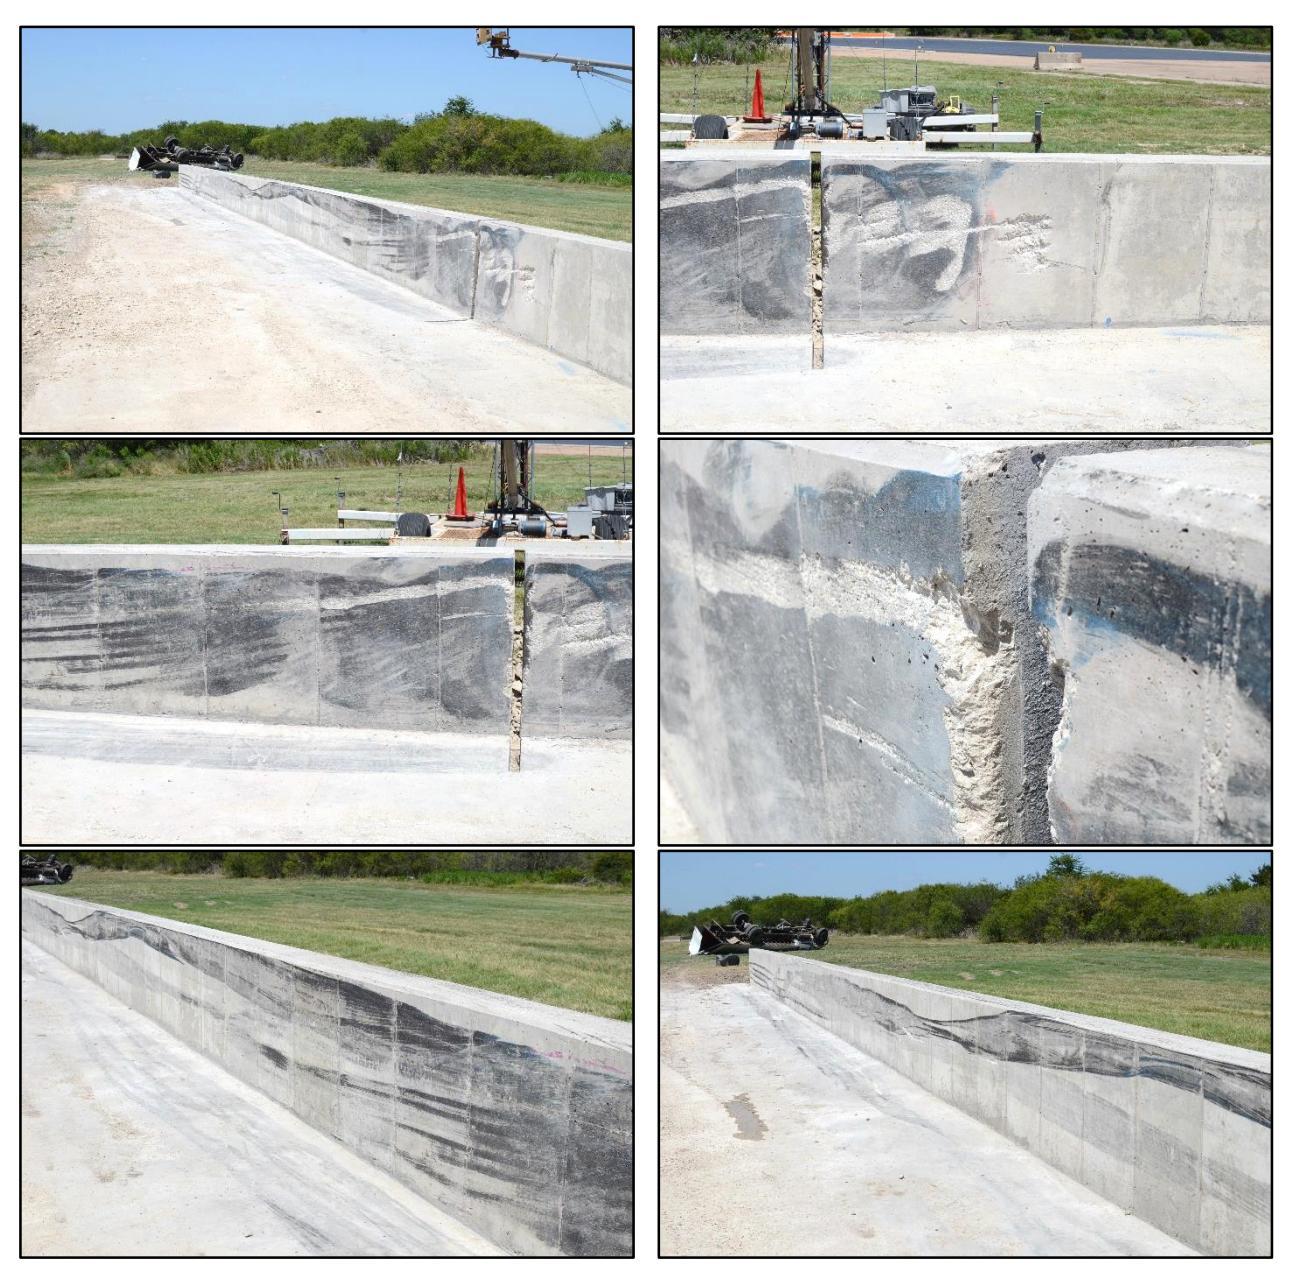
Figure 2.6. 36-inch Vertical Concrete Bridge Rail after Test No. 469467-1-1.

Figure 2.6 shows damage to the 36-inch vertical wall. Slight cracking of the concrete parapet occurred in the impact region near the expansion joint. Working width was 67 inches at a height of 104.6 inches. Maximum dynamic deflection during the test was 2.2 inches, and permanent deformation was approximately 1 inch at the top of the first section.

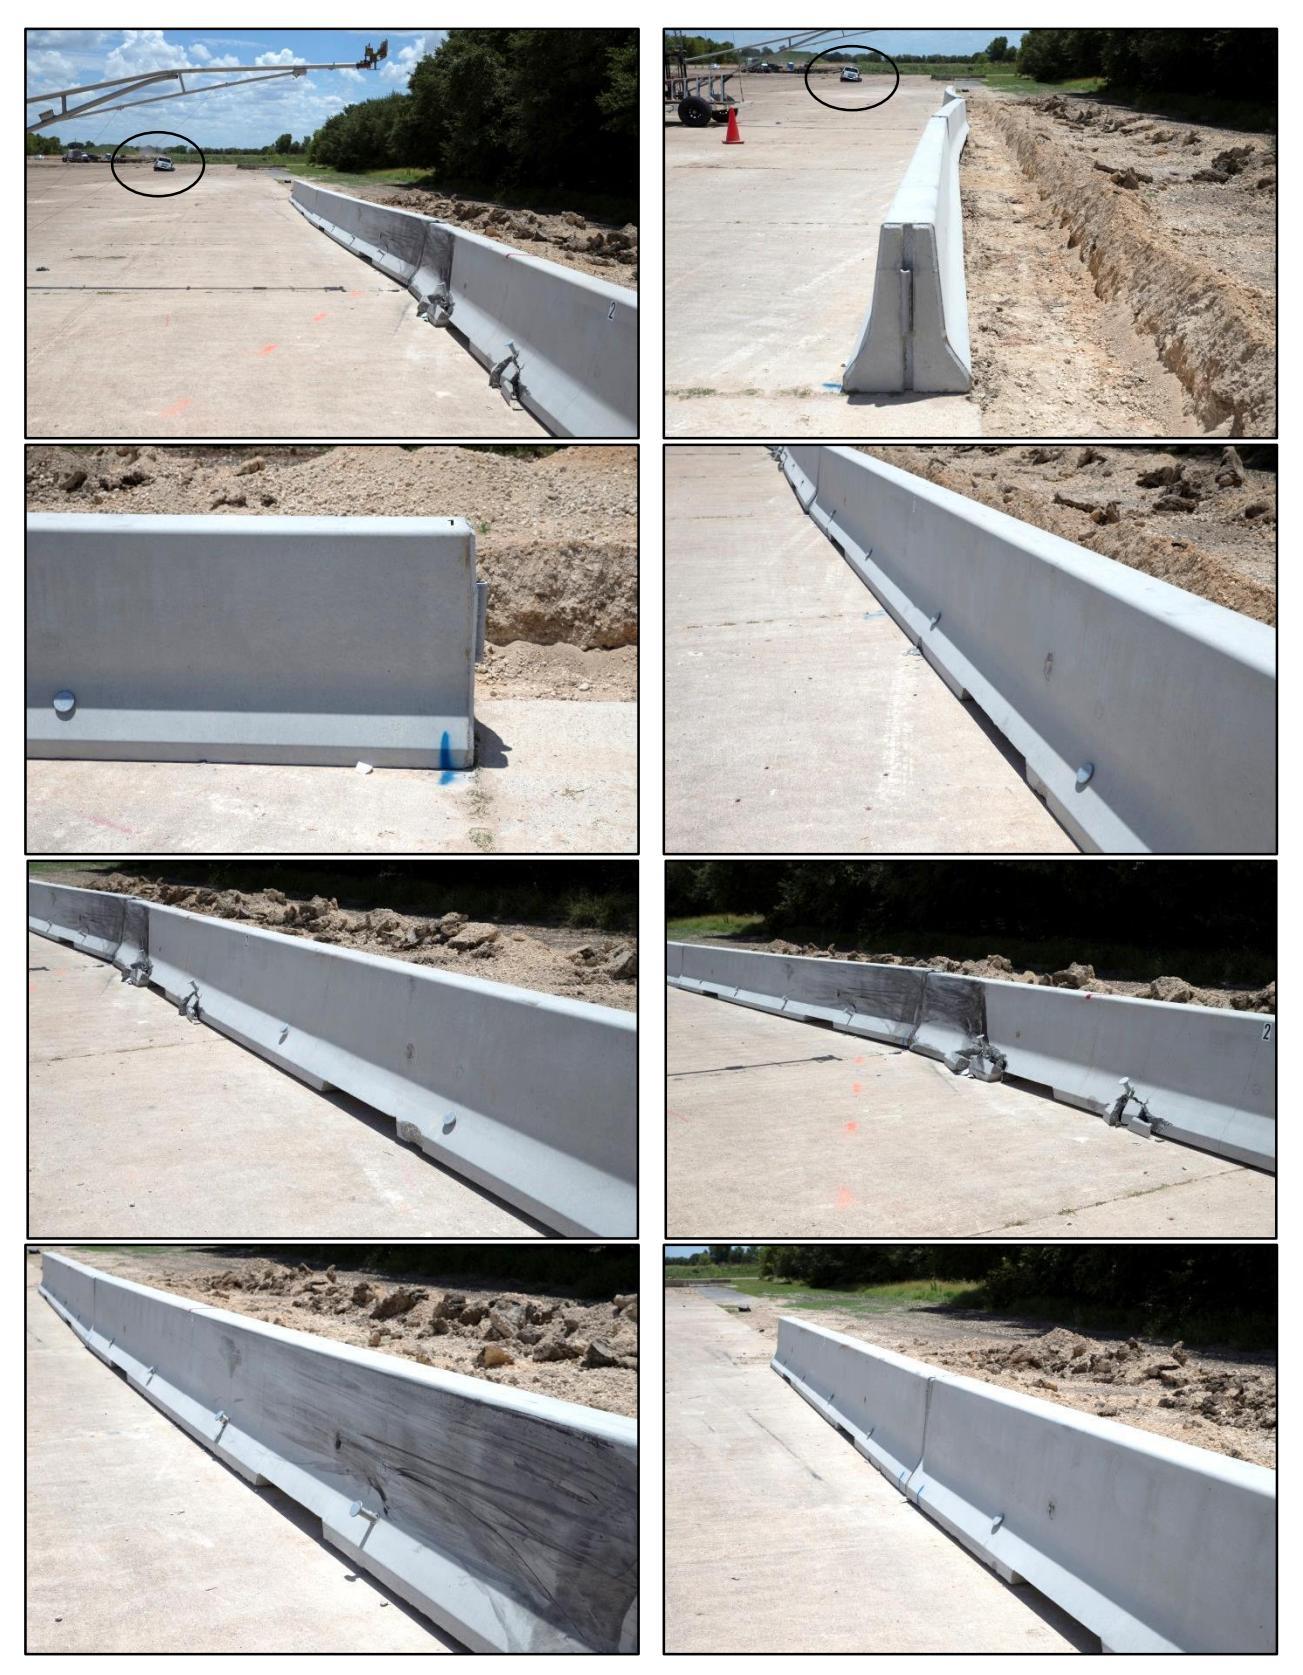
Figure 4.5. TxDOT 32-inch CSB(7)-10 Pinned to Concrete Pavement after Test No. 469467-5-1.

Figures 4.5 through 4.8 show the damage to the TxDOT 32-inch CSB(7)-10 pinned to concrete pavement. The upstream end of barrier segment 1 was pushed toward the field side 0.5 inch, and the downstream end was pushed toward traffic lanes 1.0 inch. The upstream end of barrier segment 2 was pushed toward traffic lanes 2.0 inches and was lifted upward from ground level 1.5 inches. The downstream end of barrier segment 2 was pushed 12.0 inches toward the field side and was lifted upward from ground level 0.5 inches. In barrier segment 2, pin 1 was pulled upward 0.5 inch, pin 2 was pulled up 1.0 inch, pin 3 was pulled up 3.0 inches, and pin 4 was pulled upward 4.0 inches and was deformed.

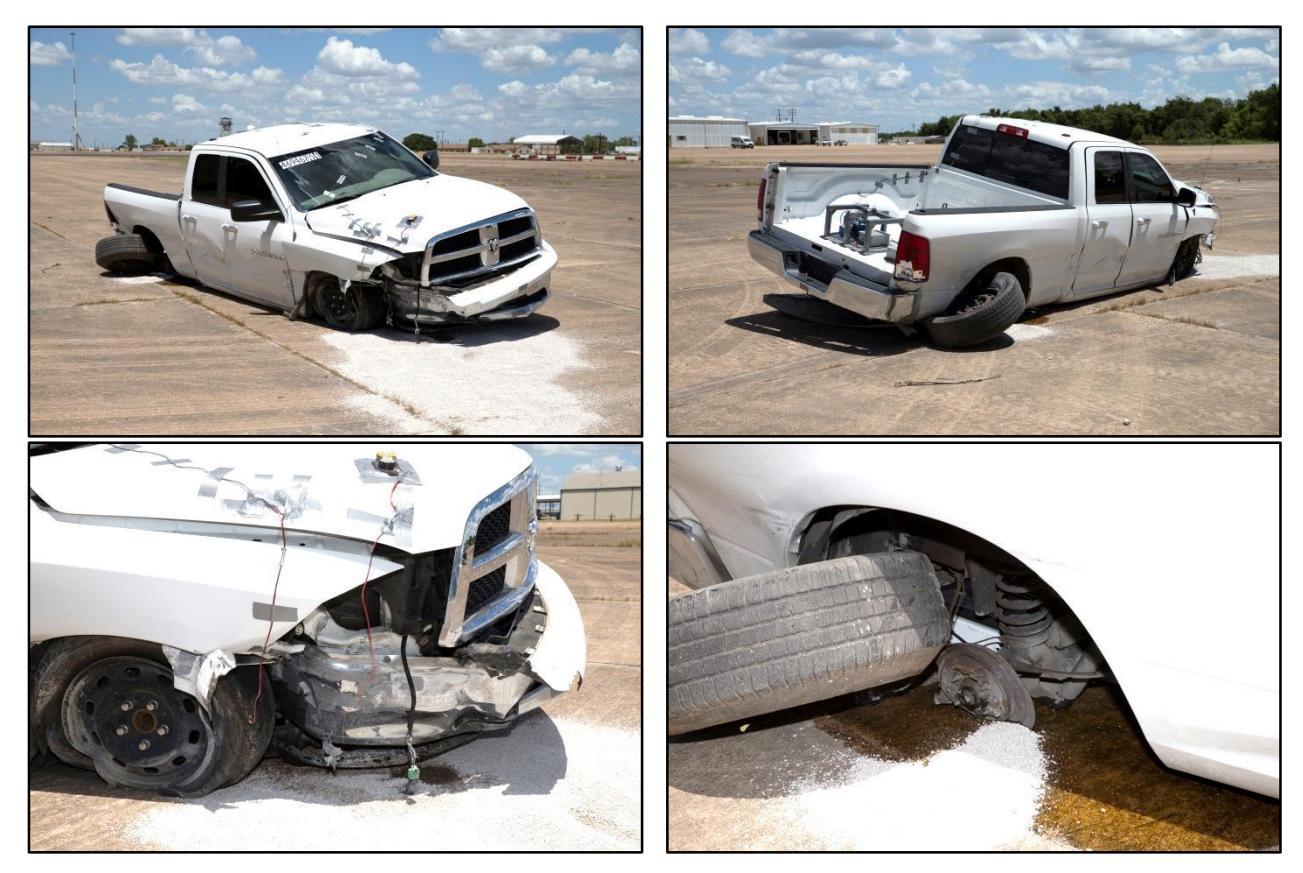
Figure 4.9. Test Vehicle after Test No. 469467-5-1.

Figure 4.9 shows the damage sustained by the test vehicle. The front bumper, grill, radiator and support, right front fender, right front tire and rim, right front and rear doors, right lower cab corner, right rear exterior bed, right rear tire and rim, right axle, rear bumper, and tailgate were damaged. Maximum exterior crush to the vehicle was 15.0 inches in the side plane at the right front corner at bumper height. No occupant compartment deformation or intrusion was noted. Figure 4.10 shows the interior of the vehicle. Tables C.3 and C.4 in Appendix C.3 provide exterior crush and occupant compartment measurements.

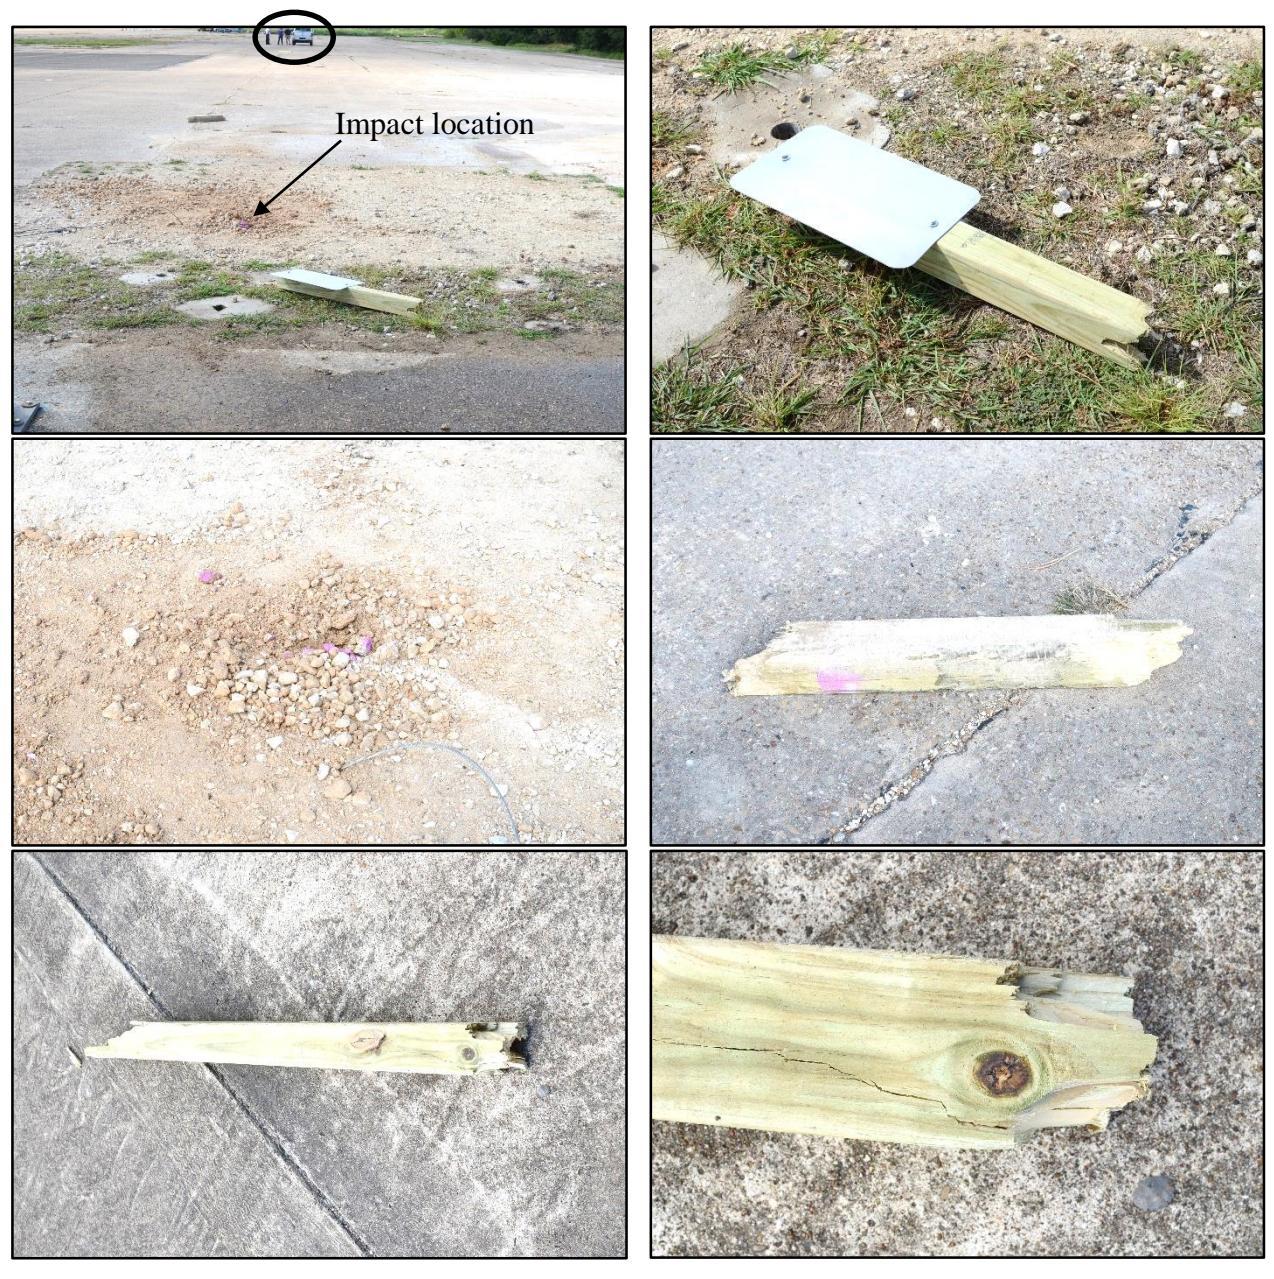
Figure 5.5. TxDOT Single Embedded Wood Post System for 0° Impact after Test No. 469467-6-1.

The support post fractured at three locations. The fracture above the vehicle hood may have been influenced by the presence of a knot on the impact face of the post. The sign panel and remaining post segment did not contact the windshield and had only minor (if any) contact with the roof. The influence of the knot on the fracture of the post may affect repeatability of the test. However, wood is a variable product with knots occurring randomly throughout. The TxDOT single embedded wood post sign system performed acceptably for *MASH* Test 3-62 at 0°.

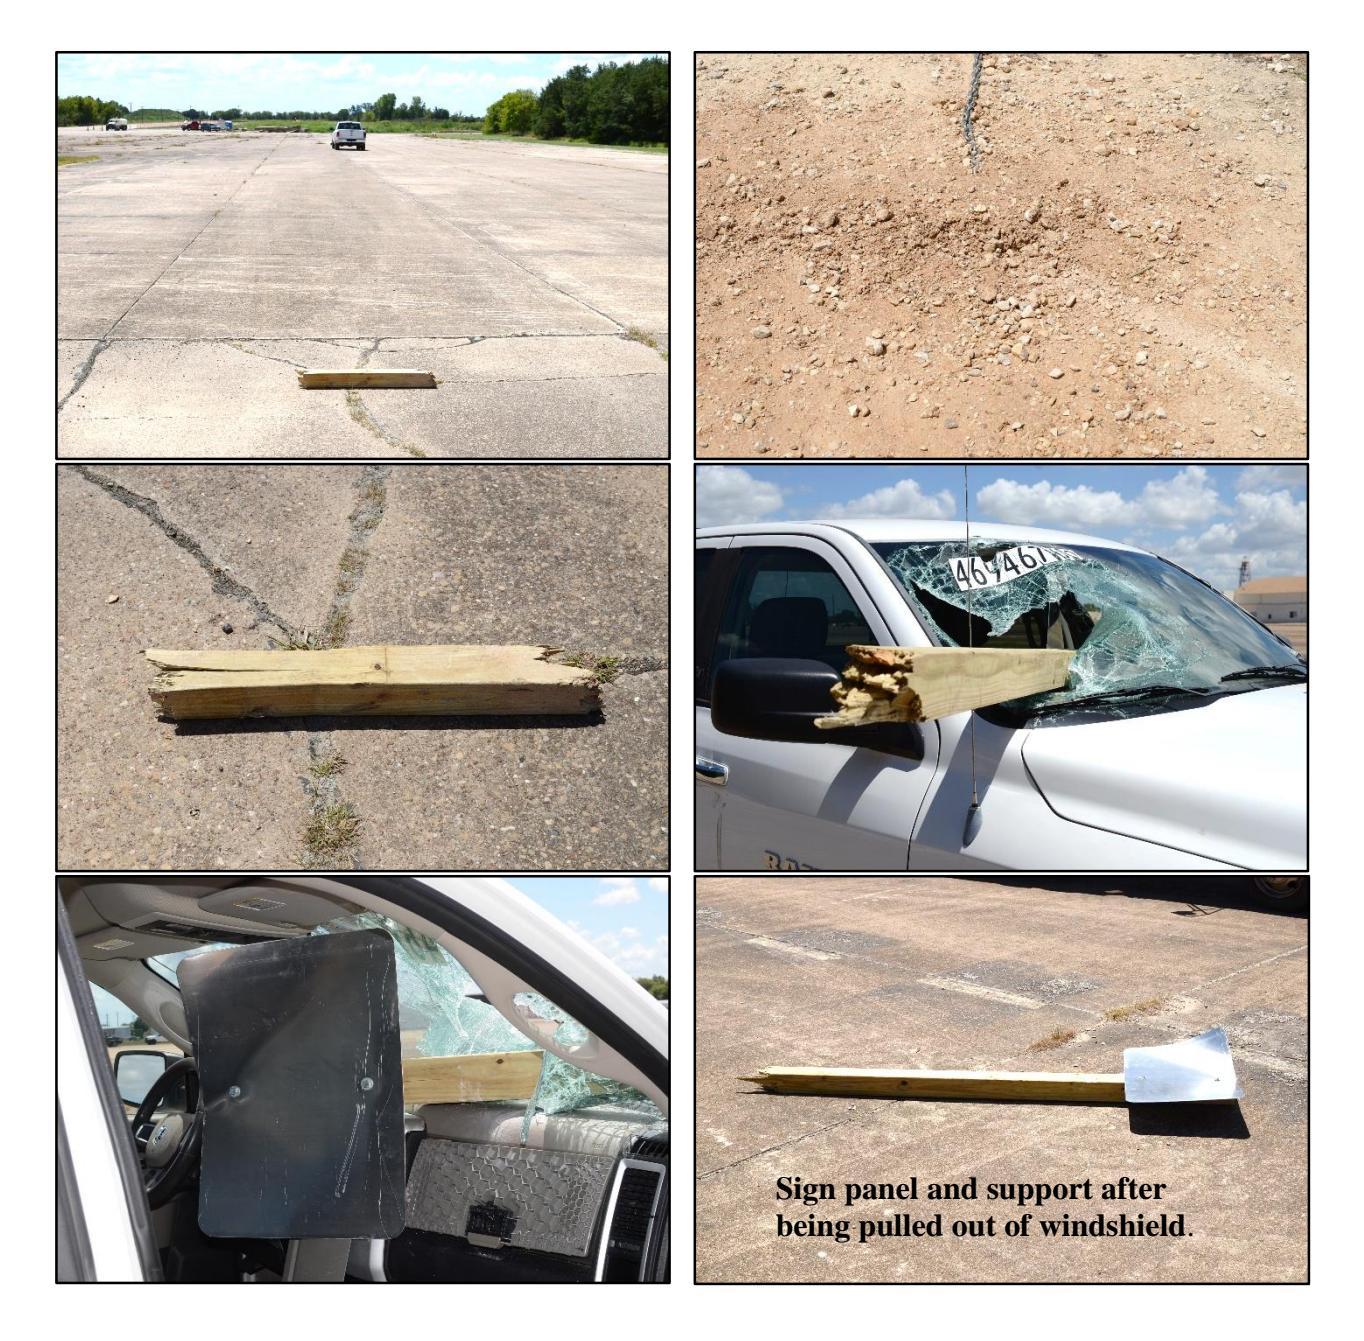
Figure 5.13. TxDOT Single Embedded Wood Post System for 90° Impact after Test No. 469467-6-3.

Figure 5.13 shows the damage to the TxDOT single embedded wood sign system. The wood post fractured in two places. A 32-inch long section was resting 155 ft upstream of impact and 11 ft to the left of centerline. An 80-inch section with the sign panel attached was embedded in the windshield of the vehicle.

The support post fractured near ground line and at bumper height. The fractured support and sign panel then rotated into the vehicle windshield, resulting in penetration of the windshield. The TxDOT single embedded wood post sign system did not perform acceptably for *MASH* Test 3-62 at 90° due to penetration of the windshield.

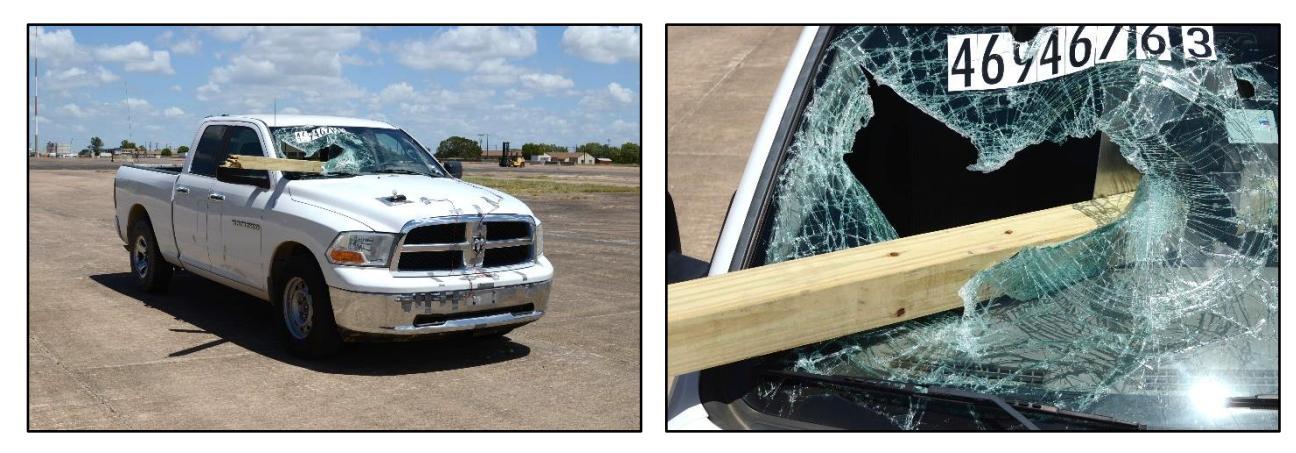
Figure 5.14. Test Vehicle after Test No. 469467-6-3.

Figure 5.14 shows damage sustained by the vehicle. The front bumper and hood had a small dent at the quarter point. The sign panel and support tore a 20×20 -inch hole in the windshield just left of centerline. The sign panel and support also caused damage to the instrument panel, glove box, and roof. Maximum exterior crush to the vehicle was not measureable in the front plane at the left quarter point at bumper height. Penetration of the windshield occurred. Figure 5.15 shows the interior of the vehicle. Table D.6 in Appendix D.2 provides occupant compartment measurements.

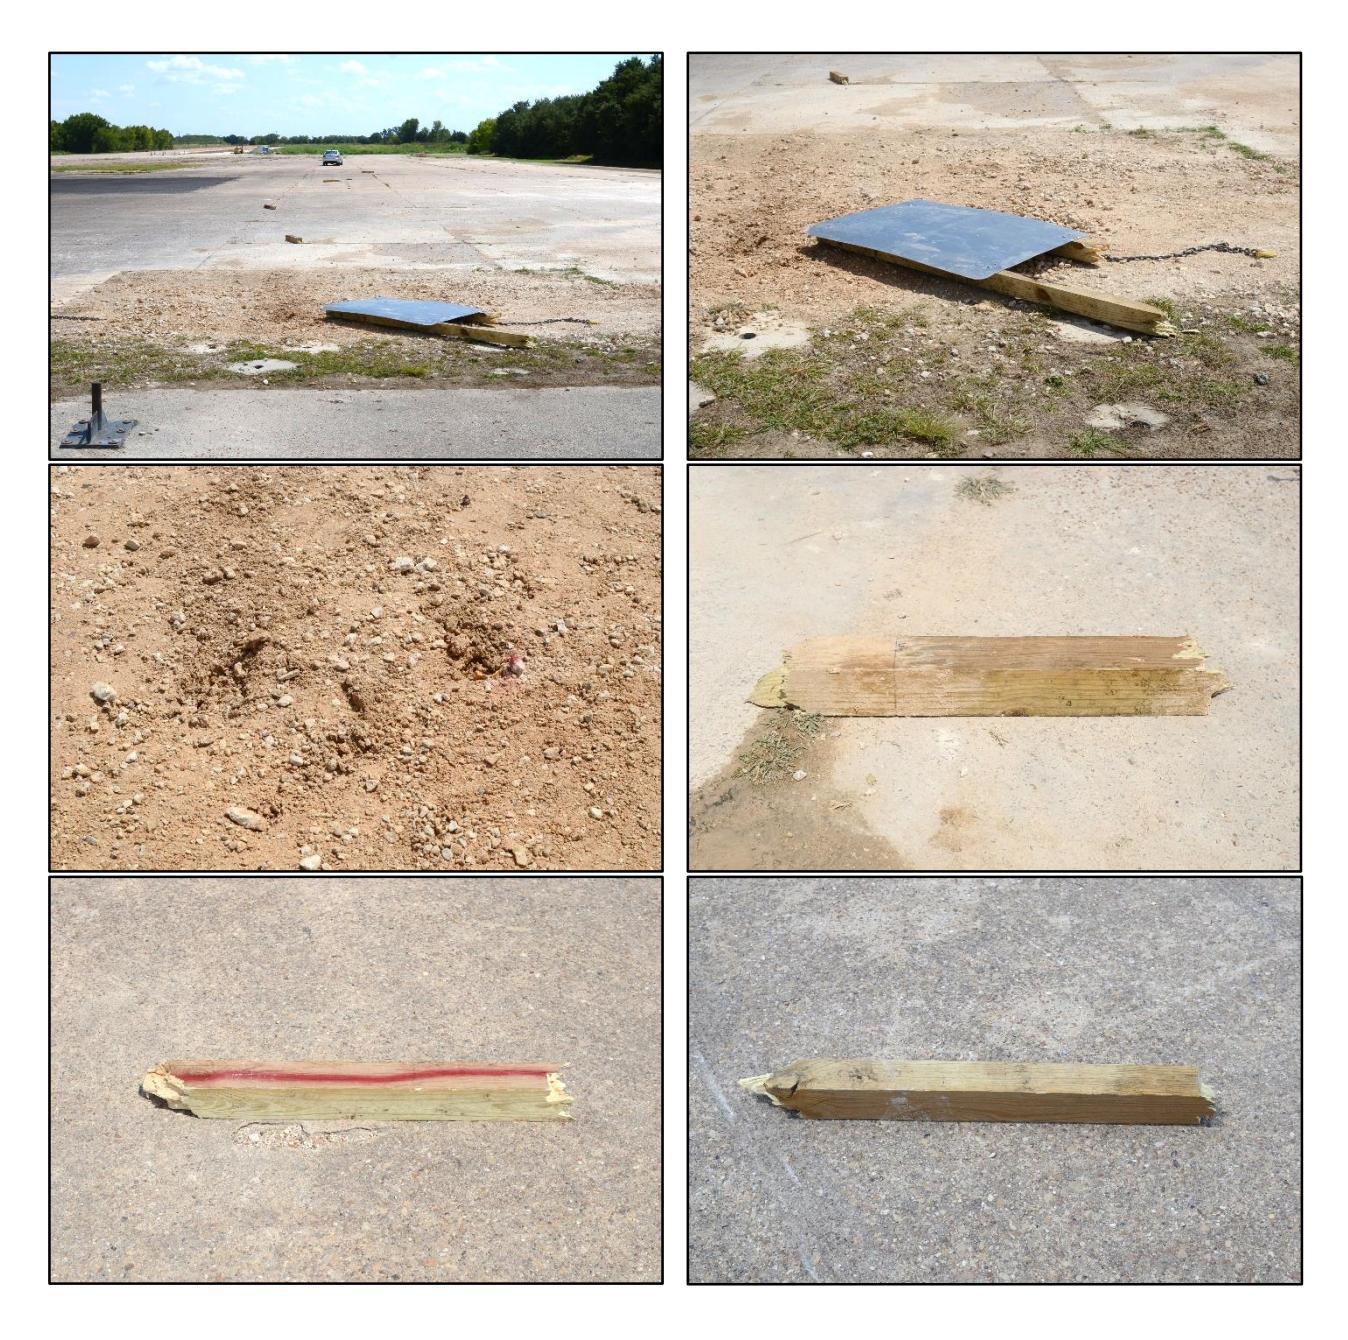
Figure 5.28. TxDOT Dual Embedded Wood Post System after Test No. 469467-6-2.

Figure 5.28 shows the damage to the TxDOT dual embedded wood sign system. The sign panel attached to an 80-inch section of the left post and a 54-inch section of the right post came to rest near impact. The left support post fractured into three pieces. An upper 80-inch long section remained attached the sign panel. A lower 24-inch long section, which included 6-inches below grade and 18 inches above grade, came to rest 25 ft downstream and 8 ft to the left of centerline. The middle 34-inch long section came to rest 121 ft downstream and 3 ft to the left of centerline. The right support post fractured into four sections. The uppermost 54-inch long section remained attached to the sign panel. The bottom 21-inch section, which included 3 inches below grade and 18 inches above grade, came to rest 55 ft downstream and 7 ft to the left of centerline. A 32-inch long section of the right post came to rest 95 ft downstream and 2 ft to the left of centerline. A 25-inch long section of the right post came to rest 175 ft downstream and 3 ft to the left of centerline.

Both support posts fractured at bumper height, and as the vehicle continued to move forward, the fractured end of the right support contacted and punctured the windshield. The TxDOT dual embedded wood post sign system did not perform acceptably for *MASH* Test 3-61 at 0° due to puncture of the windshield.
