MASH EVALUATION OF ALTERNATIVE SUPPORT MATERIALS FOR PORTABLE ROLL-UP SIGNS

Test Report 0-6639-13-1

TEXAS A&M TRANSPORTATION INSTITUTE COLLEGE STATION, TEXAS

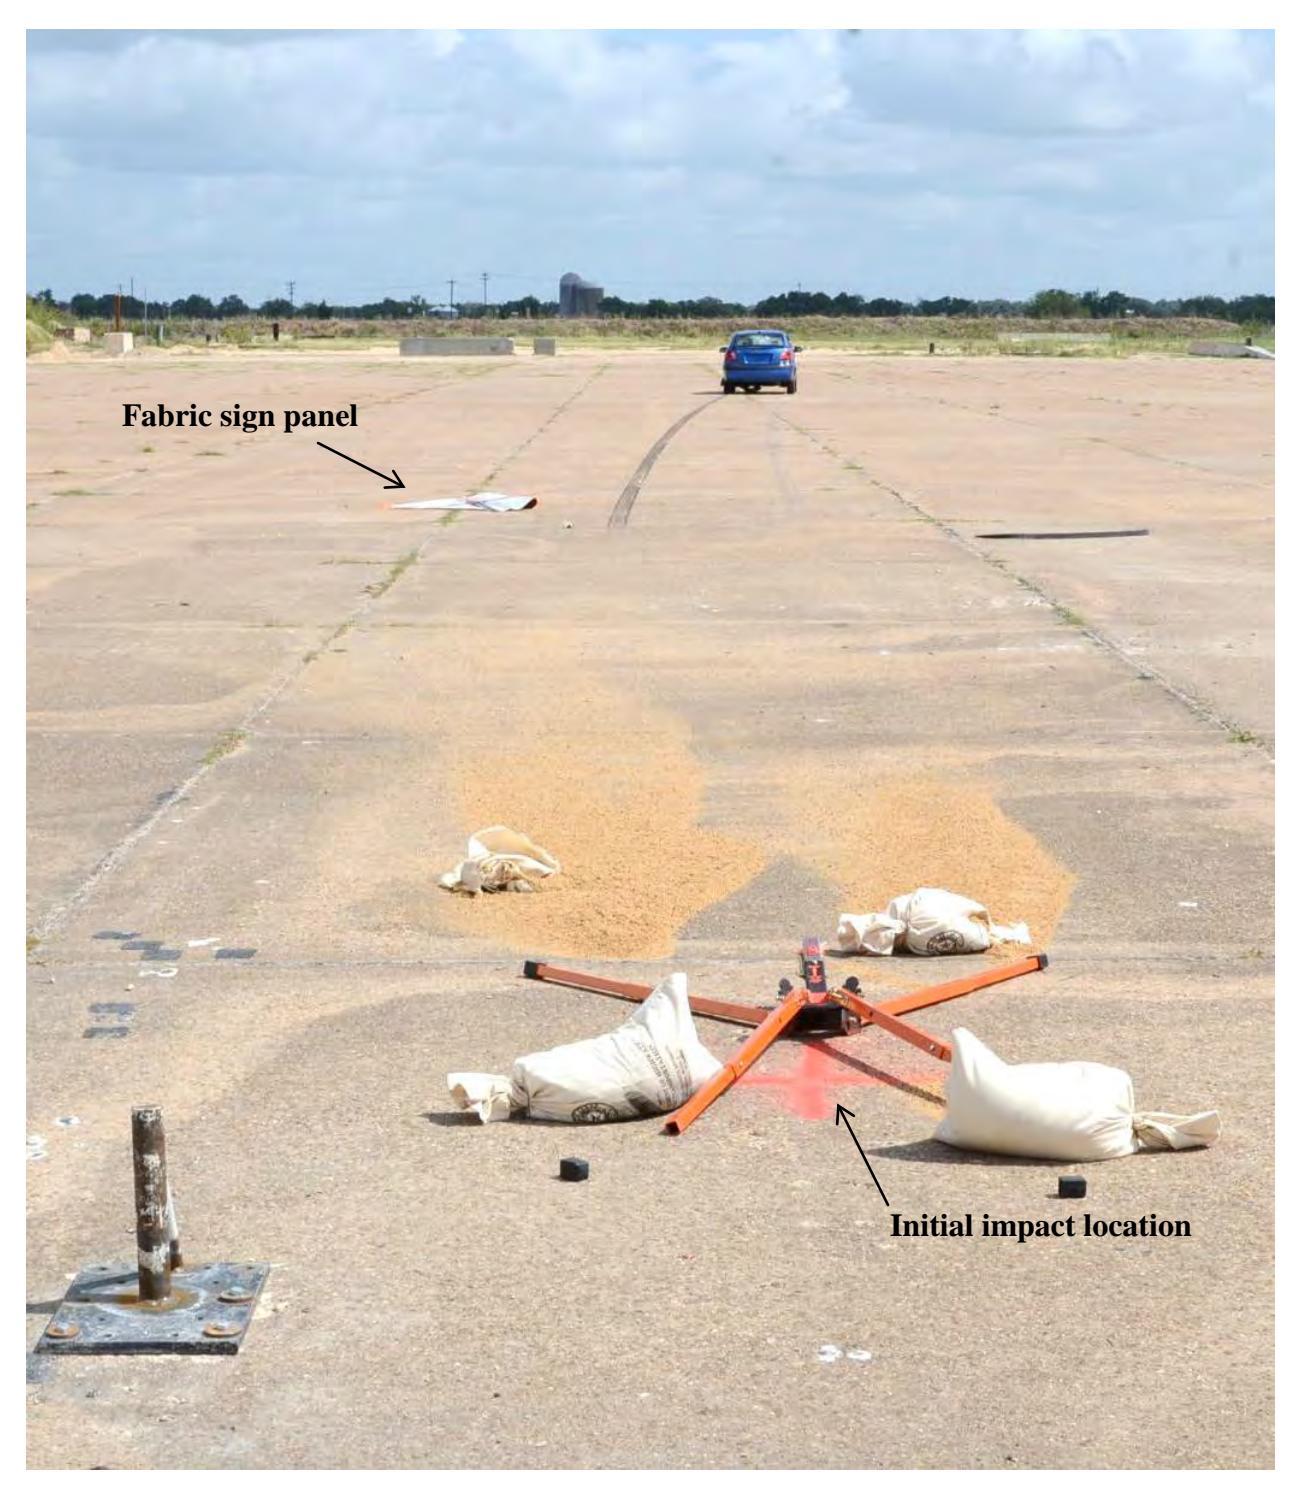
Figure 5.3. After Impact Locations for Test No. 466393-1.

Figures 5.3 and 5.4 show damage to the work zone traffic control device. The fabric sign panel and stays separated from the lower base, contacted and penetrated the windshield, rode up and over the vehicle, and came to rest 75 ft downstream of impact. The base of the temporary sign support came to rest 1.4 ft downstream of impact. Two of the sandbags remained intact, one was torn open and emptied of sand, and the fourth was torn and partially emptied.

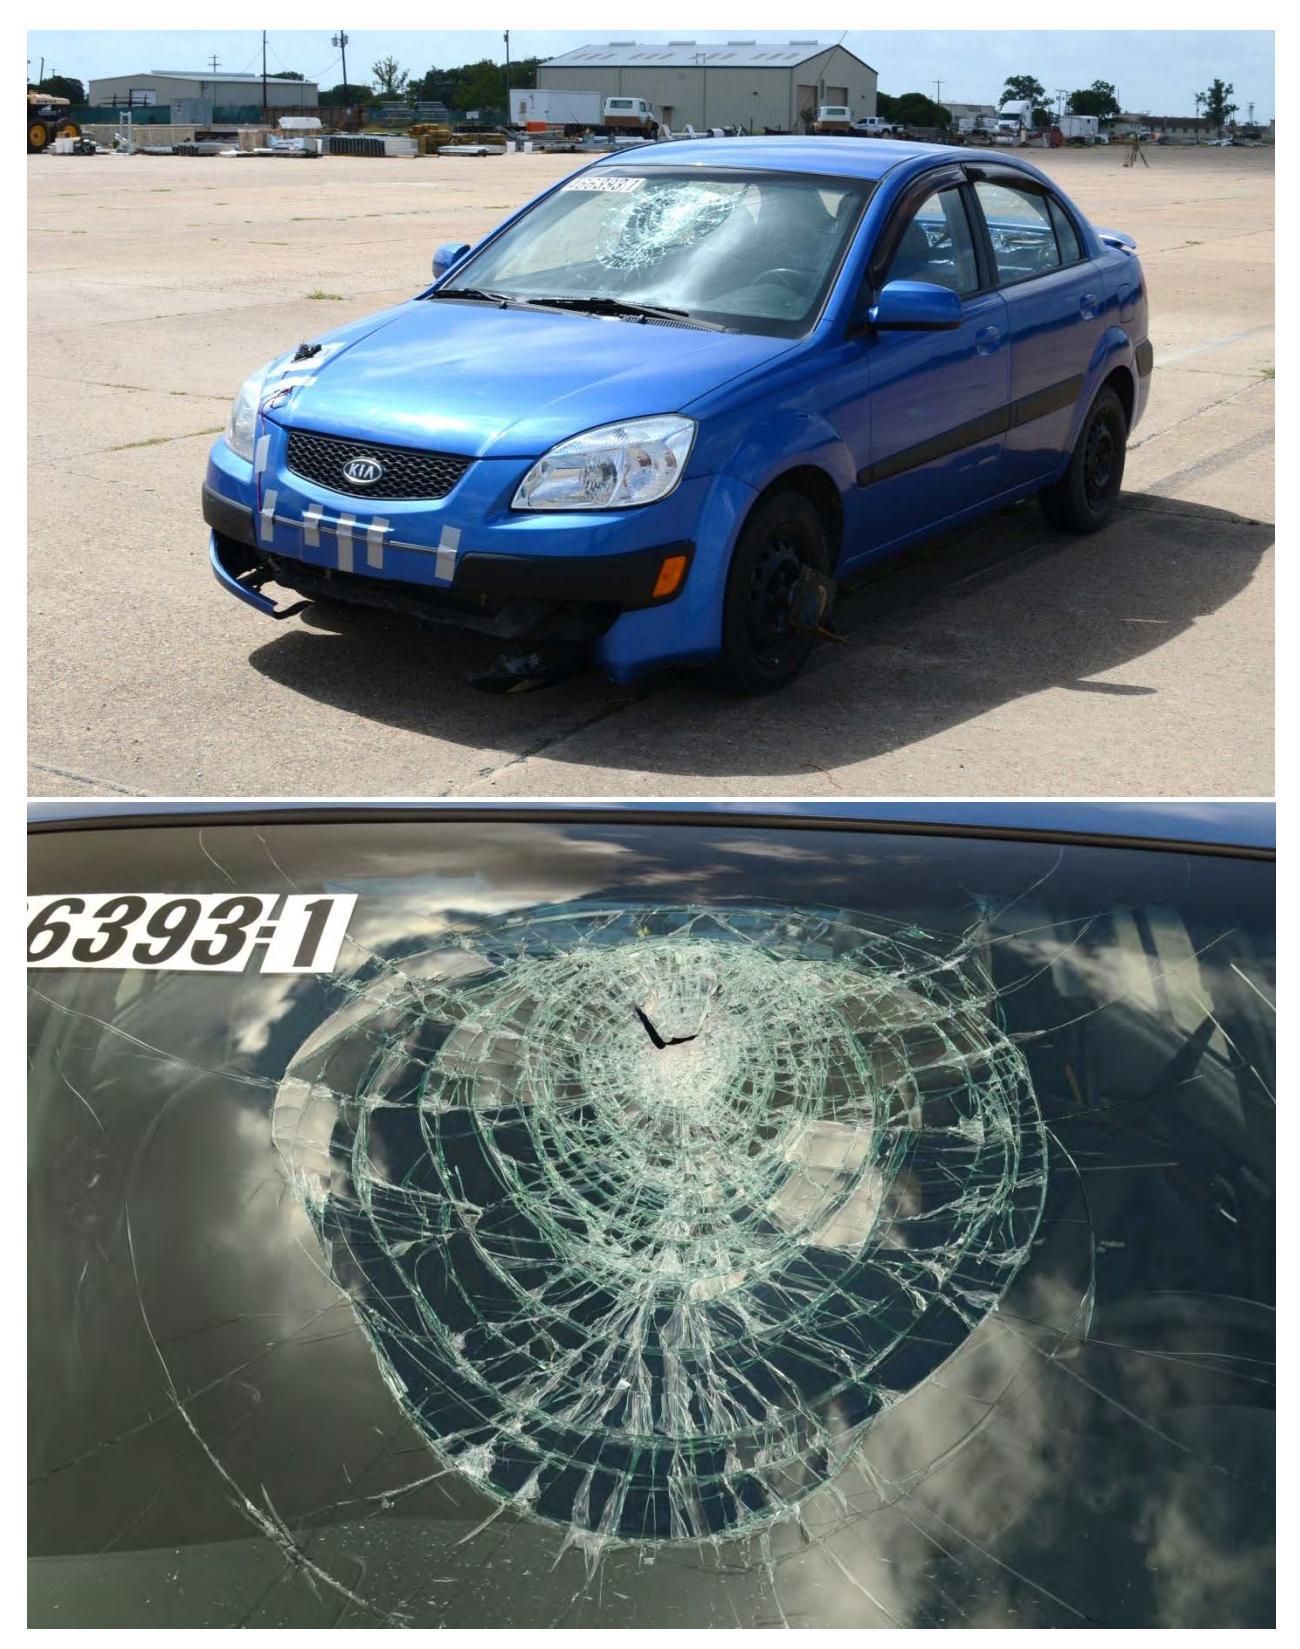
Figure 5.5. Vehicle after Test No. 466393-1.

Figure 5.5 shows damage to the 1100C vehicle. The bottom of the front bumper cover was fractured, and the hood sustained scuff marks. No measureable deformation was noted to the exterior hood or bumper. The windshield was punctured/cut by the top corner of the sign panel, leaving a 2-inch \times 1.5-inch hole. The area around the puncture was depressed into the occupant compartment 1.5 inches, and the total area shattered measured 20 inches \times 17.25 inches. Figure 5.6 shows the windshield damage from inside the occupant compartment. Table D2 and D3 in Appendix D provides exterior crush and occupant compartment measurements.

- <u>Results</u>: The detached fabric sign panel and attached stays rotated into and penetrated the windshield into the occupant compartment. (FAIL)
- *E.* Detached element, fragments or other debris from the test article, or vehicular damage should not block the driver's vision or otherwise cause the driver to lose control of the vehicle.

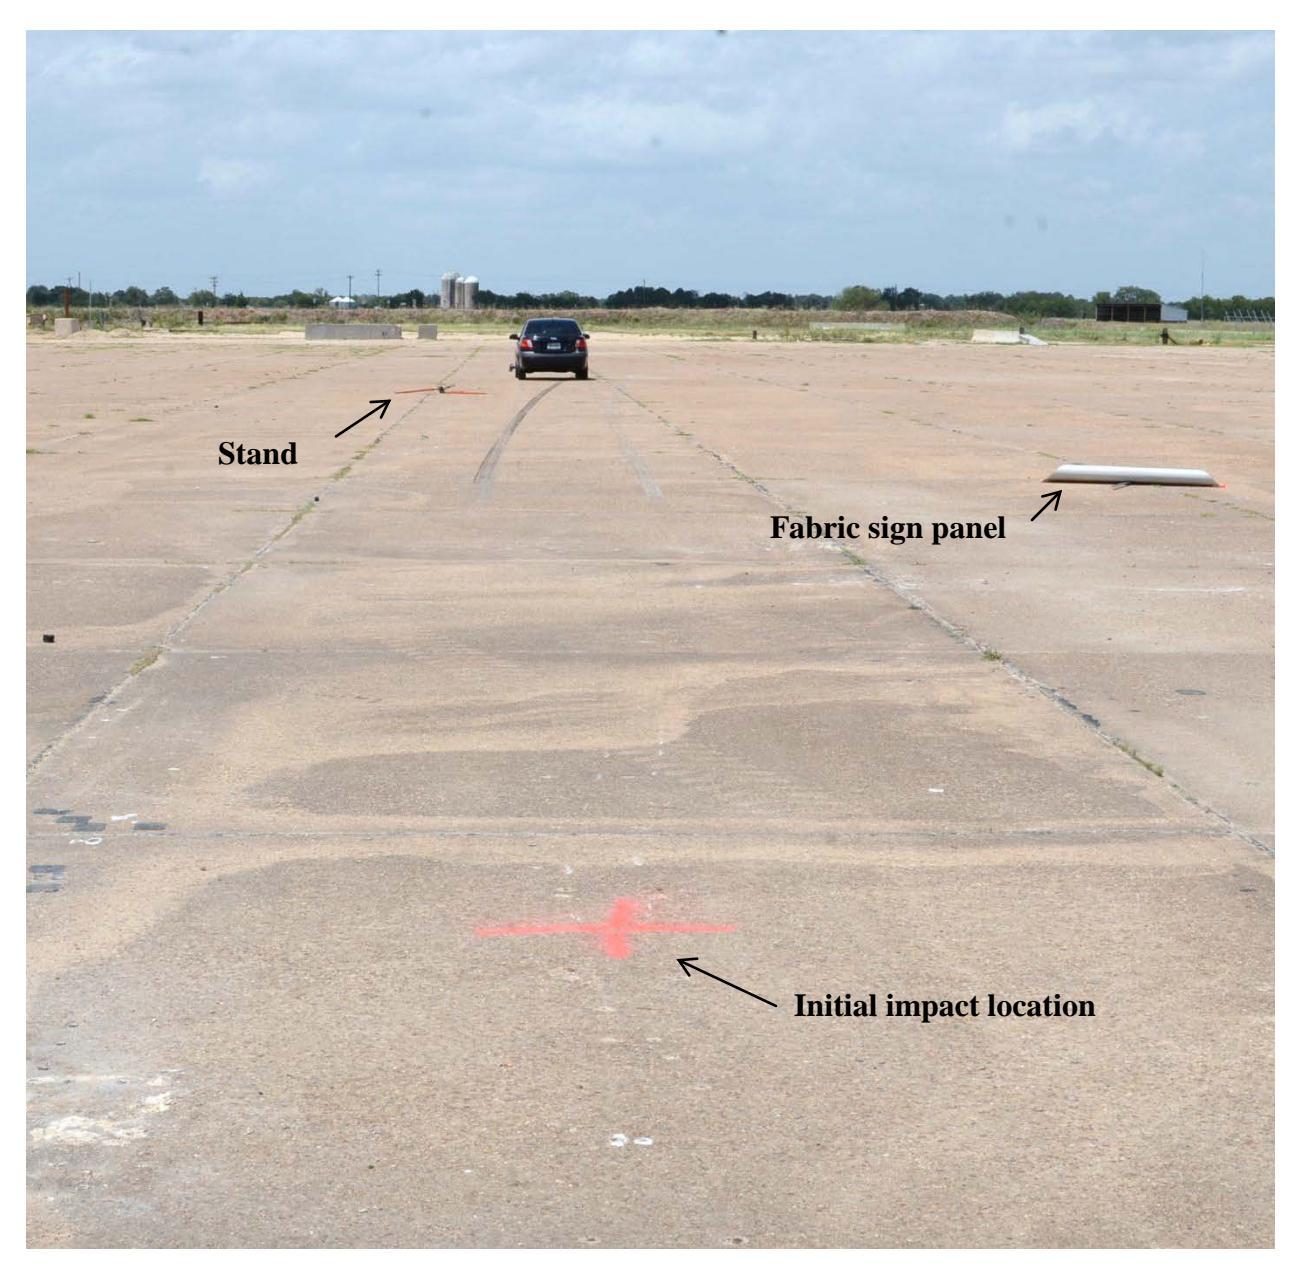
Figure 5.10. After Impact Locations for Test No. 466393-2.

Figures 5.10 and 5.11 show damage to the roll-up sign stand. The fabric sign panel and stays separated from the lower base, contacted and penetrated the windshield, rode up and over the vehicle and came to rest 65 ft downstream of impact. The base of the sign came to rest 158 ft downstream of impact.

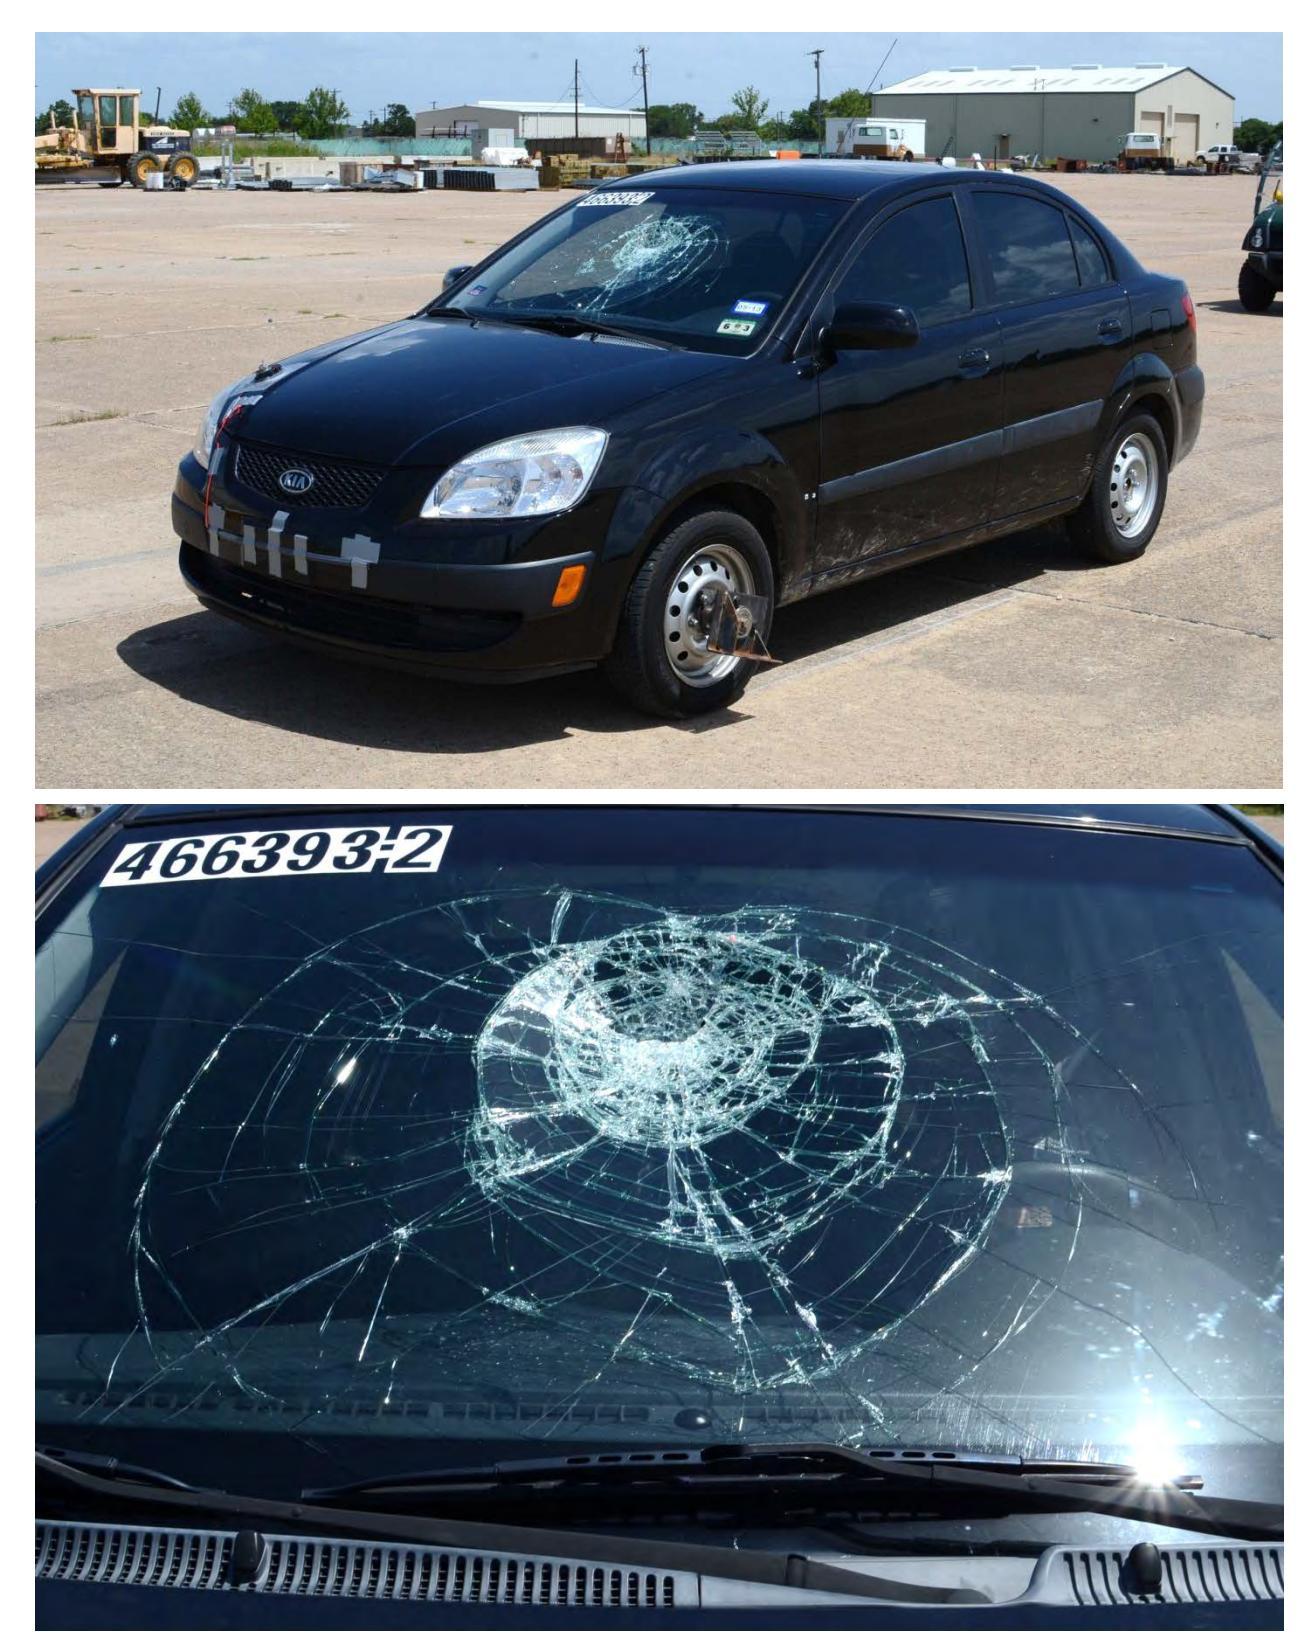
Figure 5.12. Vehicle after Test No. 466393-2.

Figure 5.12 shows damage to the 1100C vehicle. The hood sustained scuff marks. No measureable deformation was noted to the exterior hood or bumper. The windshield had a 4-inch \times 1.5-inch hole. The area around the hole was depressed into the occupant compartment 1.5 inches, and the total shattered area on the windshield measured 15 inches \times 13 inches. Figure 5.13 shows the windshield damage from inside the occupant compartment. Table D5 and D6 in Appendix D provides exterior crush and occupant compartment measurements.

- <u>Results</u>: The detached fabric sign panel and attached stays rotated into and penetrated the windshield into the occupant compartment. (FAIL)
- *E.* Detached element, fragments or other debris from the test article, or vehicular damage should not block the driver's vision or otherwise cause the driver to lose control of the vehicle.

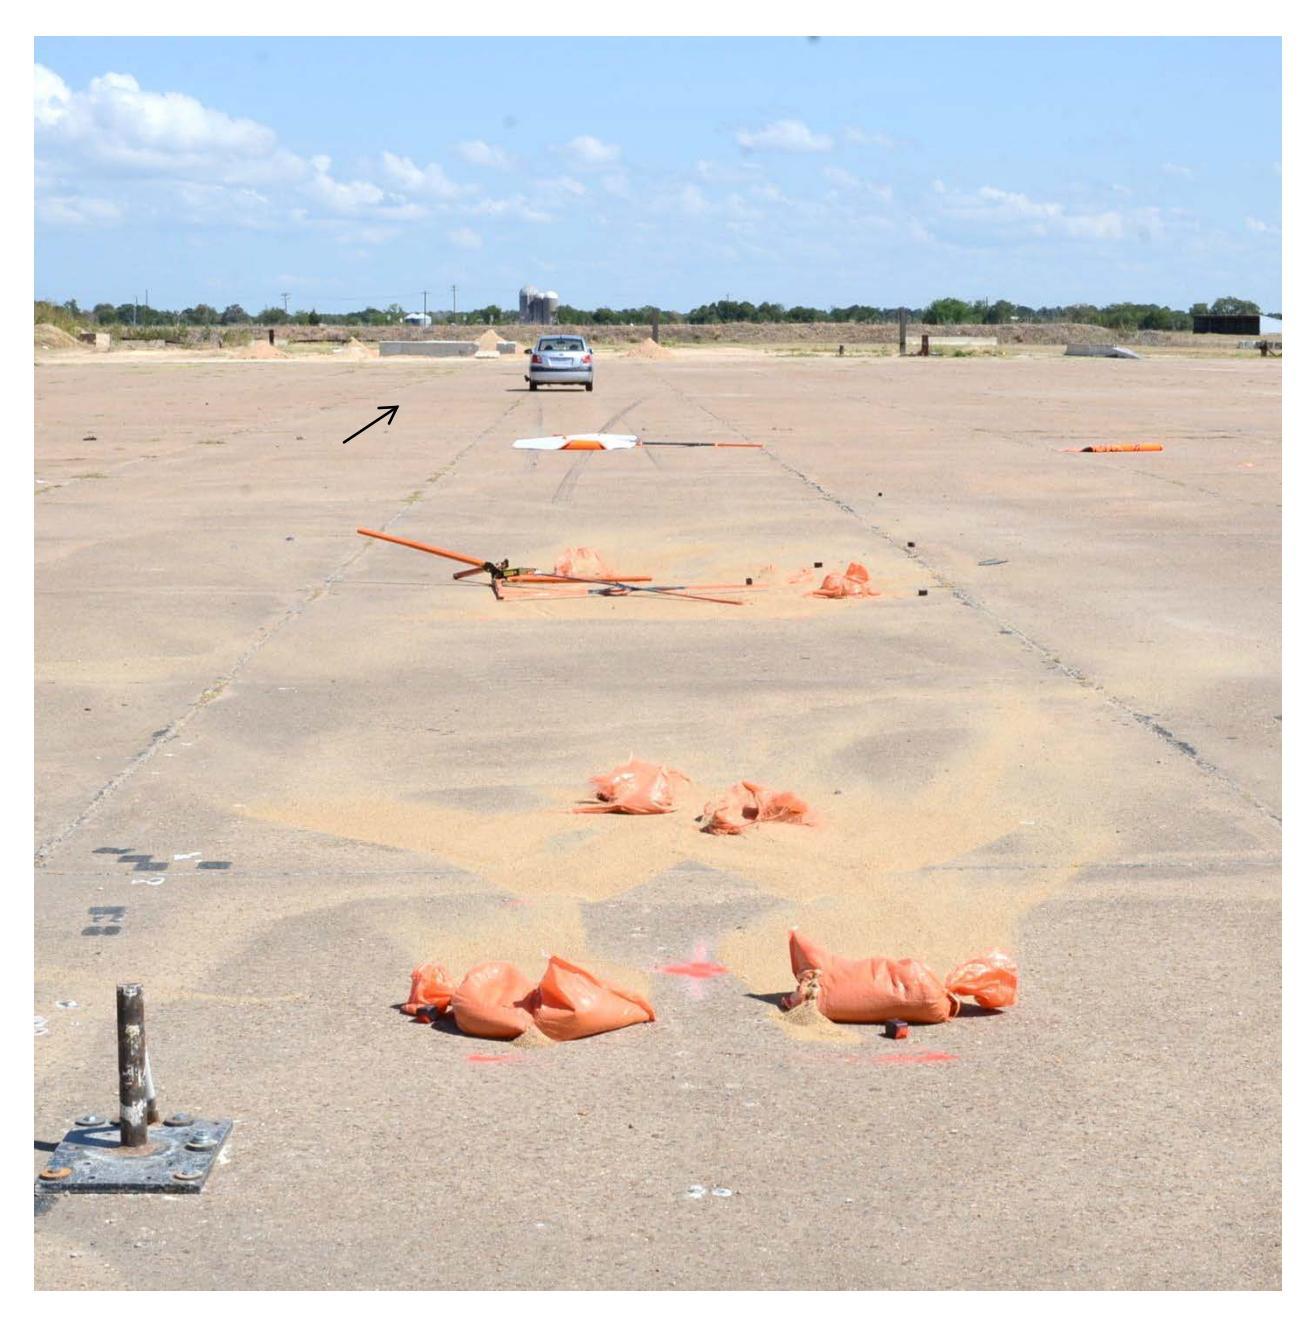
Figure 5.18. After Impact Locations for Test No. 466393-3.

Figures 5.18 and 5.19 show damage to the work zone traffic control device. The fabric sign panels separated from each of the lower bases. The plastic corner pocket at the top corner of the sign panel released from the fabric sign and struck the middle of the windshield. The fabric sign panels then rode up and over the vehicle. The base of the first work zone traffic control device came to rest 35 ft downstream of impact, and the second base came to rest 75 ft downstream of impact.

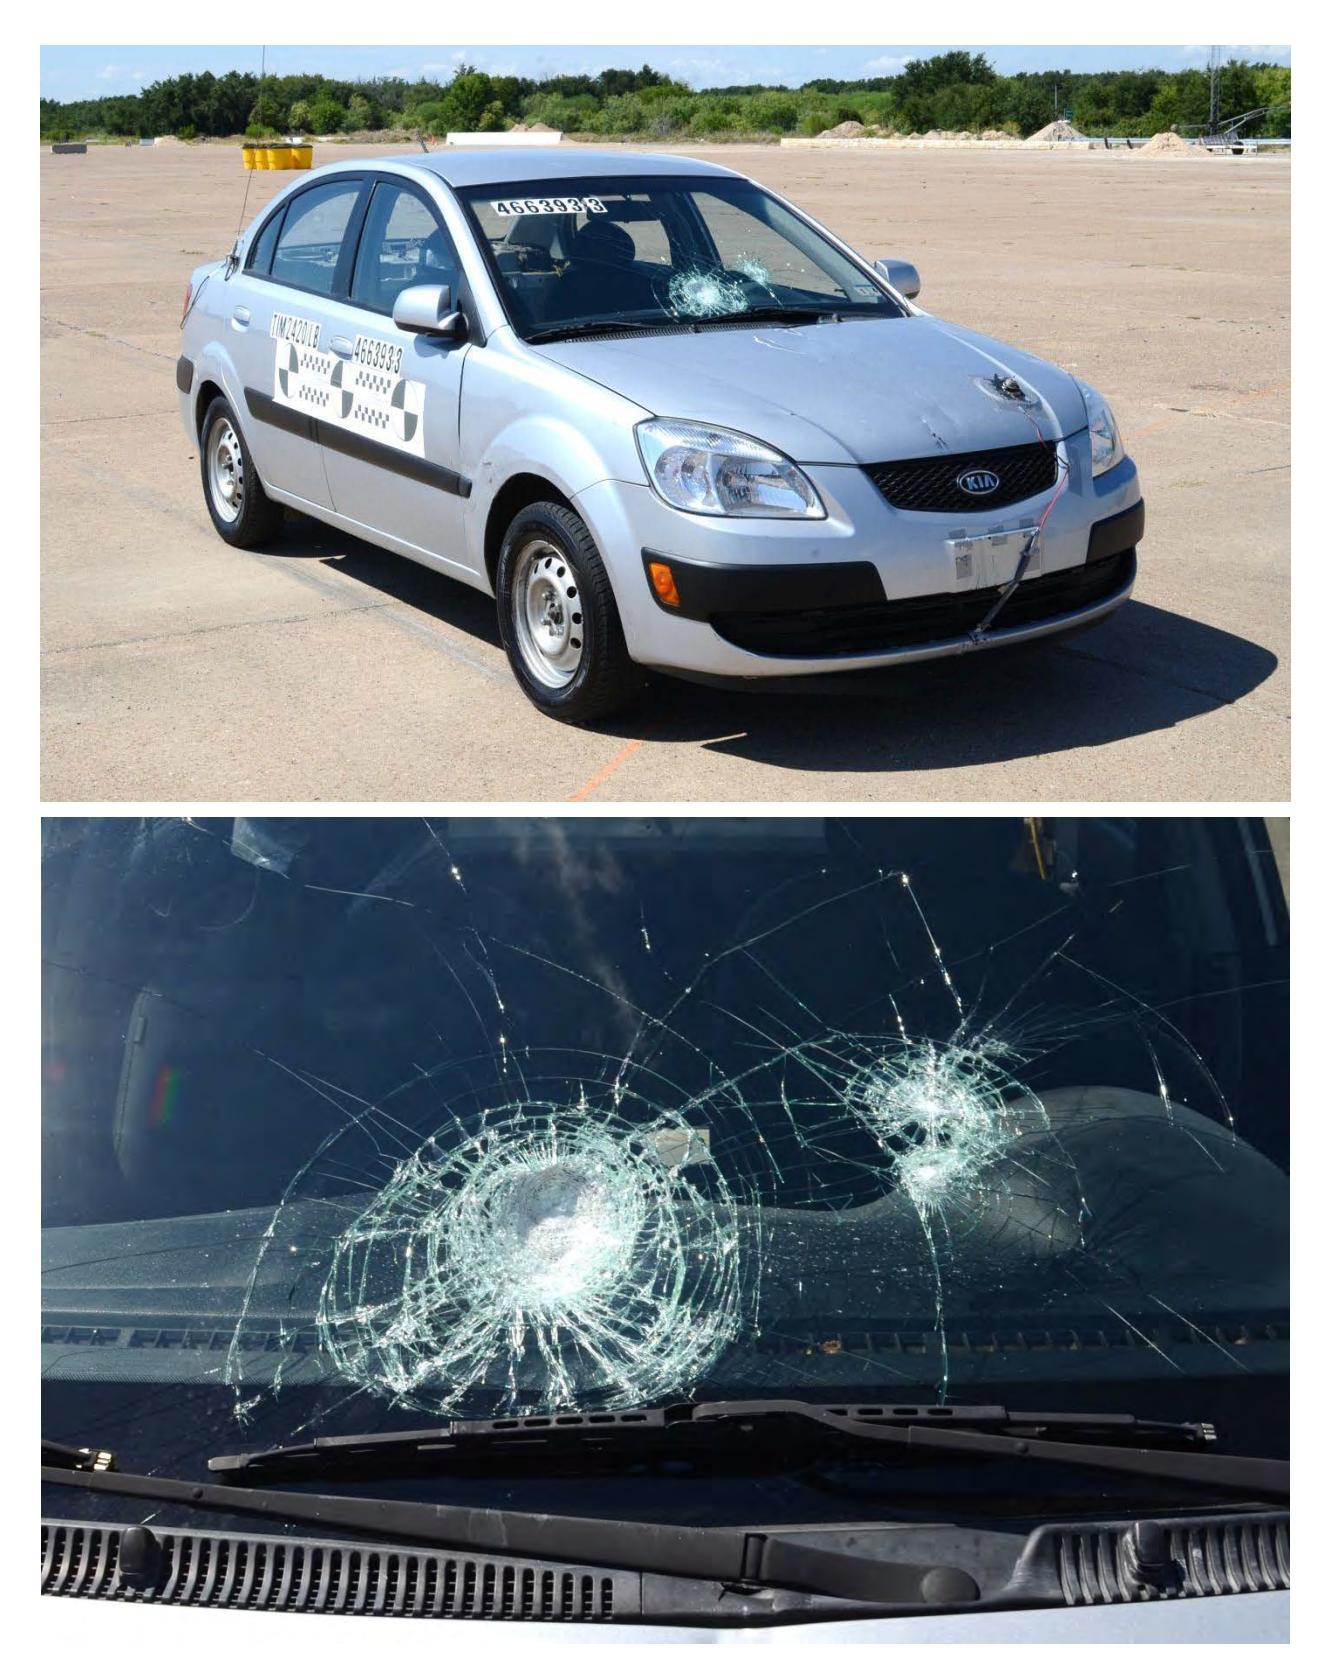
Figure 5.20. Vehicle after Test No. 466393-3.

Figure 5.20 shows damage to the 1100C vehicle. The hood sustained scuff marks. No measureable deformation was noted to the exterior hood or bumper. Contact with the top corner of the first fabric roll-up sign panel caused the windshield to shatter over an area measuring 3 inches \times 3.5 inches. This area was deformed toward the occupant compartment 0.75 inches, but there was no penetration or tear of the plastic liner. Contact of the plastic corner pocket from the second roll-up sign caused cracking of the windshield in two other small areas measuring 2.5-inch \times 2-inch and 1.5-inch \times 1-inch. There was no deformation of these areas into the occupant compartment. The gas tank had a puncture measuring 1.85 inches \times 0.26 inch. Figure 5.21 shows the damage to the gas tank. Table D8 and D9 in Appendix D provides exterior crush and occupant compartment measurements.

- <u>Results</u>: The sign panel never contacted the windshield. The plastic pocket at the top corner of the sign panel released and contacted the windshield causing some cracking over a small area. There was no deformation of the windshield toward the occupant compartment and no penetration of the plastic liner. (PASS)
