*Hawaii Department of Transportation
Research Project Number 67167*

CRASH TESTING AND EVALUATION OF THE HDOT 42-IN. TALL, AESTHETIC CONCRETE BRIDGE RAIL: MASH TEST DESIGNATION NOS. 3-10 AND 3-11

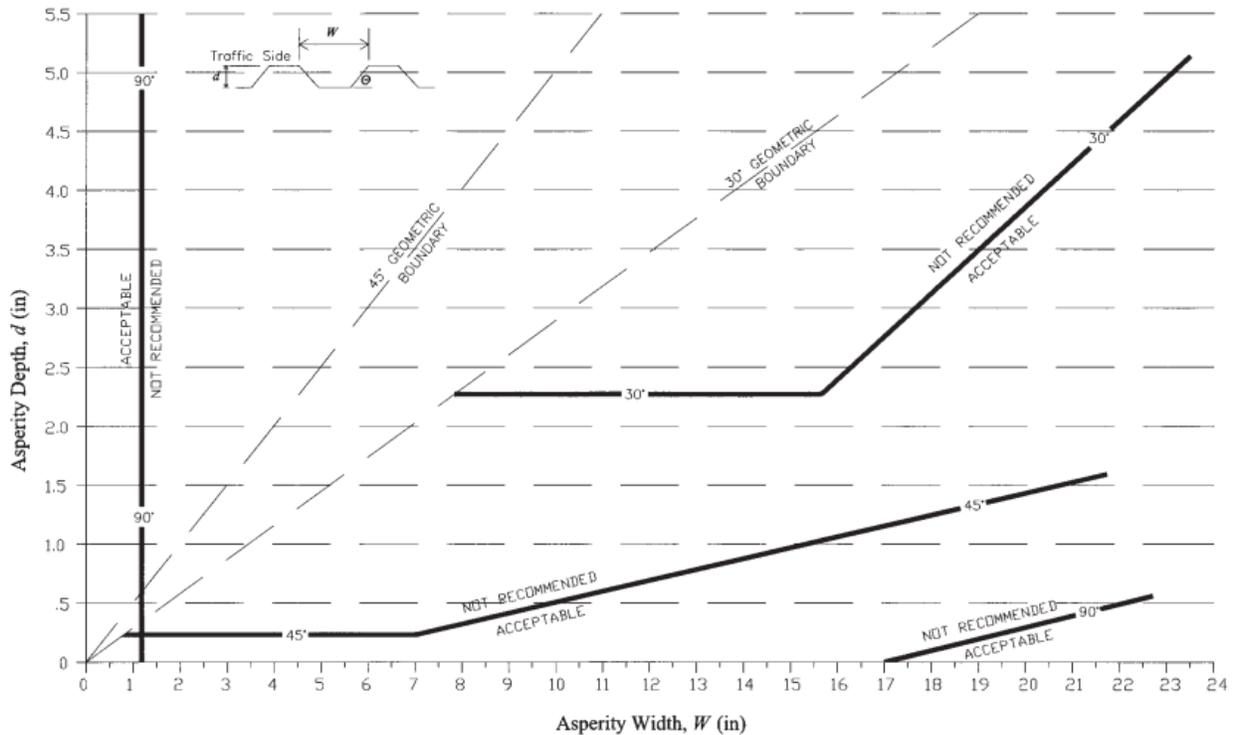
Figure 4. Final Design Guidelines for Aesthetic Surface Treatments of Safety Shape Concrete Barriers

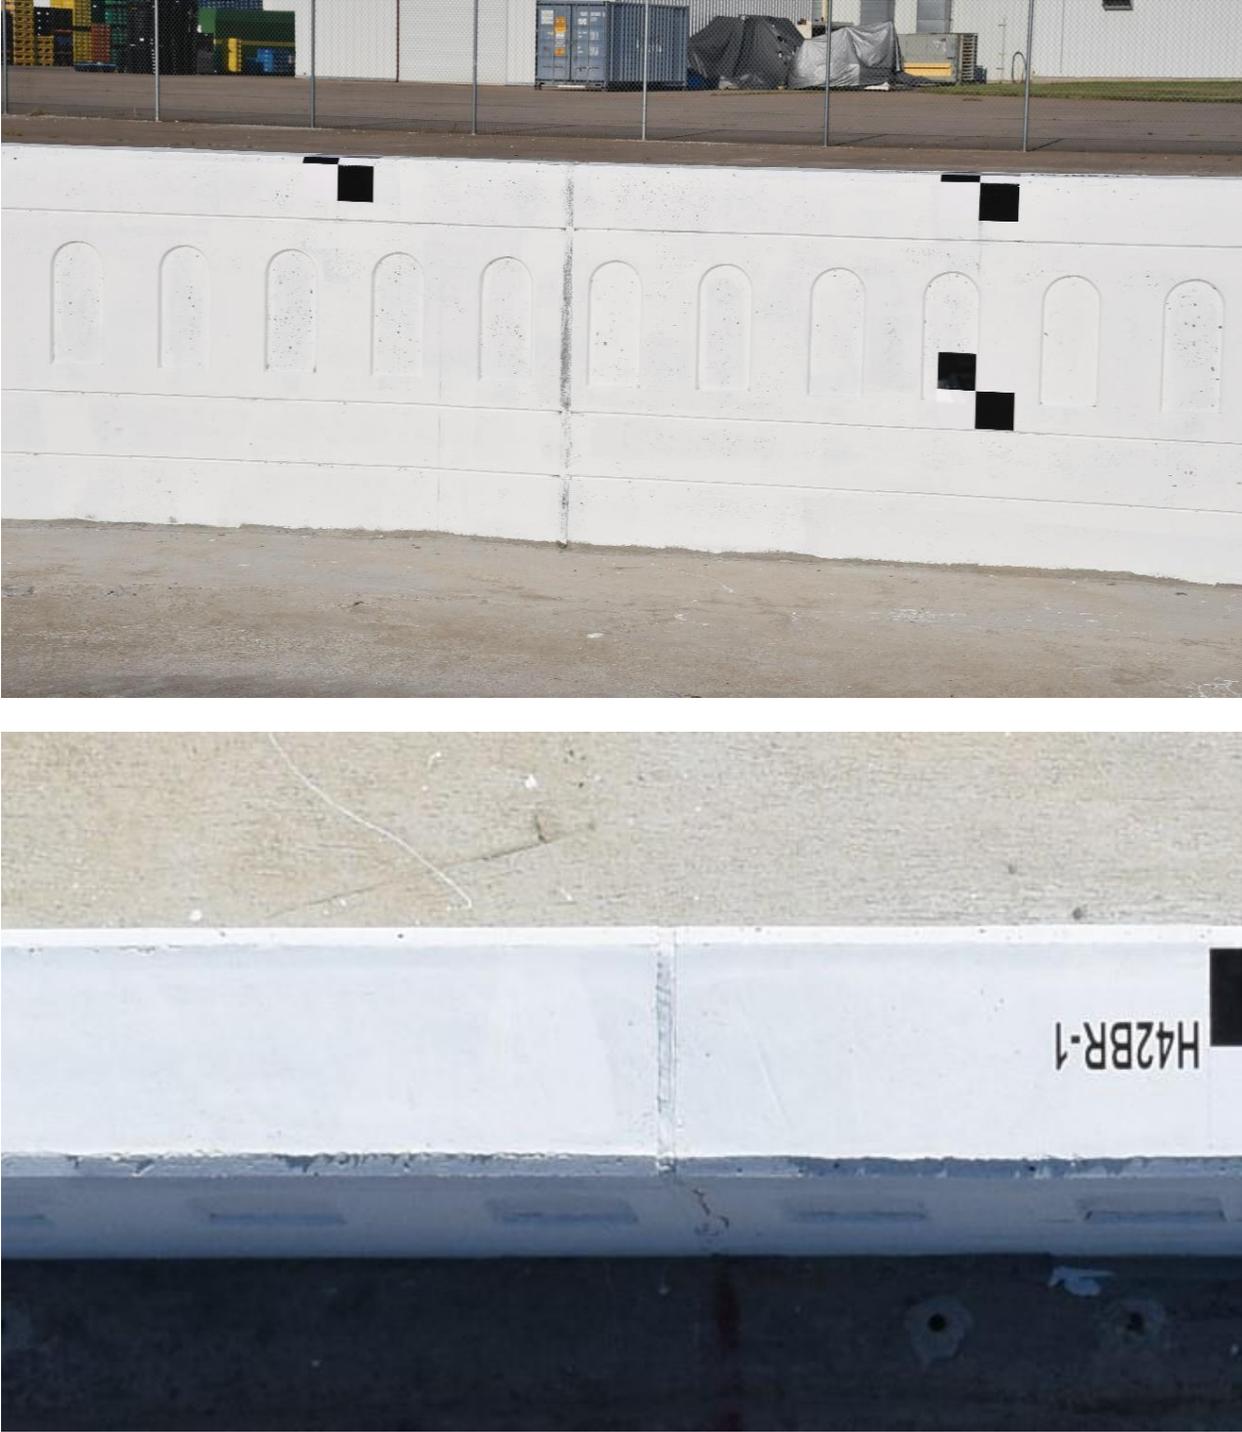
Figure 17. System Installation at Expansion Joint, Test Nos. H42BR-1 and H42BR-2

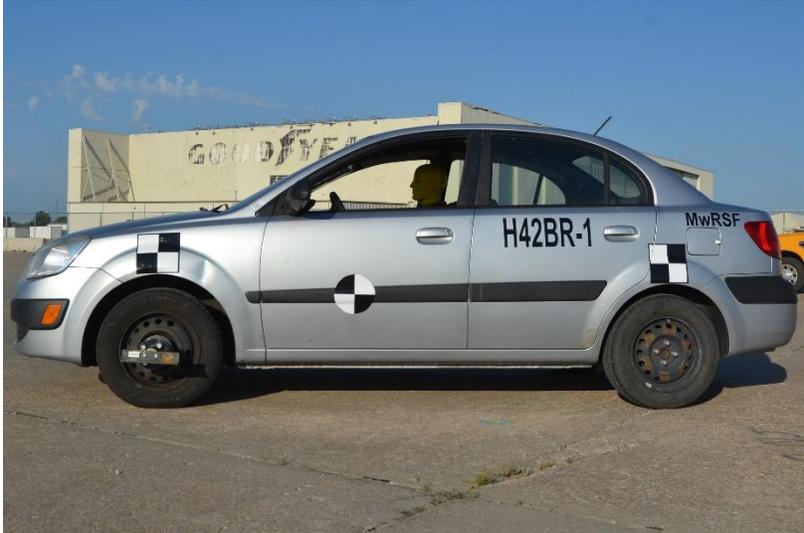
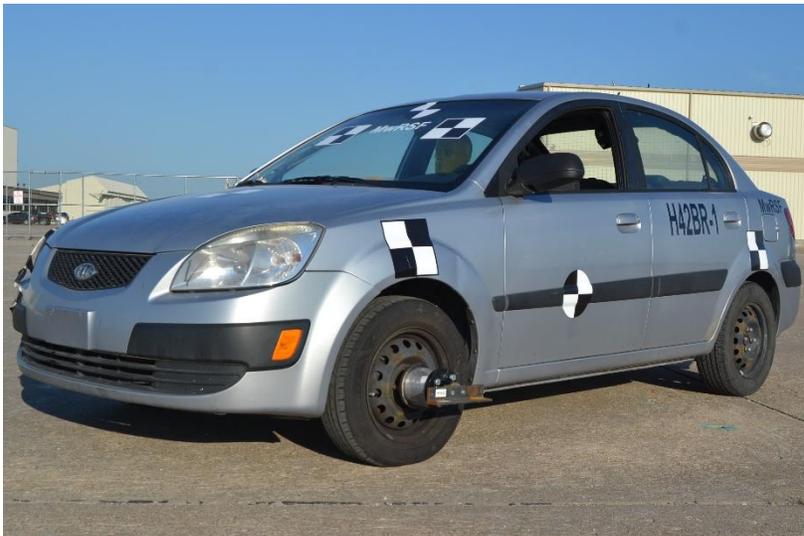
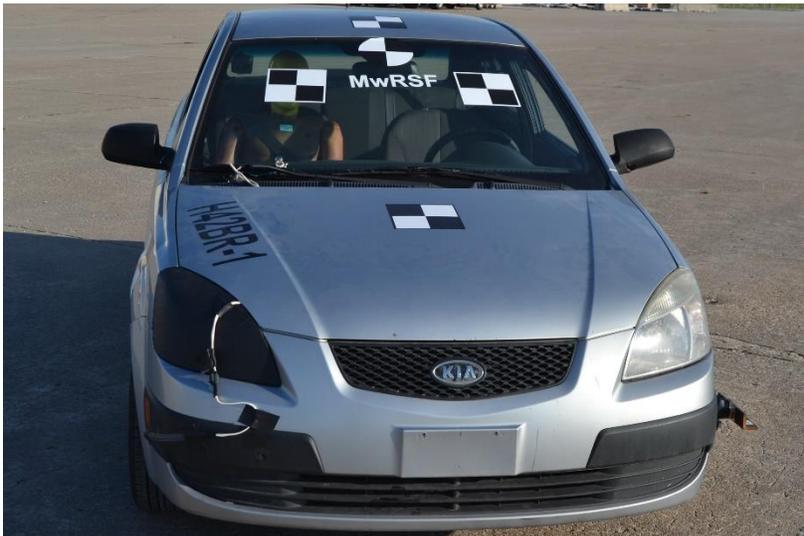
Figure 18. Test Vehicle, Test No. H42BR-1

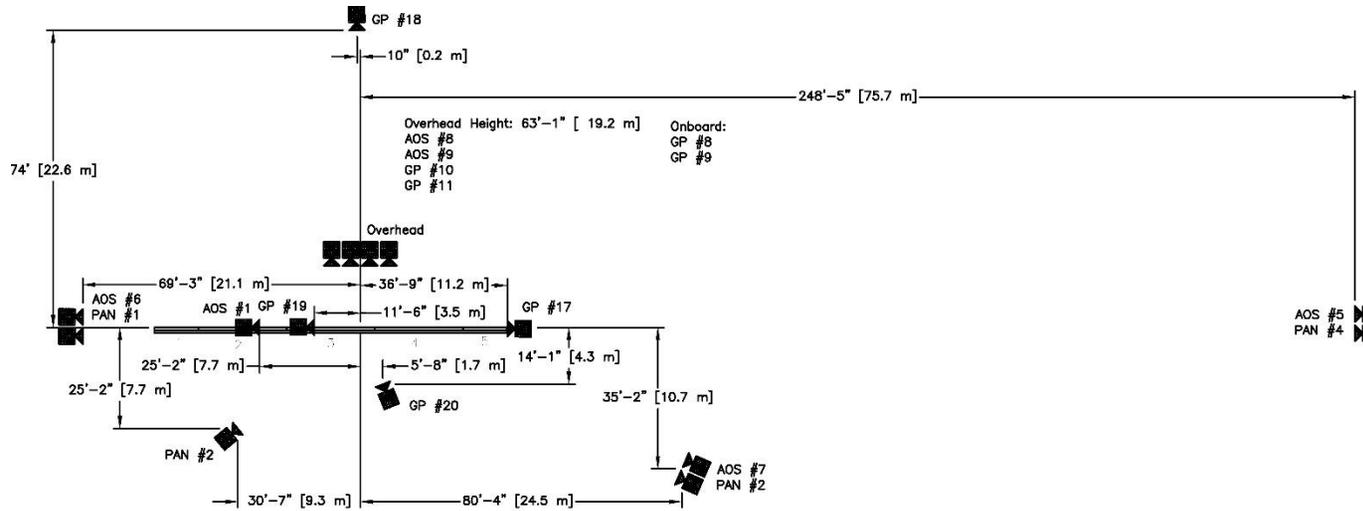
No.	Type	Operating Speed (frames/sec)	Lens	Lens Zoom Setting
AOS-1	AOS Vitcam	500	Minolta 70-210	100
AOS-5	AOS X-Pri	500	100 mm fixed	
AOS-6	AOS X-Pri	500	Sigma 28-70 #1	50
AOS-7	AOS X-Pri	500	Sigma 28-70 #2	70
AOS-8	AOS S-VIT 1531	500	KOWA 16 mm fixed	
AOS-9	AOS TRI-VIT 2236	500	KOWA 12 mm fixed	
GP-8	GoPro Hero 4	120		
GP-9	GoPro Hero 4	120		
GP-10	GoPro Hero 4	120		
GP-11	GoPro Hero 4	240		
GP-17	GoPro Hero 4	240		
GP-18	GoPro Hero 6	240		
GP-19	GoPro Hero 6	240		
GP-20	GoPro Hero 6	240		
PAN-1	Panisonic HC-V770	120		
PAN-2	Panisonic HC-V770	120		
PAN-3	Panisonic HC-V770	120		
PAN-4	Panisonic HC-V770	120

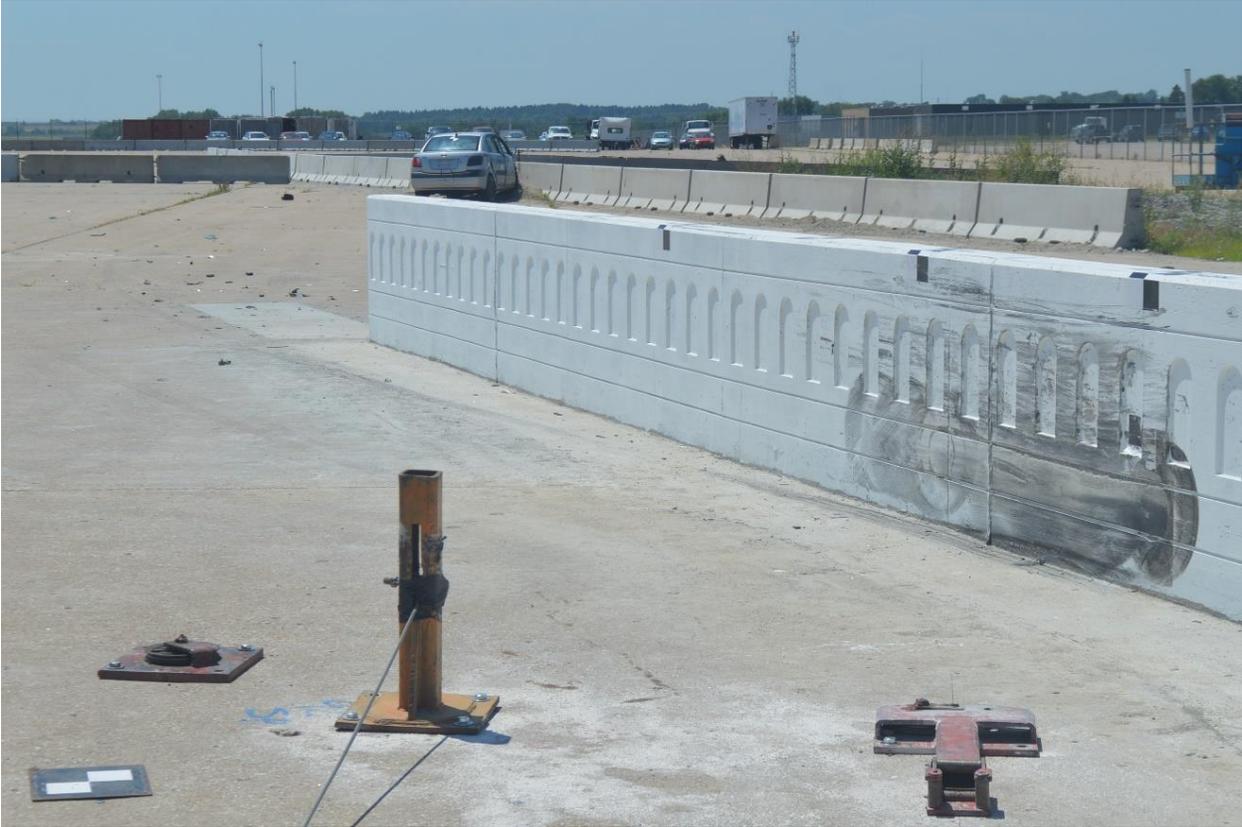
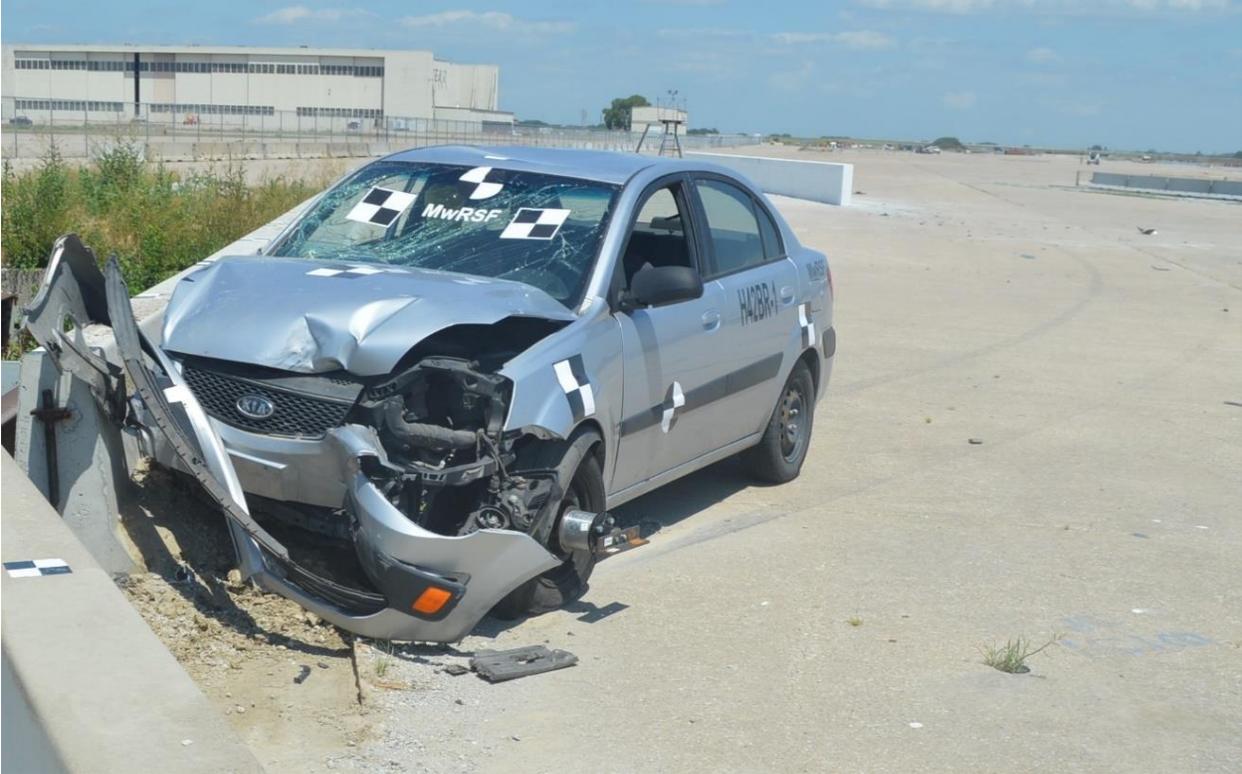
Figure 32. Vehicle Final Position and Trajectory Marks, Test No. H42BR-1

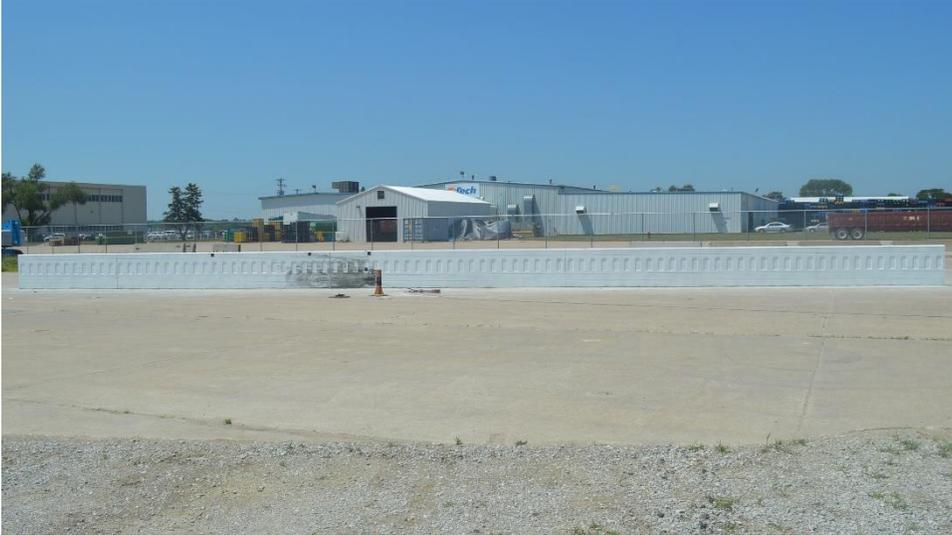
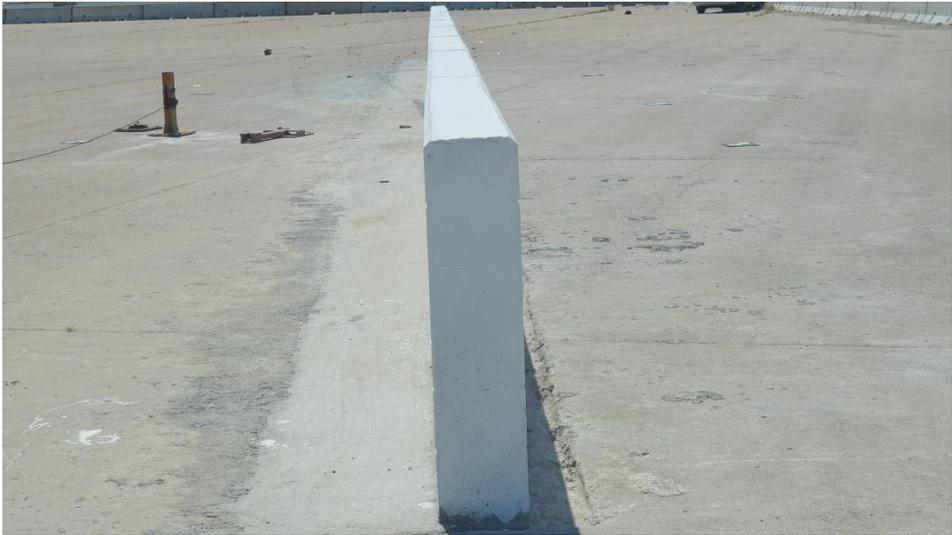
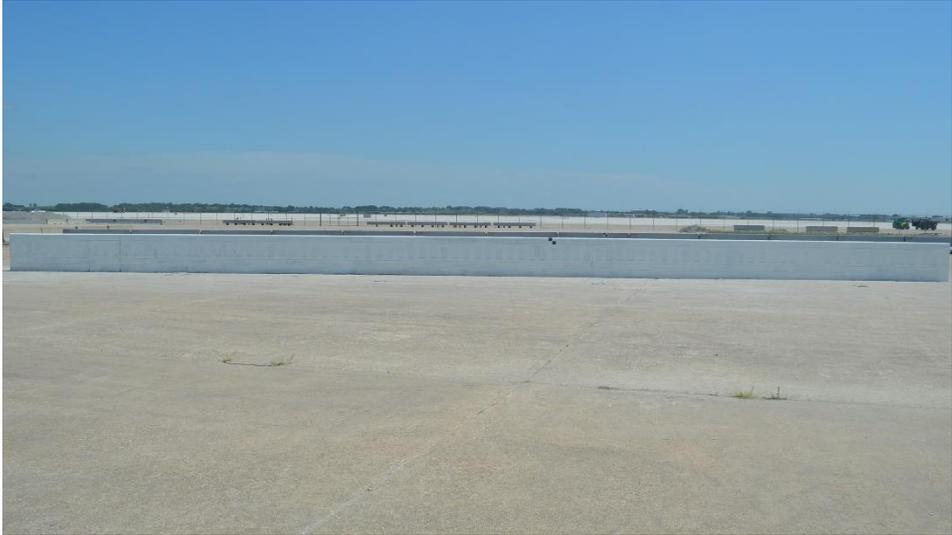
Figure 33. System Damage, Test No. H42BR-1

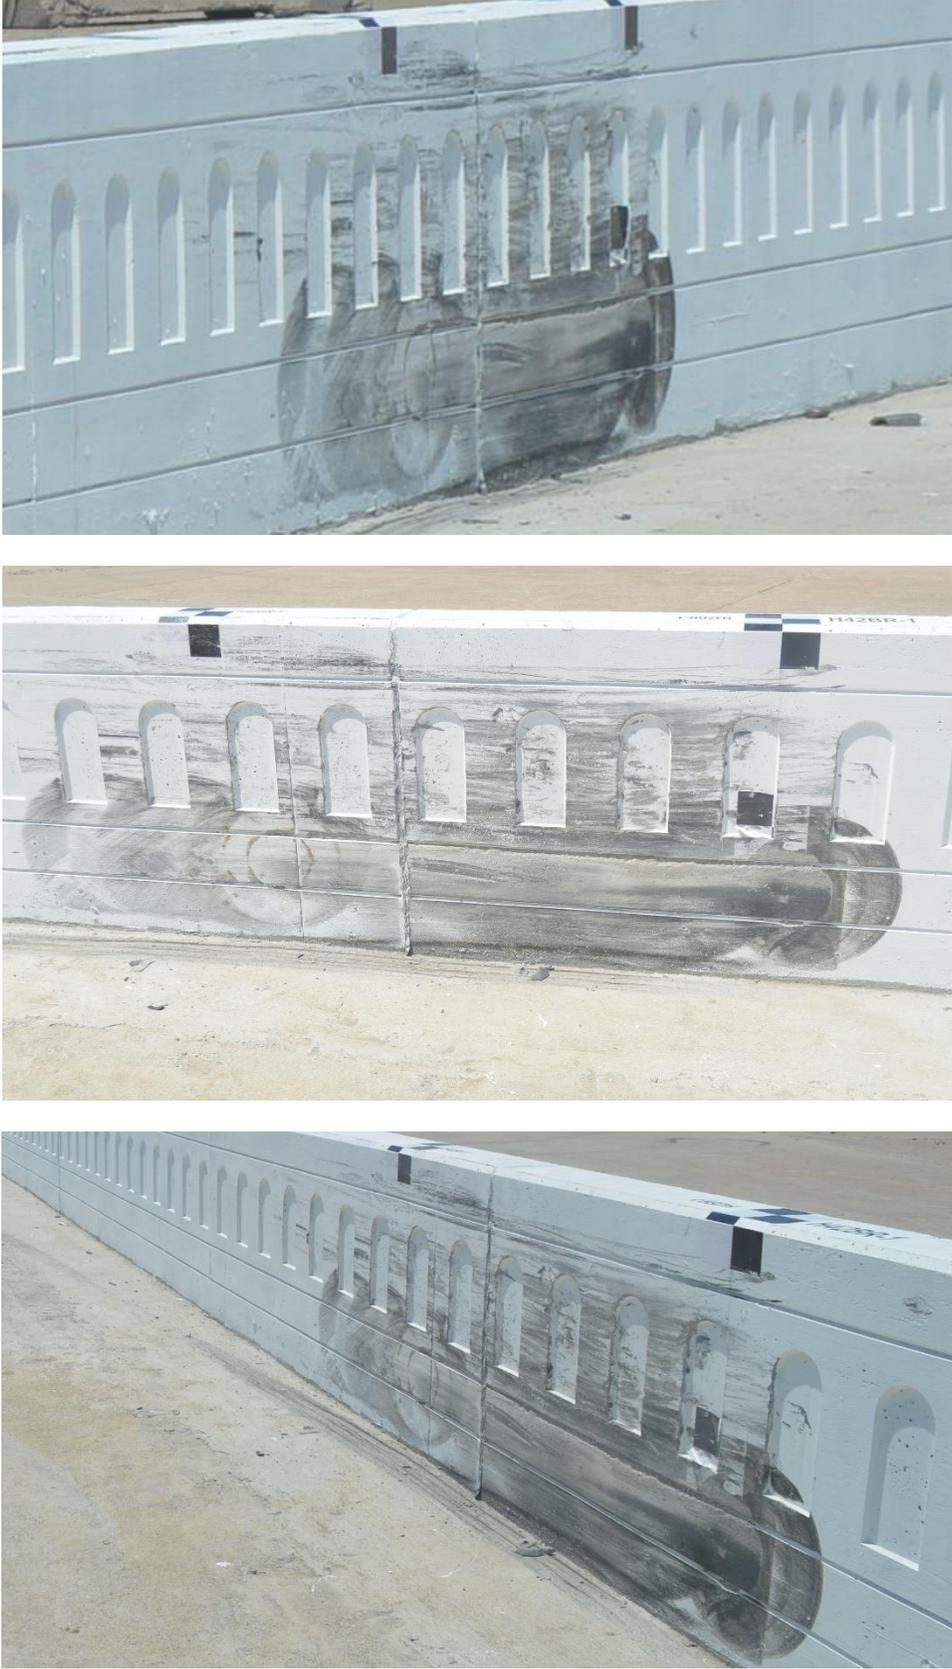
Figure 34. System Damage, Test No. H42BR-1

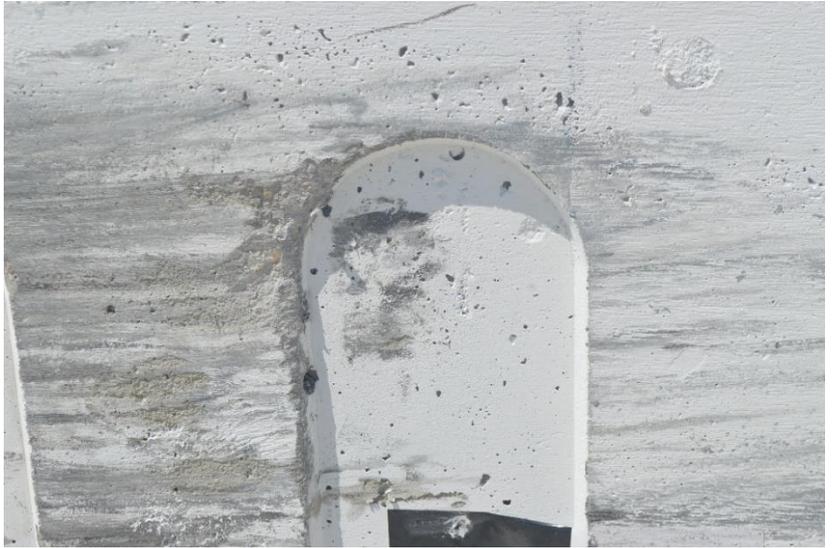
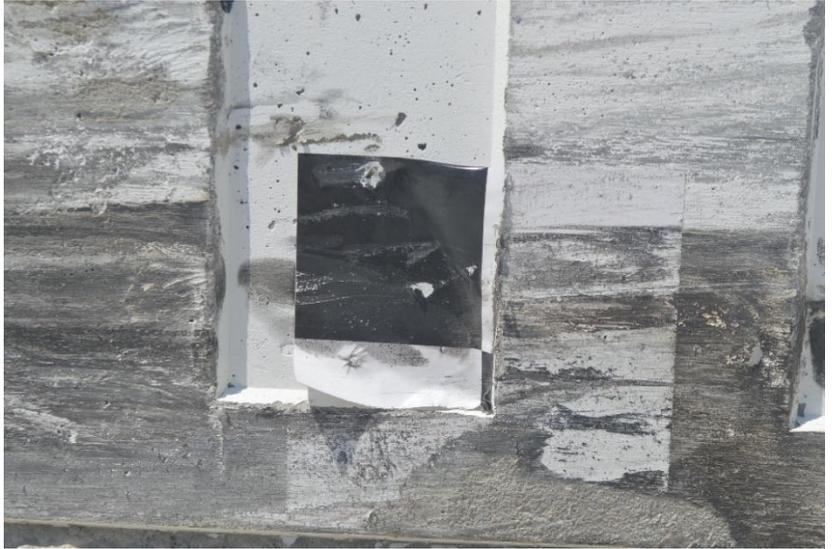
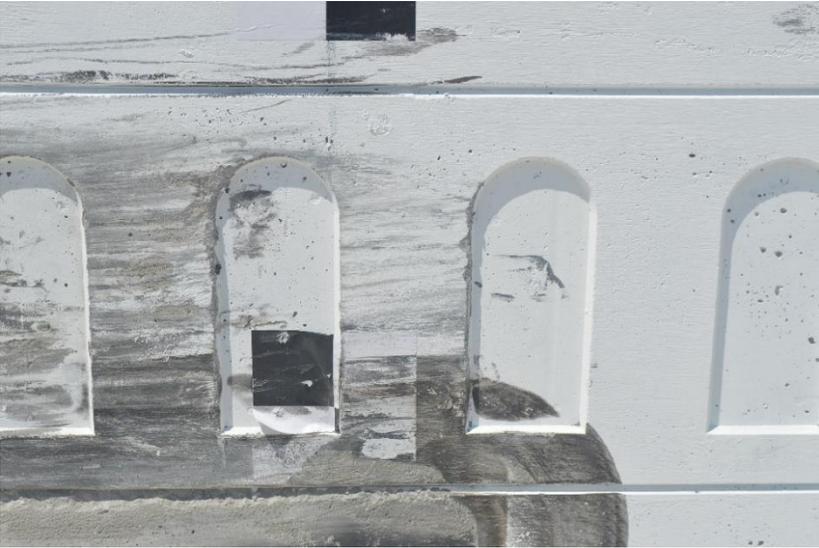
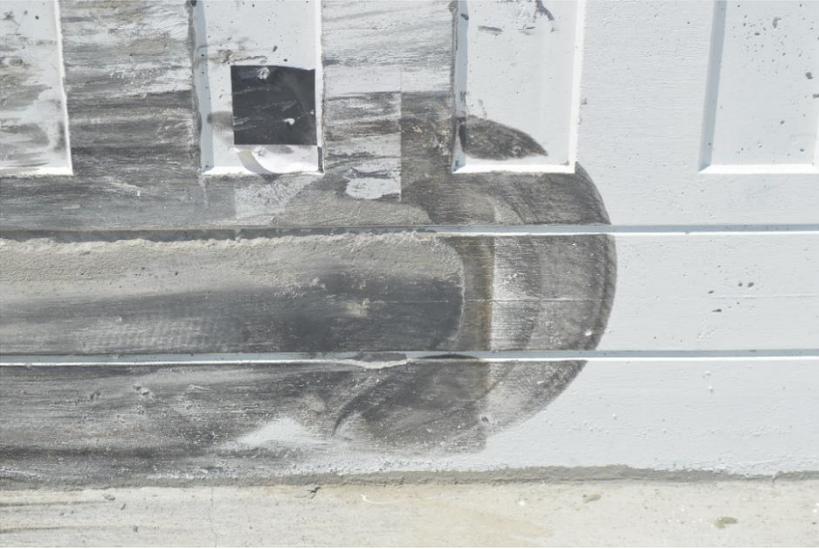
Figure 35. System Damage, Test No. H42BR-1

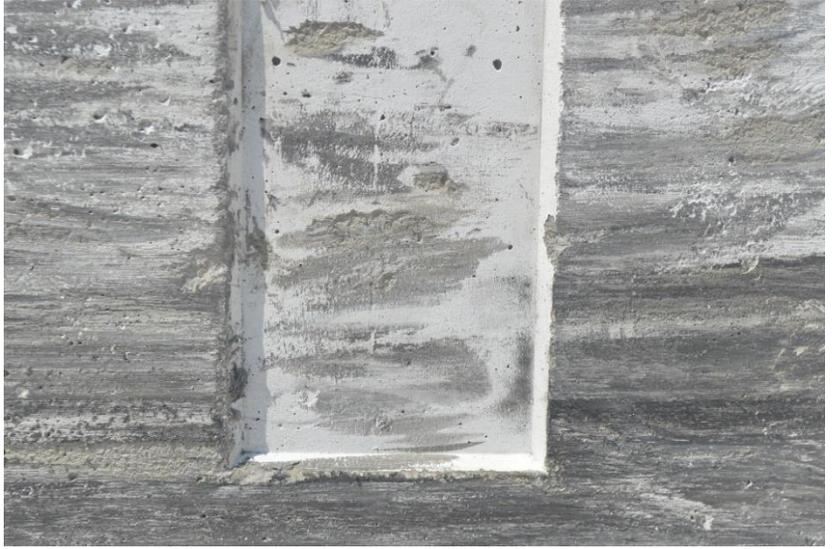
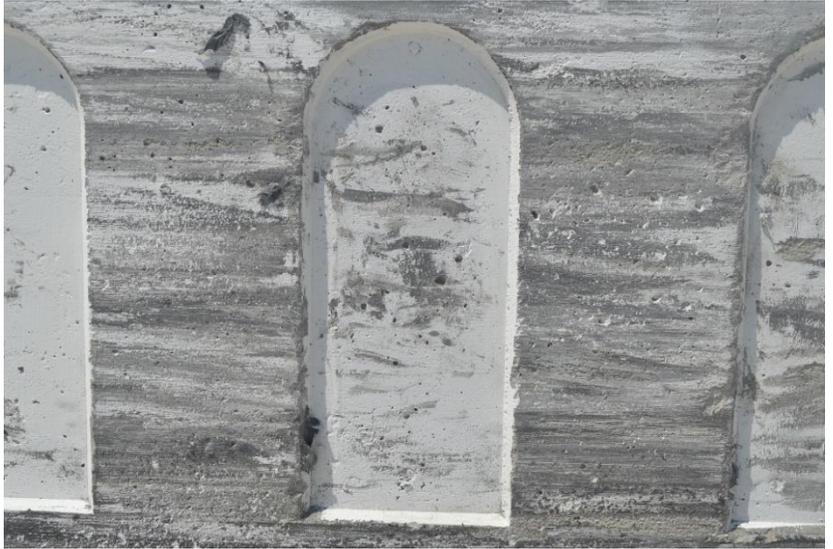
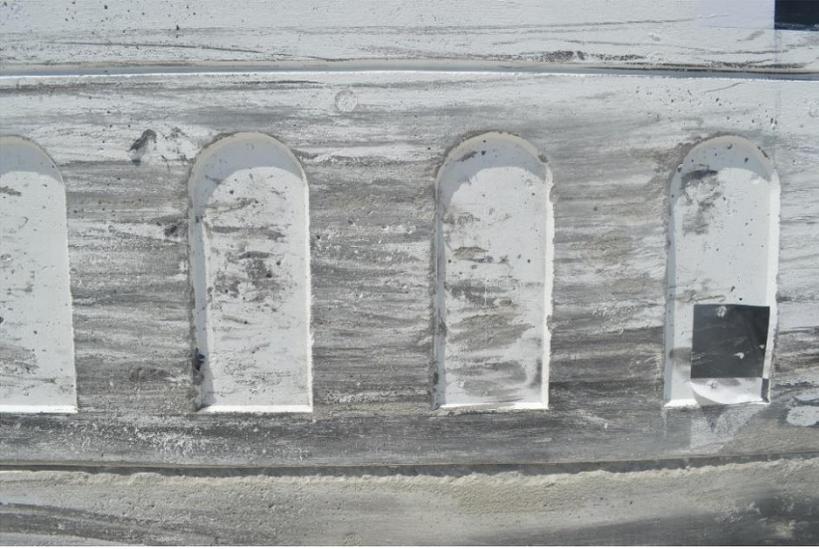
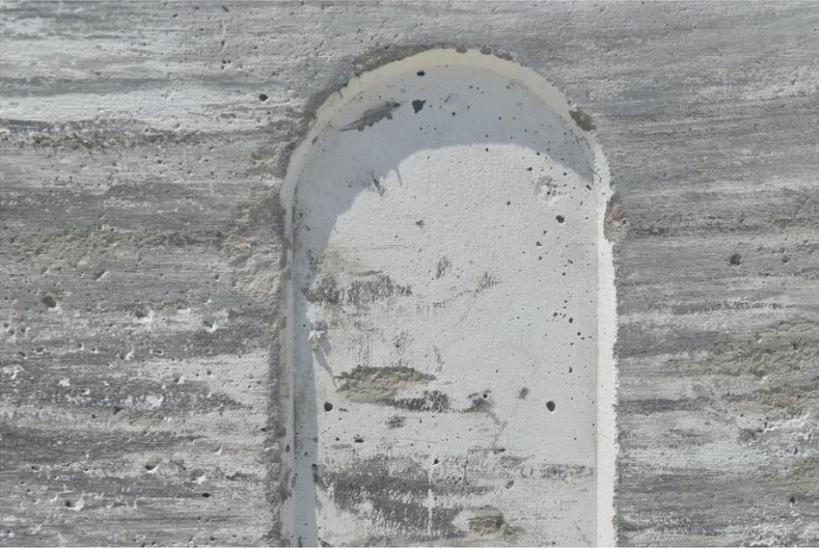
Figure 36. System Damage, Test No. H42BR-1

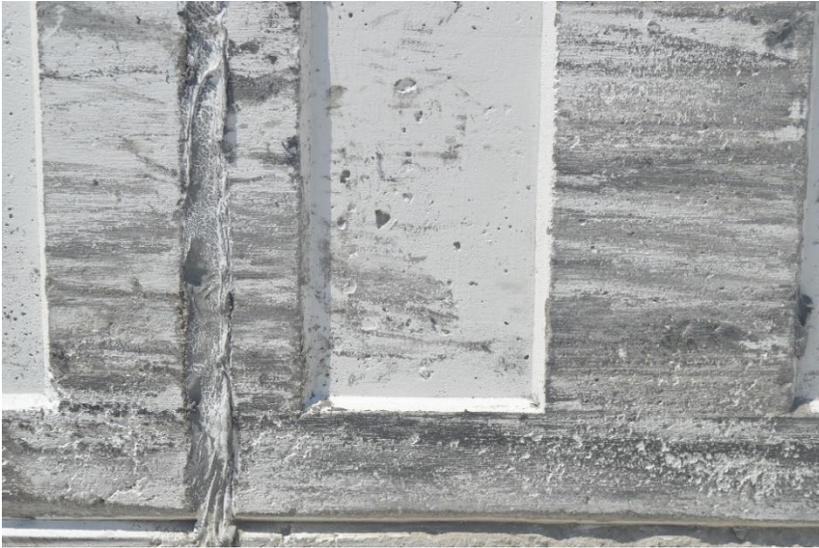
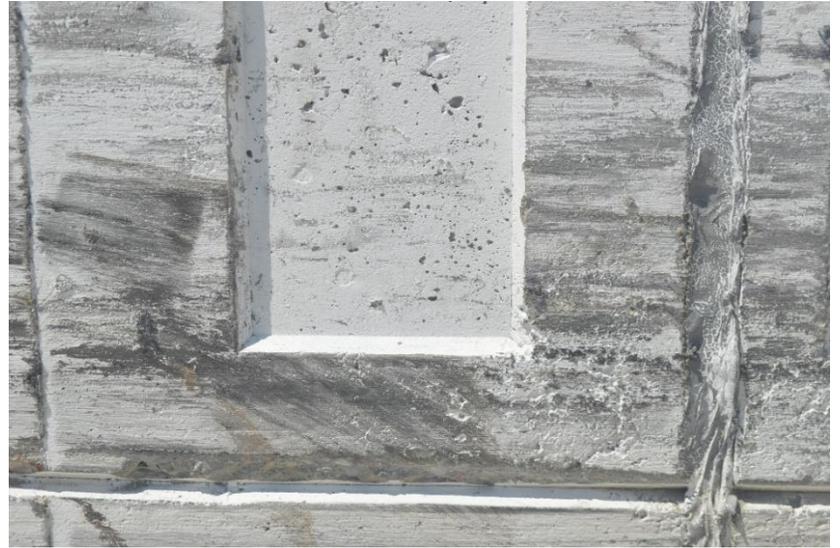
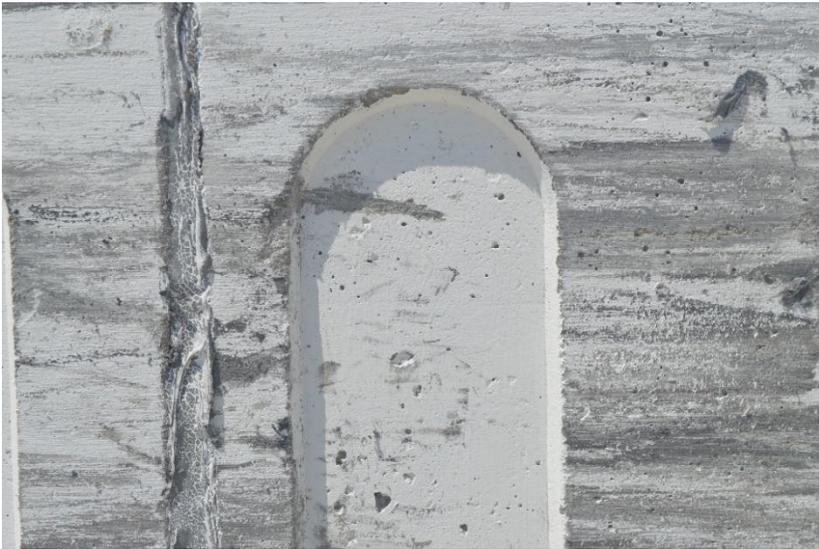
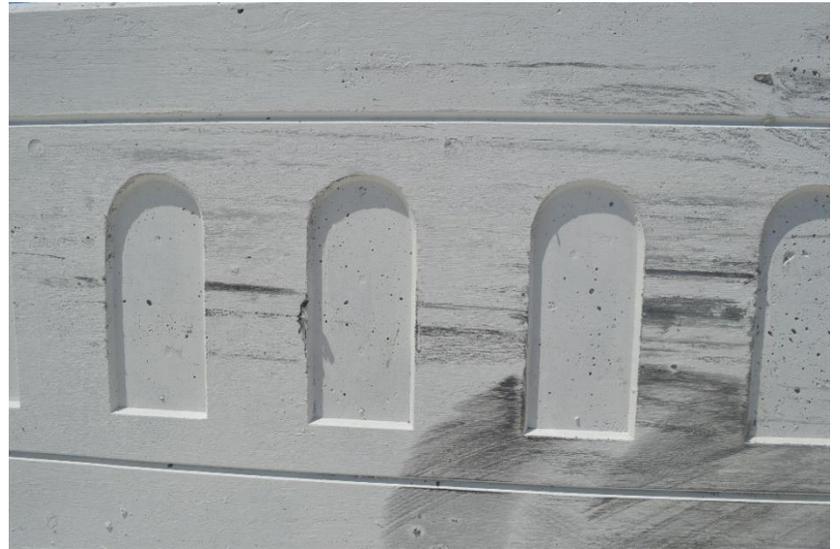
Figure 37. System Damage, Test No. H42BR-1

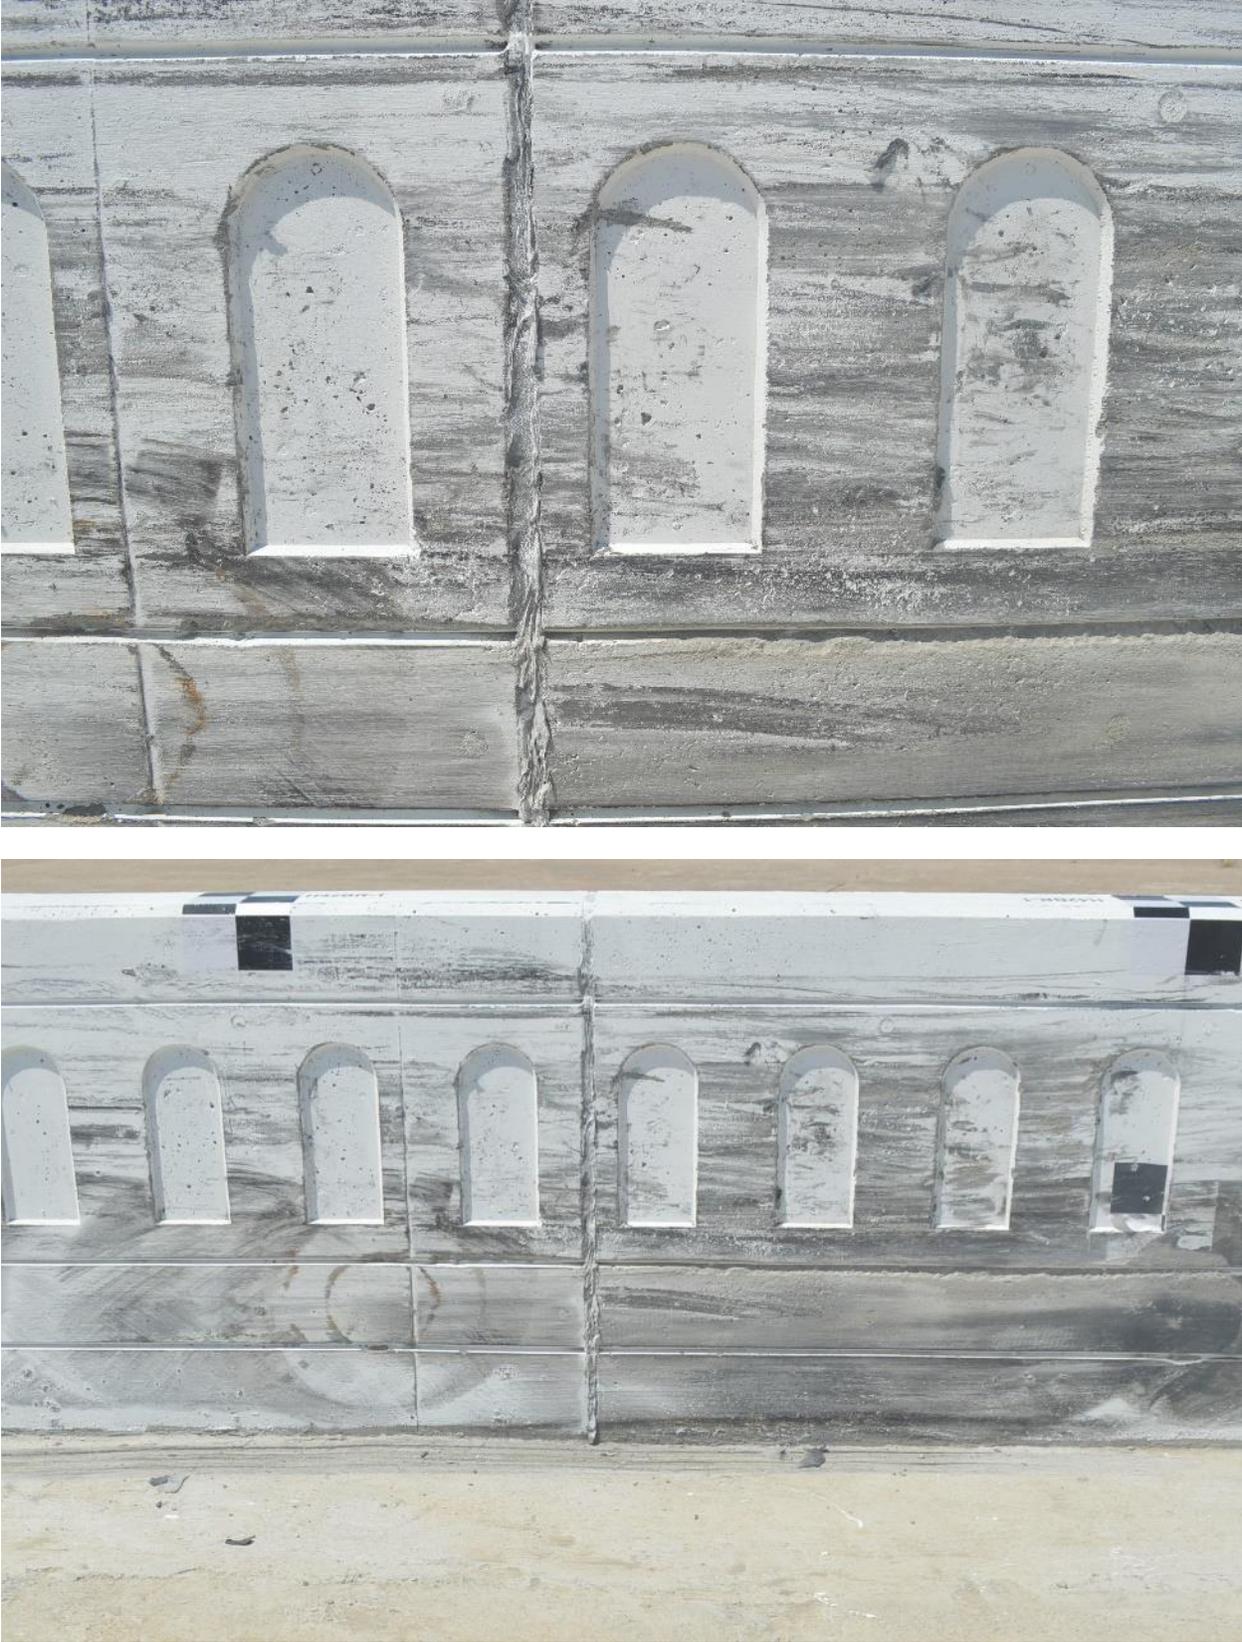
Figure 38. System Damage at Expansion Joint, Test No. H42BR-1

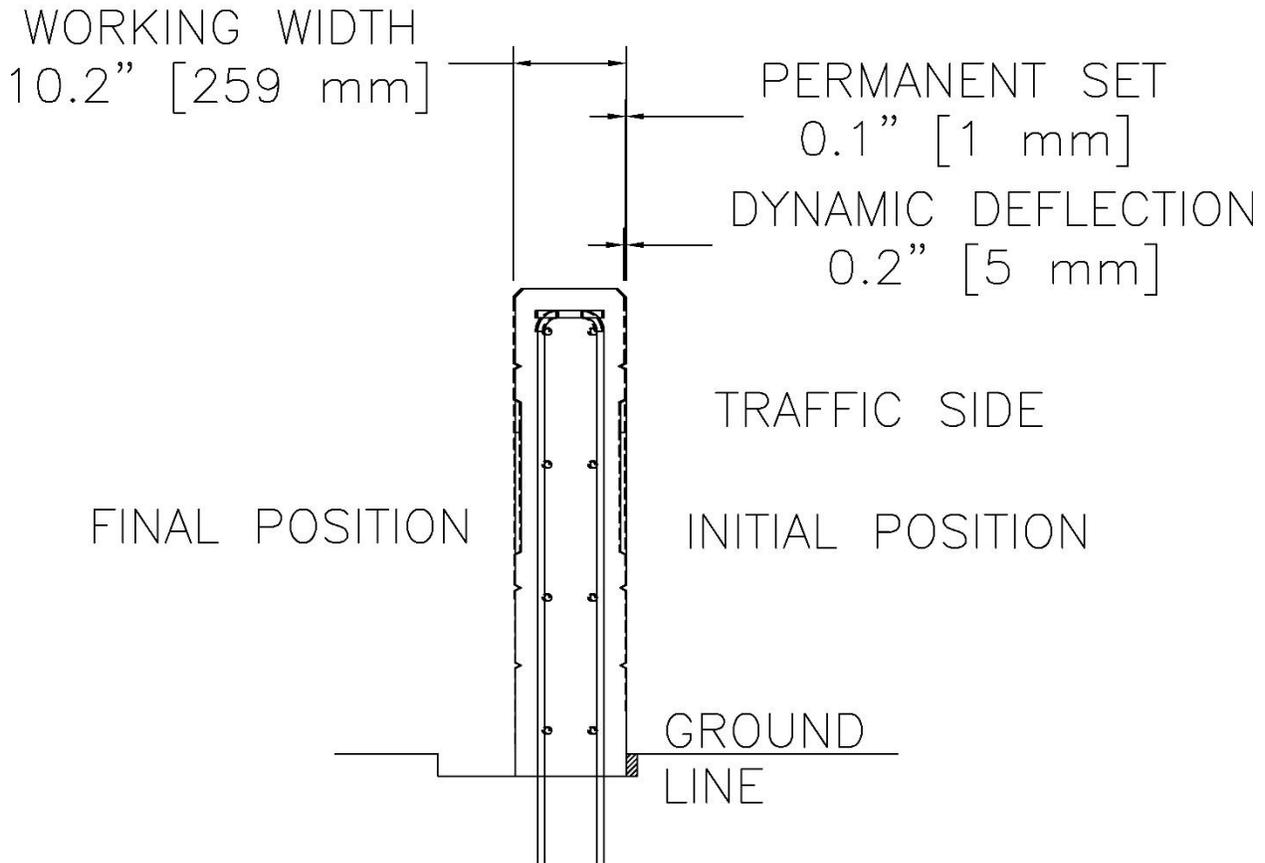
Figure 39. Permanent Set Deflection, Dynamic Deflection, and Working Width, Test No. H42BR-1

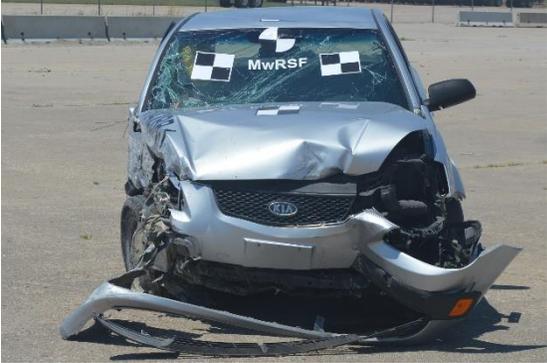
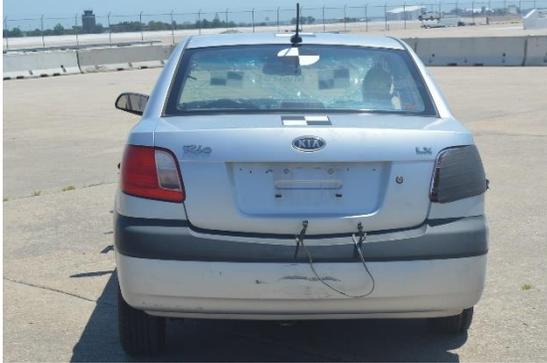
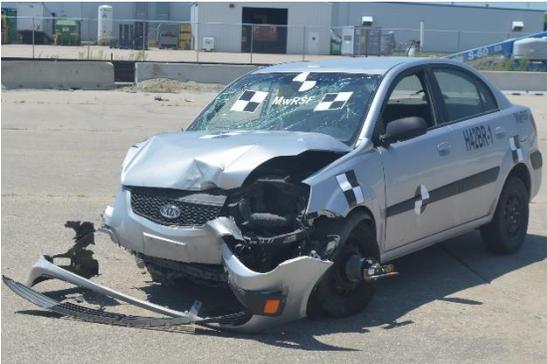
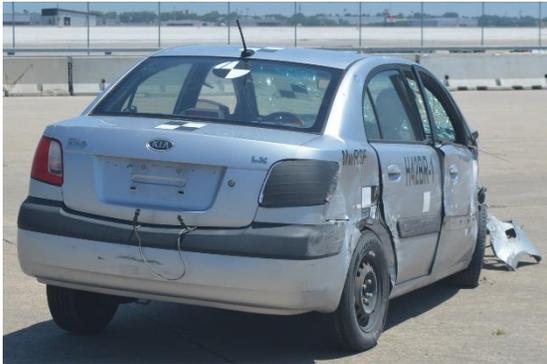
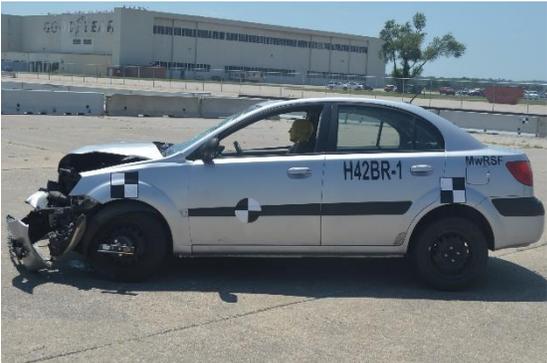
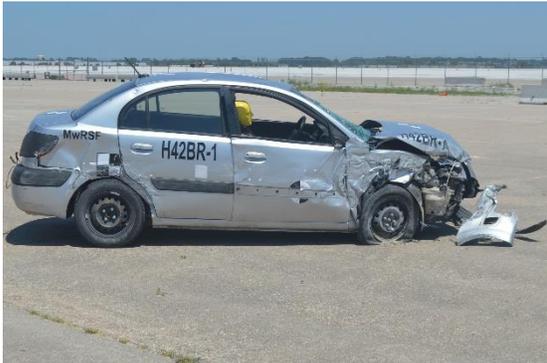
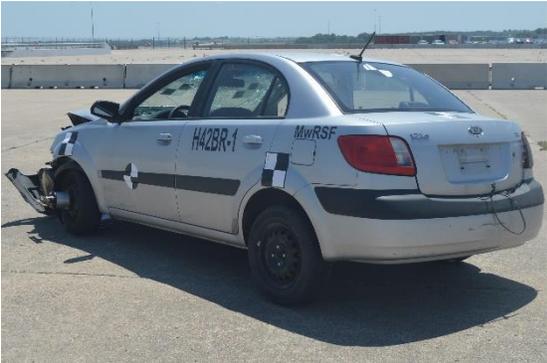
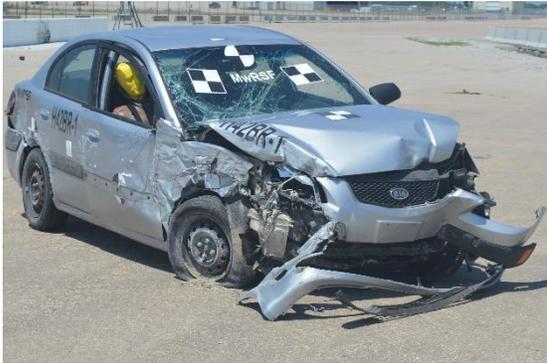
Figure 40. Vehicle Damage, Test No. H42BR-1

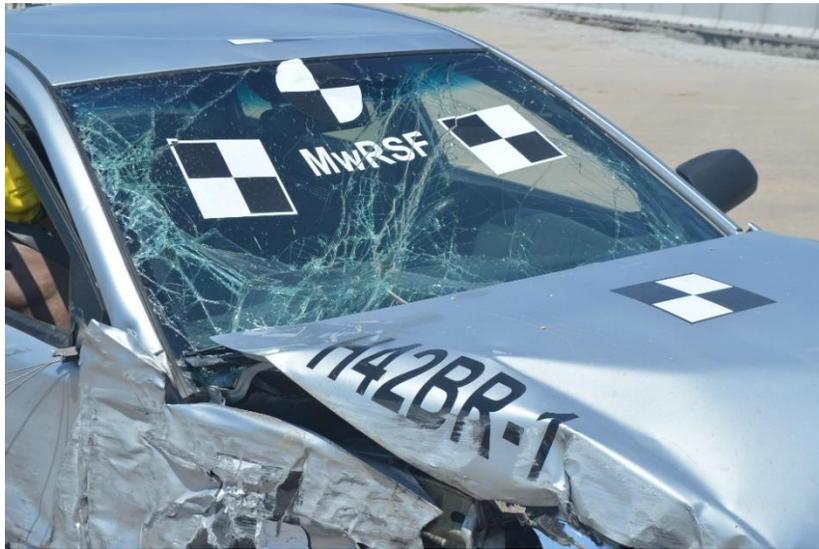
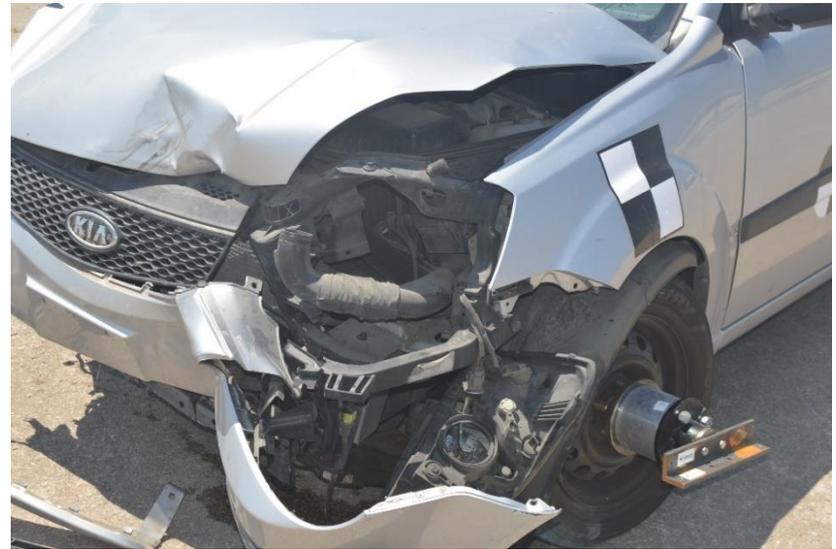
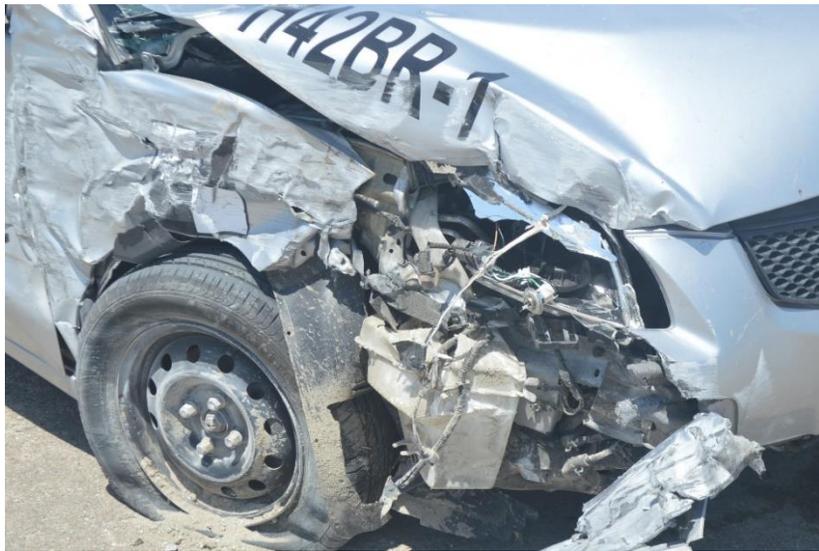
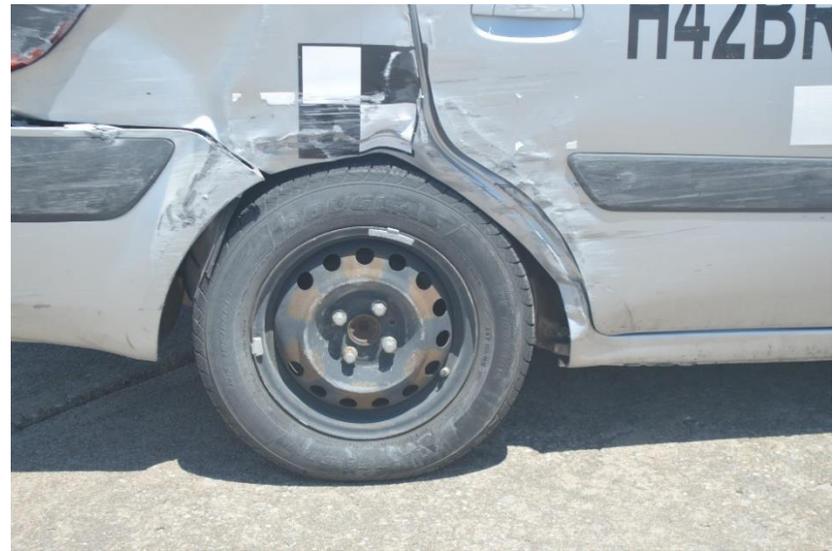
Figure 41. Vehicle Damage, Test No. H42BR-1
