*Hawaii Department of Transportation
Research Project Number 67167*

CRASH TESTING AND EVALUATION OF THE HDOT 42-IN. TALL, AESTHETIC CONCRETE BRIDGE RAIL: MASH TEST DESIGNATION NOS. 3-10 AND 3-11

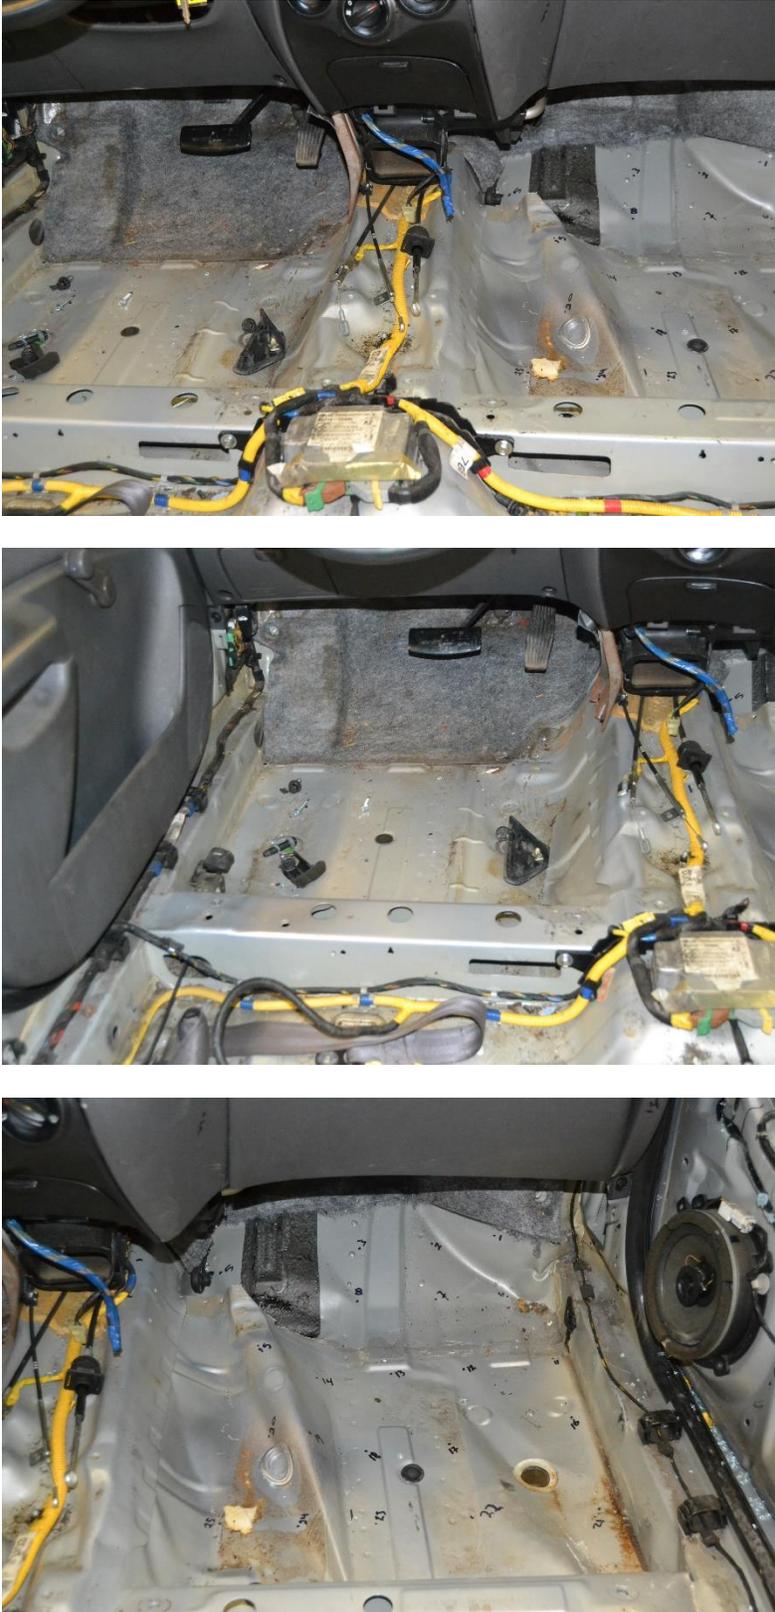
Figure 42. Occupant Compartment Damage, Test No. H42BR-1

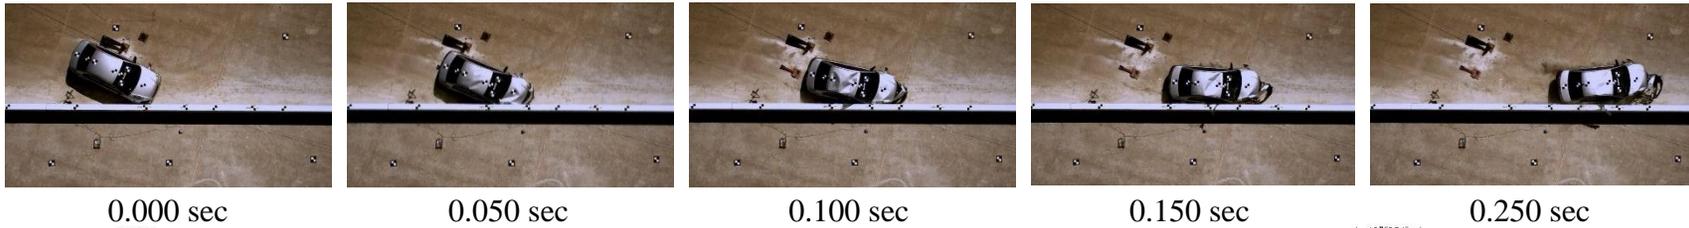
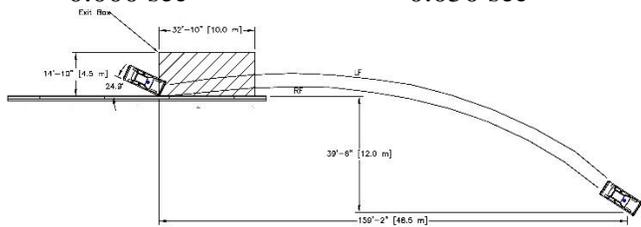
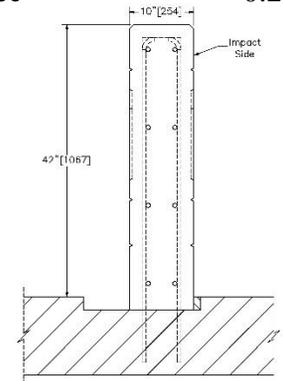
- Test Agency MwRSF
- Test Number..... H42BR-1
- Date July 17, 2019
- MASH 2016 Test Designation No..... 3-10
- Test Article..... HDOT 42-in. Tall, Aesthetic Concrete Bridge Rail

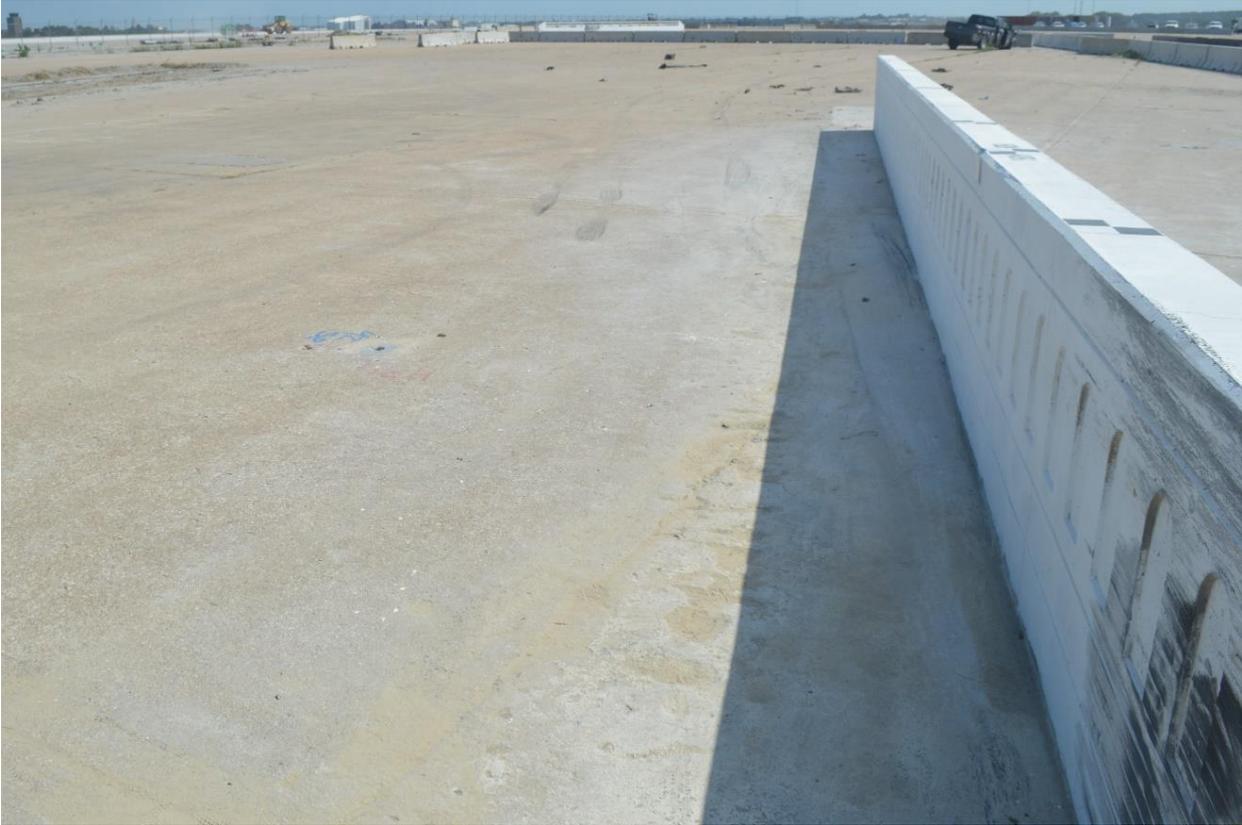
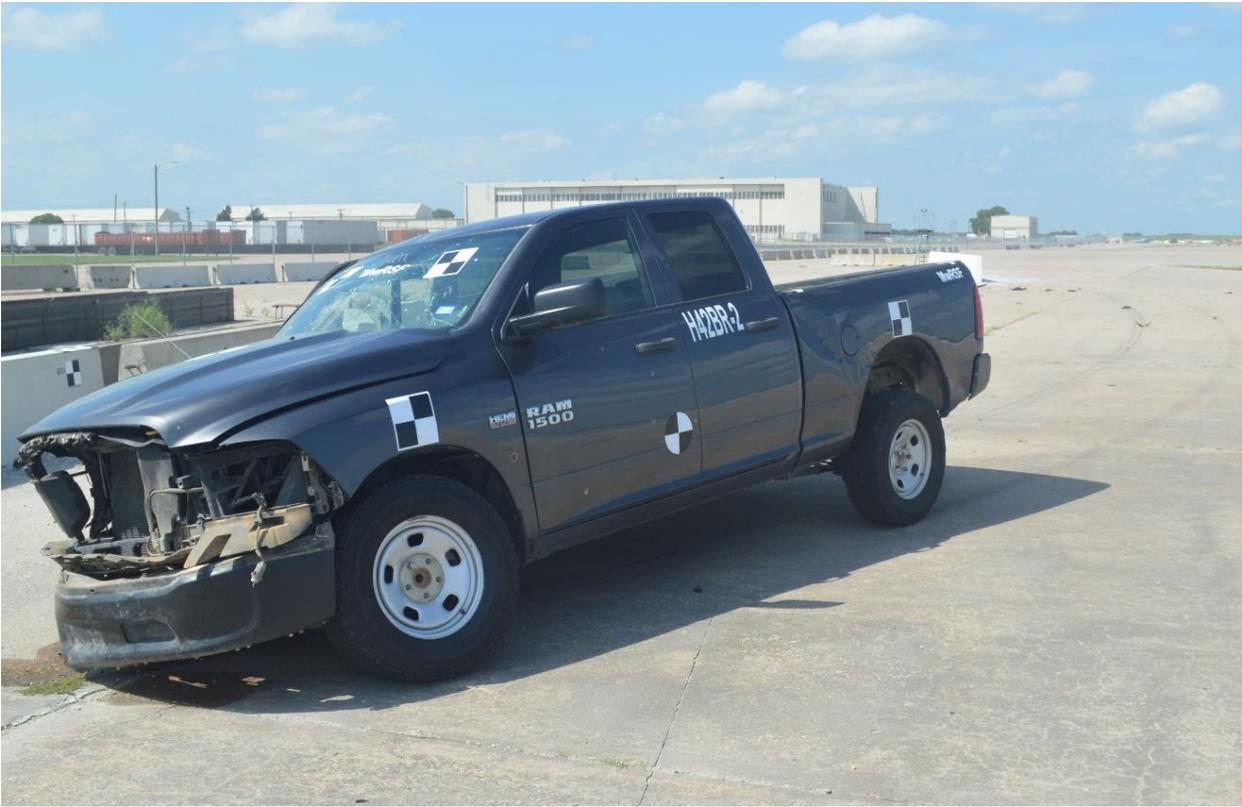
Figure 49. Vehicle Final Position and Trajectory Marks, Test No. H42BR-2

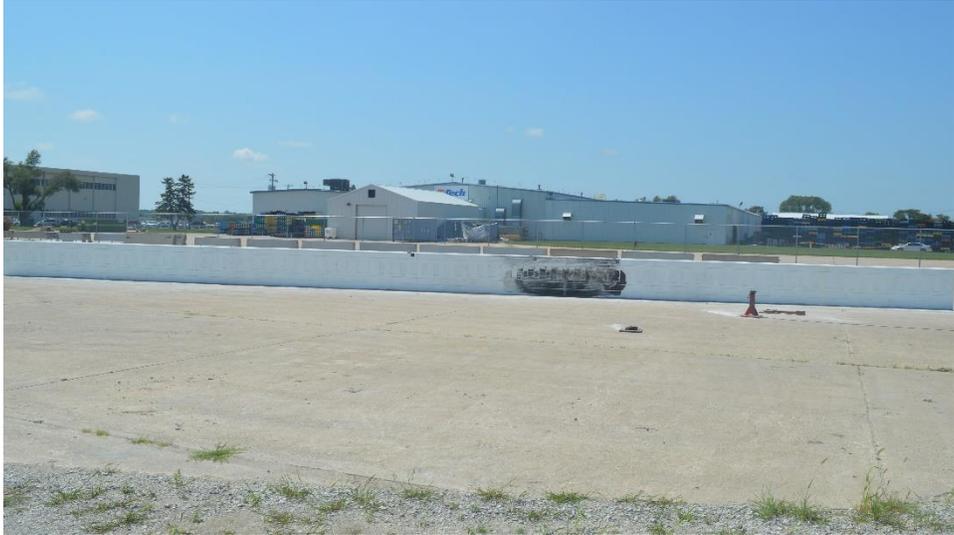
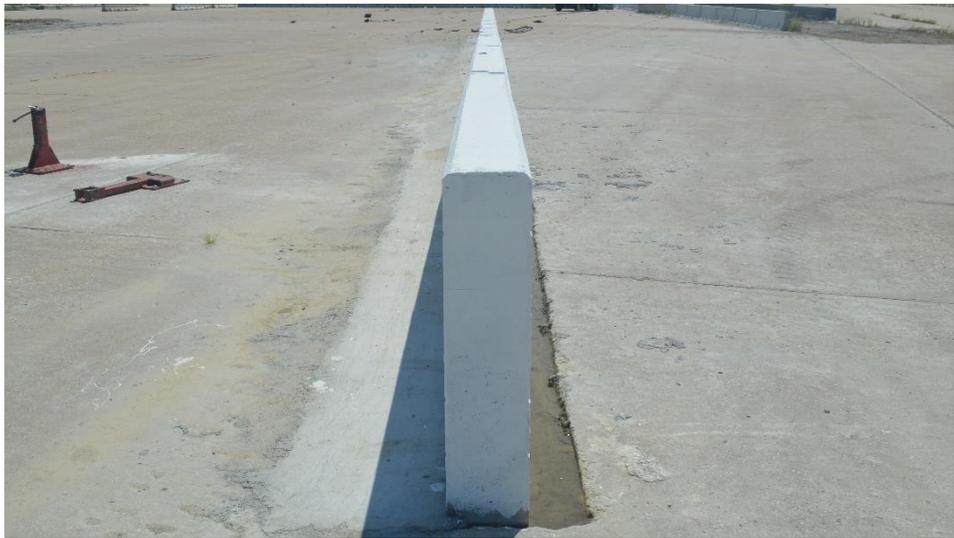
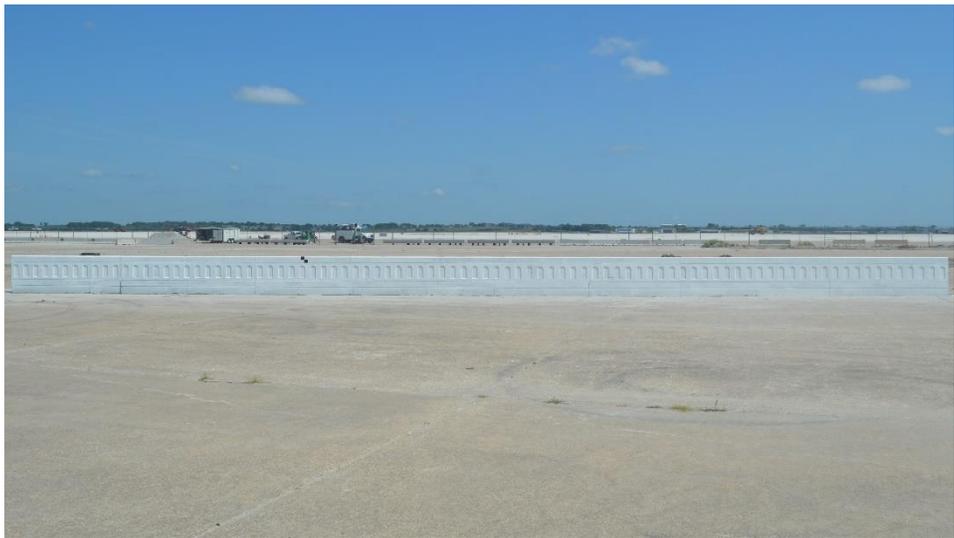
Figure 50. System Damage, Test No. H42BR-2

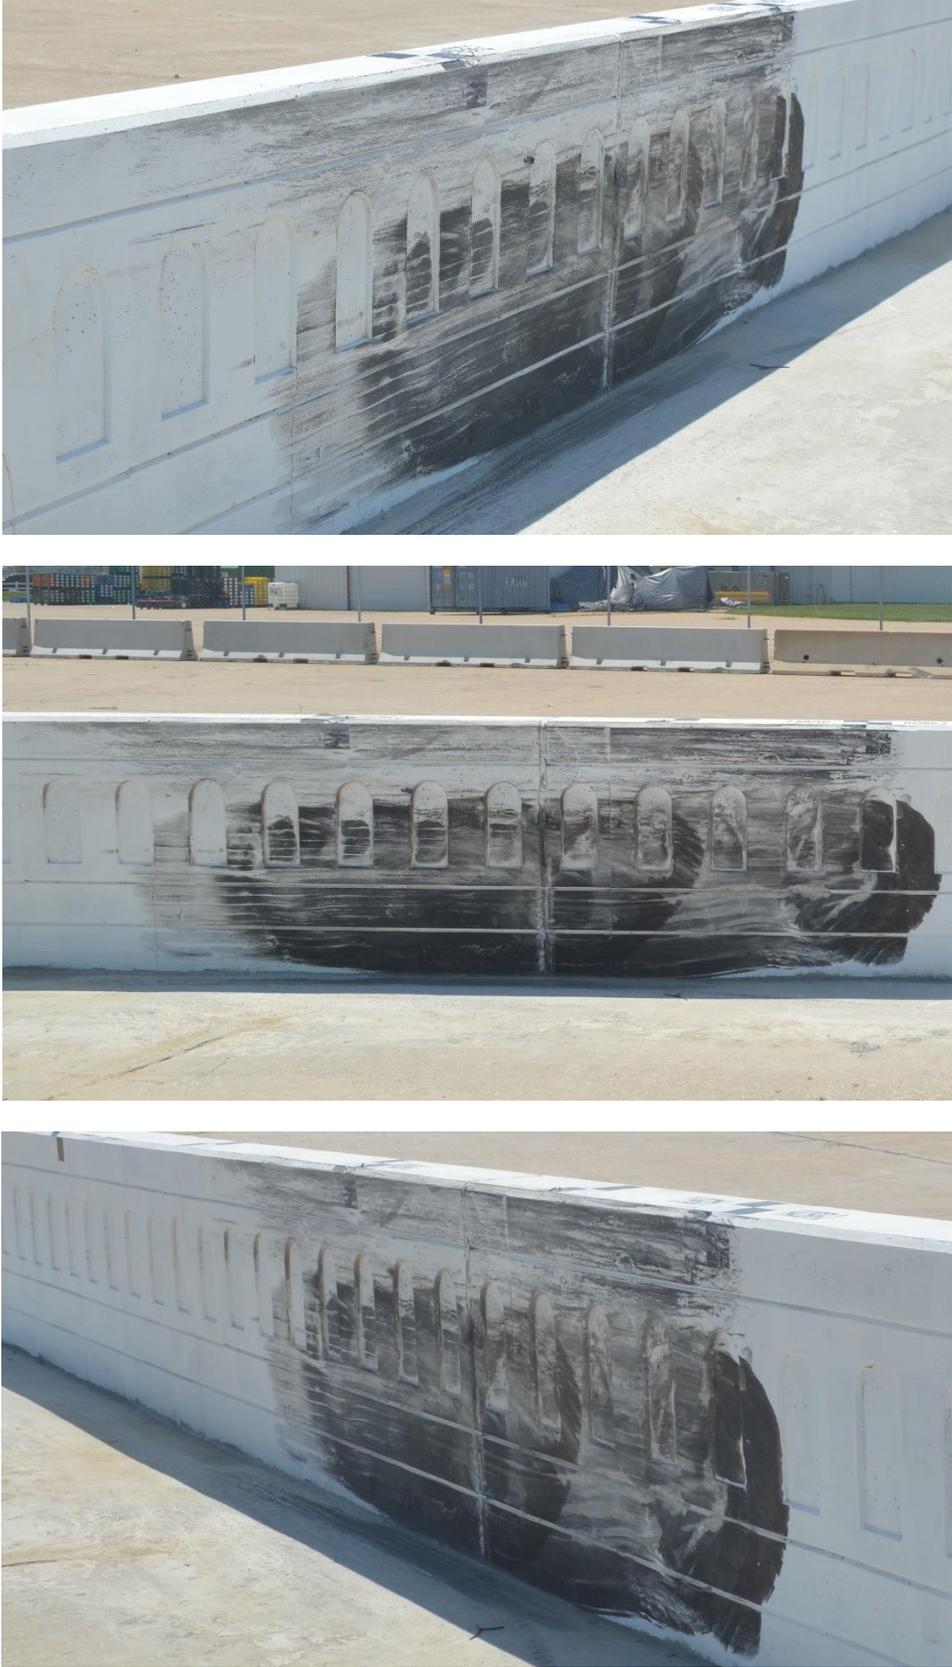
Figure 51. System Damage, Test No. H42BR-2

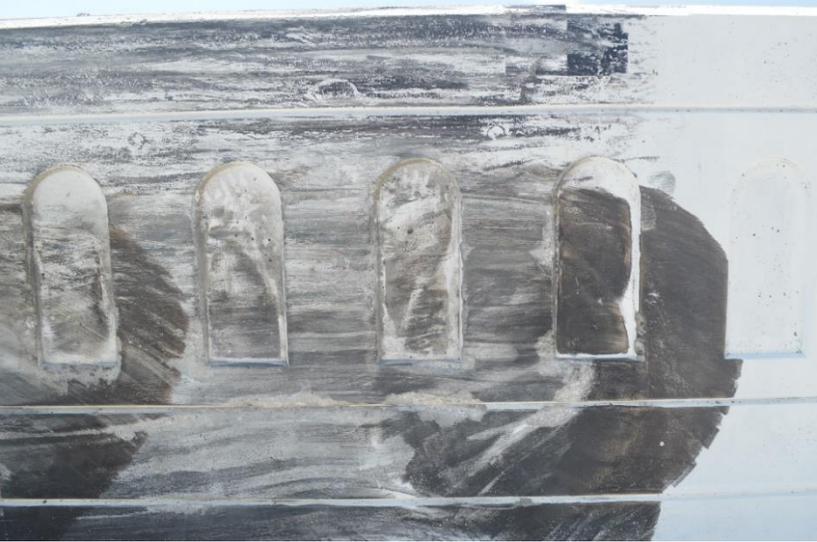
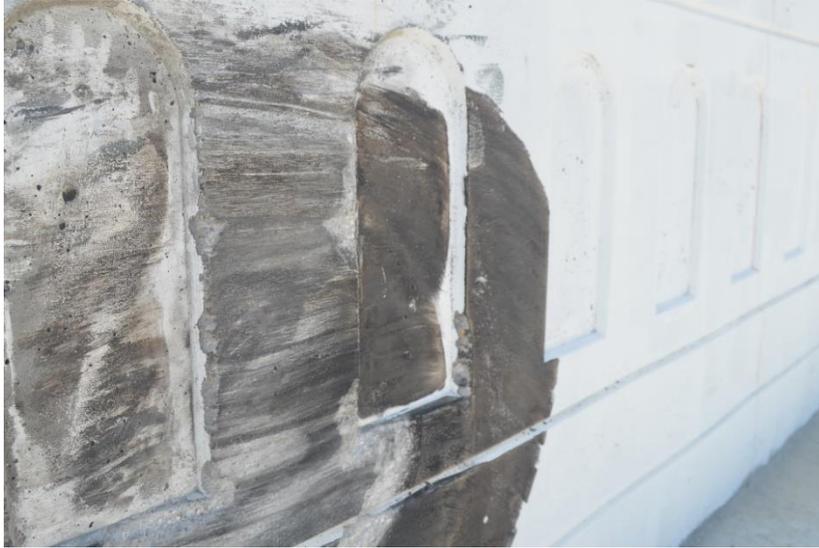
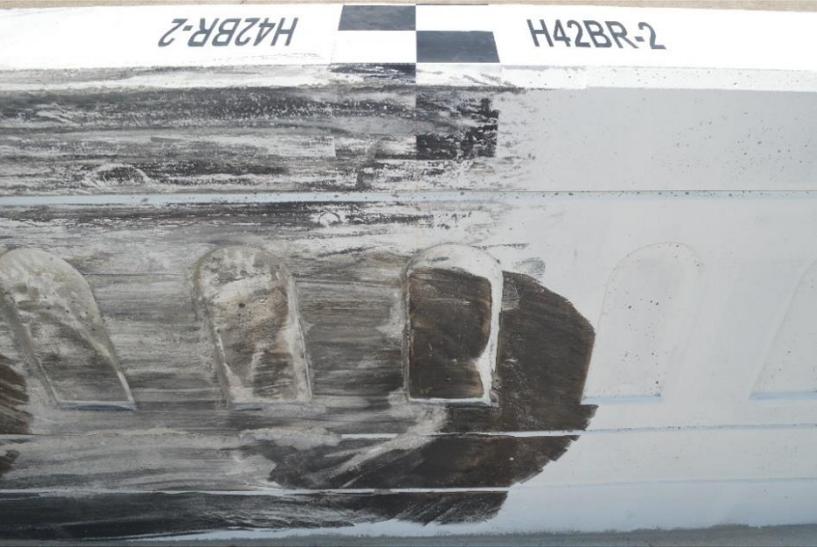
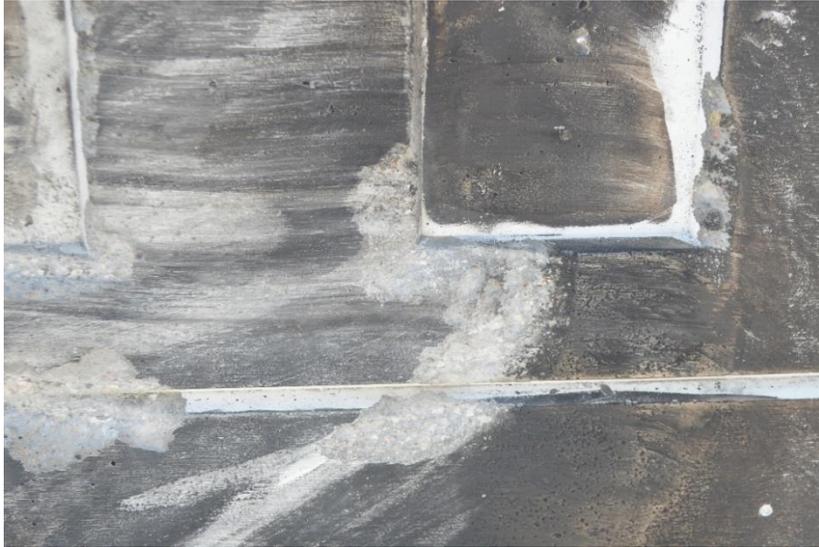
Figure 52. System Damage, Test No. H42BR-2

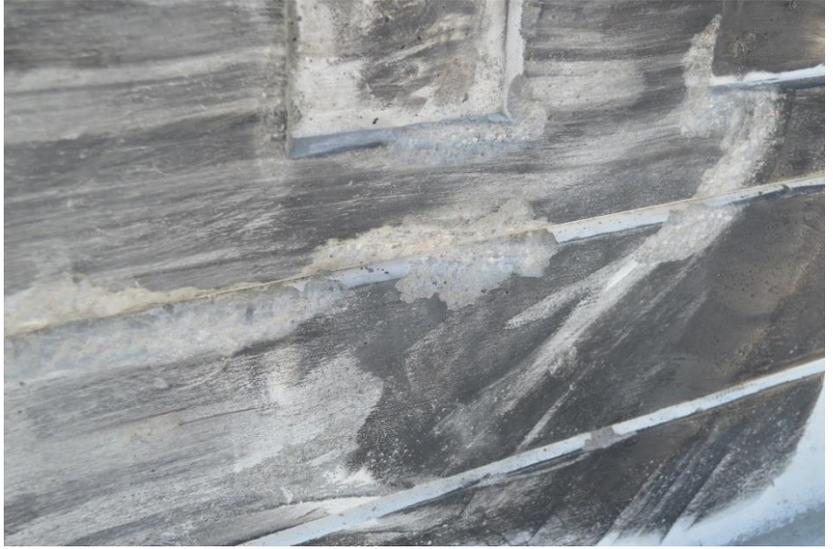
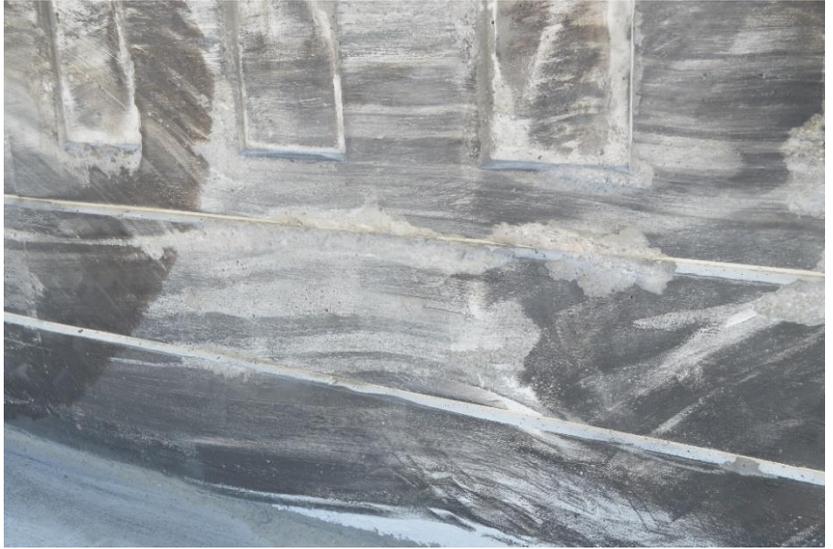
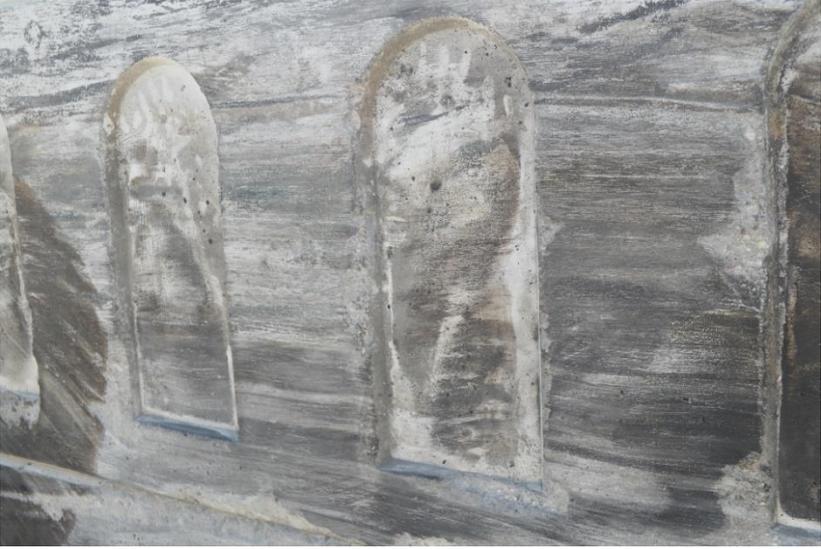
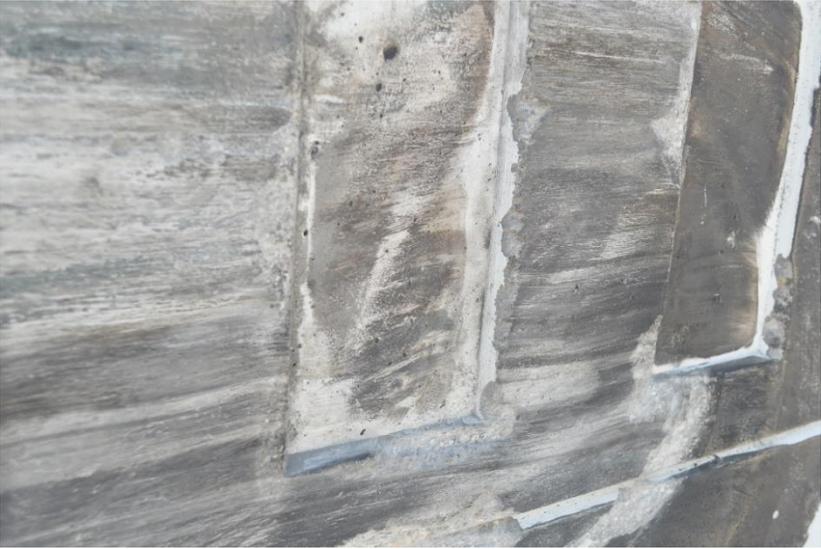
Figure 53. System Damage, Test No. H42BR-2

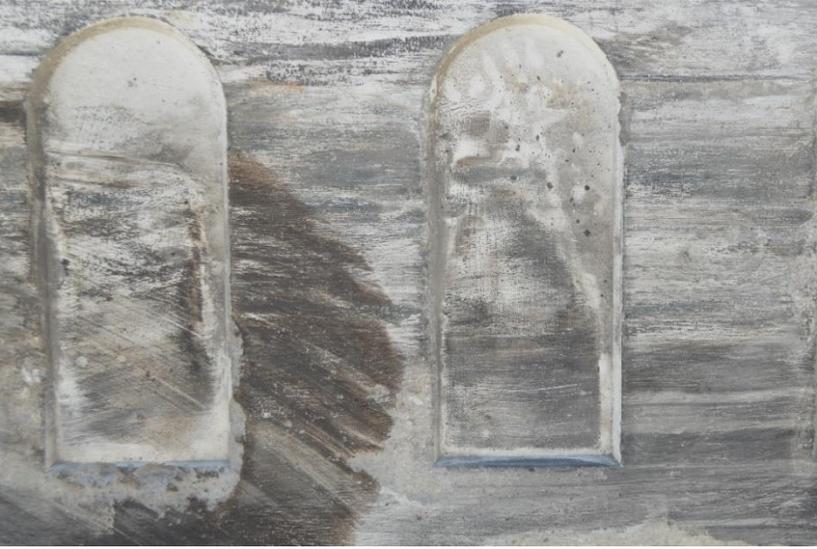
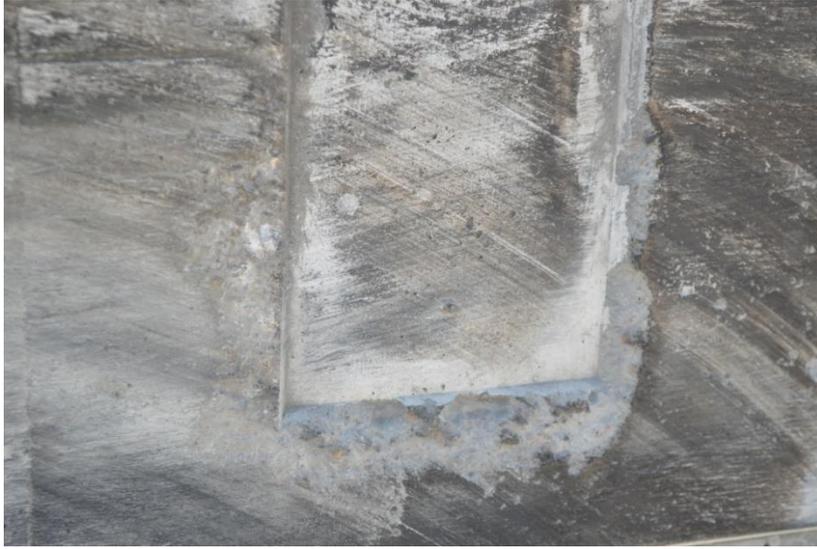
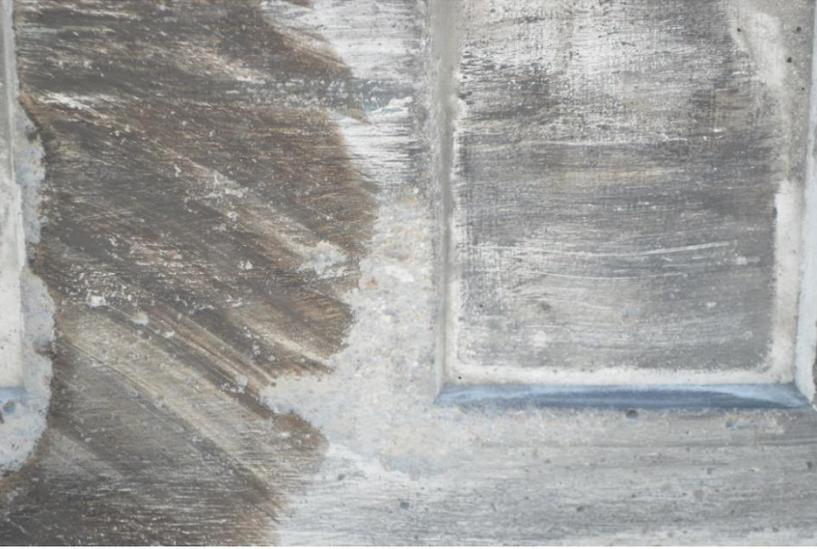
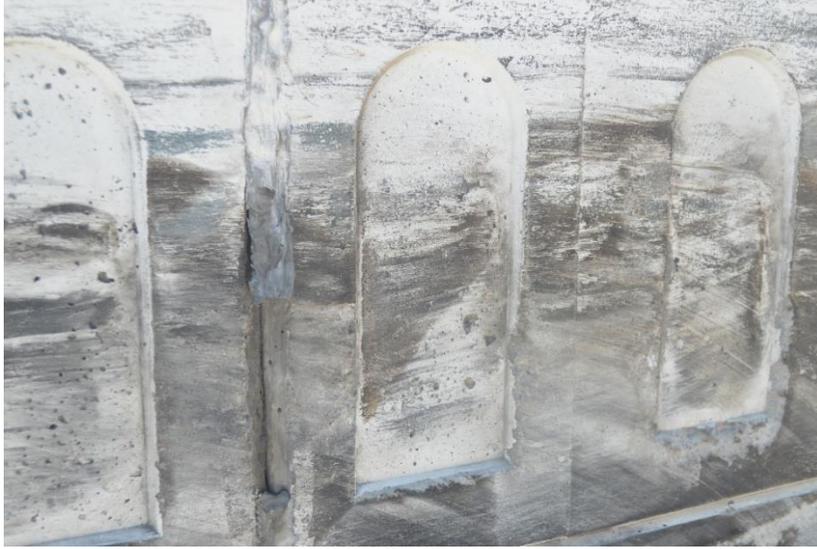
Figure 54. System Damage, Test No. H42BR-2

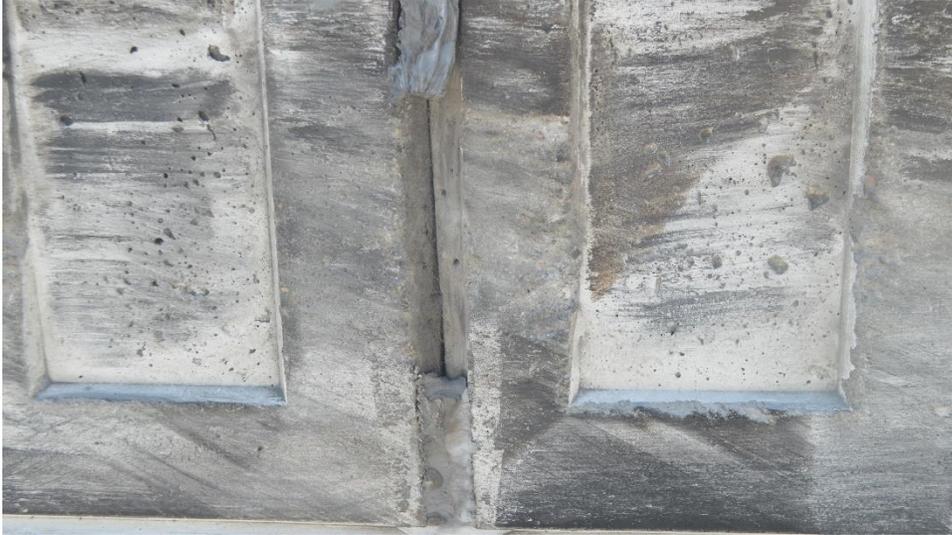
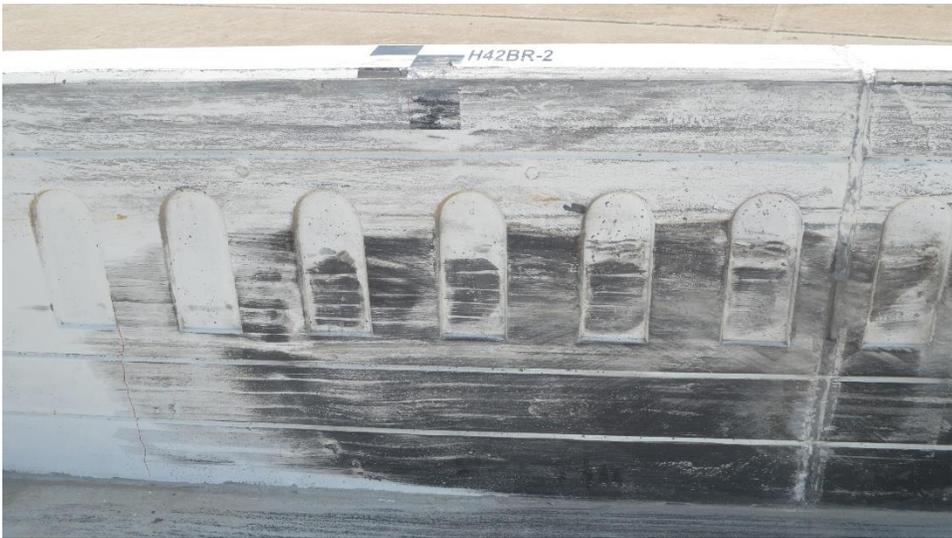
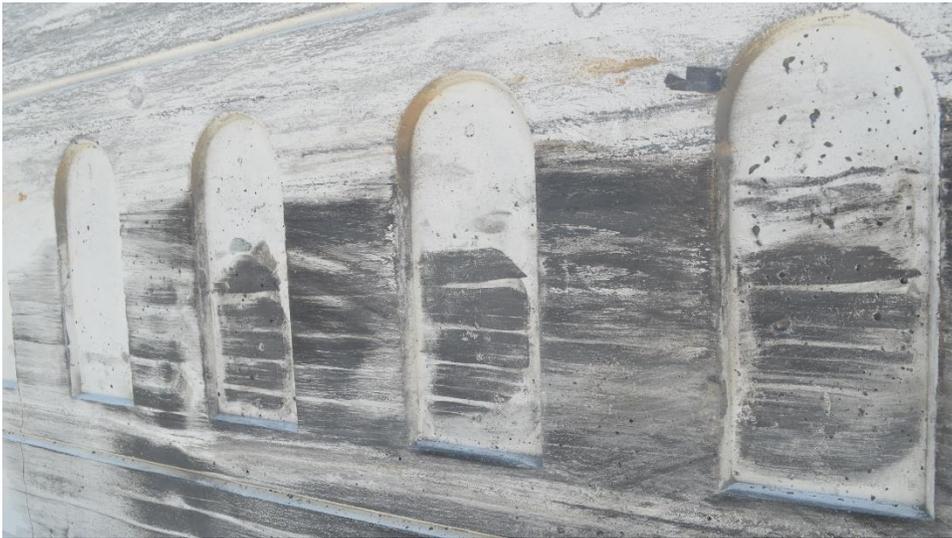
Figure 55. System Damage, Test No. H42BR-2

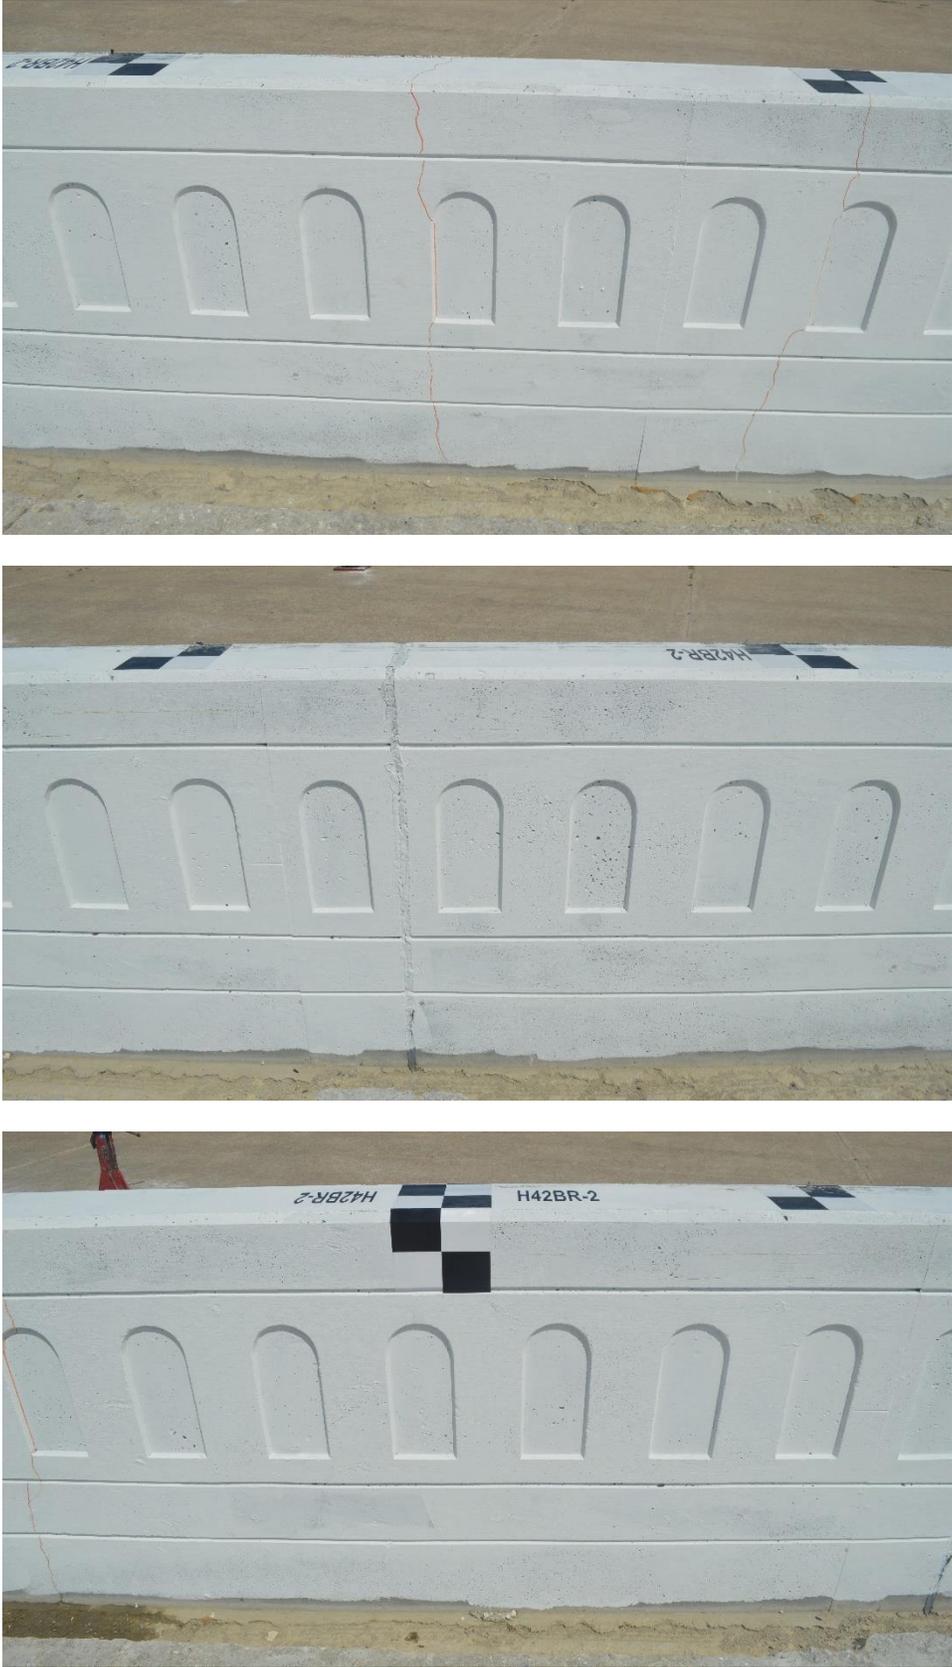
Figure 56. System Damage Behind Impact Point, Test No. H42BR-2

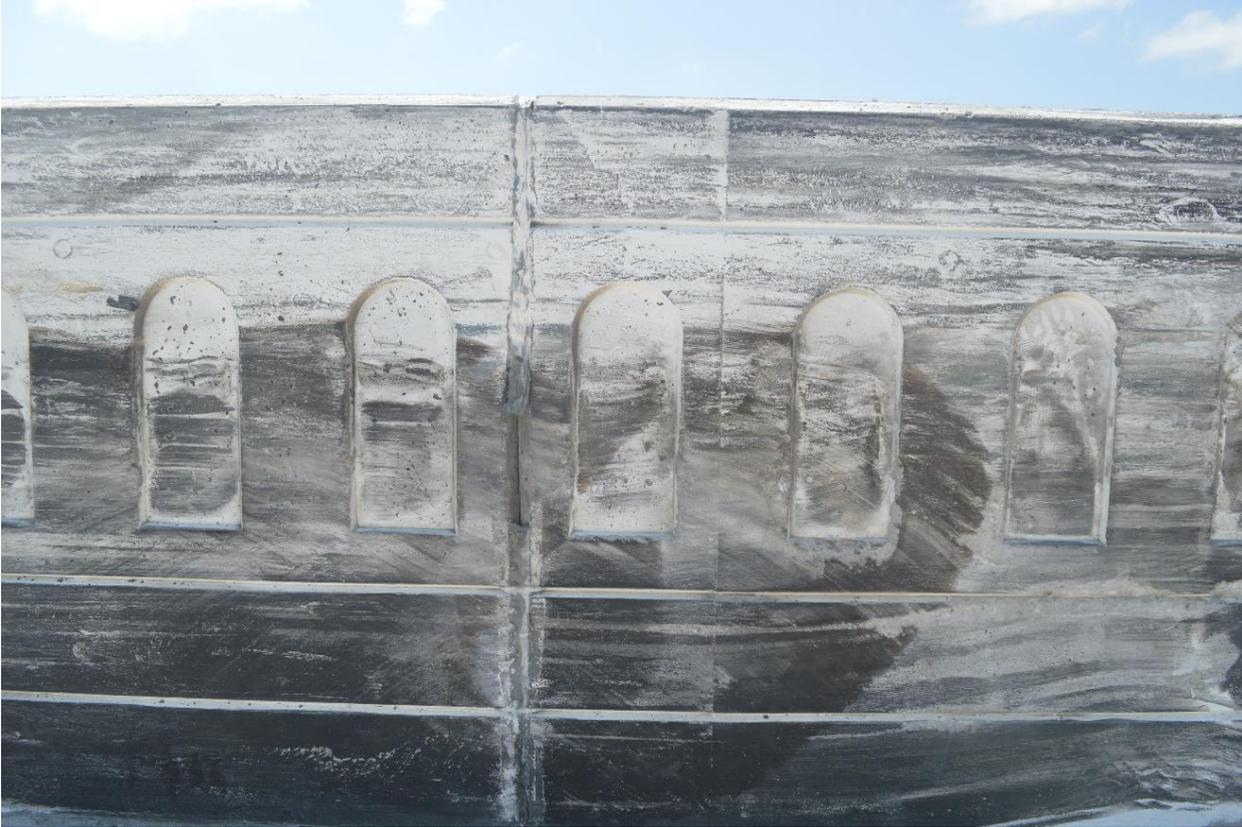
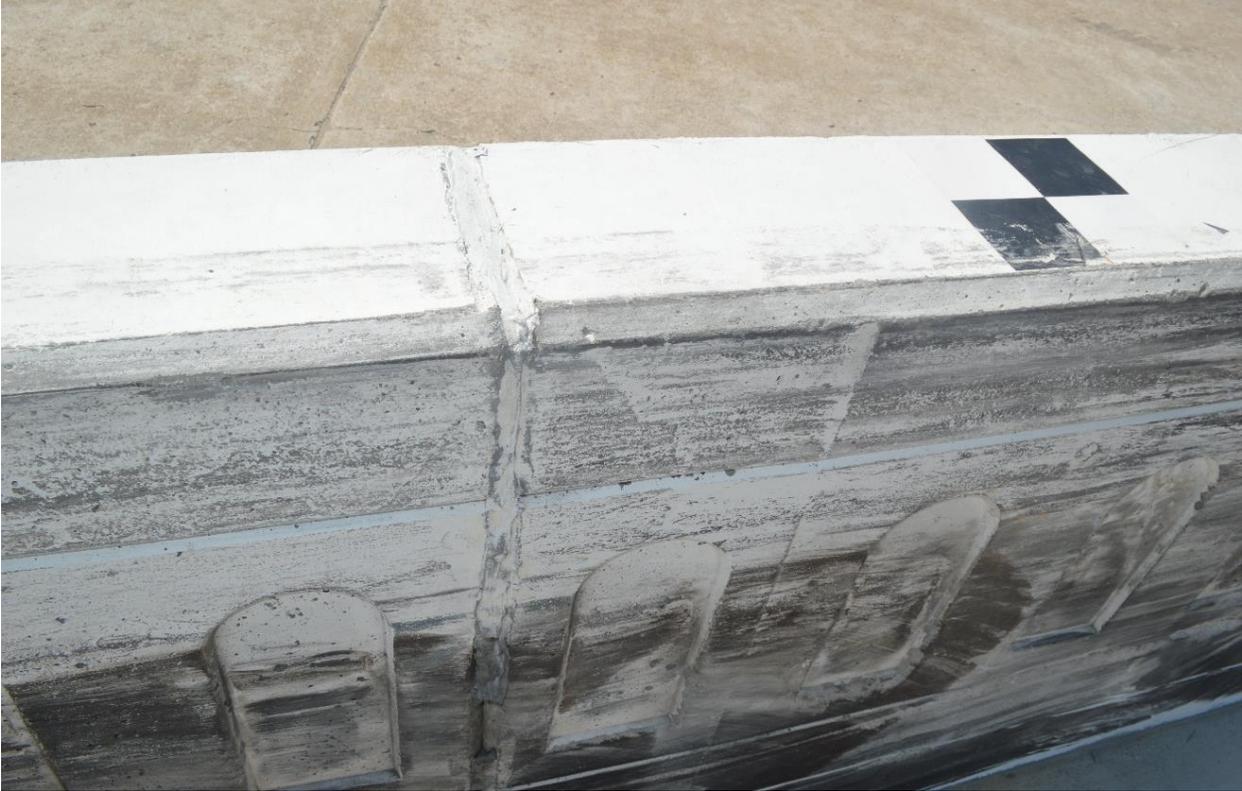
Figure 57. System Damage at Expansion Joint, Test No. H42BR-2

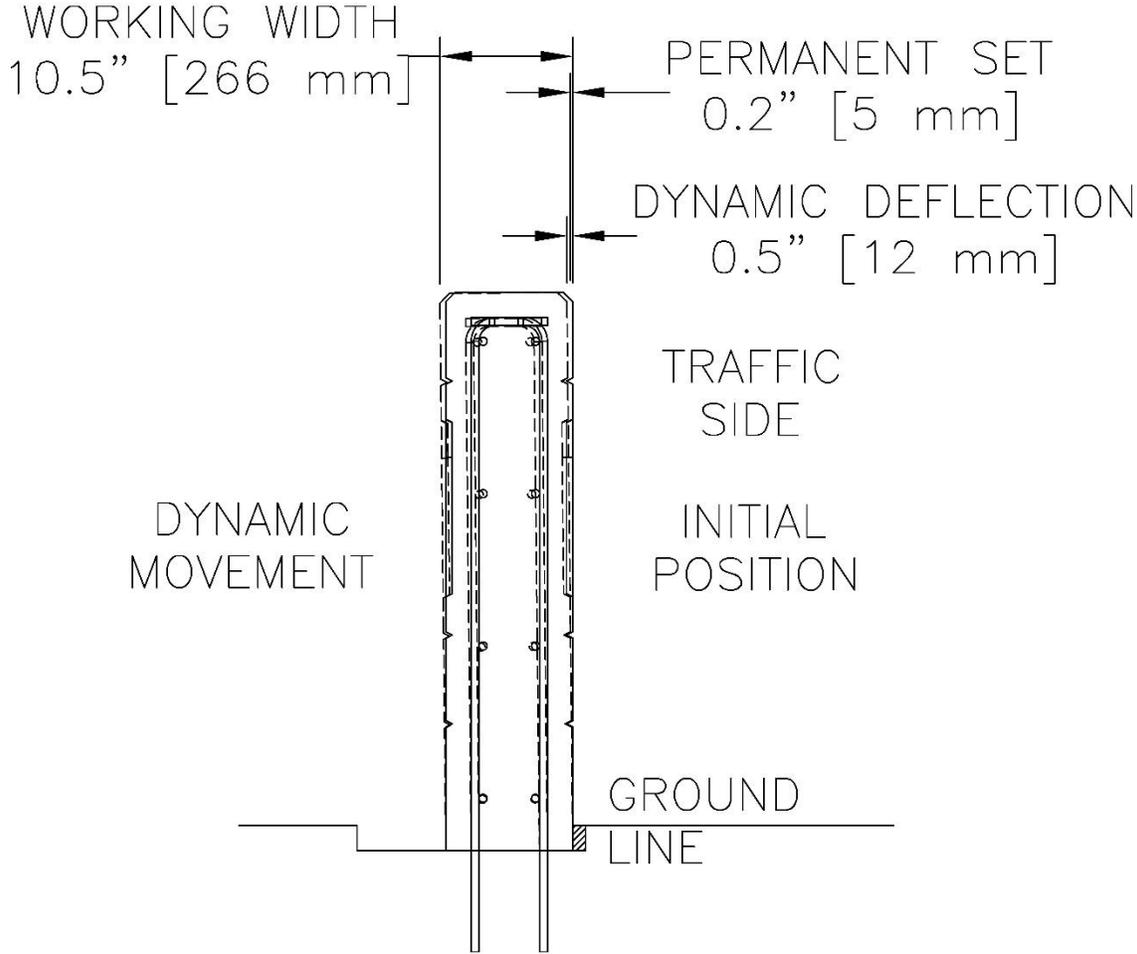
Figure 58. Permanent Set Deflection, Dynamic Deflection, and Working Width, Test No. H42BR-2

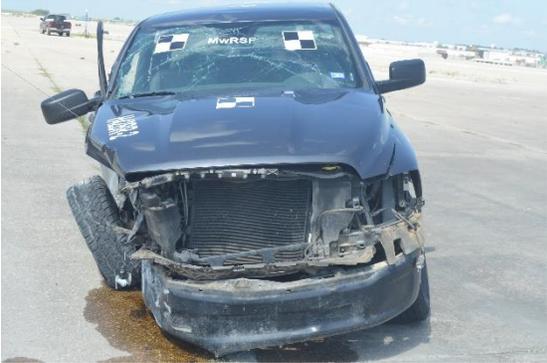
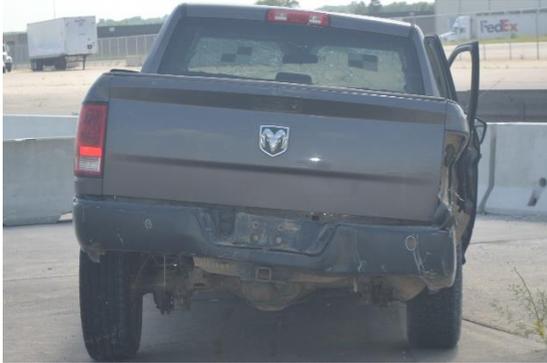
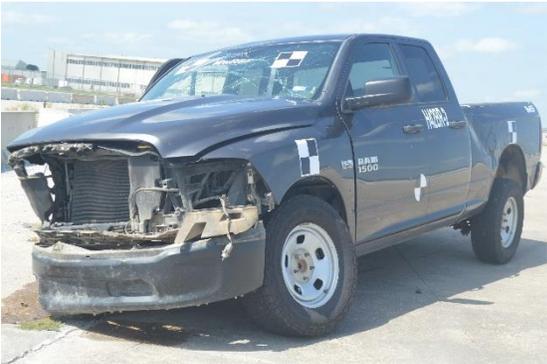
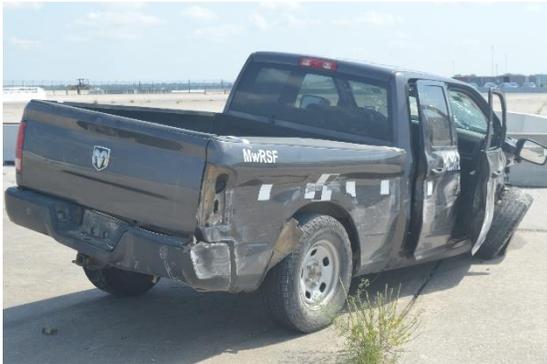
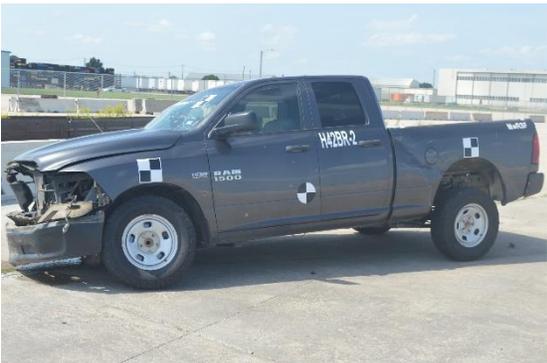
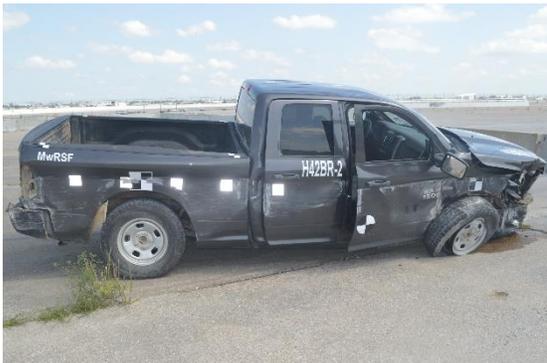
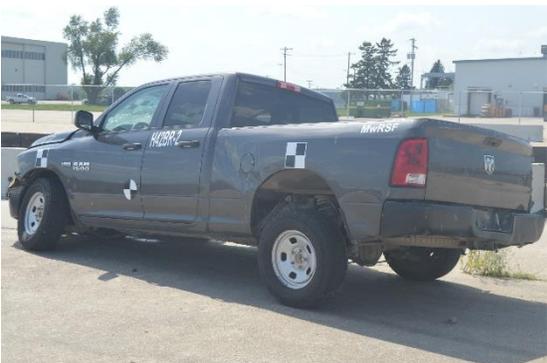
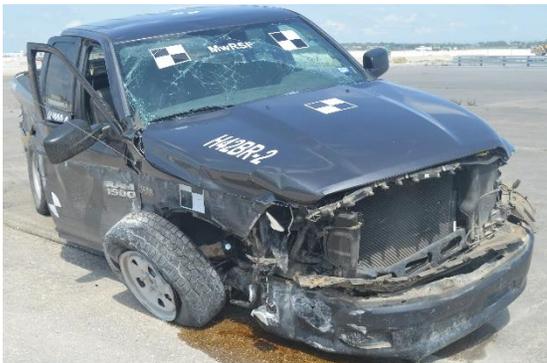
Figure 59. Vehicle Damage, Test No. H42BR-2

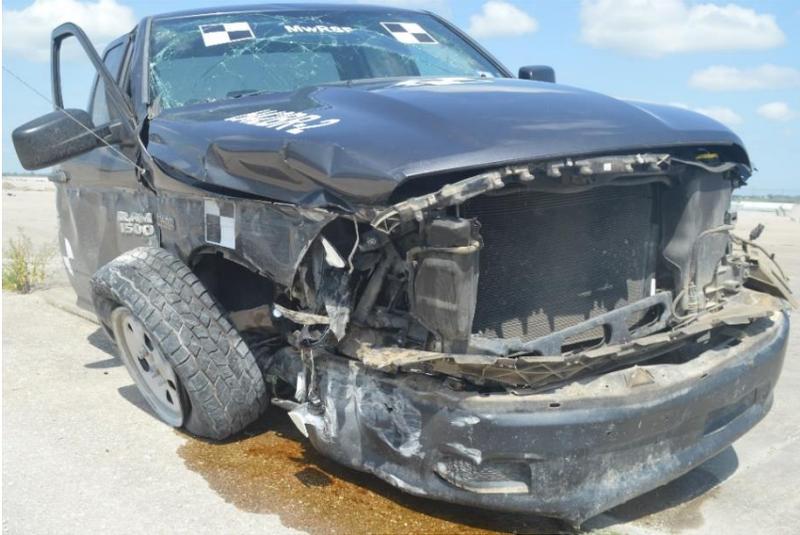
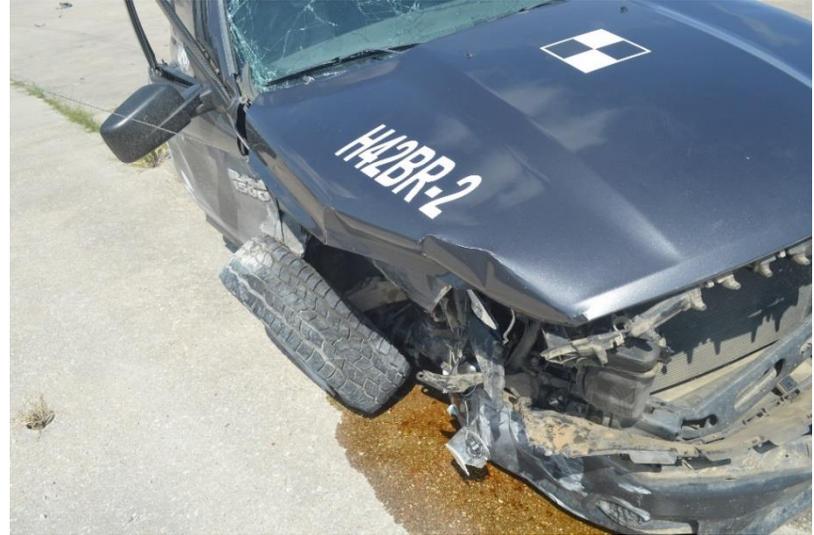
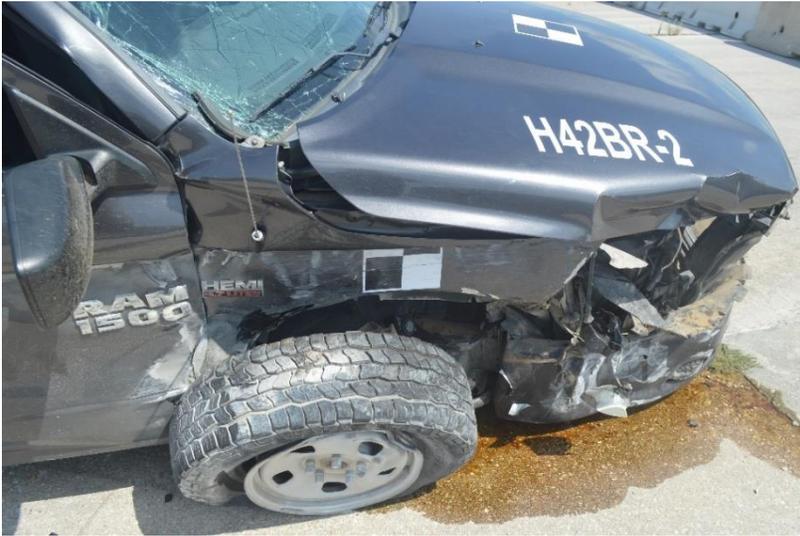
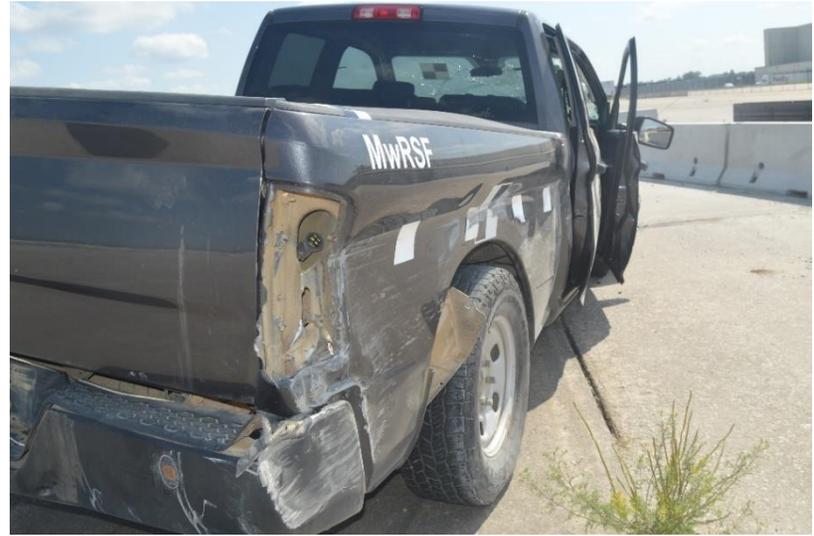
Figure 60. Vehicle Damage, Test No. H42BR-2
