*Hawaii Department of Transportation
Research Project Number 67167*

CRASH TESTING AND EVALUATION OF THE HDOT 42-IN. TALL, AESTHETIC CONCRETE BRIDGE RAIL: MASH TEST DESIGNATION NOS. 3-10 AND 3-11

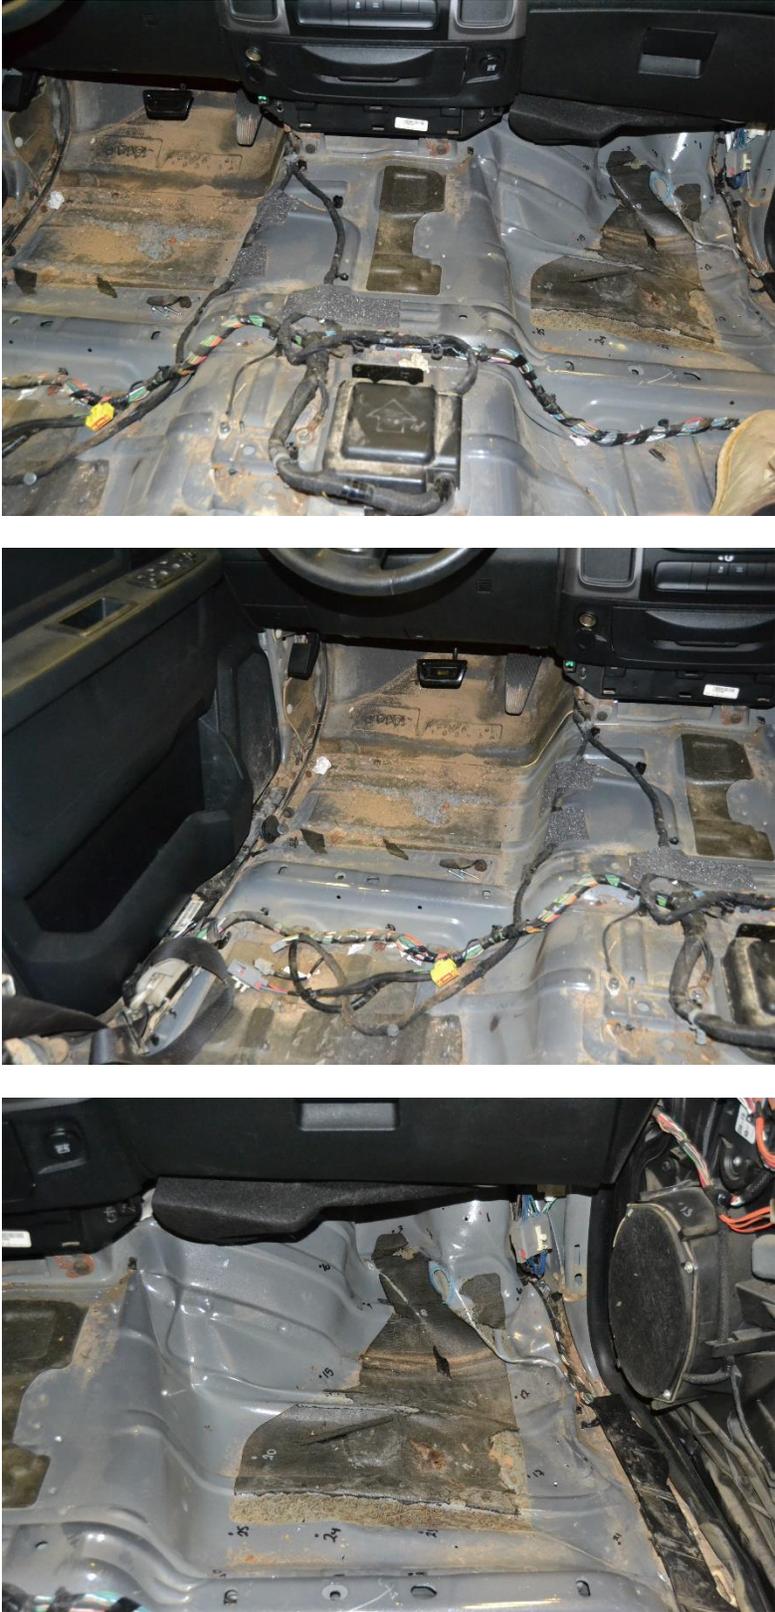
Figure 61. Occupant Compartment Damage, Test No. H42BR-2

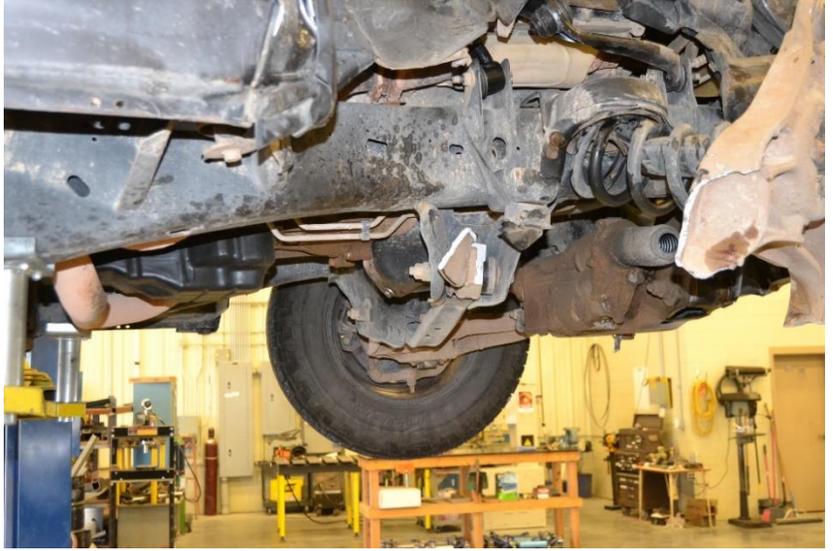
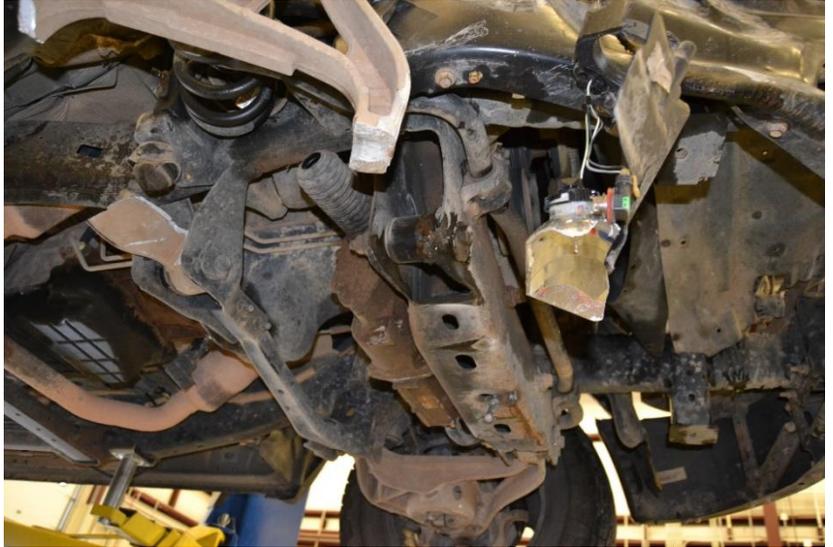
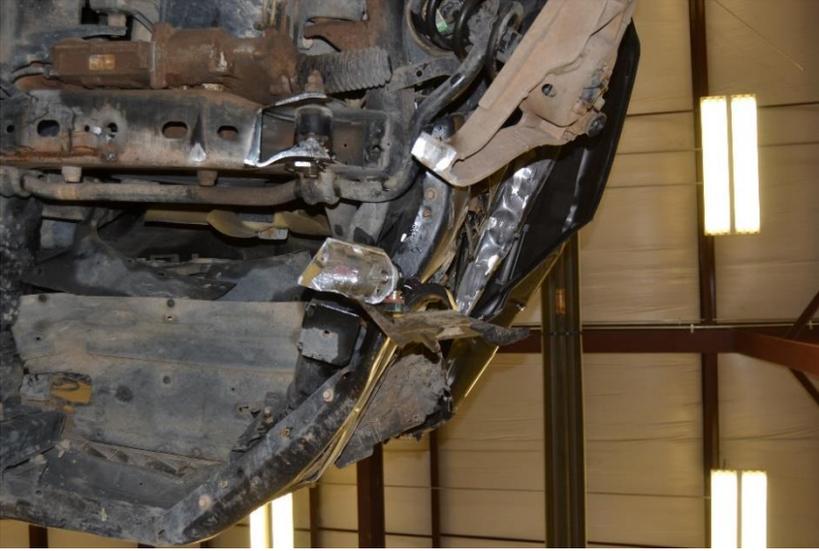
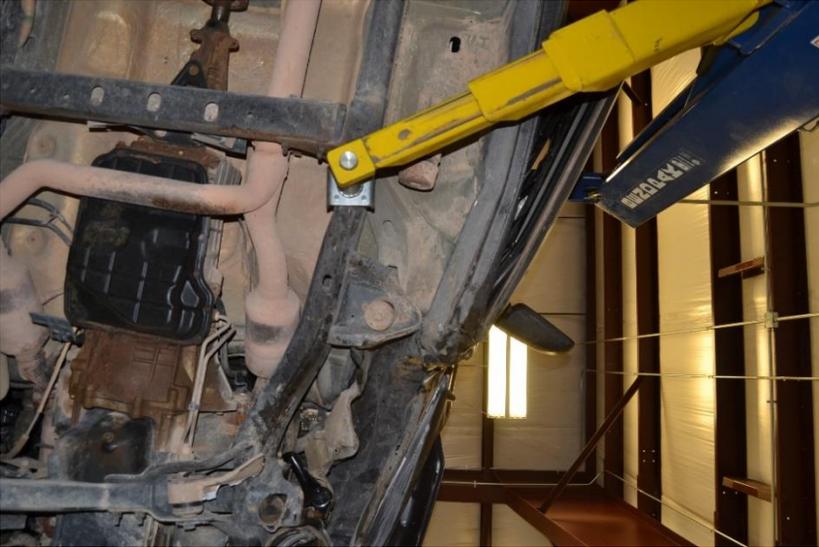
Figure 62. Undercarriage Damage, Test No. H42BR-2

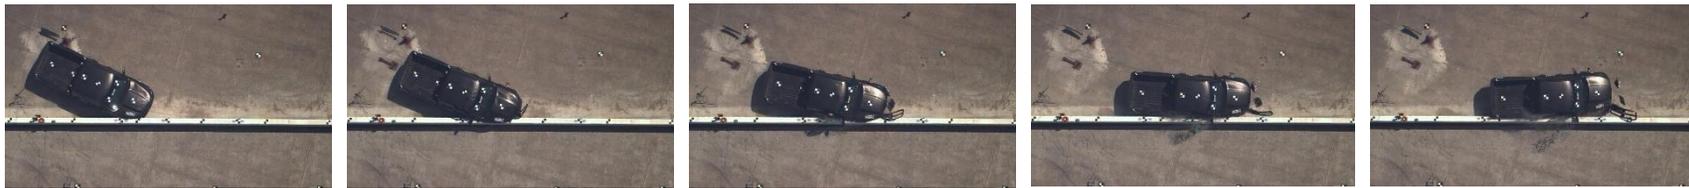
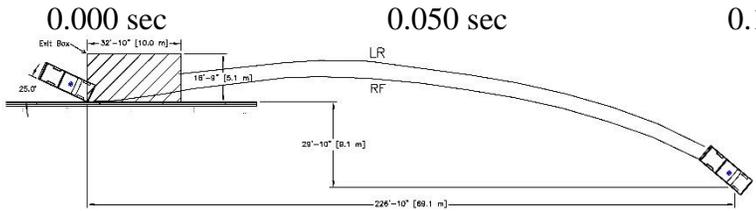
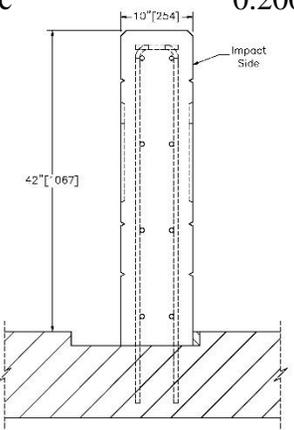
- Test Agency MwRSF
- Test Number..... H42BR-2
- Date..... August 19, 2019
- MASH 2016 Test Designation No..... 3-11
- Test Article..... HDOT 42-in. Tall, Aesthetic Concrete Bridge Rail

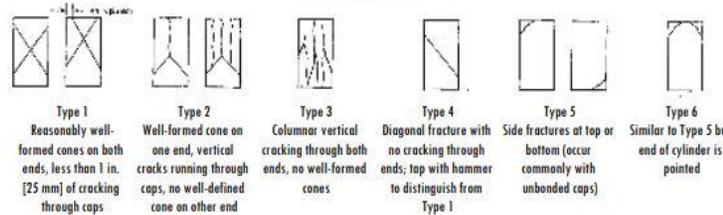
**ALFRED BENESCH & COMPANY
 CONSTRUCTION MATERIALS LABORATORY**

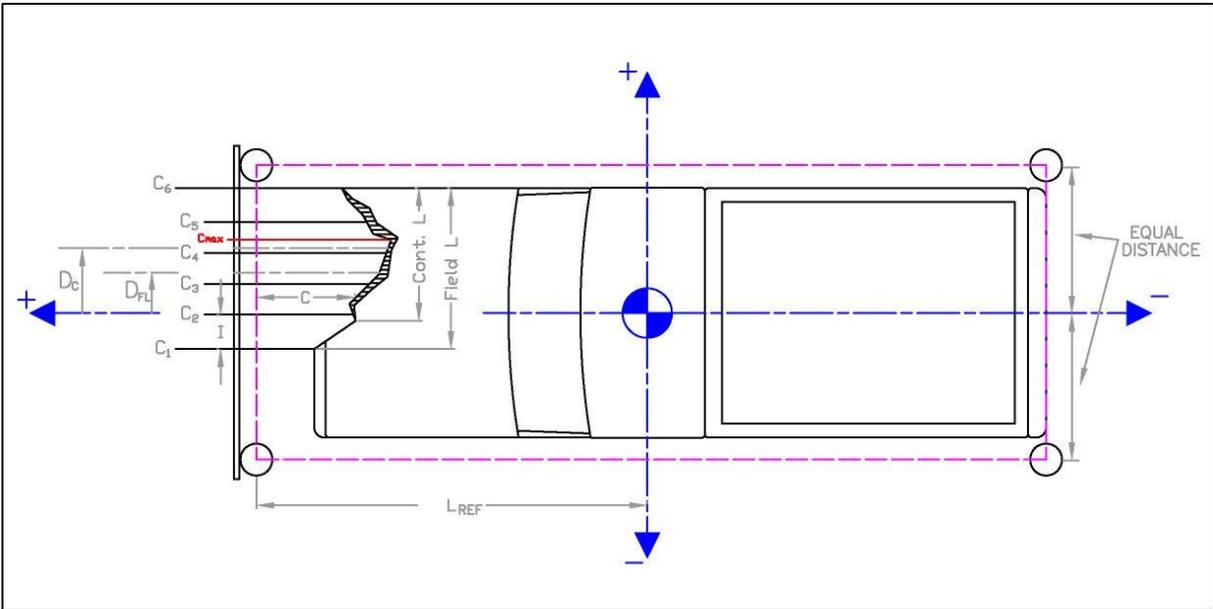
in.	(mm)
Distance from C.G. to reference line - L _{REF} :	102	(2591)
Total Vehicle Width:	77 1/2	(1969)
Width of contact and induced crush - Field L:	47	(1194)
Crush measurement spacing interval (L/5) - I:	9 3/8	(238)
Distance from center of vehicle to center of Field L - D _{FL} :	9	(229)
Width of Contact Damage:	11	(279)
Distance from center of vehicle to center of contact damage - D _C :	10 1/4	(260)

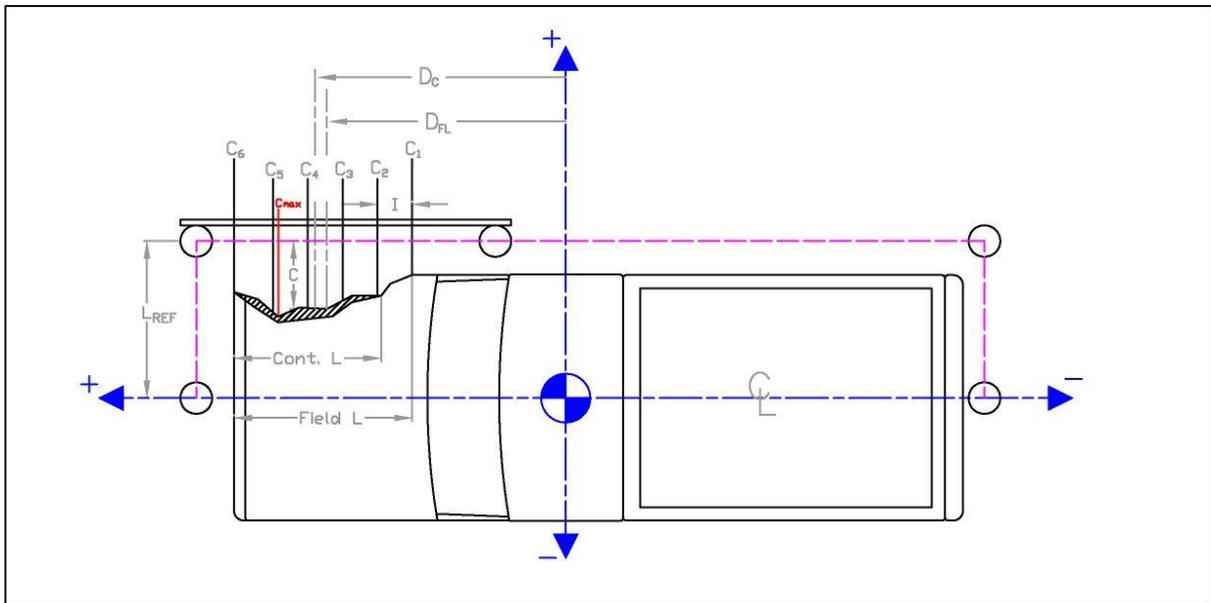
Distance from centerline to reference line - L_{REF}: 44 in. (1118) mm
Total Vehicle Length: 229 5/8 (5832)
Distance from vehicle c.g. to 1/2 of Vehicle total length: -6 5/8 (-168)
Width of contact and induced crush - Field L: 229 5/8 (5832)
Crush measurement spacing interval (L/5) - l: 45 7/8 (1165)
Distance from vehicle c.g. to center of Field L - D_{FL}: -6 5/8 (-168)
Width of Contact Damage: 229 5/8 (5832)
Distance from vehicle c.g. to center of contact damage - D_C: -6 5/8 (-168)
