Test Report No. 617231-01-1&2

MASH TL-3 EVALUATION OF LONG-SPAN W-BEAM GUARDRAIL IN FRONT OF FALL-PROTECTION FENCE

Sponsored by Washington State Department of Transportation

TEXAS A&M TRANSPORTATION INSTITUTE PROVING GROUND

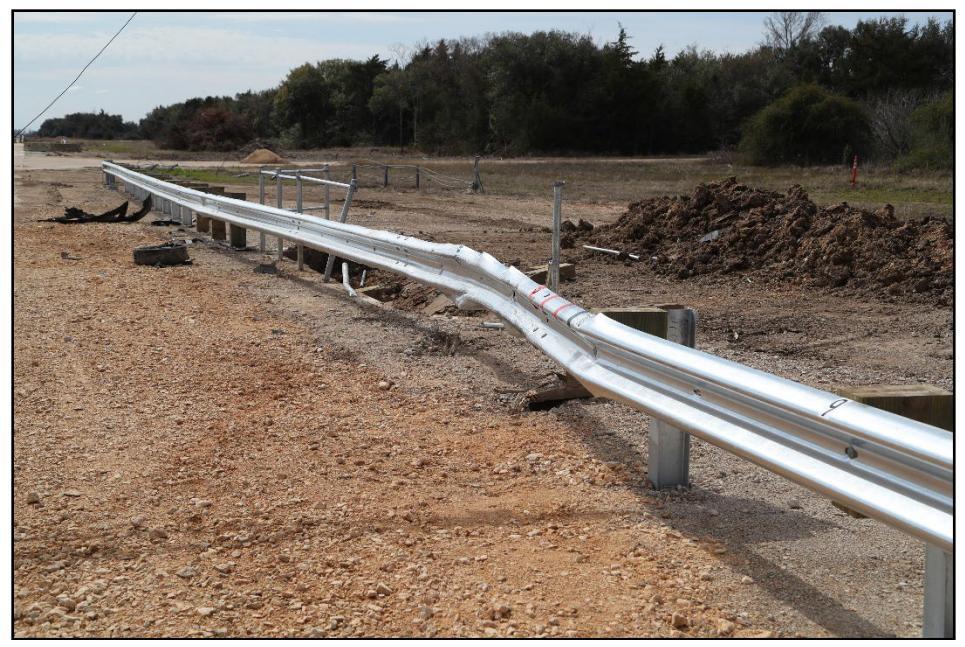
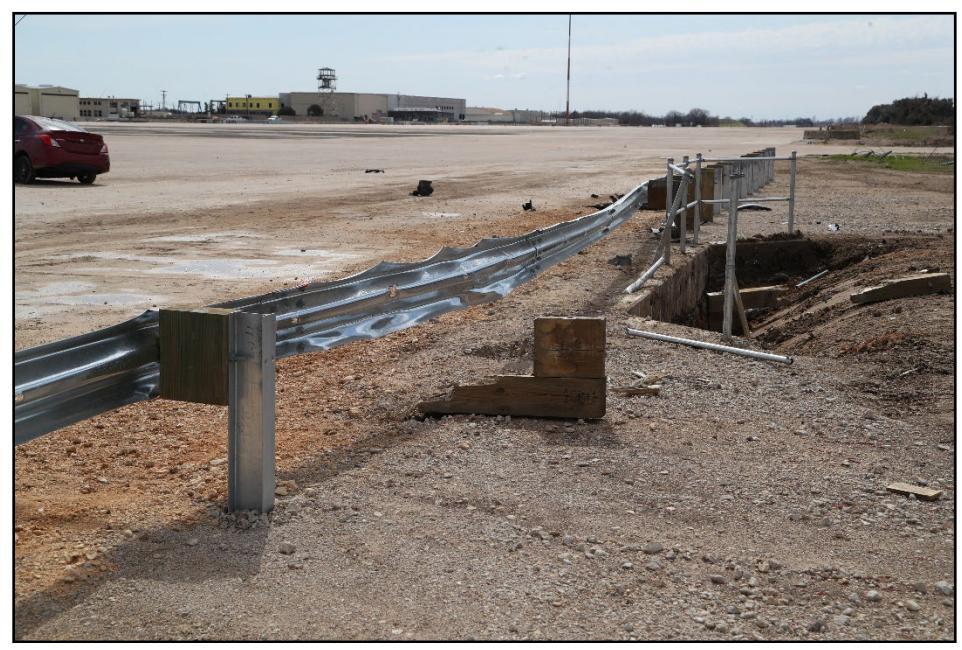
There was some soil disturbance at post 9. Post 10 had a 0.5-inch soil gap on the traffic and field sides of the post and was leaning back 1 degree from vertical. Posts 11 through 13 were broken off at grade. Post 14 had a 0.5-inch gap in the soil on the traffic side of the post and was leaning 1 degree back from vertical. The fall-protection fence was also damaged, with post 2 broken off at grade, post 3 leaning downstream, and post 4 leaning towards the field side and downstream. The rail cross members released from posts 1 through the upstream side of post 4. One cross member travelled 111 feet towards the traffic side and 322 feet downstream.

Figure 6.5. Test Installation from the Field Side at Impact Location after Test 617231-01-1.

Figure 6.6. Test Installation from the Field Side at Impact Location after Test 617231-01-1.

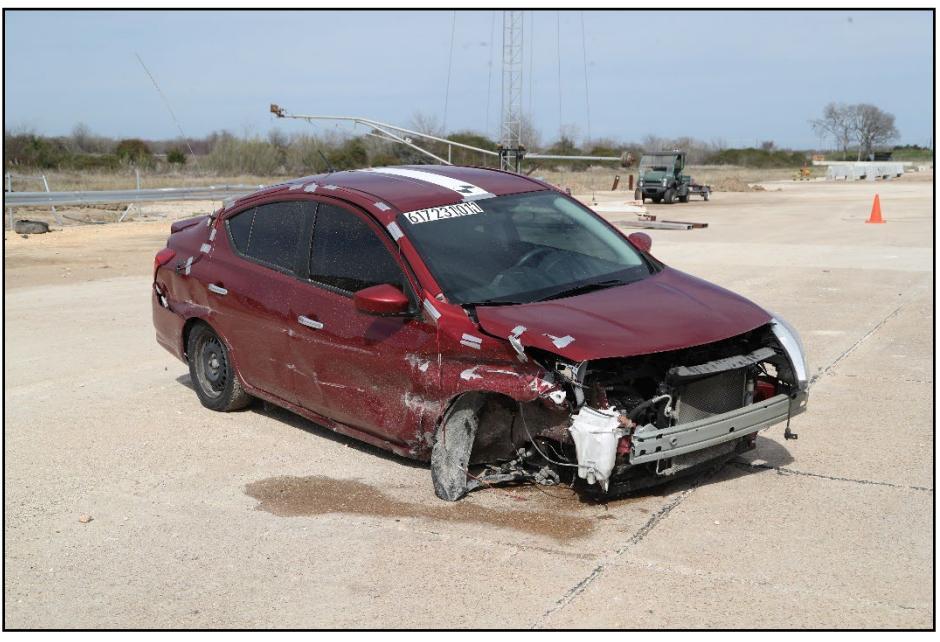
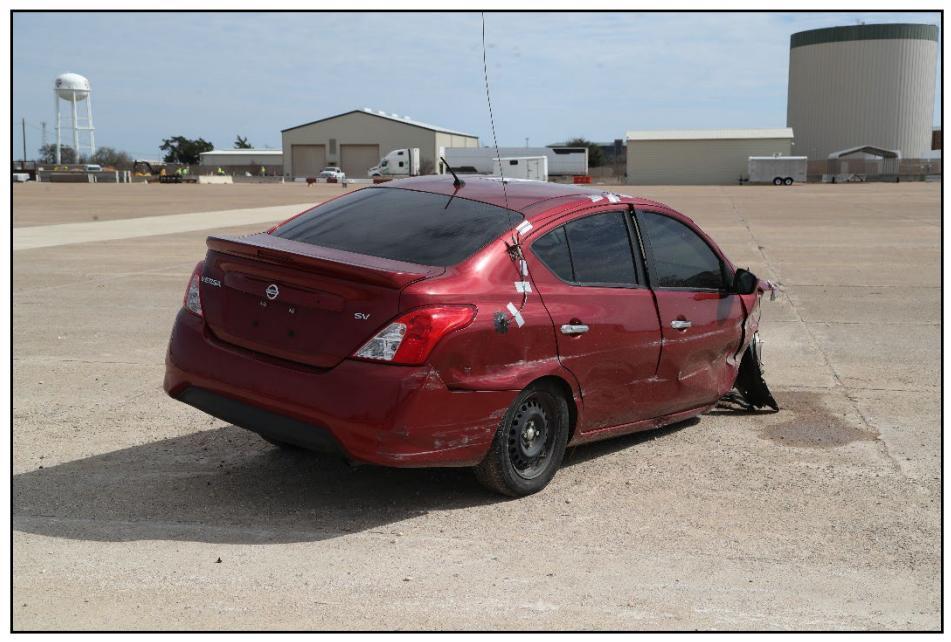
Figure 6.7. Front Impact Side of Test Vehicle after Test 617231-01-1.

Figure 6.8. Rear Impact Side of Test Vehicle after Test 617231-01-1.

Side Windows	The side windows remained intact
Maximum Exterior Deformation	10 inches in the front plane at the right front corner at bumper height
VDS	01RFQ3
CDC	01FREW2
Fuel Tank Damage	None
Description of Damage to Vehicle:	The front bumper, hood, grill, right headlight, right front quarter fender, right front tire and rim, right front strut and tower, right lower control arm, right CV shaft and joints, right front and rear door, right rear quarter fender, rear bumper, front rack and pinion, steering shaft, and right rocker panel were damaged. The right front door had a 1.5-inch gap at the top.

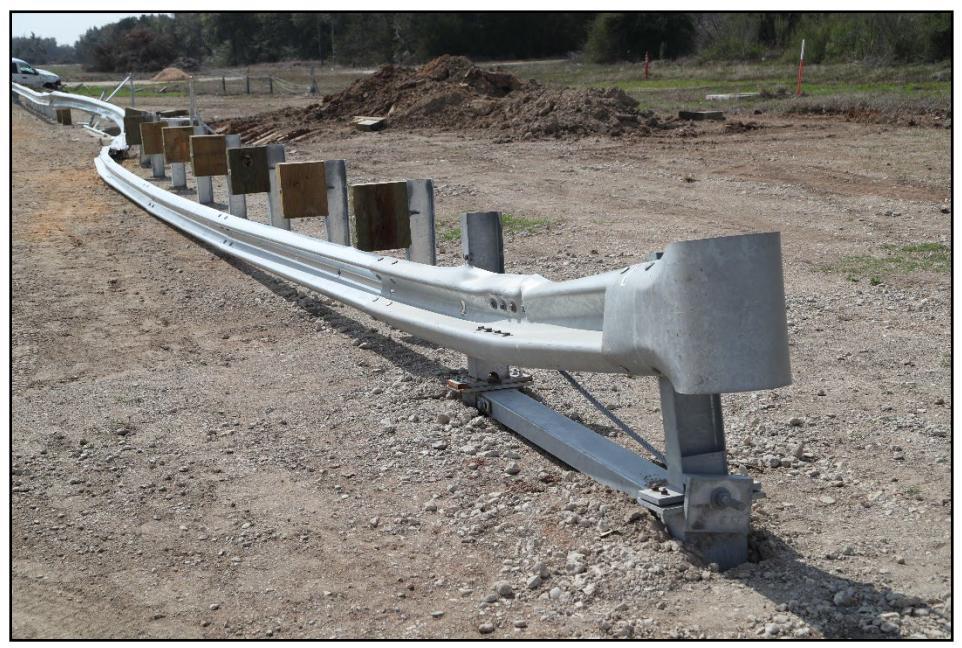
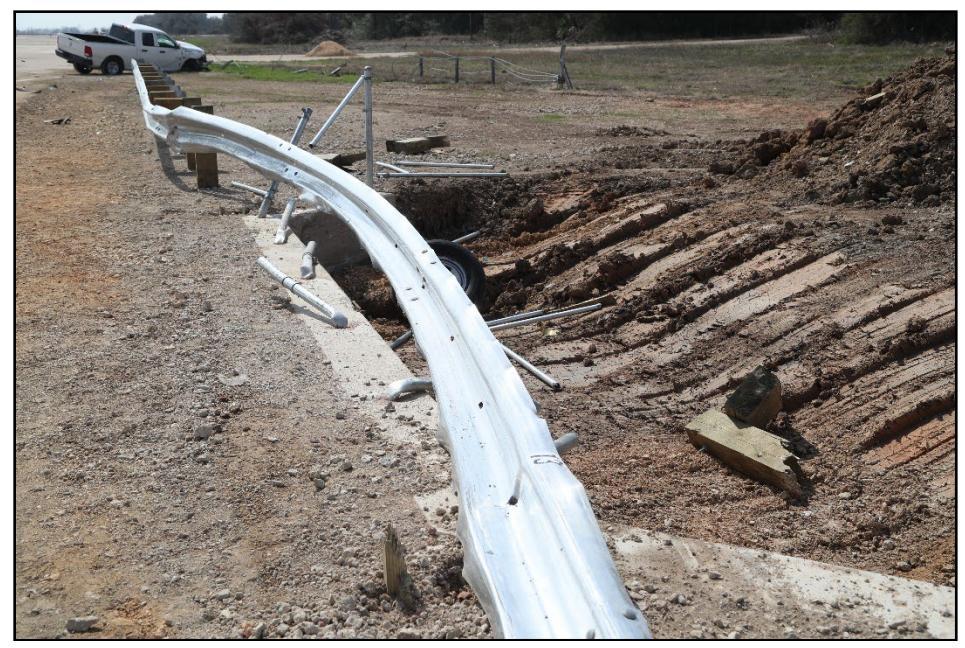
The rail released from post 2 through 17. Posts 8 and 9 were twisted clockwise, posts 11 through 14 broke off at grade, and post 15 was split at the guardrail bolt. Handrail posts 2 through 7 were bent over and their crossmembers released from the posts. Table 7.6 presents the soil gap around the posts and the post lean after the crash test. Table 7.7 presents the deflection and working width of the Long-Span Guardrail. Figure 7.5 and Figure 7.6 show the damage to the test installation.

Figure 7.5. Overall View of Test Installation after Test 617231-01-2.

Figure 7.6. Long-Span Guardrail at the Maximum Permanent Deformation after Test 617231-01-2.

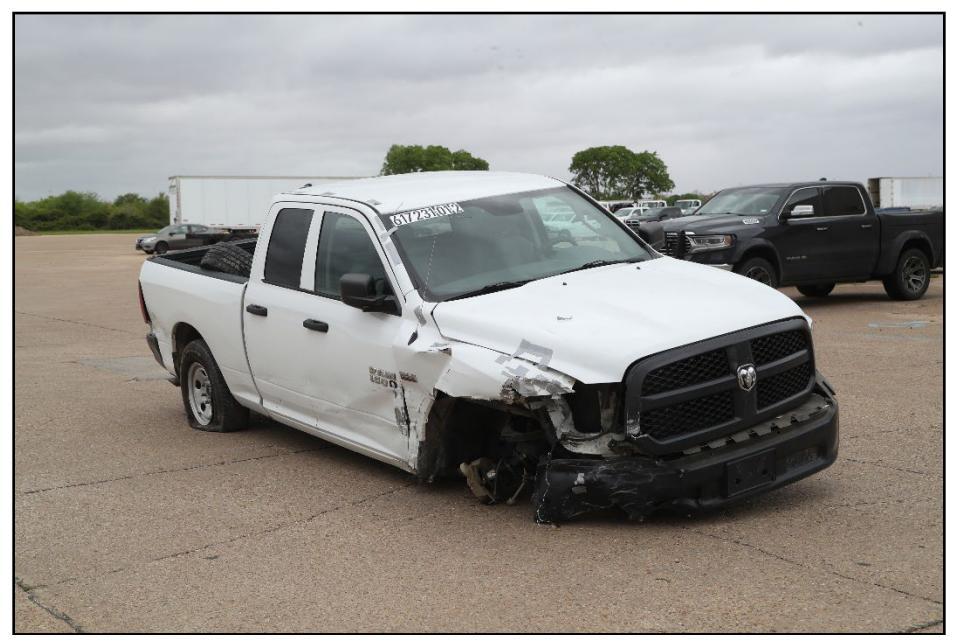
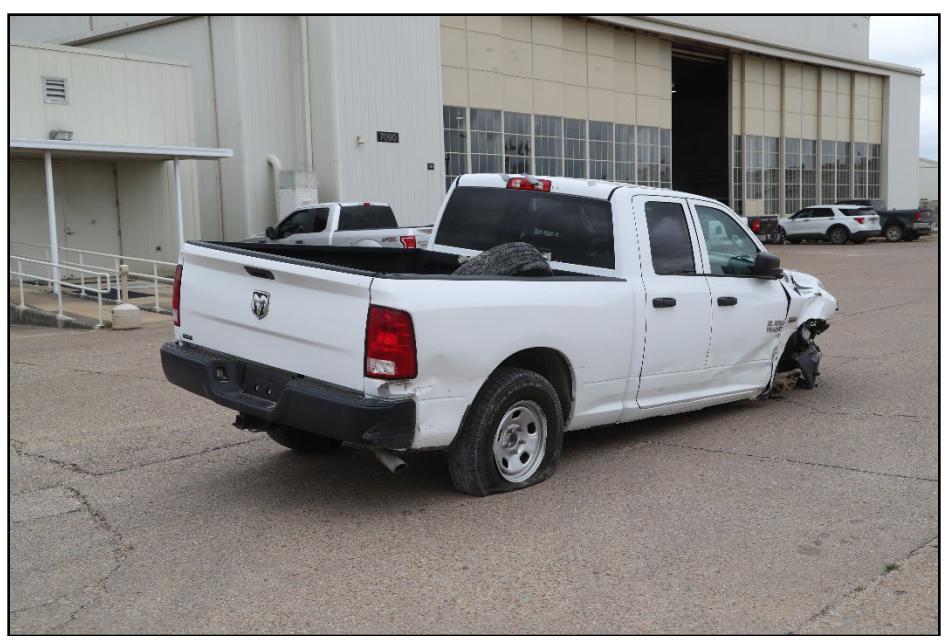
Figure 7.7. Front Impact Side of Test Vehicle after Test 617231-01-2.

Figure 7.8. Rear Impact Side of Test Vehicle after Test 617231-01-2.

Side Windows	The side windows remained intact	
Maximum Exterior Deformation	12 inches in the front plane at the right front corner at bumper height	
VDS	01RFQ3	
CDC	01FREW2	
Fuel Tank Damage	None	
Description of Damage to Vehicle:	The front bumper, hood, grill, right headlight, right front quarter fender, right frame rail, right front tire and rim, right upper and lower control arms, right front tire and rim, sway bar and tie rod end, right front door, right rear door, right cab corner, right rear quarter fender, right rear tire and rim, and rear bumper were damaged. The right front door had a 0.5-inch gap at the top of the door.
