TECHNICAL MEMORANDUM

Contract No.: T4541-AO
Report No.: 405160-12
Project Name: Steel Posts Over Underground Structures
Sponsor: Pooled Fund

DATE: January 29, 2009

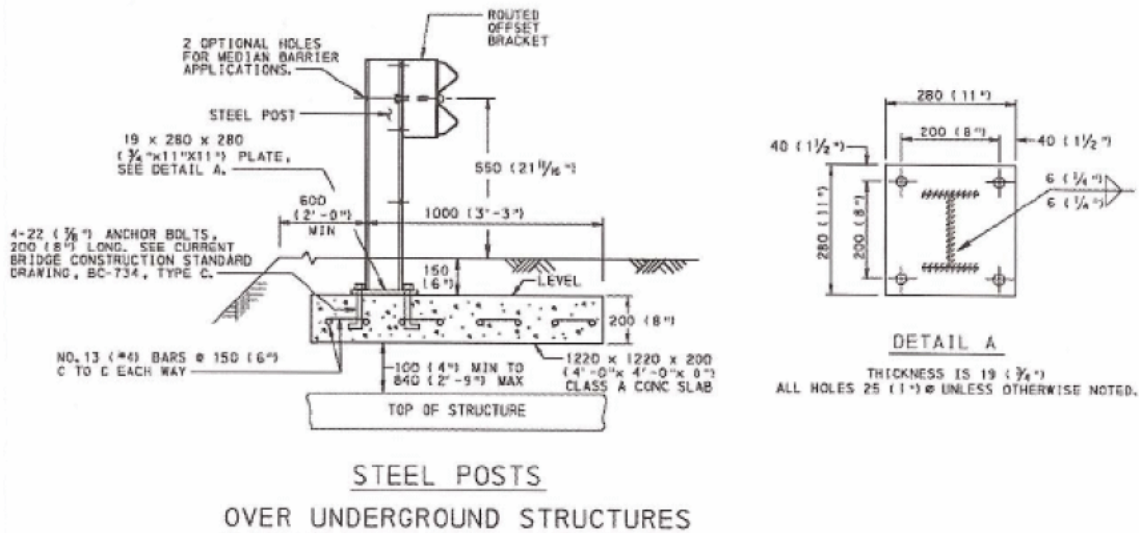
Figure 1. Steel Post Over Underground Structures.

For guardrail installations across low-fill culverts, small structures, or underground obstructions where proper post embedment cannot be achieved, either long span guardrail or steel post over underground structures similar to the details shown in figure 1 are desirable.

The details shown in figure 1 would allow for the guardrail post to be anchored to a shallow foundation that is constructed on top of the obstruction. However, physical crash testing of the details shown in this figure according to National Cooperative Highway Research Program (NCHRP) *Report 350* Test Level 3 requirements has not been performed. Moment slabs can become an expensive alternative to most local municipalities that might use a detail such as the one shown in figure 1. Therefore, there is a need for a more cost-effective design for this situation.

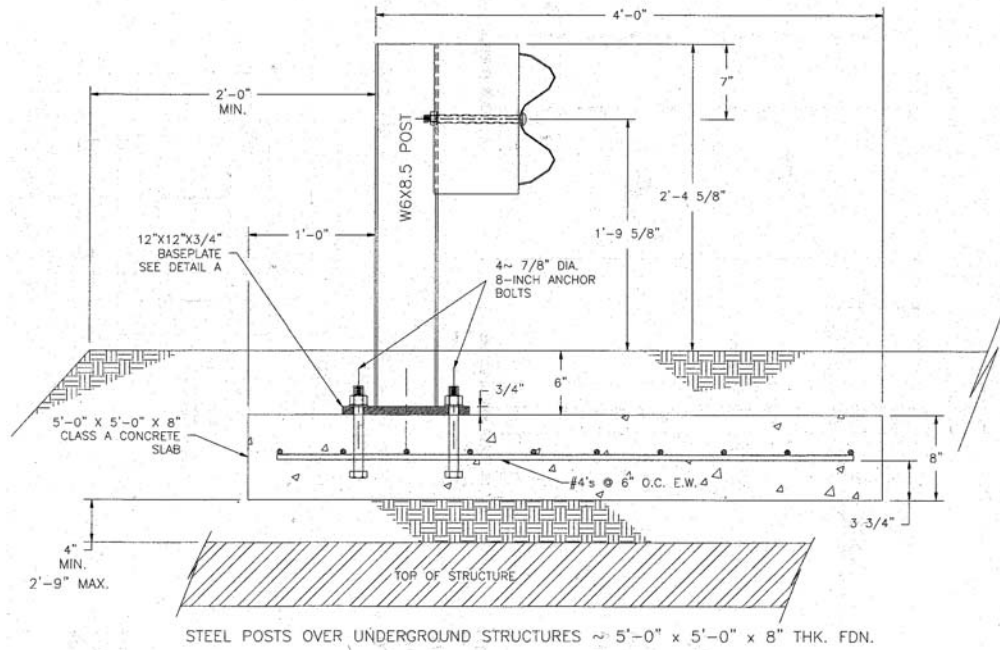
Figure 2. 5 ft x 5 ft Footing Cross-Section.

Several design options were analyzed. One option utilizing a 5 ft x 5 ft square footing was recommended for full scale pendulum testing. Details of this design are presented in figures 2 and 3. Based on the performance of this design, a 4 ft x 4 ft square footing was also a testing option.

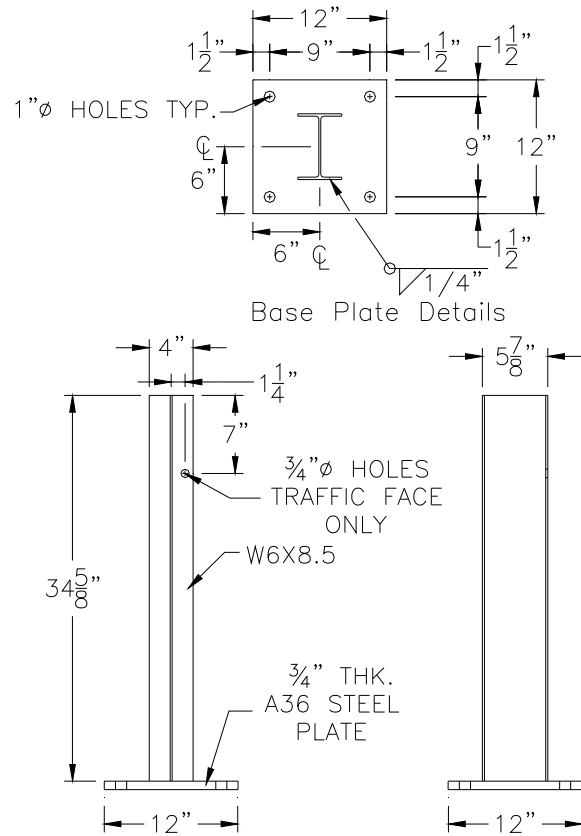
Figure 3. Steel Post Details.

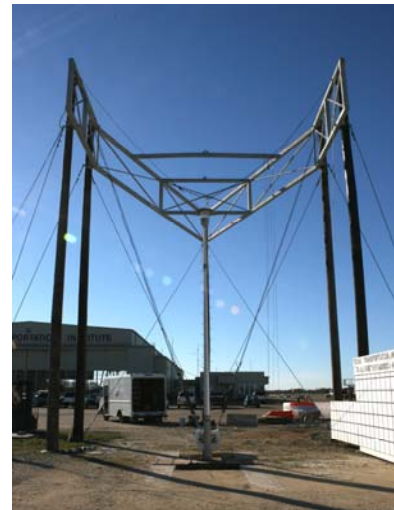
The test articles for this project were tested at Texas Transportation Institute (TTI) Proving Ground outdoor pendulum testing facility. The pendulum bogie, built according to the specifications of the Federal Outdoor Impact Laboratory's (FOIL) pendulum, and the testing area are shown in the adjacent figure. Frontal crush of the aluminum honeycomb nose of the bogie simulates the crush of an actual vehicle and the sweeper plate, constructed of steel angles and a steel plate, is attached to the body of the pendulum with a ground clearance of 6 inches to replicate roughly an automobile's undercarriage. The crushable nose configuration is the FOIL ten stage bogie nose. Cartridges of expendable aluminum honeycomb material of differing densities are placed in a sliding nose. For this project, the pendulum impacted the two steel posts mounted to the shallow concrete footings at a target speed of 22 mph and at a height of 20.5 inches above the ground. This height closely represents the bumper height of a small passenger car. After a test, the honeycomb material is replaced and the bogie is reused. A sketch of the honeycomb configuration used for the pendulum bogie is shown in Appendix A. Testing was performed in accordance with *NCHRP Report 350* and a brief description of the procedures is presented in Appendix B.

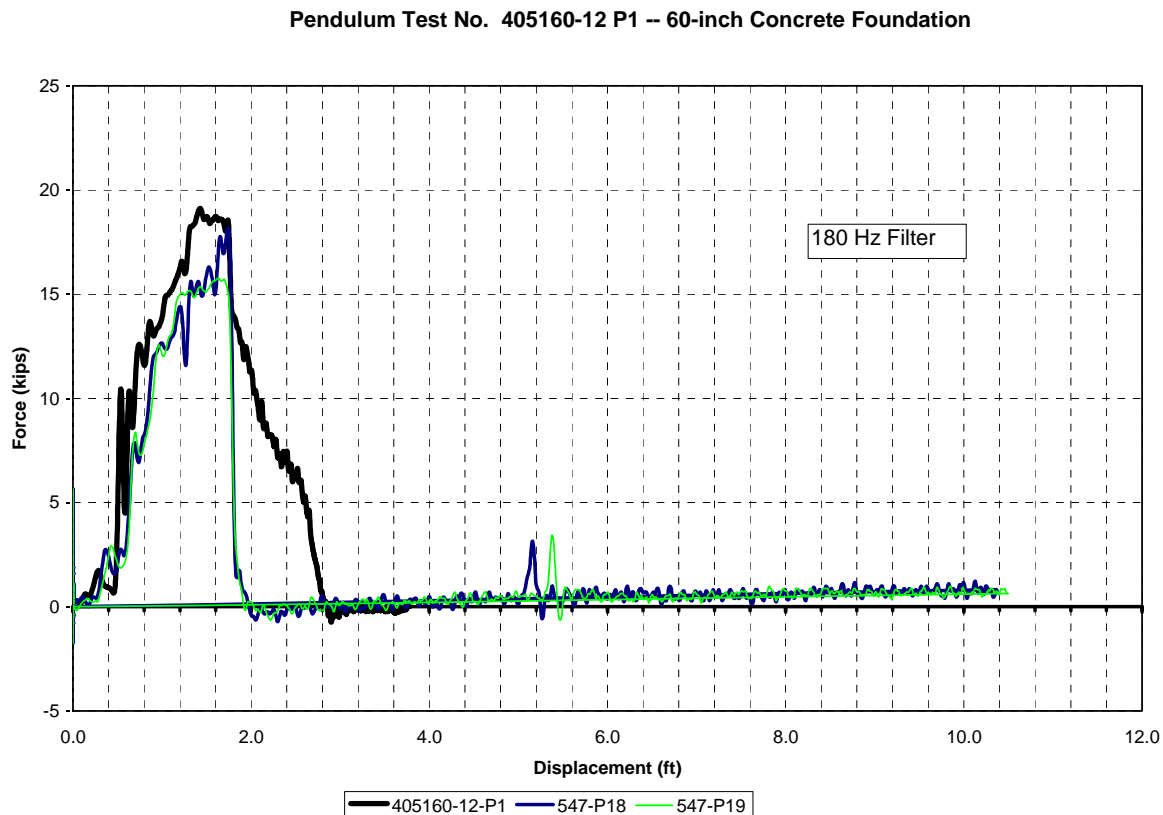
Figure 4. Force versus displacement comparison for post on 5 ft x 5 ft slab and posts in strong soil.

A comparison was made between the posts and concrete foundations tested for this project and standard W-beam guardrail line posts embedded in strong soil. Two pendulum tests were performed on W6x8.5 steel posts embedded in *NCHRP Report 350* strong soil and embedded approximately 43.4 inches (TTI Project 220547). For both tests, the center height of the pendulum was 18.0 inches above grade. Figure 4 shows the force versus displacement for the W6x8.5 post anchor to the 5 ft by 5 ft concrete foundation along with the force versus displacement curves obtained for the W6x8.5 steel post embedded in strong soil for Project 220547. Figure 5 shows the force versus displacement for the W6x8.5 steel post anchored to the 4 ft by 4 ft concrete foundations. The force versus displacement for the same W6x8.5 line posts used in Figure 5 are also shown. The force versus displacement curves for both posts tested for this project compared very closely to the force versus displacement curves for the W6x8.5 steel posts embedded 43.4 inches in strong soil.

The posts anchored to the footings exhibited greater strength than those tested in strong soil over 0 to 2 ft of displacement. The dynamic rotation of the 5 ft x 5 ft footing was approximately 30 degrees and greater than 30 degrees for the 4 ft x 4 ft footing tested for this project. The dynamic rotation of the 4 ft x 4 ft footing and post was deemed undesirable since the footing came to rest approximately 6 inches above grade surface. Based on the results of this testing, the W6x8.5 steel post anchored to the 5 ft by 5 ft concrete footing is recommended for use in cases where a single post in a guardrail length of need interferes with an underground obstruction. A full-scale crash test should be performed to validate the performance where multiple posts in succession anchored to shallow 5 ft by 5 ft concrete footing as tested herein is required.

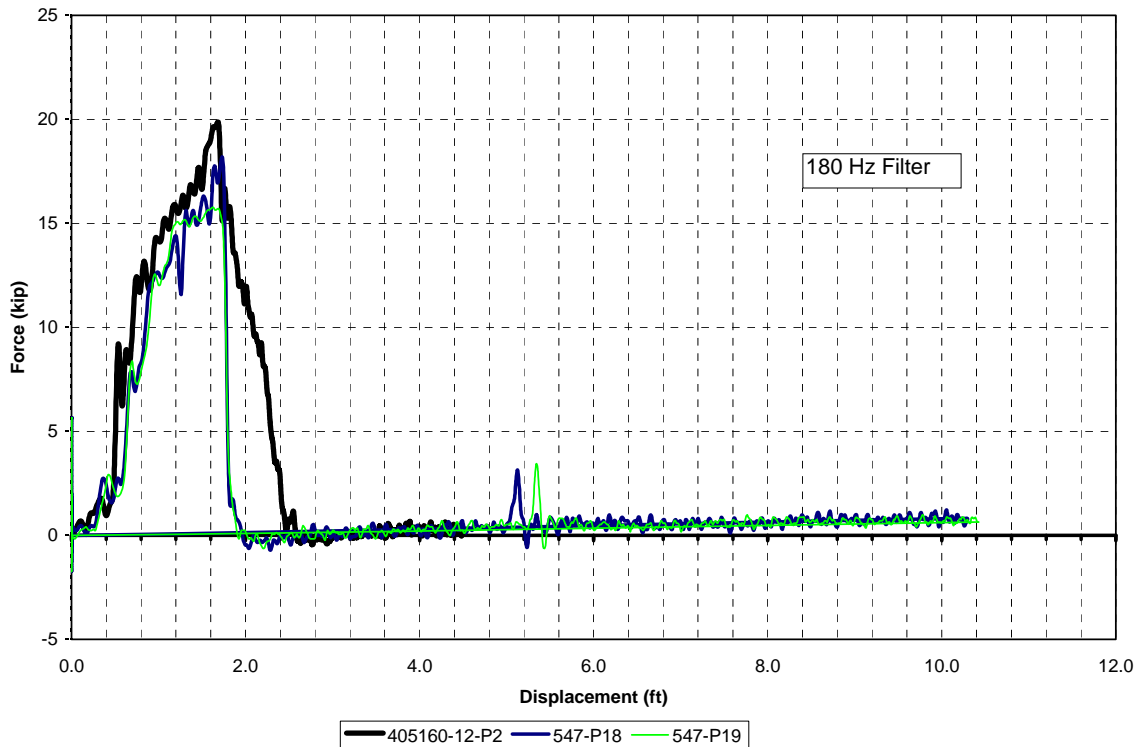
Pendulum Test No. 405160-12 P2 -- 48-inch Concrete Foundation

Figure 5. Force versus displacement comparison for post on 4 ft x4 ft slab and posts in strong soil.

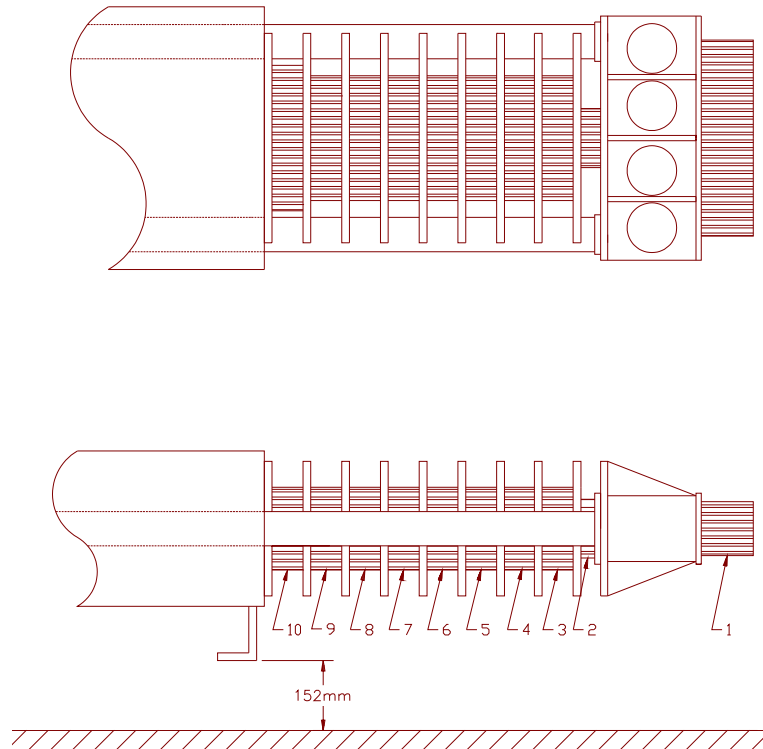
Configuration of pendulum nose and honeycomb.

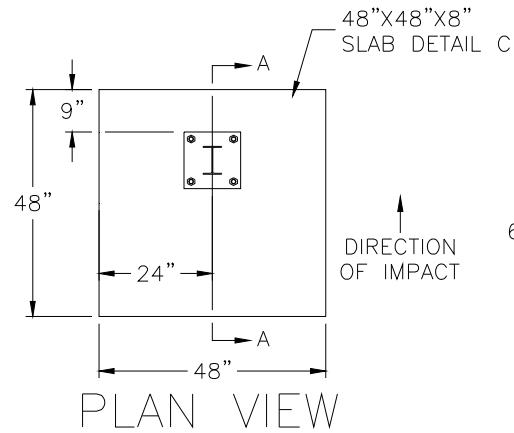
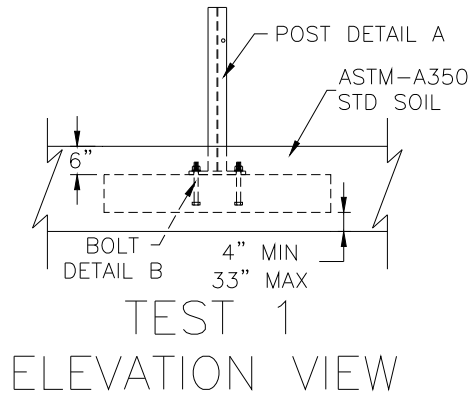
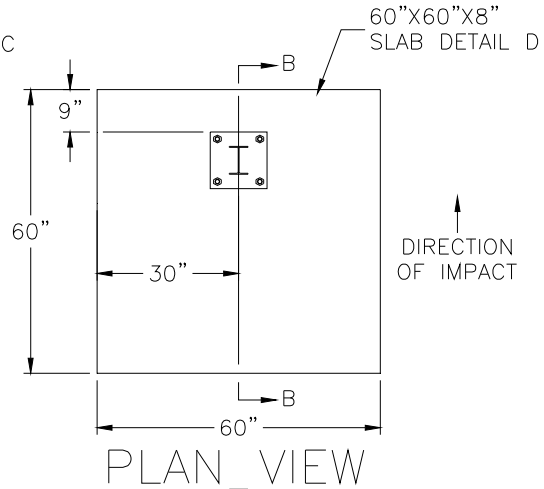
A high-speed digital camera, positioned perpendicular to the path of the pendulum bogie and the test article, was used to record the collision period. The film from this high-speed camera was analyzed on a computer to observe phenomena occurring during the collision and to obtain time-event, displacement, and angular data. A mini-DV camera and still cameras were used to document the crushable pendulum nose and the test article before and after the test.

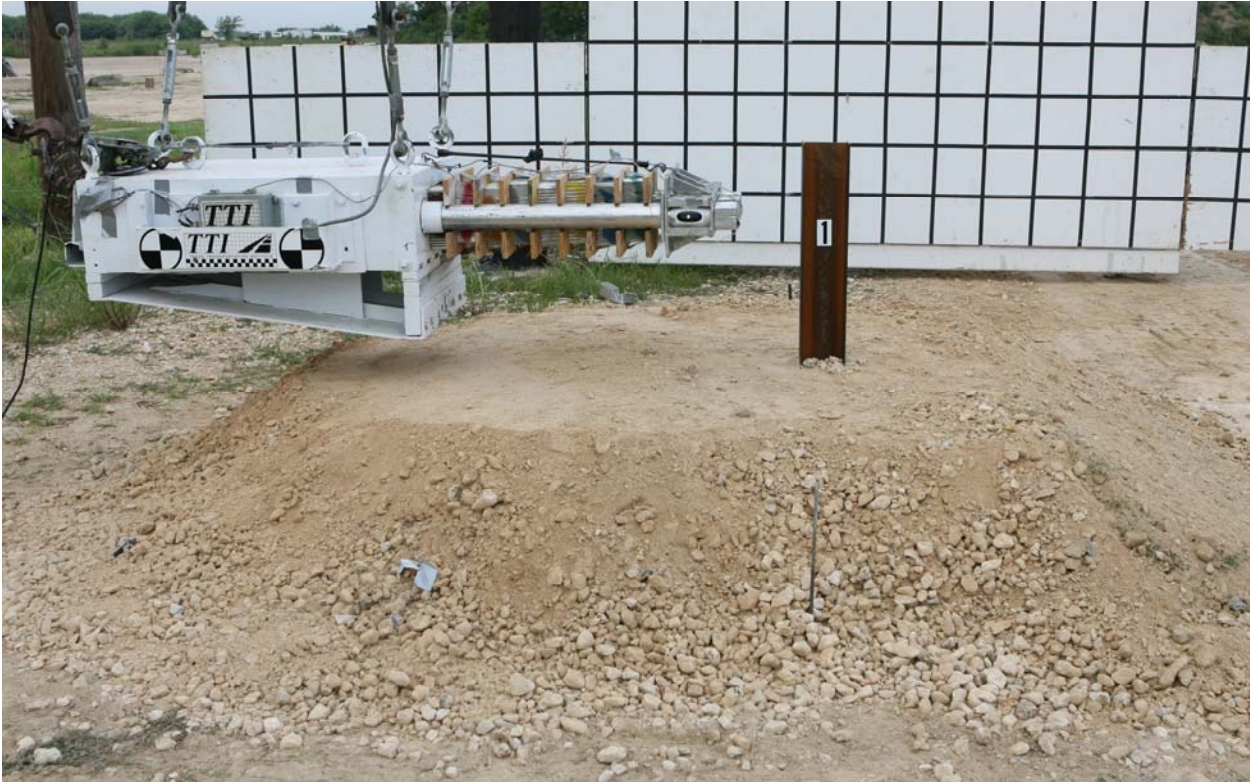
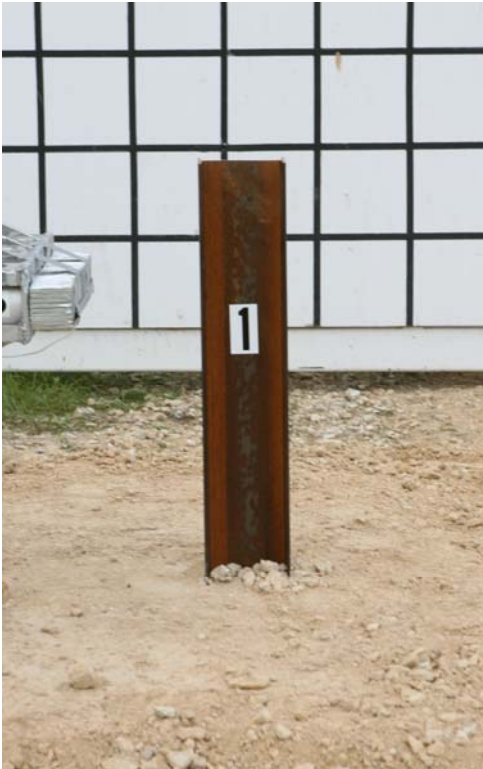
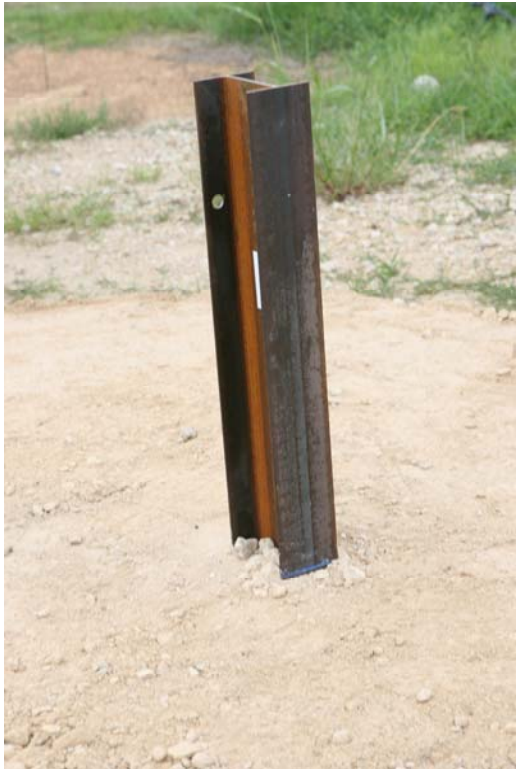
Figure D1. Steel posts over underground structure with 60-inch concrete footing before test 405160-12 P1.

Maximum rise of the nose of the pendulum during the test was 24.1 inches, and maximum crush of the honeycomb nose of the pendulum was 10.1 inches. Photographs of the installation before and after the test, are shown in Appendix D, figures D1 through D2.

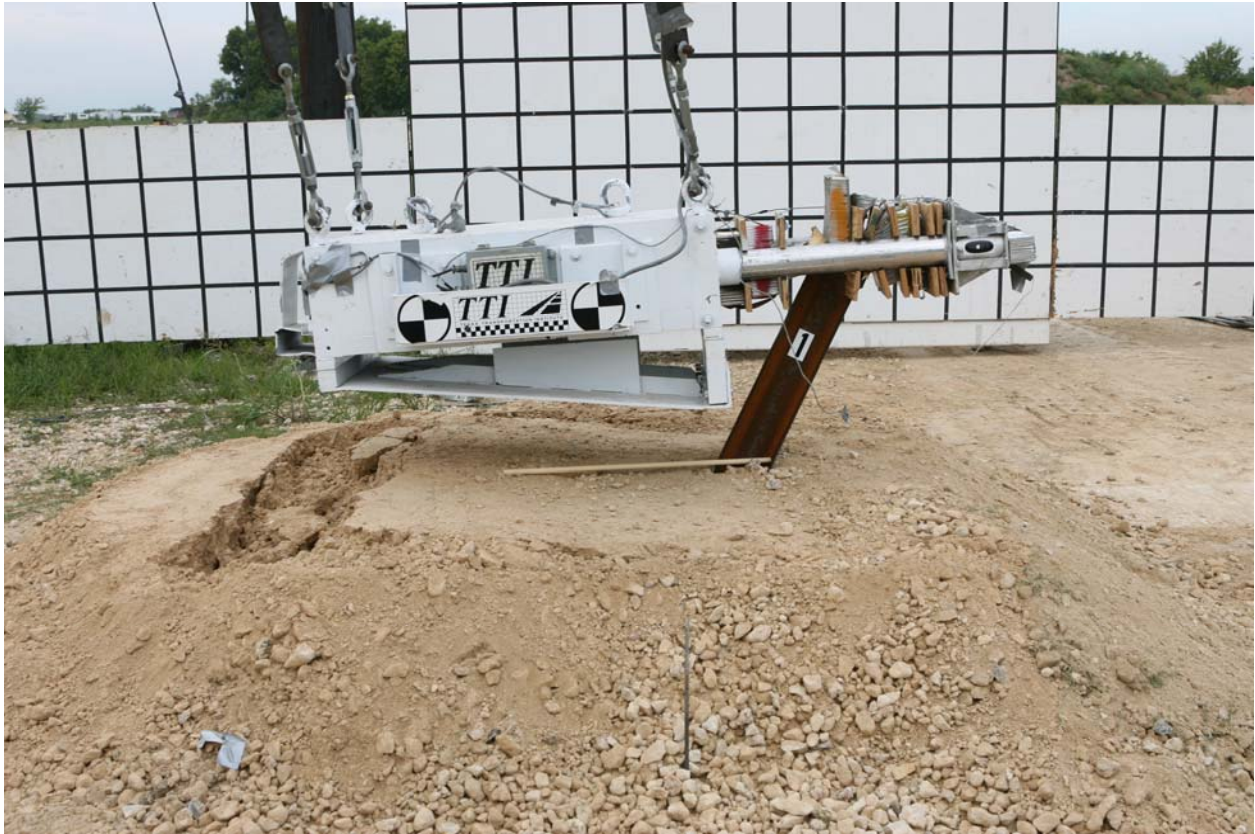
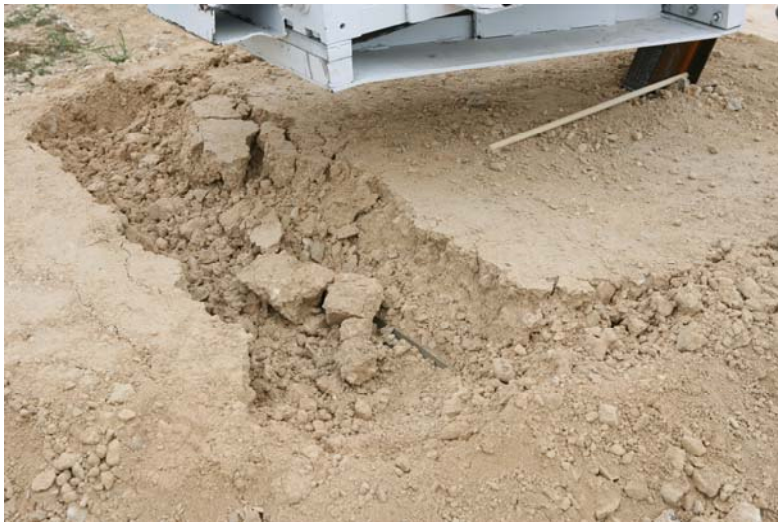
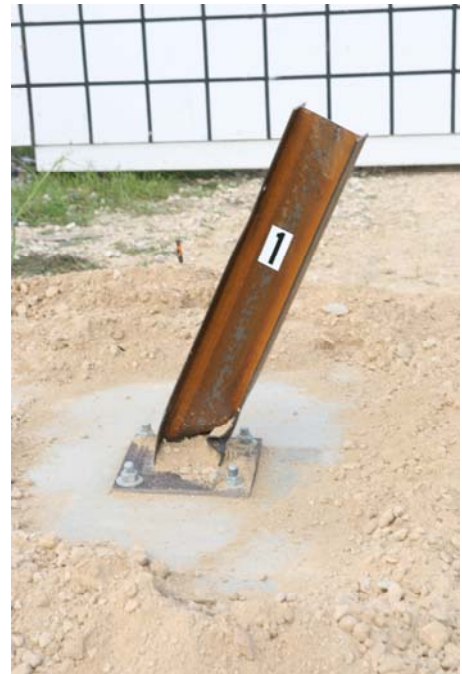
Figure D2. Steel posts over underground structure with 60-inch concrete footing after test 405160-12 P1.

The pendulum bogie, traveling at an impact speed of 21.6 mi/h (34.7 km/h), impacted the guardrail post with the centerline of the pendulum nose aligned with the centerline of the steel post. The center height of the nose was 20.5 inches above finished grade. At 0.005 s, the steel post began to deform, and at 0.046 s, the concrete footing began to lift up in the soil. The pendulum bogie lost contact with the steel post at 0.155 s, and exit speed at loss of contact was 8.5 mi/h. At 0.260 s, the concrete footing began to rotate, and at 0.352 s, the base of the pendulum contacted the post. The pendulum bogie came to rest on top the steel post at 0.994 s. Maximum dynamic deflection of the steel post during the test was 20.0 inches, and the final deformation of the steel post was approximately 12.25 inches. The footing was moved as a result of the pendulum impact on the post. The leading edge of the footing (traffic face edge) was uplifted and came to rest approximately 3.0 inches above the grade surface. After the test, no visible distress was observed in the concrete footing, post baseplate, or anchor bolts.

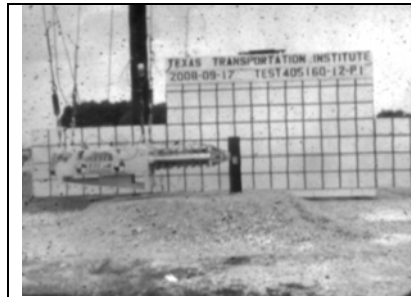
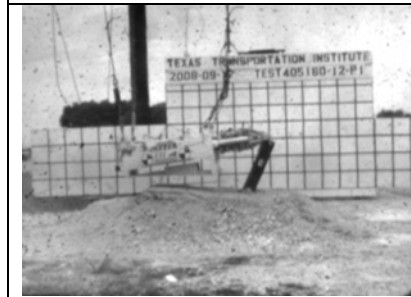
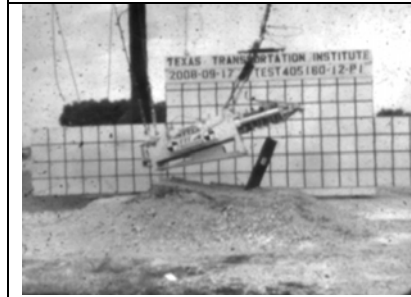
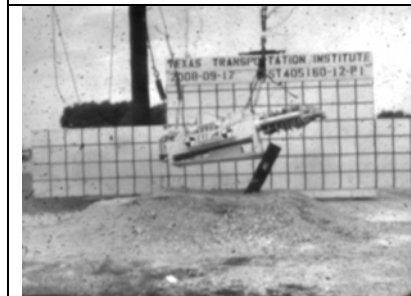
Table D1. Summary of results for pendulum test 405160-12 P1.

0.000 s

0.146 s

0.289 s

0.434 s

Impact Velocity
 Longitudinal direction..... 24.6 ft/s (7.5 m/s)
 Ridedown Accelerations
 Longitudinal direction..... -3.6 g's

Maximum Change in Velocity 19.2 ft/s

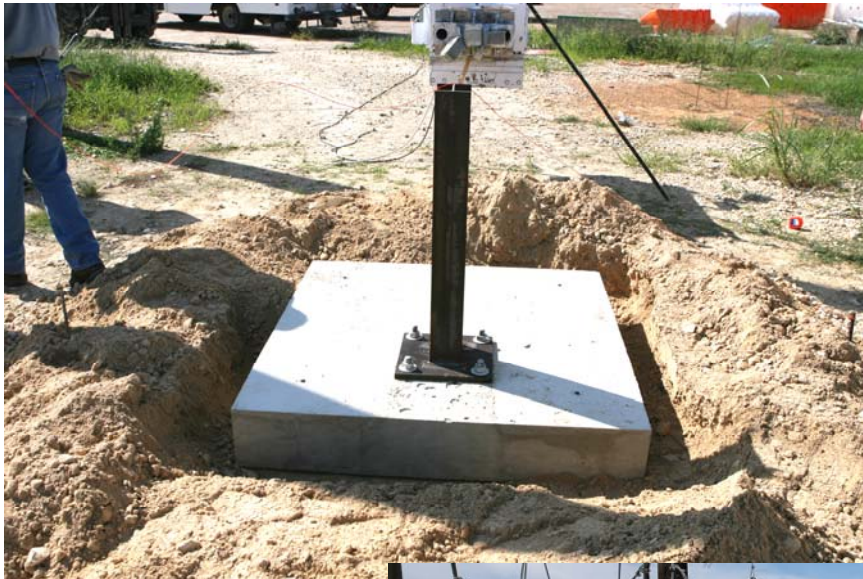
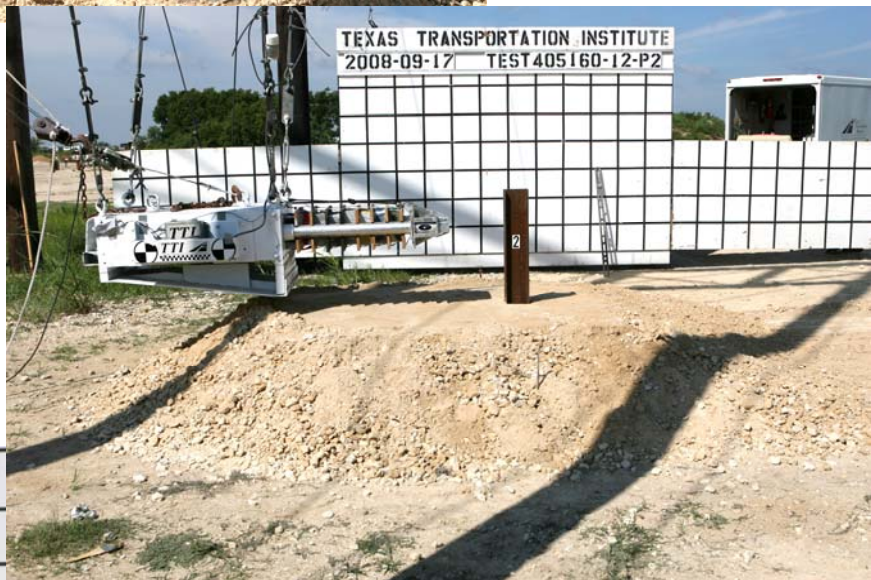
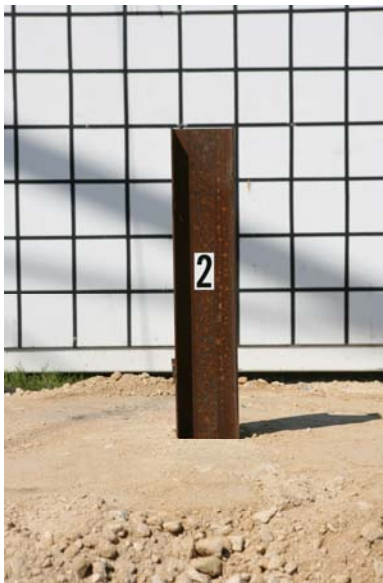
Figure D3. Steel posts over underground structure with 48-inch concrete footing before test 405160-12 P2.

Maximum deflection of the steel post during the test was 29.1 inches, and the final deformation of the post was approximately 6.5 inches. The footing was moved as a result of the pendulum impact on the post. The leading edge of the footing (traffic face edge) was uplifted and came to rest approximately 6.0 inches above the grade surface. After the test, no visible distress was observed in the concrete footing, post baseplate, or anchor bolts. Maximum rise of the nose of the pendulum during the test was 23.6 inches, and maximum crush of the honeycomb nose of the pendulum was 10.7 inches. Photographs of the installation before and after the test are shown in Appendix D, figures D3 through D4.

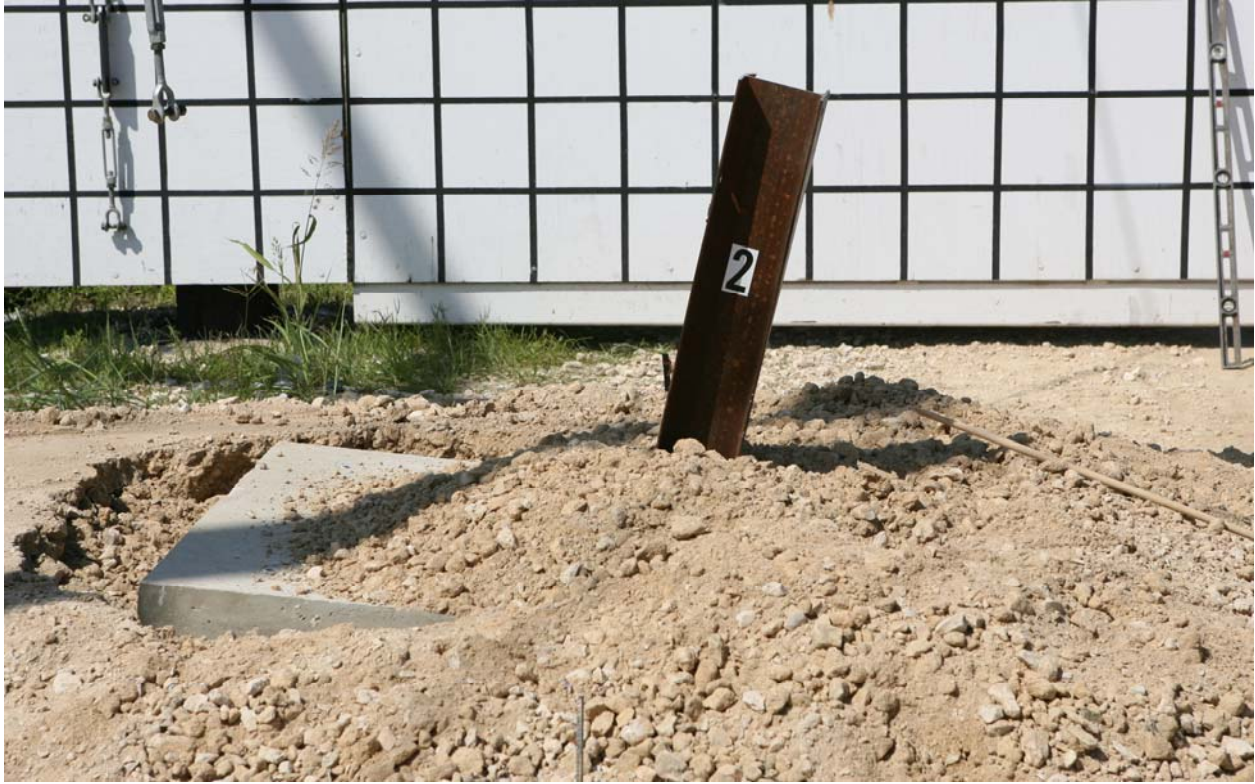
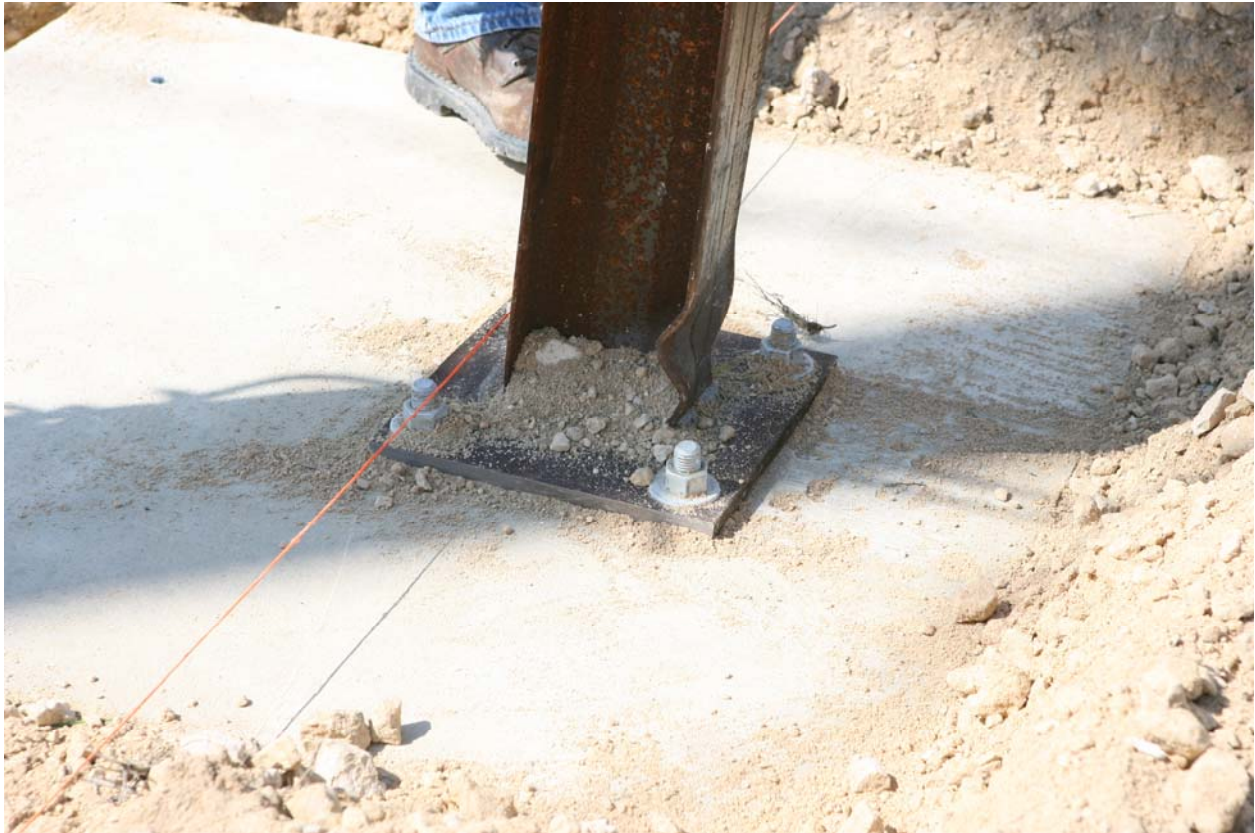
Figure D4. Steel posts over underground structure with 48-inch concrete footing after test 405160-12 P2.

The pendulum bogie, traveling at an impact speed of 21.5 mi/h (34.6 km/h), impacted the guardrail post with the centerline of the pendulum nose aligned with the centerline of the steel post. The height of the nose was measured at 20.5 inches. At 0.020 s, the steel post began to deform, and at 0.032 s, the concrete footing began to lift up in the soil. The pendulum bogie lost contact with the steel post at 0.144 s, and exit speed at loss of contact was 7.8 mi/h. The base of the pendulum contacted the steel post at 0.332 s, and then loses contact with the steel post at 0.398 s. At 0.537 s, the base contacted the steel post again, and at 0.562 s, the pendulum went over the steel post.

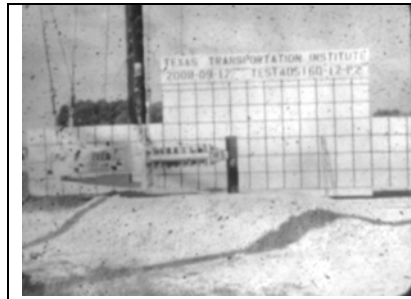
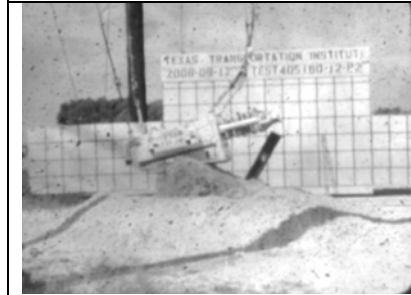
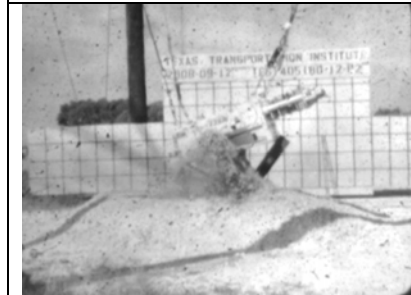
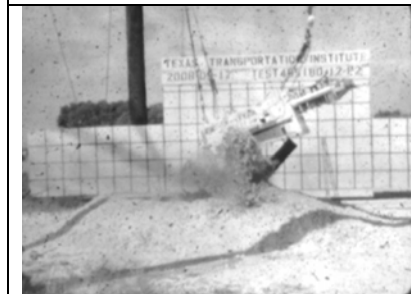
Table D2. Summary of results for pendulum test 405160-12 P2.

0.000 s

0.178 s

0.351 s

0.535 s

Impact Velocity
 Longitudinal direction..... 20.7 ft/s (6.3 m/s)
 Ridedown Accelerations
 Longitudinal direction..... -2.9 g's

Maximum Change in Velocity 20.1 ft/s

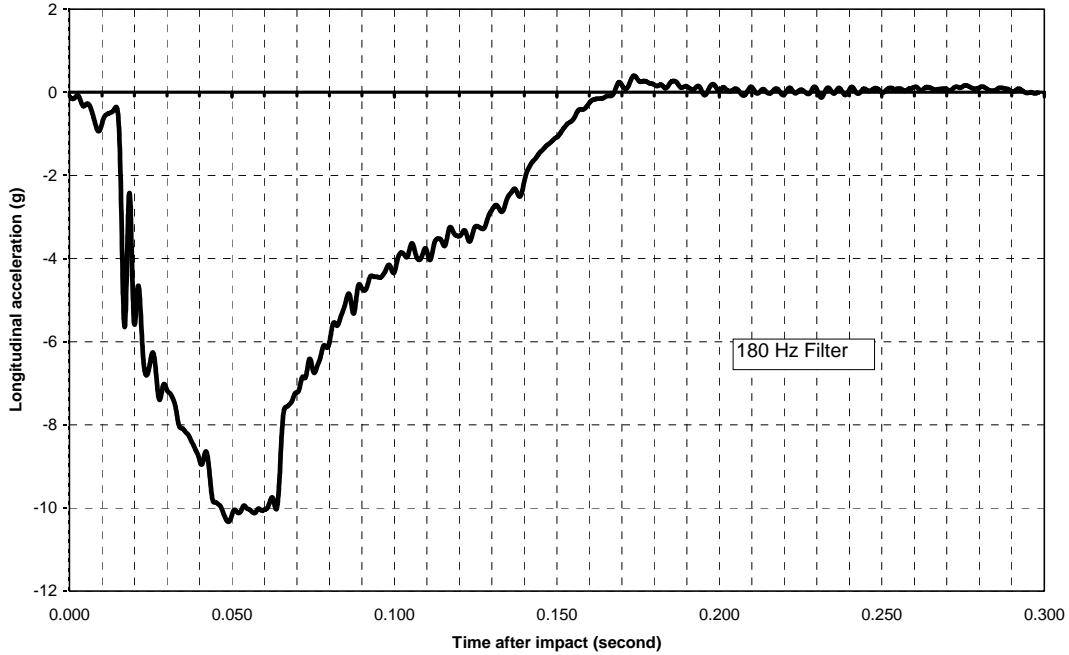
Pendulum Test No. 405160-12 P1 -- 60-inch Concrete Foundation

Figure E1. Accelerometer trace for test 405160-12 P1.

Longitudinal occupant impact velocity was 24.6 ft/s (7.5 m/s), longitudinal ridedown acceleration was $-3.6 g$'s, and maximum 50-ms average was $-8.7 g$'s. Change in velocity at loss of contact was 19.2 ft/s (5.9 m/s). The data and other pertinent information are presented in Appendix D, table D1. Acceleration and force graphs are shown in Appendix E, figure E1 and E2.

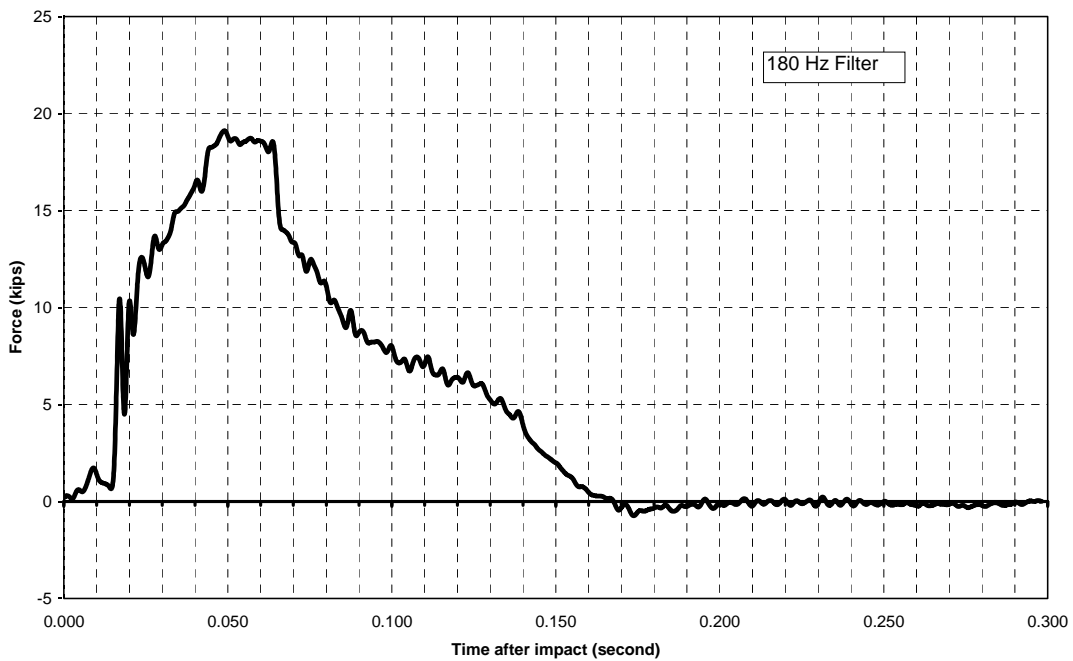
Pendulum Test No. 405160-12 P1 -- 60-inch Concrete Foundation

Figure E2. Force trace for test 405160-12 P1.

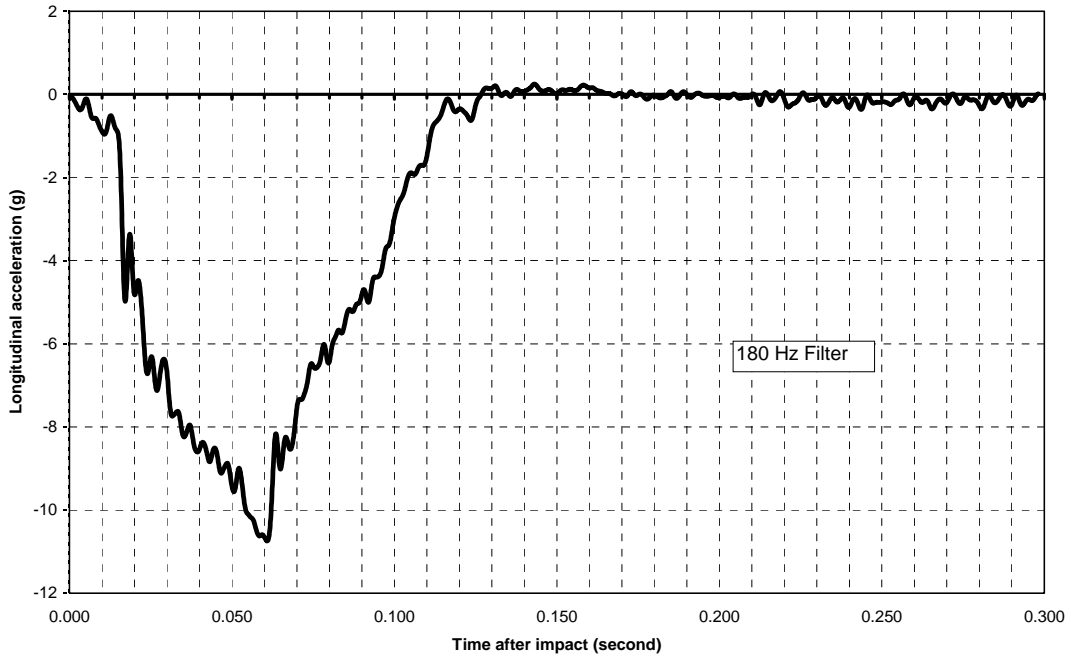
Pendulum Test No. 405160-12 P2 -- 48-inch Concrete Foundation

Figure E3. Accelerometer trace for test 405160-12 P2.

Appendix D, table D2. Acceleration and force graphs are shown in Appendix E, figure E3 and E4.

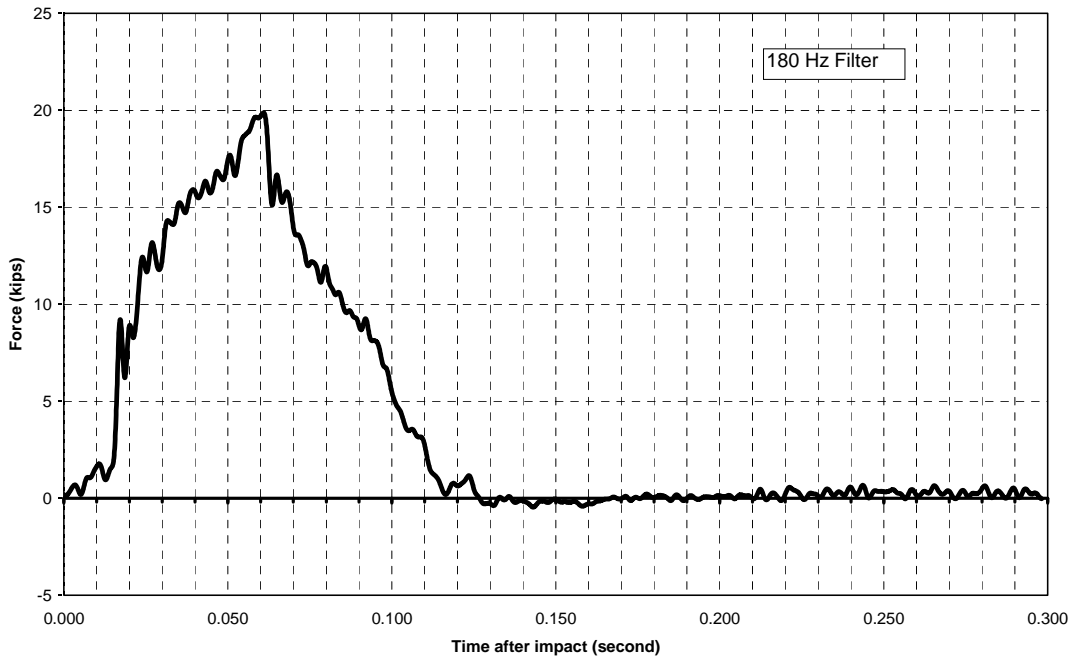
Pendulum Test No. 405160-12 P2 -- 48-inch Concrete Foundation

Figure E4. Force trace for test 405160-12 P2.
