**Texas
Transportation
Institute**
Proving Ground

Report No. 405160-10

EVALUATION OF EXISTING T-INTERSECTION GUARDRAIL SYSTEMS FOR EQUIVALENCY WITH NCHRP REPORT 350 TL-2 TEST CONDITIONS

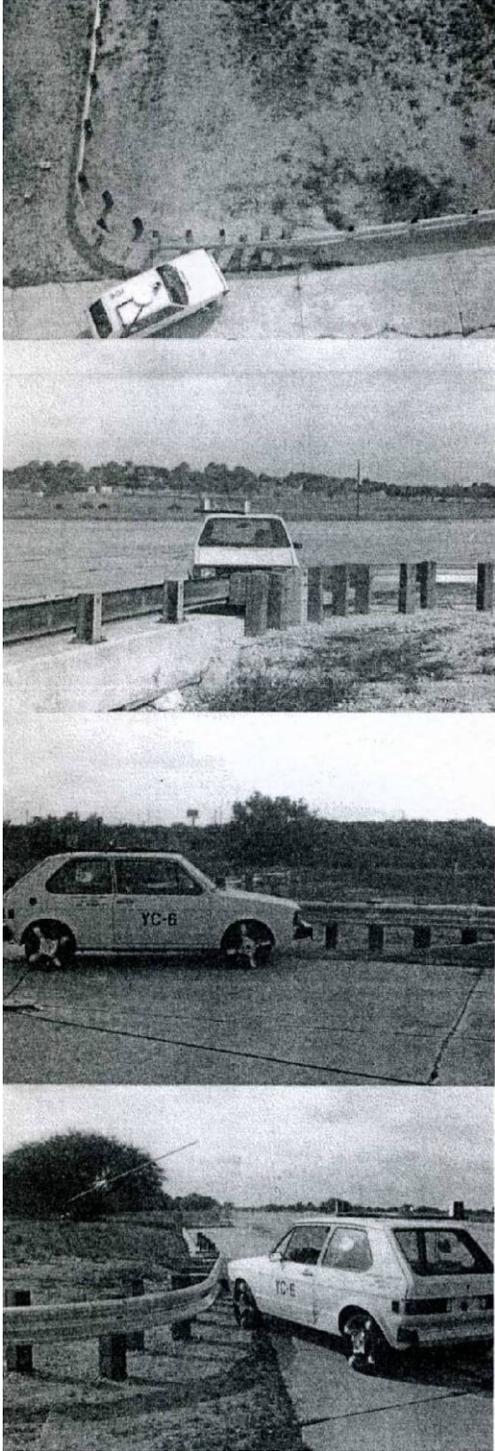
Figure 2.19 Impact conditions and YC-6 system damage (3)

Figure 2.18 and Figure 2.19 show test YC-6 impact condition and the subsequent vehicle trajectory. The vehicle impacted the barrier and was redirected without pocketing as shown in Figure 2.20. Only cosmetic damage on the rail and the concrete curb were observed in the impact area.

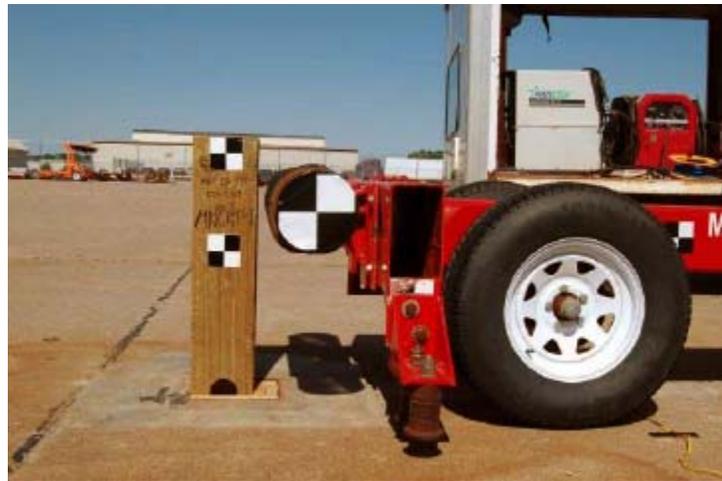
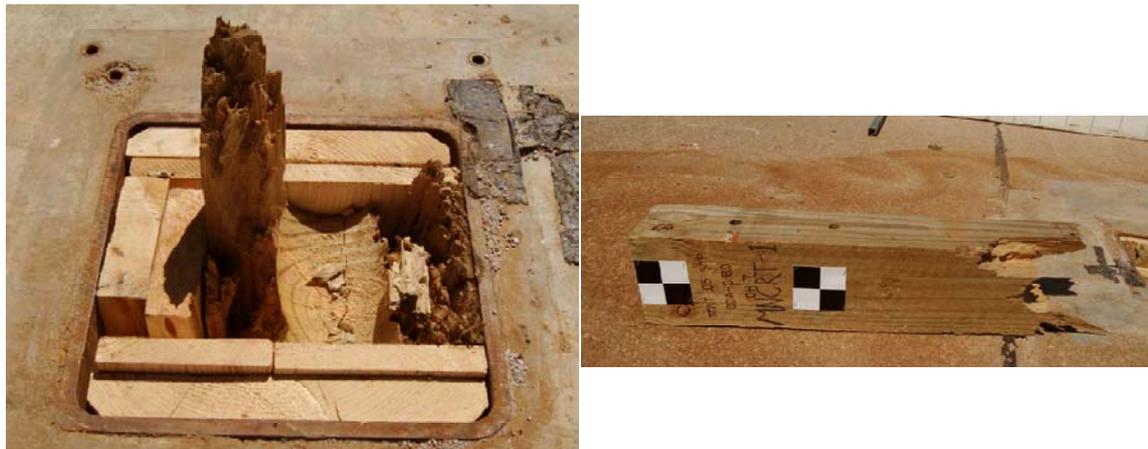
(a) Bogie and Test Setup

(b) Post impact Images (strong axis)

Figure 4.2 Dynamic impact testing (MNCRT) (11)

MwRSF performed dynamic impact testing on CRT wood posts placed in a rigid sleeve (11) as shown in Figure 4.2(a). Three sets of tests (MNCRT 1~9) were conducted along the strong axis (0 degree impact angle), along the weak axis (90 degrees impact angle), and along the diagonal axis using a 728 kg (1605 lb) bogie. Figure 4.2(b) shows typical damage of a post due to a bogie impact. The energy dissipated by the posts is presented in Table 4.3. Since the CRT posts were placed in a rigid sleeve, the energy dissipation is significantly less than the energy measured in the pendulum tests of CRT posts placed in soil.
