**Test Report No. 405160-23-2**  
**Test Report Date: February 2012**

## **MASH TEST 3-11 OF THE W-BEAM GUARDRAIL ON LOW-FILL BOX CULVERT**

### **TEXAS TRANSPORTATION INSTITUTE PROVING GROUND**

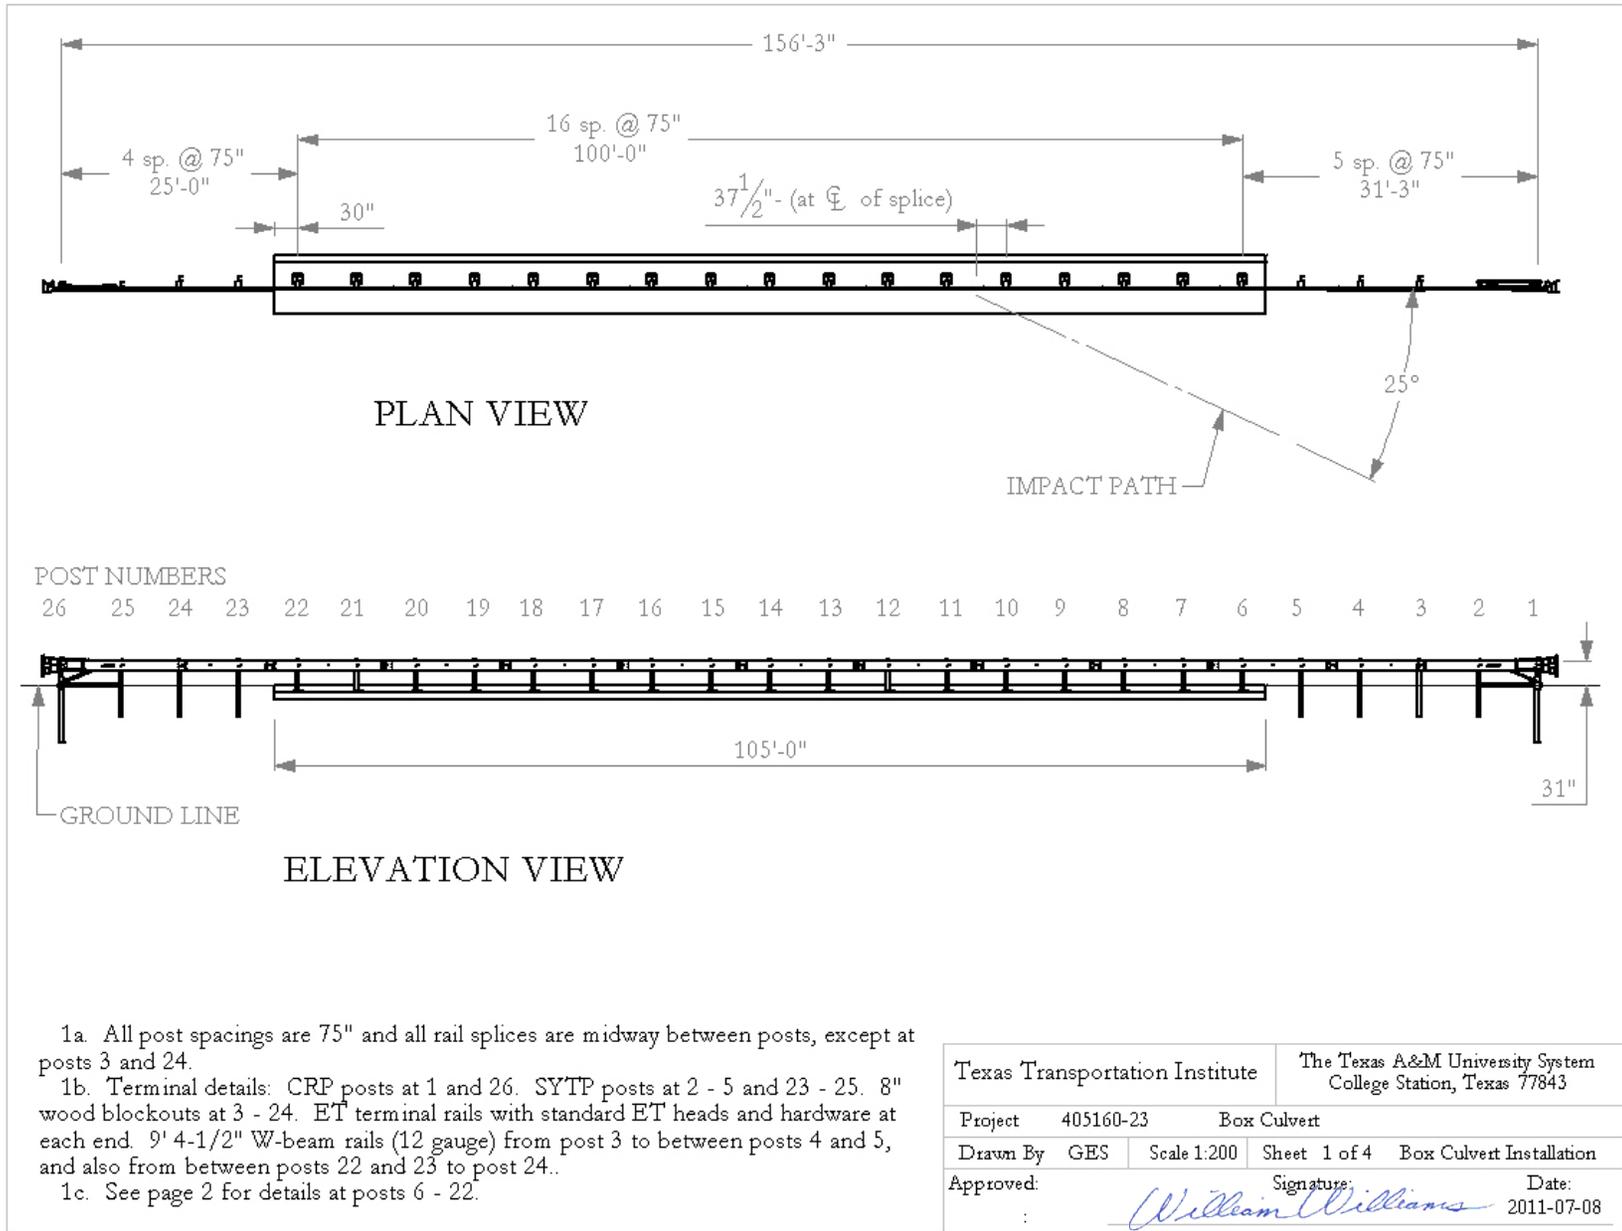
Figure 2.1. Layout of the W-Beam Guardrail on Low-Fill Box Culvert.

The box culvert guardrail installation consisted of a 12 gage W-beam guardrail system supported by W6×9 steel posts anchored to a simulated box culvert. Standard 6-inch × 8-inch × 14-inch long wood blockouts were used to block out the W-beam guardrail from the steel posts. The height of the W-beam guardrail system was 31 inches above finished grade. The posts were spaced on 6 ft-3 inches centers. The W-beam rail splices were located at the midspan of the 6 ft-3 inch post spacing. The posts were anchored to the top of a simulated box culvert slab using the Hilti RE500 epoxy anchoring system. For this test installation, 9 inches of compacted standard soil material was constructed on top of the simulated box culvert slab. The total length of the simulated concrete box culvert slab was 105 ft. The W-beam guardrail system was anchored on each end using ET Plus end terminals. TTI received detailed information regarding the box culvert slab from Mike Elle with Minnesota DOT. These details were incorporated into the box culvert slab installation.

The W6×9 steel posts were welded to 12-inch × 12-inch × 7/8-inch thick base plates. The total length of the posts was 40 1/8 inches. Each steel post with base plate was anchored to the 9-inch thick simulated box culvert slab using four 7/8-inch diameter A193 Super HAS all-threaded rods, 8 1/2 inches in length. These threaded rods were embedded approximately 6 inches in the box culvert slab and were anchored using the HILTI RE500 Epoxy Anchoring System.

The simulated box culvert slab tested for this project was 105 ft in length by 75 inches in width by 9 inches thick. The fill height constructed on top of the box culvert slab was approximately 9 inches. A 9-inch high by 10-inch wide concrete headwall was constructed on the field side edge of the box culvert slab. The W6×9 steel posts were located 28 inches from the field side edge of the simulated box culvert slab. Transverse steel reinforcement in the slab consisted of #3 bars spaced at 12 inches on centers in the top and bottom mats. Longitudinal steel reinforcement in the bottom mat consisted of #5 bars spaced 4 1/2 inches on centers. Longitudinal steel reinforcement in the top mat consisted of #3 bars spaced 6 inches on centers. Transverse reinforcement in the 9-inch high headwall consisted of #3 stirrups spaced at 12 inches on centers. Four #3 longitudinal steel bars were evenly spaced inside the stirrup reinforcement in the headwall. Please refer to figure 2.1, figure 2.2, and Appendix A for additional information on the box culvert slab test installation.

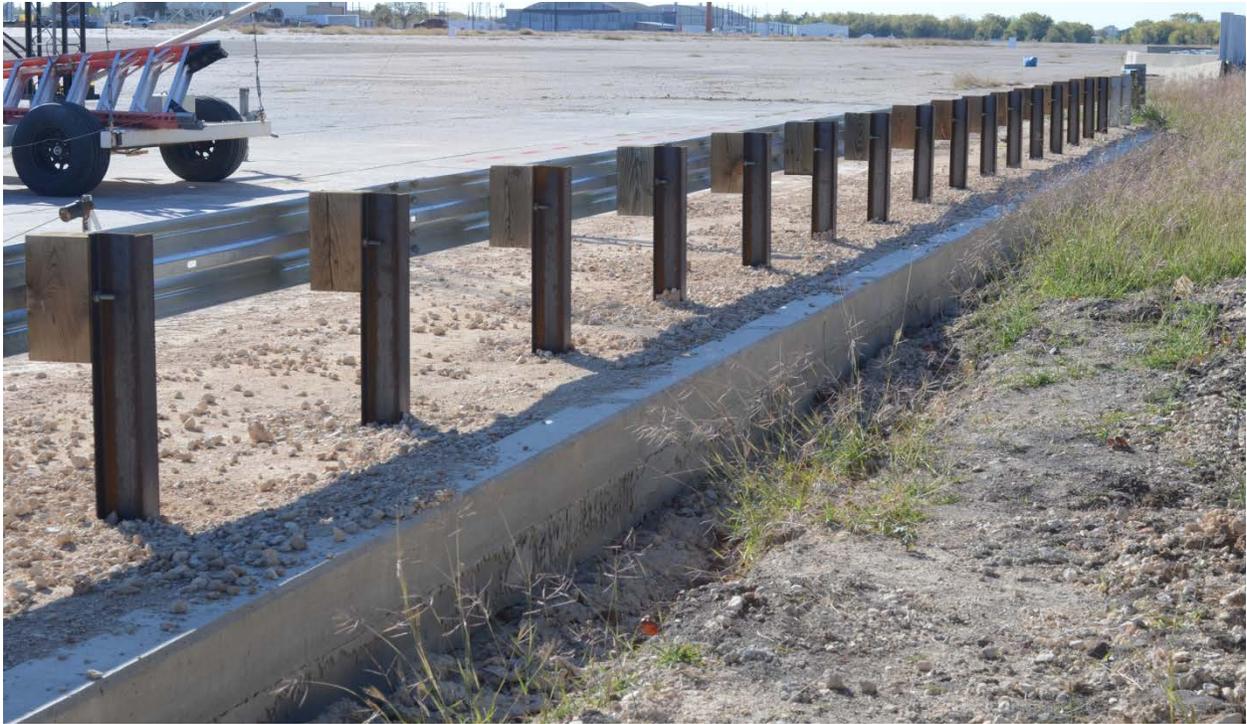
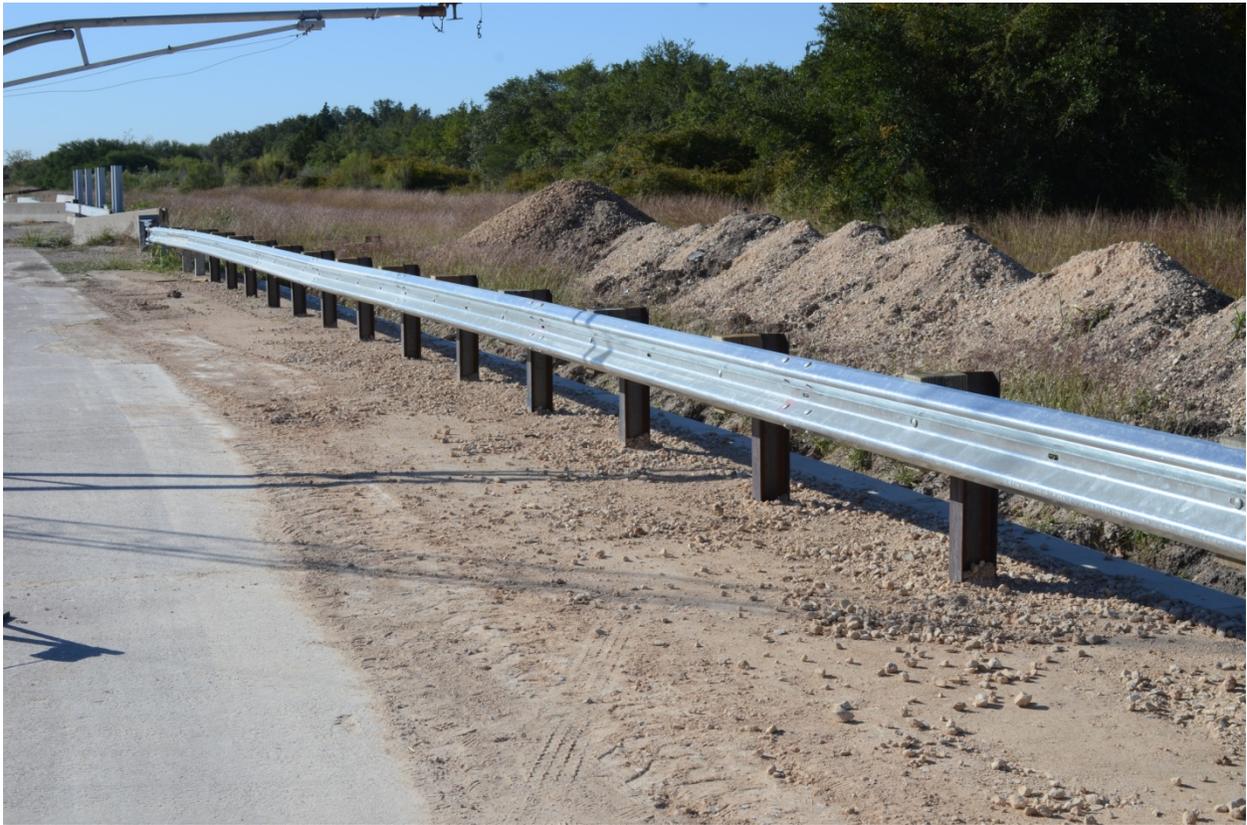
Figure 2.2. W-Beam Guardrail on Low-Fill Box Culvert prior to testing.

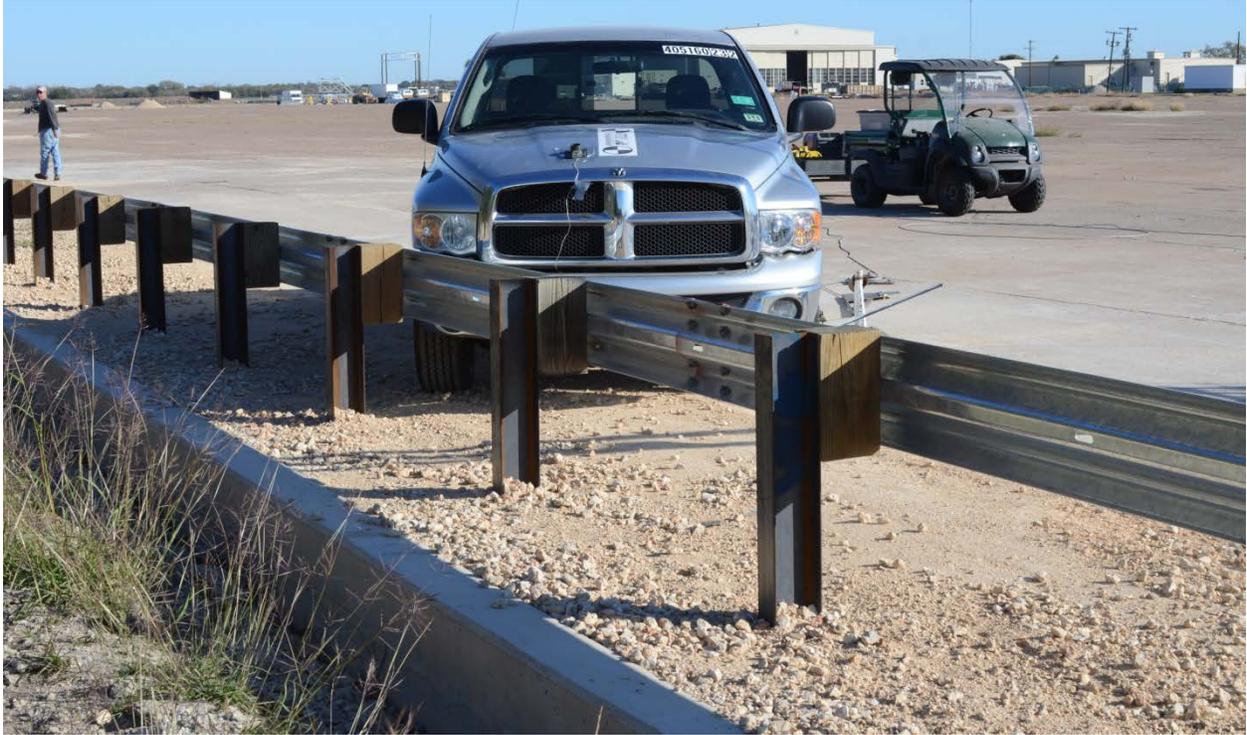
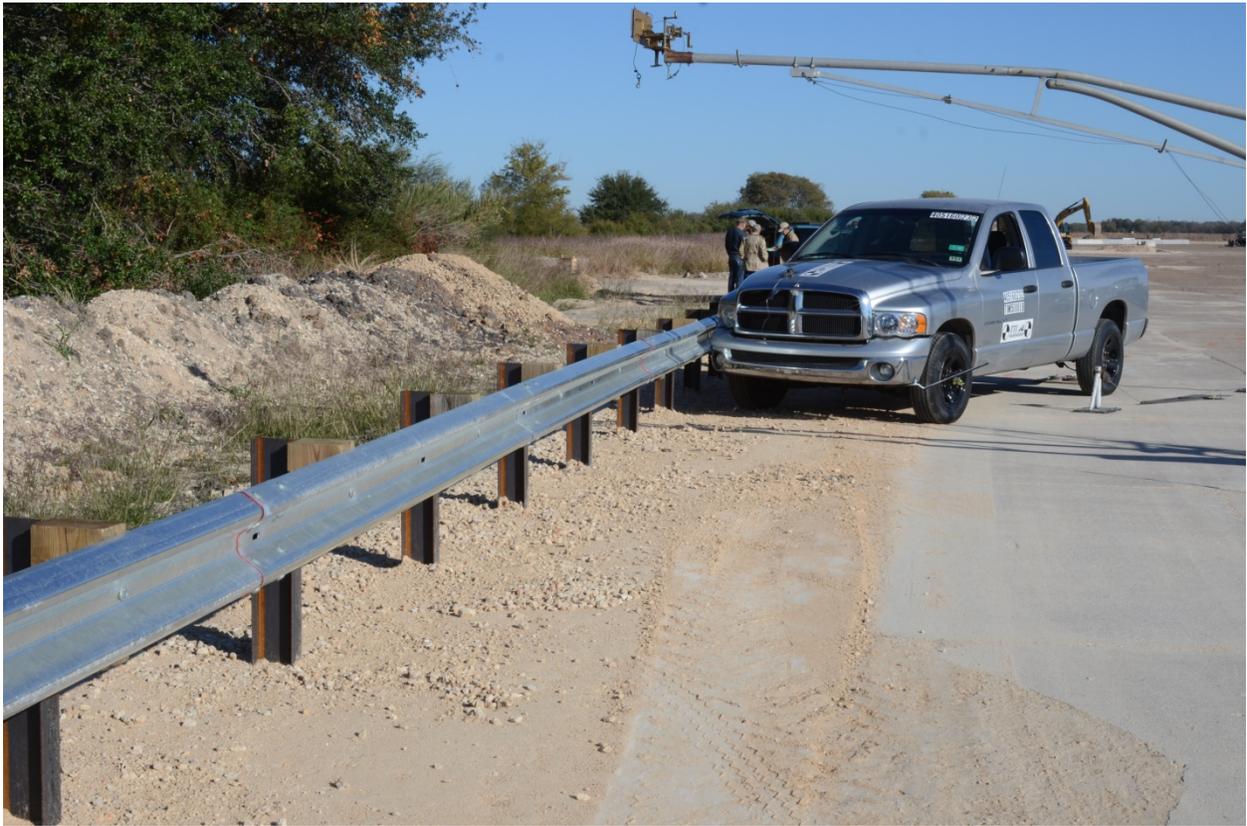
Figure 5.1. Vehicle/installation geometrics for test 405160-23-2.

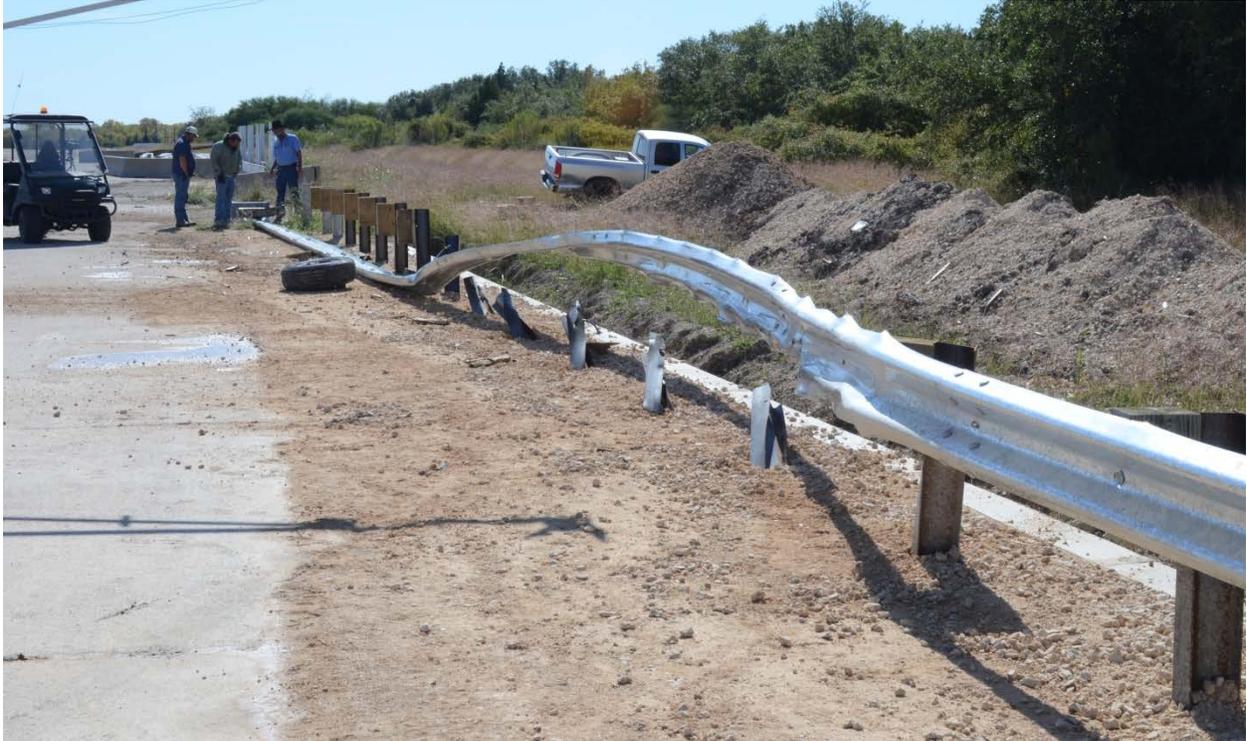
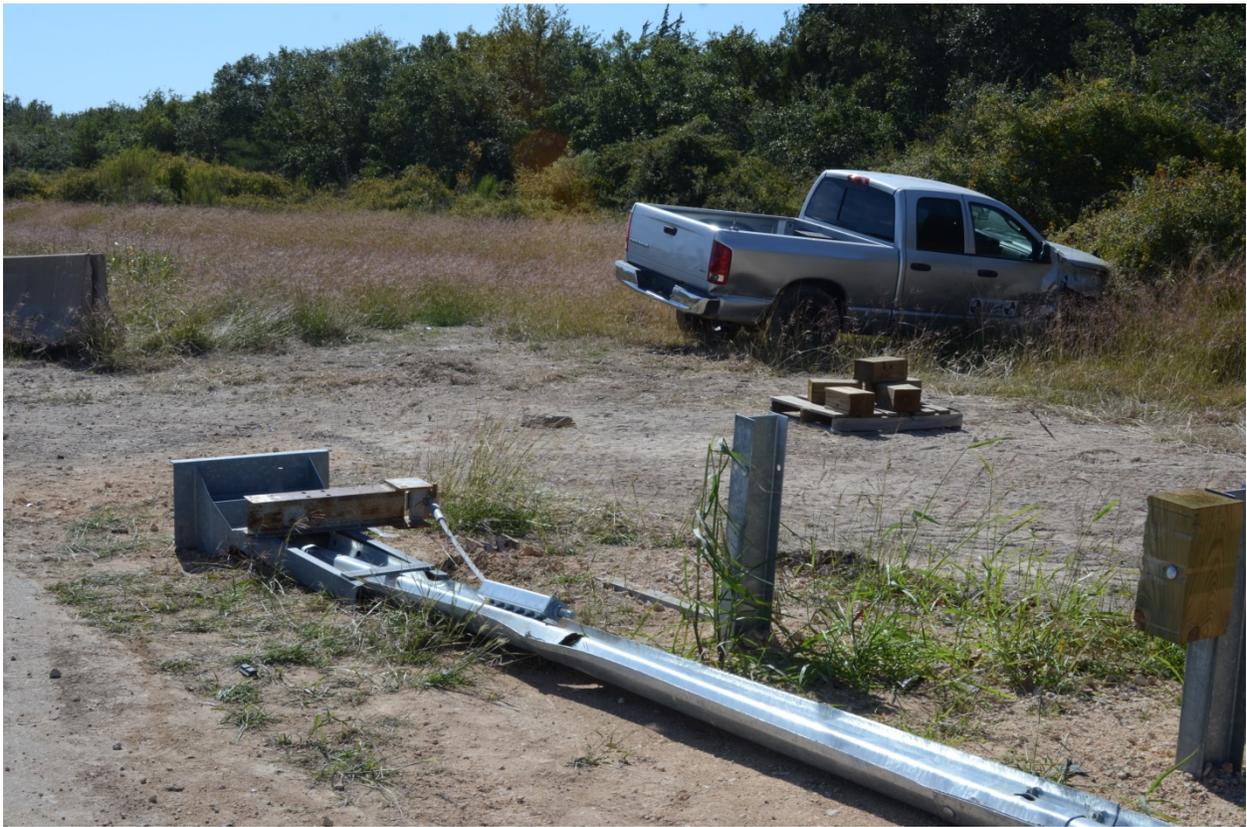
Figure 5.3. Vehicle trajectory path after test 405160-23-2.

The 2003 Dodge Ram 1500 pickup truck, traveling at an impact speed of 62.9 mi/h, impacted the W-Beam Guardrail on Low-Fill Box Culvert 5 ft-4 inches upstream of post 12 at an angle of 26.1 degrees. At approximately 0.019 s, the vehicle began to redirect, and at 0.043 s, post 12 began to deflect towards the field side. Posts 13, 14, 15, 16, and 17 began to deflect towards the field side at 0.090 s, 0.117 s, 0.178 s, 0.215 s, and 0.303 s, respectively. At 0.322 s, the vehicle was traveling parallel with the guardrail at a speed of 44.4 mi/h. Maximum deflection of the rail element was 45.1 inches at 0.400 s. At 0.644 s, the vehicle lost contact with the rail element and was traveling at an exit speed and angle of 32.2 mi/h and 10.9 degrees, respectively. Brakes on the vehicle were not applied, and the vehicle came to rest 123 ft downstream of impact and 37 ft towards the field side. Sequential photographs of the test period are shown in Appendix D, figure D2.

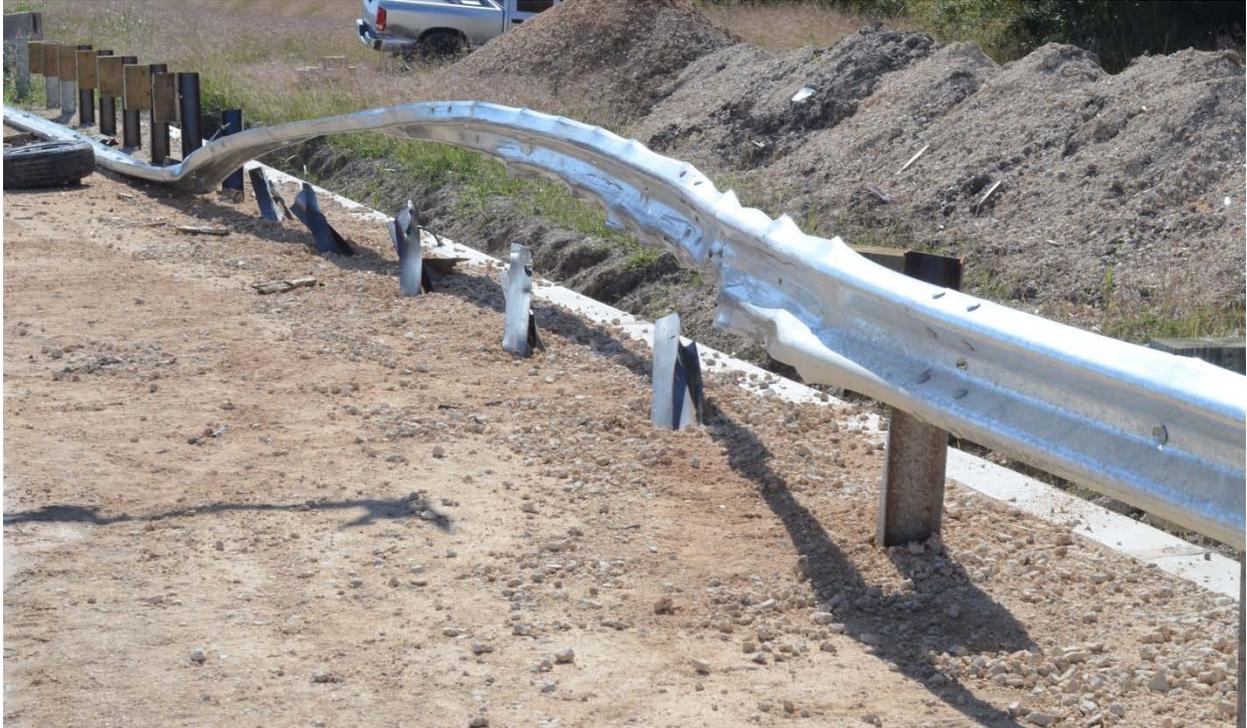
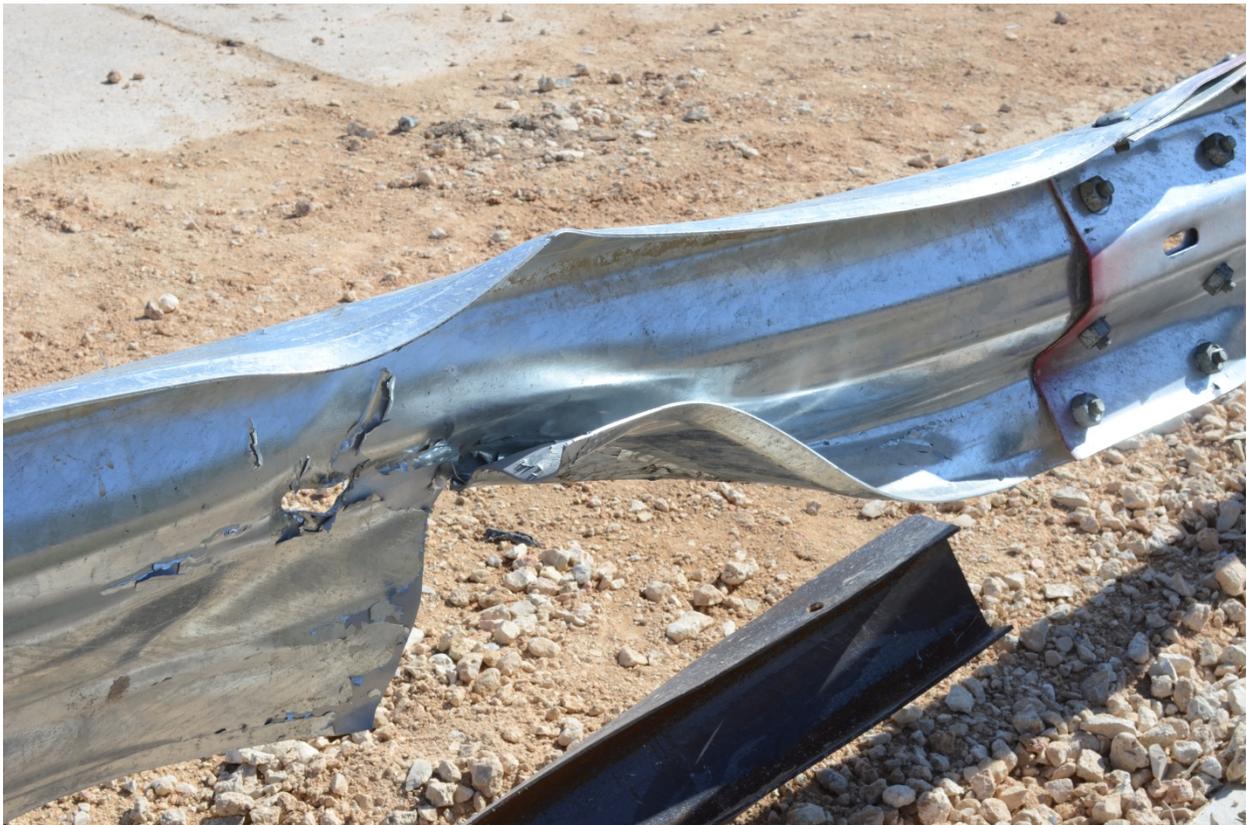
Figure 5.4. Installation after test 405160-23-2.

Figures 5.3 and 5.4 shows damage to the W-Beam Guardrail on Low-Fill Box Culvert. Post 1 was pulled downstream 1 inch. Post 11 was deflected toward the field side 0.5 inch at ground level and rotated 30 degrees clockwise. At post 12, the W-beam rail element was torn from the lower edge to half the height of the rail element. Posts 12 through 16 rotated clockwise and were leaning downstream 50 degrees, and the W-beam rail element and blockouts released from the posts. Post 17 was leaning downstream 40 degrees and the blockout separated from the post. Post 18 was leaning downstream 5 degrees. The top half of the cable release post (CRP) at post 26 released at the base, but the head remained on the post. The ground piece of the CRP was pulled upstream 2 inches. Working width during the test was 49.6 inches, dynamic deflection of the W-beam rail element was 45.1 inches.

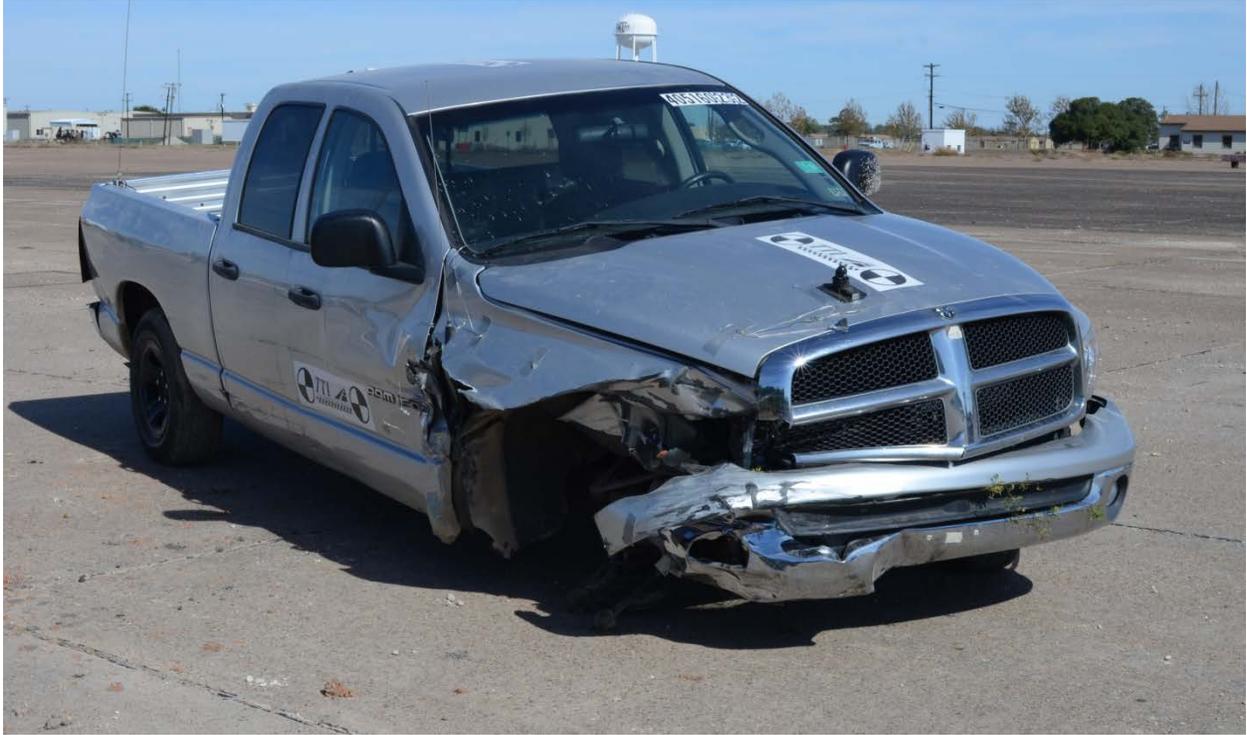
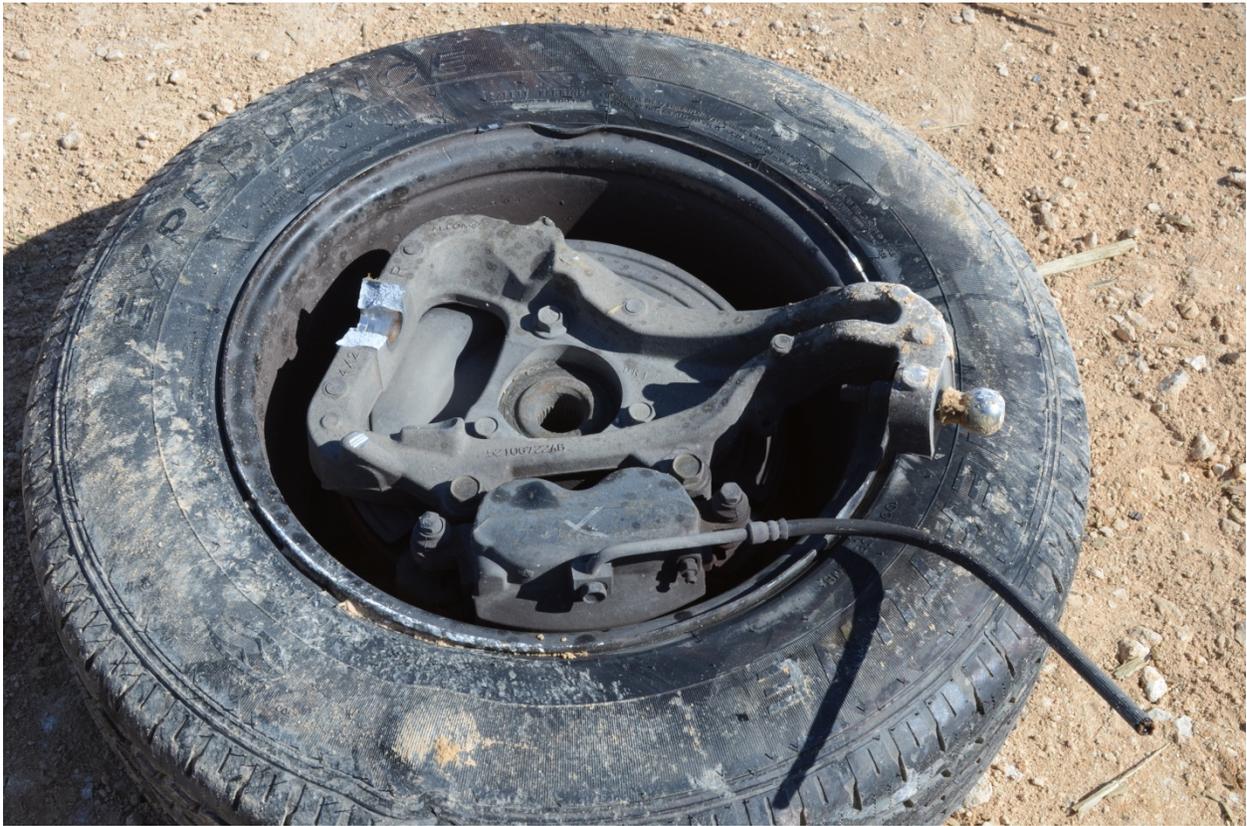
Figure 5.5. Vehicle after test 405160-23-2.

Damage to the vehicle is shown in figure 5.5. The right upper and lower ball joints were pulled out and the right upper and lower A-arms and right frame rail were deformed. Also damaged were the front bumper, grill, right front fender, right front and rear doors, right front tire and wheel rim, right rear exterior bed, right rear tire and wheel rim, and the rear bumper. Maximum exterior crush to the vehicle was 14.0 inches in the side plane at the right front corner at bumper height. No measureable occupant compartment deformation occurred. Photographs of the interior of the vehicle are shown in figure 5.6. Exterior vehicle crush and occupant compartment measurements are shown in Appendix D, tables D3 and D4.

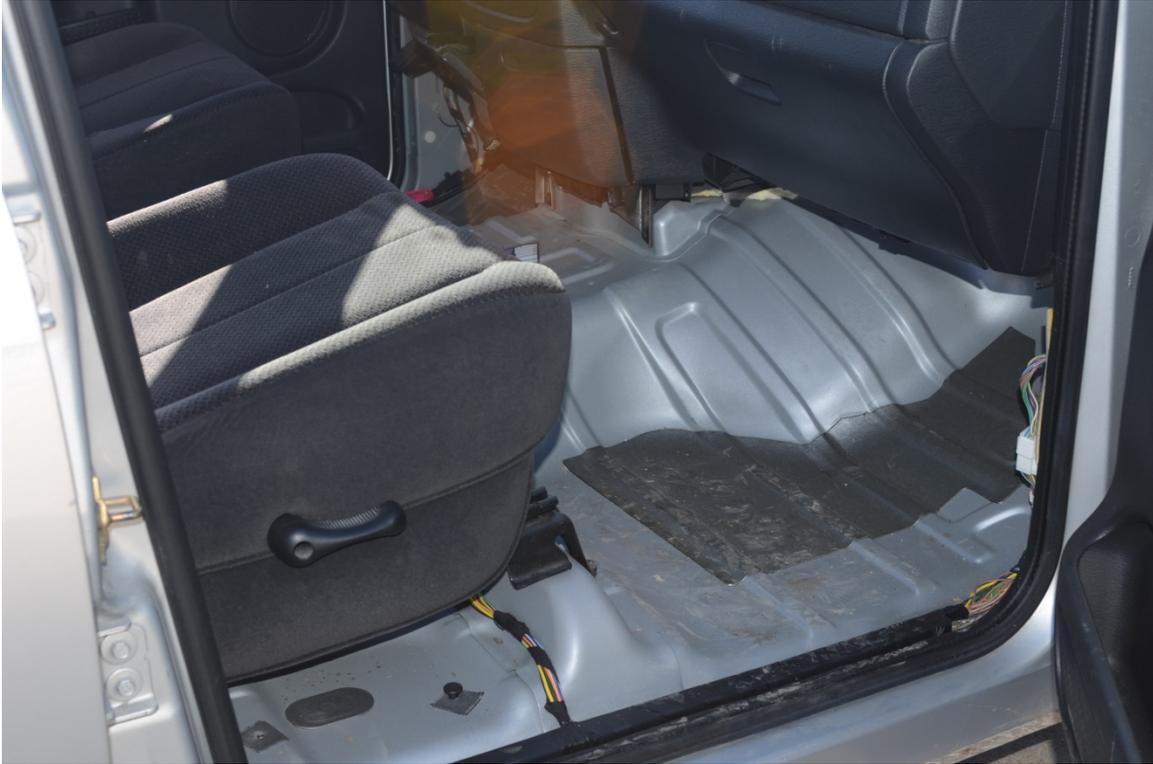
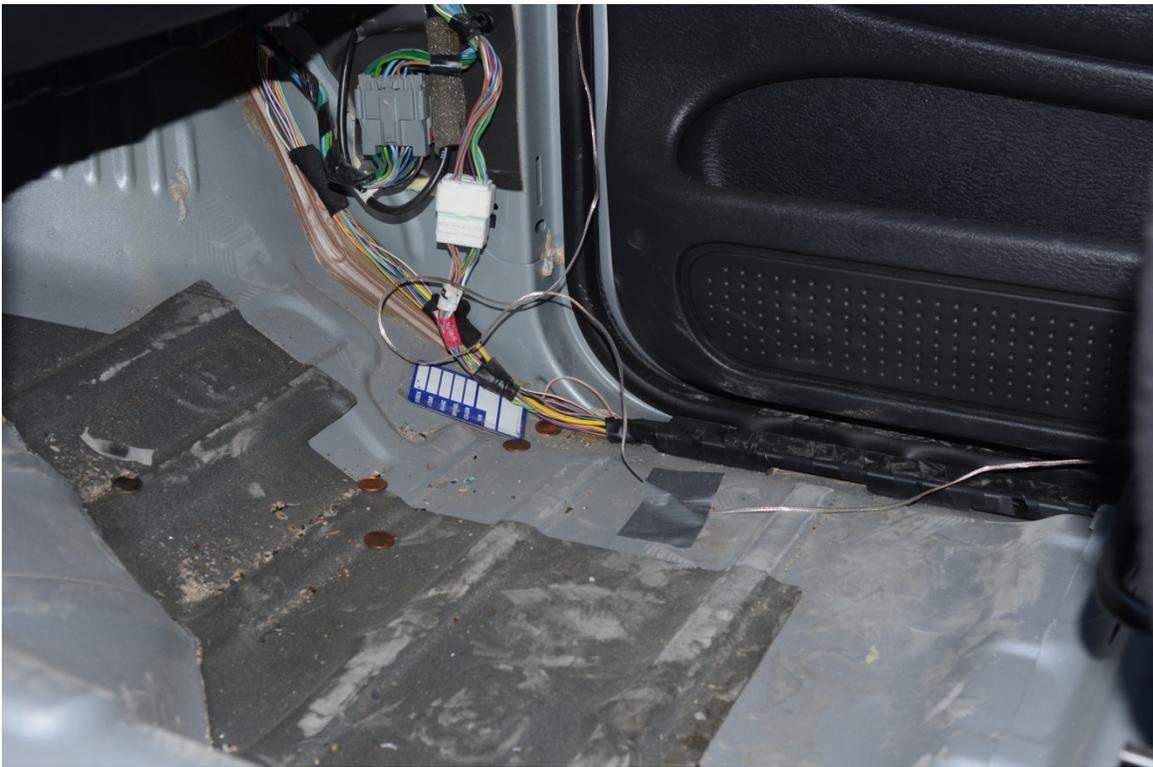
Before Test  
After Test

Figure 5.6. Interior of vehicle for test 405160-23-2.

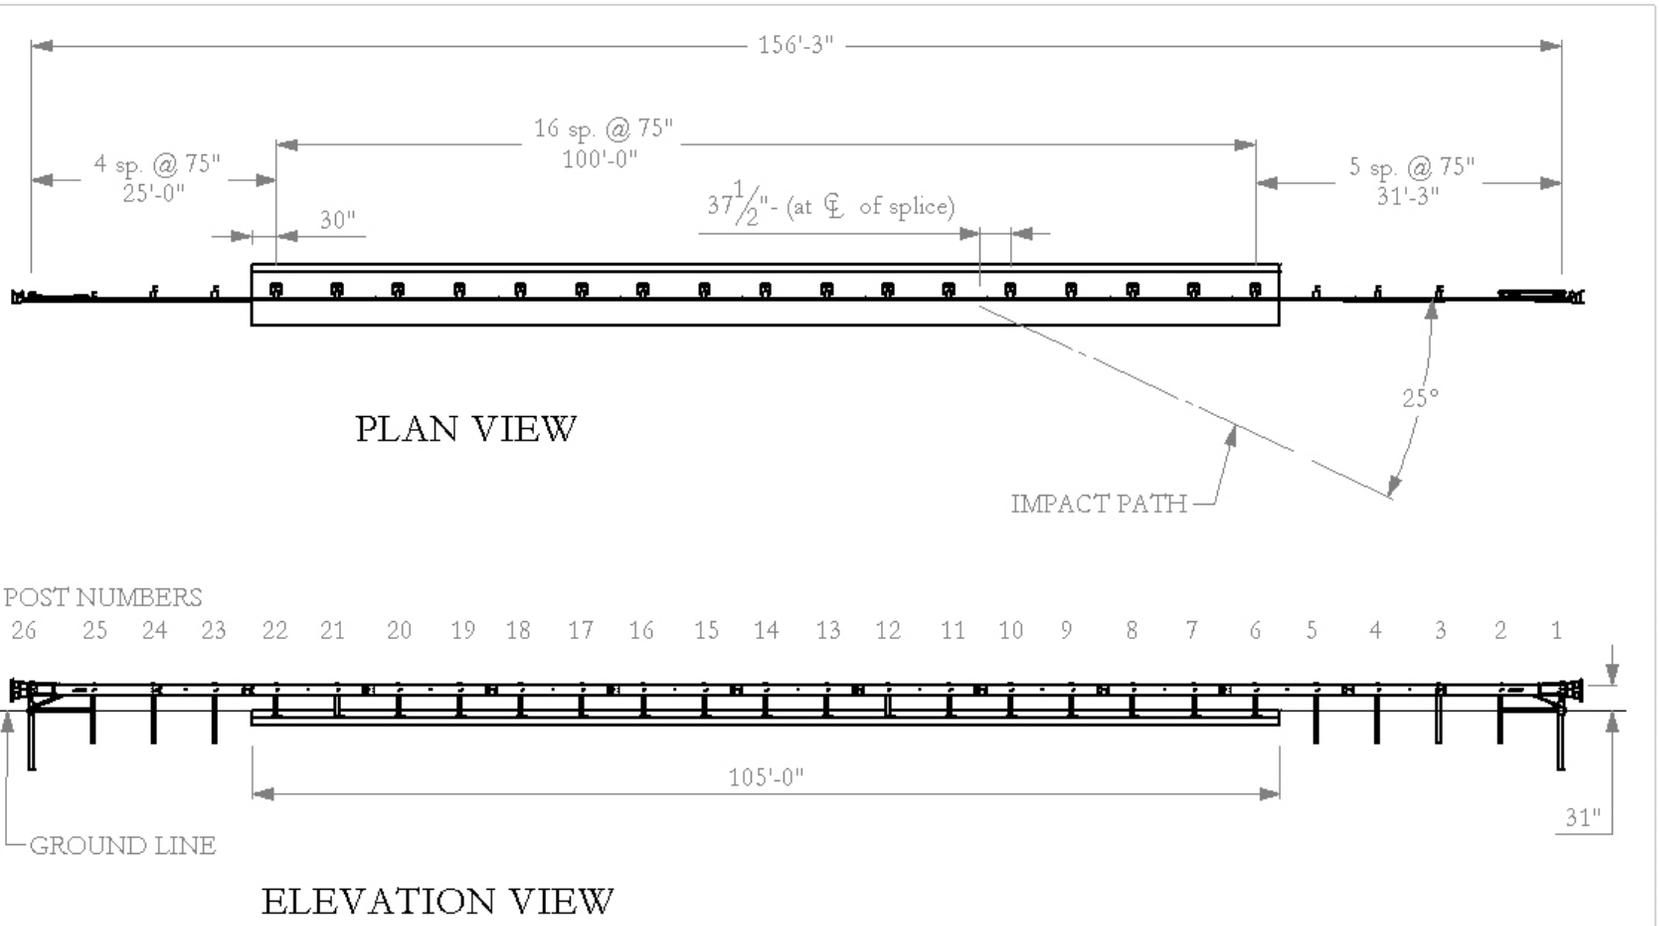
- 1a. All post spacings are 75" and all rail splices are midway between posts, except at posts 3 and 24.
- 1b. Terminal details: CRP posts at 1 and 26. SYTP posts at 2 - 5 and 23 - 25. 8" wood blockouts at 3 - 24. ET terminal rails with standard ET heads and hardware at each end. 9' 4-1/2" W-beam rails (12 gauge) from post 3 to between posts 4 and 5, and also from between posts 22 and 23 to post 24..
- 1c. See page 2 for details at posts 6 - 22.

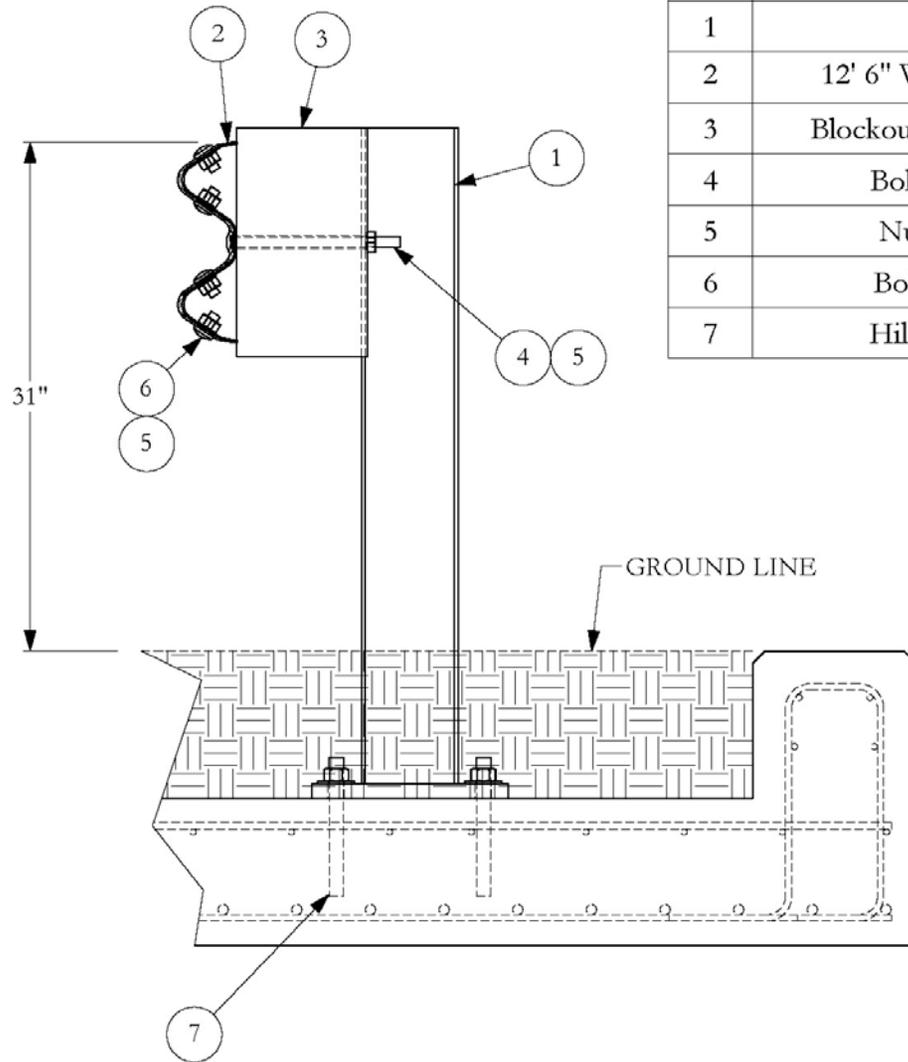
2a. HAS-E  $\varnothing 7/8$  (cut off to 8-1/2" long) with washer and nut. Installed with Hilti RE500 epoxy according to label directions with minimum 6" embedment.

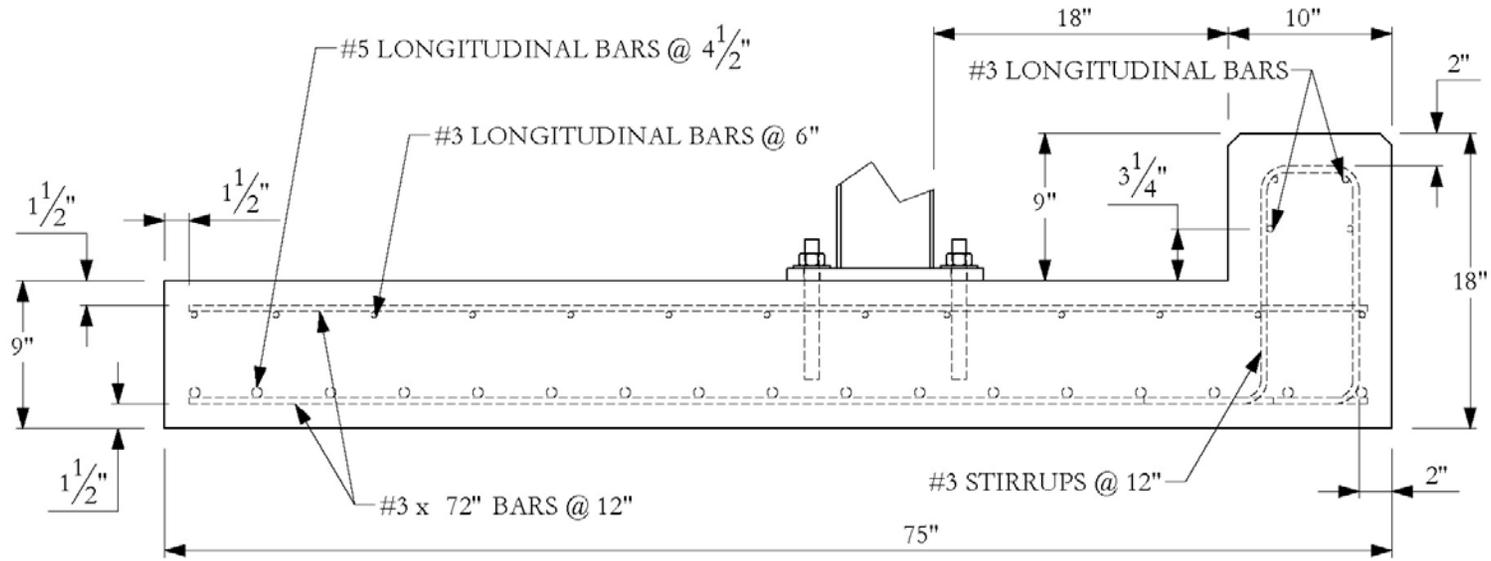
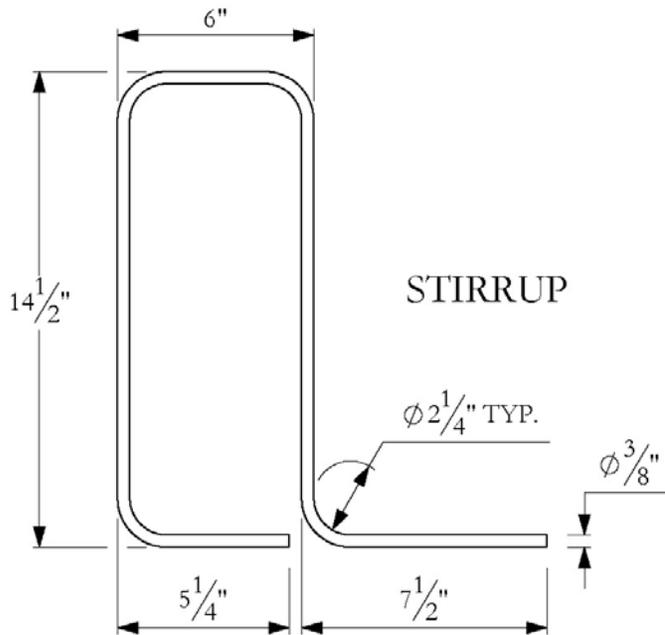
CONCRETE AND REBAR  
END VIEW

- 4a. Chamfer top edges of curb 3/4".
- 4b. Concrete strength is 5000 psi.
- 4c. Rebar laps are 20" for #3 bars and 30" for #5 bars.

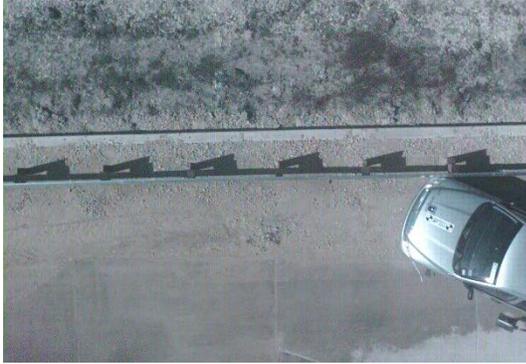
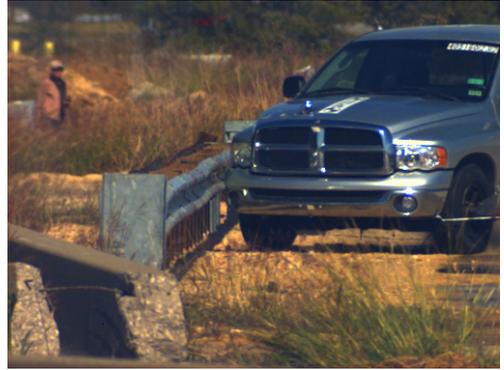
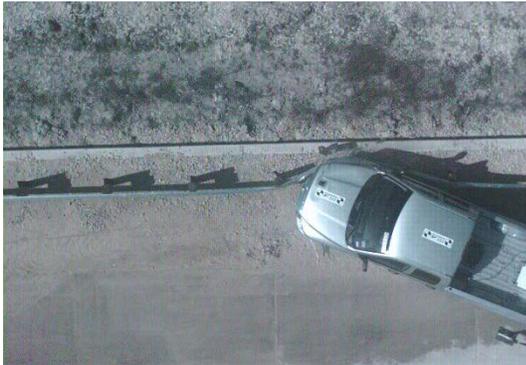
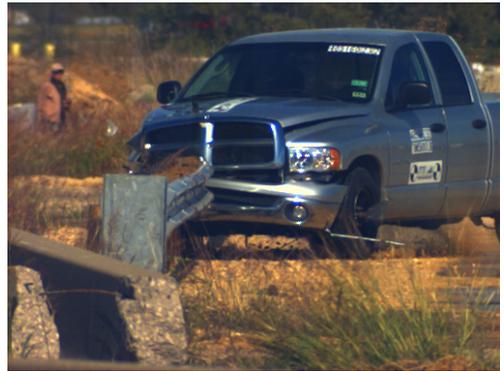
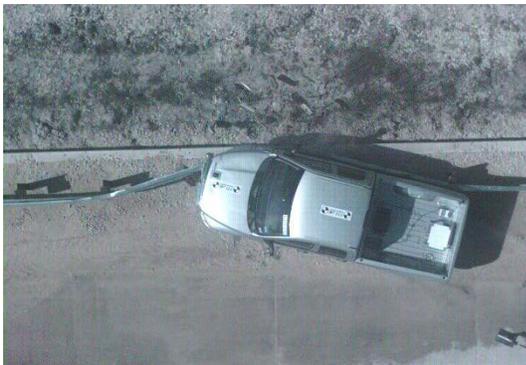
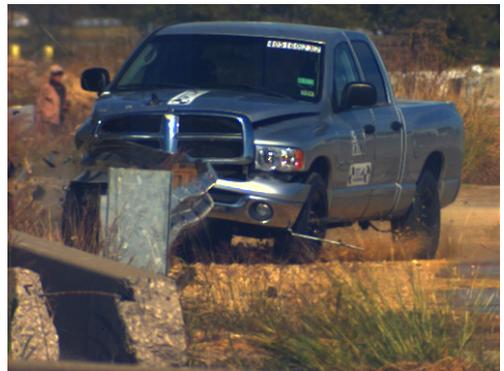
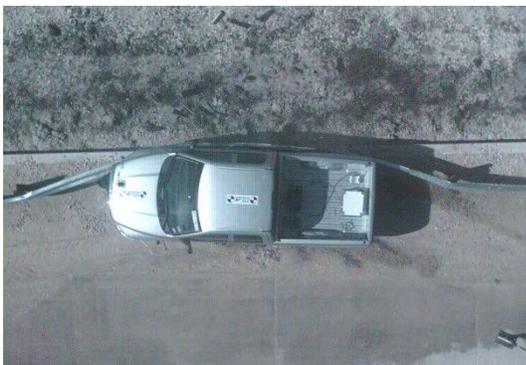
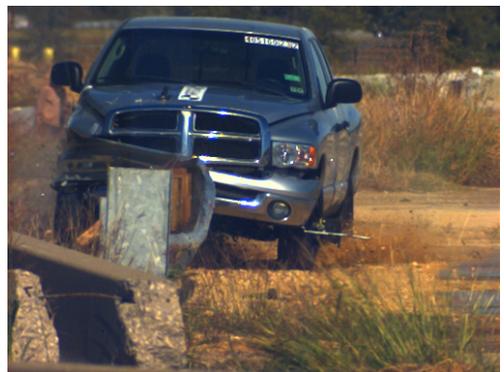
Figure D1. Sequential photographs for test 405160-23-2 (overhead and frontal views).

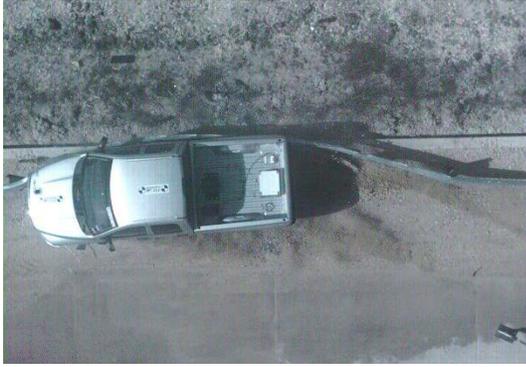
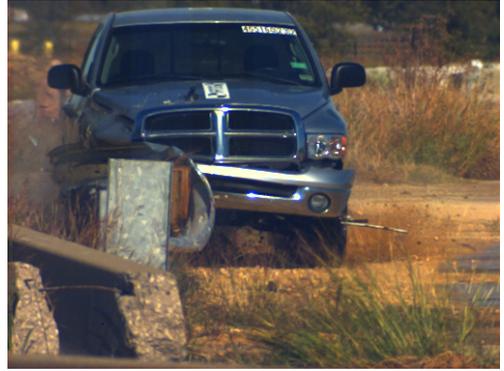
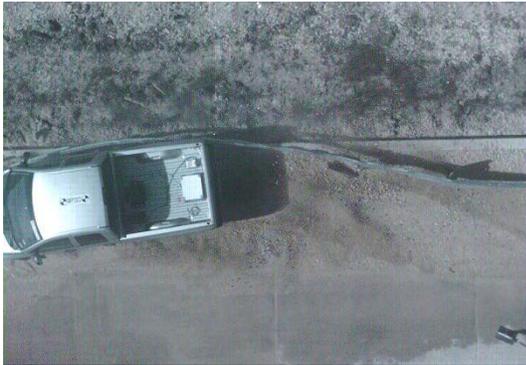
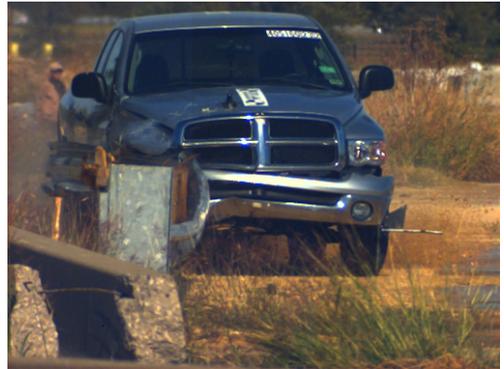
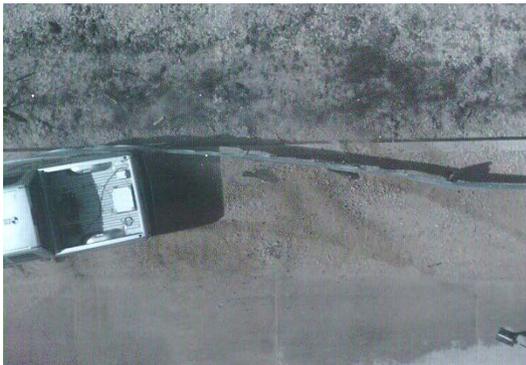
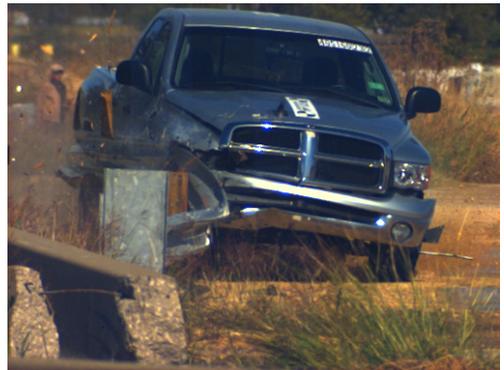
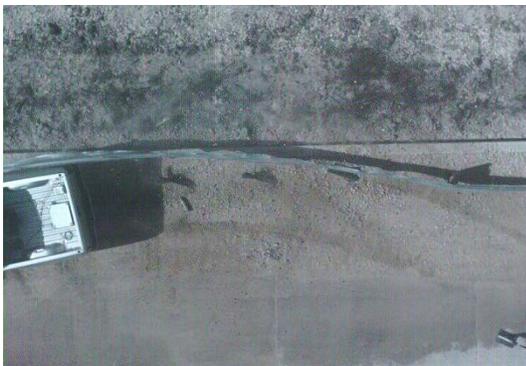
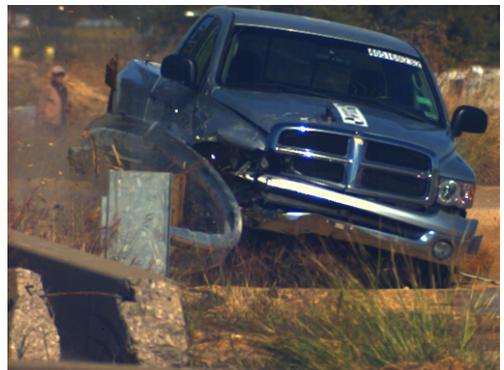
Figure D1. Sequential photographs for test 405160-23-2 (overhead and frontal views) (continued).
