**Test Report No. 405160-23-2**  
**Test Report Date: February 2012**

## **MASH TEST 3-11 OF THE W-BEAM GUARDRAIL ON LOW-FILL BOX CULVERT**

### **TEXAS TRANSPORTATION INSTITUTE PROVING GROUND**

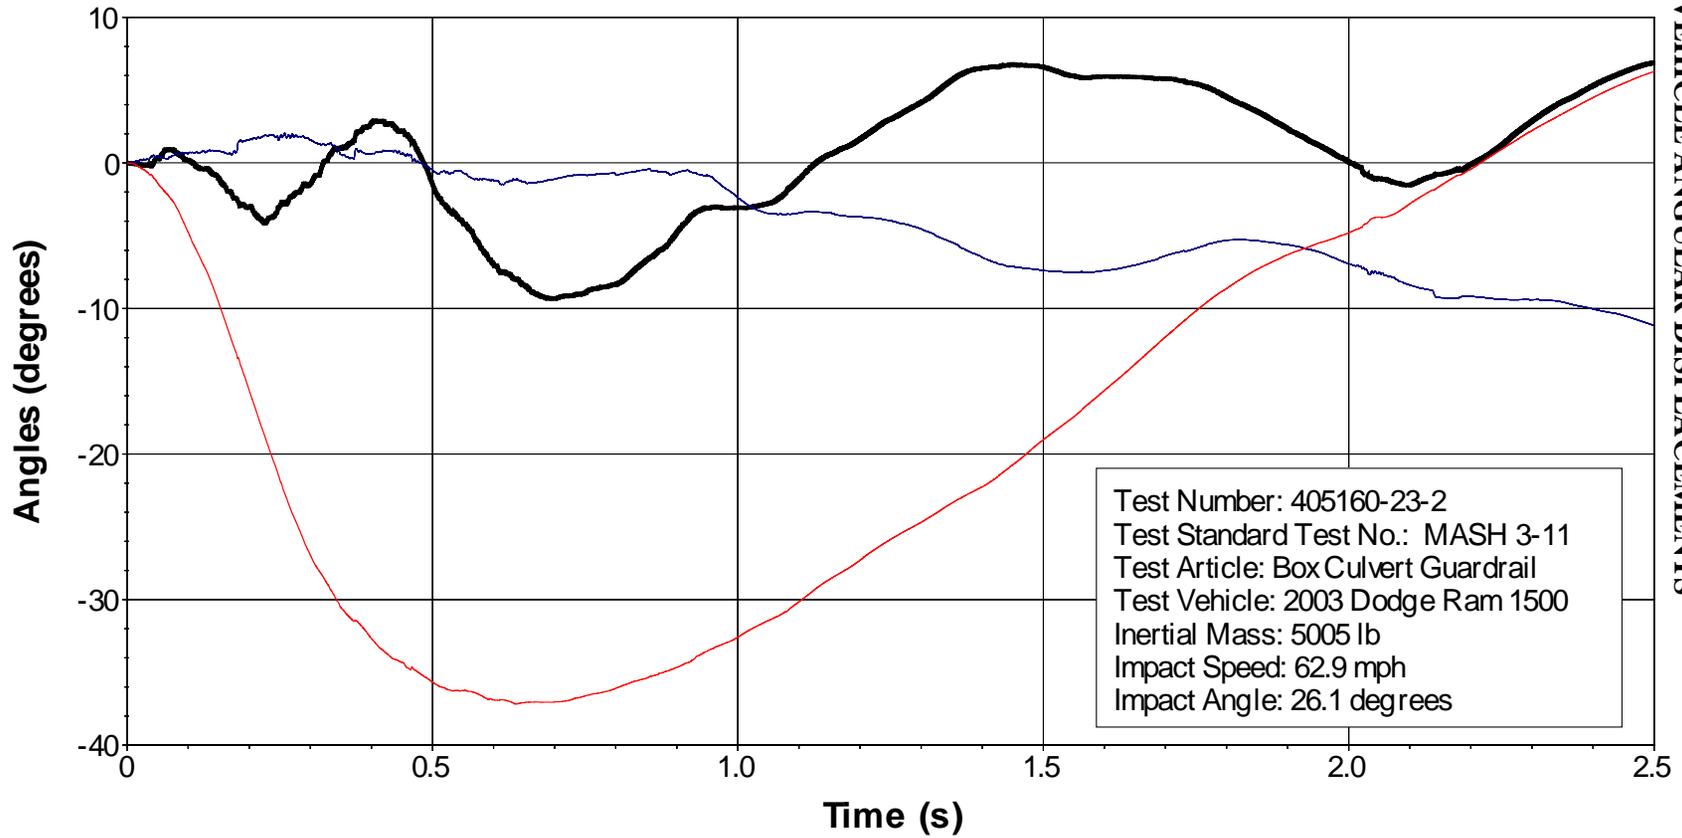
Test Number: 405160-23-2  
 Test Standard Test No.: MASH 3-11  
 Test Article: Box Culvert Guardrail  
 Test Vehicle: 2003 Dodge Ram 1500  
 Inertial Mass: 5005 lb  
 Impact Speed: 62.9 mph  
 Impact Angle: 26.1 degrees

Figure D2. Vehicle angular displacements for test 405160-23-2.

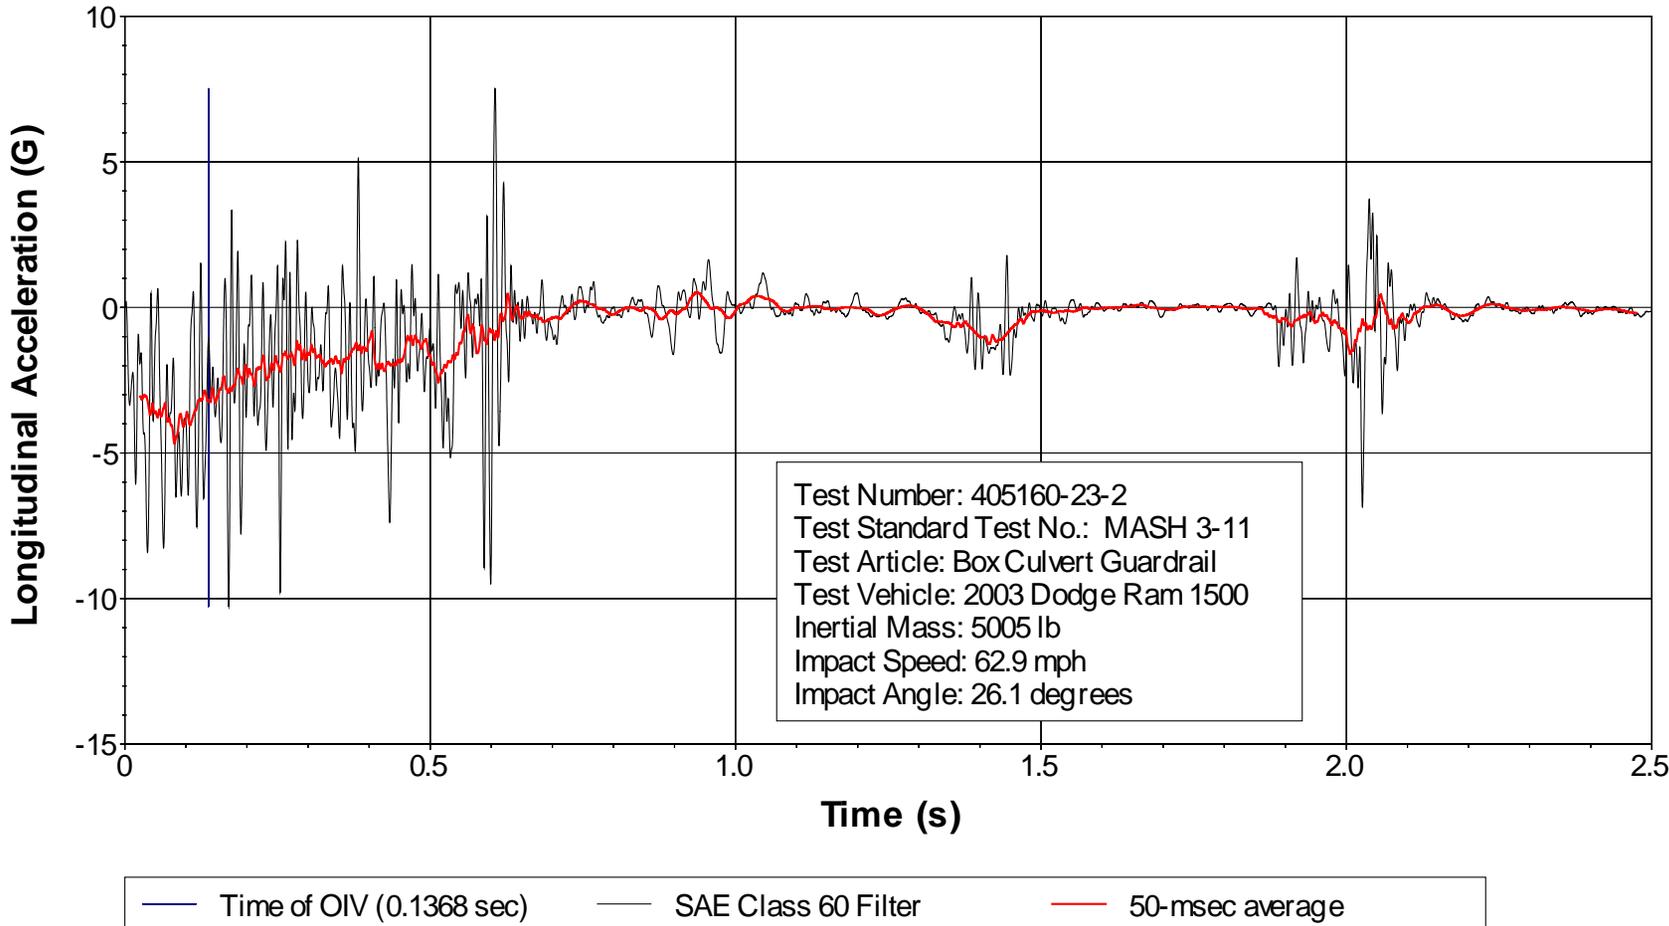
Figure D3. Vehicle longitudinal accelerometer trace for test 405160-23-2 (accelerometer located at center of gravity).

Data from the accelerometer, located at the vehicle center of gravity, were digitized for evaluation of occupant risk. In the longitudinal direction, the occupant impact velocity was 15.4 ft/s at 0.137 s, the highest 0.010-s occupant ridedown acceleration was 5.3 Gs from 0.428 to 0.438 s, and the maximum 0.050-s average acceleration was -4.7 Gs between 0.056 and 0.106 s. In the lateral direction, the occupant impact velocity was 14.4 ft/s at 0.137 s, the highest 0.010-s occupant ridedown acceleration was 6.4 Gs from 0.283 to 0.293 s, and the maximum 0.050-s average was -4.3 Gs between 0.202 and 0.252 s. Theoretical Head Impact Velocity (THIV) was 22.1 km/h or 6.1 m/s at 0.131 s; Post-Impact Head Decelerations (PHD) was 6.7 Gs between 0.283 and 0.293 s; and Acceleration Severity Index (ASI) was 0.58 between 0.072 and 0.122 s. These data and other pertinent information from the test are summarized in figure 5.7. Vehicle angular displacements and accelerations versus time traces are presented in Appendix D, figures D2 through D8.

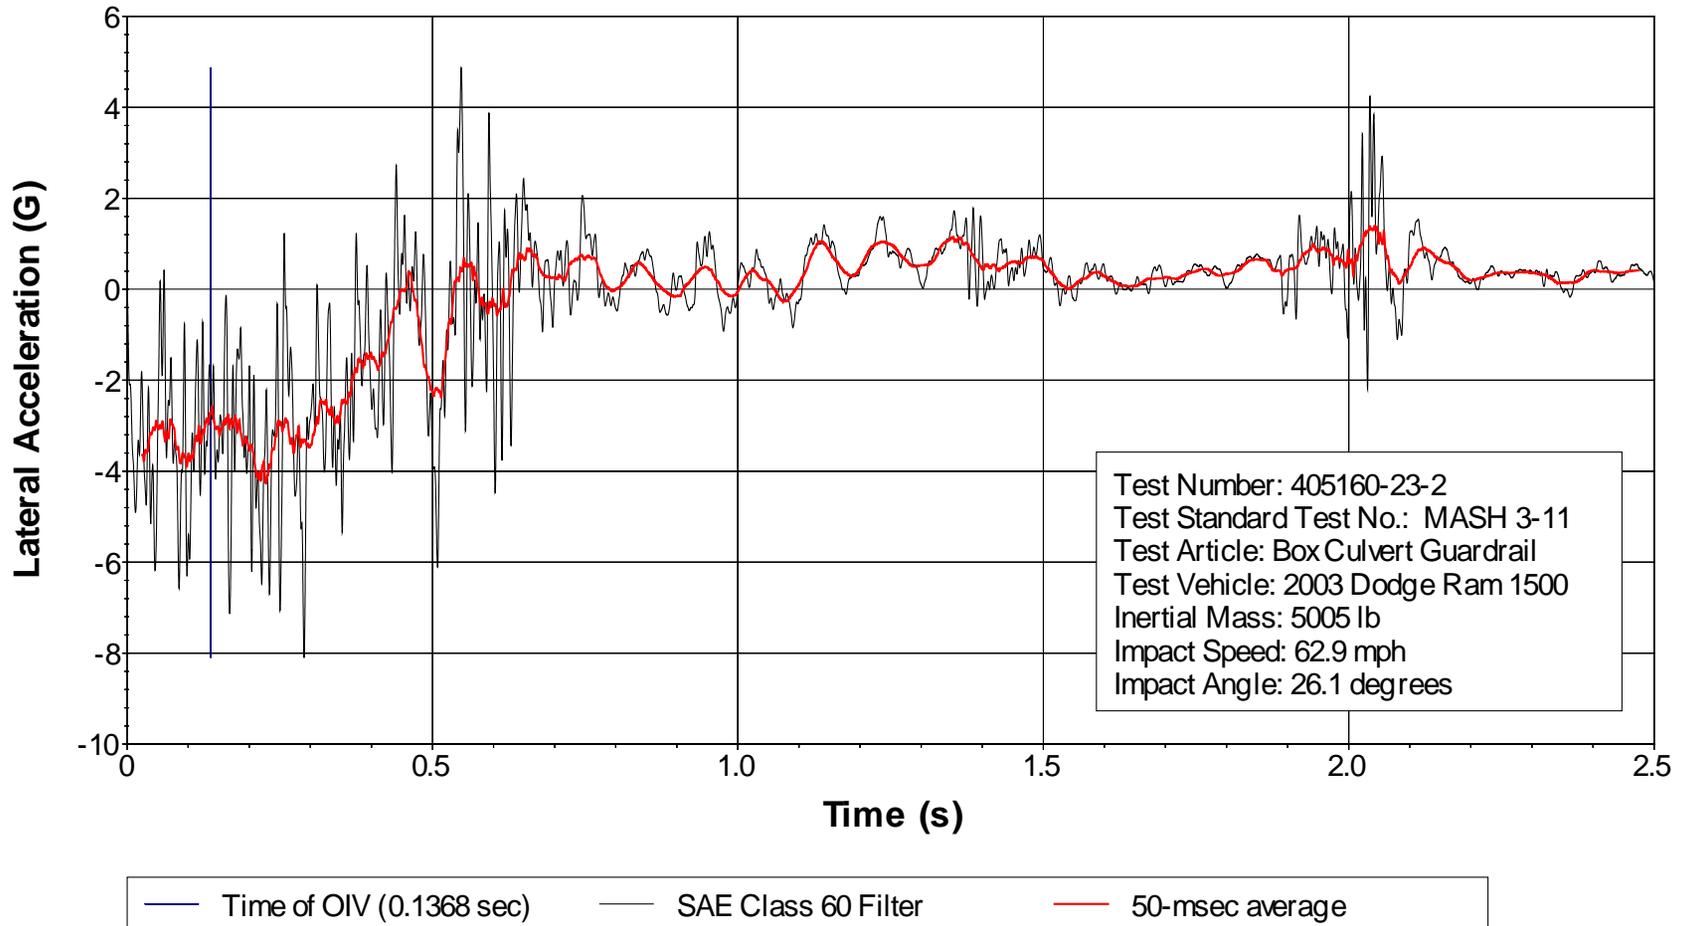
Figure D4. Vehicle lateral accelerometer trace for test 405160-23-2 (accelerometer located at center of gravity).

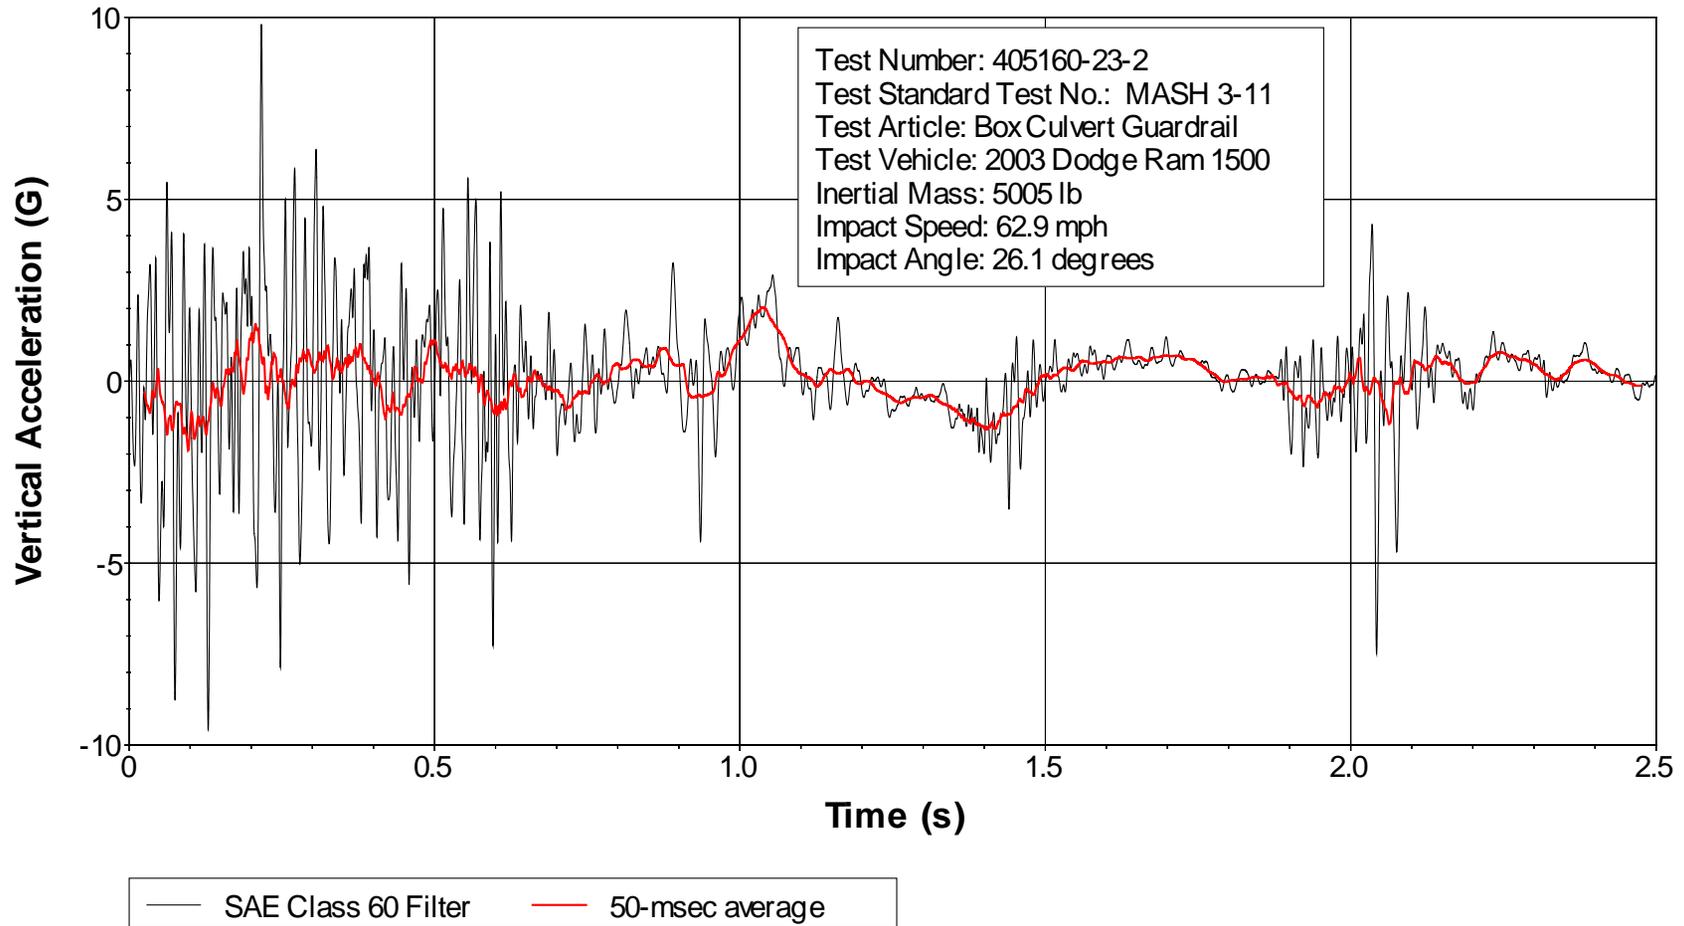
Figure D5. Vehicle vertical accelerometer trace for test 405160-23-2 (accelerometer located at center of gravity).

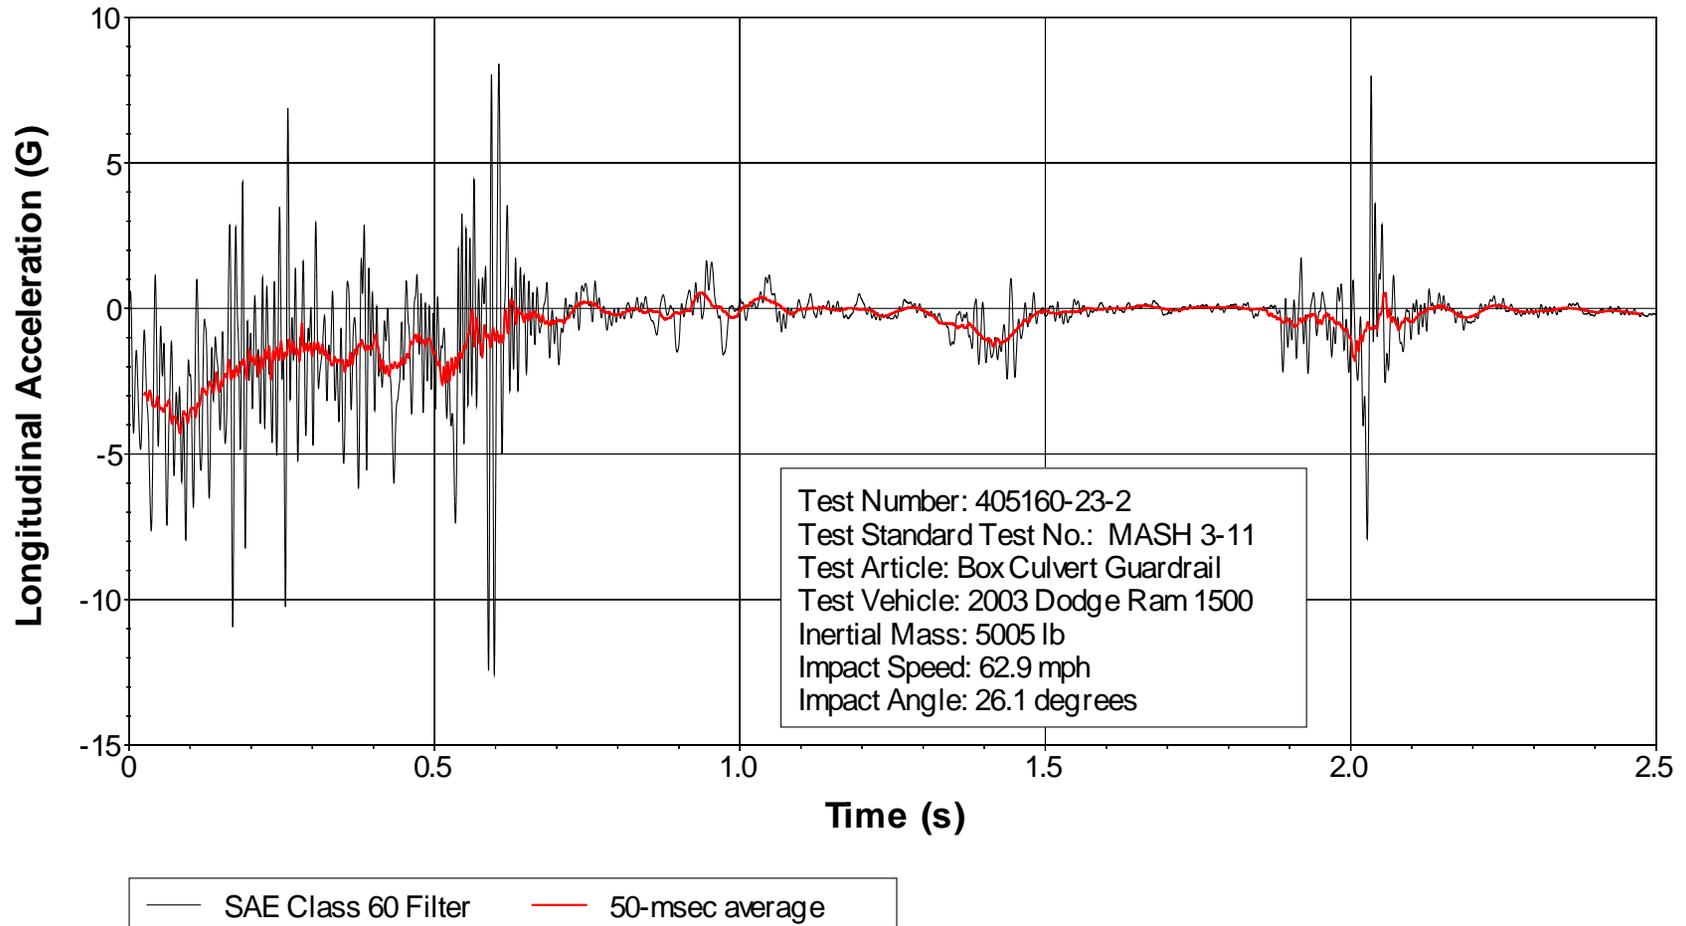
Figure D6. Vehicle longitudinal accelerometer trace for test 405160-23-2 (accelerometer located over rear axle).

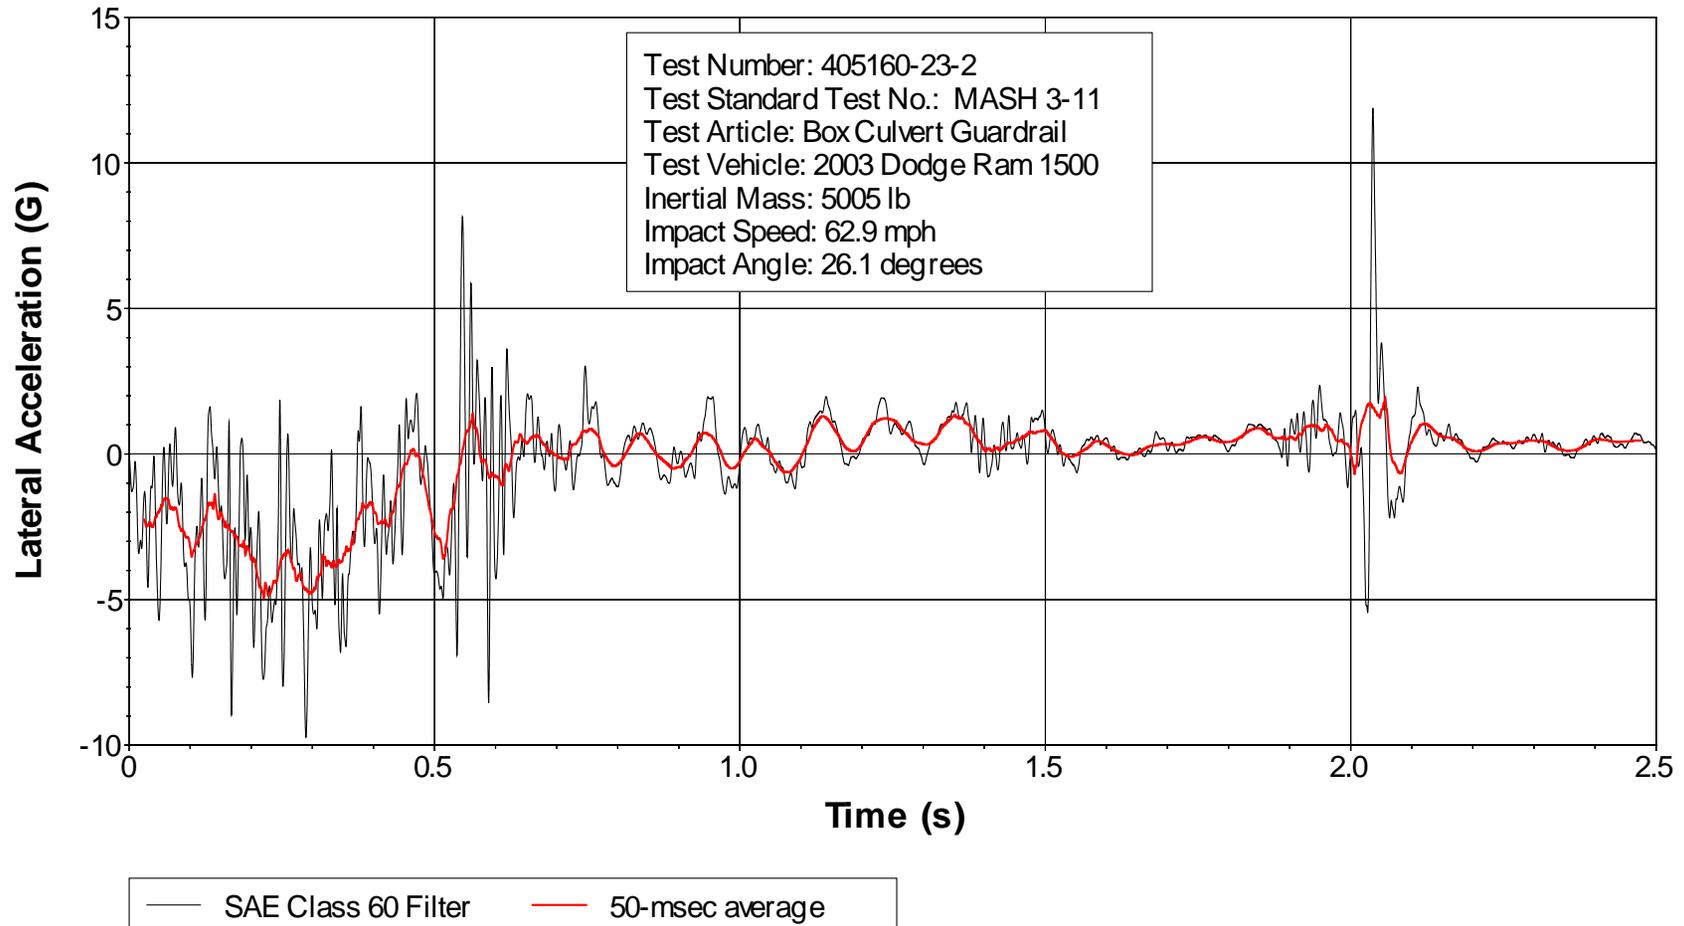
Figure D7. Vehicle lateral accelerometer trace for test 405160-23-2 (accelerometer located over rear axle).

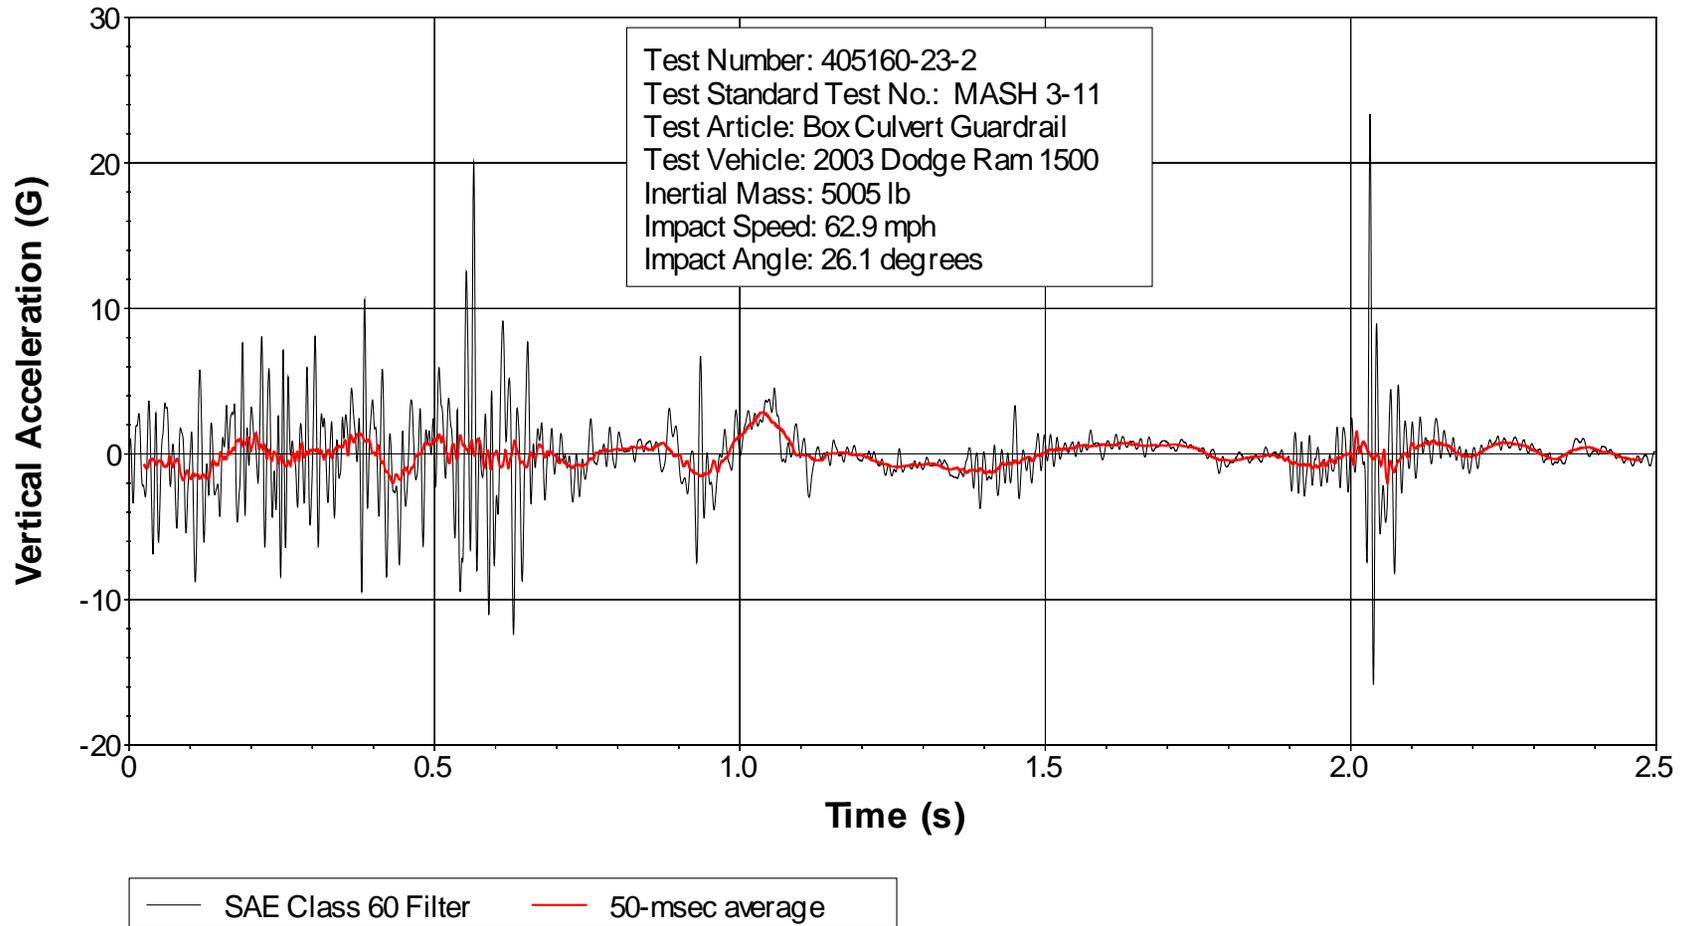
Figure D8. Vehicle vertical accelerometer trace for test 405160-23-2 (accelerometer located over rear axle).
